# **WETLAND MITIGATION EVALUATION REPORT FLORIDA KEYS BRIDGE REPLACEMENT**

**WETLAND MITIGATION EVALUATION REPORT**  
**FLORIDA KEYS BRIDGE REPLACEMENT**  
WPI No. 6116901; SP No. 90000-1560

March 30, 1994

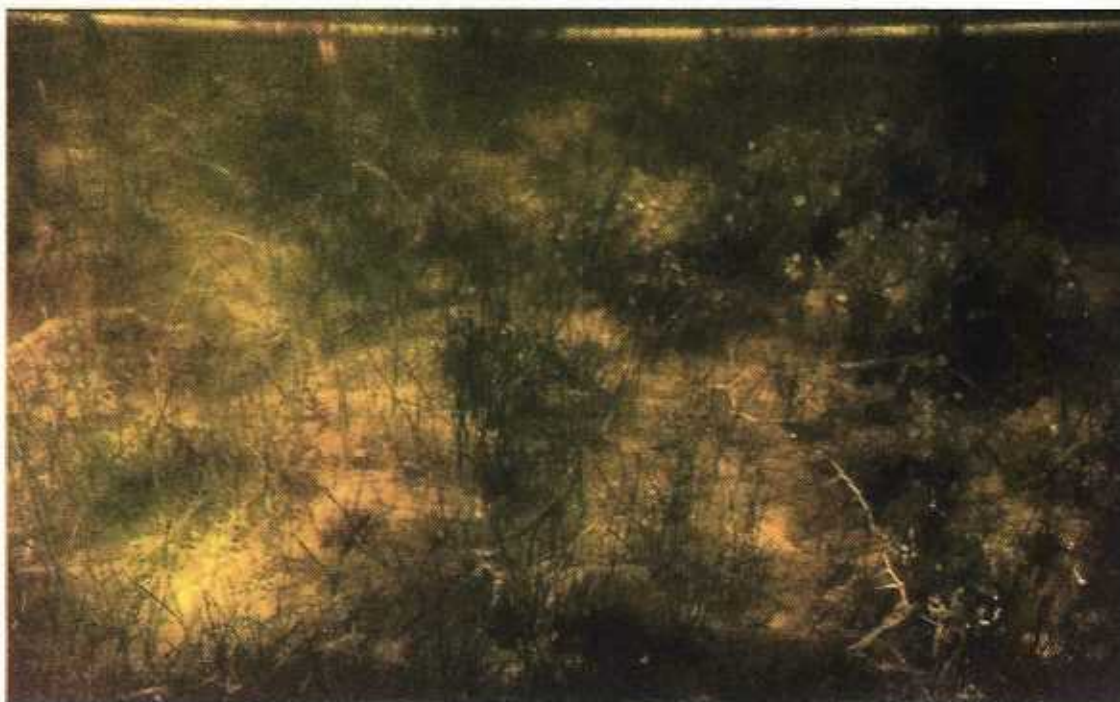
It is apparent from the data (Tables 6 and 7) and the associated photographs (Figures 37-39) that eleven years after restoration, the site is still vegetated with only approximately 40% turtle grass, similar to what was present prior to pipeline installation (15 of 38 stations; Figures 37 and 38). The rapid growth of planted *Halodule* observed by Derrenbacker and Lewis (1983) has stalled at an intermediate stage of succession and full recovery can be expected only after another ten years, and then probably only in the moderate to moderate and silty areas (Figure 35). It is also apparent that some continued disturbance of the area is occurring with seagrasses being "blown-out", probably by wave runners known to use the area (Figure 38A). The failure to completely restore the original level of sediment over the rocky substrate encountered during construction will probably limit the degree of final recovery in these areas of sparse to dense *Halodule* with sparse *Thalassia*, if present at all. This may mean that the area could be a candidate for backfilling with additional sediment and seagrass from impacts associated with the widening of U.S. Highway 1 in the area where approximately 10 acres of *Thalassia* are to be destroyed by excavation or filling.

Figure 37B. Lake Surprise, transect 1, 10-11 m from shore, November 1993.

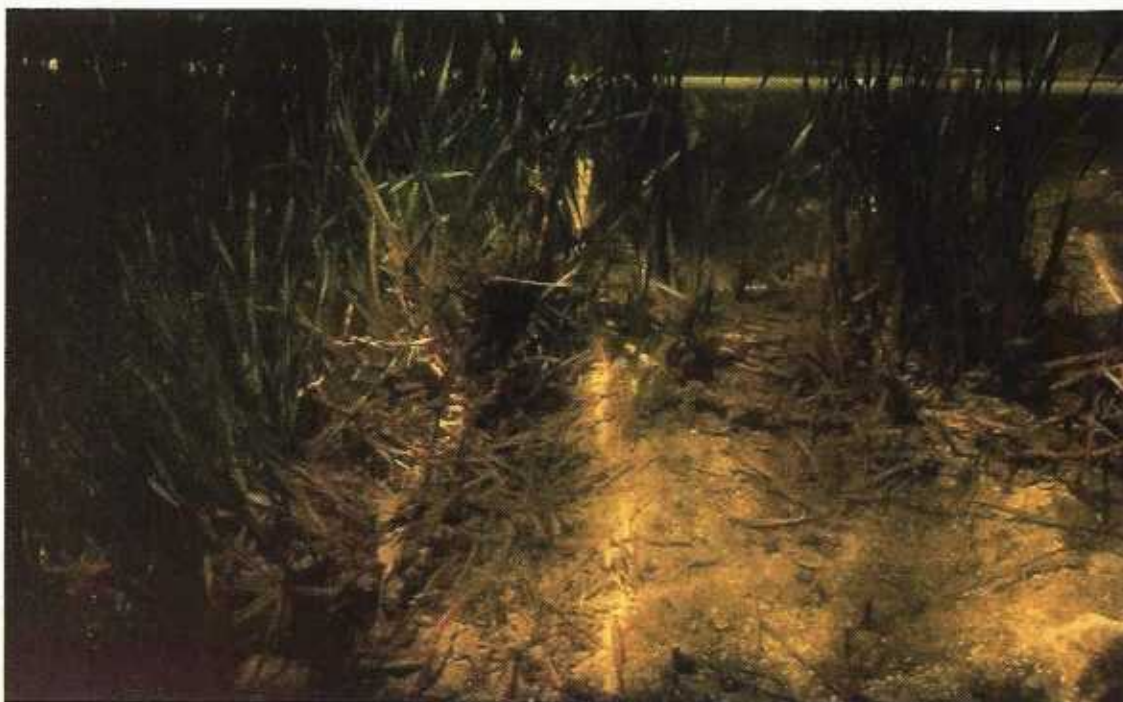
Figure 38A. Lake Surprise, transect 2, 3-4 m from shore, November 1993.

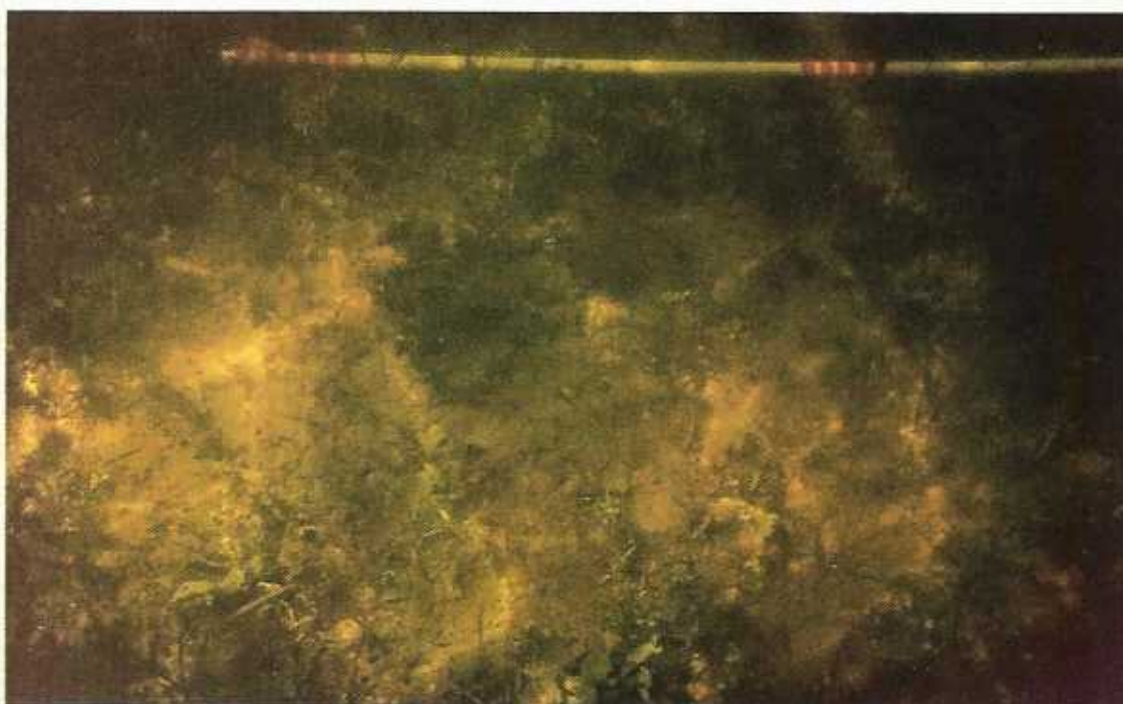
Figure 38B. Lake Surprise, transect 2, 11-12 m from shore, November 1993.

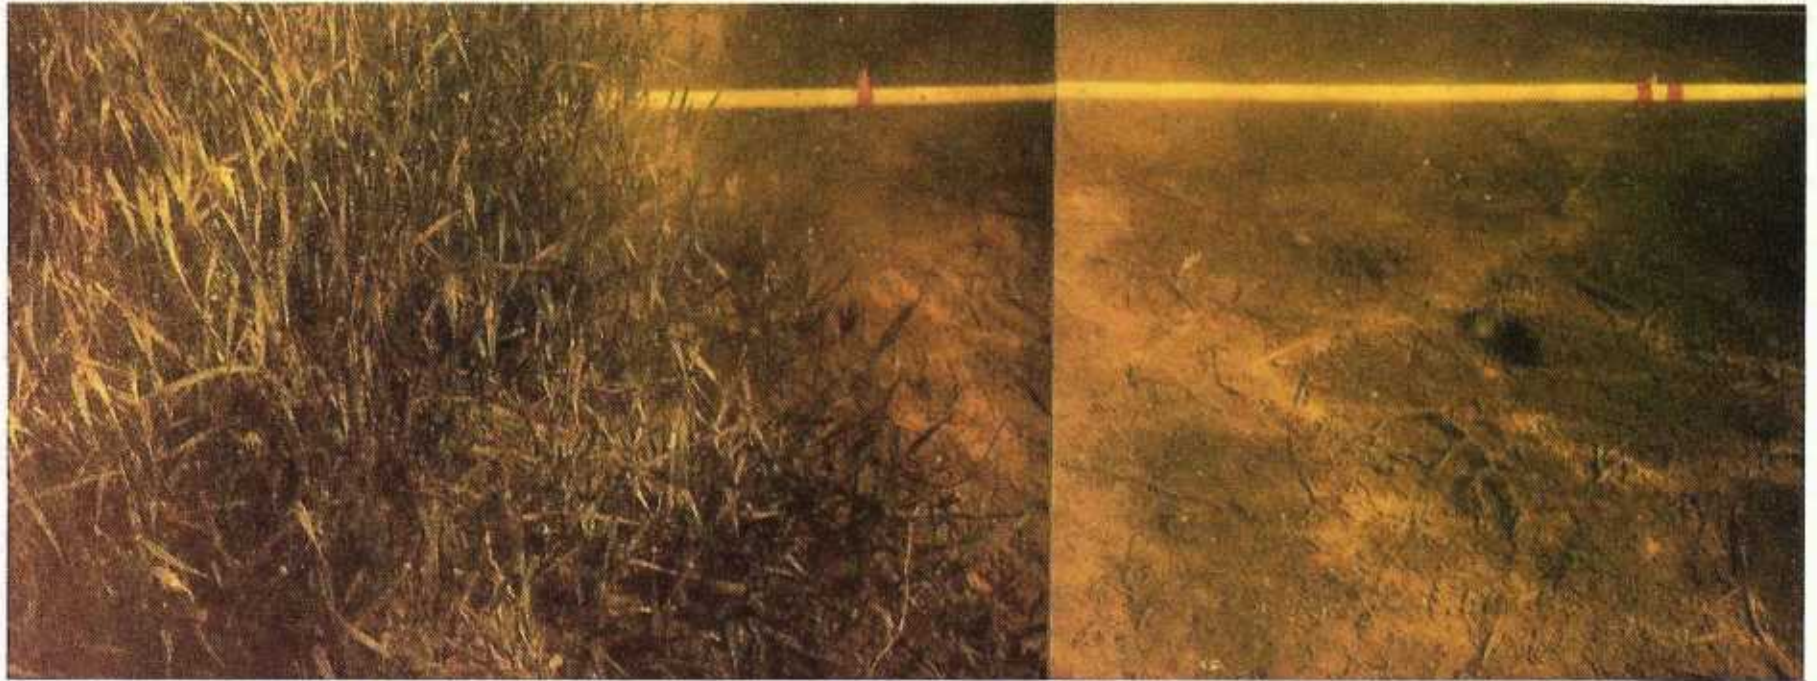
Figure 39. Composite underwater photographs of the Lake Surprise seagrass restoration area, transect 3, 7-9 m from shore, November 1993.

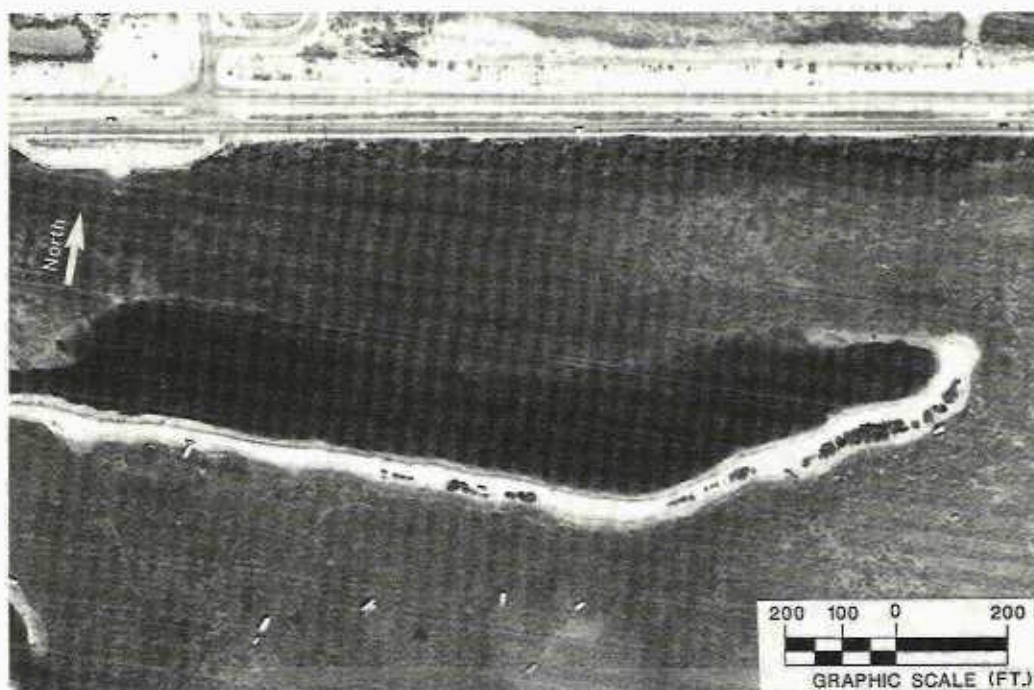
Figures 40 and 41 show the Boog Powell Marina planting area in 1981 before spit removal and in 1991, eight years after planting. The entire spit, except for a small portion with only a rock substrate, is now predominantly *Syringodium* with lesser amounts of *Halodule*.

Figure 40. Vertical aerial photograph of a filled spit near Boog Powell Marina, February 25, 1981.

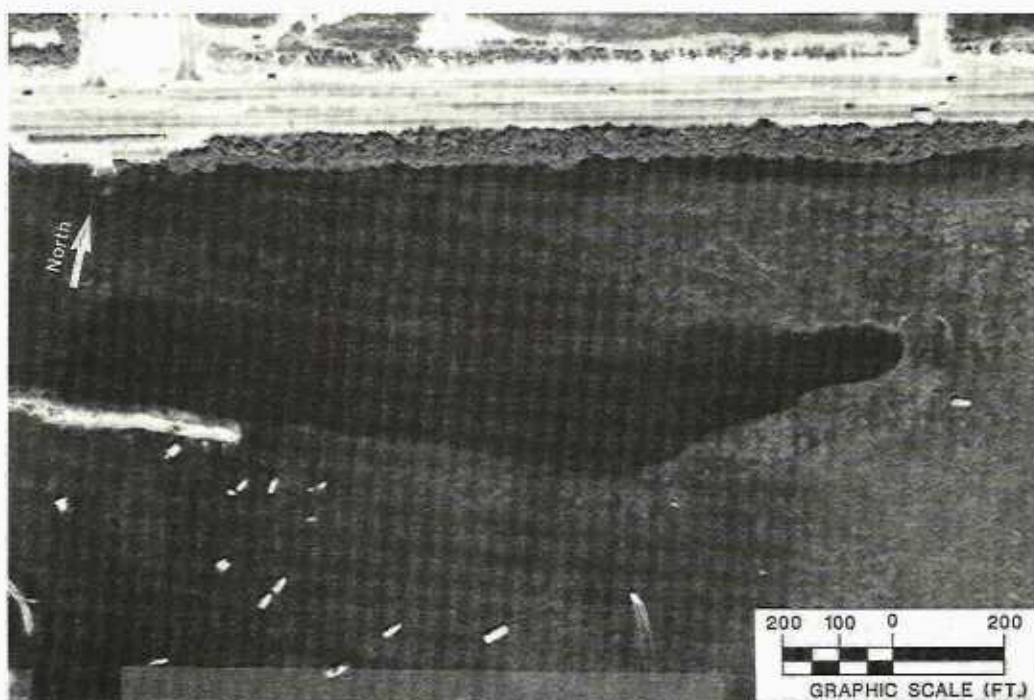
Figure 41. Vertical aerial photograph of the same area after removal of the spit and several planting efforts. Photographed February 17, 1991.

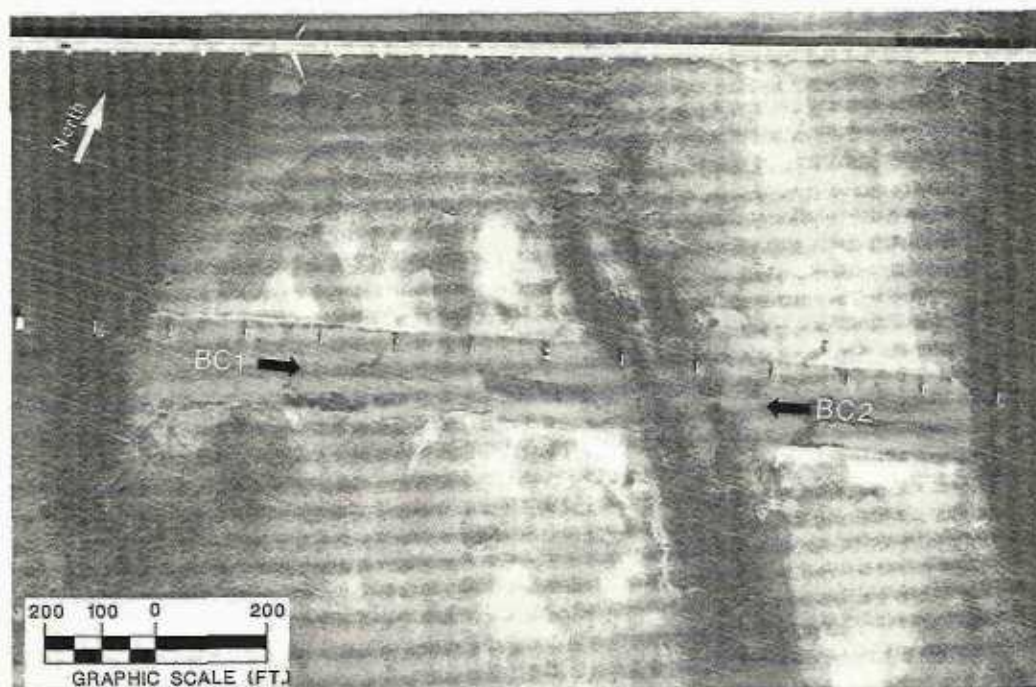
Approximately 10% of the site is vegetated with a mixture of *Thalassia* and *Halodule*. Figures 43 and 44 show a comparison of the site in 1981 and 1991. The recovery areas are primarily at RC1 and RC2.

Figure 43. Vertical aerial photograph taken February 25, 1981, showing the Pigeon Key Banks (PKB) east of Pigeon Key. The old 7-Mile Bridge is shown at the top. The alignment of the new bridge is indicated by the excavated barge access channel (BC1-BC2) and the installed pilings. Sites D and E (Figure 42) are shown here.

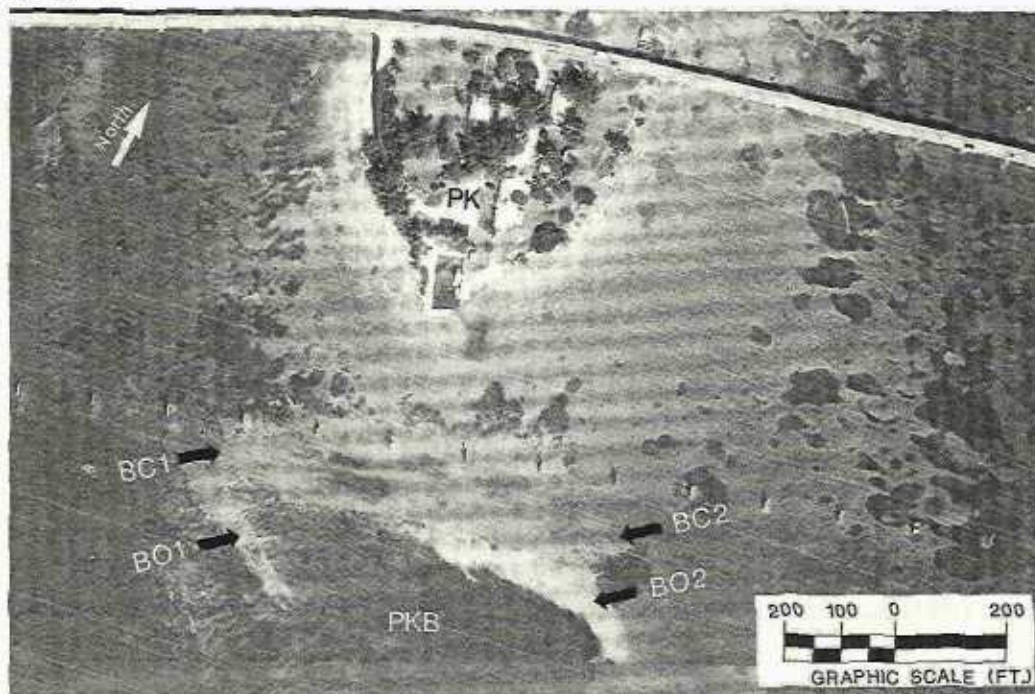
Figure 45. Vertical aerial photograph taken February 25, 1981, showing Pigeon Key (PK) and the adjacent new alignment for the 7-Mile Bridge. Pilings can be seen installed in the new alignment and in the excavated barge access canal (BC1-BC2) across the shallow Pigeon Key Banks (PKB). Two blowouts of sand are spread over the adjacent turtle grass meadow (BO1 and BO2). The old 7-Mile Bridge is at the top of the photograph. Site F (Figure 42) is shown here.

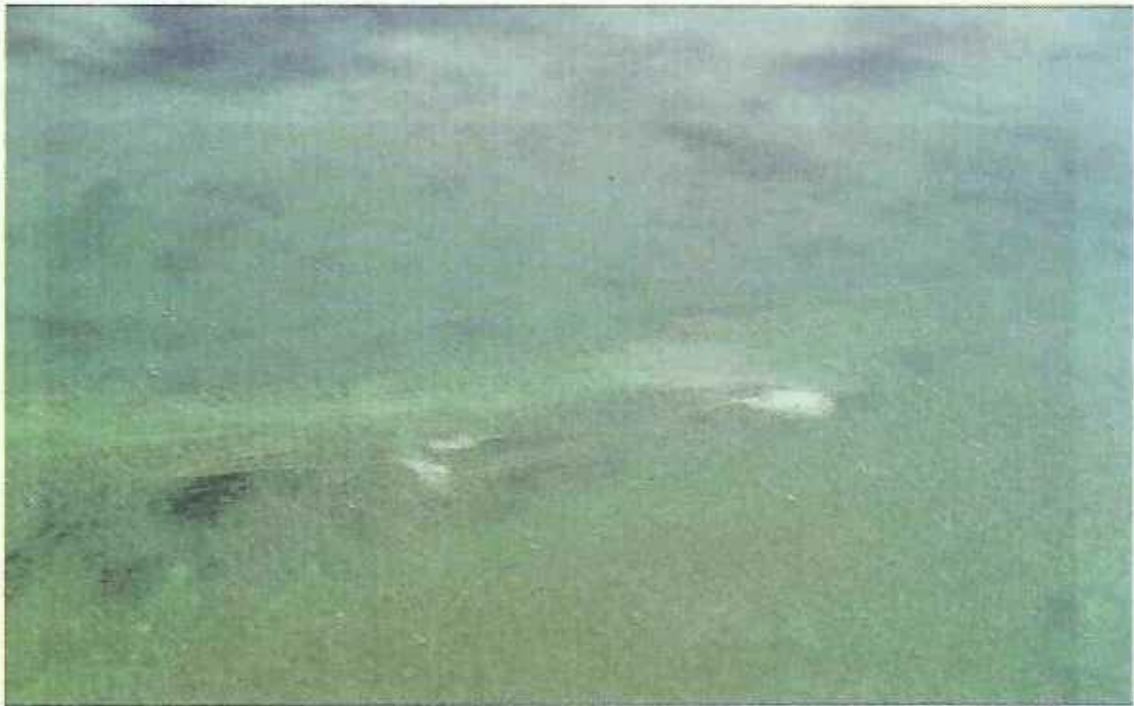
Five additional sites totaling 41.05 acres of prop damage were examined from the air and on the water. All but one showed essentially 100% recovery from the historic damage. The one site with only partial recovery is the Niles Channel site where 23.22 acres of the total 27.53 acres of damage have naturally revegetated, although substrate discontinuities still exist. Most of this is in the area of Site 2 which was composed of numerous individual prop scars extending for several miles north of Site 1, the major area of concentrated damage (Figure 49). Figure 50 shows Site 1 in 1993 and the central prop-scarred channel across the shallow bank is still quite visible.

Figure 49. Niles Channel Site 1, 1983.

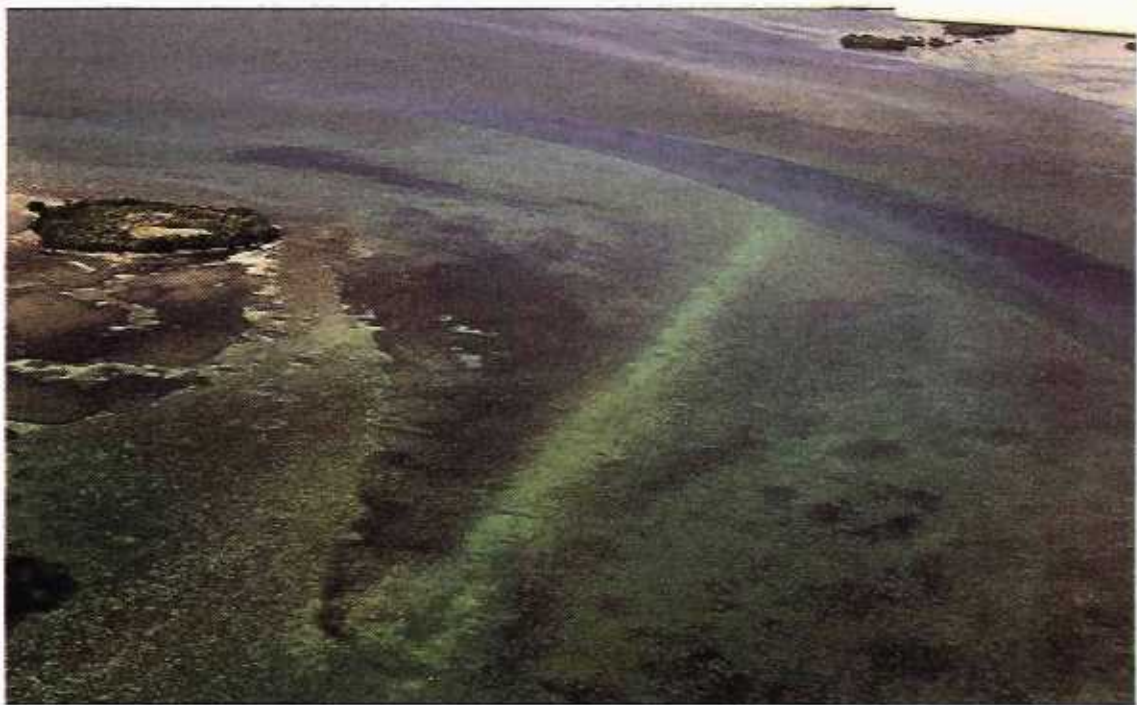
Figure 50. Niles Channel Site 1, 1993.

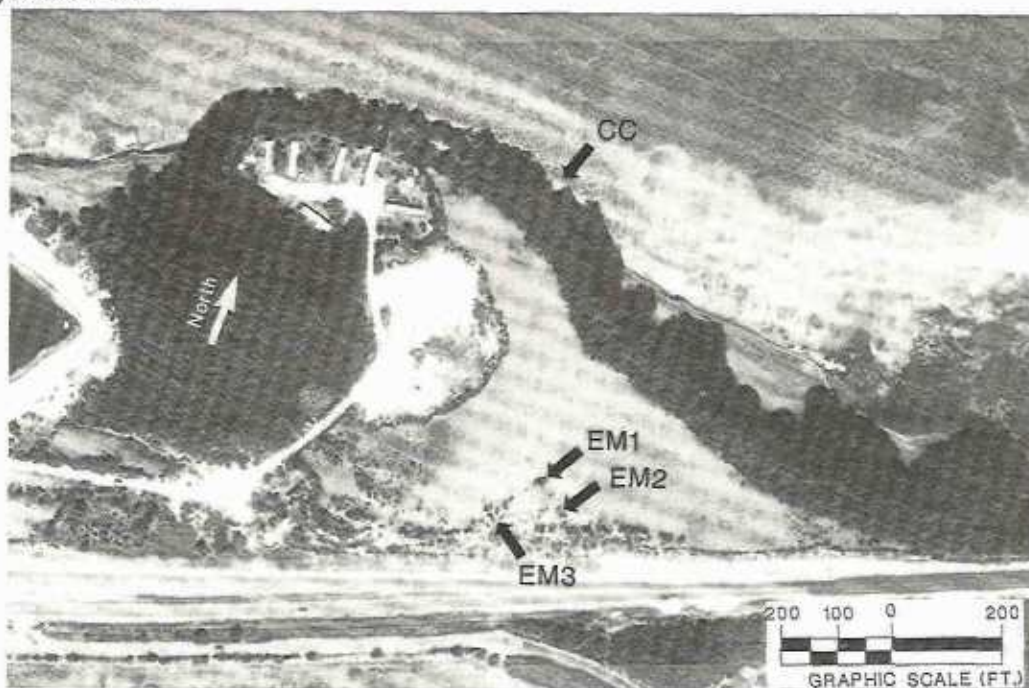
The study site is a small (6.6 acre) shallow, bay-side lagoon at the western end of Bahia Honda Key. It is bordered on the south by U.S. 1, on the west by a former Monroe County landfill, and to the north by a mangrove ridge (Figures 51-52). Limited tidal exchange occasionally occurred during high spring tides through a partially occluded existing culvert in the northwest corner of the lagoon. Storm surges generated by northerly winds sometimes breached the mangrove ridge in areas of lower elevation, but exchange was minimal. No tidal exchange was ever observed through a second existing culvert in the lagoon's southwestern corner.

Figure 51. Vertical aerial photograph of Bahia Honda Lagoon taken February 25, 1981. CC indicates the location of the circulation cut to be made. EM1, EM2 and EM3 indicate existing clumps of mangroves (also located for reference below).

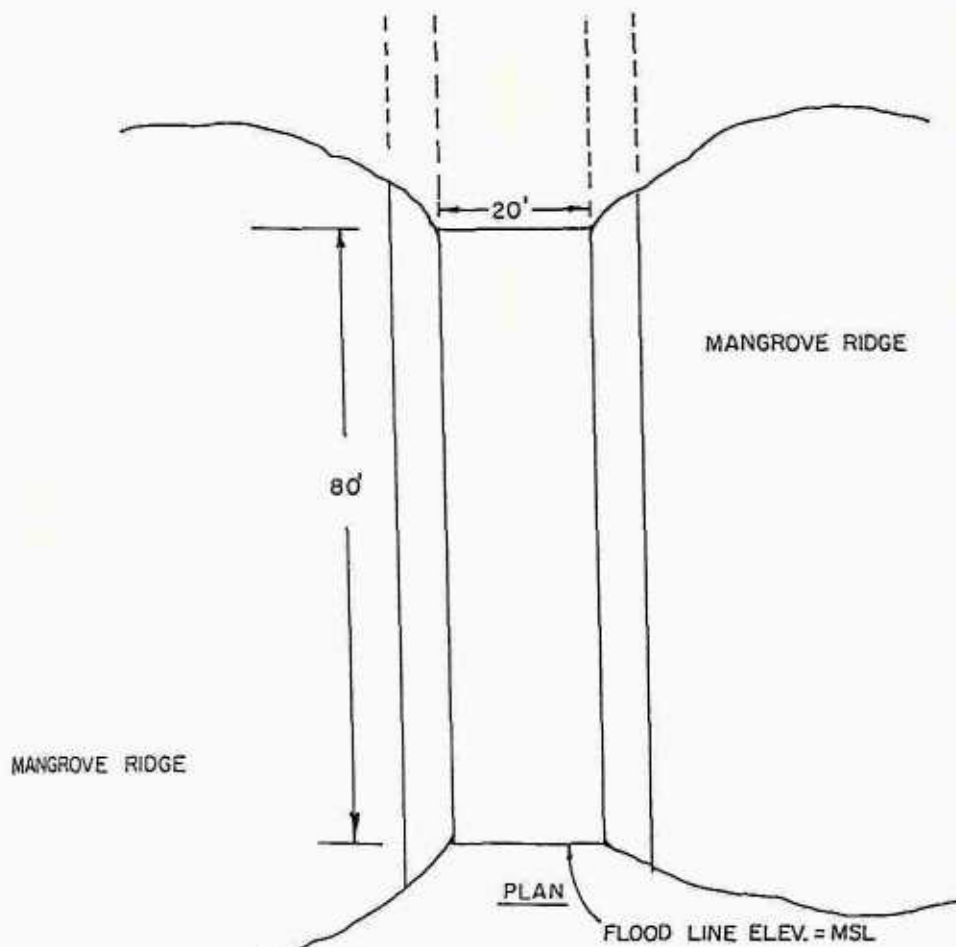
Figure 53.

For this study, several site visits were made, including one in July 1993. Figures 56 and 57 show the excavated opening in 1981 and twelve years later. Field measurements compared to Figure 53 indicate that the opening has remained remarkable stable, losing less than 20% of its area in twelve years. Figures 58 and 59 show the significant colonization by and rapid growth (to 3 m tall) of volunteer red mangroves which did not occur inside the lagoon prior to opening (see also Figures 60-61). Numerous fish and wildlife species were observed within the lagoon including reddish egrets, roseate

**Construction Drawing of Swale at Bahia Honda**

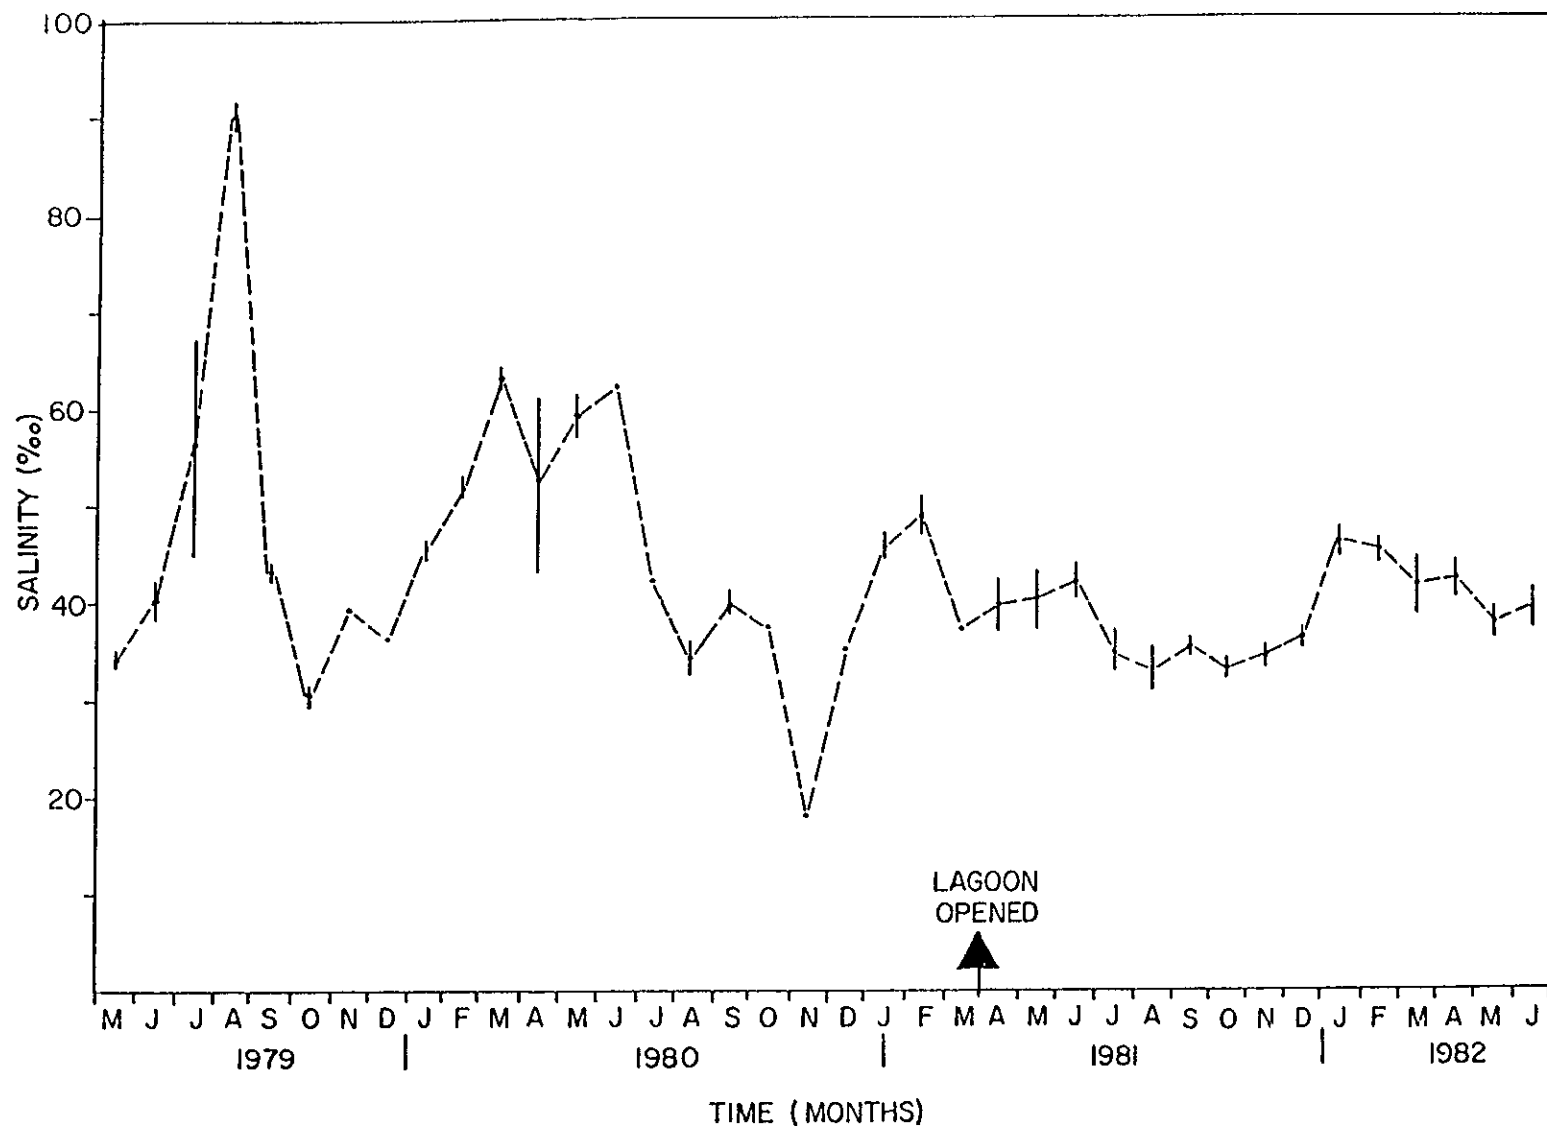
Figure 54.

2. While water temperature, pH and dissolved oxygen showed little change after opening, salinity moderated significantly (Figure 54), eliminating hypersaline conditions that routinely stressed the lagoon's plants and animals.

**Temporal Variations in Salinity at Station BH-15**

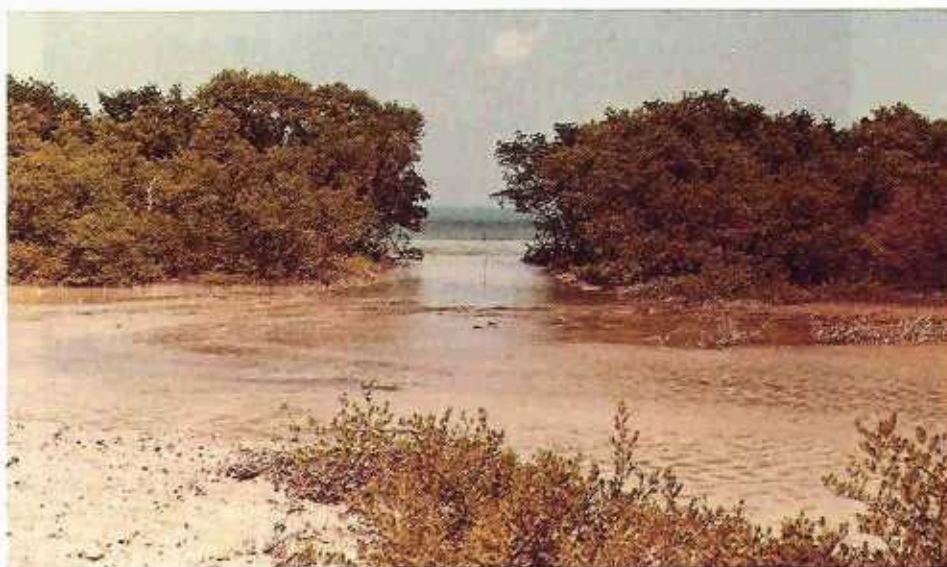
Figure 56. Bahia Honda Lagoon, circulation cut, 4/81.

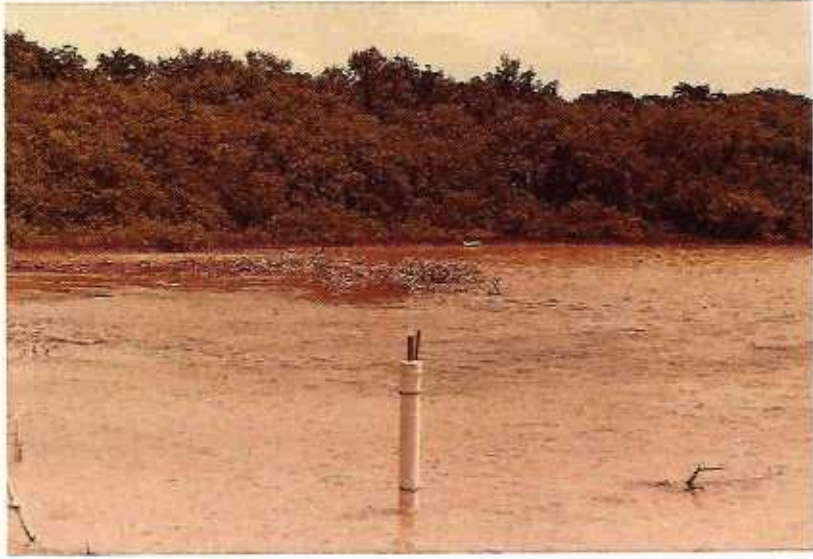
Figure 58. Bahia Honda Lagoon, no red mangroves on inside, 4/81.

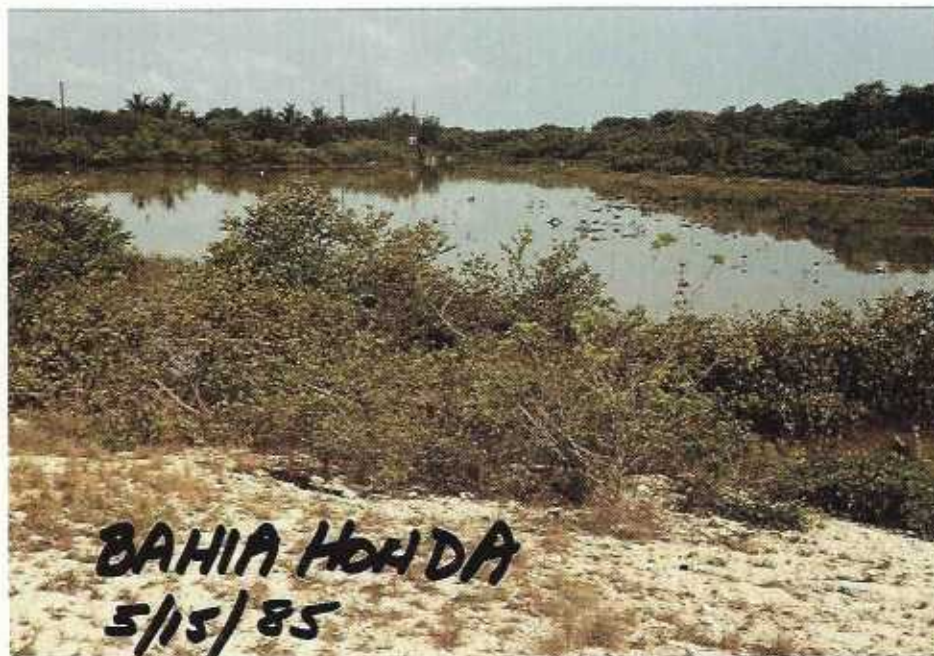
Figure 60. Bahia Honda Lagoon, view from U.S. 1, 5/85.

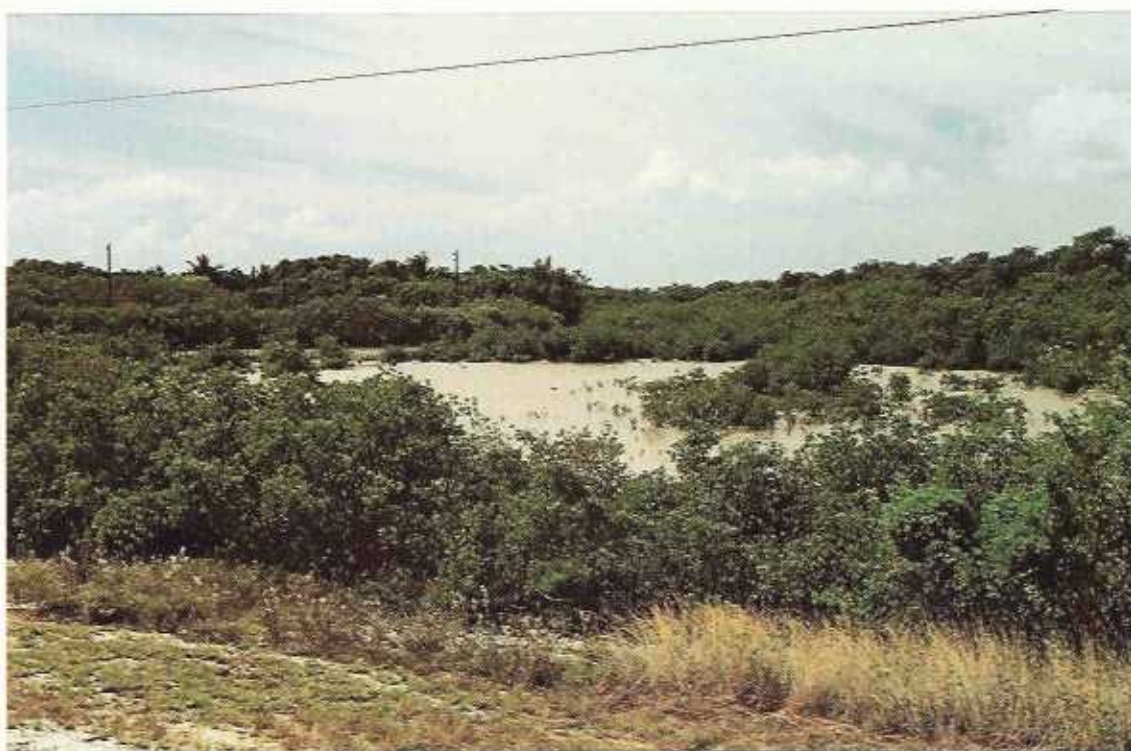
Figure 61. Bahia Honda Lagoon, view from U.S. 1, 7/93.

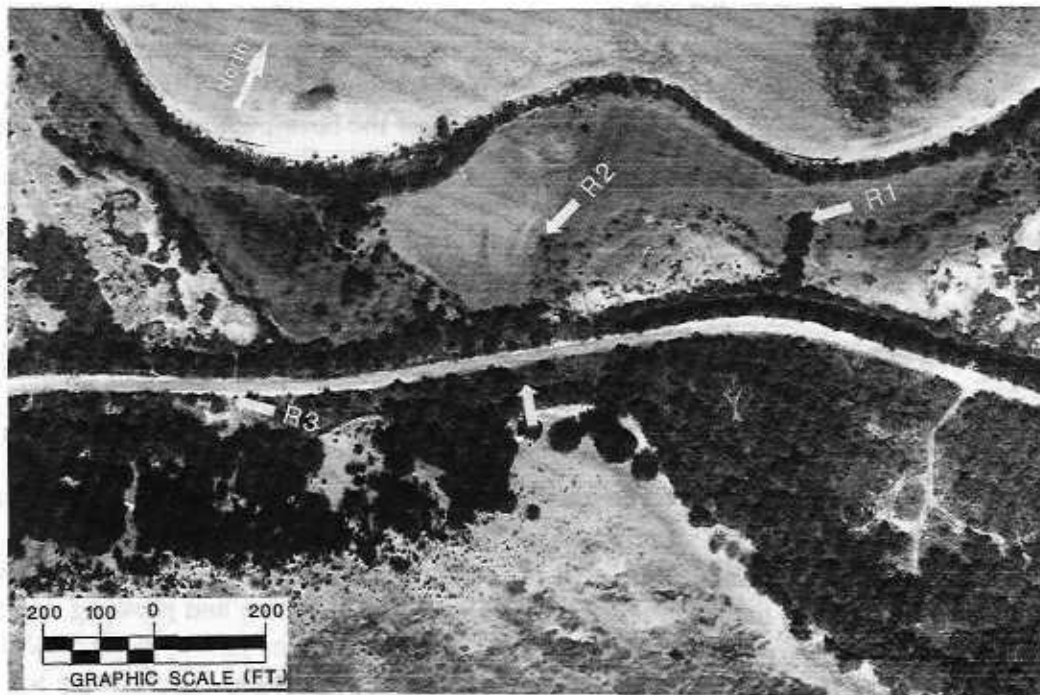
This culvert site, the easternmost of the three FDOT Boca Chica culverts (Figures 64-65), was inspected on July 19 (high water), and September 18 and September 20 (low water), 1993. The culverts connect a relatively small, shallow (+0.5' to -1.0' MSL) pond to the Atlantic. Separating this pond from the large lagoon to the north is a natural, low, storm-generated sand and shell berm that forms the south edge of the lagoon. This berm (about 80 m from the culvert) achieves only about +3' MSL elevation and 15-25' width but is large enough to form a barrier between the pond flushed by the culvert and the lagoon. Berm vegetation includes buttonwood, bay cedar, black mangroves, saltgrass, sea ox-eye, glasswort, and scattered red mangroves. Tidal flow from the culvert moves east and west on the south side of this berm, apparently overtopping the berm only in a few locations and only during the very highest tides.

Figure 64. Vertical aerial photograph taken February 25, 1981, of the proposed location (at arrow) of culvert C2 into Boca Chica Lagoon. Reference locations are marked R1, R2 and R3.

It is recommended that consideration be given to excavating or blasting two breaks in the berm a minimum of 5 m wide to the depth of the natural rock (about -0.5' MSL). The two locations recommended are approximately due north of the culvert and about 80 m to the east of this site. Also, because of the encroachment of red mangrove on the ocean side, root and possible tree removal out from the culvert should occur at the same time of excavation of the berm cuts in order to maximize tidal currents that may serve to maintain these openings.

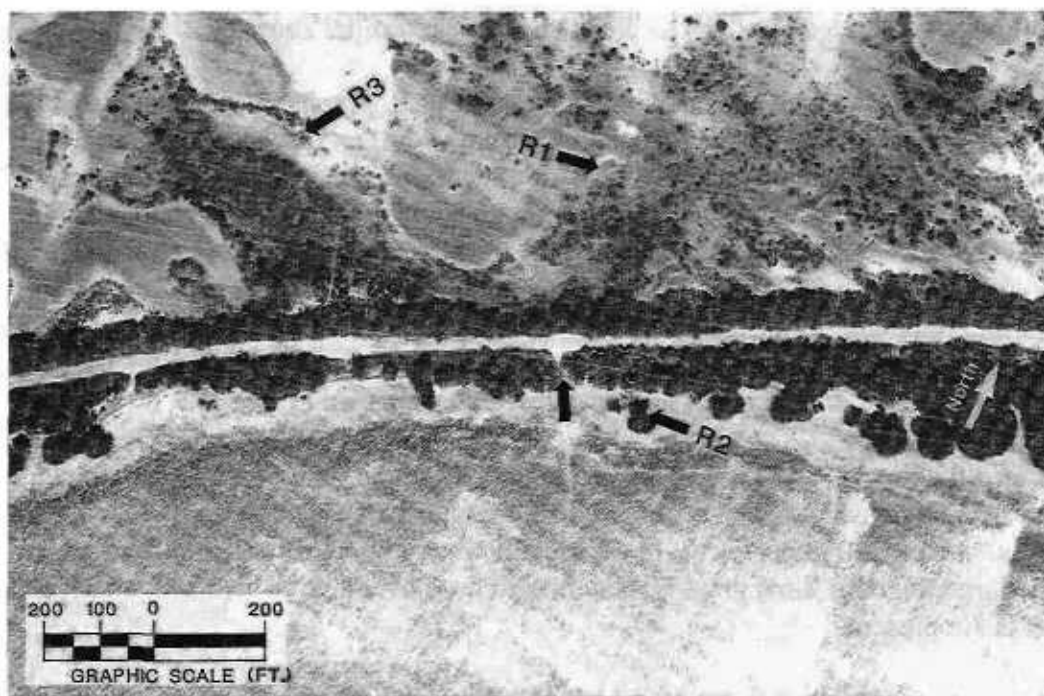
The central of the three culverts placed by FDOT provides tidal flushing to the southeast corner of the westernmost large lagoon of Boca Chica (Figures 66-67). What was once a shallow, open pond immediately north of the culvert site now has the appearance of a tidal creek (-1.5' to +0.5' MSL) with red mangroves encroaching into the "pond", framing the creek sides. During low water periods, flow-ways north of the culvert are limited to two small tidal creeks through the mud and seagrass flats that extend to the northwest.

Figure 66. Vertical aerial photograph taken February 25, 1981, of the proposed location (at arrow) of culvert C3 into Boca Chica Lagoon. Reference locations are marked R1, R2 and R3.

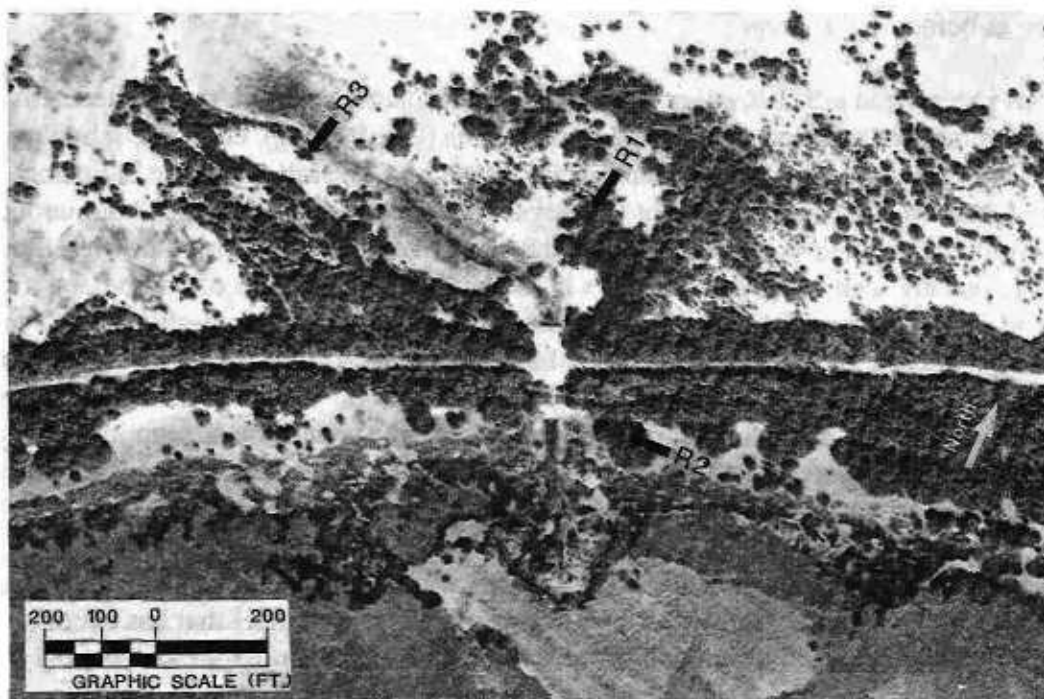
This site was inspected on May 25 (high water), and September 18 and 20 (lower water), 1993, and January 15, 1994 (low water). On September 20, during an oceanside low tide, the water appeared perched 0.5-1.0' to the north of the culvert, a result of water levels in the ocean dropping faster than water could drain from the interior. Late September and early October are high water periods in the Keys, as a result of high mean sea level and rainfall.

Figure 67. Vertical aerial photograph of the location of culvert C3 taken February 17, 1991. The same three reference points are marked as above.
