# **HYDROGEOLOGY OF MARION COUNTY, ORANGE LAKE SUBSURFACE, AND DYE TRACING**

**ORANGE CREEK BASIN INTERAGENCY WORKING GROUP  
HYDROGEOLOGY WORKSHOP 11/05/2015**

Jeffrey B. Davis, P.G  
St. Johns River Water Management District  
[jdavis@sjrwmd.com](mailto:jdavis@sjrwmd.com)

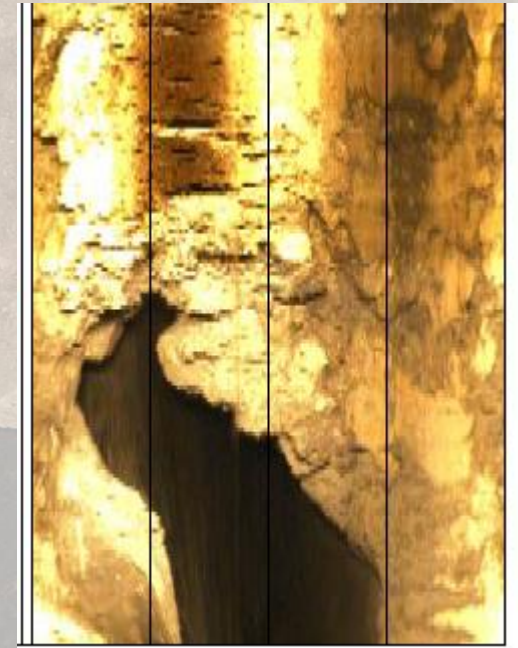
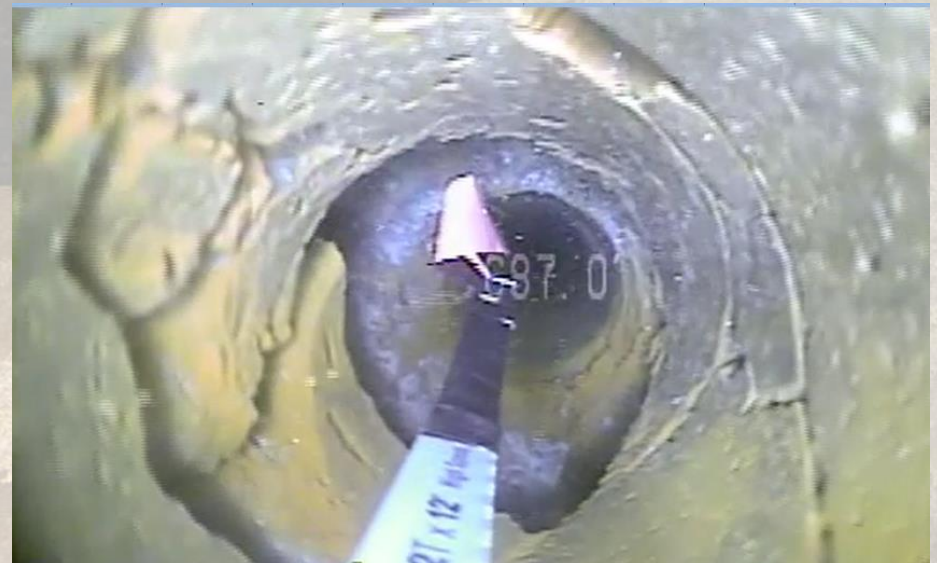
# SUBSURFACE EXPLORATION

GEOPHYSICAL LOGS  
RUN IN BOREHOLES  
TO SEE WHAT IS  
UNDERGROUND

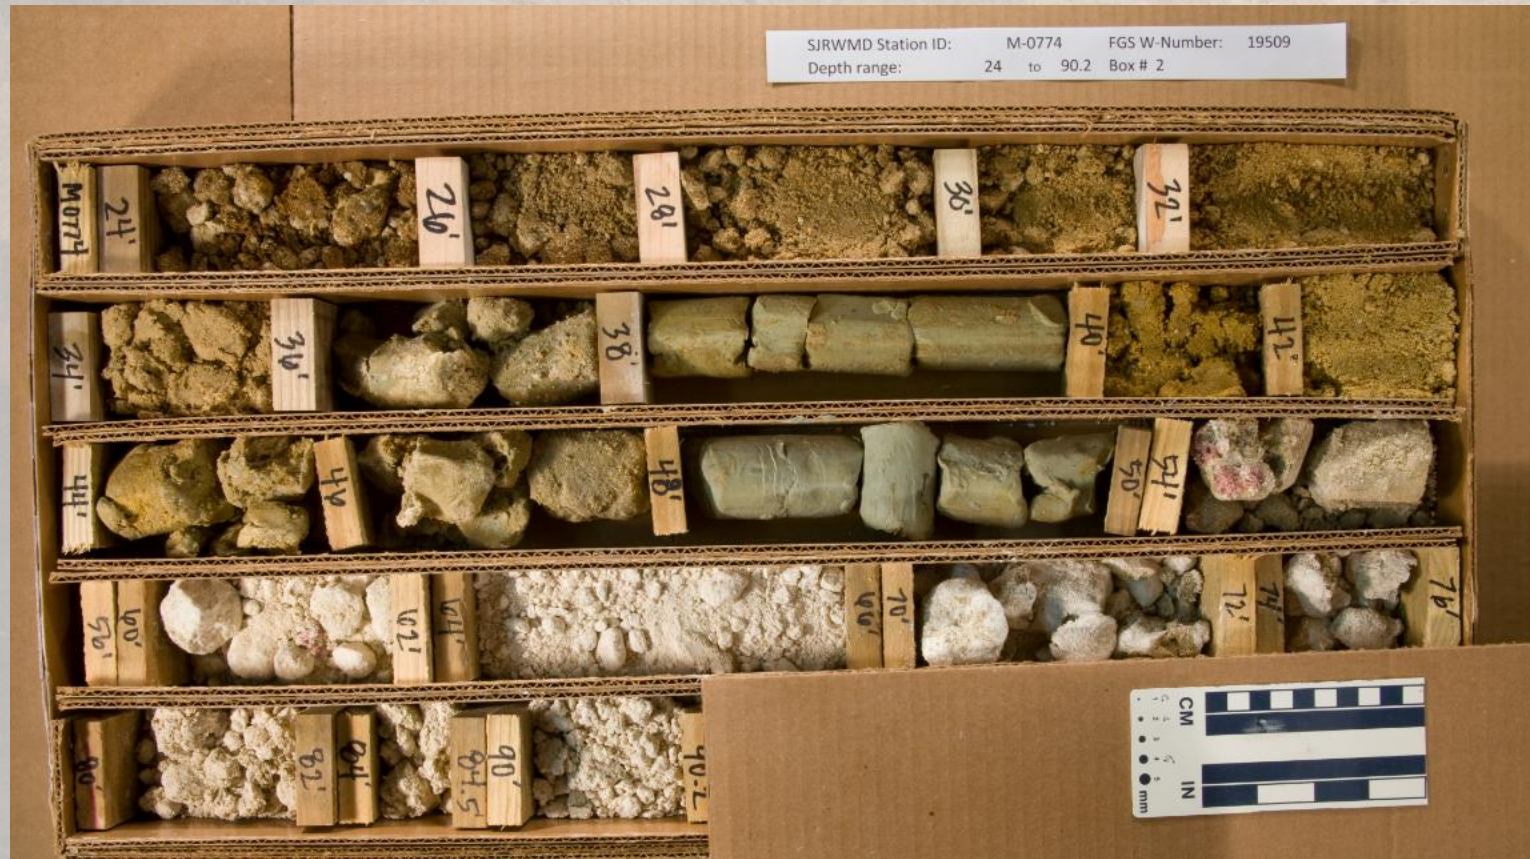
EXAMPLE WHERE NO ICU IS PRESENT. SOME CLAY ZONES IN THE SAS MAY PROVIDE SOME MINIMAL CONFINEMENT TO THE FLORIDAN.

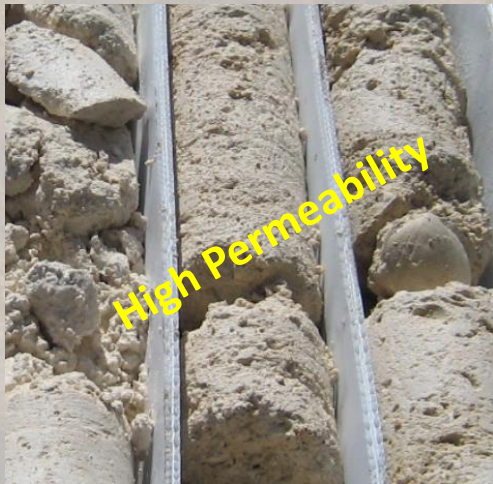
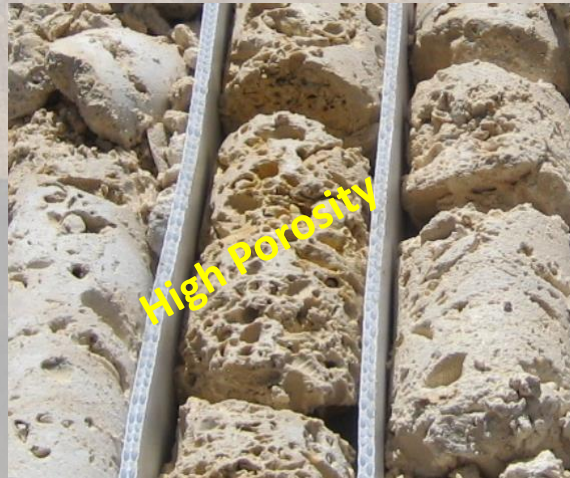
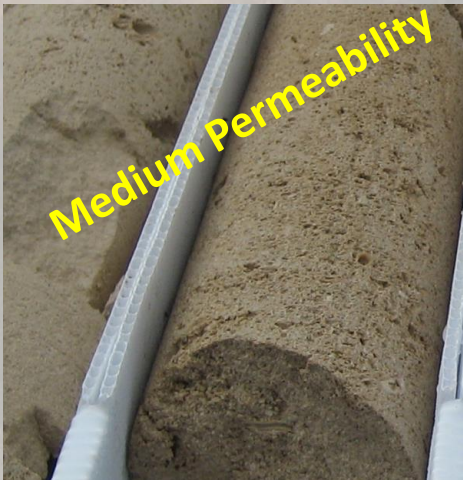
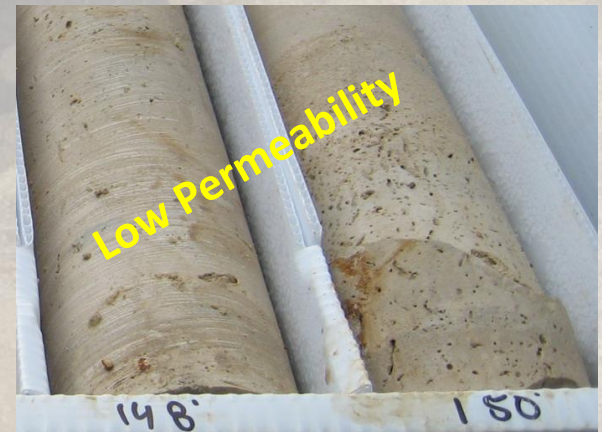
# UPPER FLORIDAN AQUIFER

HIGHLY VARIABLE BUT GENERALLY MORE PERMEABLE THAN UNDERLYING UNITS

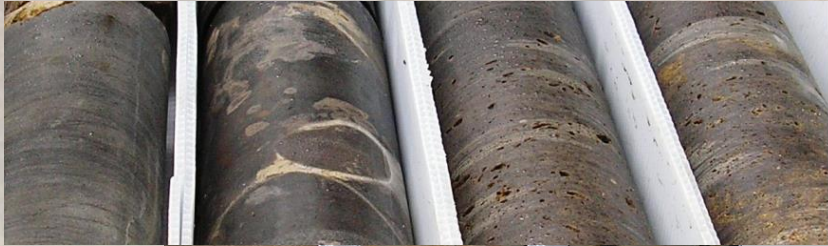
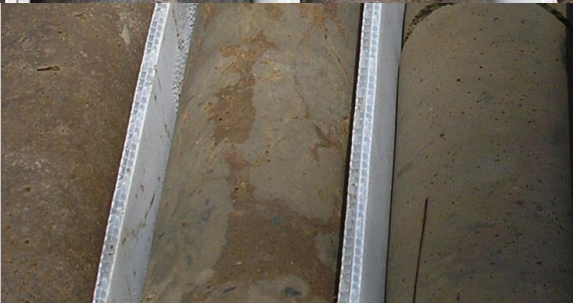
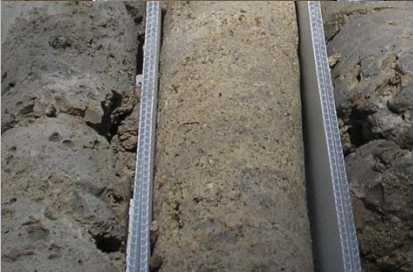
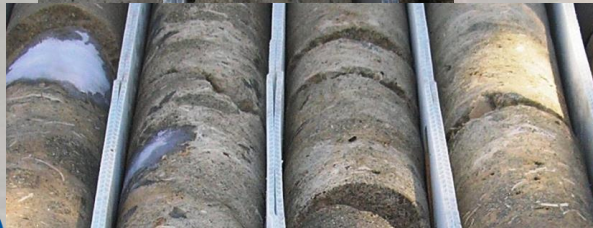
# MIDDLE CONFINING UNITS

EXTREMELY LOW VERTICAL  
CONDUCTIVITY ( $K_h$ )

LOW VERTICAL  
CONDUCTIVITY ( $K_h$ )

HIGH VERTICAL  
CONDUCTIVITY ( $K_h$ )

**MULTIPLE LAYERS,  
EACH WITH  
DIFFERENT  $K_h$   
BUT THE CUMULATIVE  
EFFECTS OF ALL LIMIT  
CONNECTION BETWEEN  
THE UPPER FLORIDAN  
AND  
LOWER FLORIDAN  
AQUIFERS**

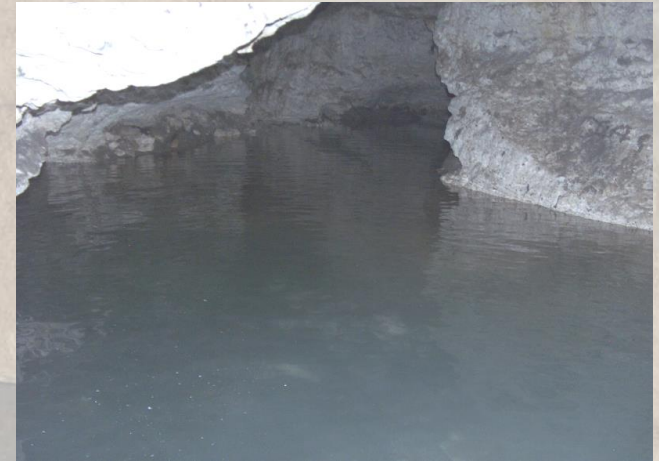
**NATURAL FEATURES SUCH  
AS CAVES MAY INDICATE  
A PREFERRED GROUNDWATER  
FLOW PATHWAY**

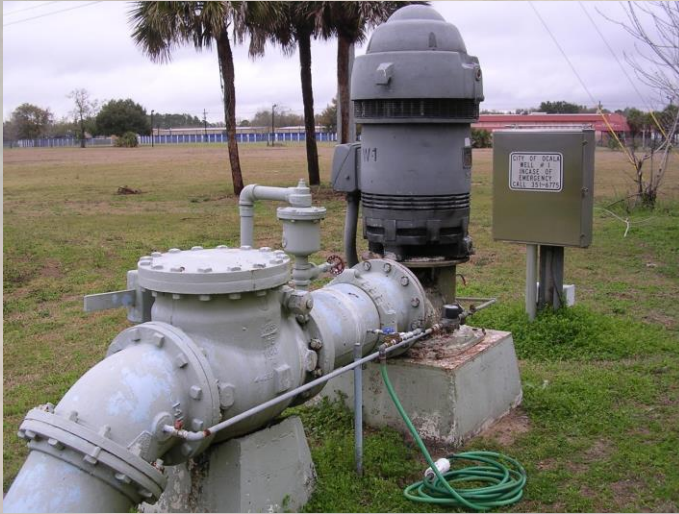
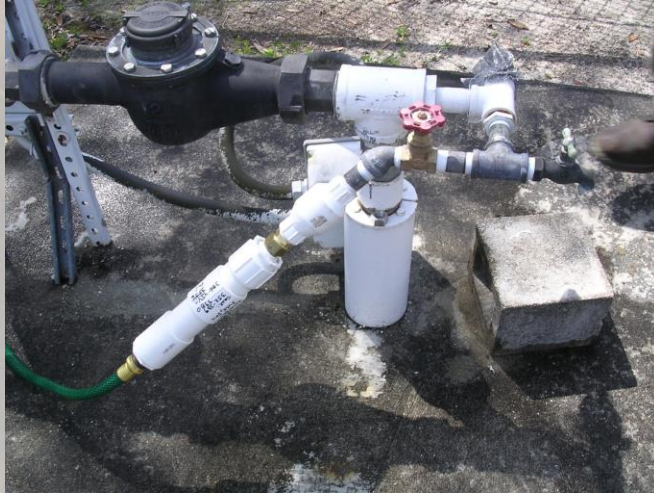
# WELL SAMPLING

- Avoid exposure to chlorination.
- Don't compromise water system or sanitation.
- Well sampling sites set up so when pump turned on, water trickled through the charcoal sampler.

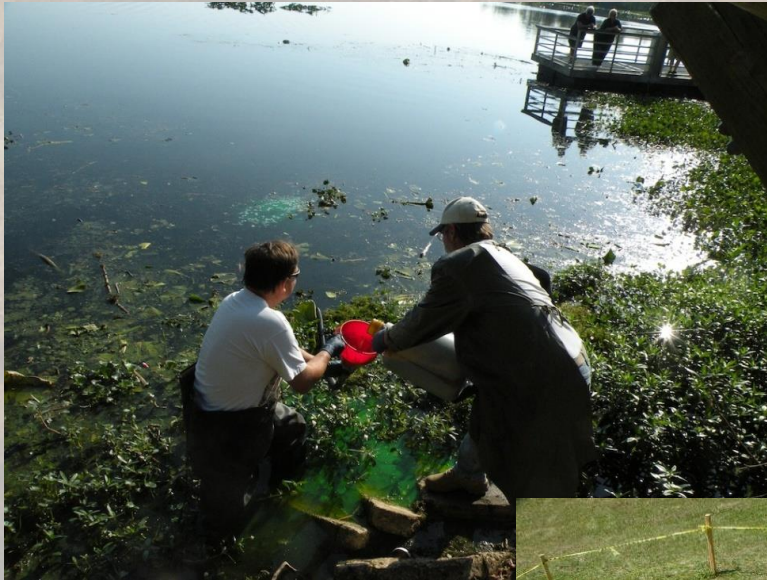
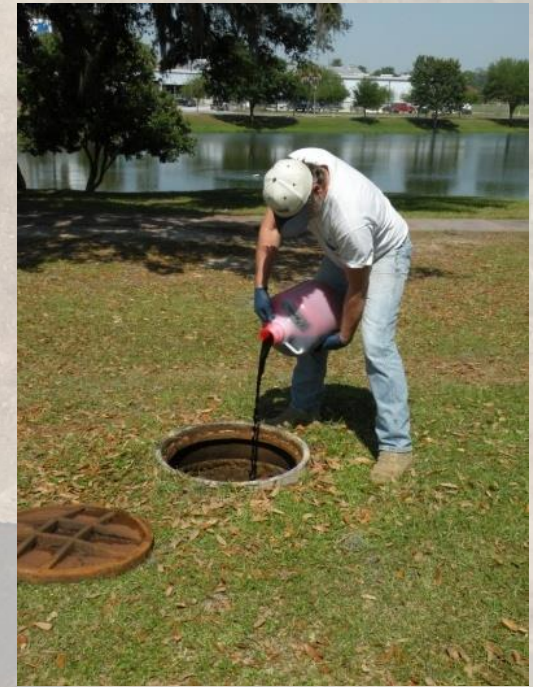
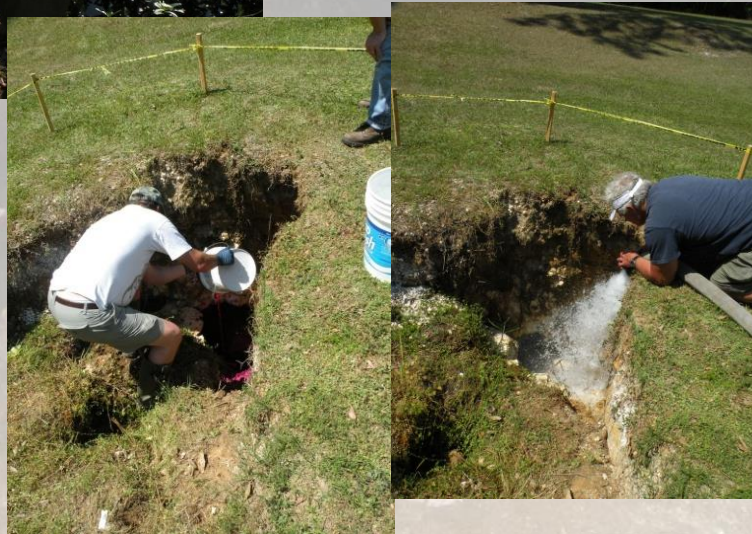
# DYE RELEASE; APRIL 23, 2010

SOMETIMES THE DYE  
NEEDS SOME HELP TO  
GET INTO THE SYSTEM.

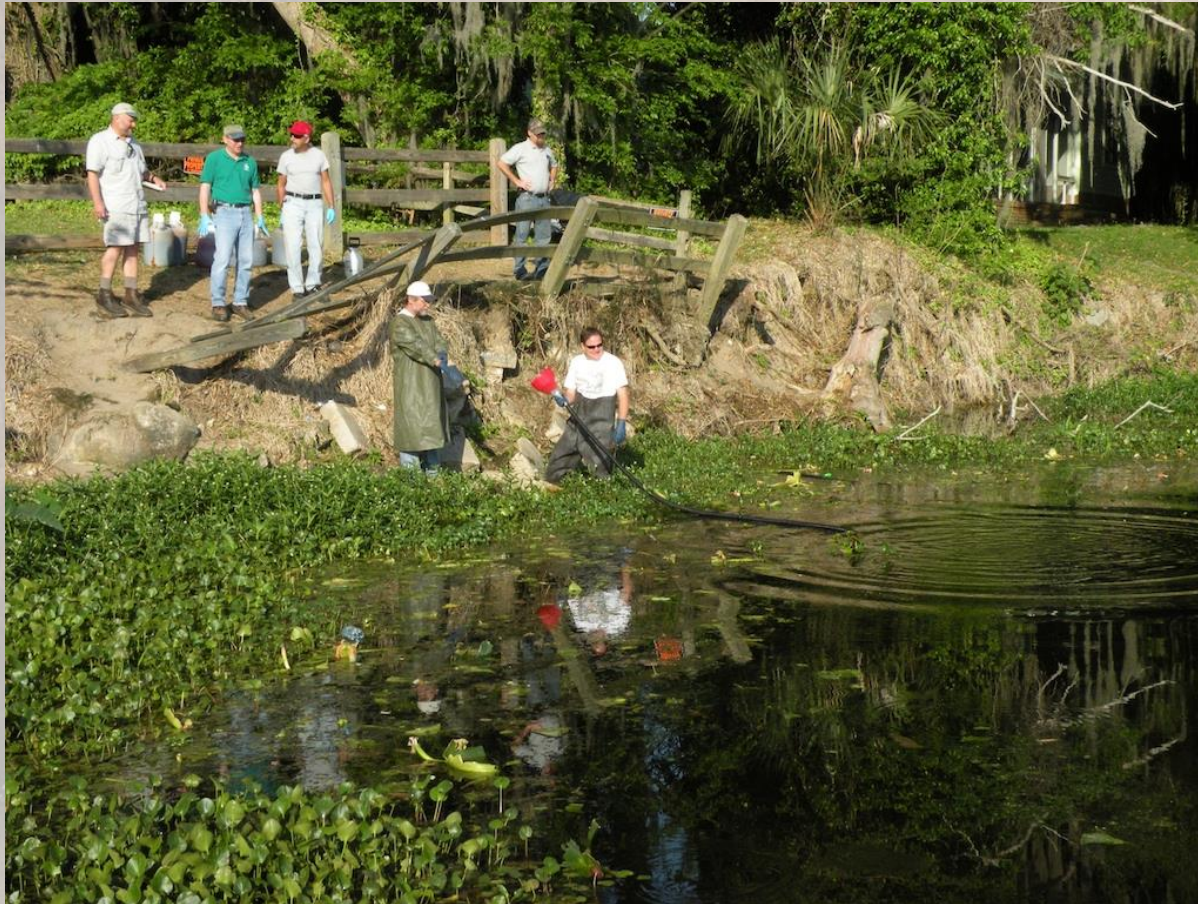
# ORANGE LAKE HEAGY-BURRY PARK DYE RELEASE

WATER IS ACTIVELY DRAINING INTO THE SINKHOLE IN ORANGE LAKE
