# **Well Construction at the Lake Marion Well Site in Levy County, Florida**

By Anna L. Janosik

January 2012

# **Southwest Florida Water Management District**

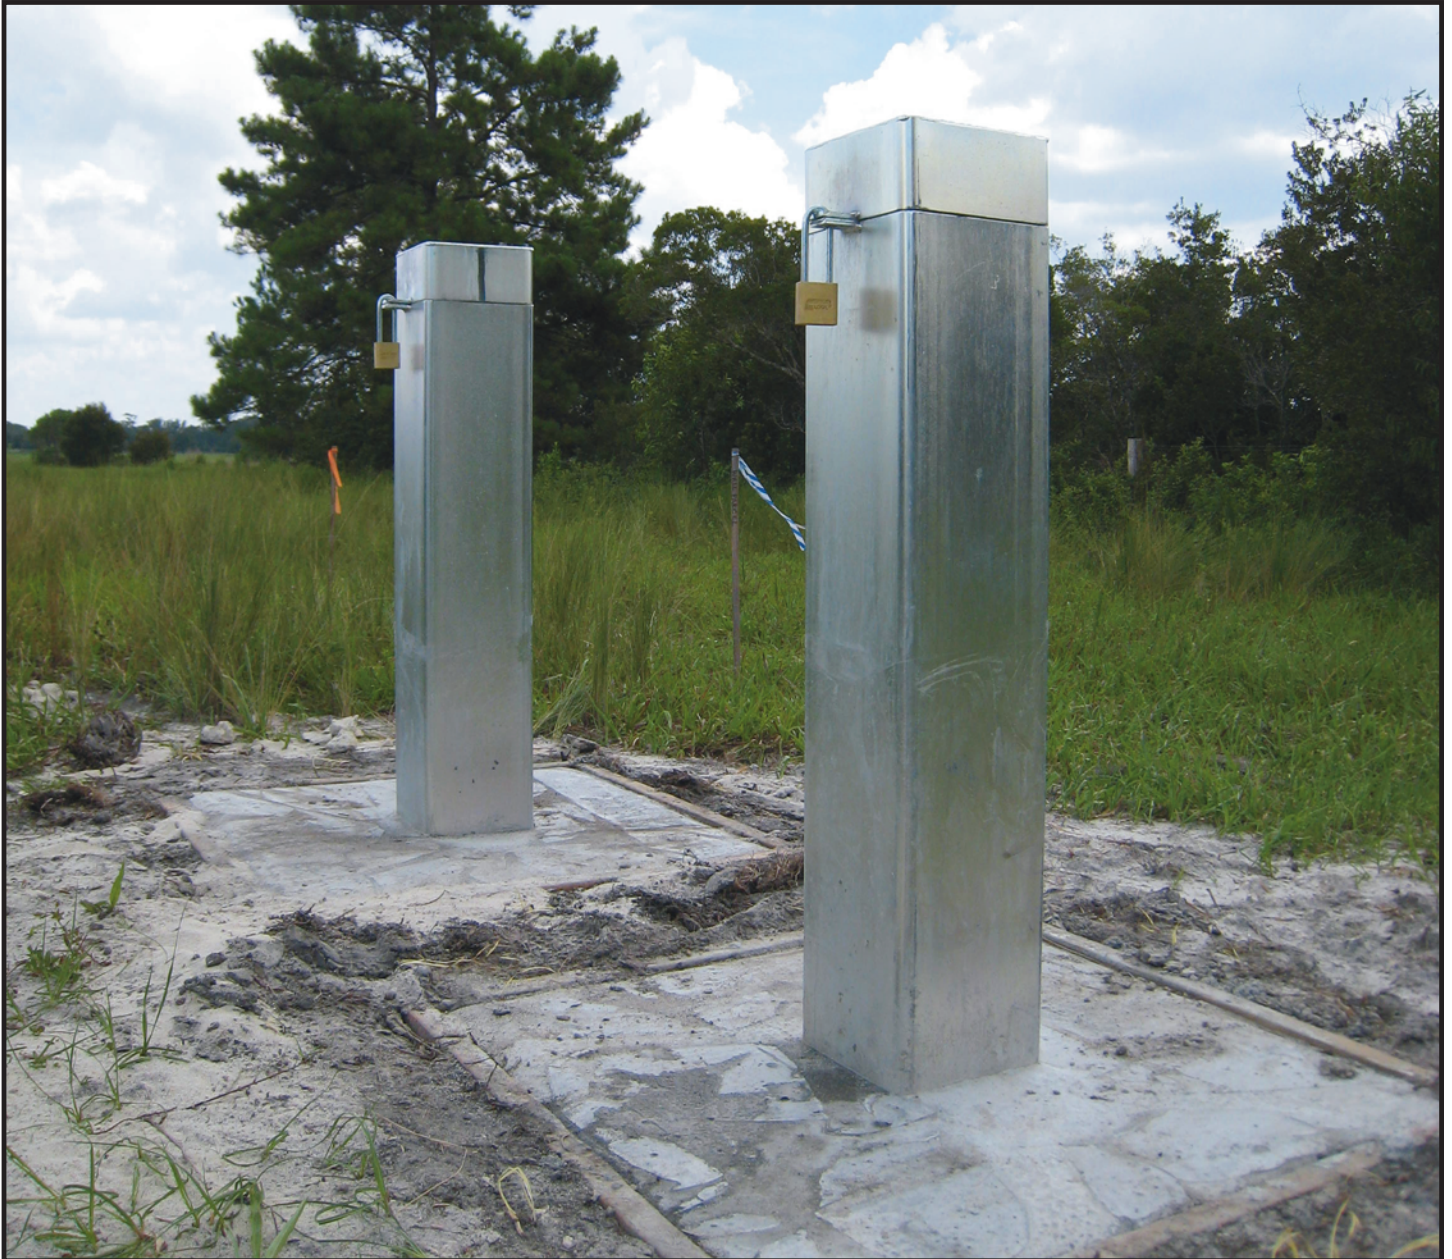
**Cover Photo:** Upper Floridan and surficial monitor wells at the Lake Marion well site in Levy County, Florida. Photograph by Anna Janosik.
