HAMMER RIG

AMS 9120 RAP

49354 LEVEL BOOK

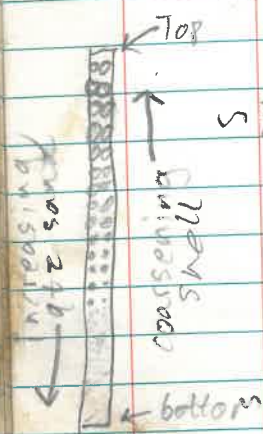
20'-24' Graded shell bed

w/ qtz sand &  
what appears to be  
~ 3% phosphate  
shell is cream to  
pink color
