INLET BEHAVIOR AND THE EFFECTS ON BEACH EROSION  
IN LEE COUNTY, FLORIDA

February 1991

Emmett R. Foster, P.E.

Florida Department of Natural Resources

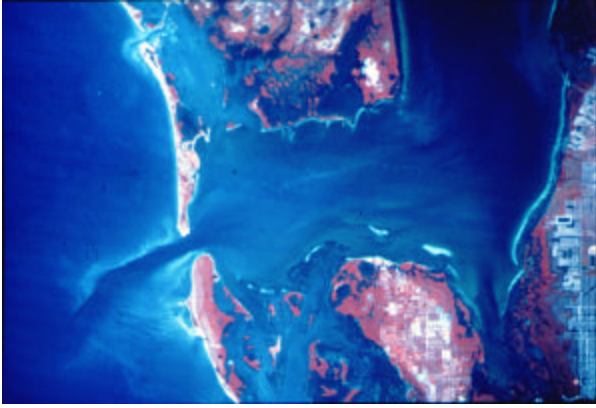
Figures 2A, 2B, 2C, and 2D are photographs of Landsat images of this coast in 1986. These images are useful in examining the area as a whole, and especially in viewing the shoal systems of the larger inlets and their relationship to shoreline shape. Based on these images and the other historic shoreline change data, this coast can be theoretically divided into two geographic regions. The regions differ in the controlling coastal processes.

This is the San Carlos Bay area, and it is a distinctly different region. The satellite imagery of Figure 2D suggests that this area can best be considered as one very large and complex tidal inlet system. In the image it appears that there are two sets of shoals at the Entrance: those extending from the eastern point of Sanibel, and those deposits which are building the south end of Estero Island. Waves appear to be only secondary modifying forces in this region due to limited fetch and shoaling in the relatively shallow waters. Tidal flows appear to be predominate, gradually moving and depositing large amounts of littoral material. Consistent with this theory, the sands in this area are generally very fine quartz, mixed with shell in
