## **Apalachicola River Floodplain Restoration by Breaching a Dredge Spoil Berm: Restoring Habitat and Helping a Community**

Dr. Joann Mossa, PI, University of Florida and Apalachicola Riverkeeper

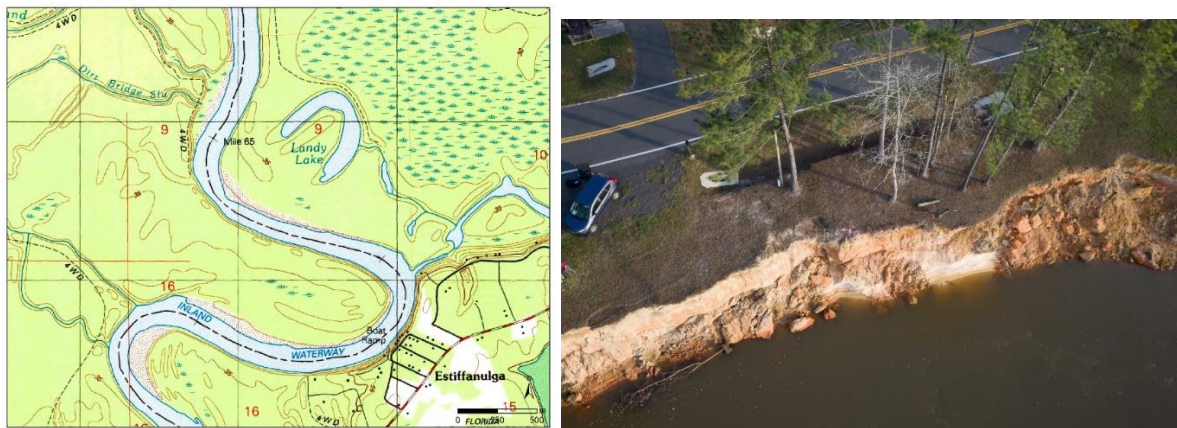
Figure 1. a) Topographic map of the Estiffanugla area in the 1980s shows several houses both west and east of the road adjacent to the river; b) Drone photograph of the eroding bluff at Estiffanugla taken March 2016 is a short distance from a road and houses. Signs of active erosion include fallen fence post and tension cracks, eroded sediment blocks, an overhanging fence line and a few eroded trees at the base (Photograph taken by Scott Walls).

The following includes several figures of the site to be improved including topographic map of the site and drone photography of the eroding bluff (Figure 1), ground photography of the eroding bluff (Figure 2), and conceptual diagram of a natural floodplain and crevasses through natural levee paired with a less modified section of the Apalachicola River showing multiple crevasses (Figure 3). Figure 4 shows the hummocky ground topography of the spoil berm and Figures 5 and 6 show the elevations of the site and channel constructed by combined LiDAR and sonar data. Figure 7 shows transects where we would build breaches by removing sand in order to increase the frequency and duration of flood overtopping and by allowing lower stage flows to go through this area.
