**Final Report**

**Bio-sorption Activated Media for Nitrogen Removal**

**In a Rapid Infiltration Basin – Monitoring Project**

**Project Agreement No. NS 003**

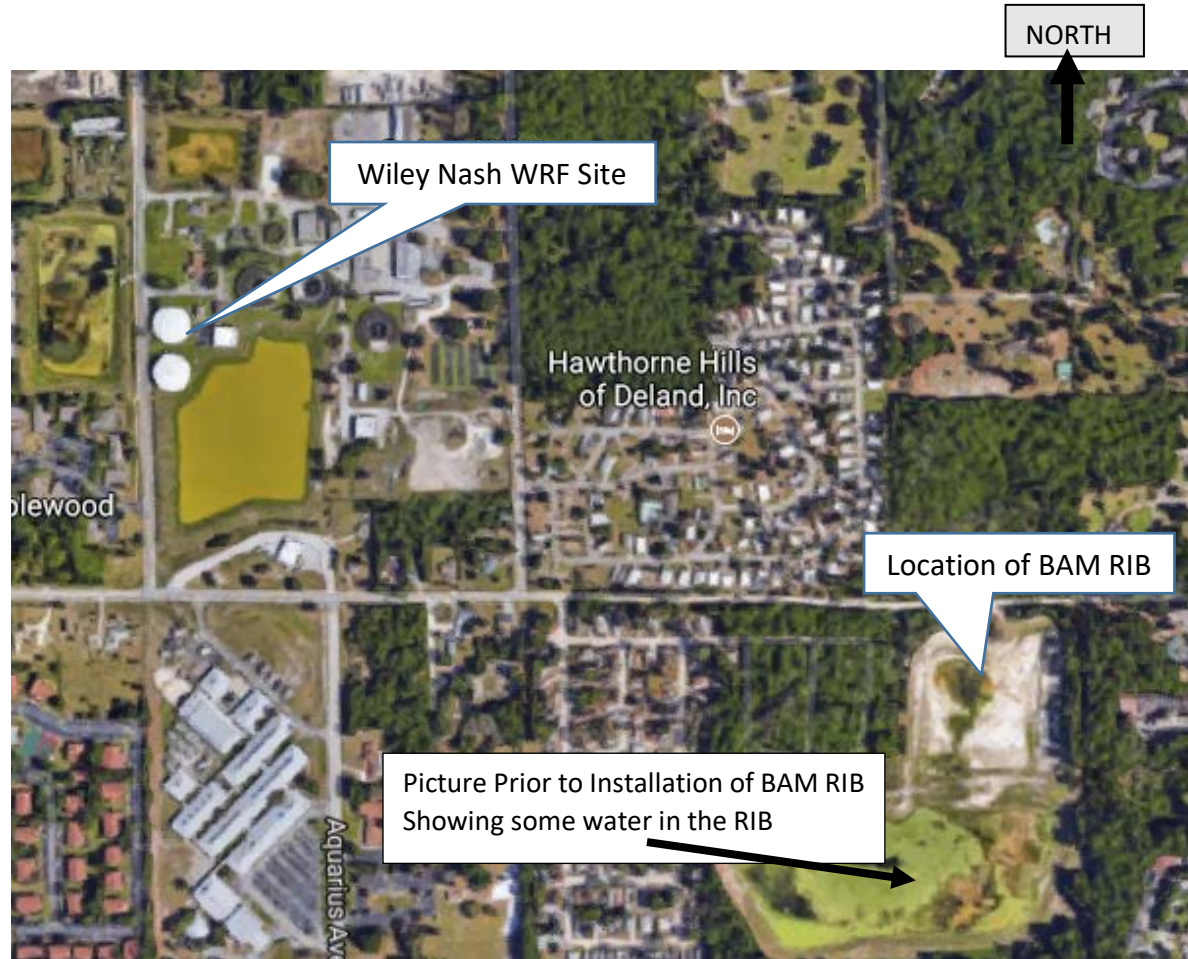
**Figure 3 Aerial Photograph Depicting Main WRF Site and RIB Site Prior to Installation of BAM.**  
**Source: Google Maps (reference time is 2016)**

The RIBs for disposal are located approximately 1/2 mile east of the DeLand WRF (see Figure 3).

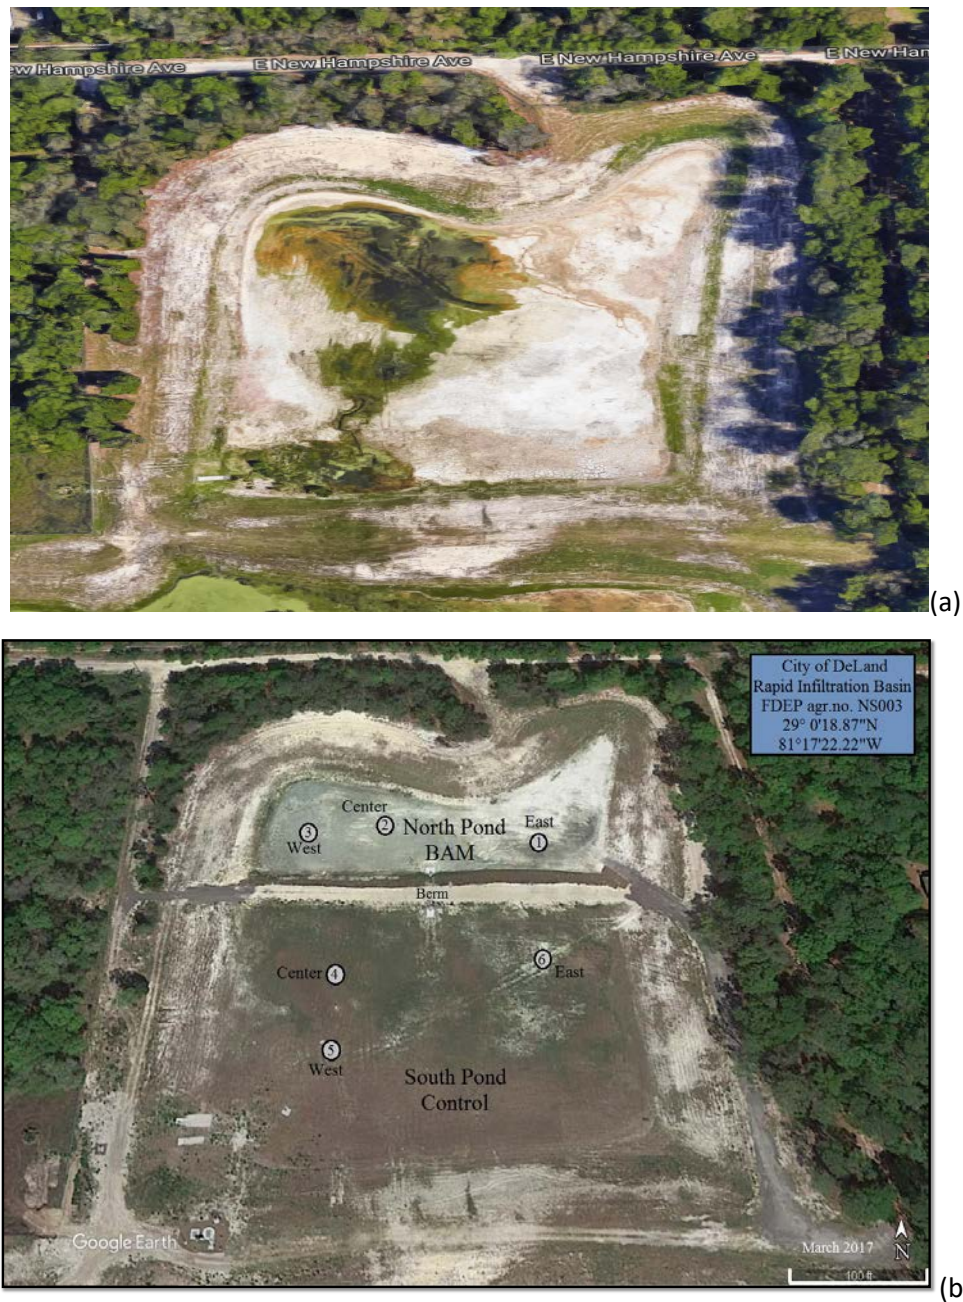
**Figure 4 Aerial Photographs of (a) North (pre-study) RIB without separation berm and (b) BAM RIB (North) and Control RIB (South) with Lysimeter Locations**  
Source: Google Maps (reference time is May 2016 and March 2017)

The RIB to be modified with BAM is part of a larger RIB site. The larger and smaller part of the RIB can be loaded independent of each other. Thus, minimal modification of the RIB plumbing was necessary. All the RIB areas are used by the City of DeLand for reclaimed and excess stormwater disposal when the water is not used for irrigation. Reclaimed water, river water and excess stormwater are pumped to the RIBs. The existing northern RIB is approximately 3 Acres and is shown in Figure 4. The location of the berm separating the BAM RIB from the Control RIB and the lysimeters is shown in Figure 4 (b).

The existing RIB was modified with a dividing berm. The dividing berm separates the RIB with BAM from the Control RIB (see Figure 4). The BAM RIB was constructed on the north side of the RIB and has 2 feet of BAM under an area of about 1 acre (43,600 SF). The Control RIB remained with the existing soil condition and is about 1.68 acres (73,200 SF). Figure 5 is the “as-built” plan. Reclaimed water

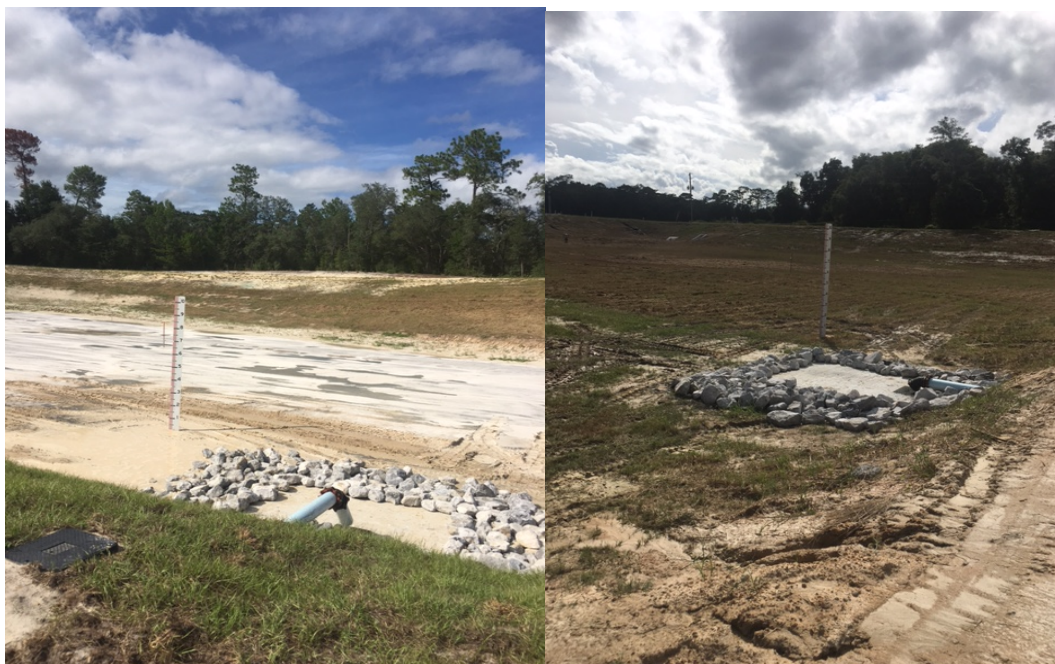
(a) BAM RIB looking northeast

(b) Control RIB looking southwest

Staff gages were used to directly measure the water levels in both RIBs. Shown in Figure 6 are the staff gages for the BAM RIB and the Control RIB. Also shown are the inlet pipes that discharge water into the RIBs. The inlet pipes include vales and meters to distribute equally (on a RIB area basis) the same input flow rate from the reclaimed water reservoir of the Deland WRF.

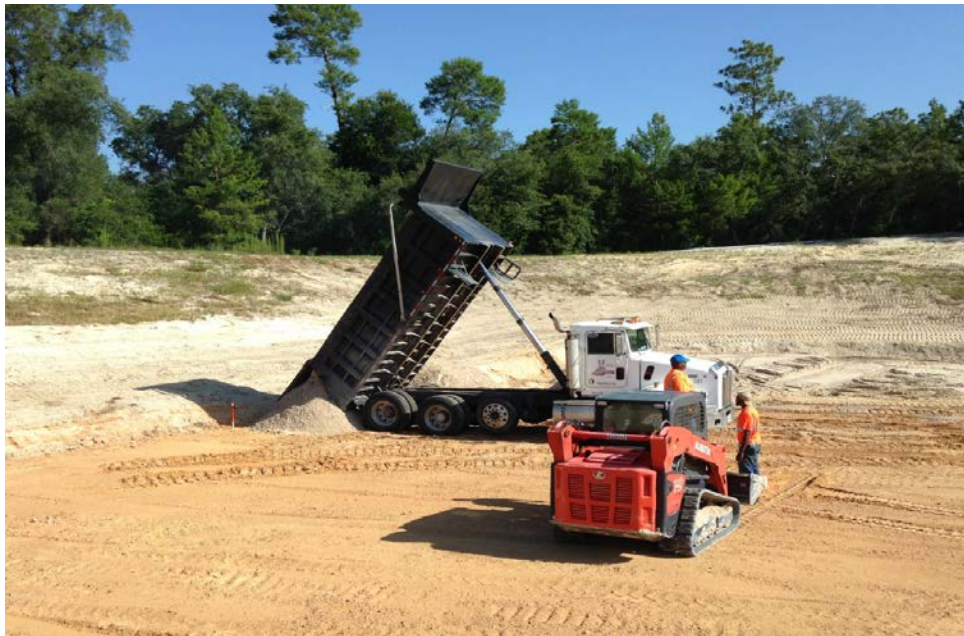
**Figure 10 Installation of the BAM in the one-acre RIB**

**1. The installation time for BAM:** The installation was completed in one week. City staff placed 3227 CY of BAM. The BAM was delivered in dump trucks (see Figure 10).

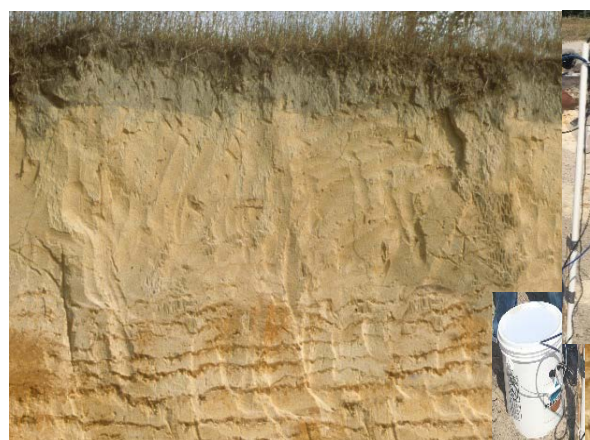
Bottom of RIB or loading zone

No topsoil added at the BAM RIB

The area of the BAM is 43,600 SF (about 1 Acre). The bottom of the RIB and top of the BAM is barren without vegetation but can develop natural vegetation or be planted (seeded) if desired. A section of the installation is in Figure 11. The Lysimeters for sampling percolating water were placed two feet under the RIB bottom. Thus, for the BAM RIB, it was under the BAM layer as shown in Figure 11.

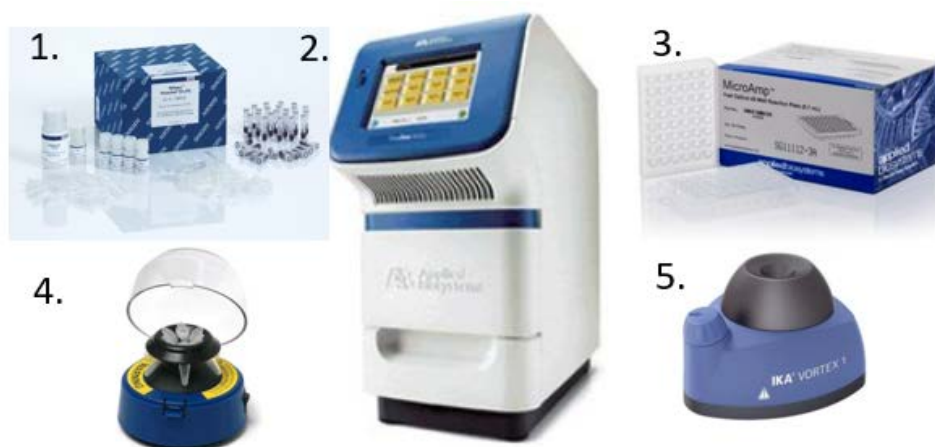
**Figure 22 qPCR instrument and Accessories used in UCF Lab (1. DNeasy PowerSoil kit, 2. Applied Biosystem StepOne Real-Time PCR System, 3. PCR 48-well plate, 4. Centrifuge, 5. Vortex mixer)**

Figure 22 is shown to validate the DNA method of analysis as other lesser accurate instruments can be used. These are the highest-grade instrumentation.

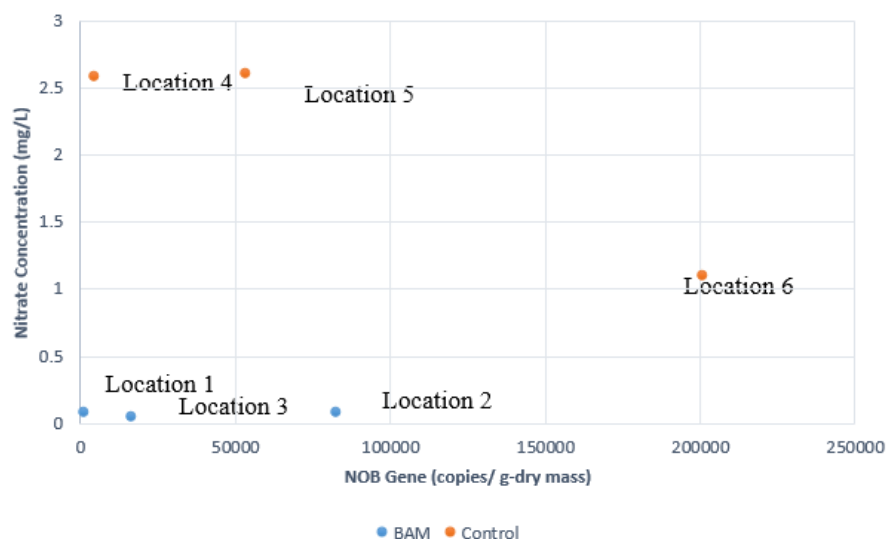
**Figure 23 (a) NOB Gene for BAM (Locations 1, 2, and 3) and Control (Locations 4, 5, and 6) in initial (2/2/2017) and final (2/16/2018) sampling, (b) Comparison of nitrate concentration and NOB gene at surface layer for BAM and Control RIB for locations 1-6 for second sampling event for nitrate removal.**

Results from second sampling event for the NOB show that the optimum depth for nutrient removal was at the surface layer for BAM RIB, and only at locations 5, and 6 for Control RIB (Fig. 23 (a)). The increase presence of NOB, 1 foot below the surface at location 4 can be attributed to ponding effect. The ponding of reclaimed water at this location could have affected adsorption of nutrients in the soil consequently affecting the NOB activity by reducing oxygen in the top layer. The accumulation of nutrient at the surface on the RIB provided the required environment for microbial growth. As the quantity of NOB is associated with nutrient availability in the soil and nitrogen removal. The increase in NOB population in the BAM RIB from the first and second sampling event demonstrate the relationship between microbial population and nitrate removal. The more NOB available at the BAM RIB the more microbiological activity present by NOB to convert nitrite to nitrate.

The difference in NOB and denitrifier population in the distinct depths (0, 1, 2 ft) for both the BAM and Control RIBS for first sample data is due to the initial state of the project. Initially the organisms require time to stabilize before a consistent trend is observed. The inlet water nitrogen concentration varied adding to the required microbial adjustment. A trend of decreasing NOB population with depth is observed at the final stage for all the locations apart from location 4, which has an increase in NOB population at depth of 1 foot before decreasing (Fig. 23(a)). Further, NOB increased
