**Fecal BMAP Implementation:  
Source Identification  
Hillsborough River Watershed  
Summary Report  
*Draft Final April 2008***

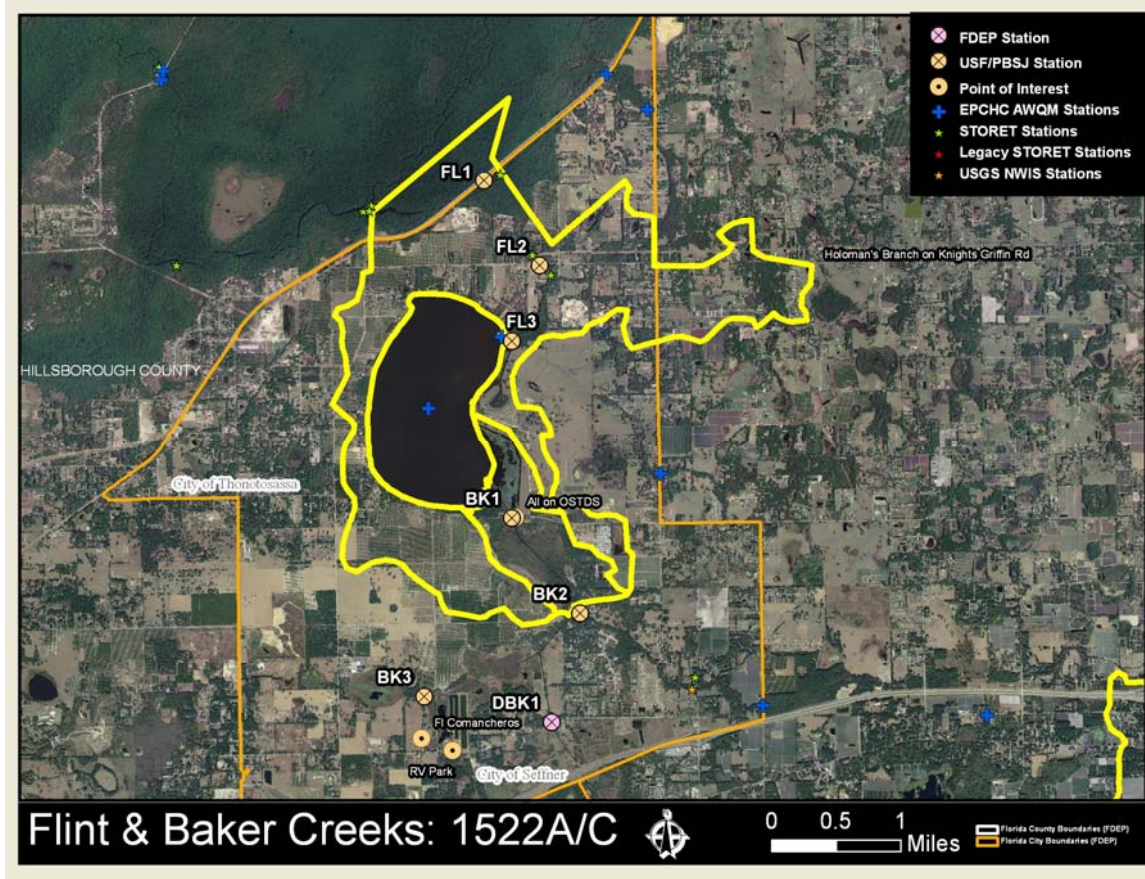
**Map 5.** Map of Flint and Baker Creeks upon completion of Phase I, including identified sampling locations for Phase II, historical sampling locations, and general points of interest.

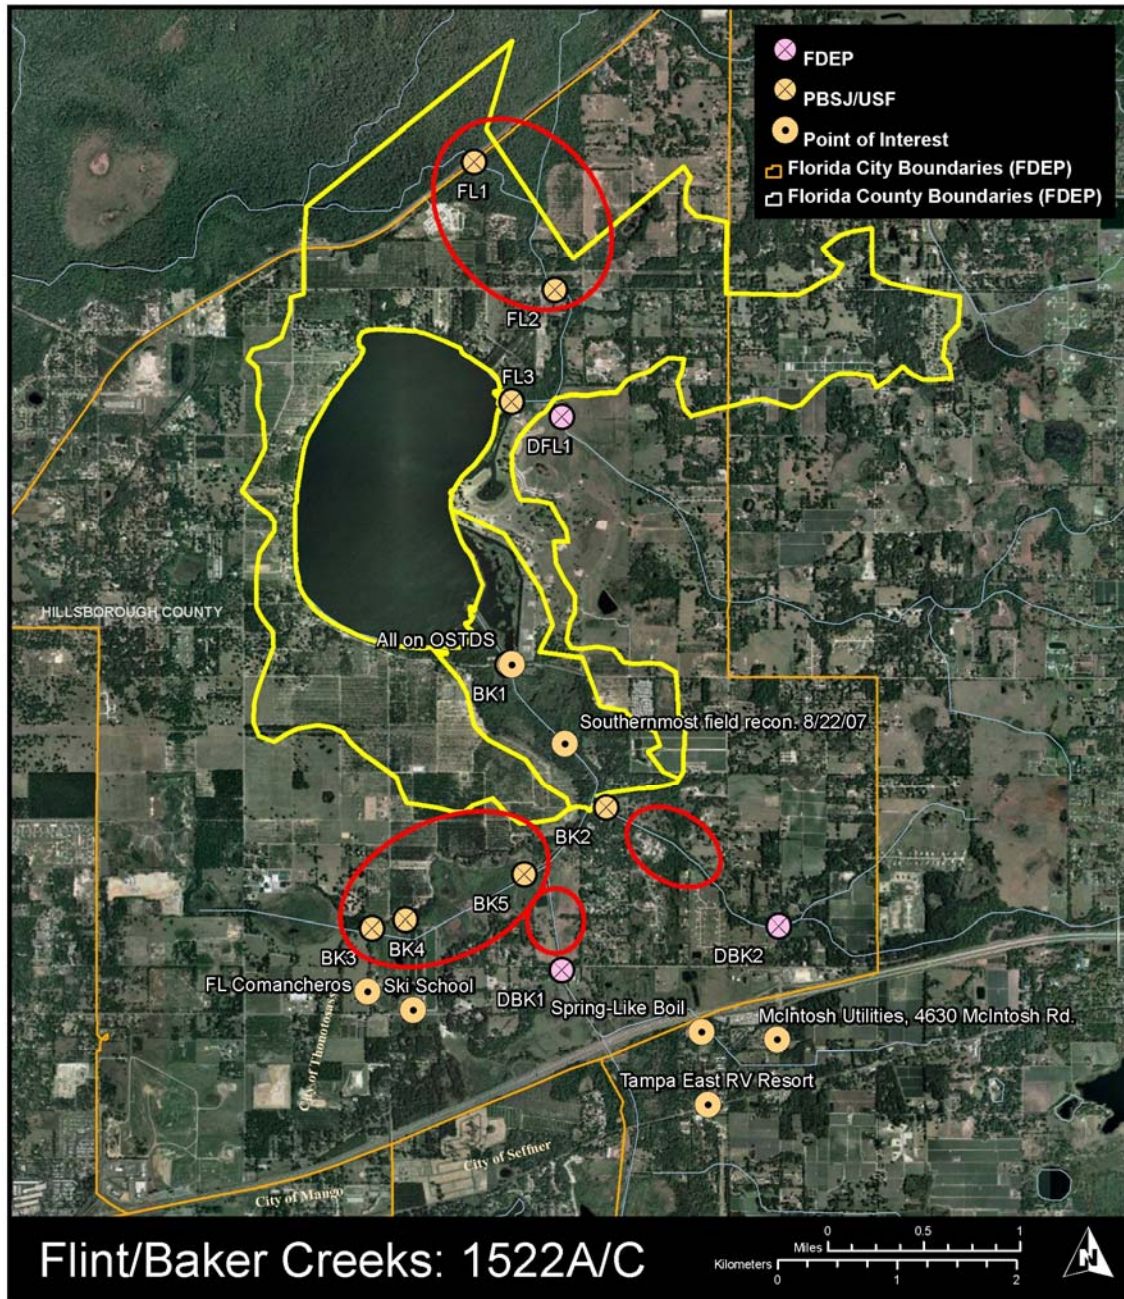
**Map 6.** Map of the Flint and Baker Creeks upon completion of Phase II, including identified sampling locations for Phase II, historical sampling locations, and general points of interest. Results of the May through December 2007 sampling events suggest the presence of “hot spots” for fecal contamination between BK2 and BK3, downstream of DBK1, between DBK2 and BK2, and between FL2 and FL1. The general areas are denoted by red circles.
