# Assessment of the Hydraulic Connection Between Ground Water and the Peace River, West-Central Florida

U.S. Geological Survey

Water-Resources Investigations Report 97–4211

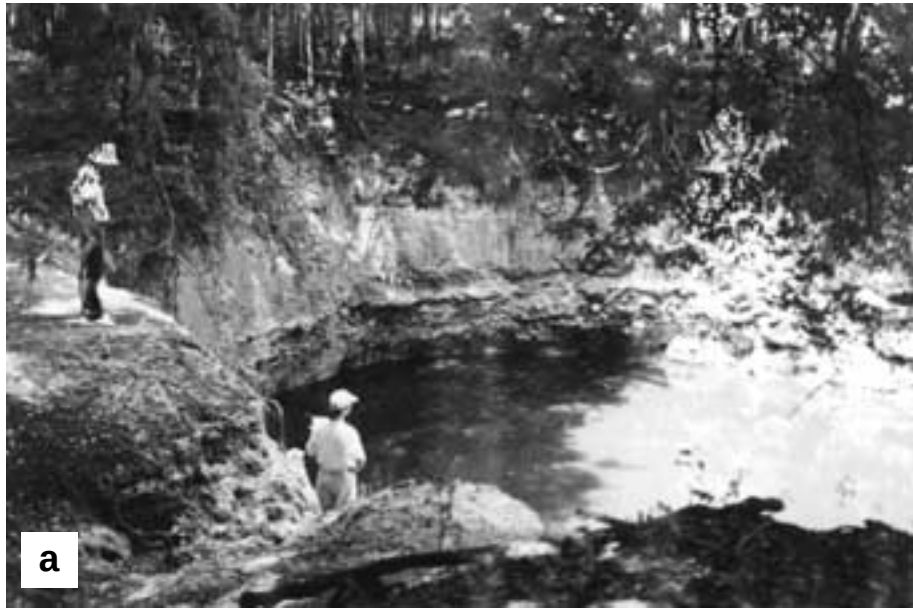
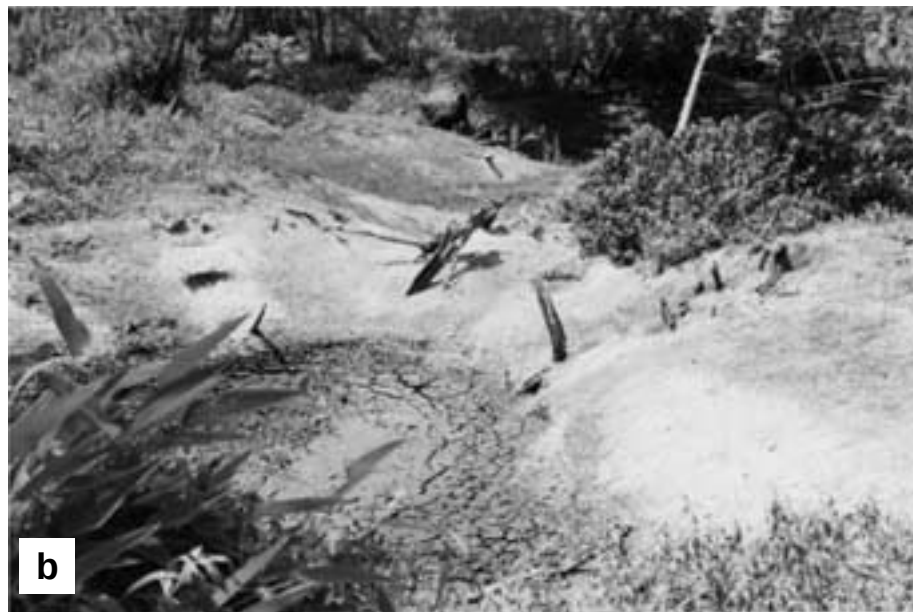
**Figure 22.** Examples of subsidence features observed in the upper Peace River floodplain: (a) large collapse feature with steep walls and (b) small sand-filled depressions. (Location of subsidence features are shown in figure 18.)

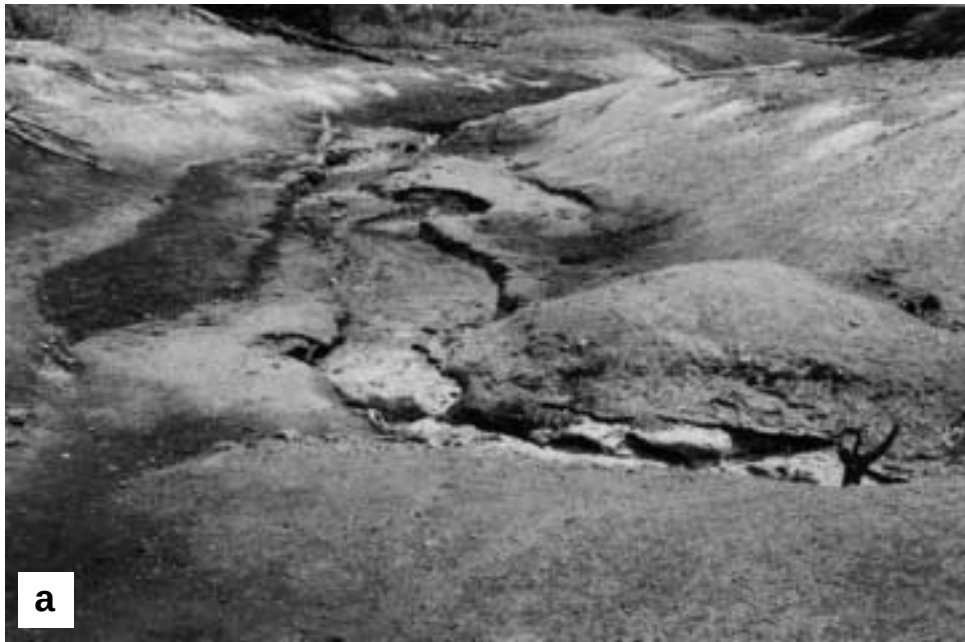
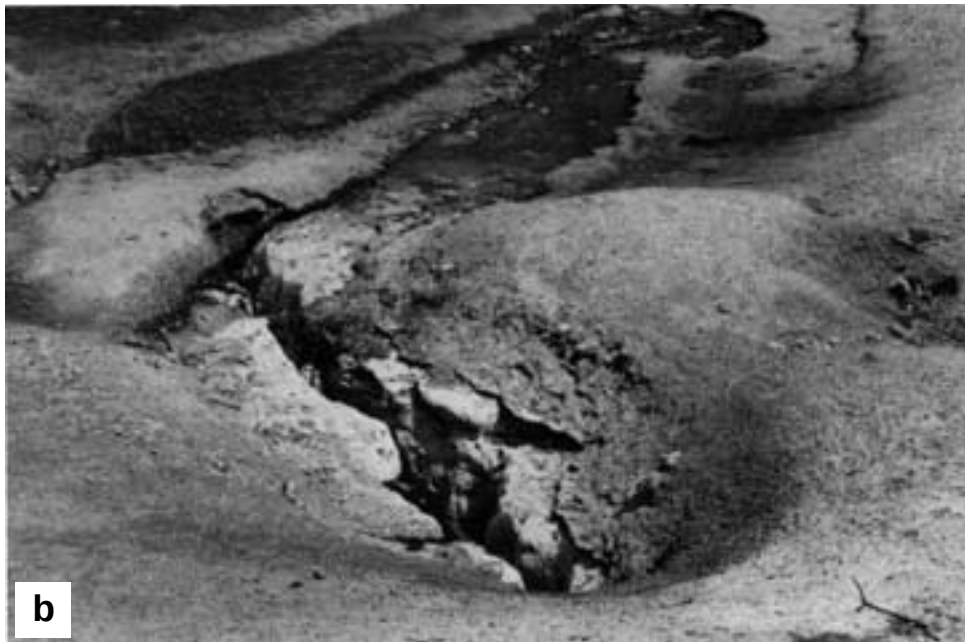
**Figure 23.** Example (a and b) of an enlarged linear solution feature capturing Peace River flow during low base-flow conditions, May 1995. (Location of solution feature is shown in figure 18.)
