# **Mercury TMDL for the State of Florida**

## **Appendix I**

**Spatial Distribution of Water Column Total and Methylmercury in 133 Lakes  
and 131 Streams Collected in the 2008 – 2010 Period**

**Watershed Evaluation and TMDL Section**

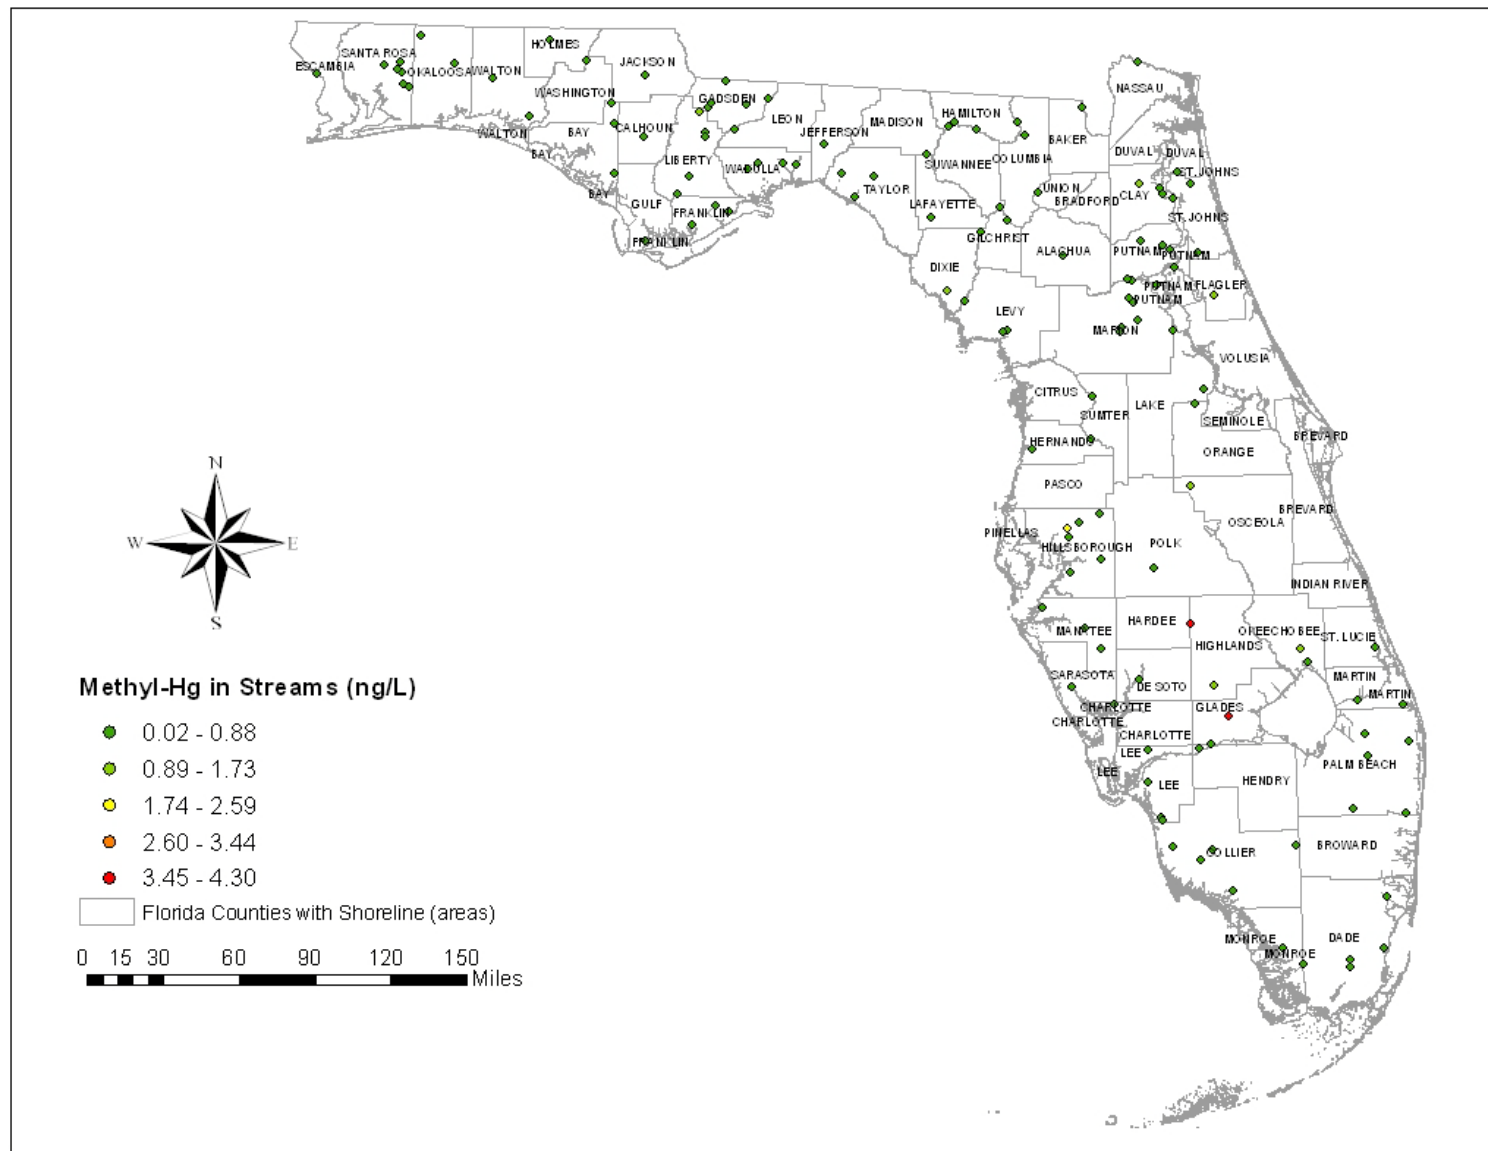
Figure I-2. Spatial Distribution of Water Column Methylmercury Concentration in Florida Streams

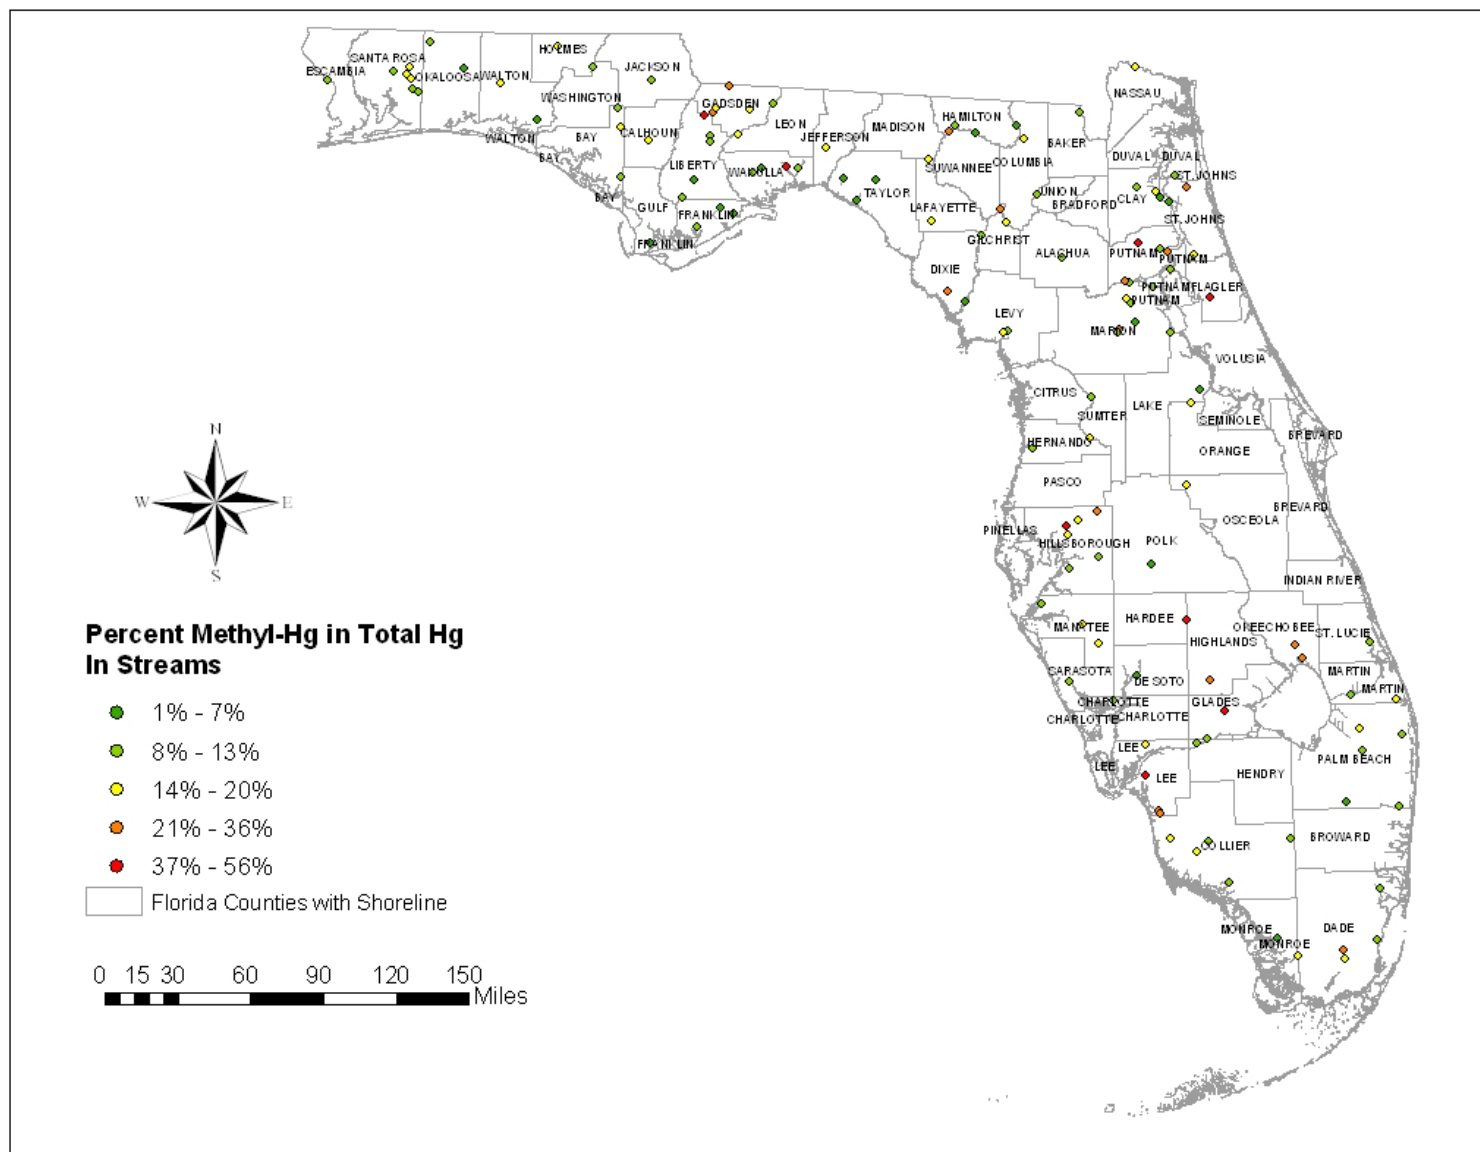
Figure I-3. Spatial Distribution of Water Column Methylmercury to Total Mercury Ratio in Florida Streams

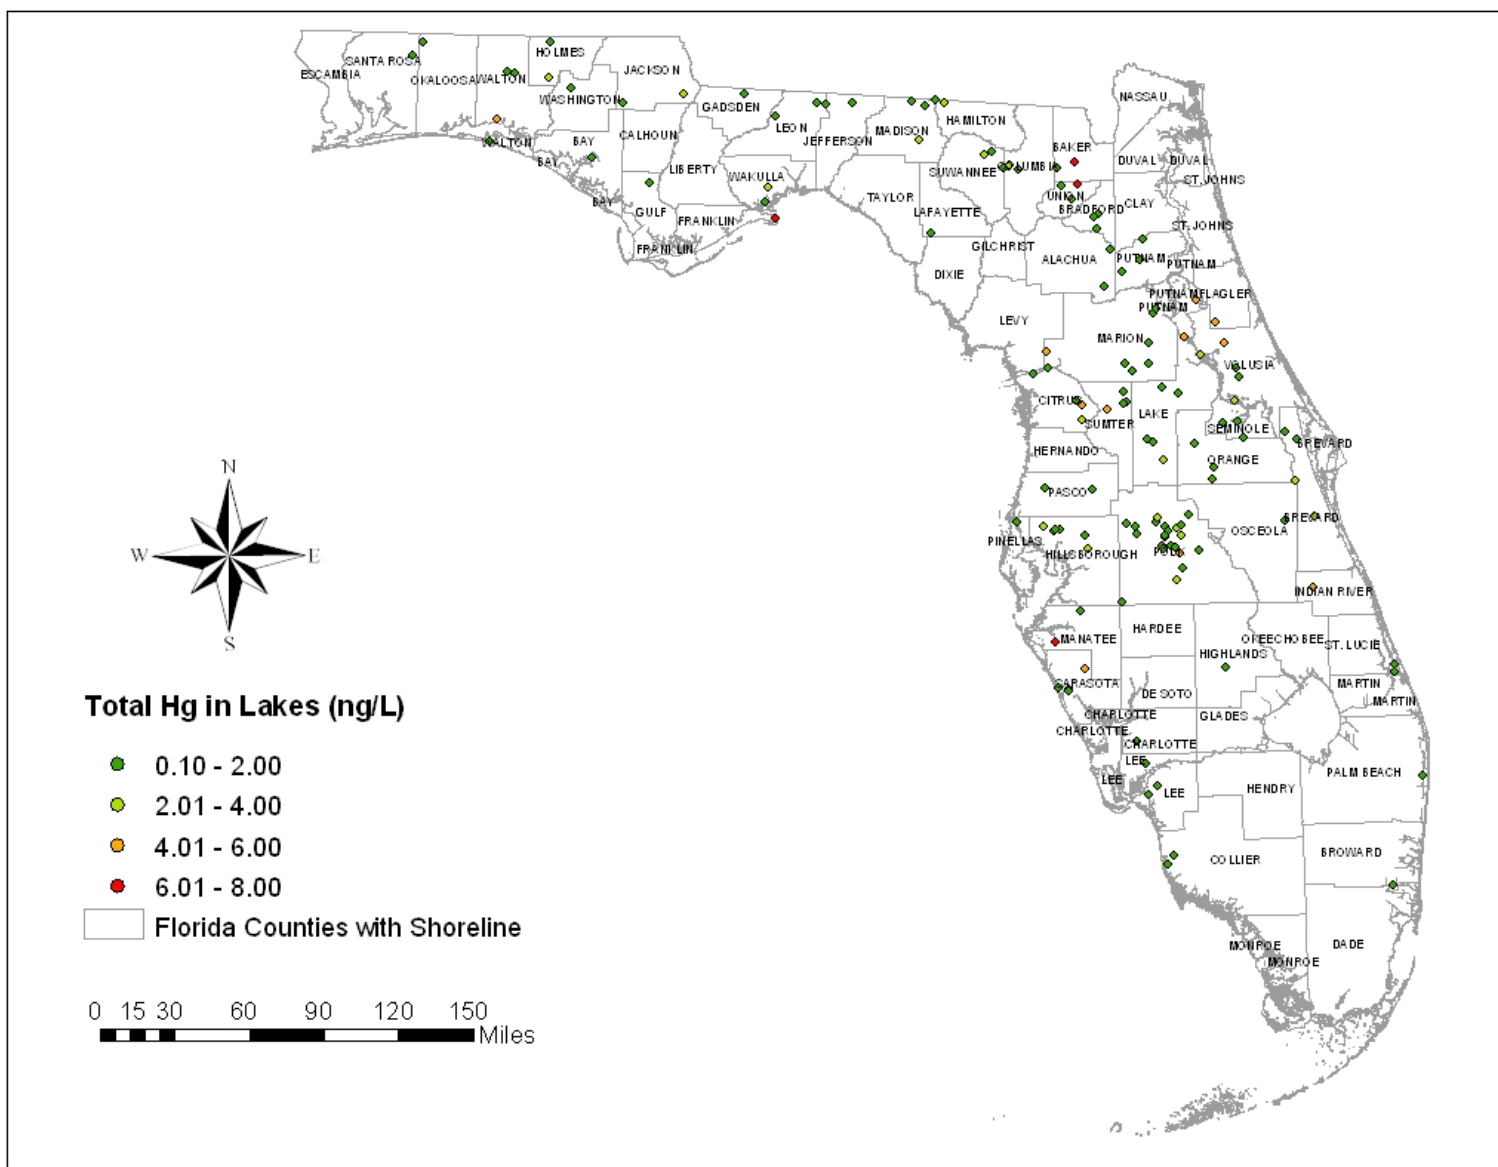
Figure I-4. Spatial Distribution of Water Column Total Mercury Concentration in Florida Lakes

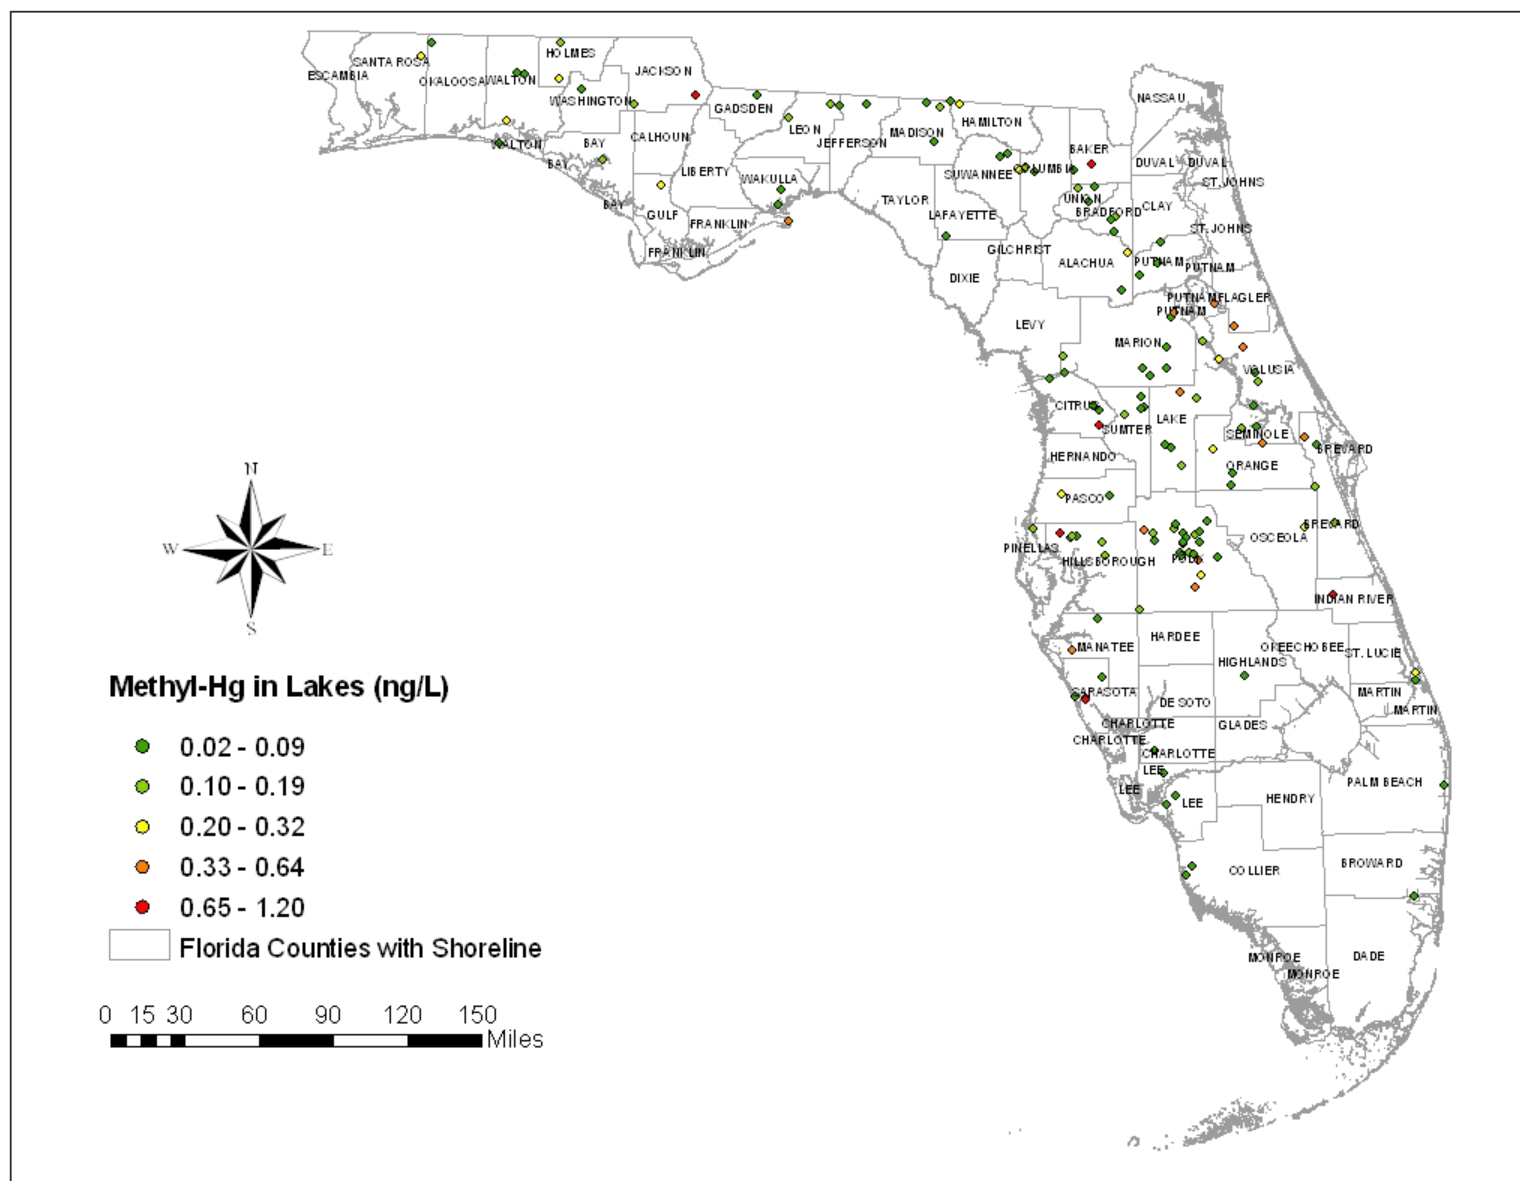
**Figure I-5. Spatial Distribution of Water Column Methylmercury Concentration in Florida Lakes**

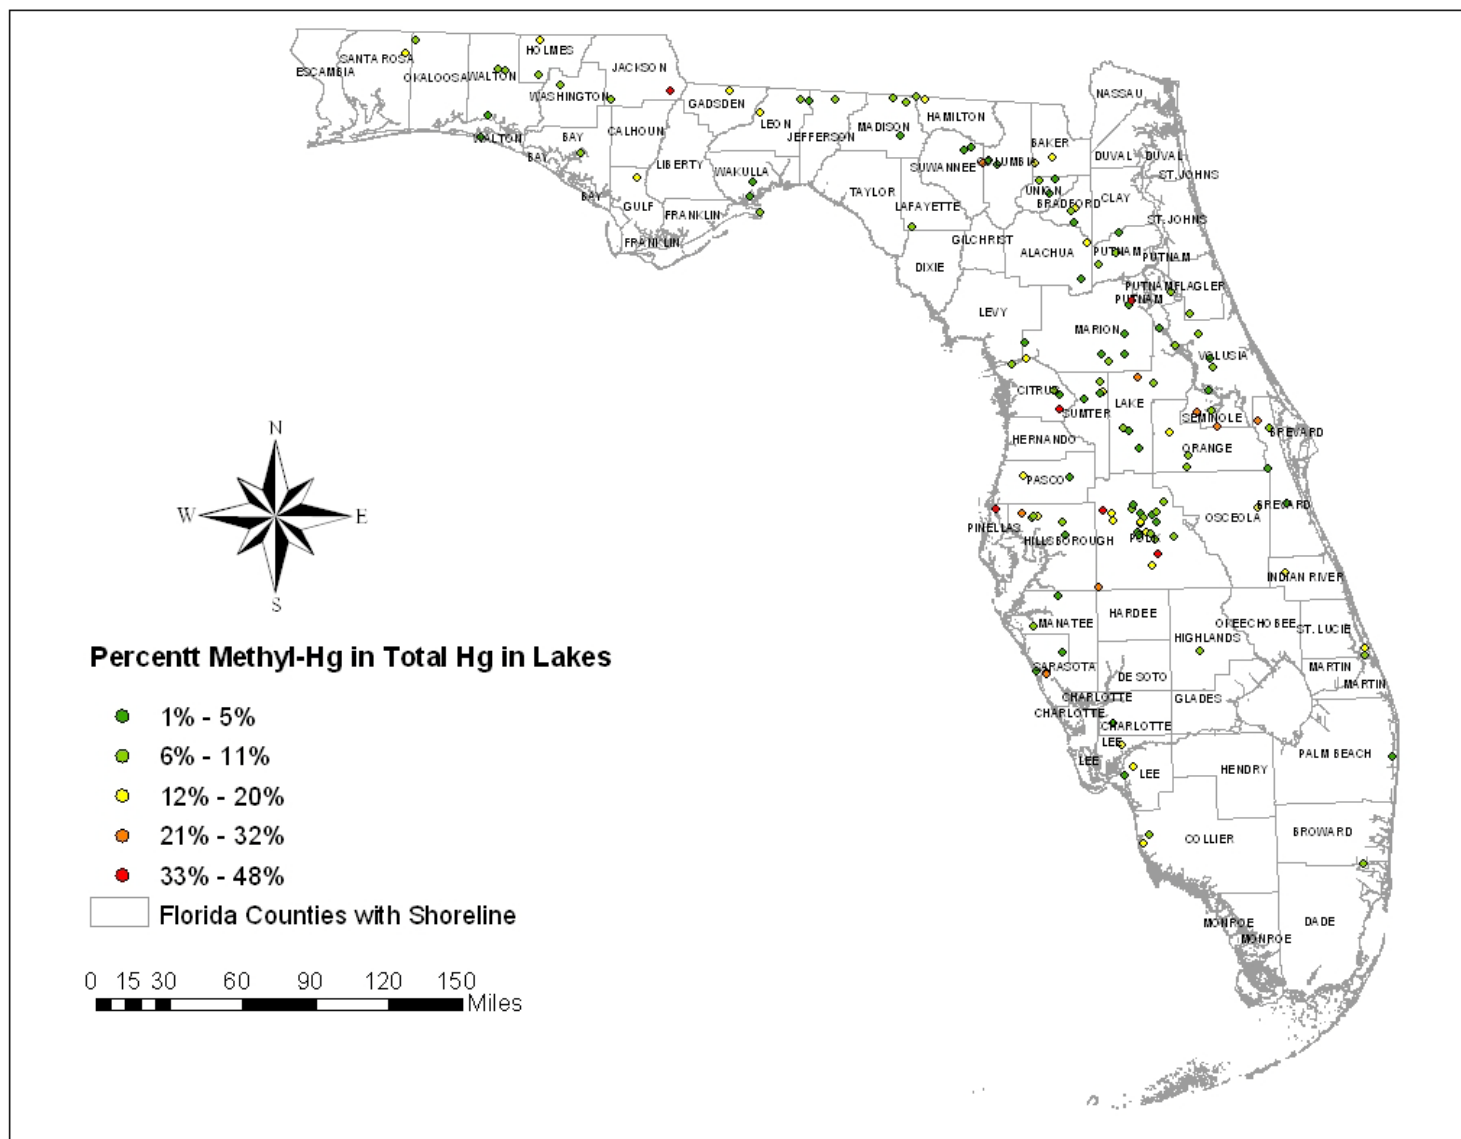
Figure I-6. Spatial Distribution of Water Column Methylmercury to Total Mercury Ratio in Florida Lakes
