# **Mercury TMDL for the State of Florida**

## **Appendix I**

**Spatial Distribution of Water Column Total and Methylmercury in 133 Lakes  
and 131 Streams Collected in the 2008 – 2010 Period**

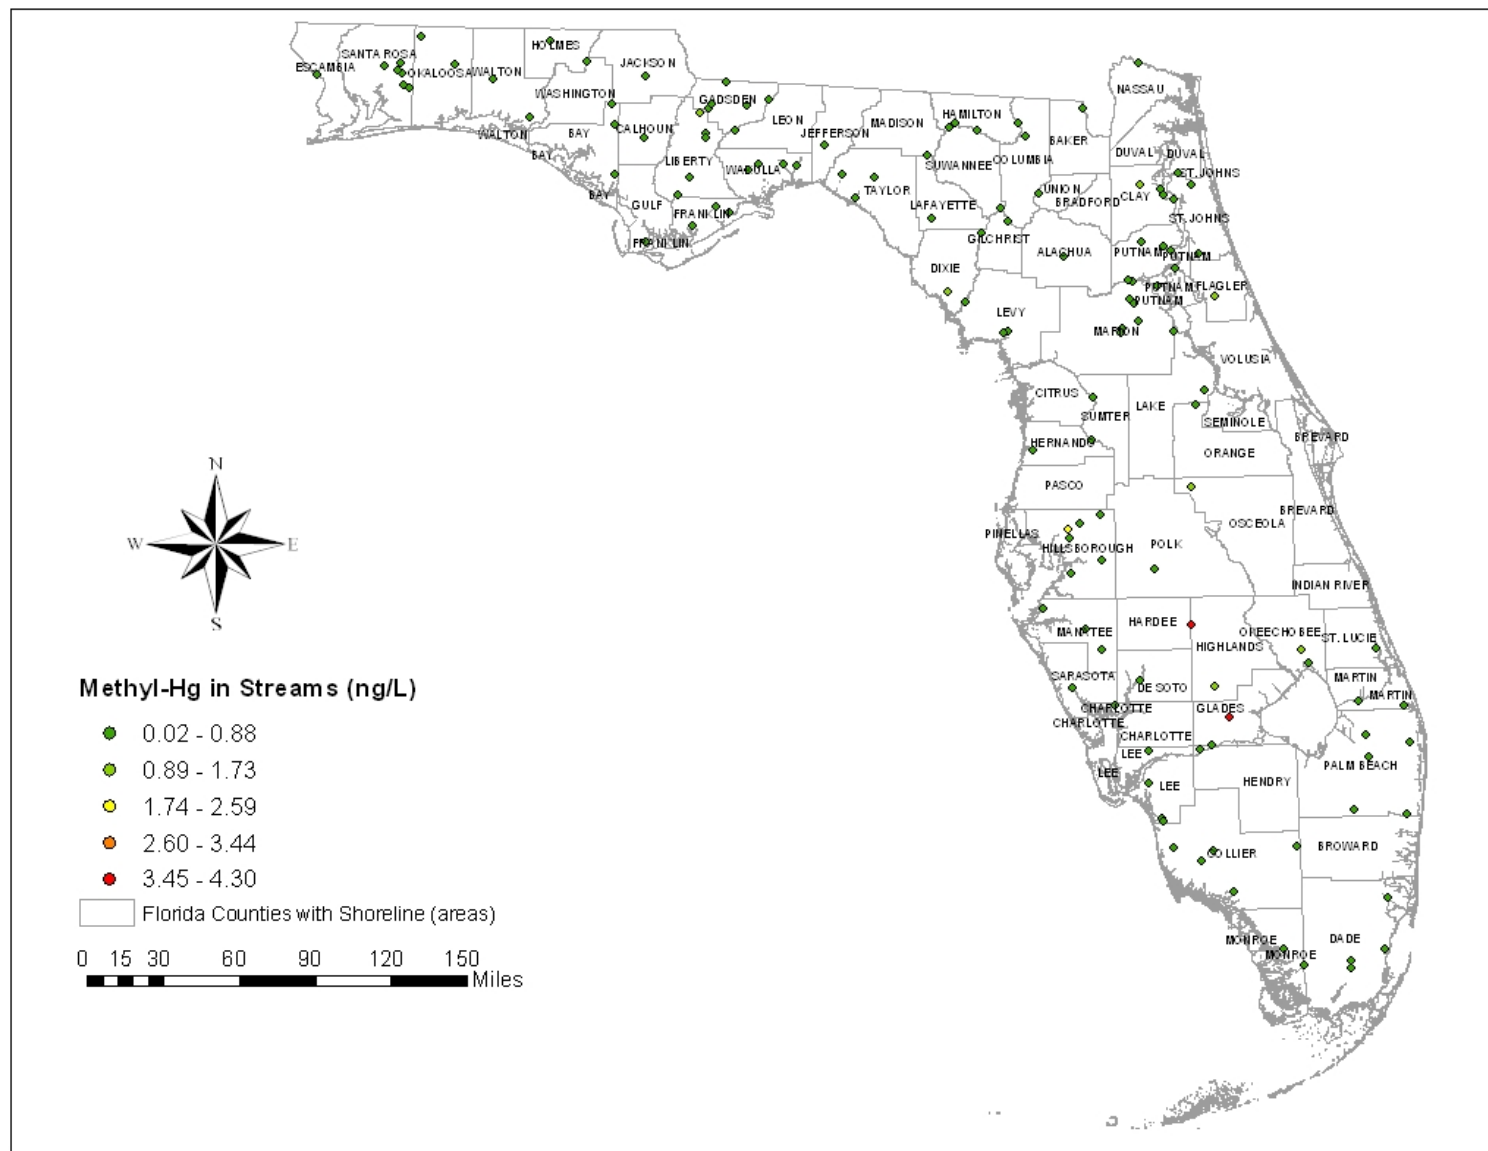
Figure I-2. Spatial Distribution of Water Column Methylmercury Concentration in Florida Streams

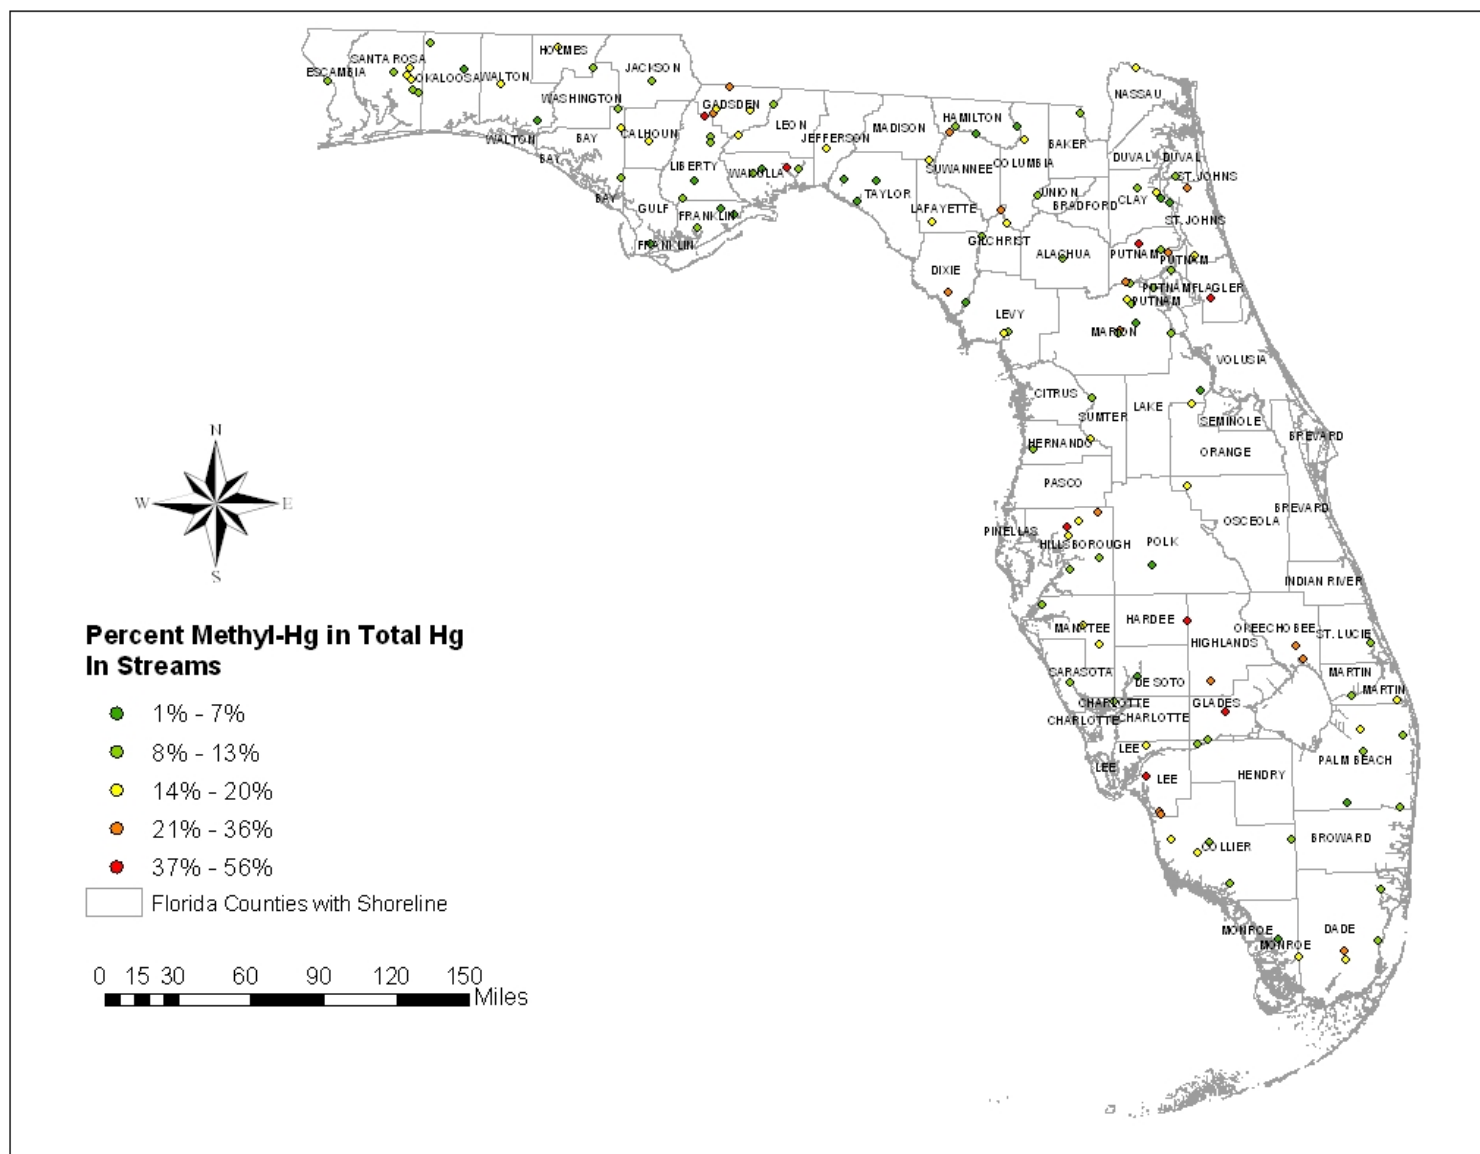
Figure I-3. Spatial Distribution of Water Column Methylmercury to Total Mercury Ratio in Florida Streams

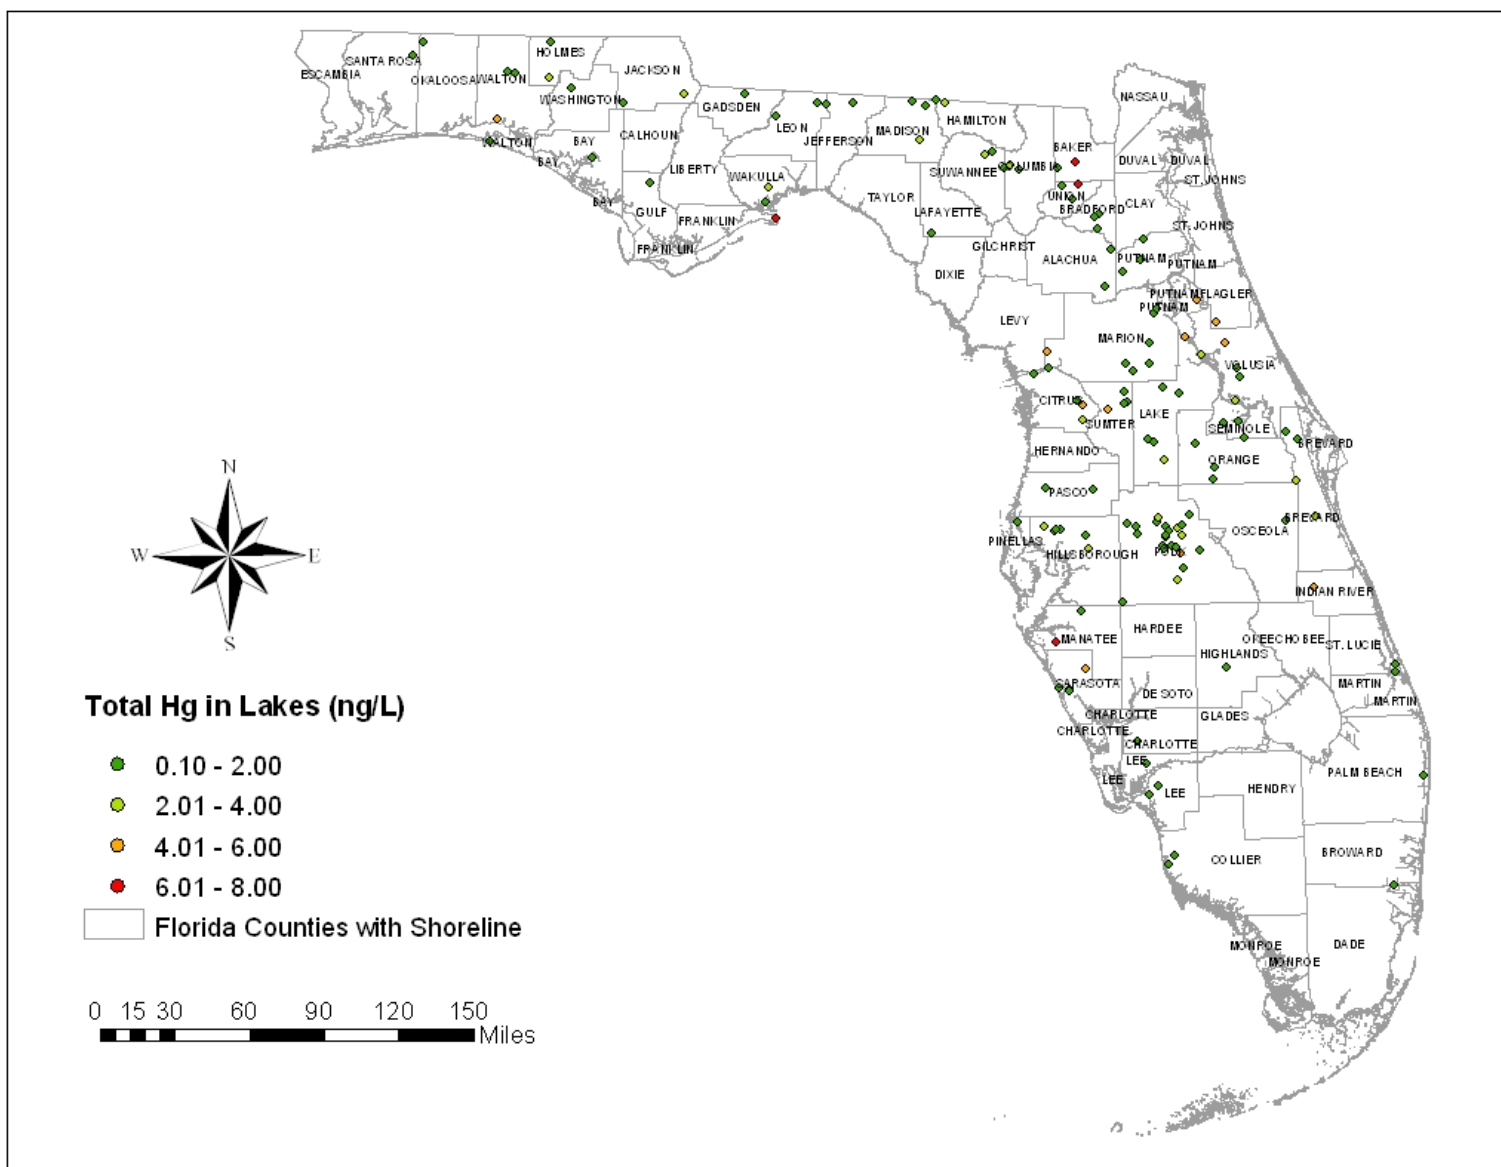
Figure I-4. Spatial Distribution of Water Column Total Mercury Concentration in Florida Lakes

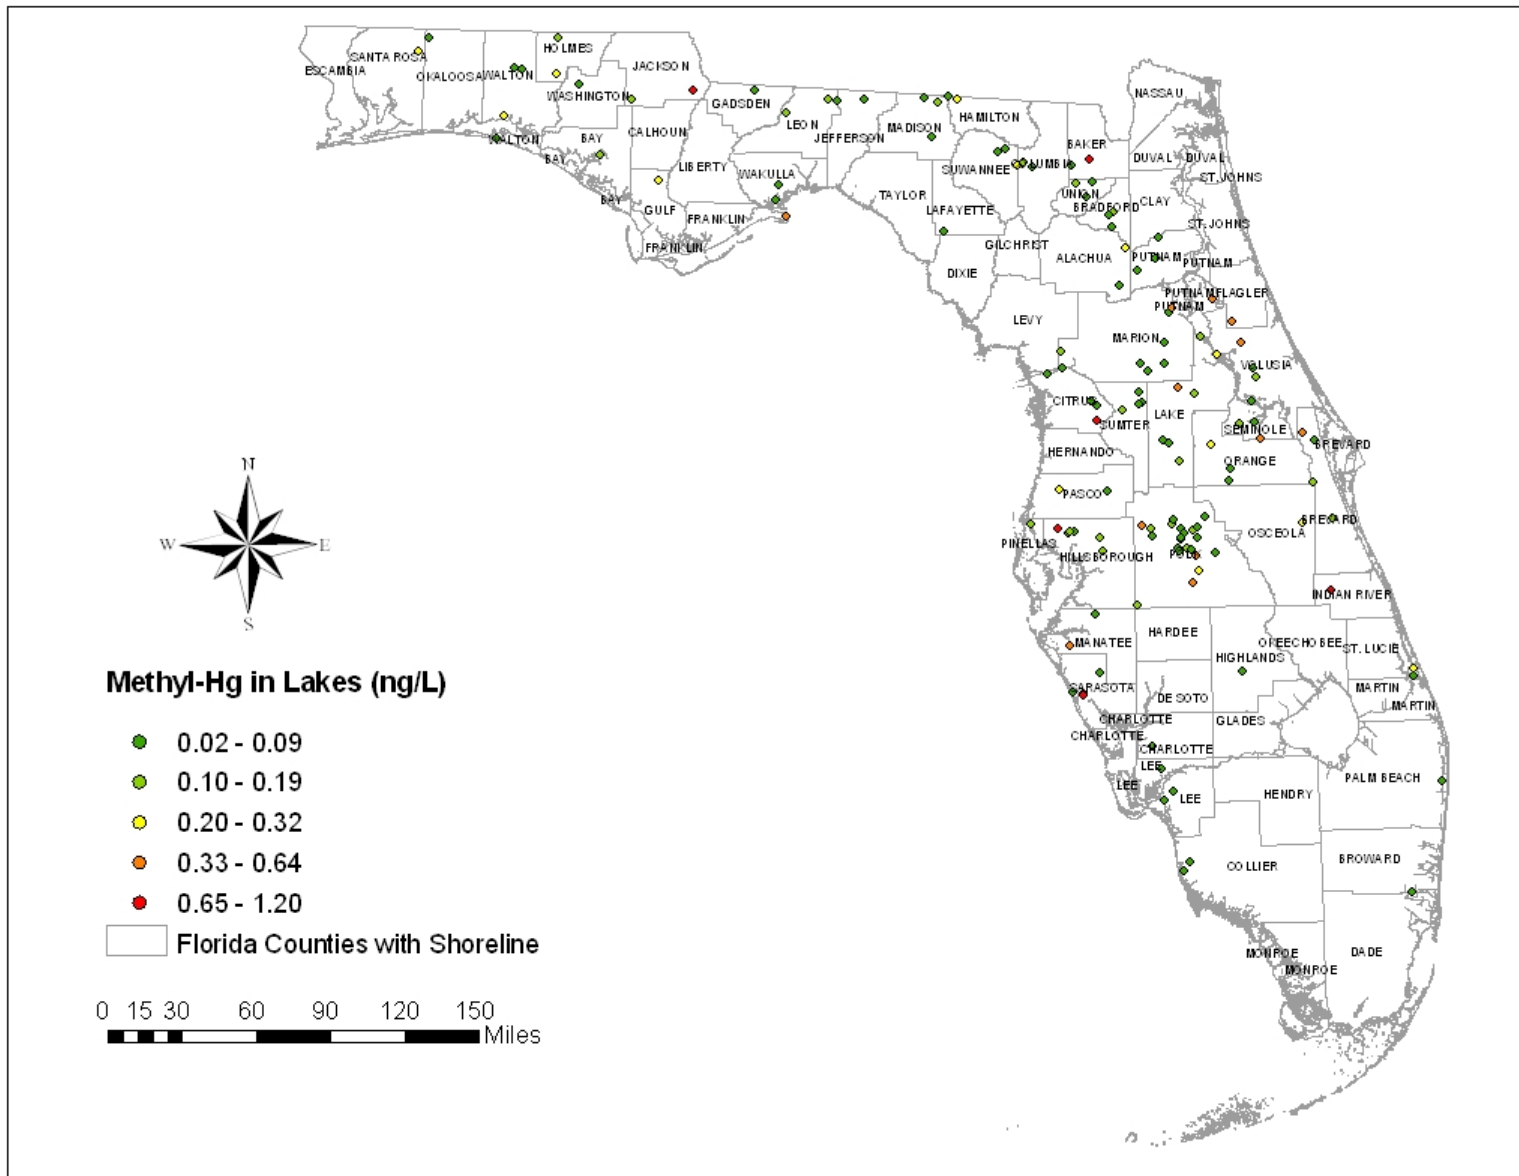
**Figure I-5. Spatial Distribution of Water Column Methylmercury Concentration in Florida Lakes**

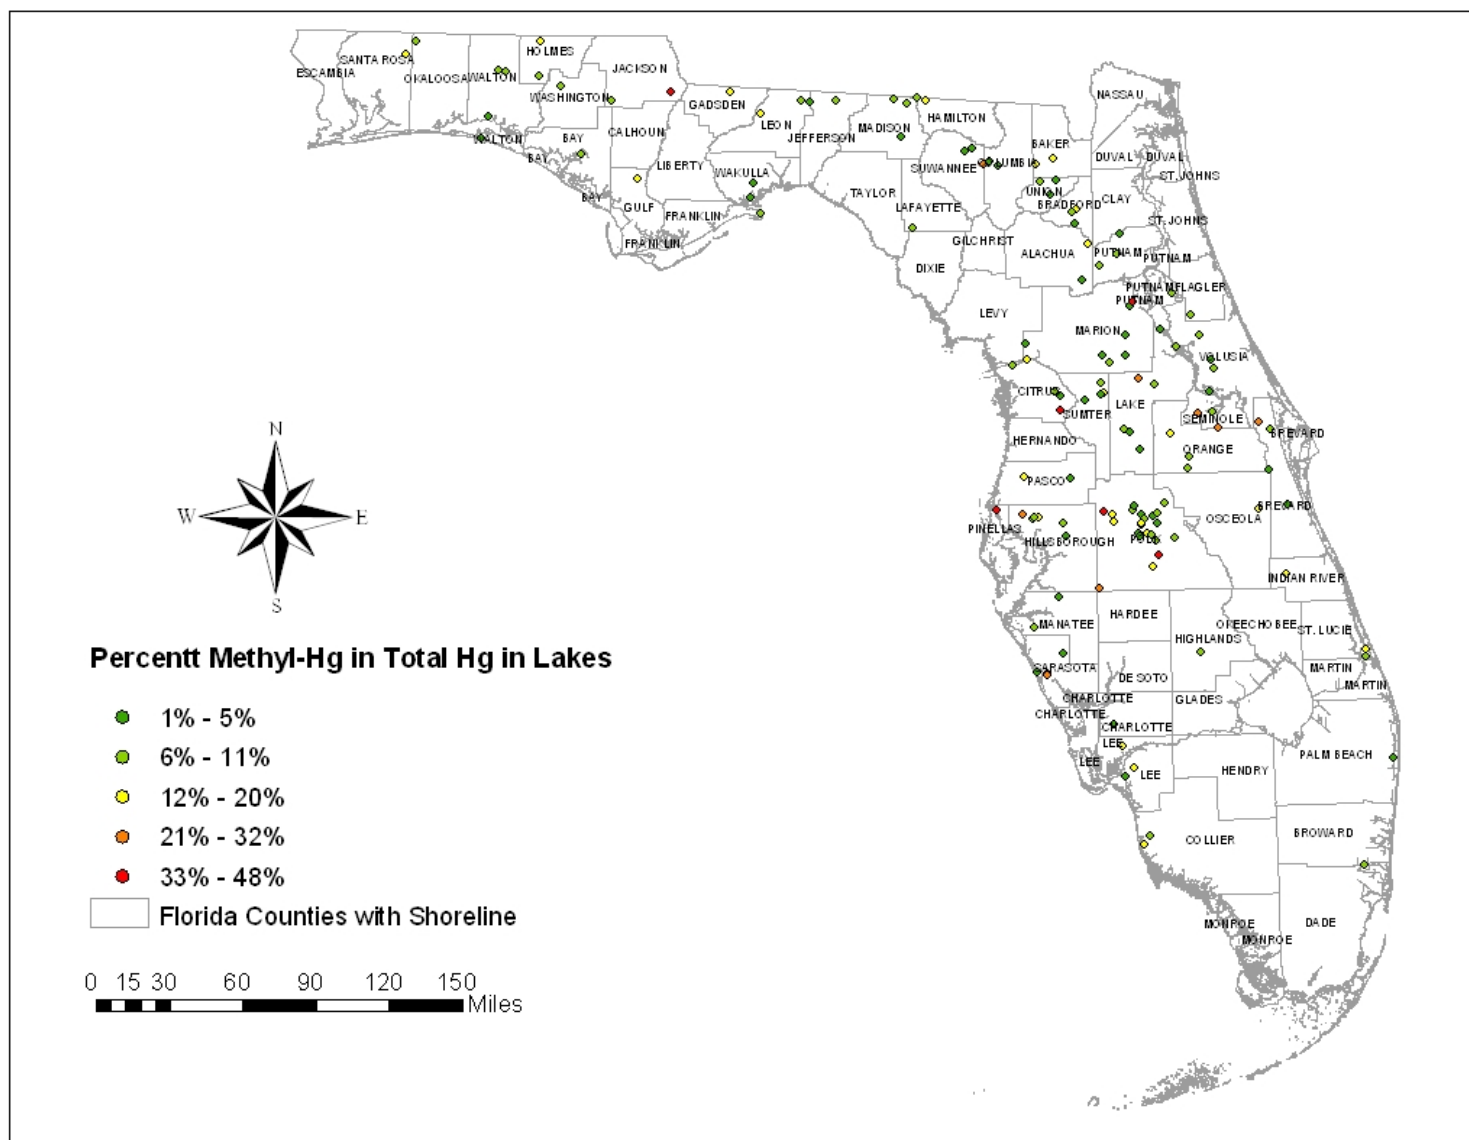
Figure I-6. Spatial Distribution of Water Column Methylmercury to Total Mercury Ratio in Florida Lakes
