# Chloride in Status Network Intermediate Aquifer System Wells

Created April 30, 2015 by Florida Department of Environmental Protection staff in the Division of Environmental Assessment and Restoration. This map is a cartographic representation and is not intended for further analysis.

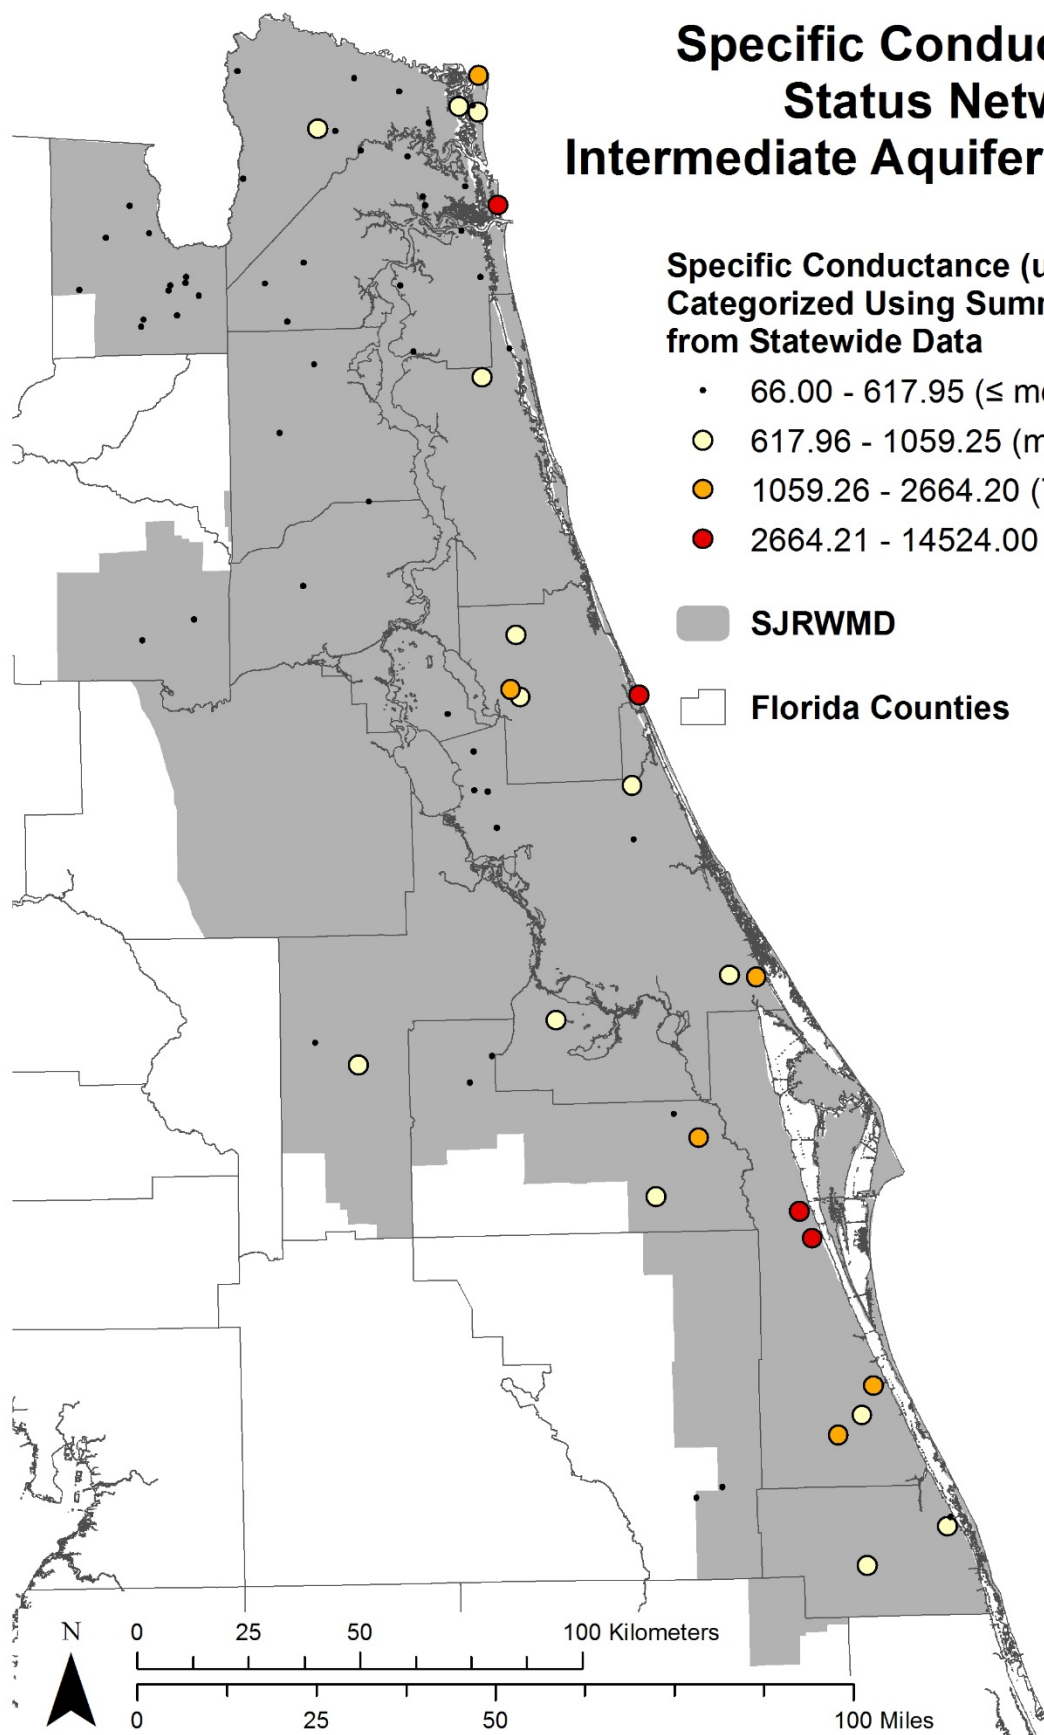
# Specific Conductance in Status Network Intermediate Aquifer System Wells

Specific Conductance (umhos/cm)  
Categorized Using Summary Statistics  
from Statewide Data

- 66.00 - 617.95 ( $\leq$  median)
- 617.96 - 1059.25 (median to 75th percentile)
- 1059.26 - 2664.20 (75th to 90th percentile)
- 2664.21 - 14524.00 ( $>$  90th percentile)

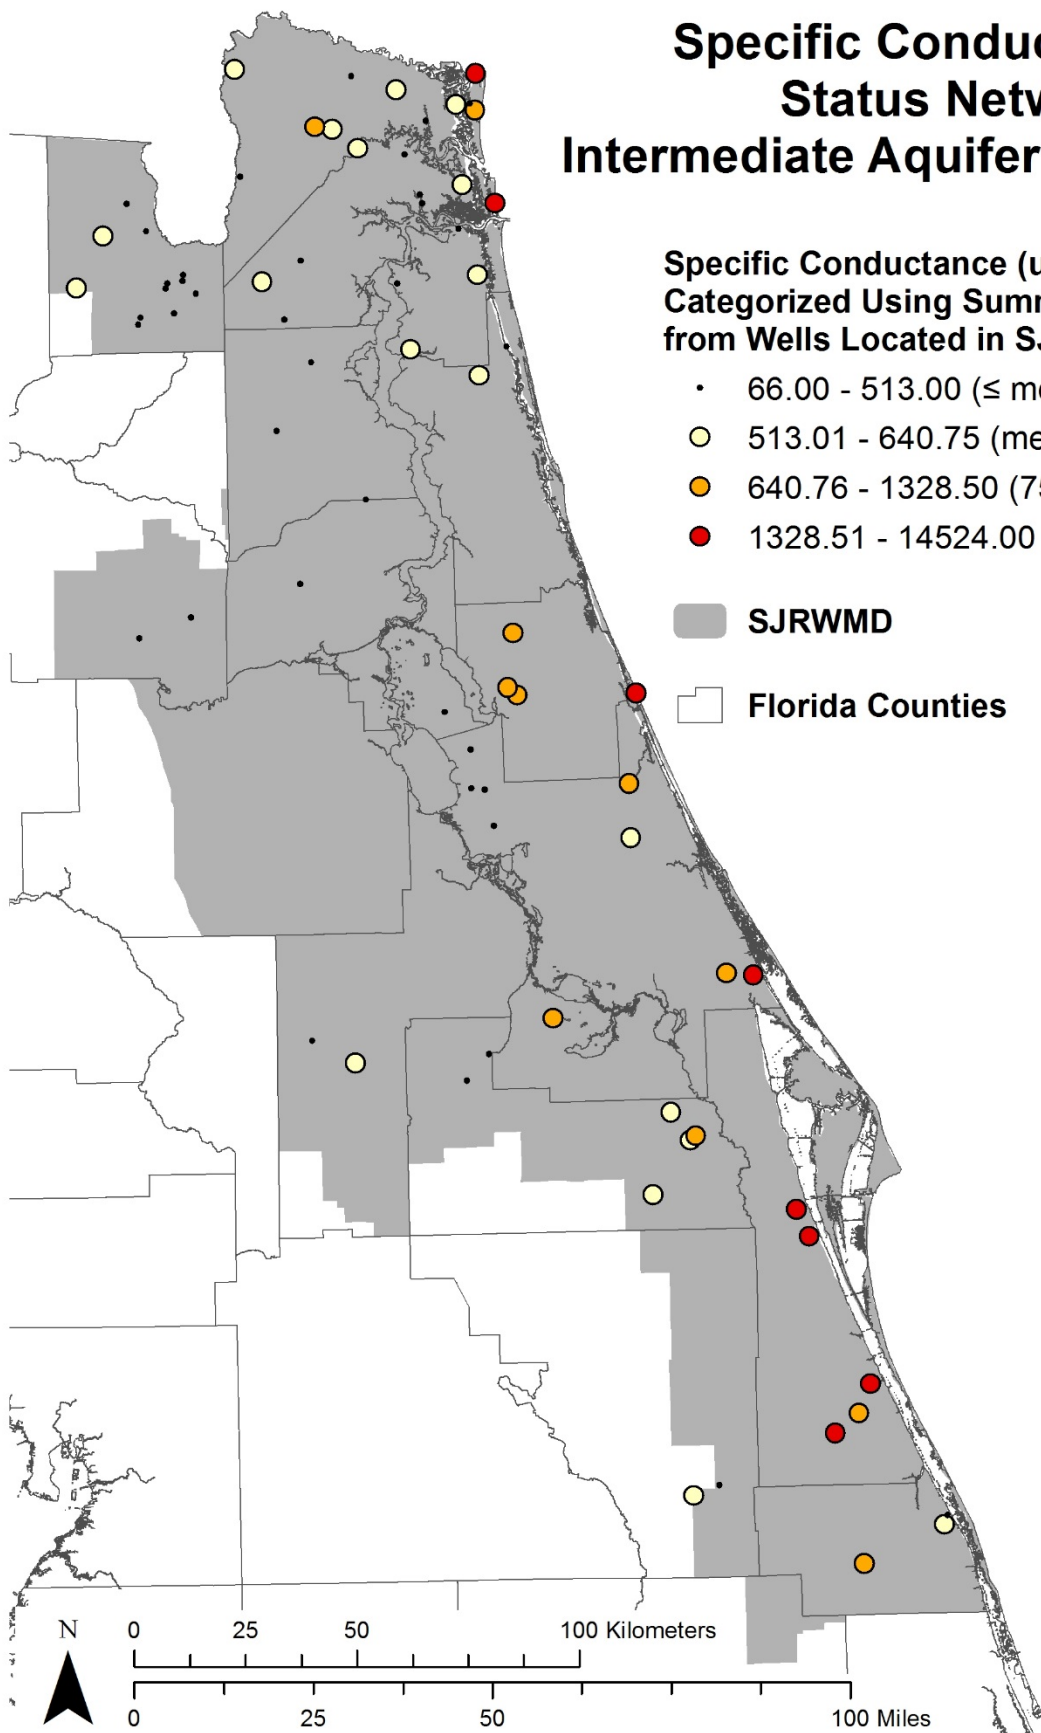
# Specific Conductance in Status Network Intermediate Aquifer System Wells

Specific Conductance (umhos/cm)  
Categorized Using Summary Statistics  
from Wells Located in SJRWMD

- 66.00 - 513.00 ( $\leq$  median)
- 513.01 - 640.75 (median to 75th percentile)
- 640.76 - 1328.50 (75th to 90th percentile)
- 1328.51 - 14524.00 ( $>$  90th percentile)
