# DEP FORM FD 9000-31: LAKE OBSERVATION FIELD SHEET

SAMPLE ID: 822 82440 MACROPHYTE ID: 11884 LATITUDE: N 30.552917  
 COUNTY: Washington (Vernon) STORET #: 32010045 LONGITUDE: W 85.68175  
 DATE: 06/16/2021 TIME: 10:30 - 12:06 - 13:45 SAMPLING AGENCY: FL DEP - NWROC  
 SITE NAME: Dunford Lake WBID: 526A  
 FIELD ID/NAME: DUNFORDREF LAKE SIZE: 190 RQ: 2021-06-14-53  
 LIMBS ID: 2255625

# DEP Form FD 9000-6: Lake Habitat Assessment Field Sheet

## DEP FORM FD 9000-27 LAKE VEGETATION INDEX FIELD SHEET

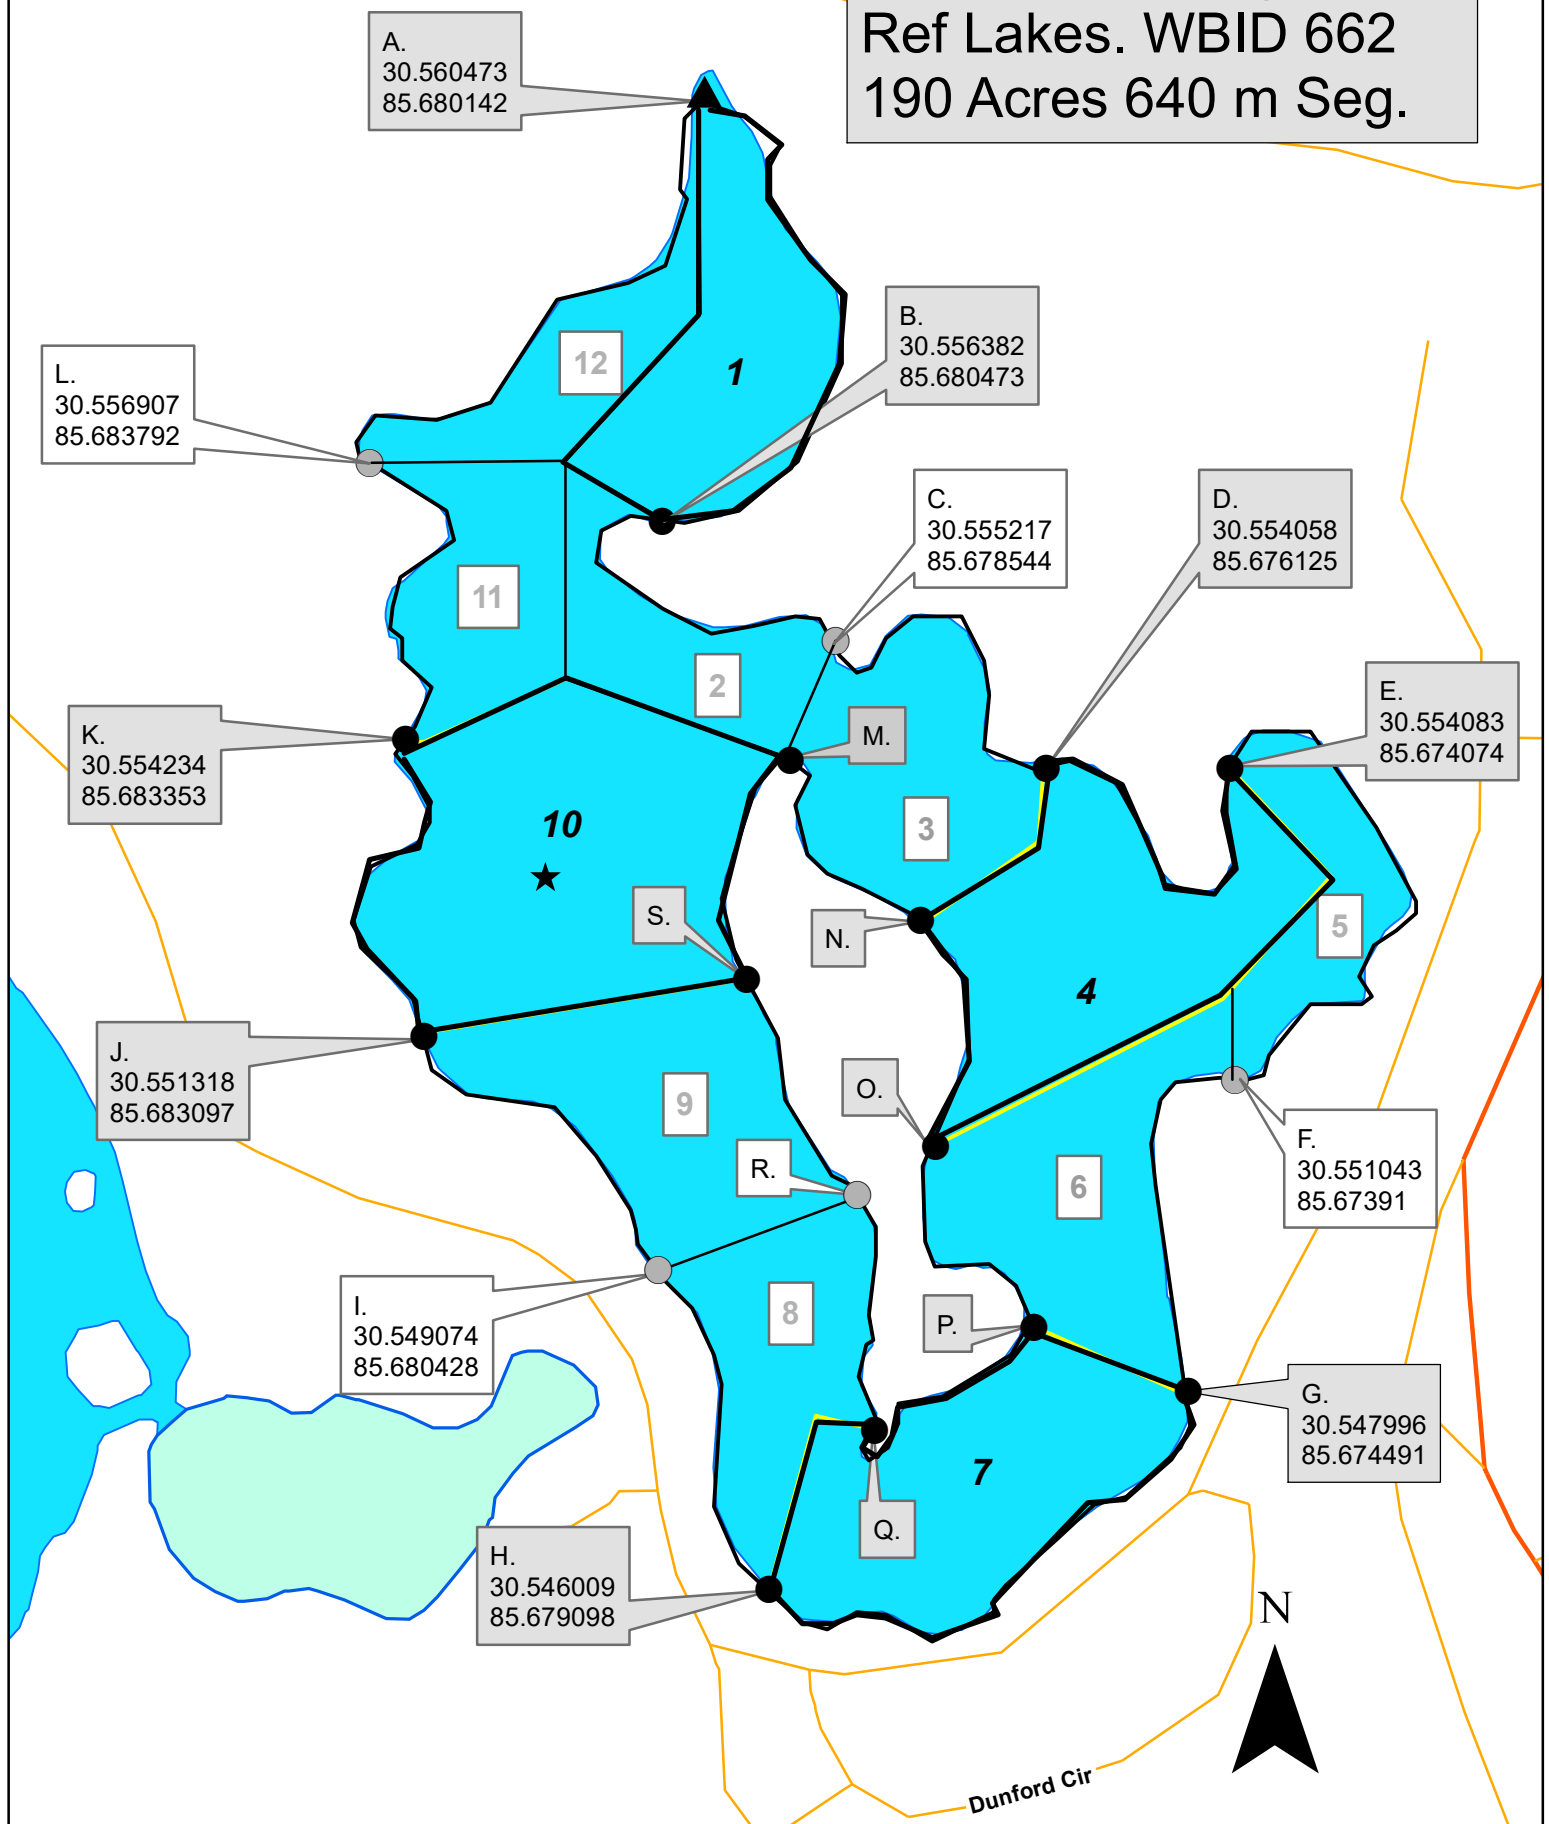
32010045\_Dunford Lk  
Vernon, Washington Co.  
Ref Lakes. WBID 662  
190 Acres 640 m Seg.

Receiving Water No Outlet  
 Basin / WBID St. Andrews's Bay / 662  
 City, County Vernon, Washington County  
 Lake Acreage 190.41  
 Circumference (M) 7679  
 Seg. Length (M) 639.9166667
