# FLORIDA DEPARTMENT OF ENVIRONMENTAL PROTECTION STRATEGIC MONITORING PROGRAM FIELD SHEET

**DEP Form FD 9000-5 Stream/River Habitat Assessment Field Sheet**

# DEP FORM FD 9000-25 Rapid Periphyton Survey Field Sheet

DEP Form FD 9000-4 Stream/River Habitat Assessment Sketch Sheet

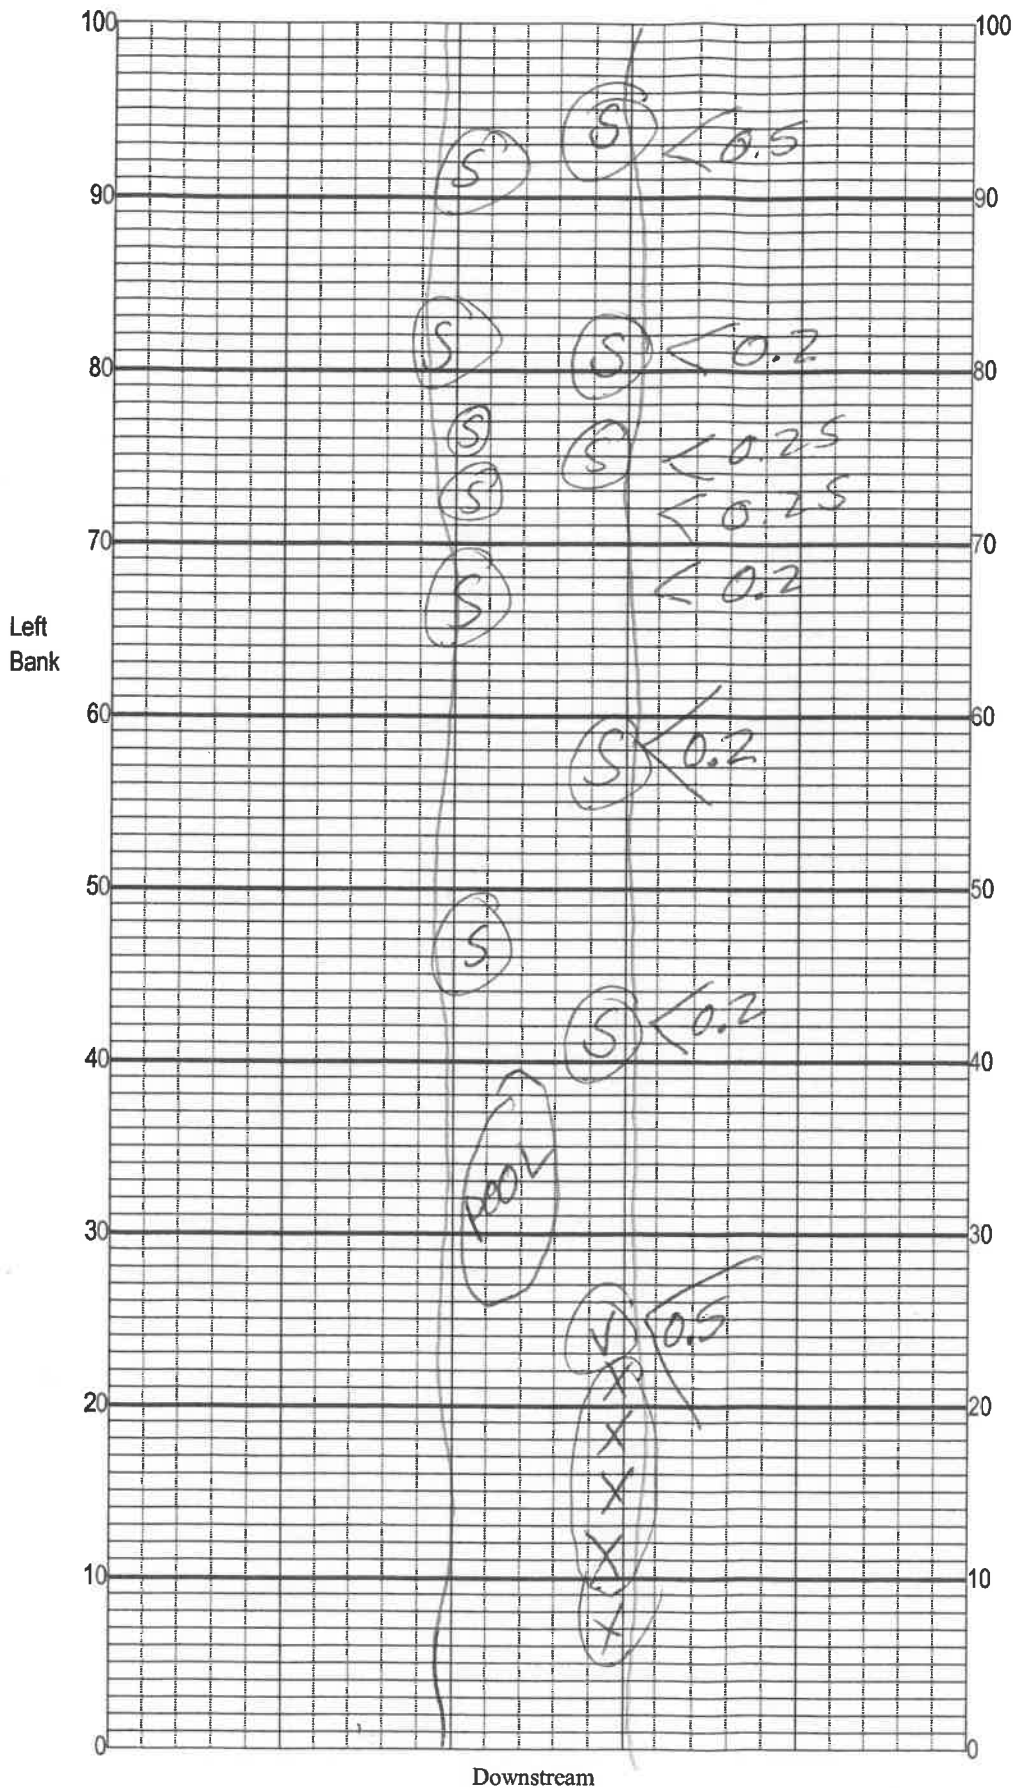
Length of grid represents 100 m of stream (not linear meters).  
(Horizontal scale is double vertical scale, draw proportionately).

Substrates: Code key, draw proportionate habitat abundance. %

☒ S Snags 1.2 %

☒ V Aquatic Macrophytes 0.3 %

☒ Pools total # observed = 1  
# range expected = ~5-11

Average width 1.5 m

Average depth 0.2 m

Velocity measured at 50 meter mark.

WQ & chemistry taken at 0 meter mark.

- low water levels with larger, snags (only partially submerged)
