# FLORIDA DEPARTMENT OF ENVIRONMENTAL PROTECTION STRATEGIC MONITORING PROGRAM FIELD SHEET

WIN Station Name: Bull Creek Canal 1.0M Upstr of Dead Lake Date: 10/30/19  
(mm/dd/yyyy)

DEP Form FD 9000-5 Stream/River Habitat Assessment Field Sheet

DEP Form FD 9000-4 Stream/River Habitat Assessment Sketch Sheet

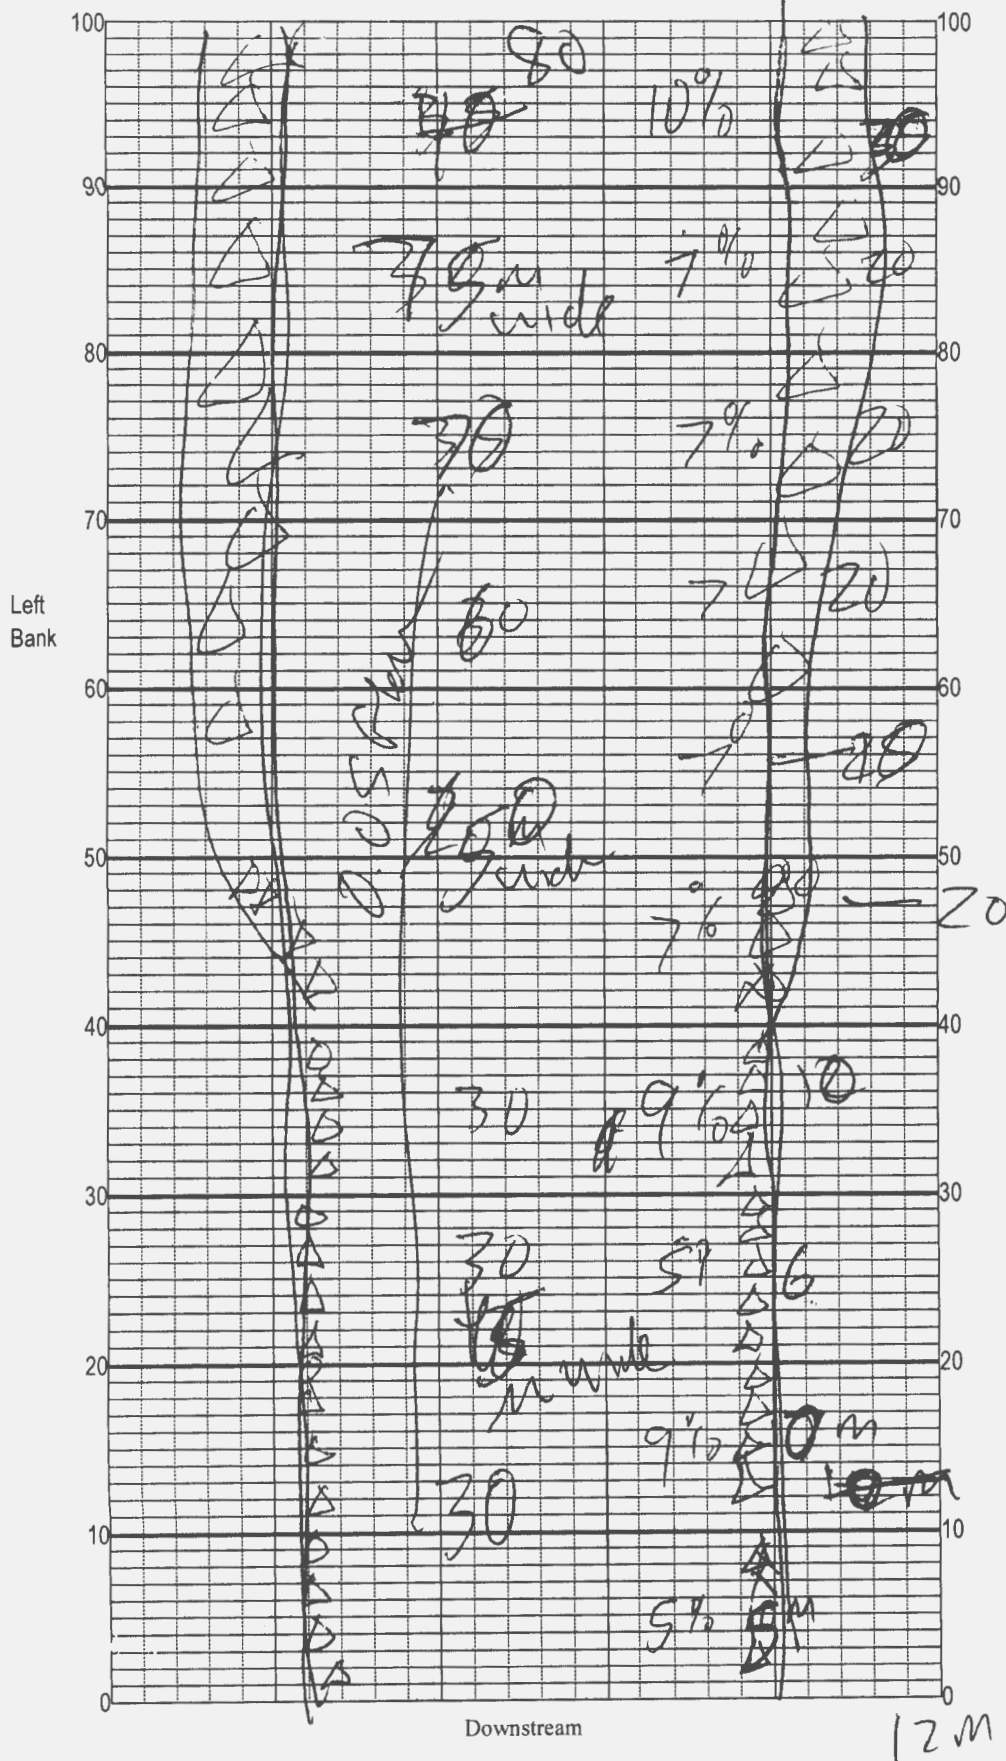
Location: Bullcreek 1 mile upstream  
 Date: 10/30/19  
 Sampler: SPm

2500 total  
 plants  
 5000 total

Length of grid represents 100 m of stream (not linear meters).  
 (Horizontal scale is double vertical scale, draw proportionately).
