# FLORIDA DEPARTMENT OF ENVIRONMENTAL PROTECTION STRATEGIC MONITORING PROGRAM FIELD SHEET

WIN Station Name: SJR at inlet to Little Lake Sawgrass

DEP Form FD 9000-5 Stream/River Habitat Assessment Field Sheet

DEP Form FD 9000-4 Stream/River Habitat Assessment Sketch Sheet

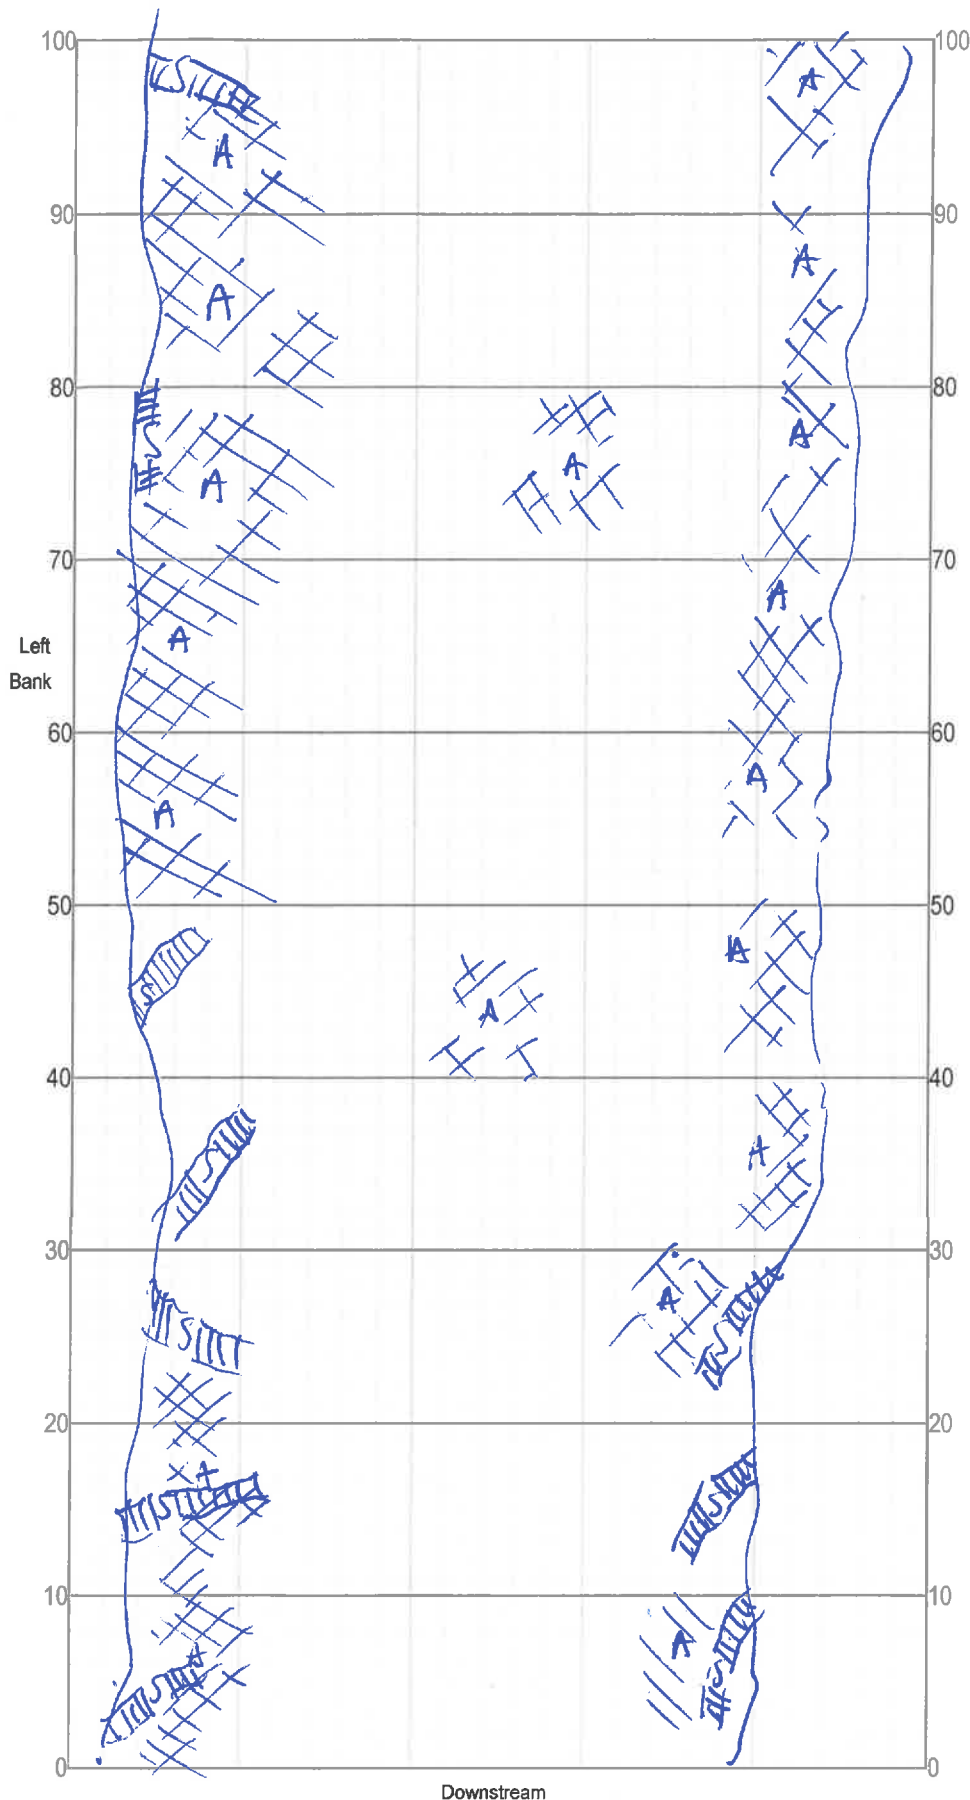
Location: SIR at inlet to Little Lake  
 Date: 12/16/2019 Sungass  
 Sampler: Leif Brown, Terry Riordan

Substrates: Code key, draw proportionate habitat abundance. %

| <input checked="" type="checkbox"/> | Snags | <u>0.67</u> |
| <input checked="" type="checkbox"/> | Aquatic Macrophytes | <u>1.67</u> |

Average width 30 m  
 Average depth \_\_\_\_\_ m

Velocity measured at 0.50 meter mark.

WQ & chemistry taken at 0 meter mark.
