Site Name Allen Lake (Middle)

Project: SMP / TMDL Studies

# DEP FORM FD 9000-31: LAKE OBSERVATION FIELD SHEET

**STATE OF FLORIDA, DEPARTMENT OF ENVIRONMENTAL PROTECTION**  
**Lake Habitat Assessment Field Sheet**

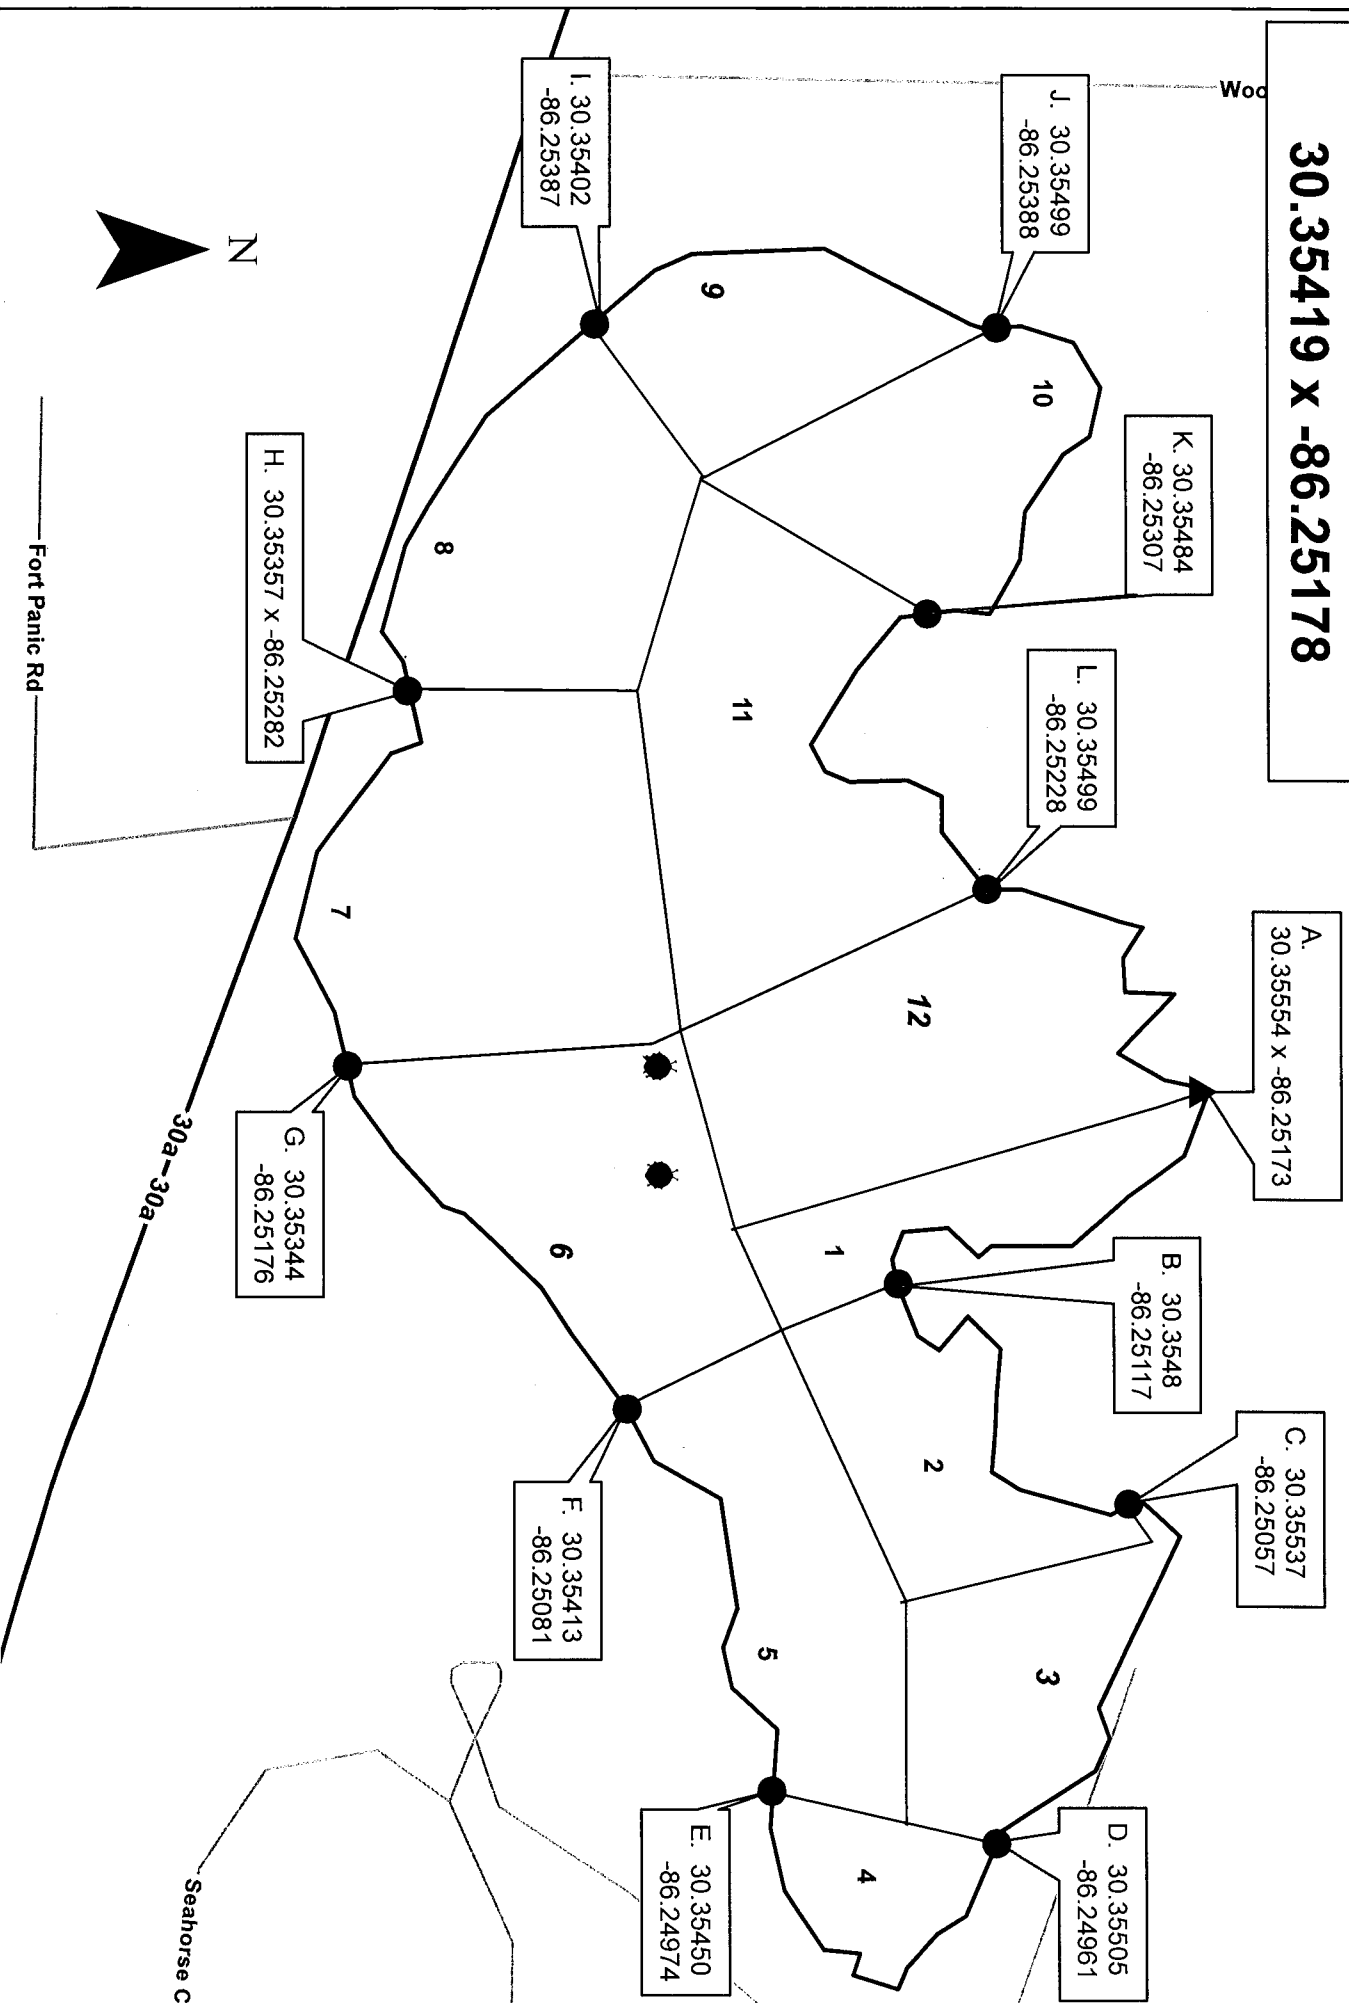
**Allan Lake Storet G3NW0085  
WBID 959H. SMP Lakes 2018  
30.35419 x -86.25178**

- 1 Section 12 - North
- 2 Section 12 - Surface
- 3 North - Shore
- 4 East - Shore
- 5 South - shore
- 6 West - shore
- 7 \_\_\_\_\_
- 8 \_\_\_\_\_
- 9 \_\_\_\_\_
- 10 \_\_\_\_\_
- 11 \_\_\_\_\_
- 12 \_\_\_\_\_
- 13 \_\_\_\_\_
- 14 \_\_\_\_\_
- 15 \_\_\_\_\_
- 16 \_\_\_\_\_
- 17 \_\_\_\_\_
