# FLORIDA DEPARTMENT OF ENVIRONMENTAL PROTECTION STRATEGIC MONITORING PROGRAM FIELD SHEET

WIN Station Name: Red House Br @ Hefferon Rd

DEP Form FD 9000-4 Stream/River Habitat Assessment Sketch Sheet

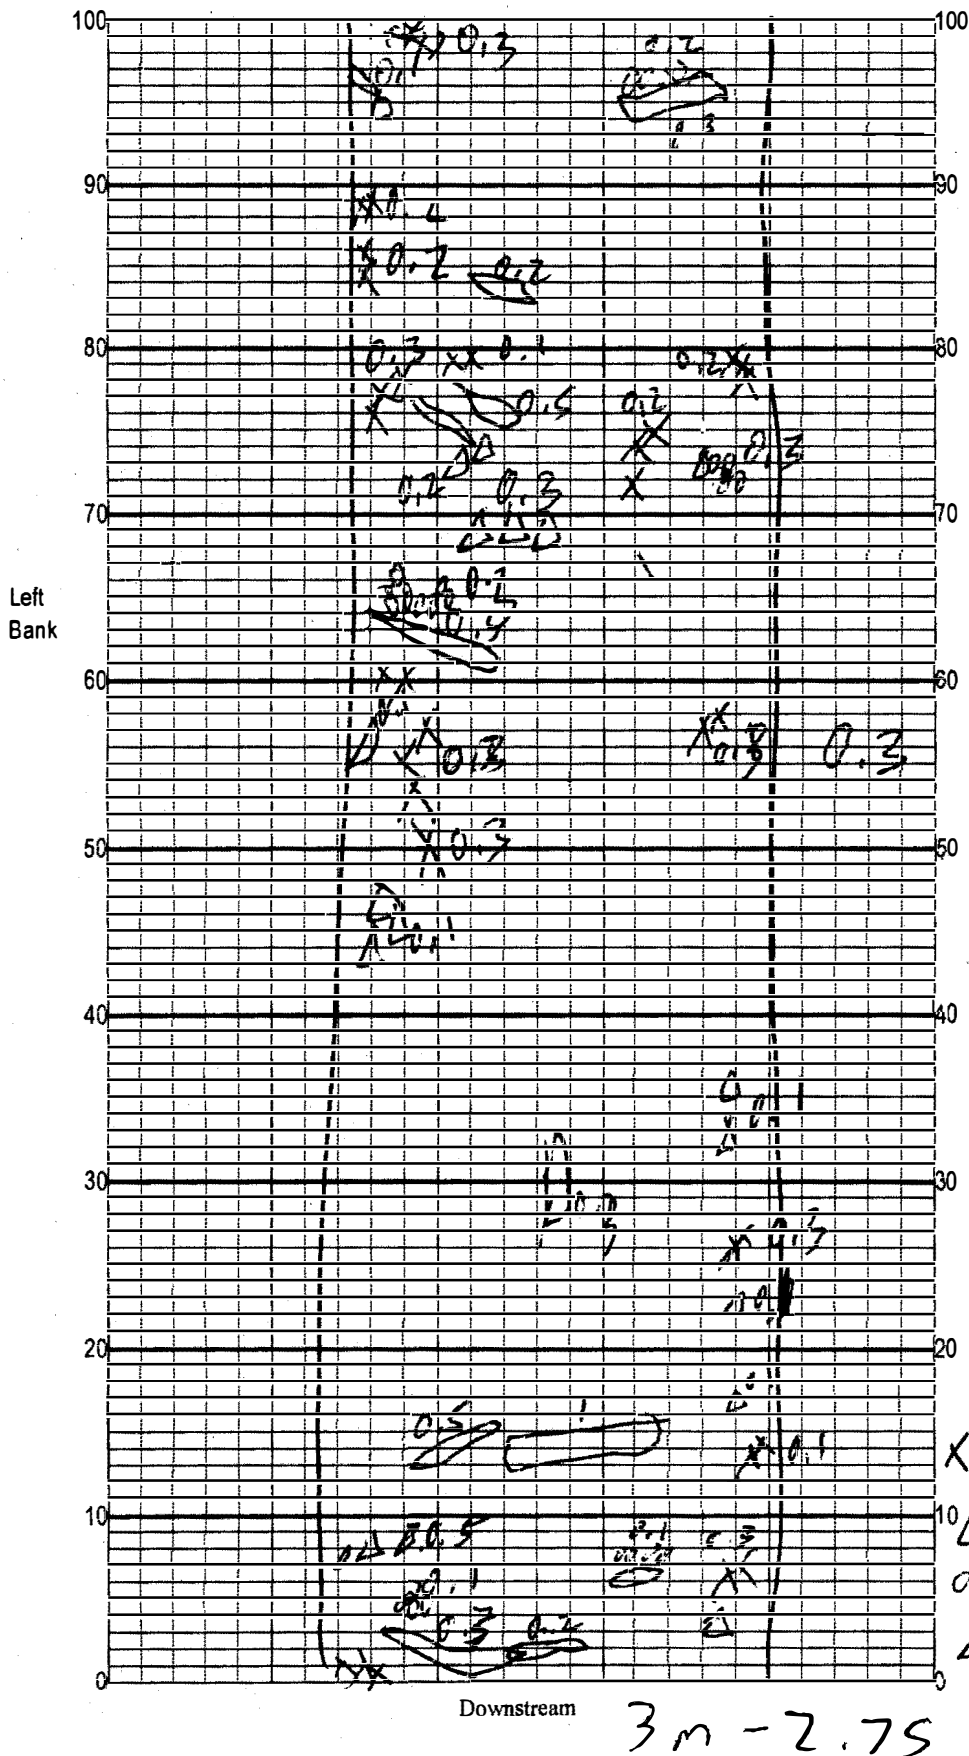
Location: Rothaus Branch @ Hottel

Substrates: Code key, draw proportionate habitat abundance. %

| | Snags | 2.5 |
| | Roots/undercut banks | 1.5 |
| | Leaf Packs (or mats) | 1 |
| | Aquatic Macrophytes | 1 |

Average width 0.5 m  
Average depth 0.5 m

0.3 m sec

Length of grid represents 100 m of stream (not linear meters).  
(Horizontal scale is double vertical scale, draw proportionately).
