# FLORIDA DEPARTMENT OF ENVIRONMENTAL PROTECTION STRATEGIC MONITORING PROGRAM FIELD SHEET

**WIN Station Name:** Wildcat Slough @ Mosaic S2 **Date:** 12/8/2020  
**WIN/Field ID:** G3SW0055 **WBID:** 1955 **ENR:** **Latitude:** 27.2362  
**County:** MANATEE **Org ID:** 21FLTPA **Longitude:** -82.1067  
**Receiving Body of Water:** Sarasota Bay - Peace - Myakka **RQ:** 2020-10-26-02

## DEP Form FD 9000-4 Stream/River Habitat Assessment Sketch Sheet

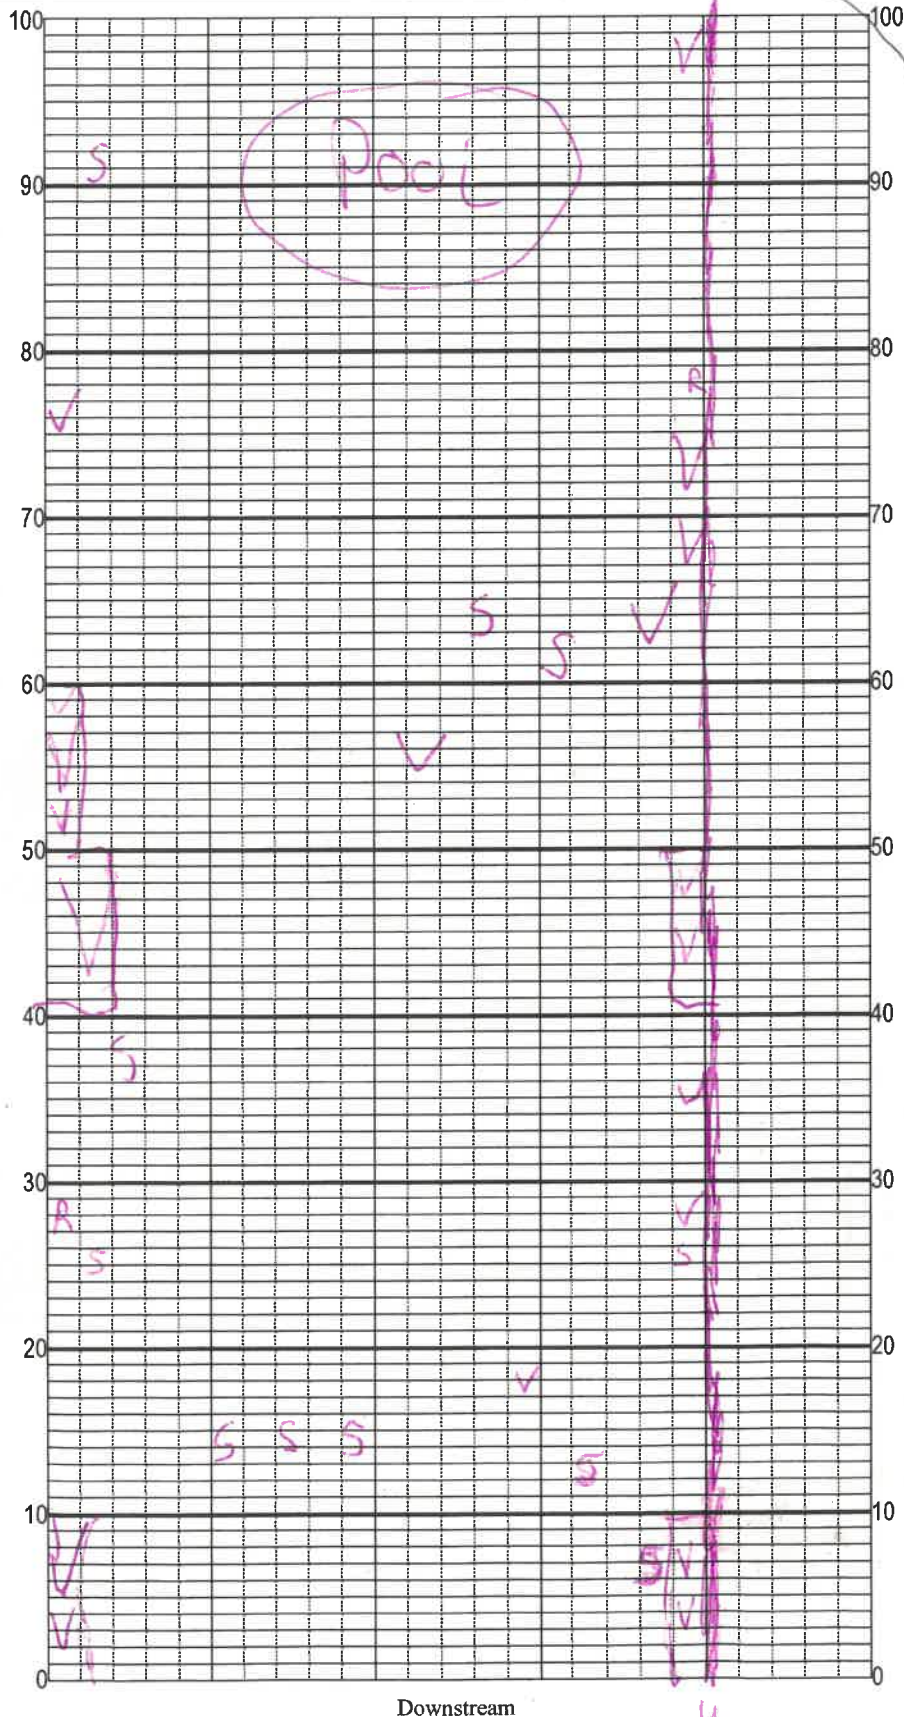
Length of grid represents 100 m of stream (not linear meters).  
(Horizontal scale is double vertical scale, draw proportionately).

Snags

1.9

Aquatic Macrophytes

4.4

total # observed = 1

S = 38/2000 1.9  
V = 88/2000 4.4  
Handwritten notes and sketches are present below the grid.
