# FLORIDA DEPARTMENT OF ENVIRONMENTAL PROTECTION STRATEGIC MONITORING PROGRAM FIELD SHEET

**WIN Station Name:** Sugar Creek @ Suwannee River **Date:** 3/30/2021  
**WIN/Field ID:** G1TLHR0047 **WBID:** 3389 **ENR:** - **Latitude:** 30.3981  
**County:** HAMILTON **Org ID:** 21FLTLHR **Longitude:** -82.9343  
**Receiving Body of Water:** Suwannee **RQ:** 2021-01-18-44

# DEP Form FD 9000-5 Stream/River Habitat Assessment Field Sheet

**DEP Form FD 9000-4 Stream/River Habitat Assessment Sketch Sheet**

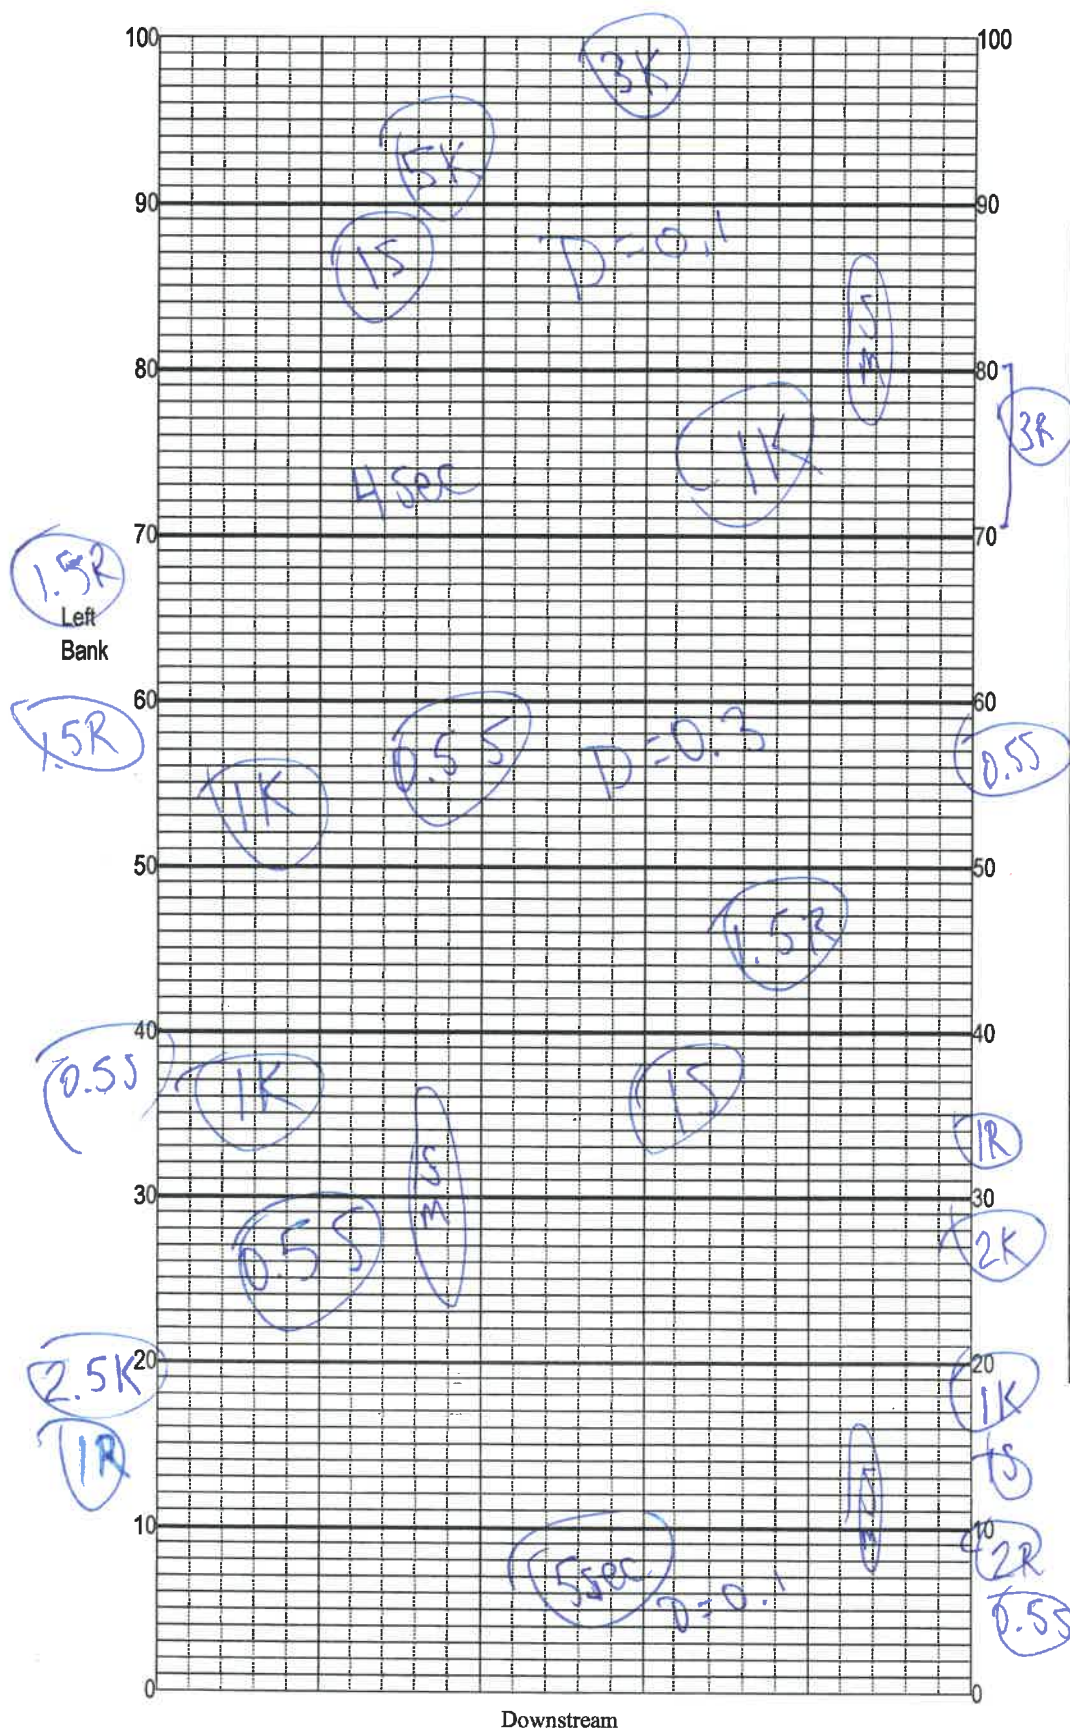
Location: Sugar Creek @ Sullivan

| Substrates: Code key, draw proportionate habitat abundance. % |
| <input checked="" type="checkbox"/> S Snags 4.3 |
| <input checked="" type="checkbox"/> R Roots/undercut banks 7 |
| <input checked="" type="checkbox"/> K rock 11 |
| Average width <del>0.25</del> 0.34 m |
| Average depth 0.16 m |
| Velocity measured at 75 meter mark. |
| WQ & chemistry taken at 10 meter mark. |

16.5 K  
6.5 S  
10.5 R

Length of grid represents 100 m of stream (not linear meters).  
(Horizontal scale is double vertical scale, draw proportionately).
