# FLORIDA DEPARTMENT OF ENVIRONMENTAL PROTECTION

## STRATEGIC MONITORING PLAN FIELD SHEET

**WIN Station Name:** Inter-Coastal 450m d-stream Pine Log Boat Ramp **Date:** 6/7/2022

DEP Form FD 9000-4 Stream/River Habitat Assessment Sketch Sheet

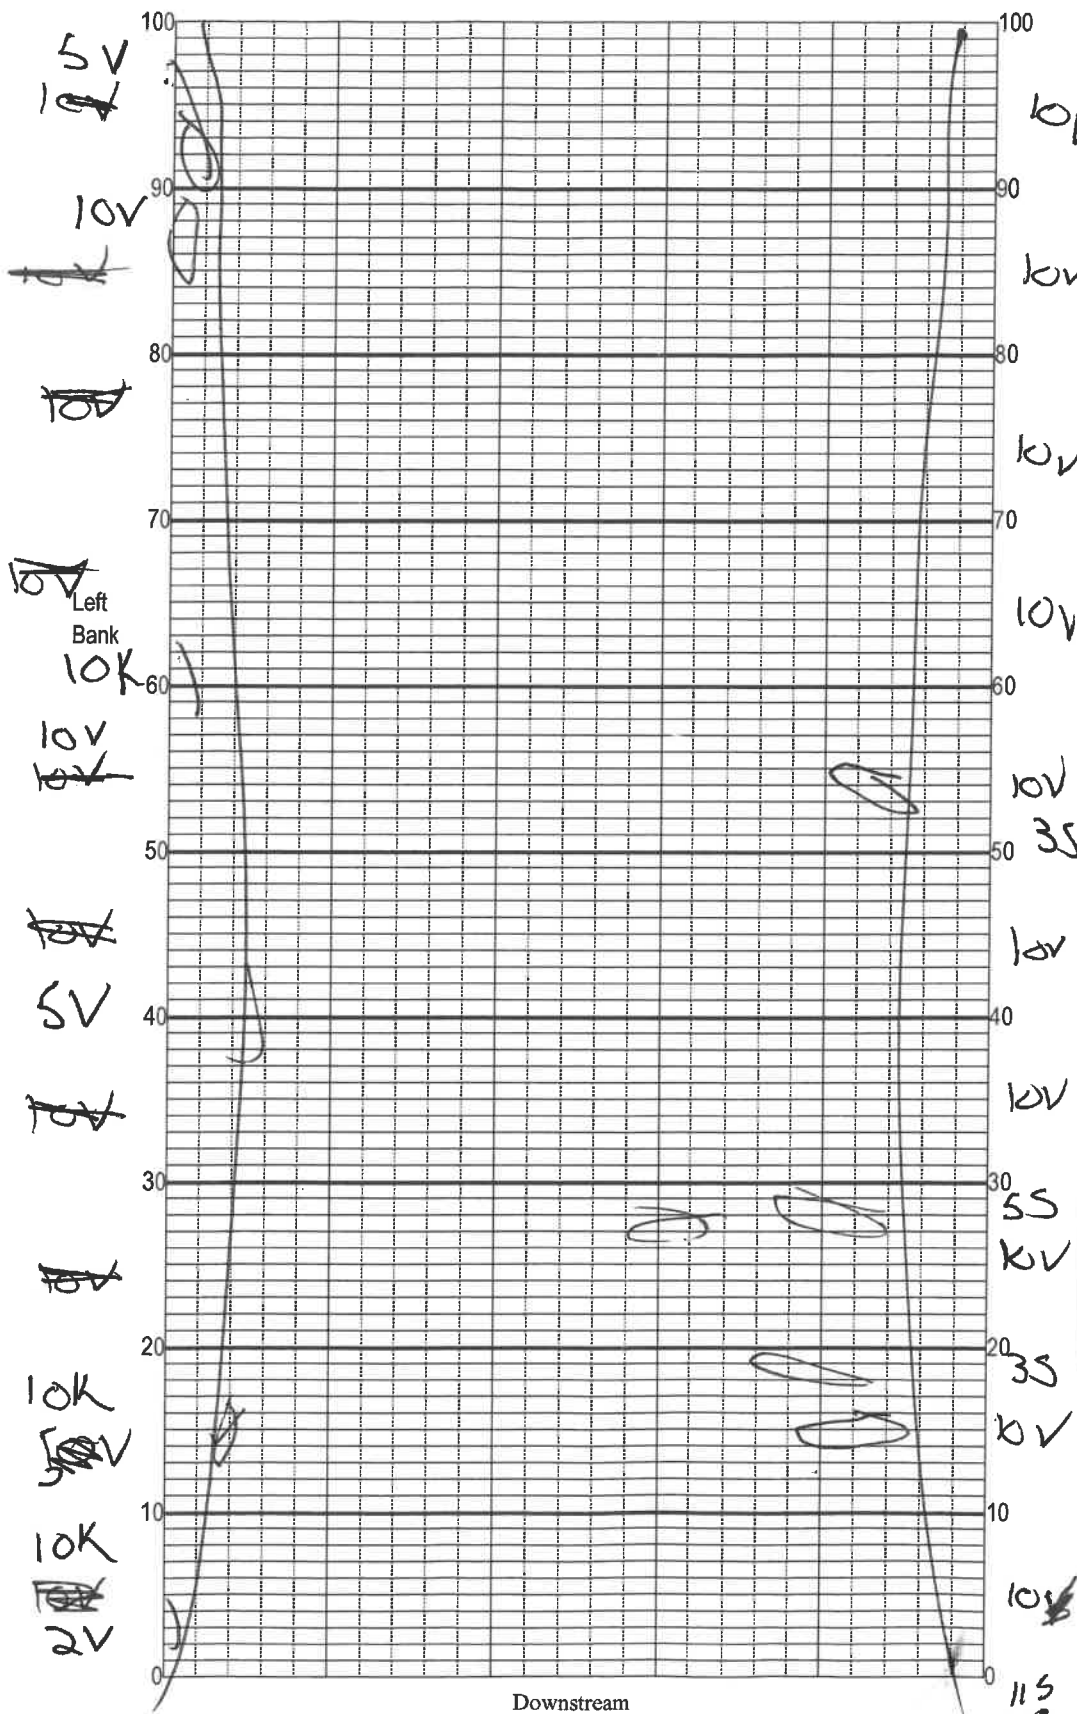
Average width 110 m  
 Average depth 3.6 m

Velocity measured at 50 meter mark.

WQ & chemistry taken at 0 meter mark.

11 S  
 137 A  
 30 K

Length of grid represents 100 m of stream (not linear meters).  
 (Horizontal scale is double vertical scale, draw proportionately).

37 A
