## Fanning Springs Restoration Plan

ENV 6932K – Spring Systems, Dr. Knight

# **Fanning Springs Restoration Plan**

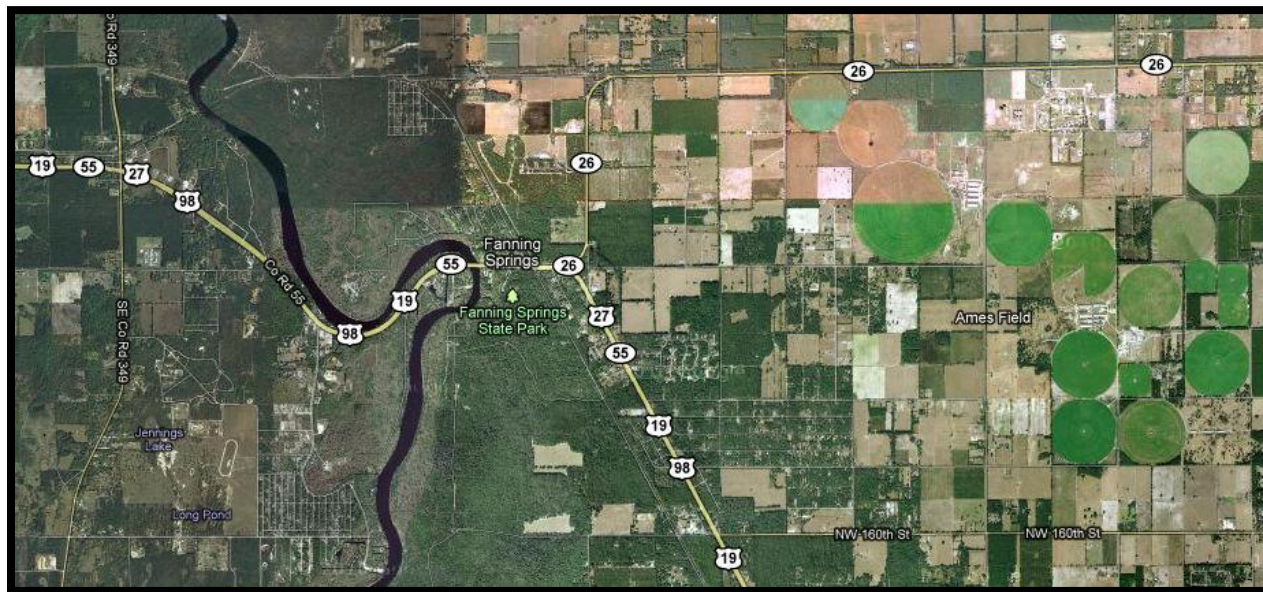
Fanning Springs (Latitude 29° 35' 15.3", Longitude 82° 56' 7.1") is located in Levy County, FL inside of a Florida State Park. The spring run flows 450 feet to the Suwannee River (Scott et al. 2002). Figure 1 shows an aerial view of Fanning Springs State Park and some of the surrounding land.

**Figure 1. Aerial view of Fanning Springs and surrounding land.**

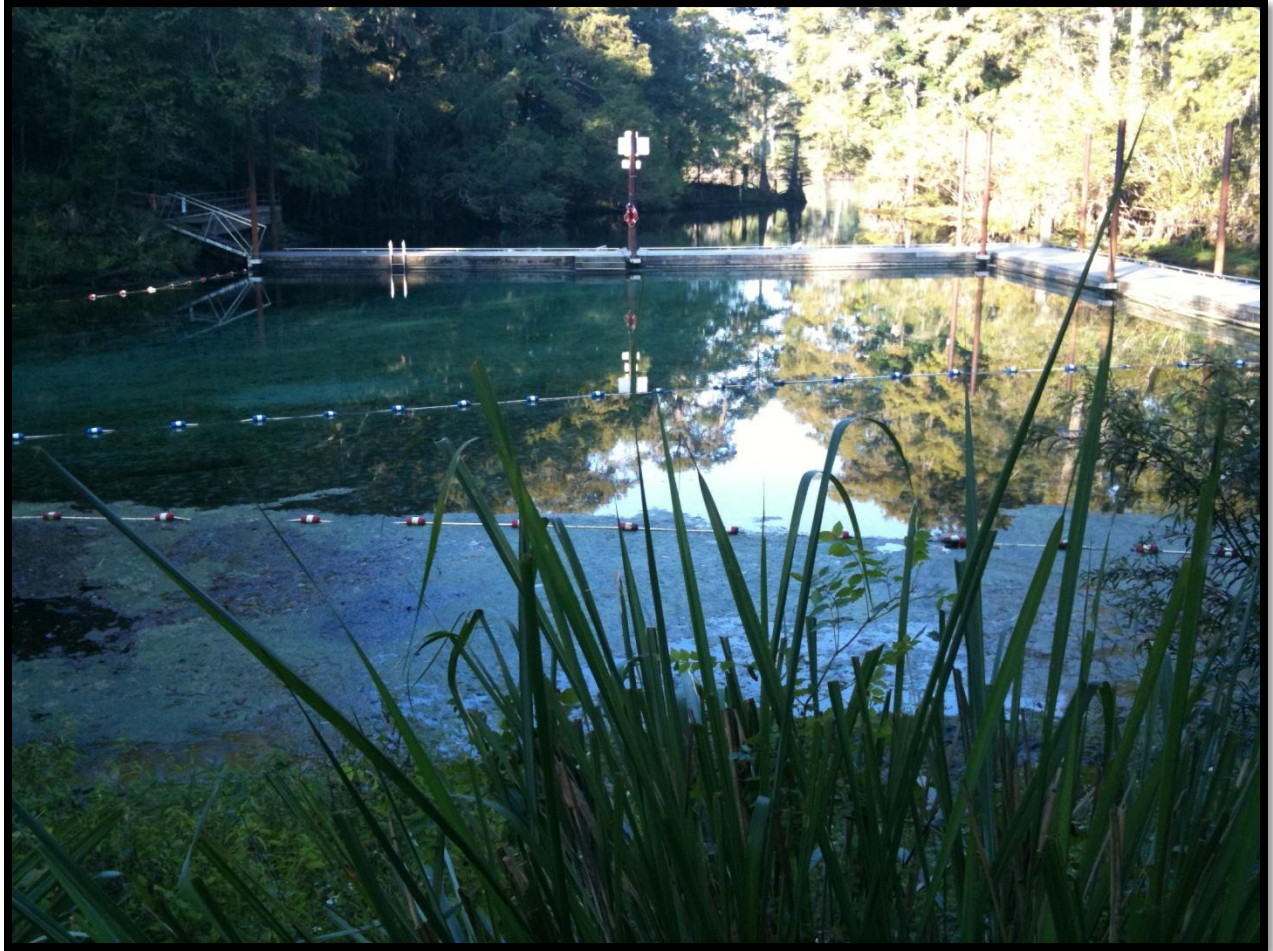
Figure 5. The floating dock spans almost the entire spring run.

A floating dock spans the width of the spring run and may make it difficult for manatees to reach the spring during low water levels, reducing its habitat capability (see Figure 5). In order to support boat travel, the spring run must be occasionally dredged, damaging submerged aquatic vegetation and causing increased erosion. (Farrell & Upchurch 2005)

- Remove the floating dock that spans the length of the spring run. This dock is used by recreational visitors for sunbathing and by boaters to tie their boats when they come in from the Suwannee. This dock is potentially limiting the access of manatees to the warm spring waters. Its location also requires the occasional dredging of the spring run for boat access, which destroys the submerged aquatic vegetation (SAV) there. The loss of SAV results in less habitat viability for spring fauna, and less nutrient treatment for downstream waters.

Relocating the dock on to the Suwannee River and allowing boaters access to the spring from there via an extended boardwalk would promote natural plant and animal life to return while accommodating visitors. This was done at Manatee Springs with success (White 2003).

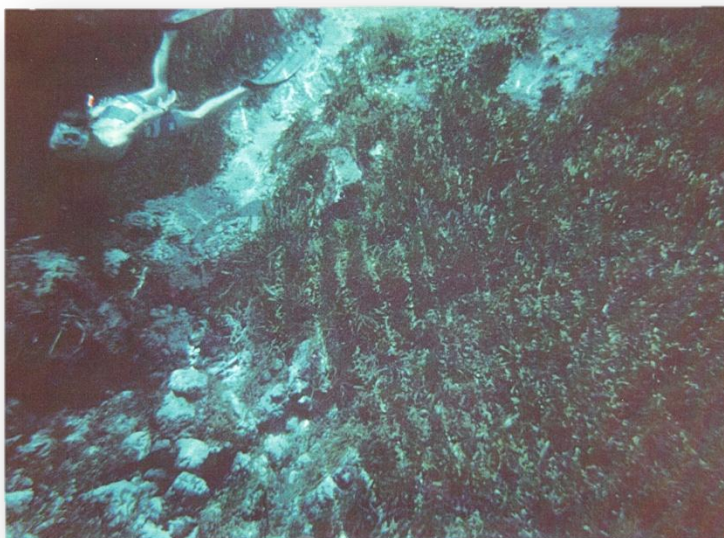
Figure 6. Photo of Fanning Spring from 1989 showing the dense SAV cover.

SAV coverage in Fanning Springs was dominant before the site became a public park in 1997 (Spear 2010) (See Figure 6). Over the course of a little more than a decade the SAV has almost vanished from this system (see Figure 7). SAV, such as *Vallisneria* or *Sagittaria*, is an important component of a spring ecosystem, providing a habitat structure for flora and fauna to survive as well as a food source for species ranging from snails to manatees. The loss of this vegetation severely limits the ability of the spring to support life. This plan aims to restore the SAV to its former abundance according to Table 4. Due to the popularity of the park, it is unlikely to restore 100% vegetation in the spring pool unless swimming is no longer allowed, which is considered unrealistic at this time. That is why the SAV coverage goal for the spring run (where no swimming occurs) and the spring boil (where it is too deep to wade) are 100% coverage and the spring pool is 50%.
