# **FLORIDA SEA GRANT PROGRAM**

## **ST. LUCIE INLET Glossary of Inlets Report # 1**

by Todd L. Walton

July 1974

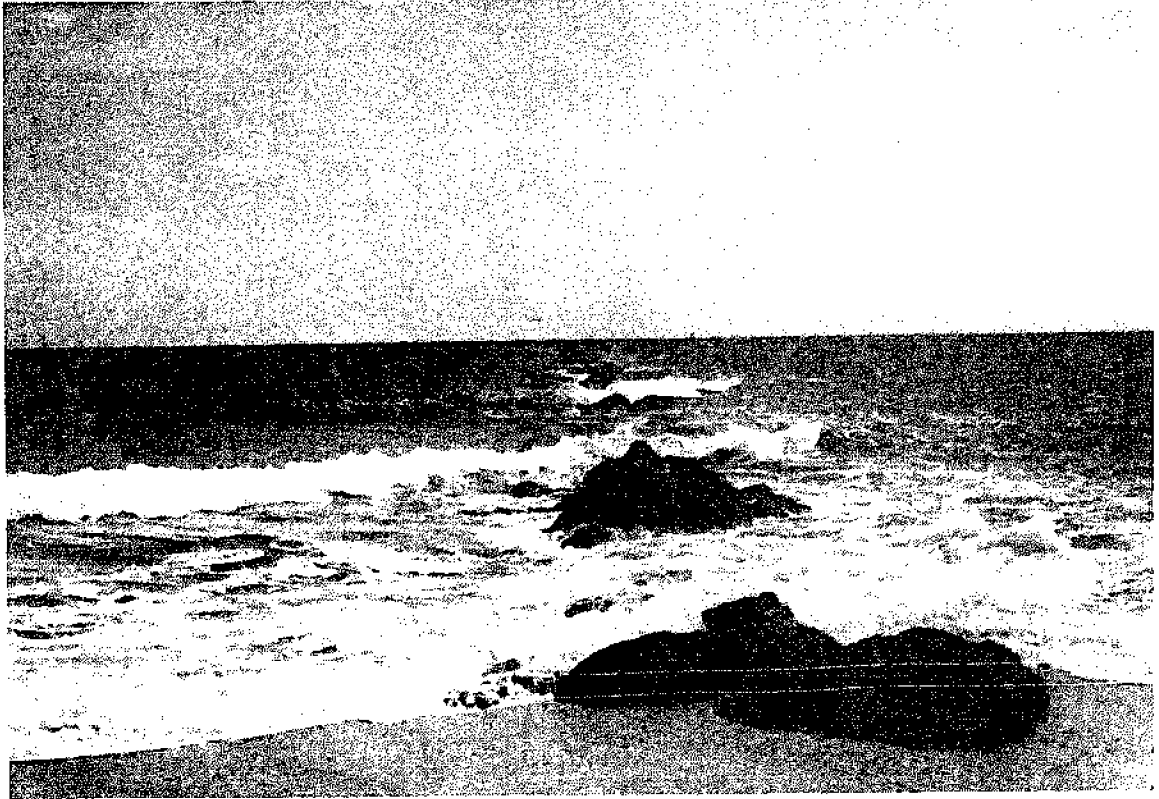
FIGURE 3. PORTION OF NORTH JETTY AT ST.  
LUCIE INLET

During the same 1926-1929 period, local interests constructed a jetty extending from the North inlet point to the rock reef, about 3,325 feet long. The jetty material was mainly coquina rock with a density of 113-125 lbs./ft.<sup>3</sup> (Specific gravity 1.8-2.0) and maximum dimensions of 6-7 feet (see Figure 3). The offshore portion of the jetty was partly covered with granite blocks.

The jetty originated from the 1926-1929 shoreline which is approximately 1800 feet west of the present shoreline on the north side of the Inlet. A sand and shell levee with stone revetment was planned on the south side of the inlet to act as a contraction work, but was never constructed. A portion of the dredged material from the channel was spoiled at this location as mentioned. The constriction caused by spoiling of dredged material in the vicinity of the planned contraction work, along with the confining action of the North Jetty caused some scour in the inlet, allowing for a controlling depth through the inlet of approximately 5 to 6 feet mean low water (MLW).

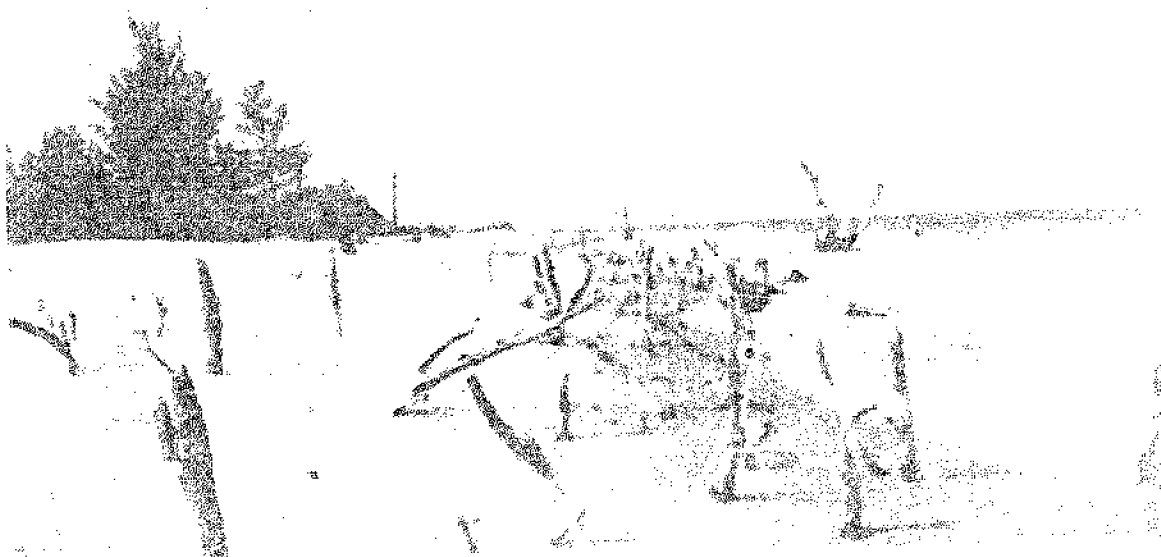
FIGURE 9. EROSION DIRECTLY SOUTH OF ST. LUCIE  
INLET
