**PRELIMINARY GROUND WATER BASIN DELINEATION  
FOR THE SPRING LAKE SPRING GROUP  
JACKSON COUNTY, FLORIDA**

**PREPARED BY:  
NORTHWEST FLORIDA  
WATER MANAGEMENT DISTRICT  
JUNE 2003**

Water Resources Special Report 03-02

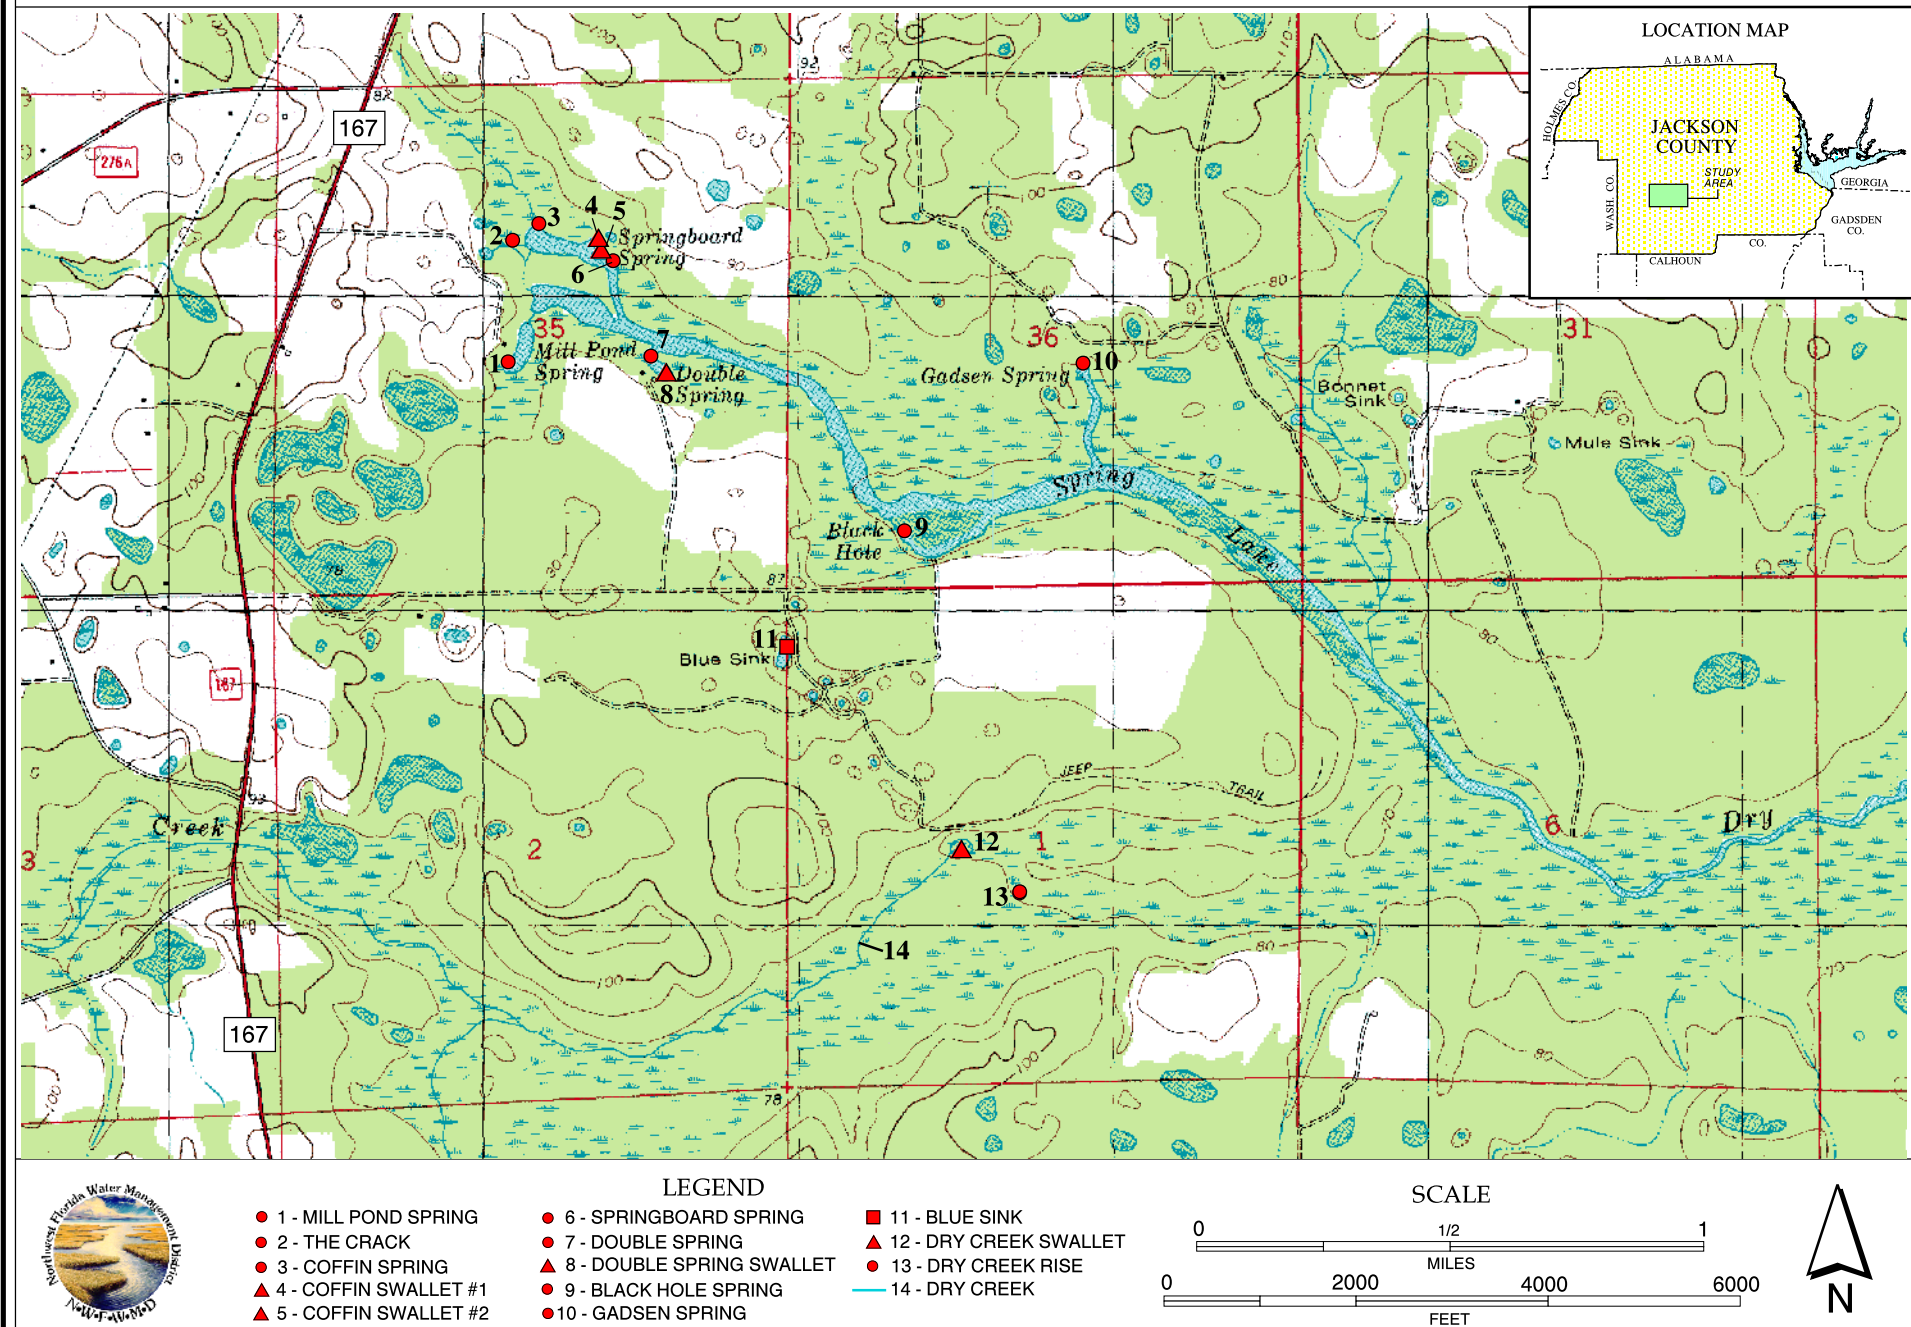
FIGURE 1

# LOCATIONS OF KARST FEATURES PERTINENT TO STUDY

A thorough field reconnaissance was conducted to locate karst features pertinent to the study (Figure 1). Understanding the relative spatial proximity of these features was crucial when considering issues such as dye introduction and recovery. Eight springs, four swallets, a karst window and a sinking stream were visited and located with differential GPS. Numerous other sinkholes were visited, but were deemed not relevant to the study. Blue Sink is considered to be a karst window. Although water flow across the sink was not observed during the study, conversations with the landowner indicate that divers have previously observed water discharging from the south end of the feature and sinking at the north end.

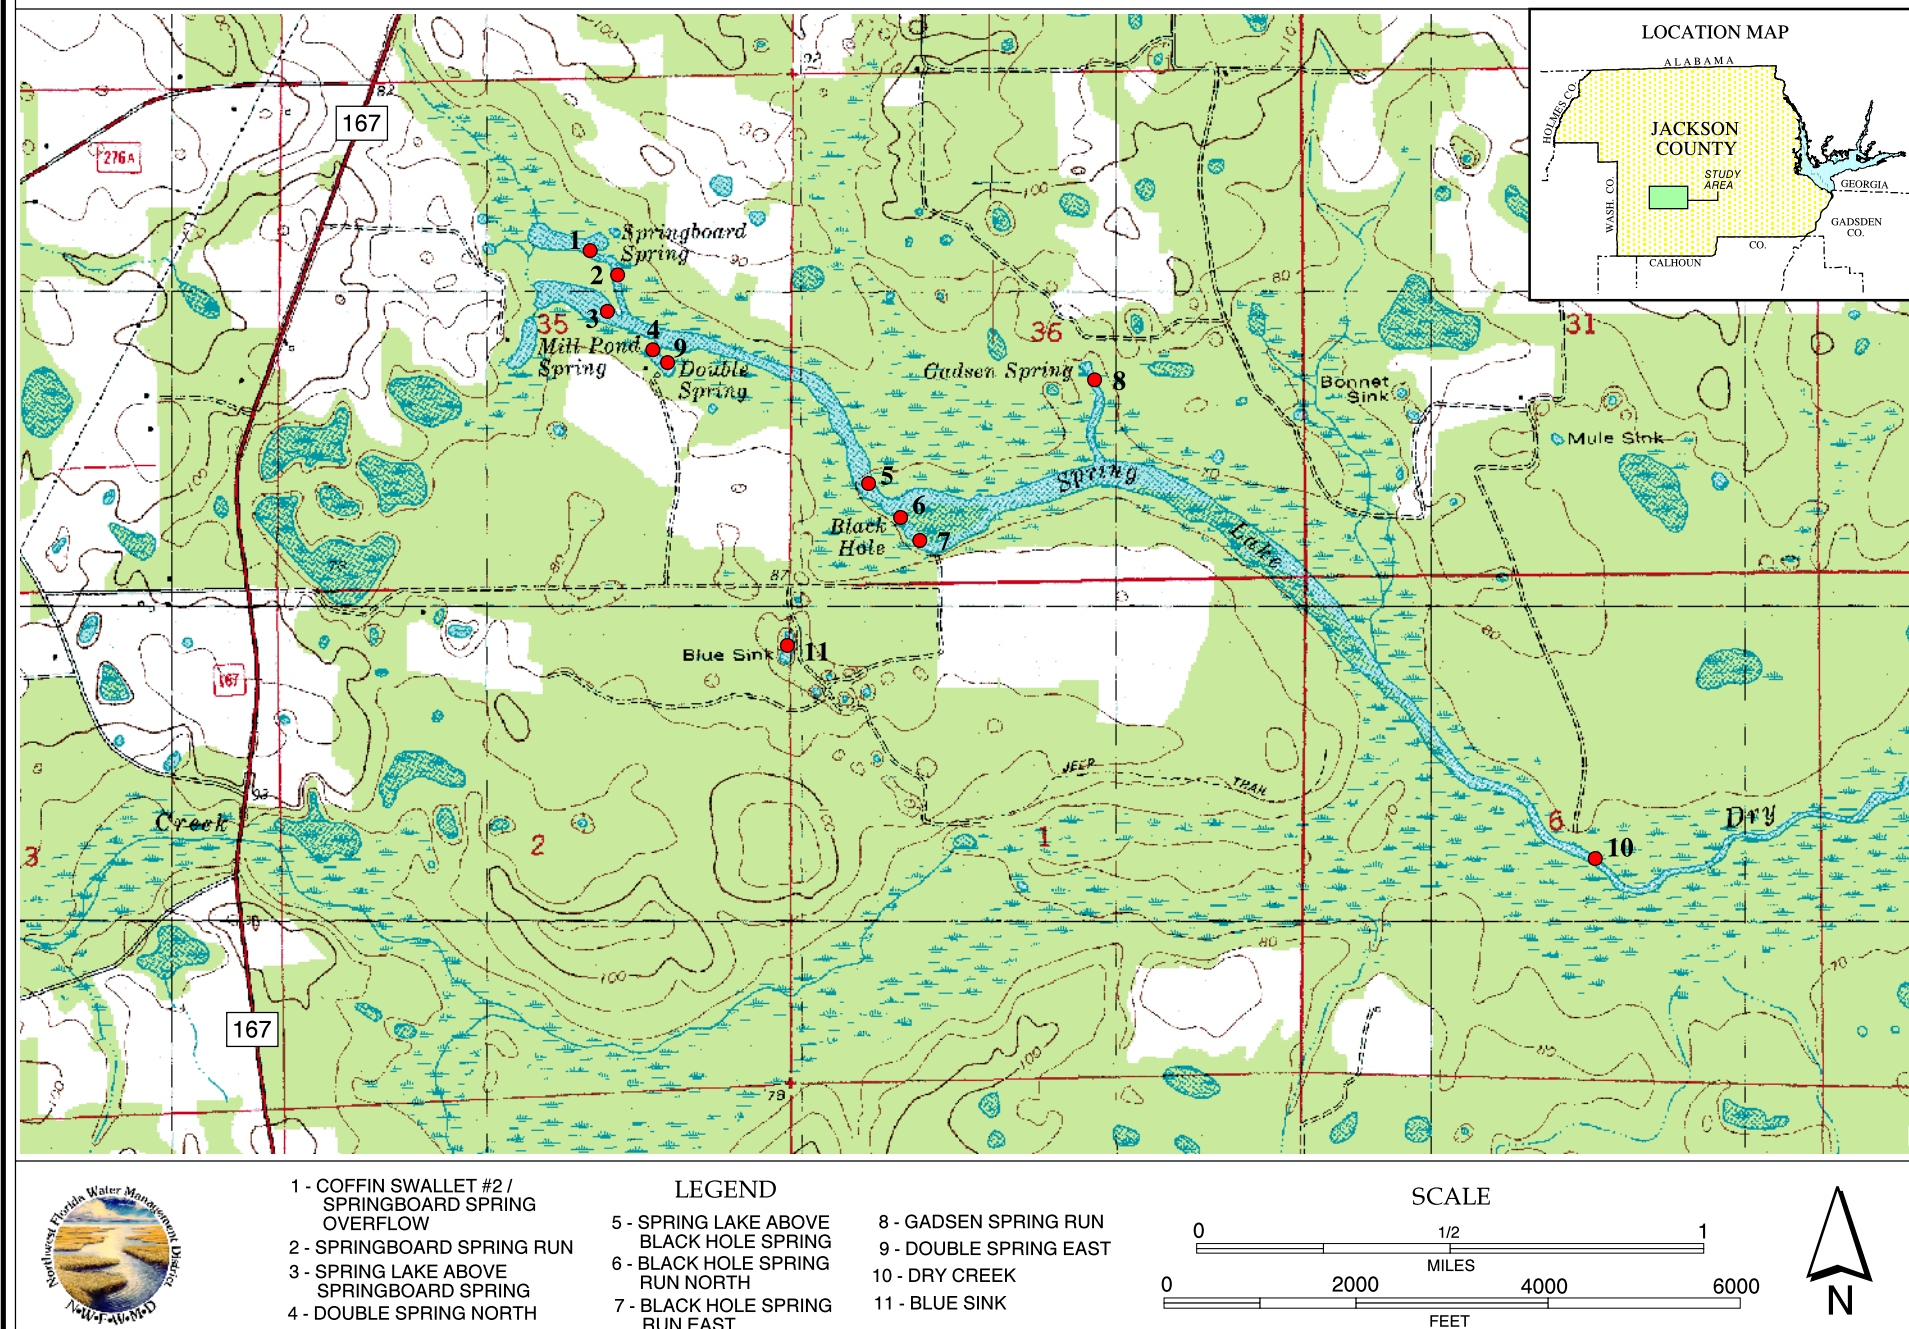
# DYE MONITORING LOCATIONS

Detectors were deployed at the following locations:

1—Surface water overflow between Coffin swallet #2 and Springboard Spring run. The site was established as a confirmation that dye was not traveling overland during trace I and being recovered at location 2. This feature conveyed water for the entirety of the study period.

2—Springboard Spring run downgradient of Springboard Spring vent. The site was established to recover dye discharging from Springboard Spring.

3—Spring Lake upgradient of the confluence of the Springboard Spring run and Spring Lake. The site was established as a confirmation that dye was not discharging from Mill Pond Spring or the Crack.

4—Double Spring. The site was established to recover dye discharging from Double Spring.

5—Spring Lake upgradient of Black Hole Spring. The site was established to recover dye that may have been discharging to Spring Lake between Double Spring and Black Hole Spring.

6—Northerly flowing limb of the Black Hole Spring run. Black Hole Spring run bifurcates around a small island. For the duration of the study, water flowed out from Black Hole Spring to Spring Lake along both limbs of the bifurcated run. At no point did water flow in from Spring Lake and over Black Hole spring.

7—Easterly flowing limb of Black Hole Spring run.

8—Gadsen Spring run downgradient of Gadsen Spring vent. The site was established to recover dye discharging from Gadsen Spring.

9—Double Spring run downgradient of Double Spring vent. The site was established to confirm that dye discharging from Double Spring was traveling downgradient and sinking at Double Spring swallet.

10—Dry Creek downgradient of known springs in the group. The site was established to recover dye that may have been discharging from unknown locations.

11—Blue Sink. The site was established to recover dye discharging from the south end of the sink.

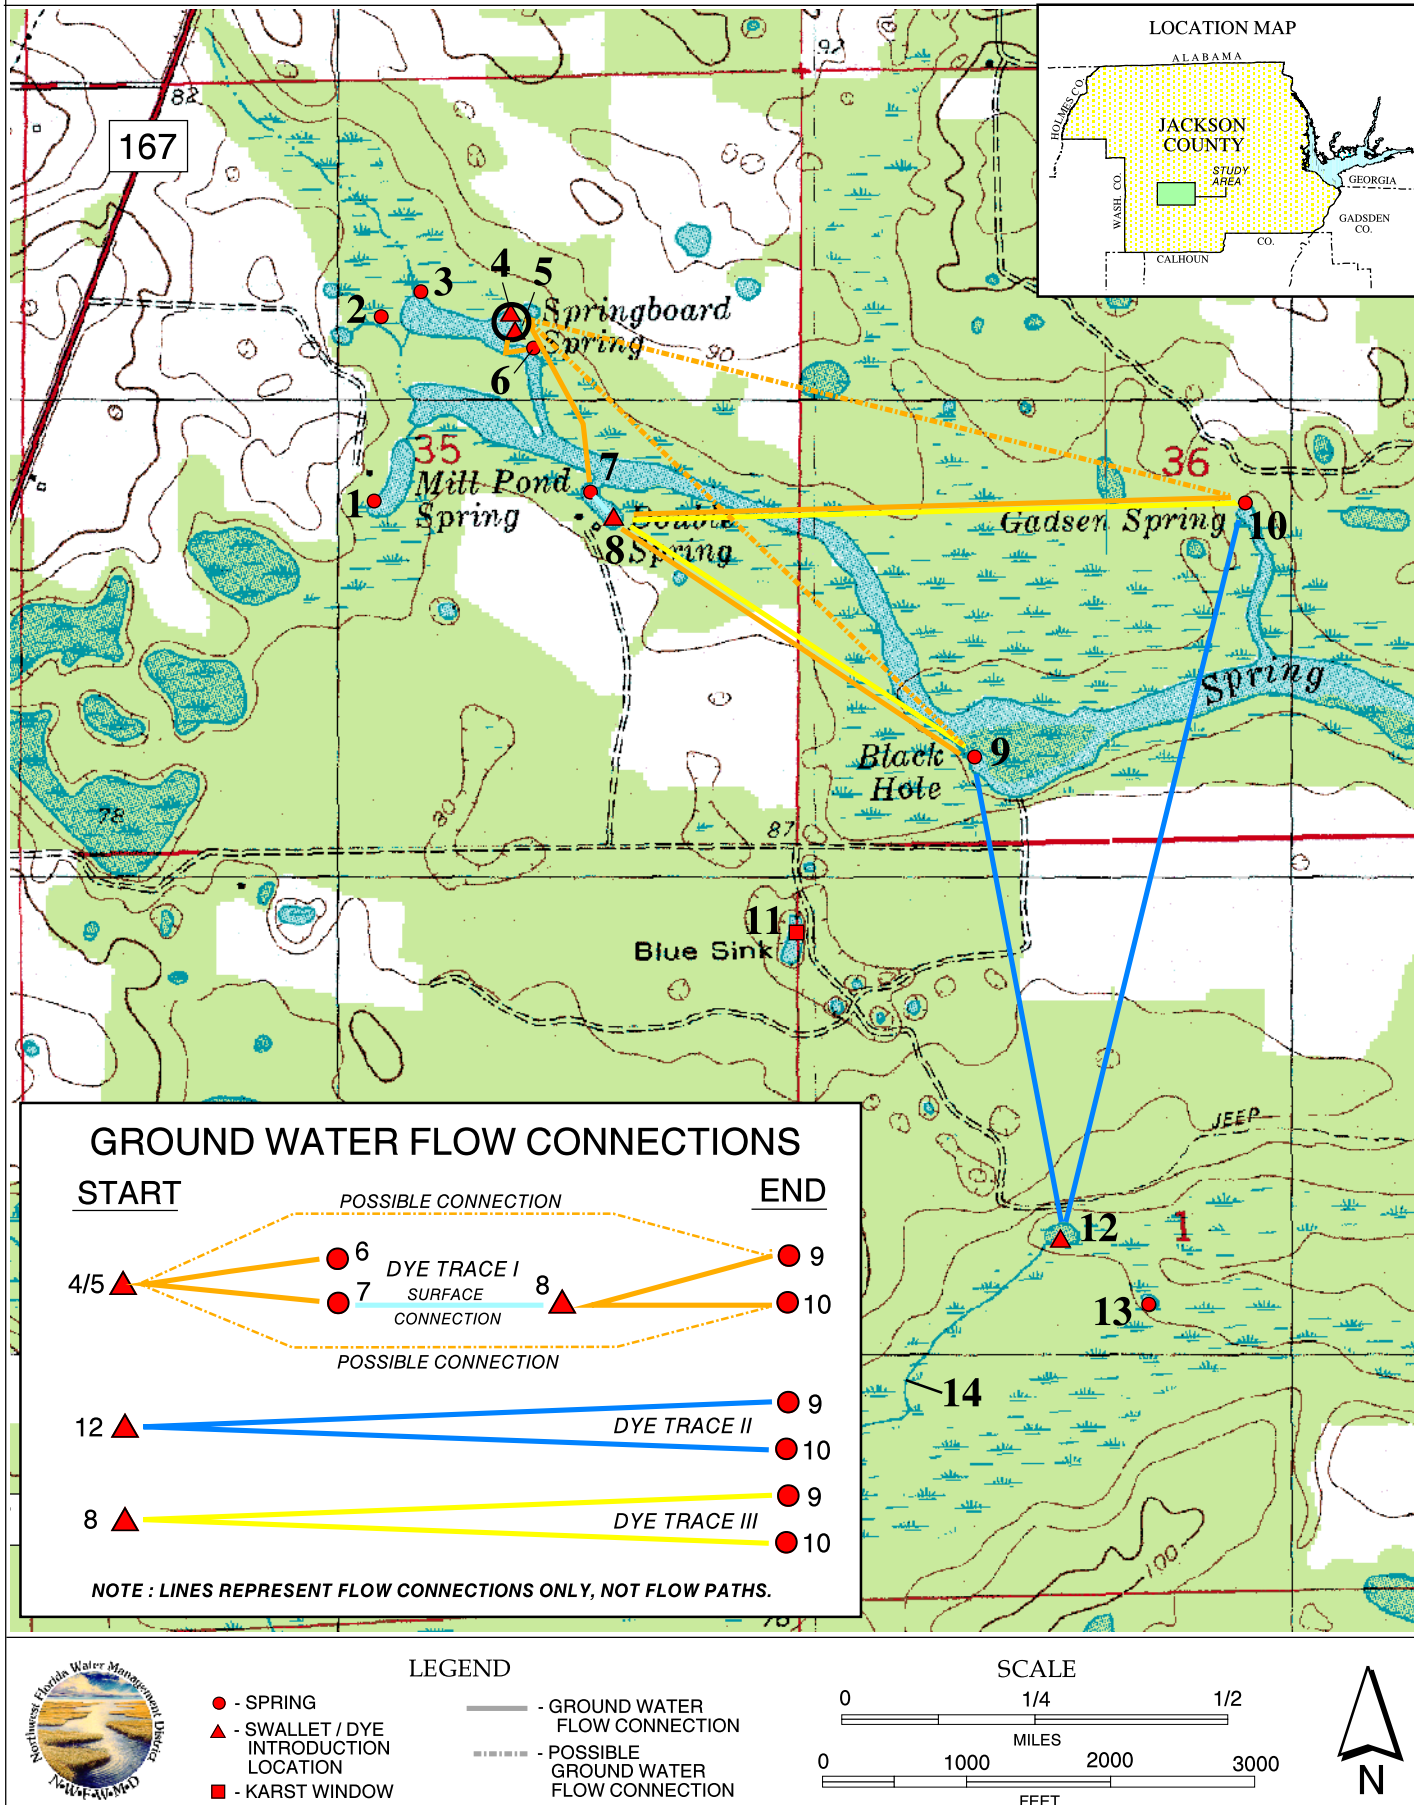
FIGURE 3

# RESULTS FROM TRACER STUDY: GROUND WATER FLOW CONNECTIONS

The results from the tracer study allow for a better understanding of the existing connections between the swallets and springs in the area of the Spring Lake spring group (Figure 3). With these connections established, some general remarks can be made about the ground water basin contributing water to these springs. However, qualifying statements must be made about several of the reported recoveries.

The recoveries for trace II and III were much more definitive. Results from trace II show a ground water flow connection between Dry Creek swallet and Black Hole and Gadsen springs. As stated above, results from trace III show a connection between Double Spring swallet and Black Hole and Gadsen springs.

Flow connections established through this study show that Black Hole (Figure 8) and Gadsen (Figure 9) springs serve as the ultimate discharge points for much of the ground water flow and a portion of the surface flow in the area. Although no definitive ground water basins can be drawn, sources for a significant portion of the water discharging from these springs can be discerned. Ground water basins for Coffin Spring (Figure 10), Double Spring (Figure 11), and Dry Creek Rise can be included in that of Black Hole and Gadsen springs via the Double Spring and Dry Creek swallets. In addition, the entire surface basin for Dry Creek can be included in the Black Hole/Gadsen Spring basin via the Dry Creek swallet. Based on available cave and flow data, it may be that the ground water basin for Springboard Spring (Figure 12) is essentially the same as that of Coffin Spring. Additional work is needed to confirm this. It appears Mill Pond Spring (Figure 13) and the Crack (Figure 14) possess ground water basins that, to a large degree, are isolated from those of Black Hole and Gadsen Springs. However, during times when flow from the main channel enters the Double Spring run and sinks at the swallet, some portion of the water from these springs enters the Black Hole/Gadsen basin.

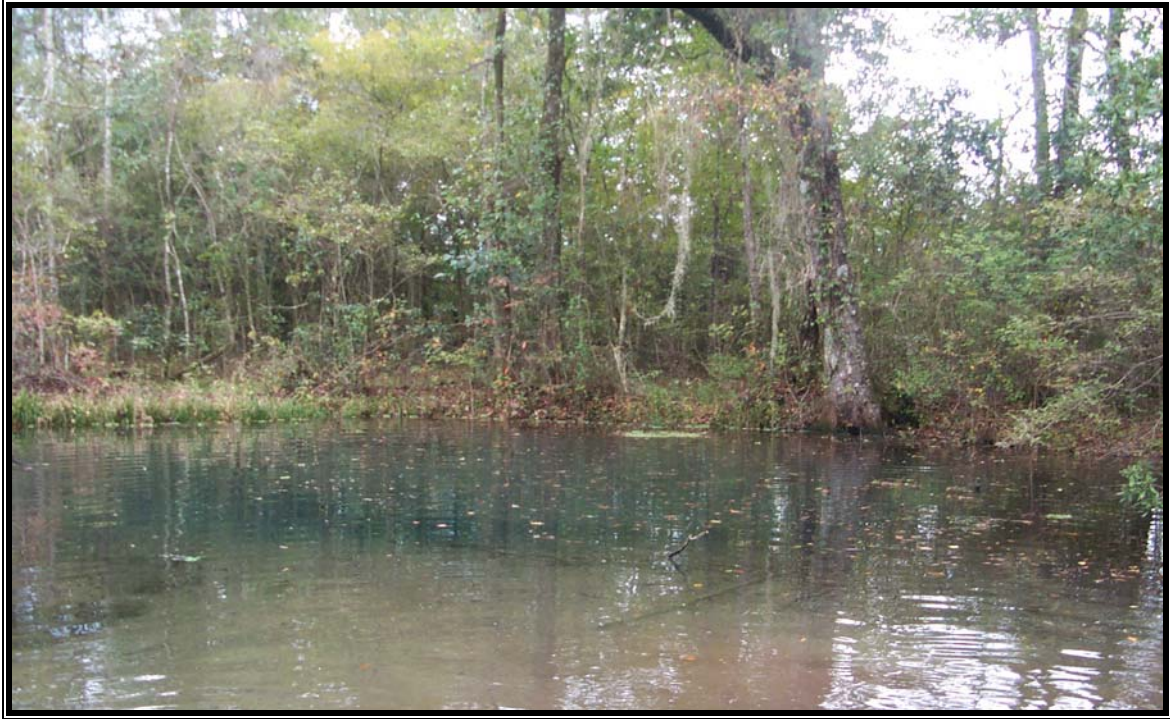
Figure 4. Coffin swallet #2. View from spring run looking east across swallet.

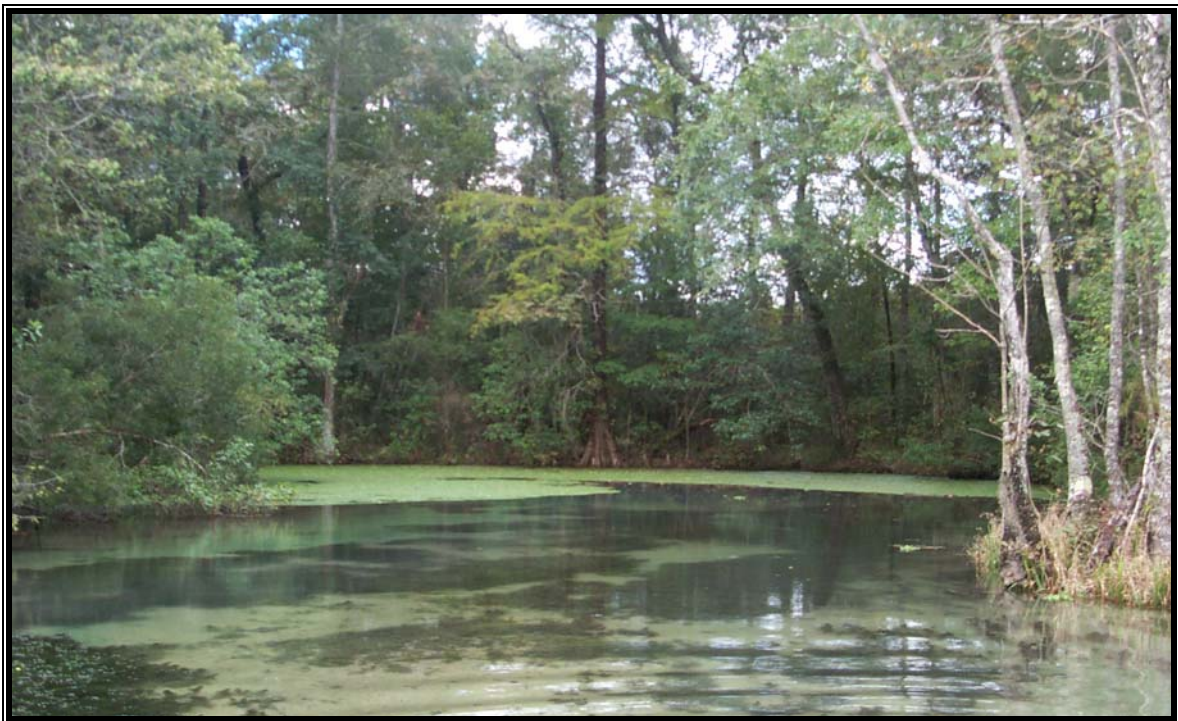
Figure 5. Coffin swallet #1. View looking north down the spring run toward the swallet. The swallet is largely covered with duckweed.

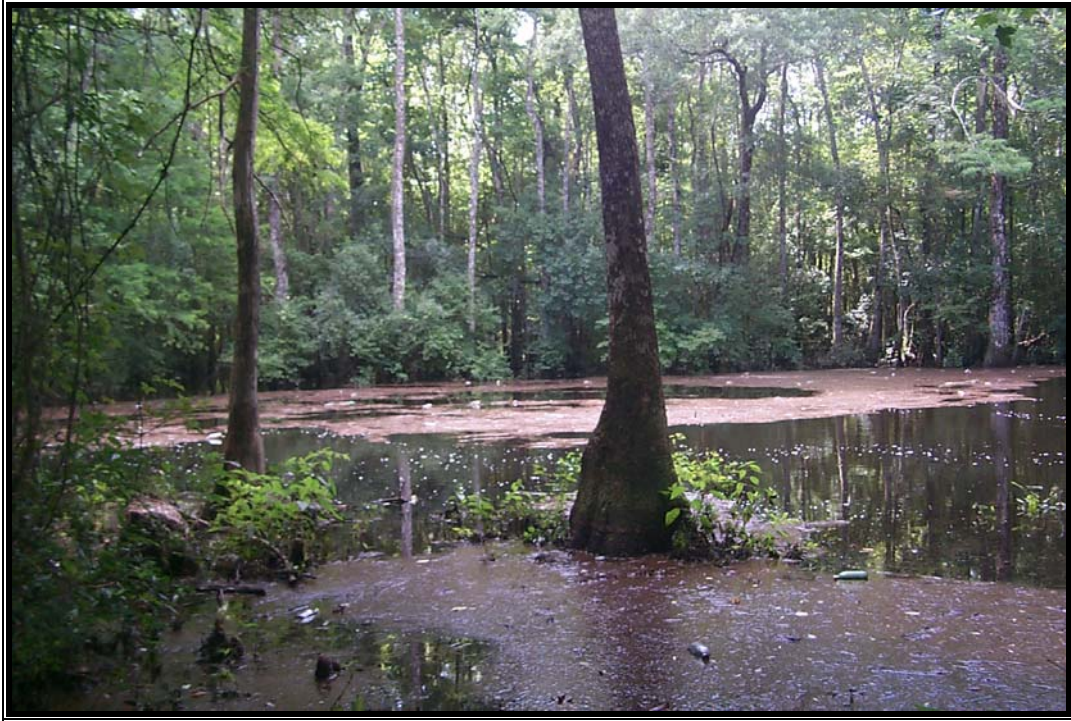
Figure 6. Dry Creek swallet. View looking south across swallet. Inflow from Dry Creek enters right of image. Inflow from Dry Creek Rise enters left of image.

On May 15, 2003, fluorescein was introduced to ground water through Dry Creek swallet (Figure 6). One pound of a 50 percent solution of fluorescein (diluted to two liters) was released in the spring run that descends from Dry Creek Rise approximately ten feet upgradient of the swallet. Upon release of the dye, it flowed down the spring run into the swallet. The discoloration of water in Dry Creek swallet subsided within 15 minutes following each stage of the release.

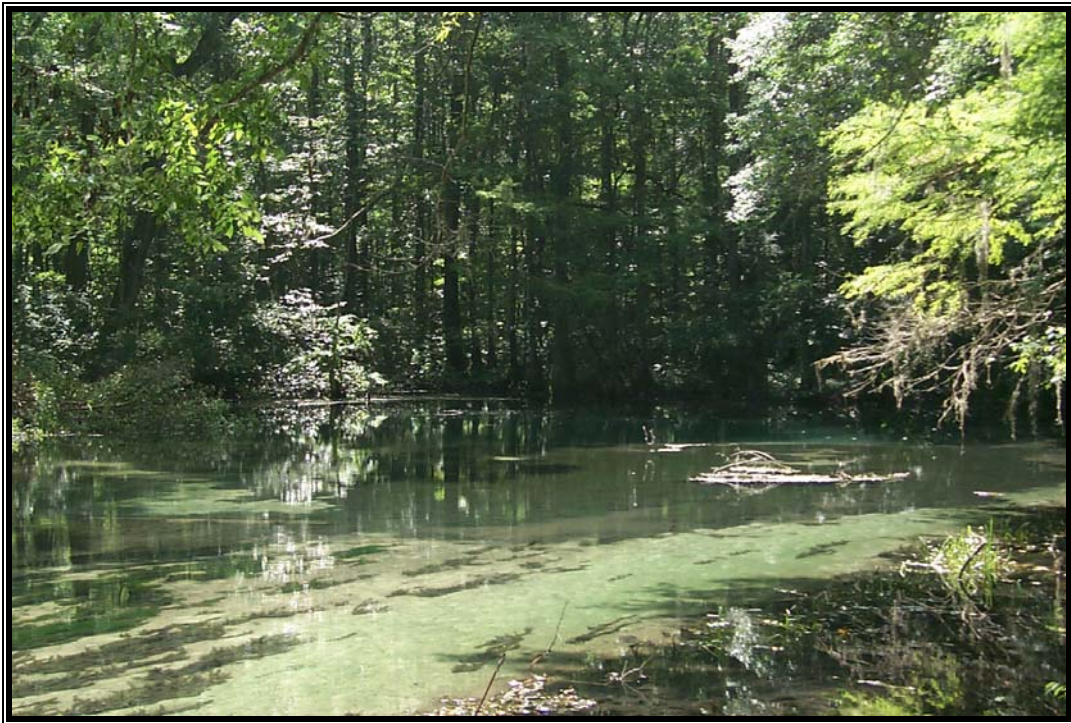
Figure 7. Double Spring swallet. View looking southeast down the spring run toward the swallet.

On June 6, 2003, fluorescein was introduced through Double Spring swallet (Figure 7). At the time of the introduction, a pronounced rotation was observed at the surface of the swallet. Of the one pound of a 50 percent solution (diluted to two liters) prepared, approximately three quarters was released. The dye was released in multiple stages from a position approximately 15 feet up the spring run leading to the swallet. The discoloration of the water was significantly diminished between stages. Within 2 hours after the final release, the discoloration of water in the swallet had completely dissipated.

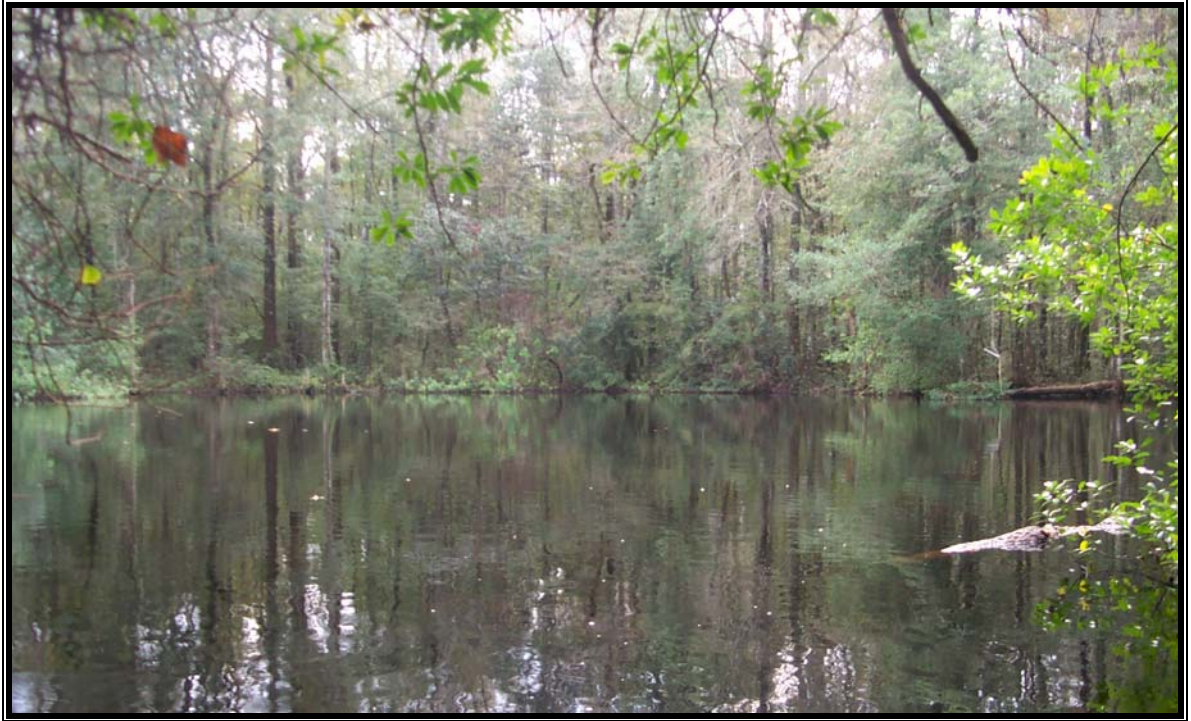
Figure 8. Black Hole Spring. View looking south across spring pool.

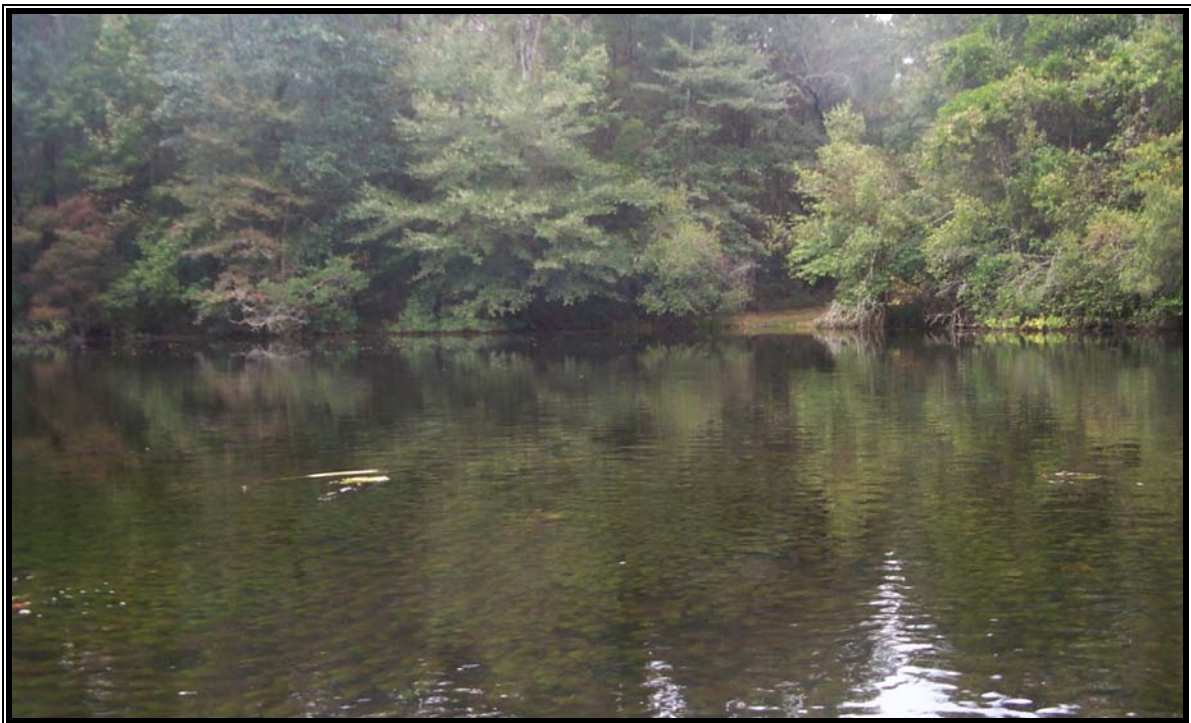
Figure 9. Gadsen Spring. View looking north across spring pool.

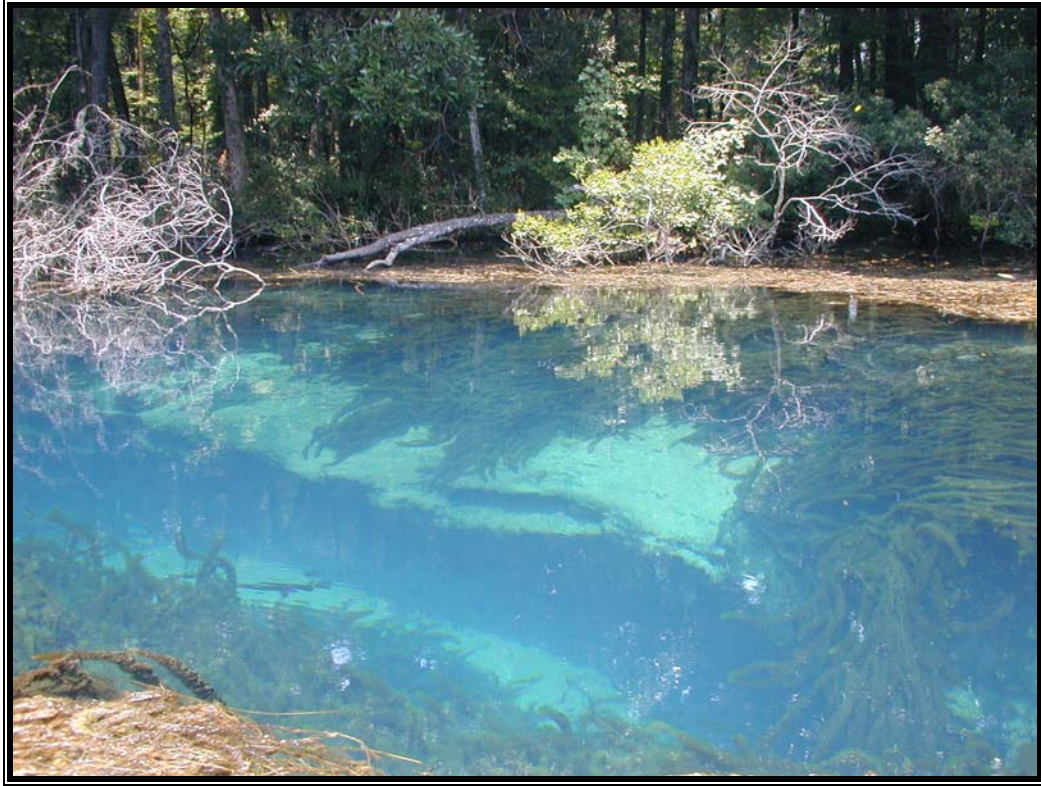
Figure 10. Coffin Spring. View looking north across spring pool.

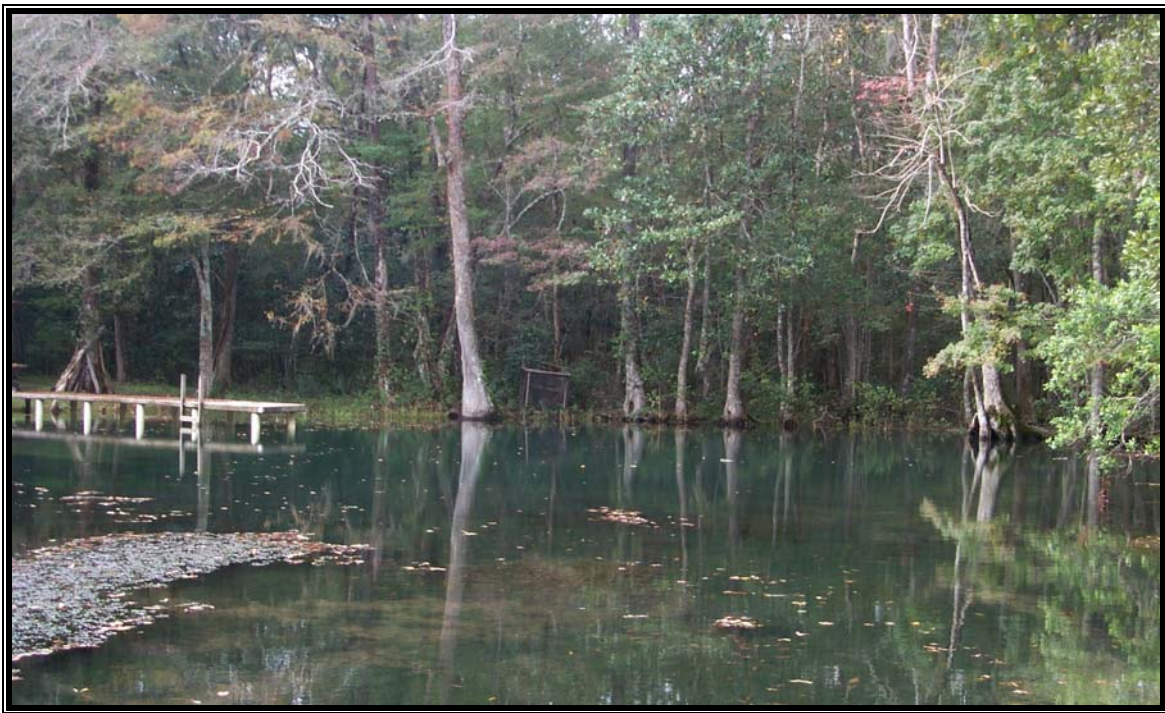
Figure 11. Double Spring. View looking west up the spring run towards the spring pool.

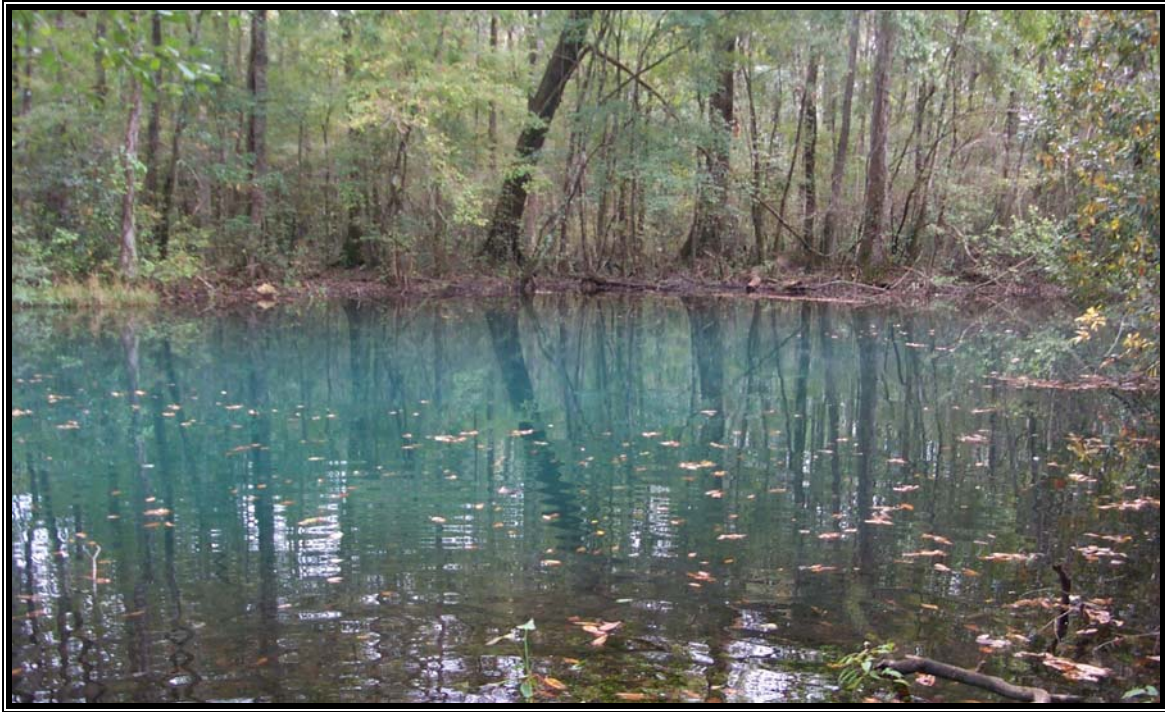
Figure 12. Springboard Spring. View from overflow channel looking east across spring pool.

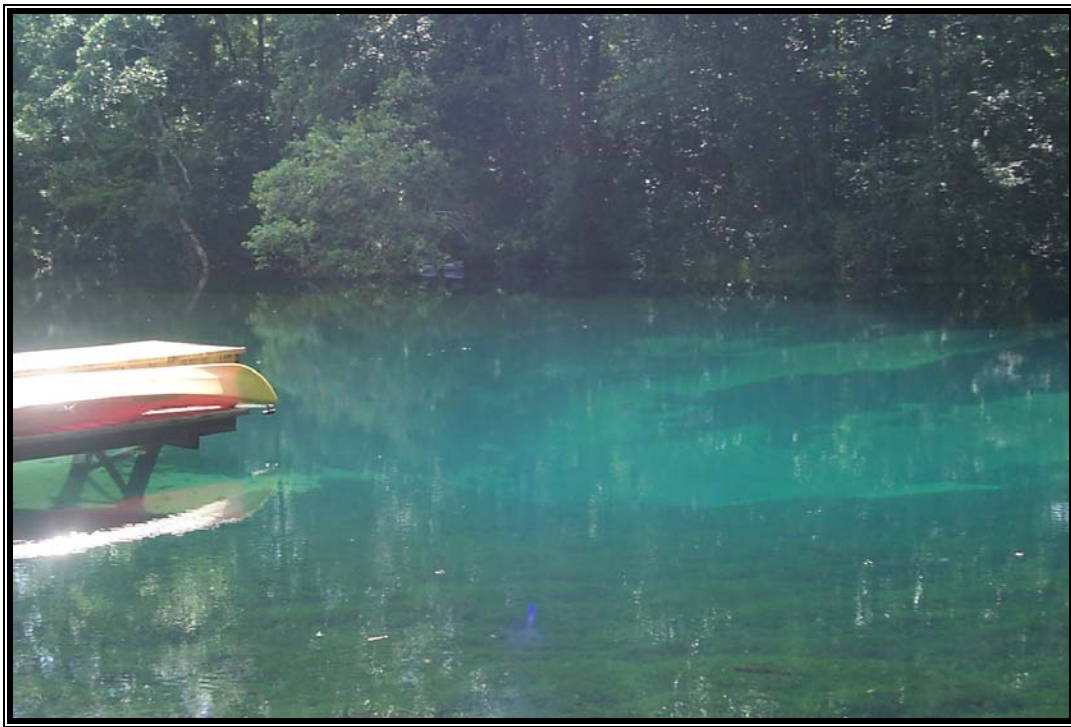
Figure 13. Mill Pond Spring. View looking east across spring pool.

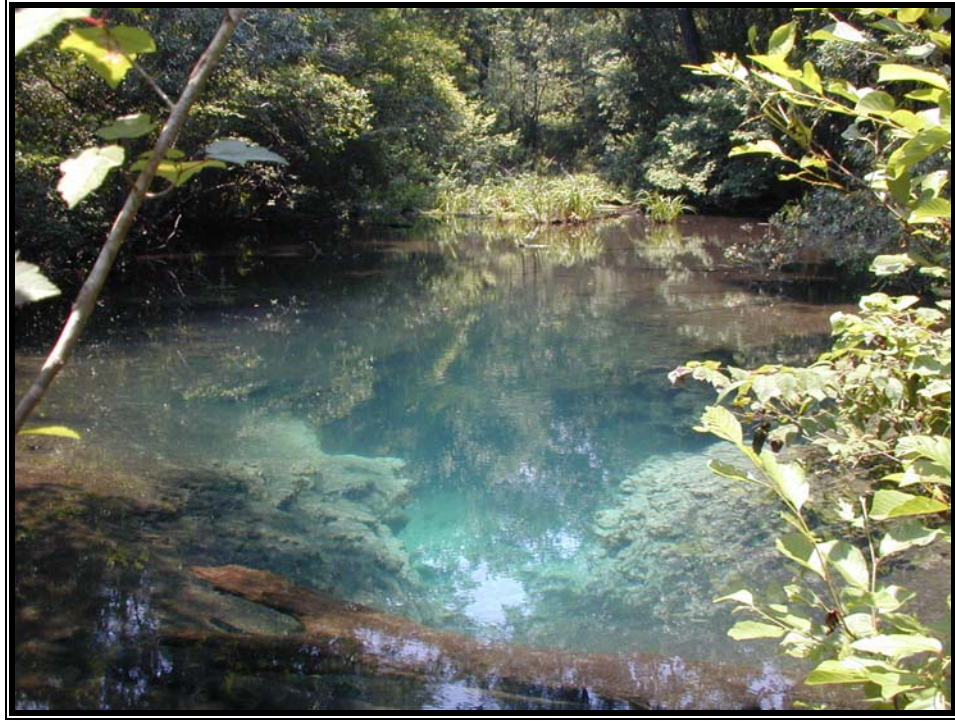
Figure 14. The Crack. View up the spring run looking northwest across spring pool.
