# R-123 PROFILES

BAY  
 PROGRAM SUPPORT GIS  
 DIVISION OF WATER RESOURCE MANAGEMENT  
 FLORIDA DEPARTMENT OF ENVIRONMENTAL PROTECTION

RANGE: R-123  
 EST DATE: JAN1973  
 SURVEY DATE: 19DEC18  
 AZIMUTH: 205.0

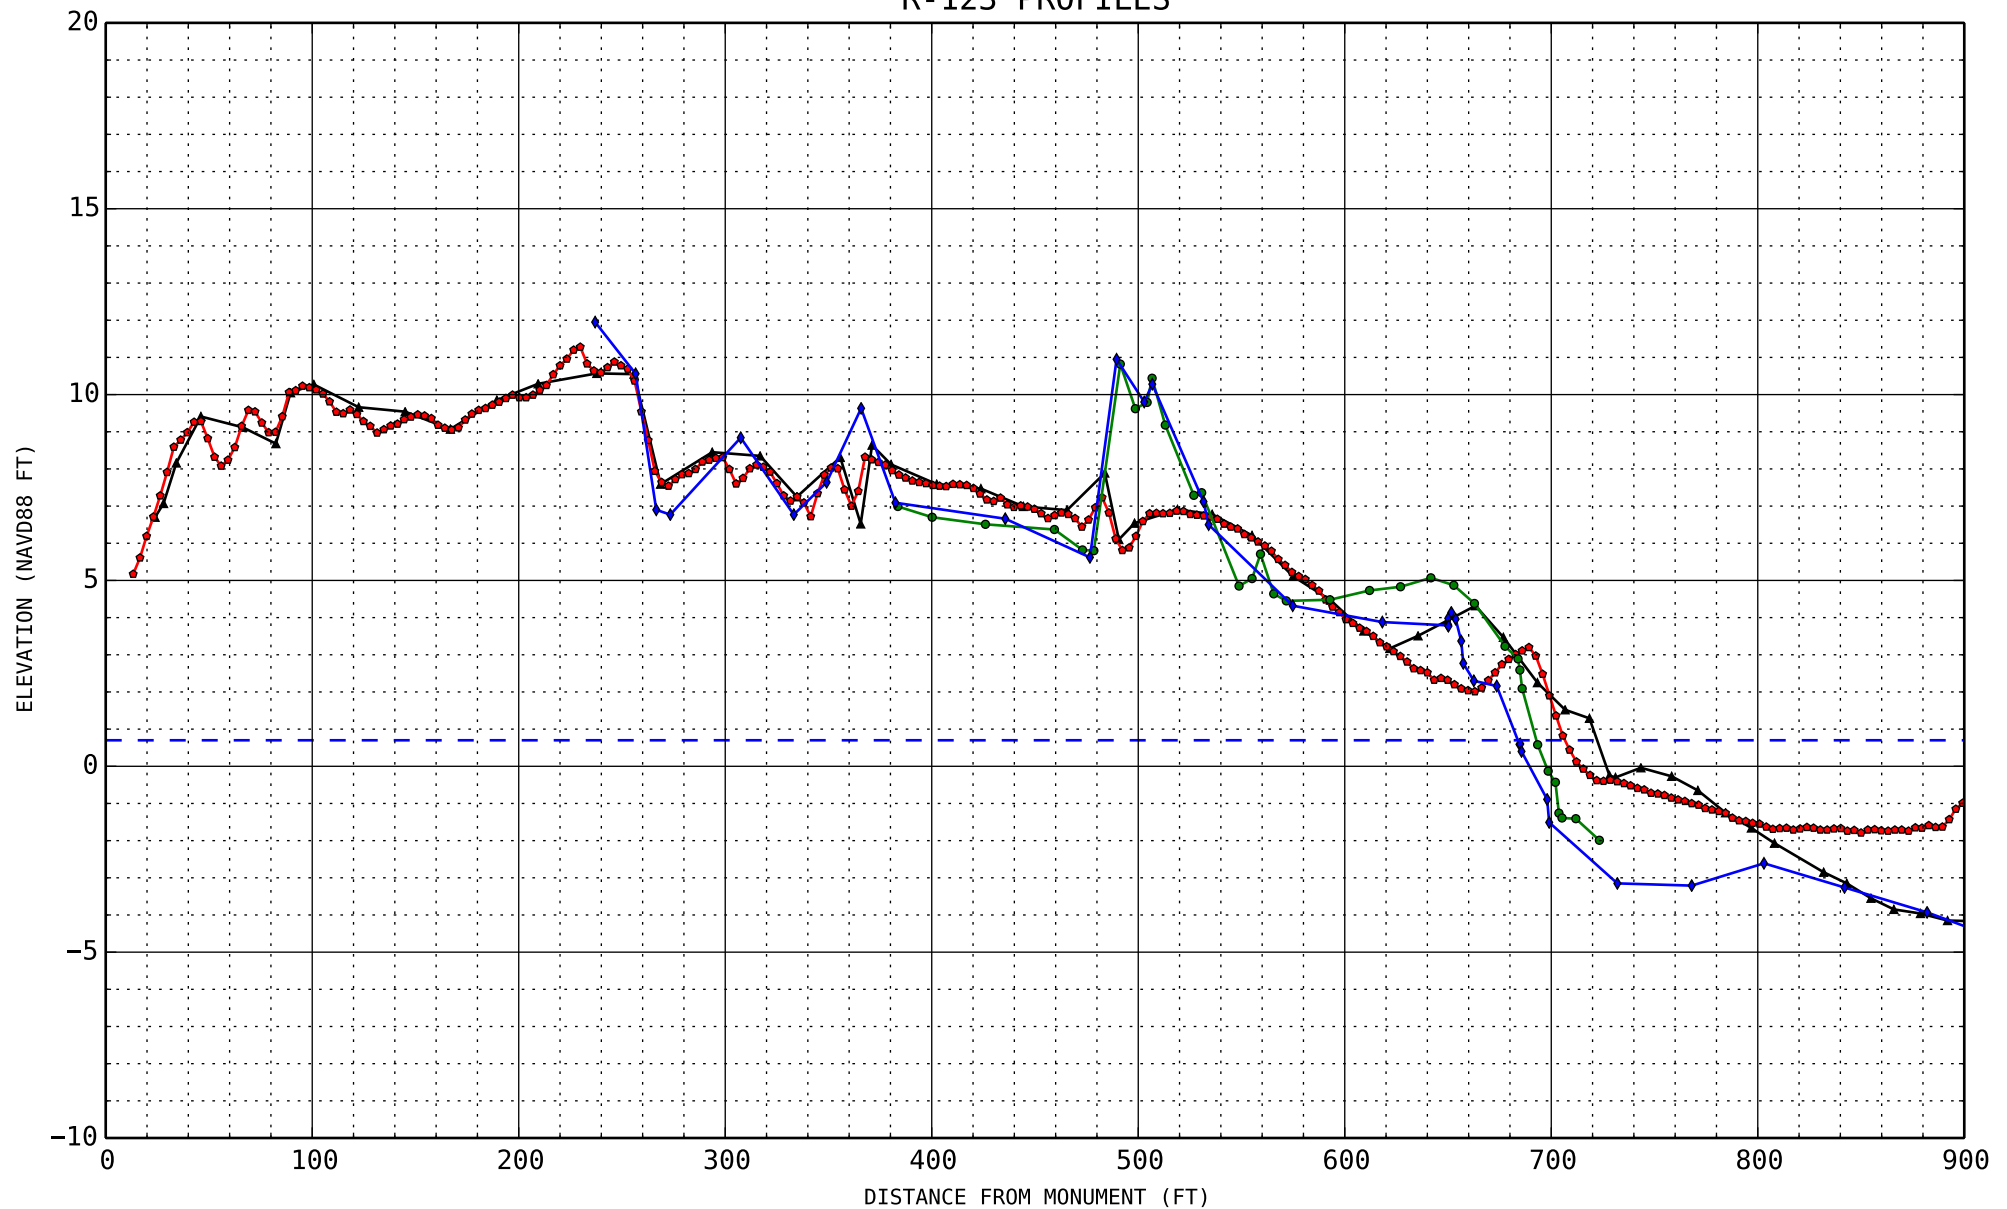
- ▲ 2018-DEC MONITORING BY DEW
- 2018-OCT MONITORING BY USACE-LIDAR
- 2016-OCT MONITORING BY DEP
- ▲ 2013-SEP MONITORING BY DEP
- - - MHW CONTOUR (0.7 FT)

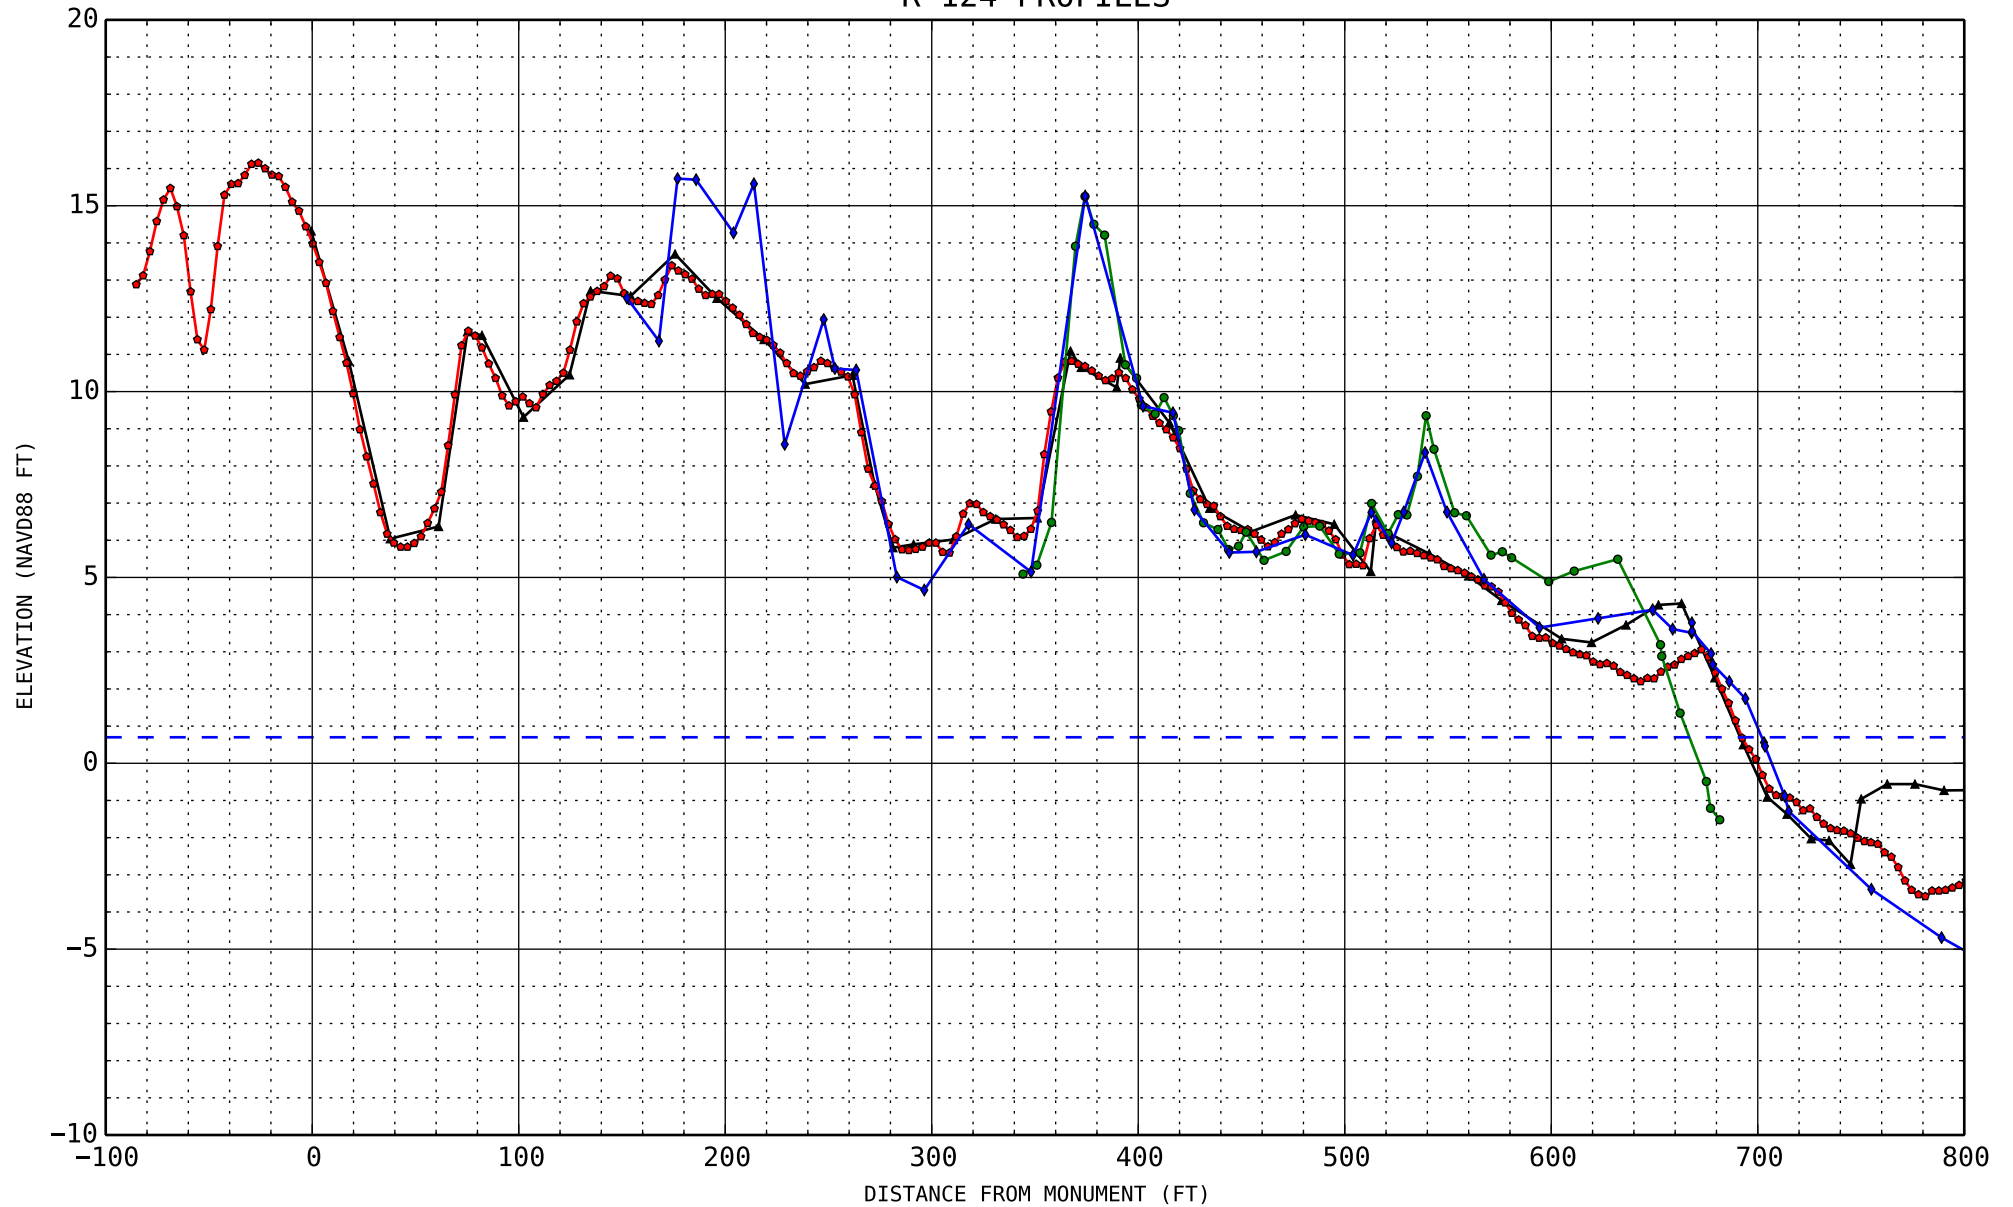
# R-124 PROFILES

▲ 2018-DEC MONITORING BY DEW  
 ● 2018-OCT MONITORING BY USACE-LIDAR  
 ● 2016-OCT MONITORING BY DEP  
 ◆ 2013-SEP MONITORING BY DEP  
 - - - MHW CONTOUR (0.7 FT)

RANGE: R-124  
 EST DATE: JAN1973  
 SURVEY DATE: 19DEC18  
 AZIMUTH: 203.0

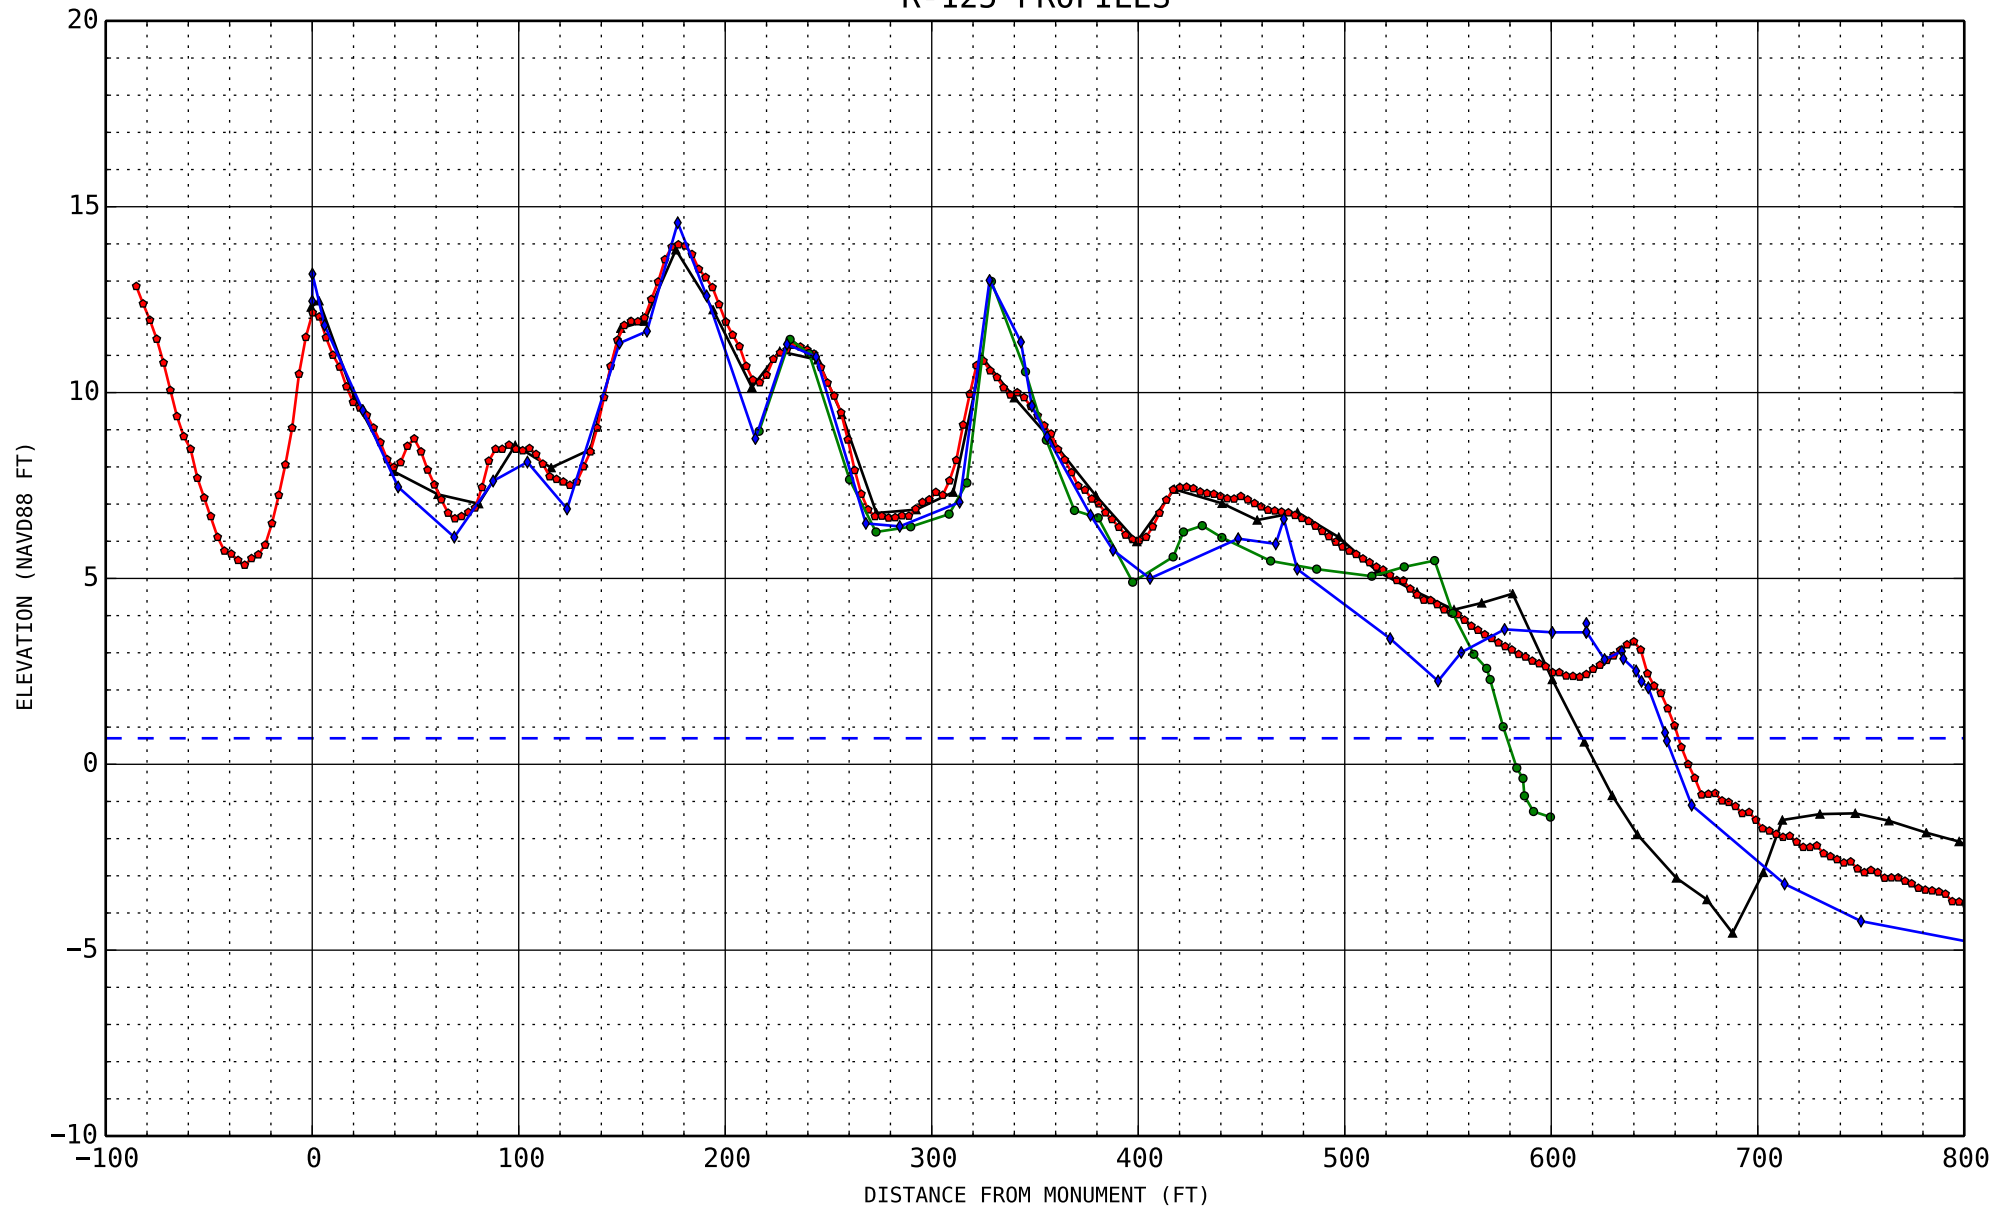
# R-125 PROFILES

- ▲ 2018-DEC MONITORING BY DEW
- 2018-OCT MONITORING BY USACE-LIDAR
- 2016-OCT MONITORING BY DEP
- ◆ 2013-SEP MONITORING BY DEP
- - - MHW CONTOUR (0.7 FT)

RANGE: R-125  
EST DATE: JAN1973  
SURVEY DATE: 19DEC18  
AZIMUTH: 197.0

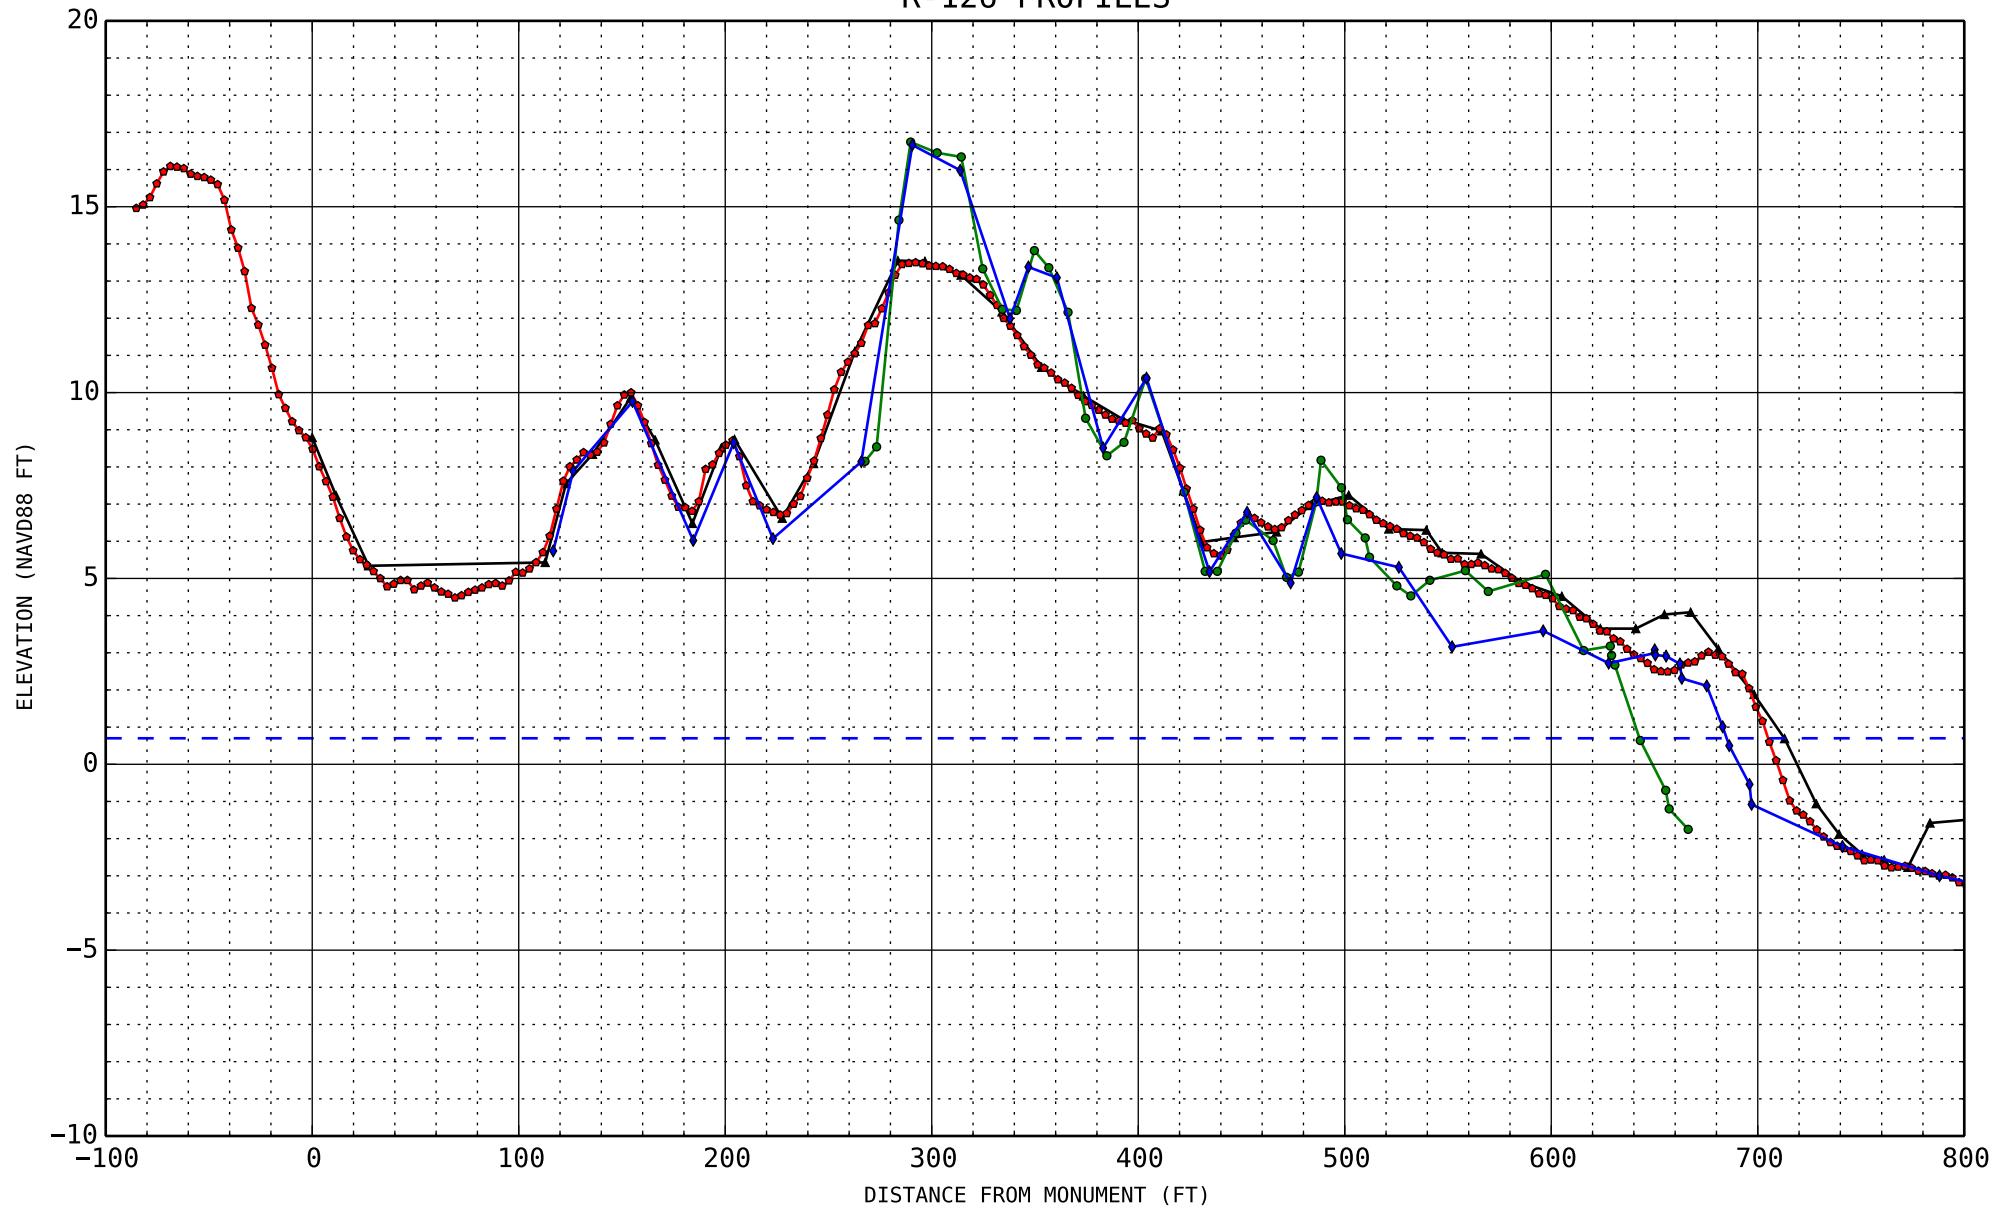
# R-126 PROFILES

- ▲ 2018-DEC MONITORING BY DEW
- 2018-OCT MONITORING BY USACE-LIDAR
- 2016-OCT MONITORING BY DEP
- ◆ 2013-SEP MONITORING BY DEP
- - - MHW CONTOUR (0.7 FT)

RANGE: R-126  
 EST DATE: JAN1973  
 SURVEY DATE: 19DEC18  
 AZIMUTH: 197.0

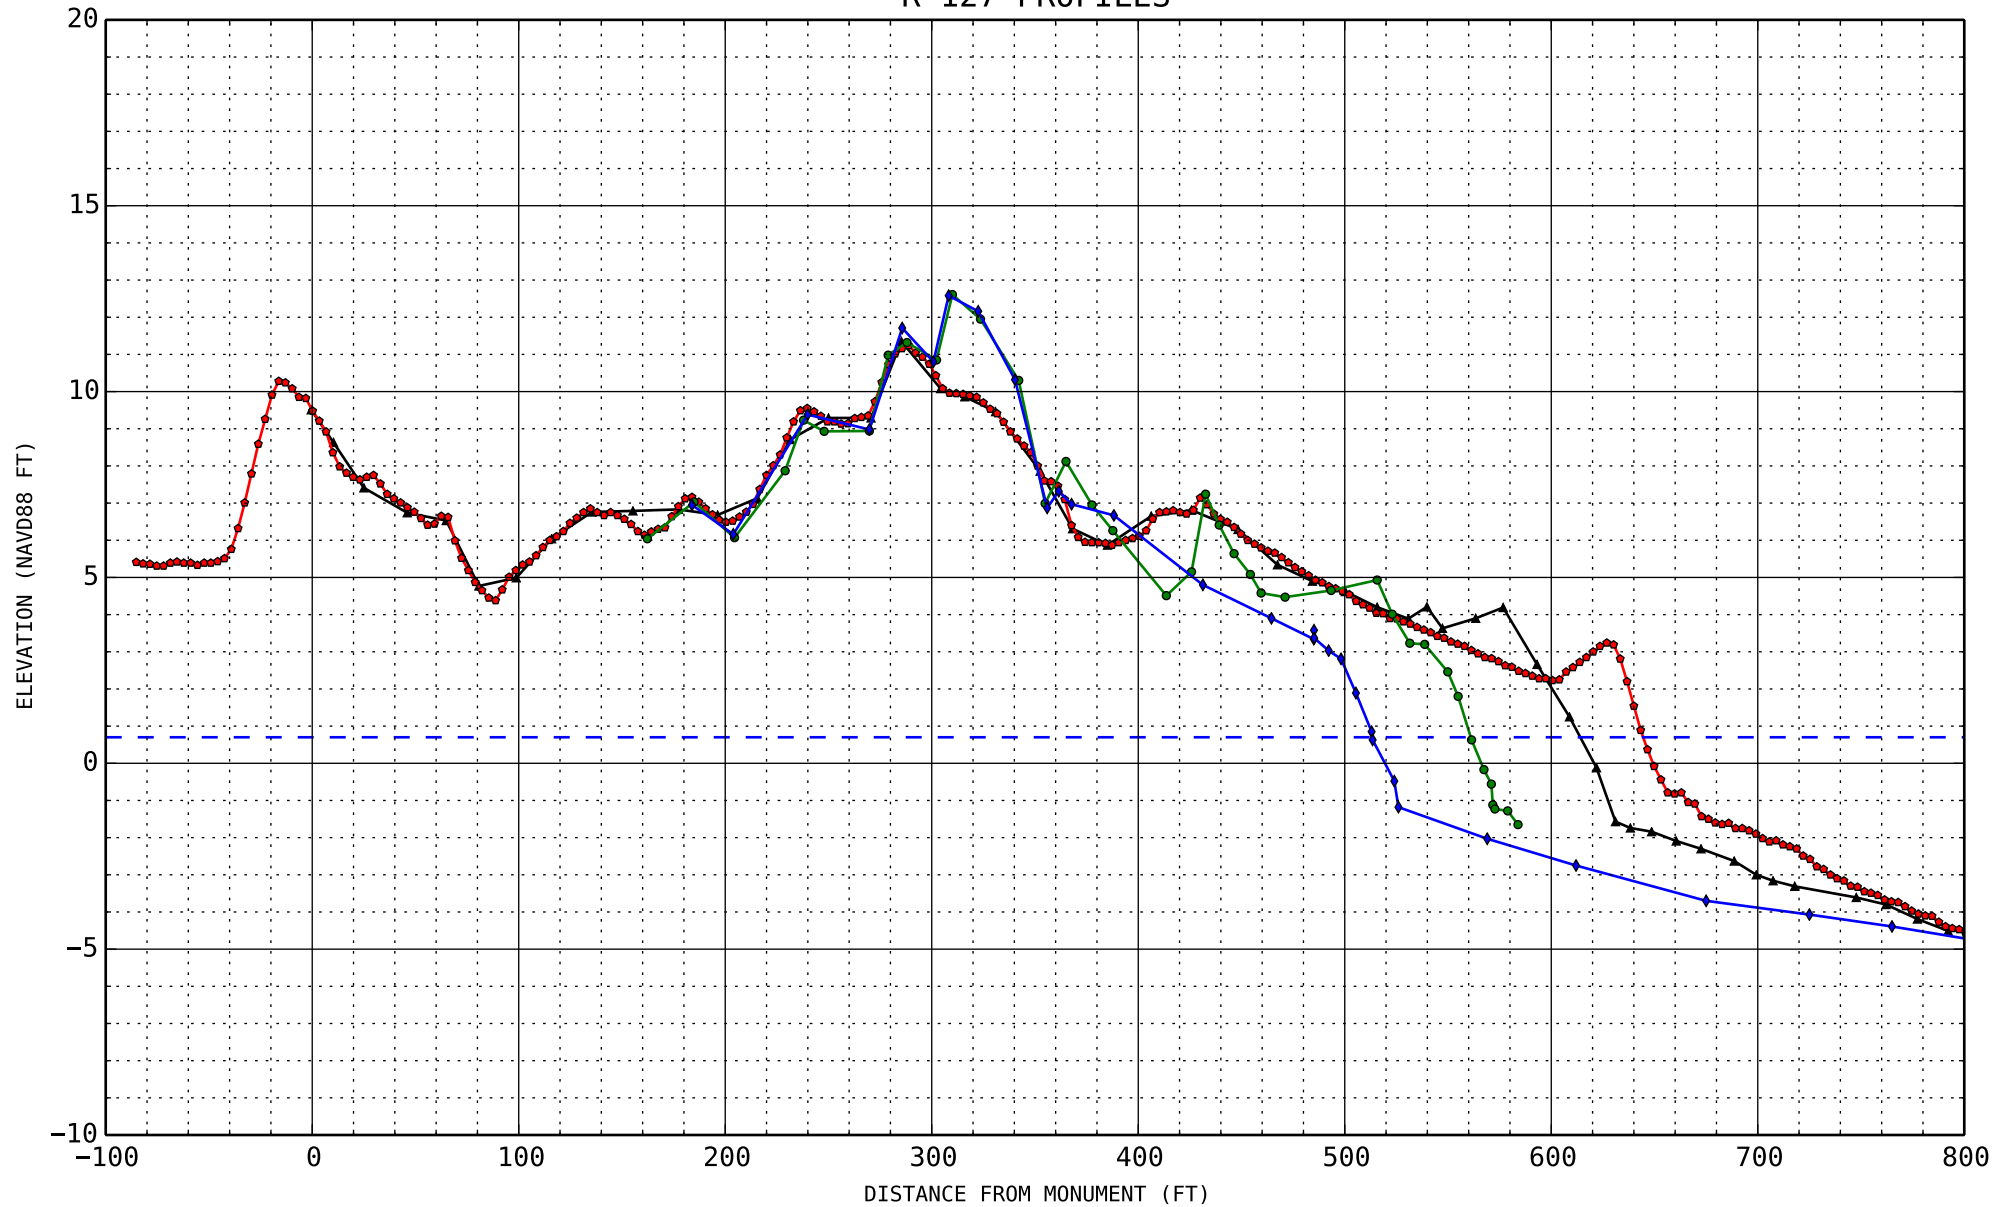
# R-127 PROFILES

- ▲ 2018-DEC MONITORING BY DEW
- 2018-OCT MONITORING BY USACE-LIDAR
- 2016-OCT MONITORING BY DEP
- ◆ 2013-SEP MONITORING BY DEP
- - - MHW CONTOUR (0.7 FT)

RANGE: R-127  
 EST DATE: JAN1973  
 SURVEY DATE: 19DEC18  
 AZIMUTH: 197.0

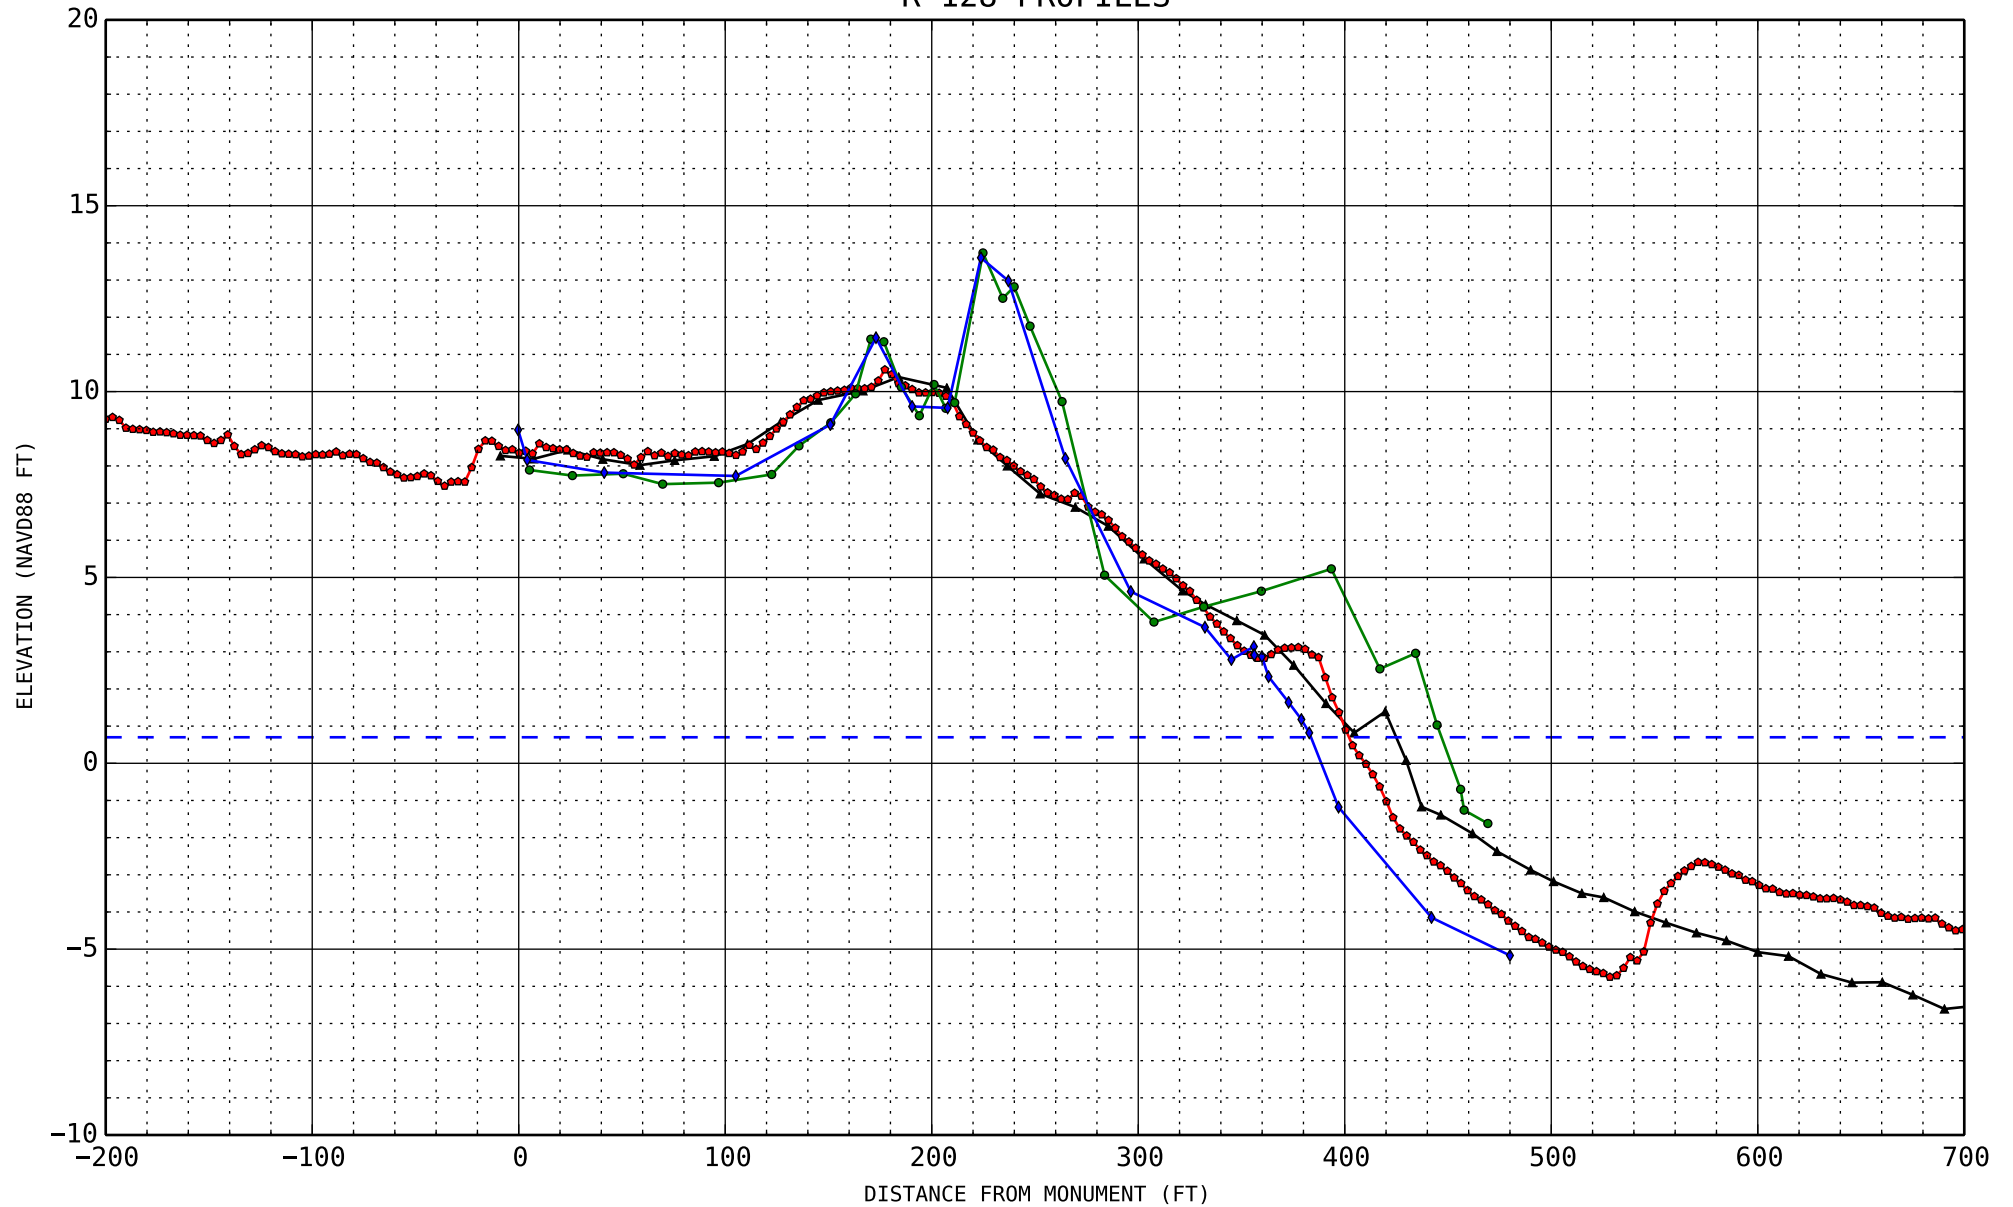
# R-128 PROFILES

- ▲ 2018-DEC MONITORING BY DEW
- 2018-OCT MONITORING BY USACE-LIDAR
- 2016-OCT MONITORING BY DEP
- ▲ 2013-SEP MONITORING BY DEP
- - - MHW CONTOUR (0.7 FT)

RANGE: R-128  
EST DATE: JAN1973  
SURVEY DATE: 19DEC18  
AZIMUTH: 200.0

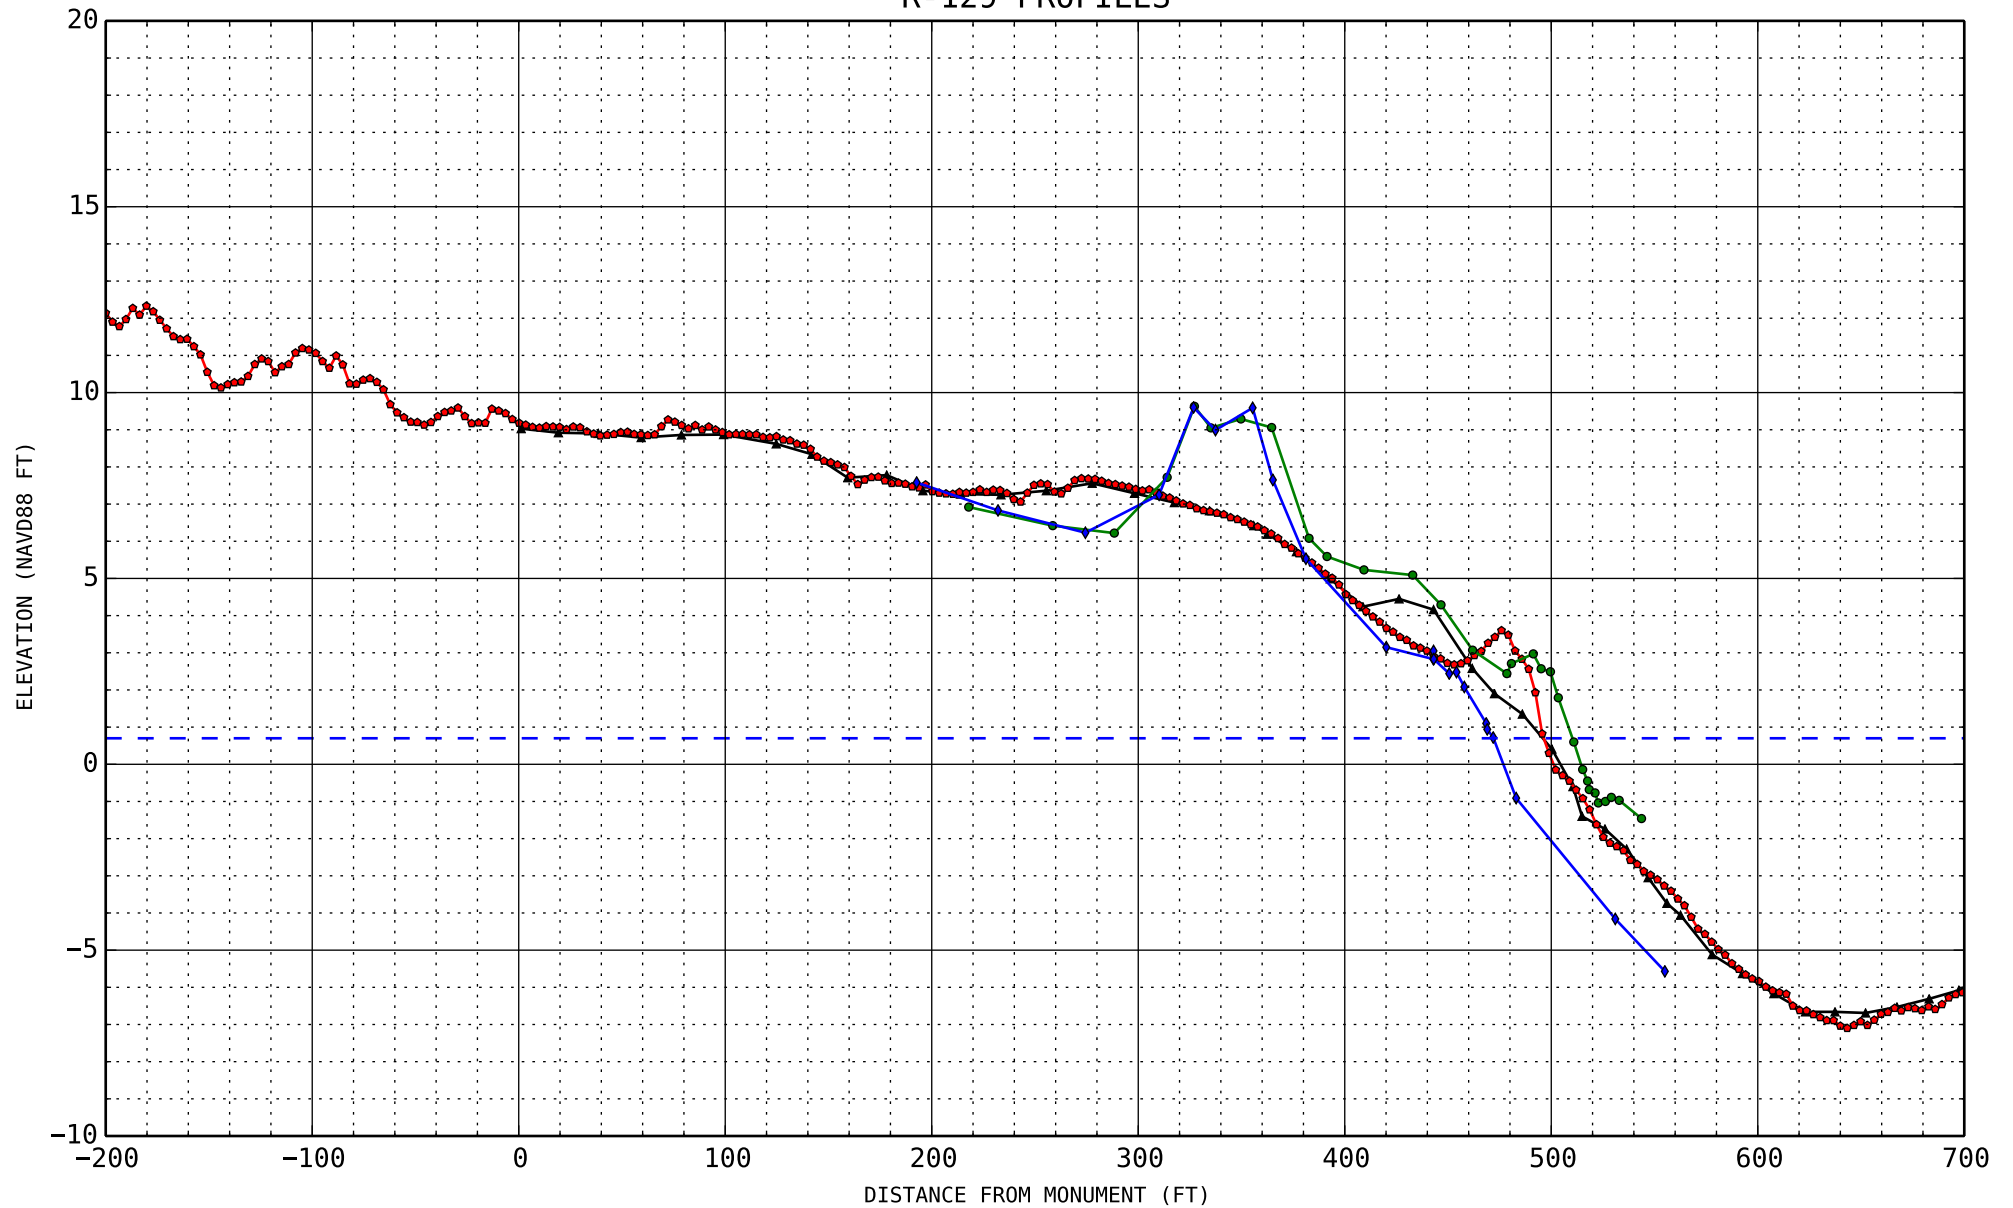
# R-129 PROFILES

▲ 2018-DEC MONITORING BY DEW  
 ● 2018-OCT MONITORING BY USACE-LIDAR  
 ● 2016-OCT MONITORING BY DEP  
 ◆ 2013-SEP MONITORING BY DEP  
 - - - MHW CONTOUR (0.7 FT)

RANGE: R-129  
 EST DATE: APR1991  
 SURVEY DATE: 19DEC18  
 AZIMUTH: 205.0

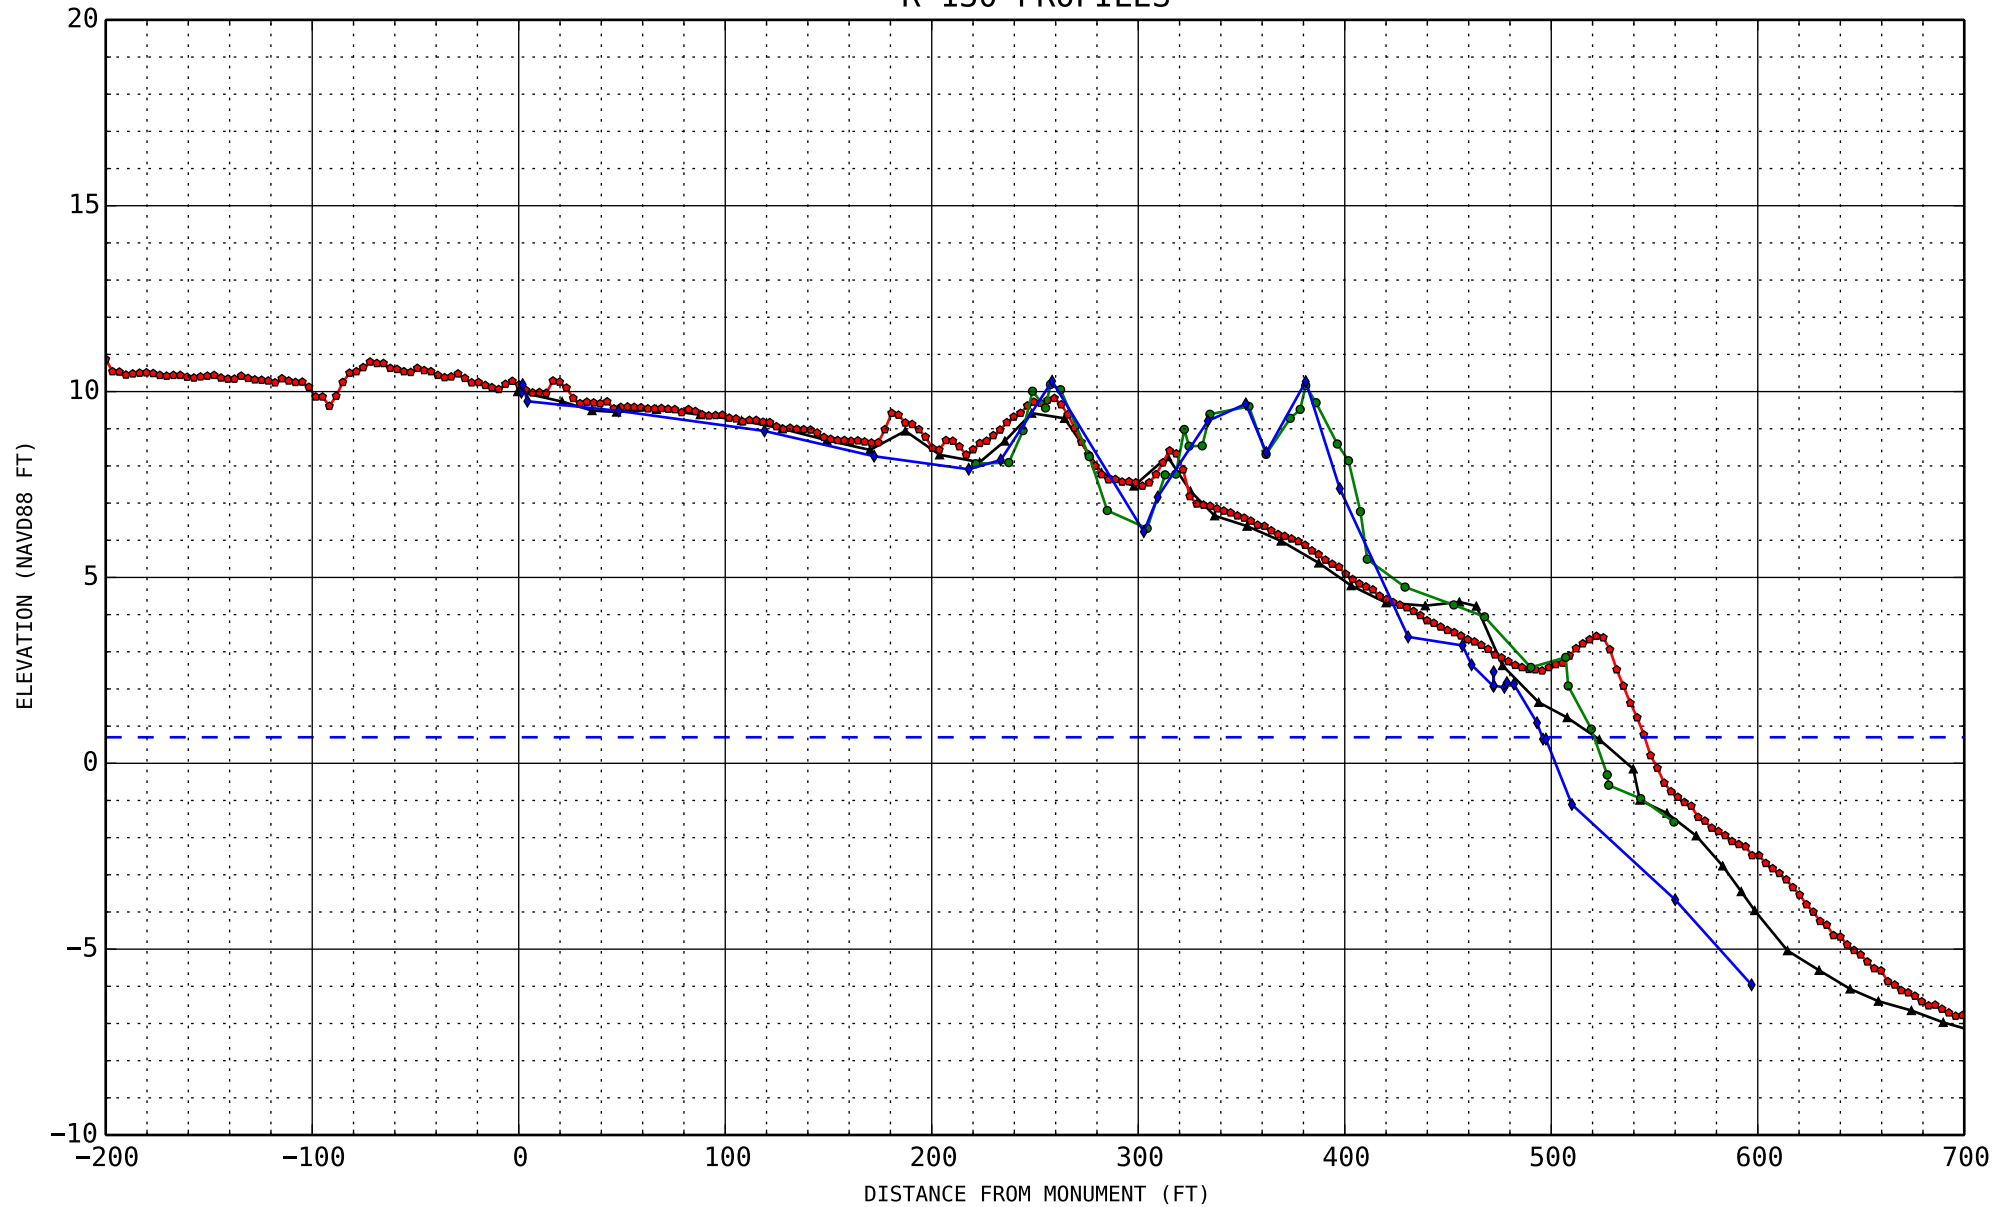
# R-130 PROFILES

▲ 2018-DEC MONITORING BY DEW  
 ● 2018-OCT MONITORING BY USACE-LIDAR  
 ● 2016-OCT MONITORING BY DEP  
 ◆ 2013-SEP MONITORING BY DEP  
 - - - MHW CONTOUR (0.7 FT)

RANGE: R-130  
 EST DATE: JAN1973  
 SURVEY DATE: 19DEC18  
 AZIMUTH: 205.0

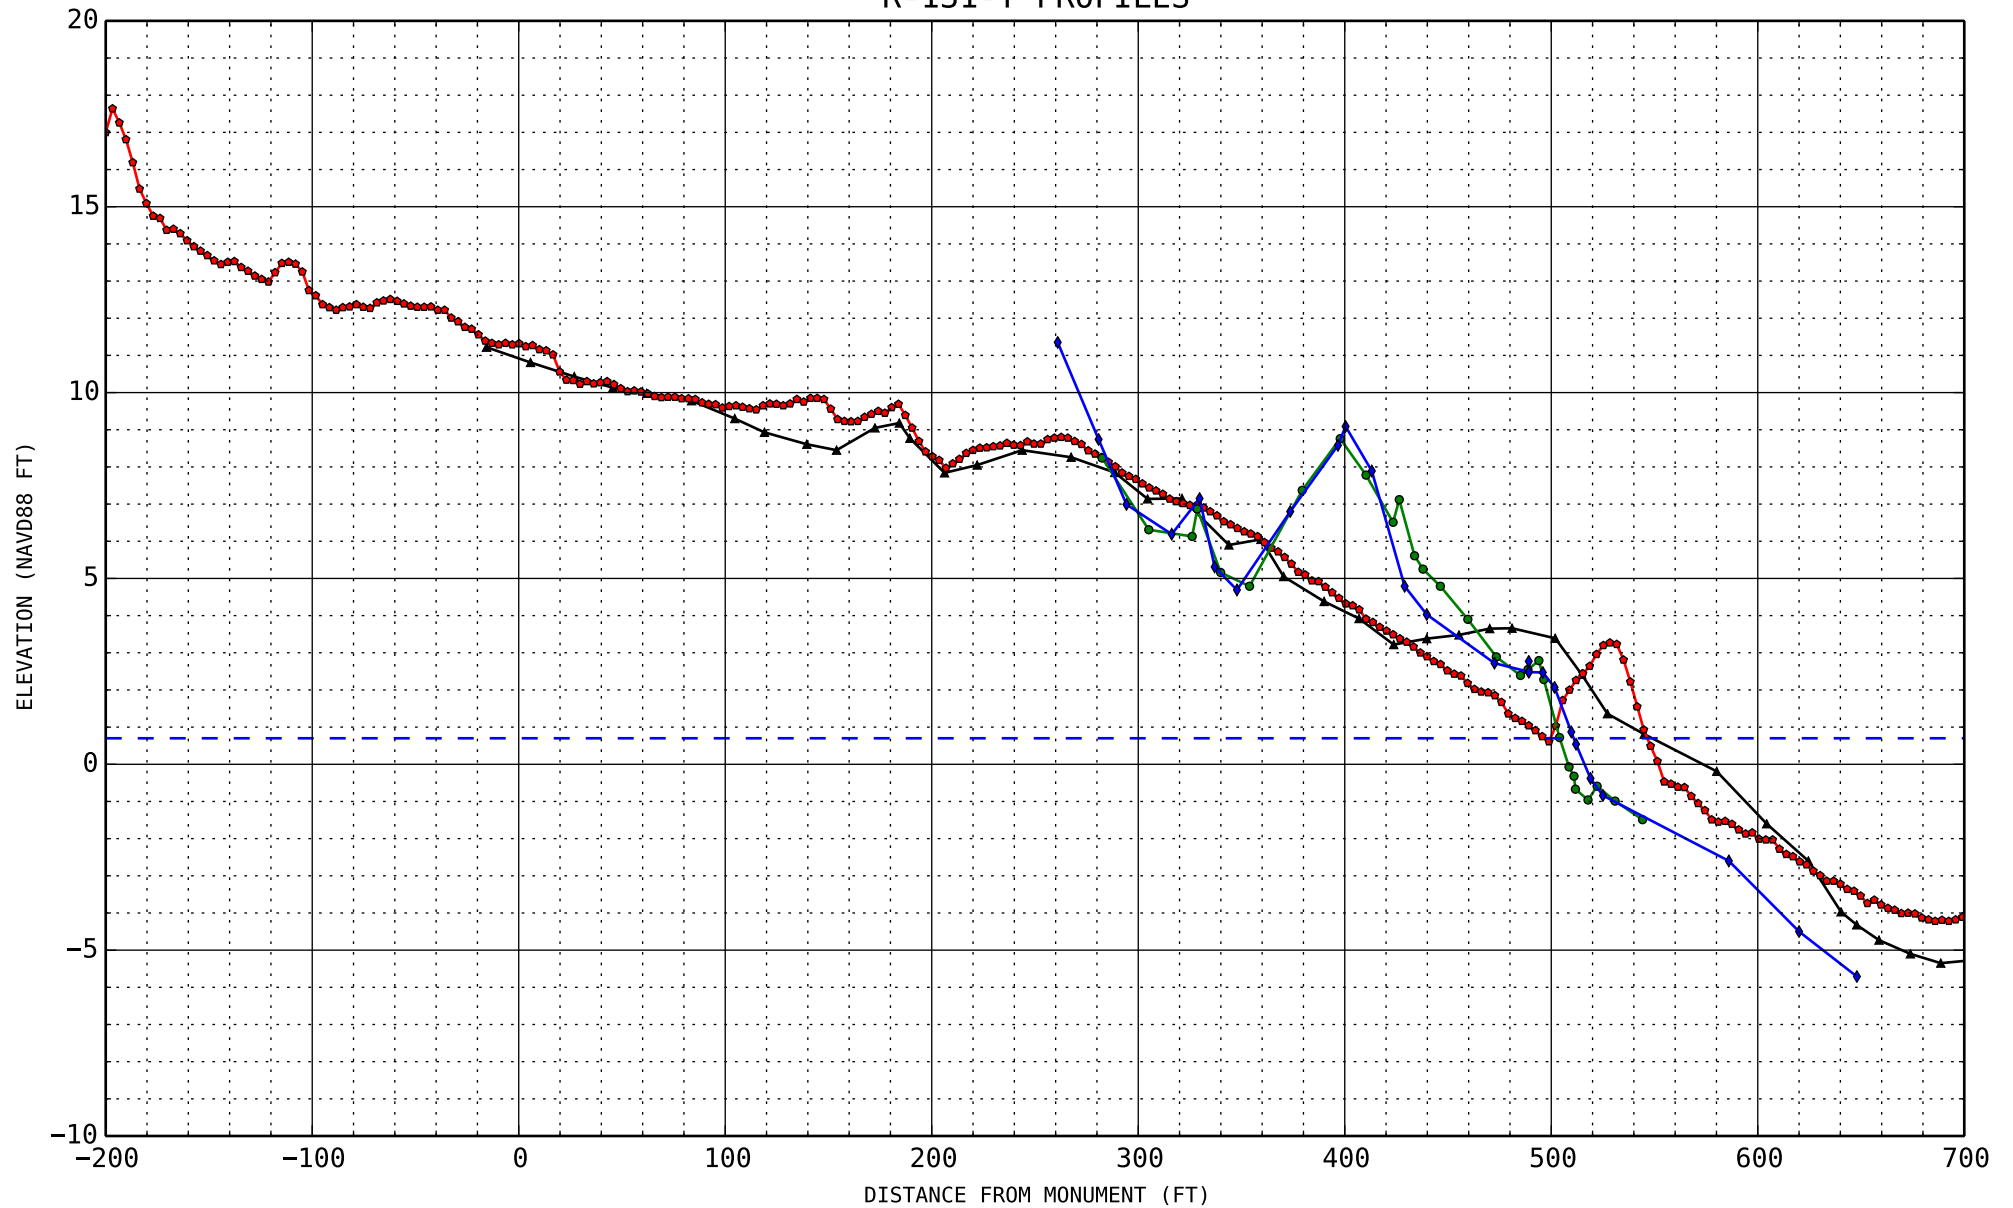
# R-131-T PROFILES

- ▲ 2018-DEC MONITORING BY DEW
- 2018-OCT MONITORING BY USACE-LIDAR
- 2016-OCT MONITORING BY DEP
- ◆ 2013-SEP MONITORING BY DEP
- - - MHW CONTOUR (0.7 FT)

RANGE: R-131-T  
EST DATE: OCT1979  
SURVEY DATE: 18DEC18  
AZIMUTH: 205.0
