# R-123 PROFILES

BAY  
 PROGRAM SUPPORT GIS  
 DIVISION OF WATER RESOURCE MANAGEMENT  
 FLORIDA DEPARTMENT OF ENVIRONMENTAL PROTECTION

RANGE: R-123  
 EST DATE: JAN1973  
 SURVEY DATE: 19DEC18  
 AZIMUTH: 205.0

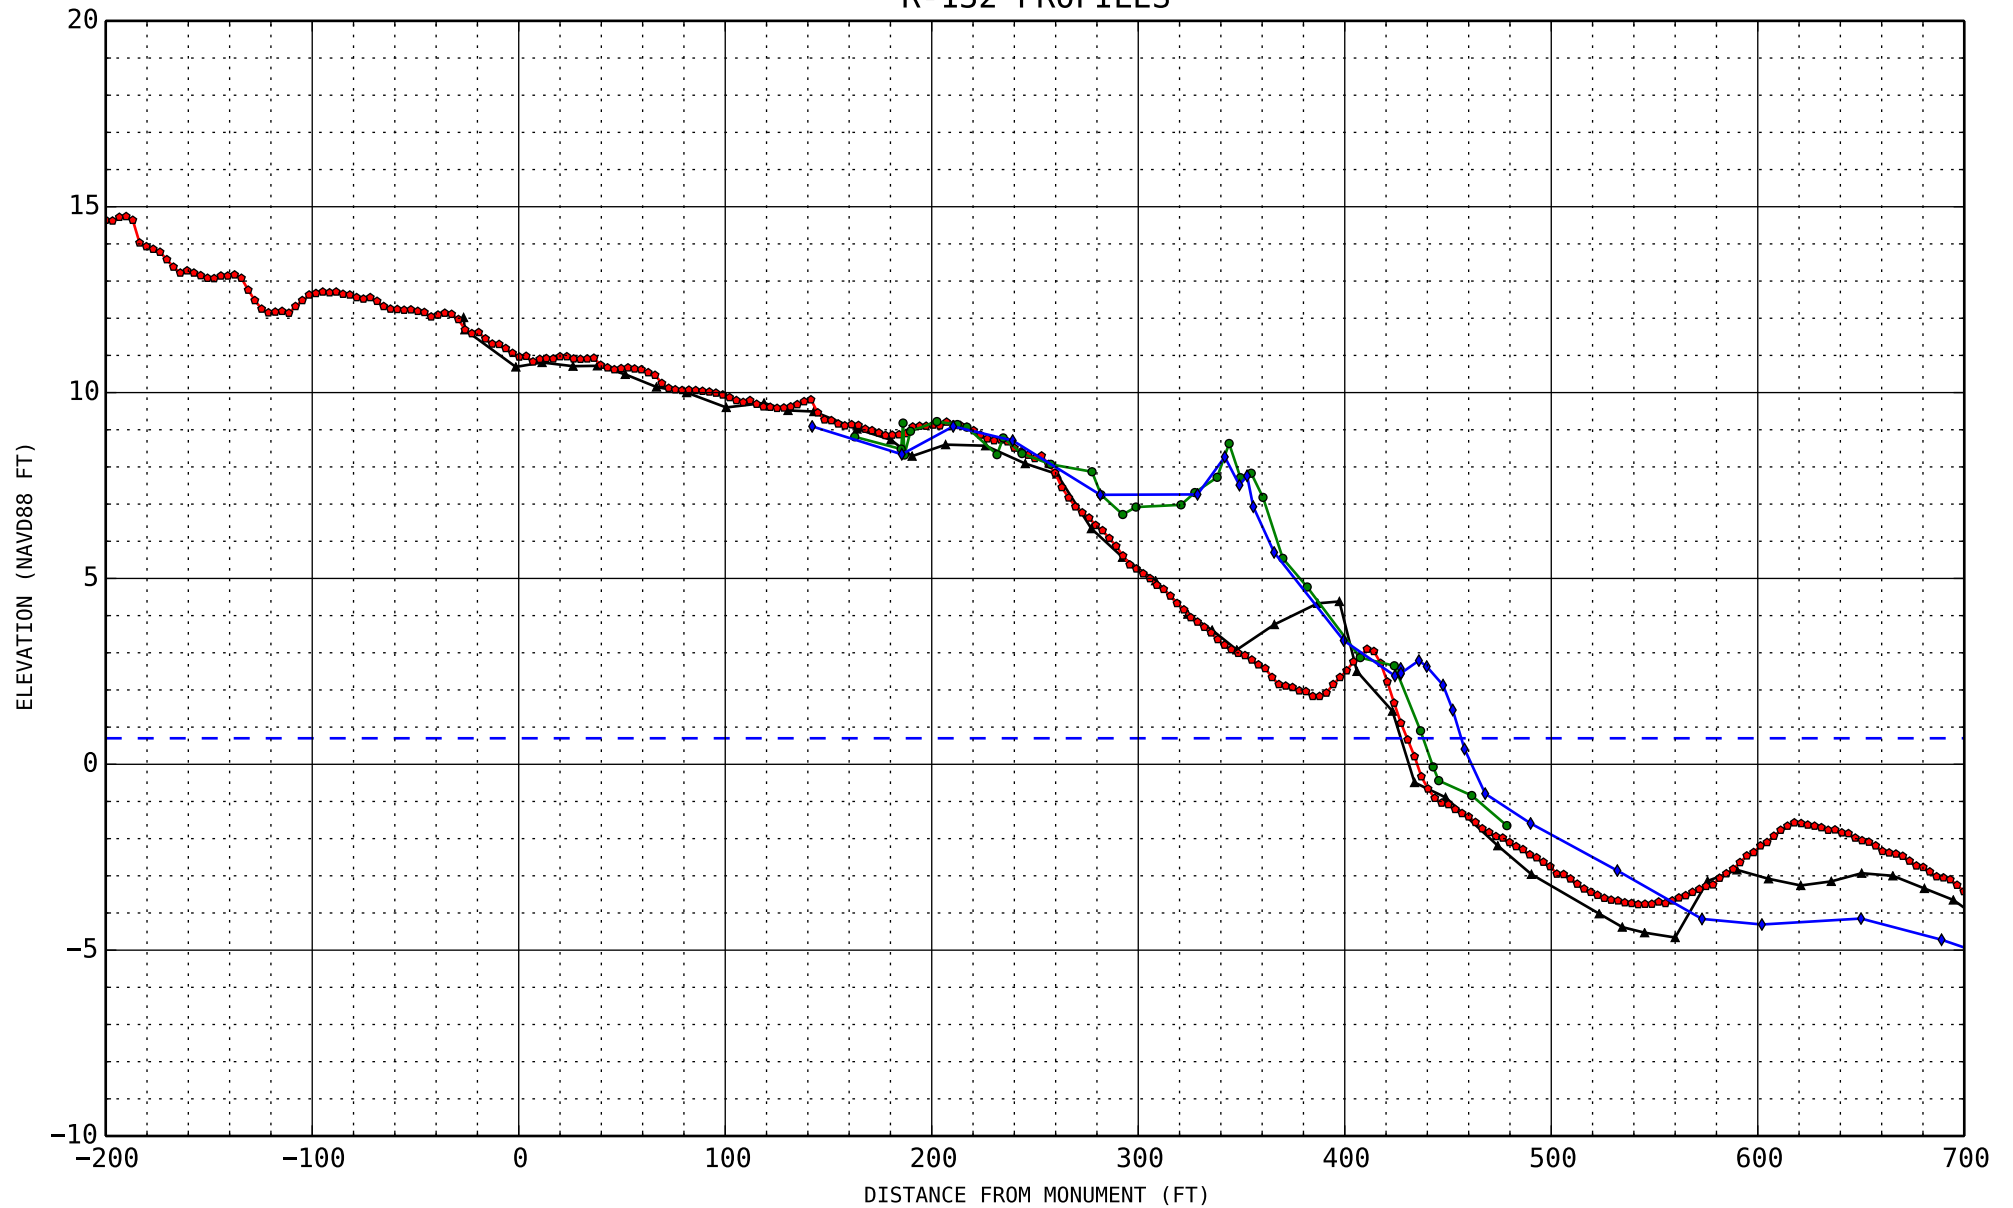
# R-132 PROFILES

▲ 2018-DEC MONITORING BY DEW  
 ● 2018-OCT MONITORING BY USACE-LIDAR  
 ● 2016-OCT MONITORING BY DEP  
 ◆ 2013-SEP MONITORING BY DEP  
 - - - MHW CONTOUR (0.7 FT)

RANGE: R-132  
 EST DATE: APR1991  
 SURVEY DATE: 18DEC18  
 AZIMUTH: 215.0

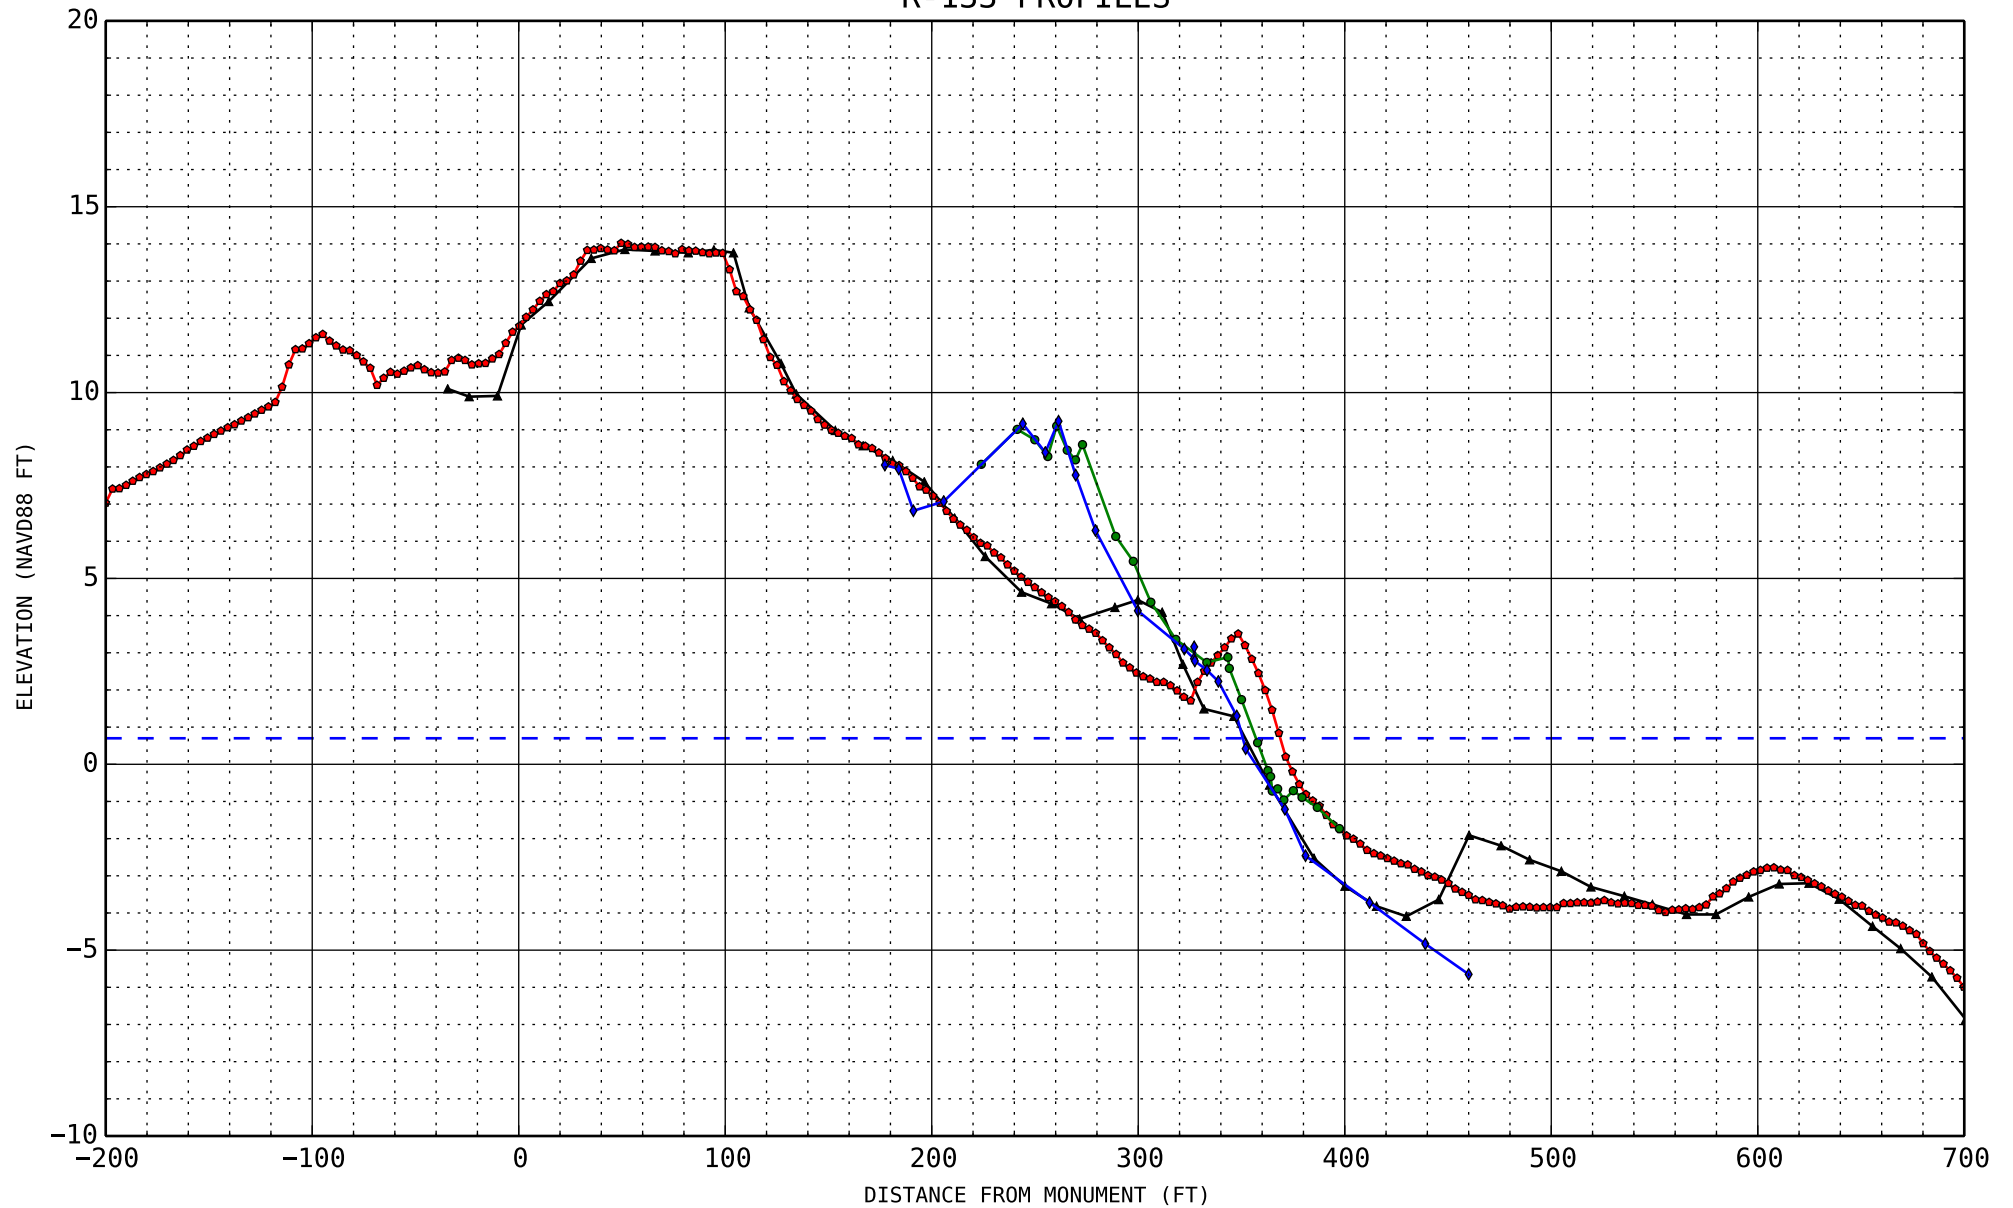
# R-133 PROFILES

▲ 2018-DEC MONITORING BY DEW  
 ● 2018-OCT MONITORING BY USACE-LIDAR  
 ● 2016-OCT MONITORING BY DEP  
 ◆ 2013-SEP MONITORING BY DEP  
 - - - MHW CONTOUR (0.7 FT)

RANGE: R-133  
 EST DATE: JAN1973  
 SURVEY DATE: 18DEC18  
 AZIMUTH: 215.0

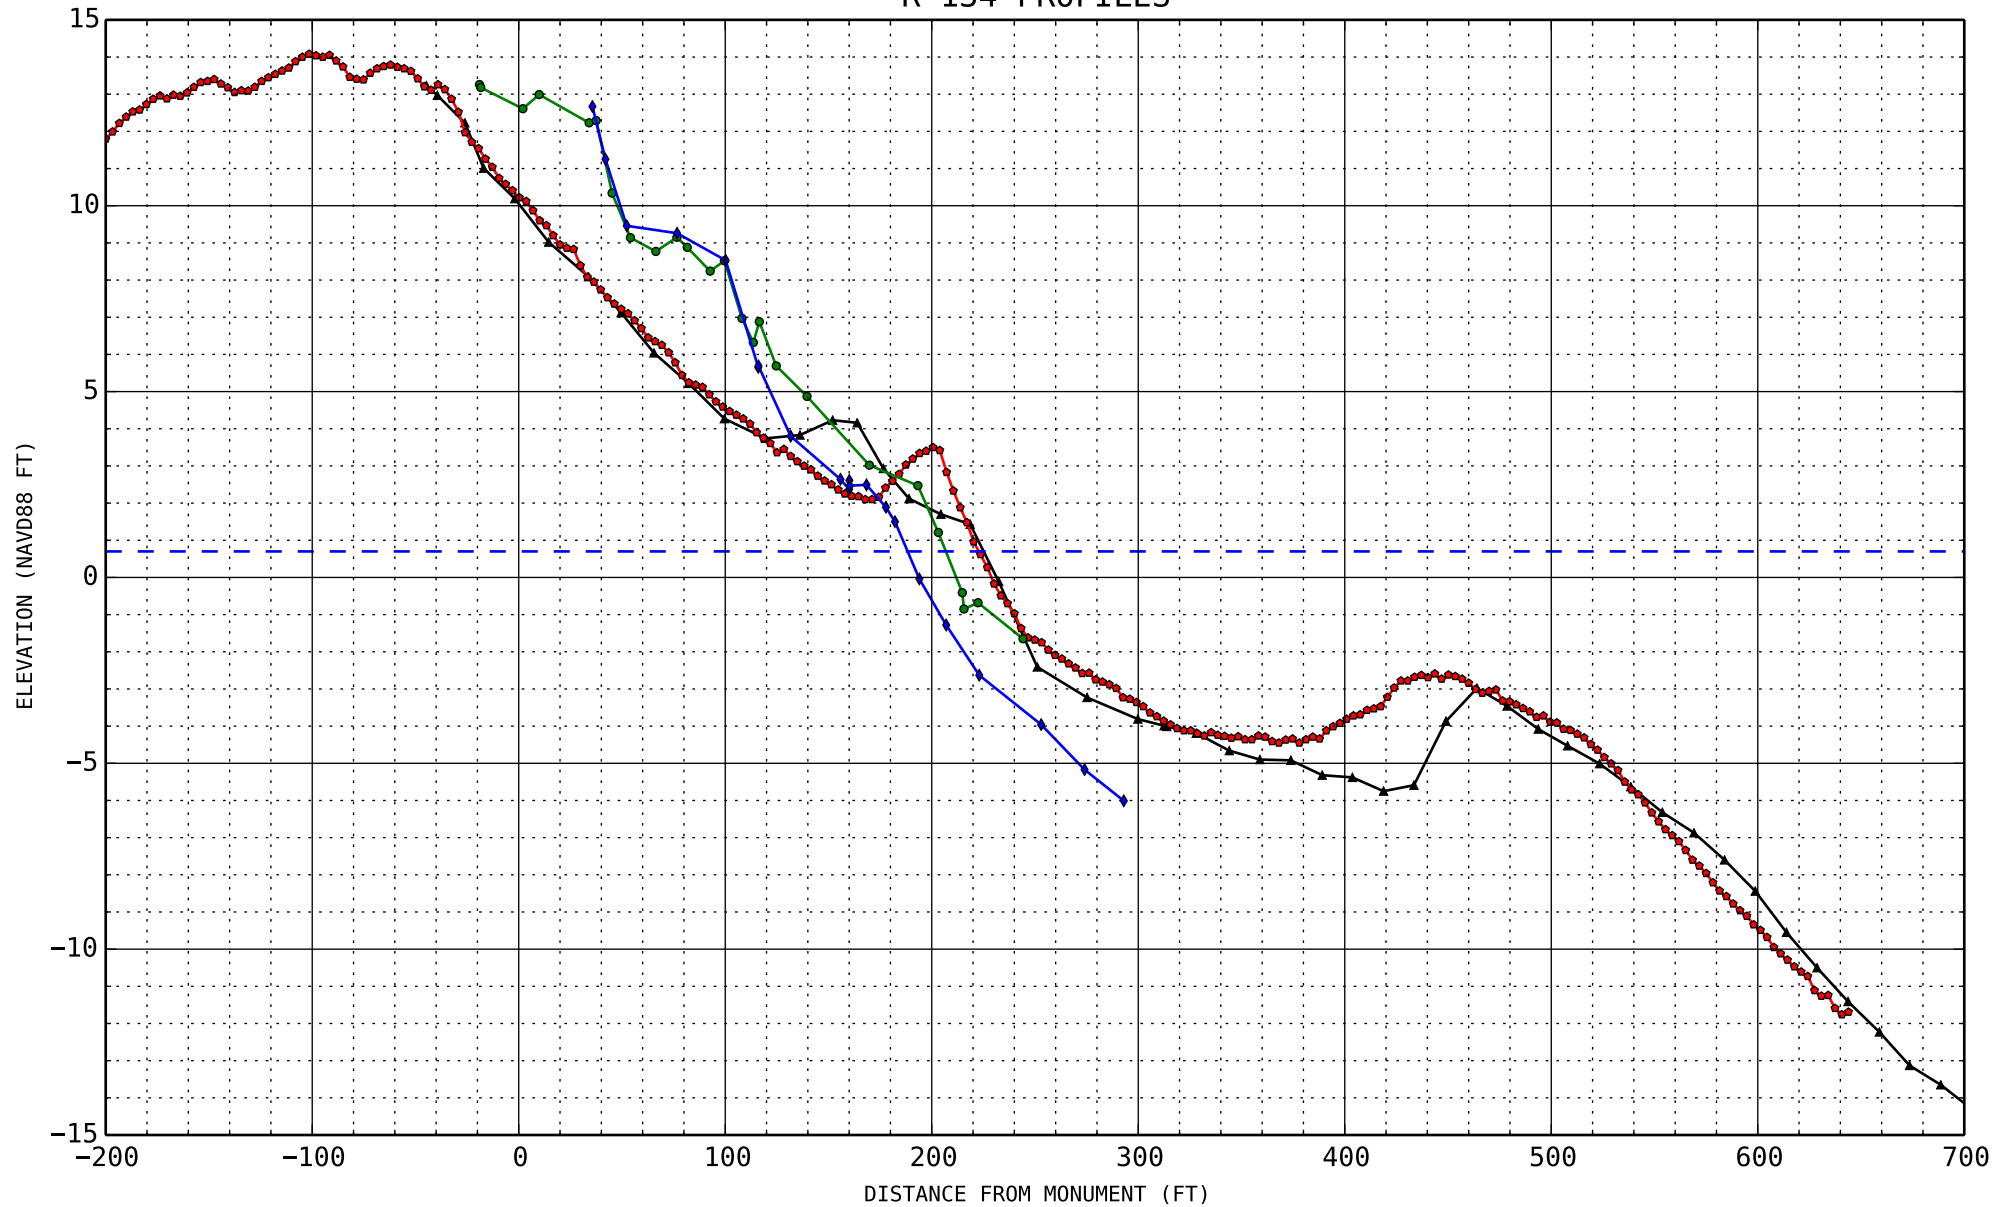
# R-134 PROFILES

- ▲ 2018-DEC MONITORING BY DEW
- 2018-OCT MONITORING BY USACE-LIDAR
- 2016-OCT MONITORING BY DEP
- ◆ 2013-SEP MONITORING BY DEP
- - - MHW CONTOUR (0.7 FT)

RANGE: R-134  
EST DATE: JAN1973  
SURVEY DATE: 18DEC18  
AZIMUTH: 220.0

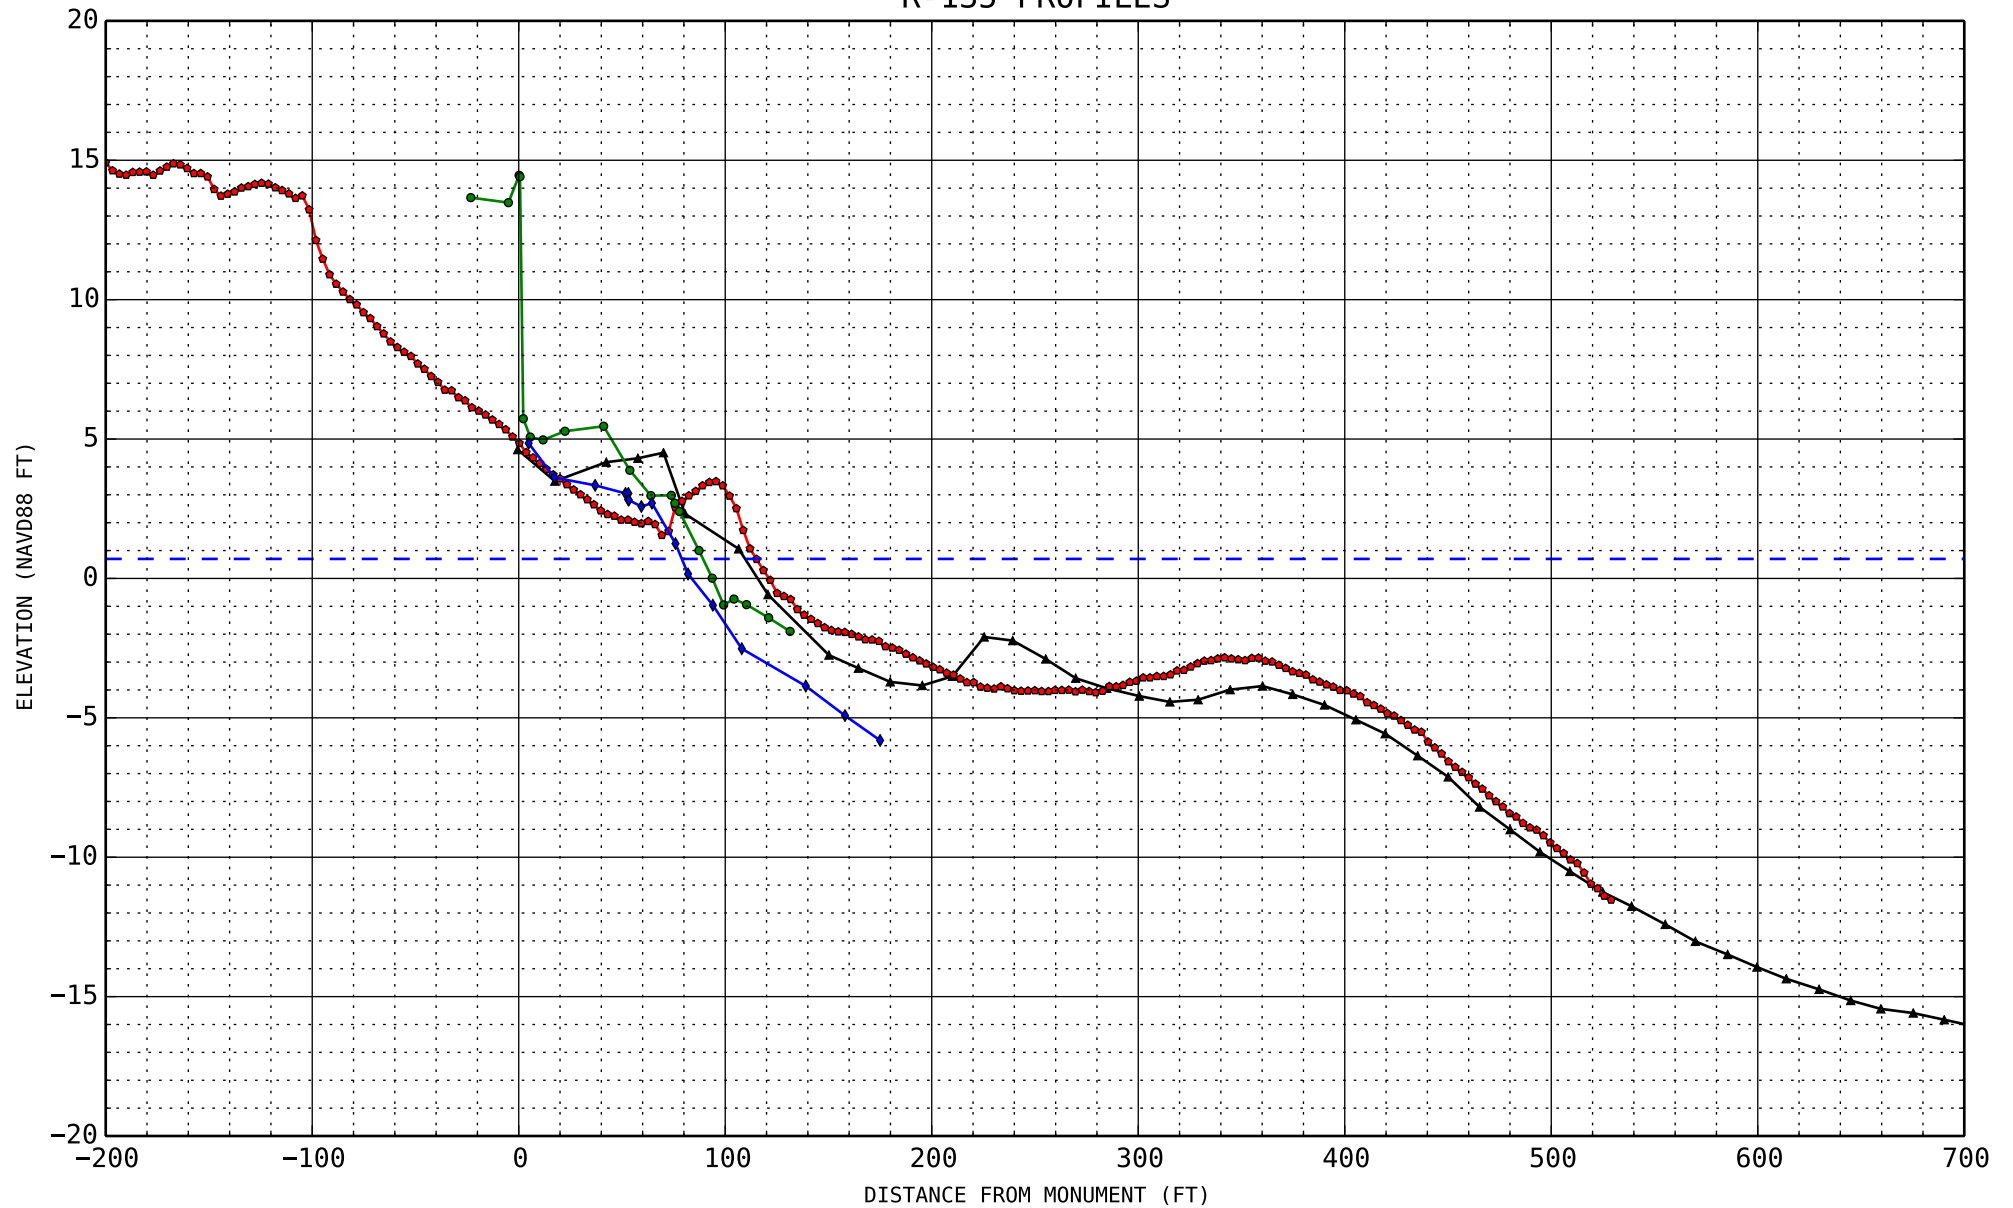
# R-135 PROFILES

- ▲ 2018-DEC MONITORING BY DEW
- 2018-OCT MONITORING BY USACE-LIDAR
- 2016-OCT MONITORING BY DEP
- ◆ 2013-SEP MONITORING BY DEP
- - - MHW CONTOUR (0.7 FT)

RANGE: R-135  
EST DATE: HYD1992  
SURVEY DATE: 18DEC18  
AZIMUTH: 220.0

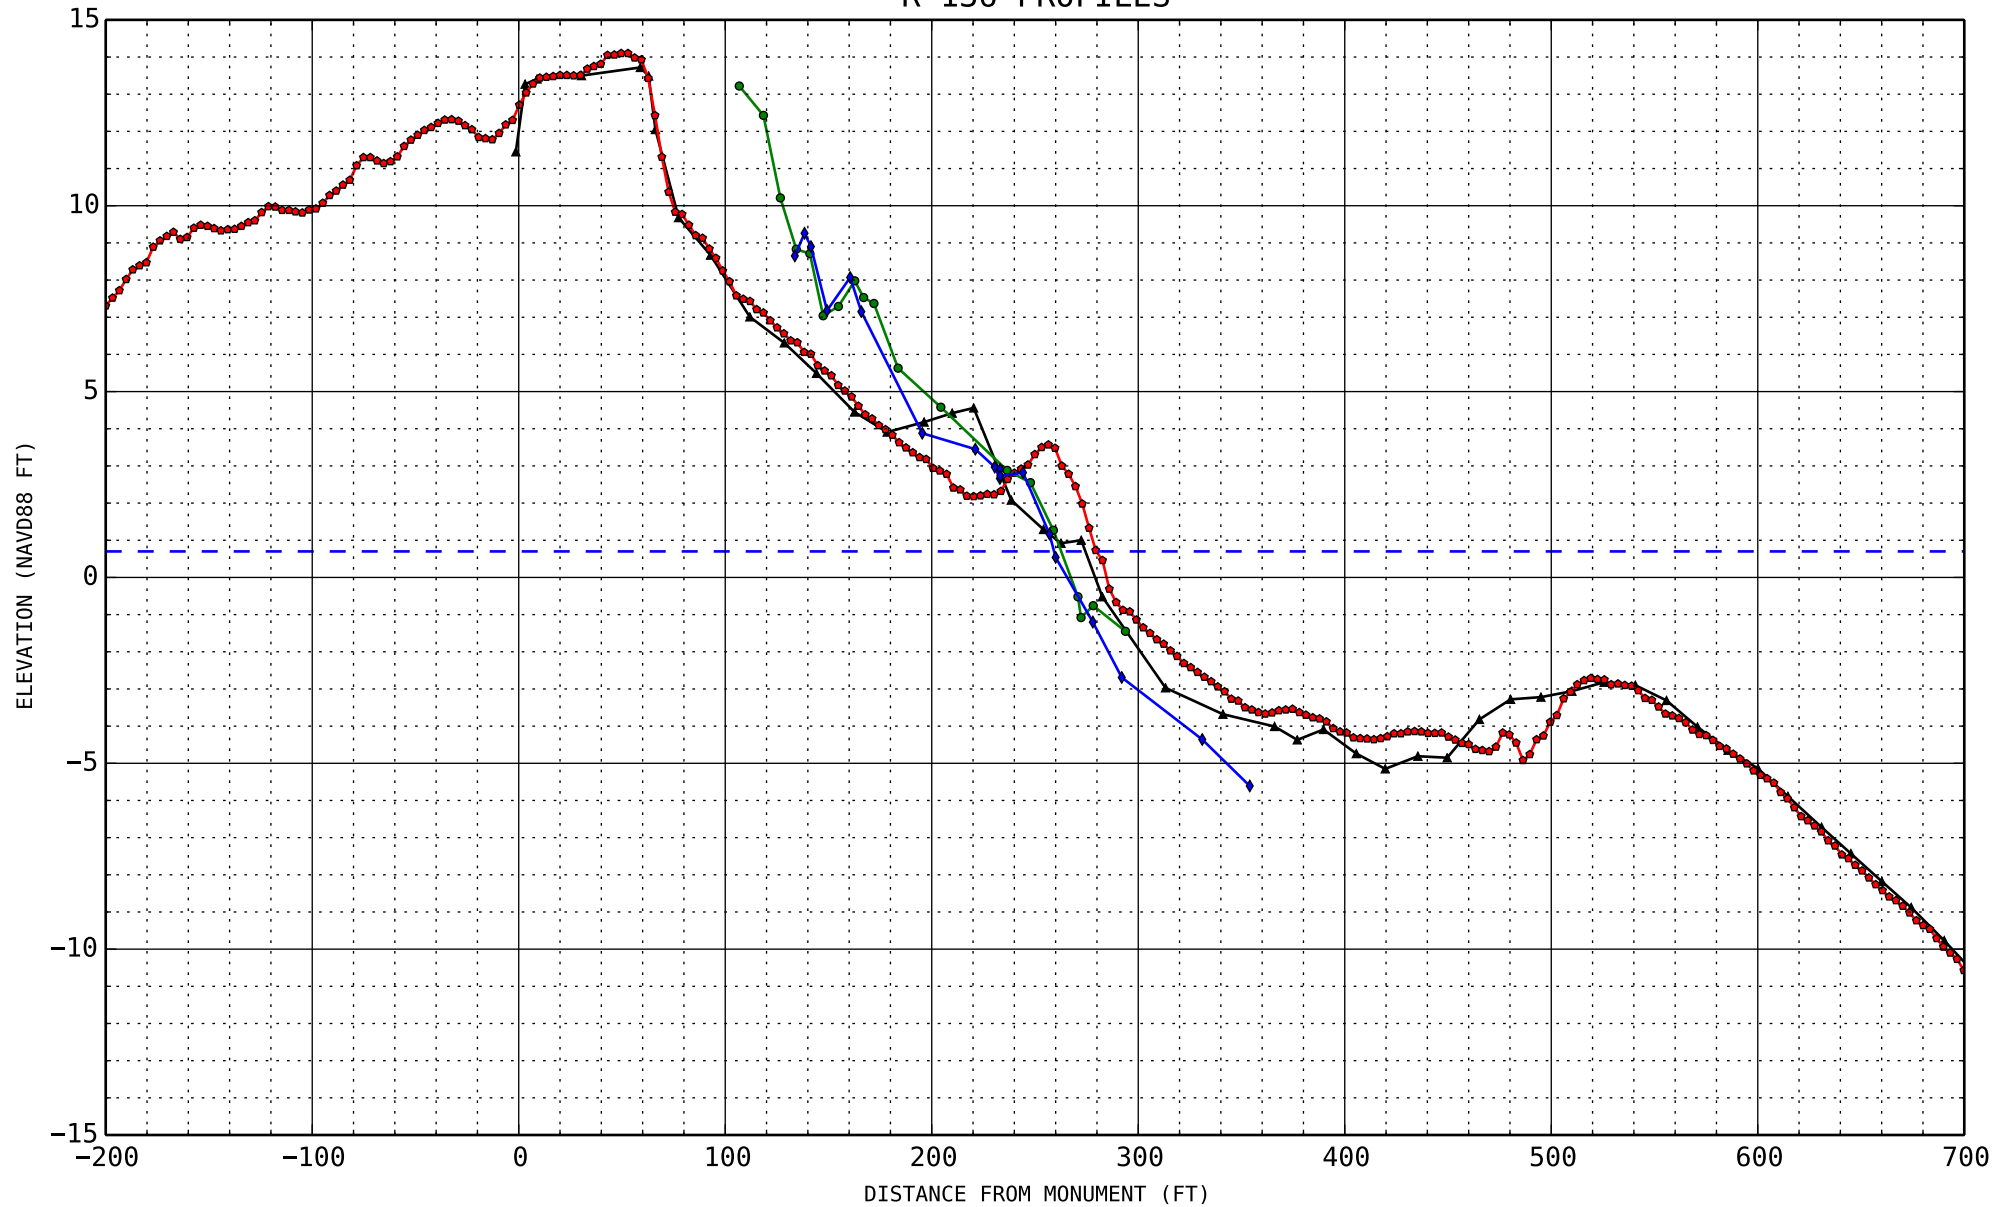
# R-136 PROFILES

- ▲ 2018-DEC MONITORING BY DEW
- 2018-OCT MONITORING BY USACE-LIDAR
- 2016-OCT MONITORING BY DEP
- ◆ 2013-SEP MONITORING BY DEP
- - - MHW CONTOUR (0.7 FT)

RANGE: R-136  
EST DATE: JAN1973  
SURVEY DATE: 18DEC18  
AZIMUTH: 220.0

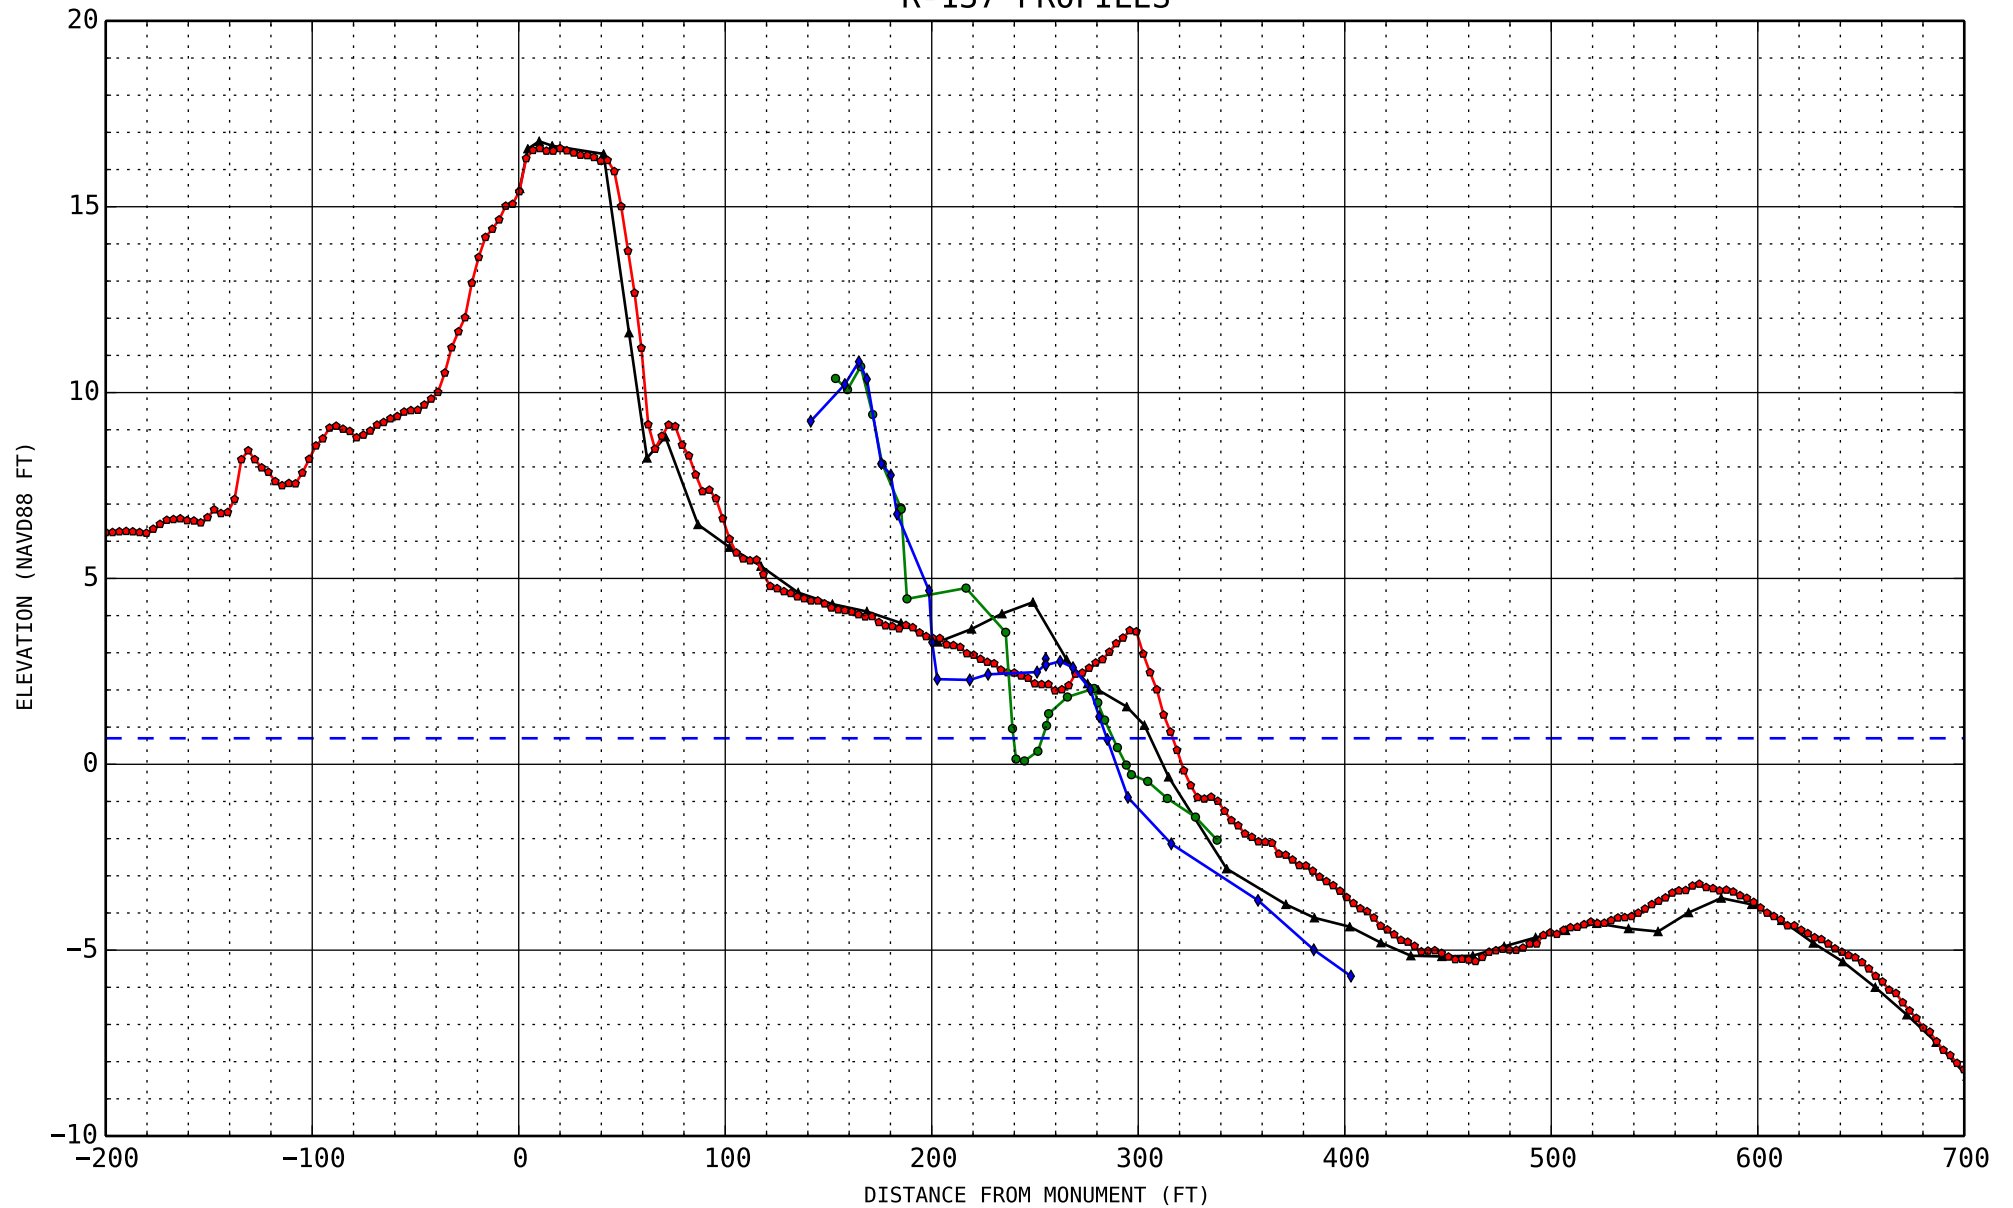
# R-137 PROFILES

- ▲ 2018-DEC MONITORING BY DEW
- 2018-OCT MONITORING BY USACE-LIDAR
- 2016-OCT MONITORING BY DEP
- ◆ 2013-SEP MONITORING BY DEP
- - - MHW CONTOUR (0.7 FT)

RANGE: R-137  
EST DATE: APR1991  
SURVEY DATE: 18DEC18  
AZIMUTH: 220.0

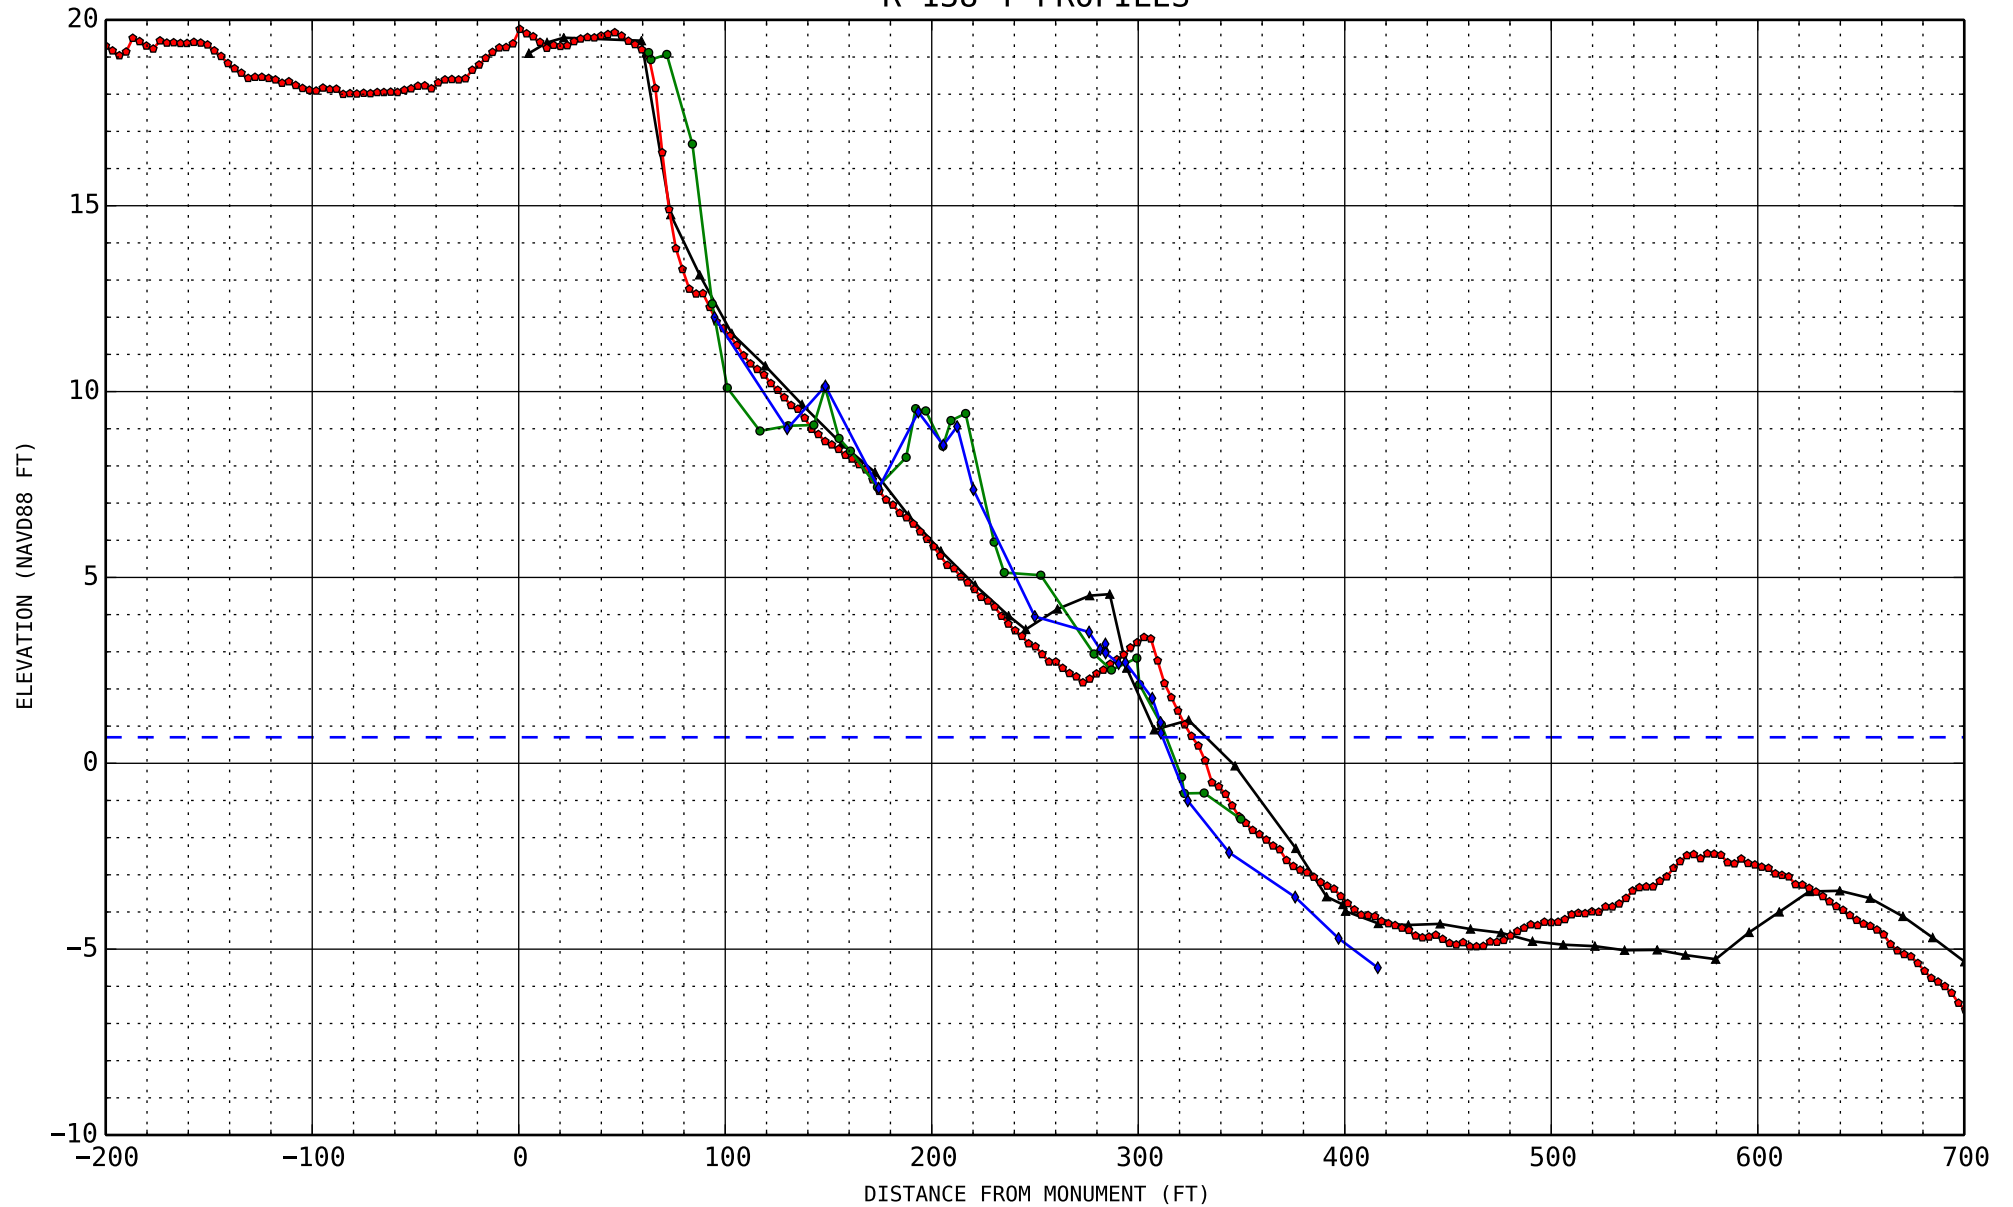
# R-138-T PROFILES

- ▲ 2018-DEC MONITORING BY DEW
- 2018-OCT MONITORING BY USACE-LIDAR
- 2016-OCT MONITORING BY DEP
- ◆ 2013-SEP MONITORING BY DEP
- - - MHW CONTOUR (0.7 FT)

RANGE: R-138-T  
EST DATE: JUN1979  
SURVEY DATE: 18DEC18  
AZIMUTH: 225.0

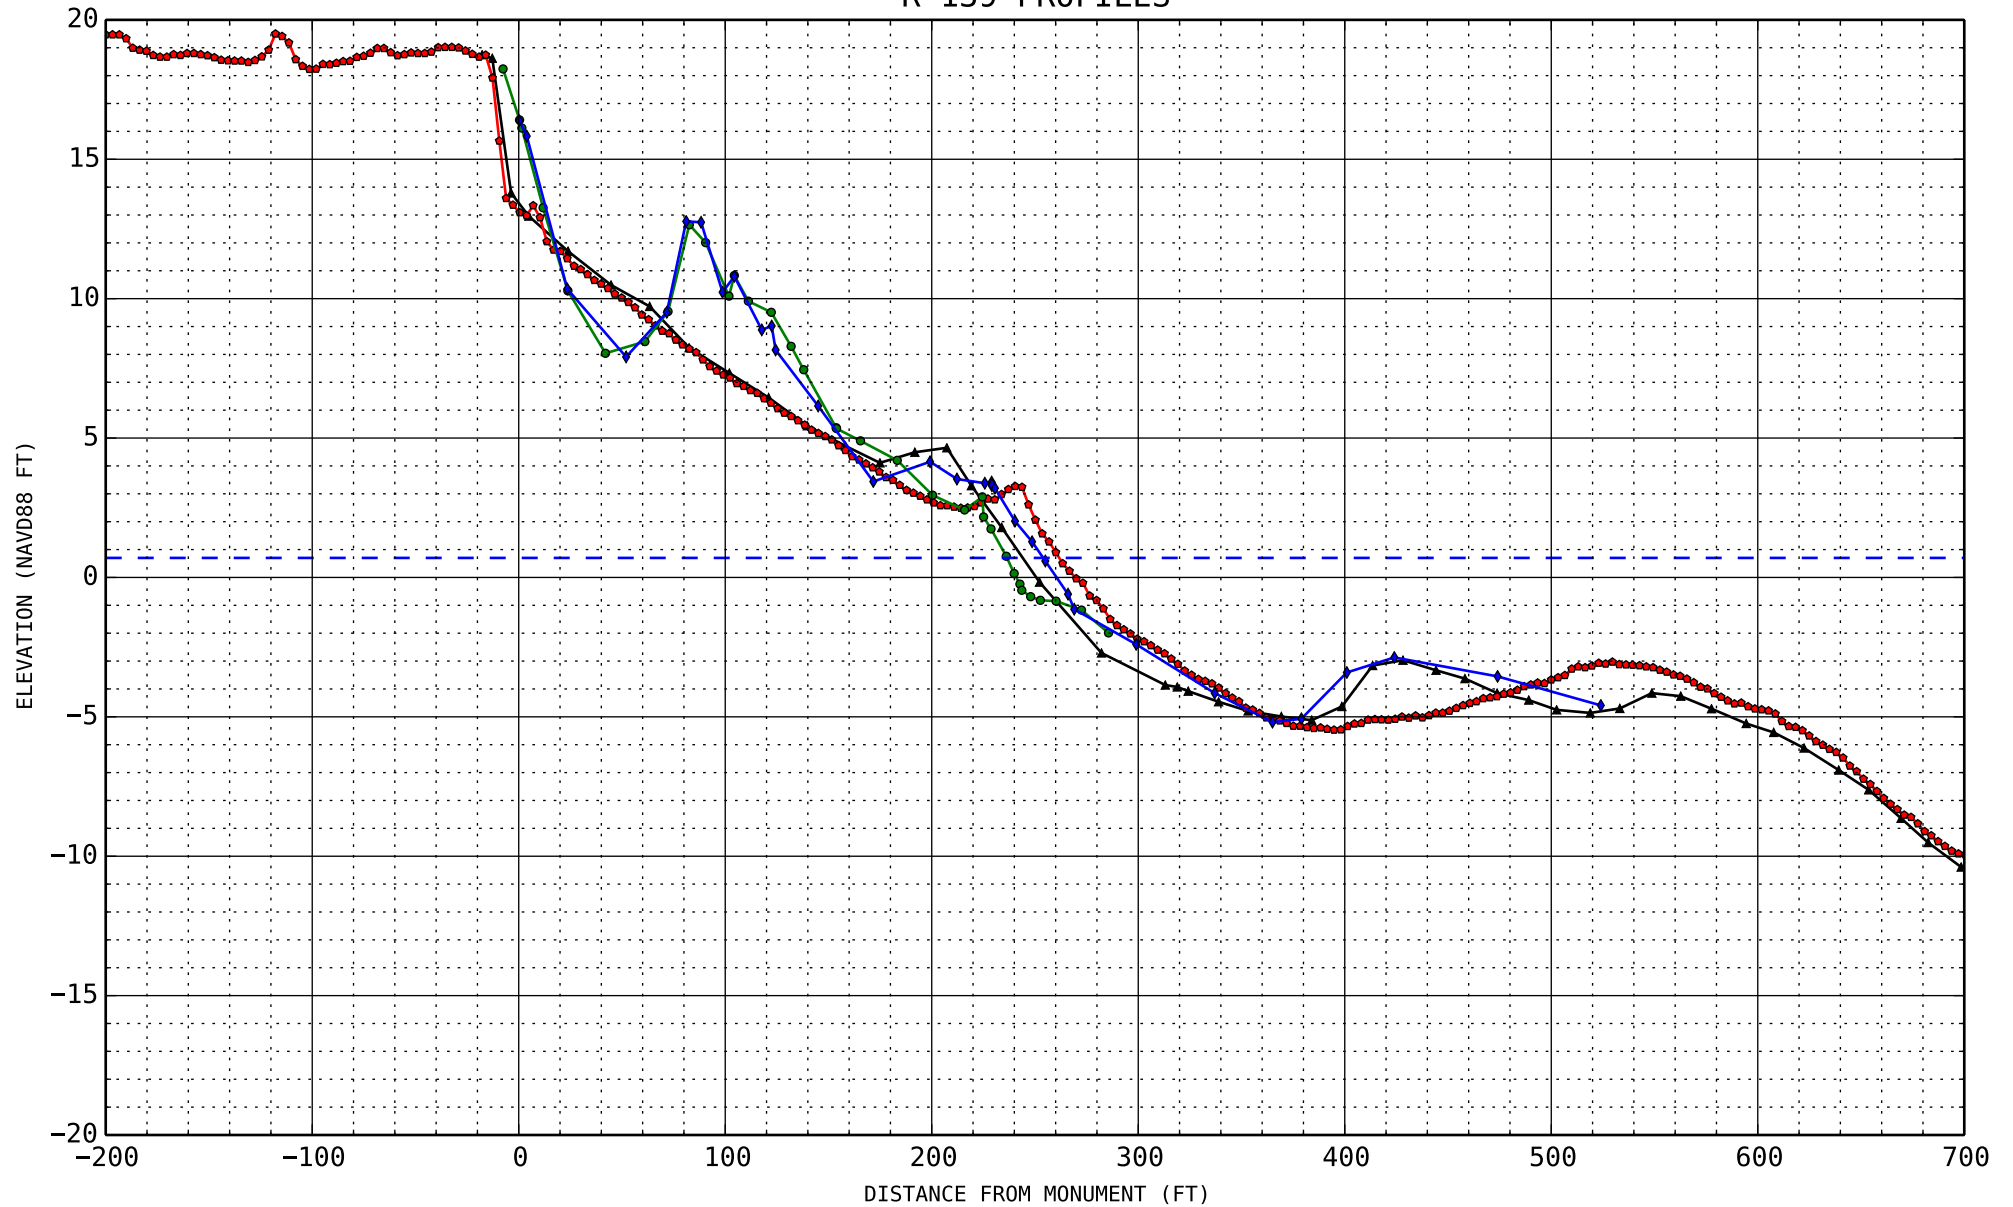
# R-139 PROFILES

- ▲ 2018-DEC MONITORING BY DEW
- 2018-OCT MONITORING BY USACE-LIDAR
- 2016-OCT MONITORING BY DEP
- ▲ 2013-SEP MONITORING BY DEP
- - - MHW CONTOUR (0.7 FT)

RANGE: R-139  
EST DATE: JUN1996  
SURVEY DATE: 18DEC18  
AZIMUTH: 225.0

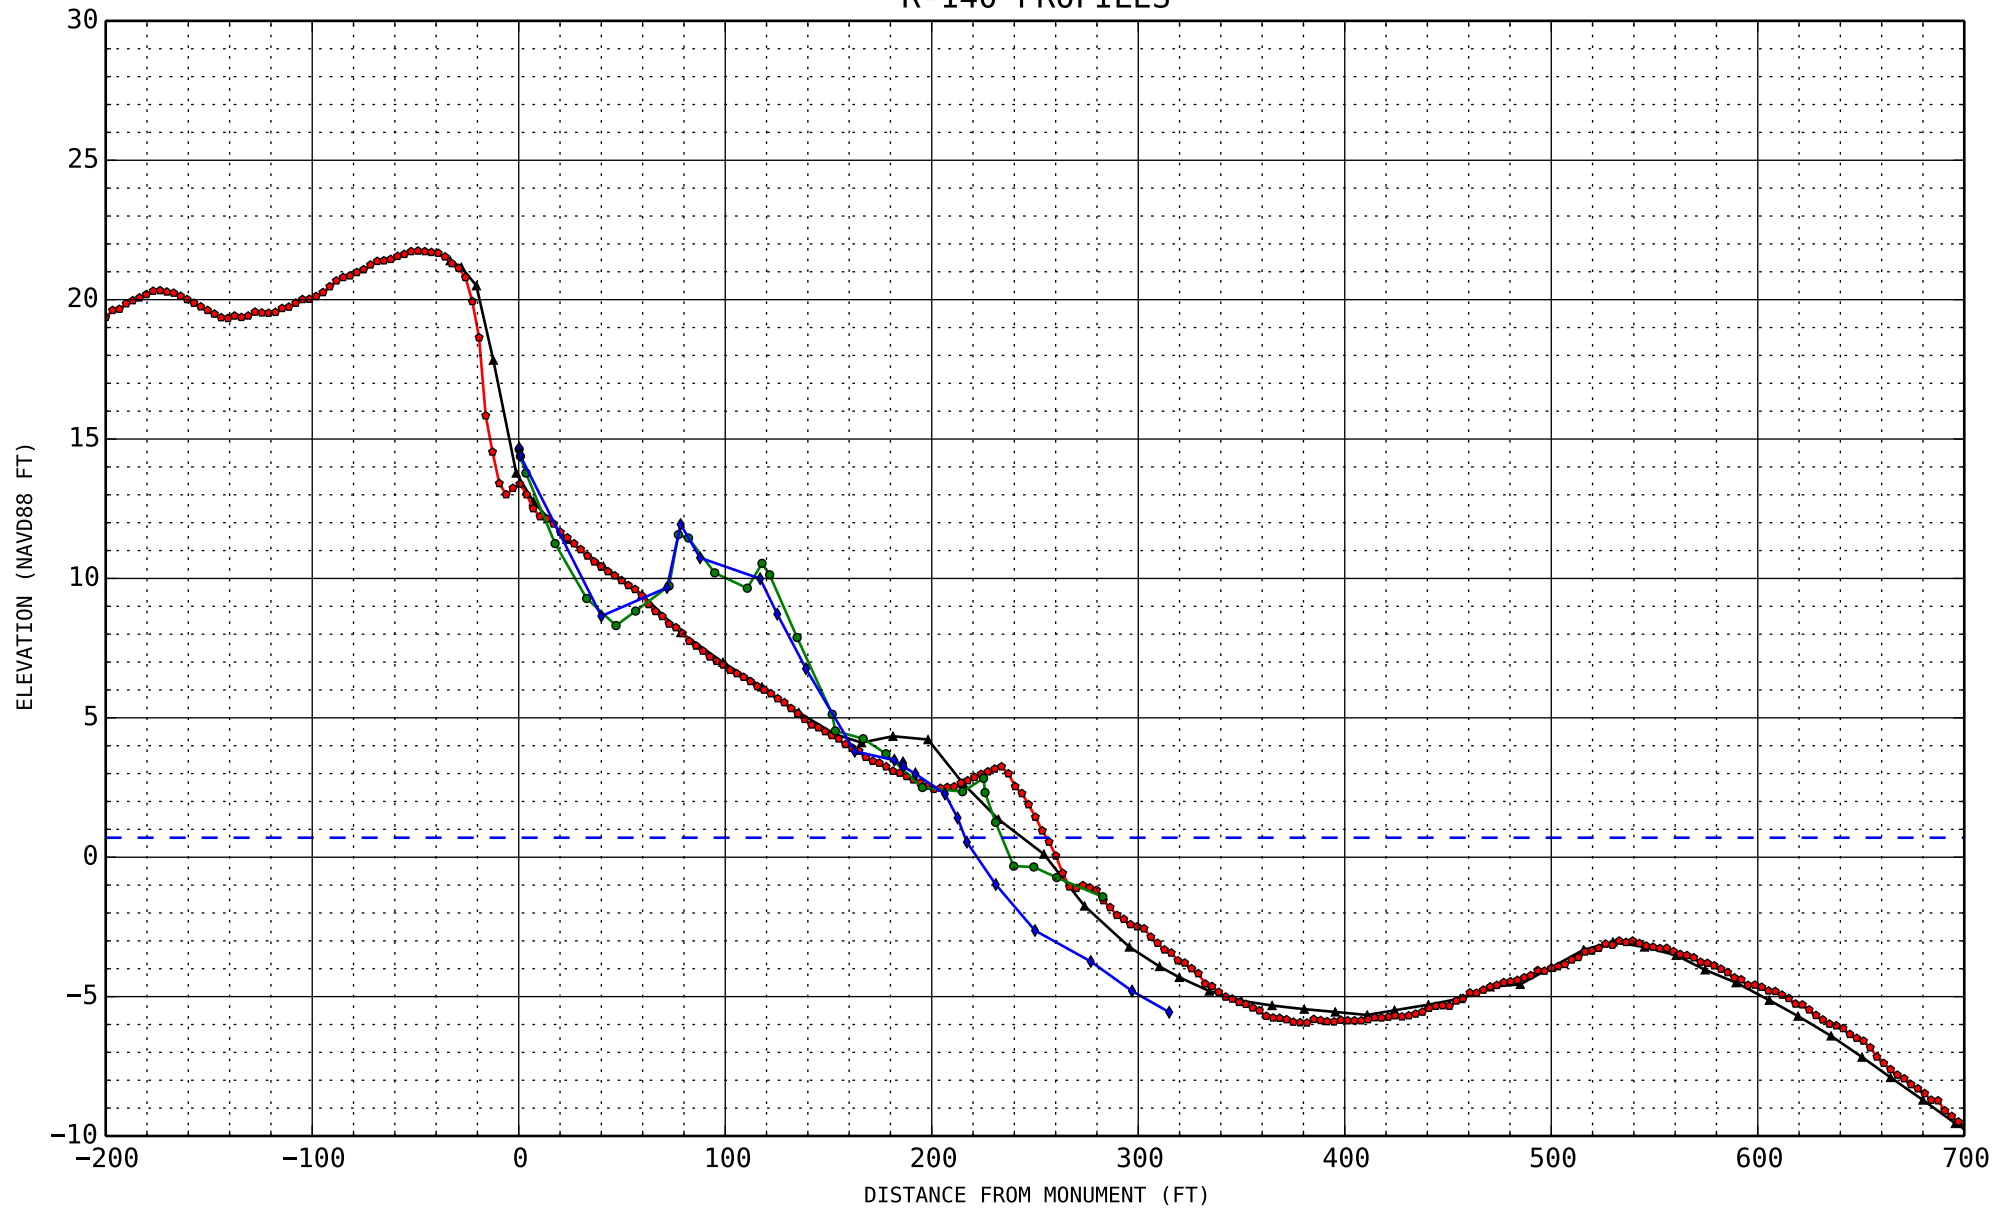
# R-140 PROFILES

- ▲ 2018-DEC MONITORING BY DEW
- 2018-OCT MONITORING BY USACE-LIDAR
- 2016-OCT MONITORING BY DEP
- ◆ 2013-SEP MONITORING BY DEP
- - - MHW CONTOUR (0.7 FT)

RANGE: R-140  
EST DATE: JAN1973  
SURVEY DATE: 18DEC18  
AZIMUTH: 225.0
