# R-123 PROFILES

BAY  
 PROGRAM SUPPORT GIS  
 DIVISION OF WATER RESOURCE MANAGEMENT  
 FLORIDA DEPARTMENT OF ENVIRONMENTAL PROTECTION

RANGE: R-123  
 EST DATE: JAN1973  
 SURVEY DATE: 19DEC18  
 AZIMUTH: 205.0

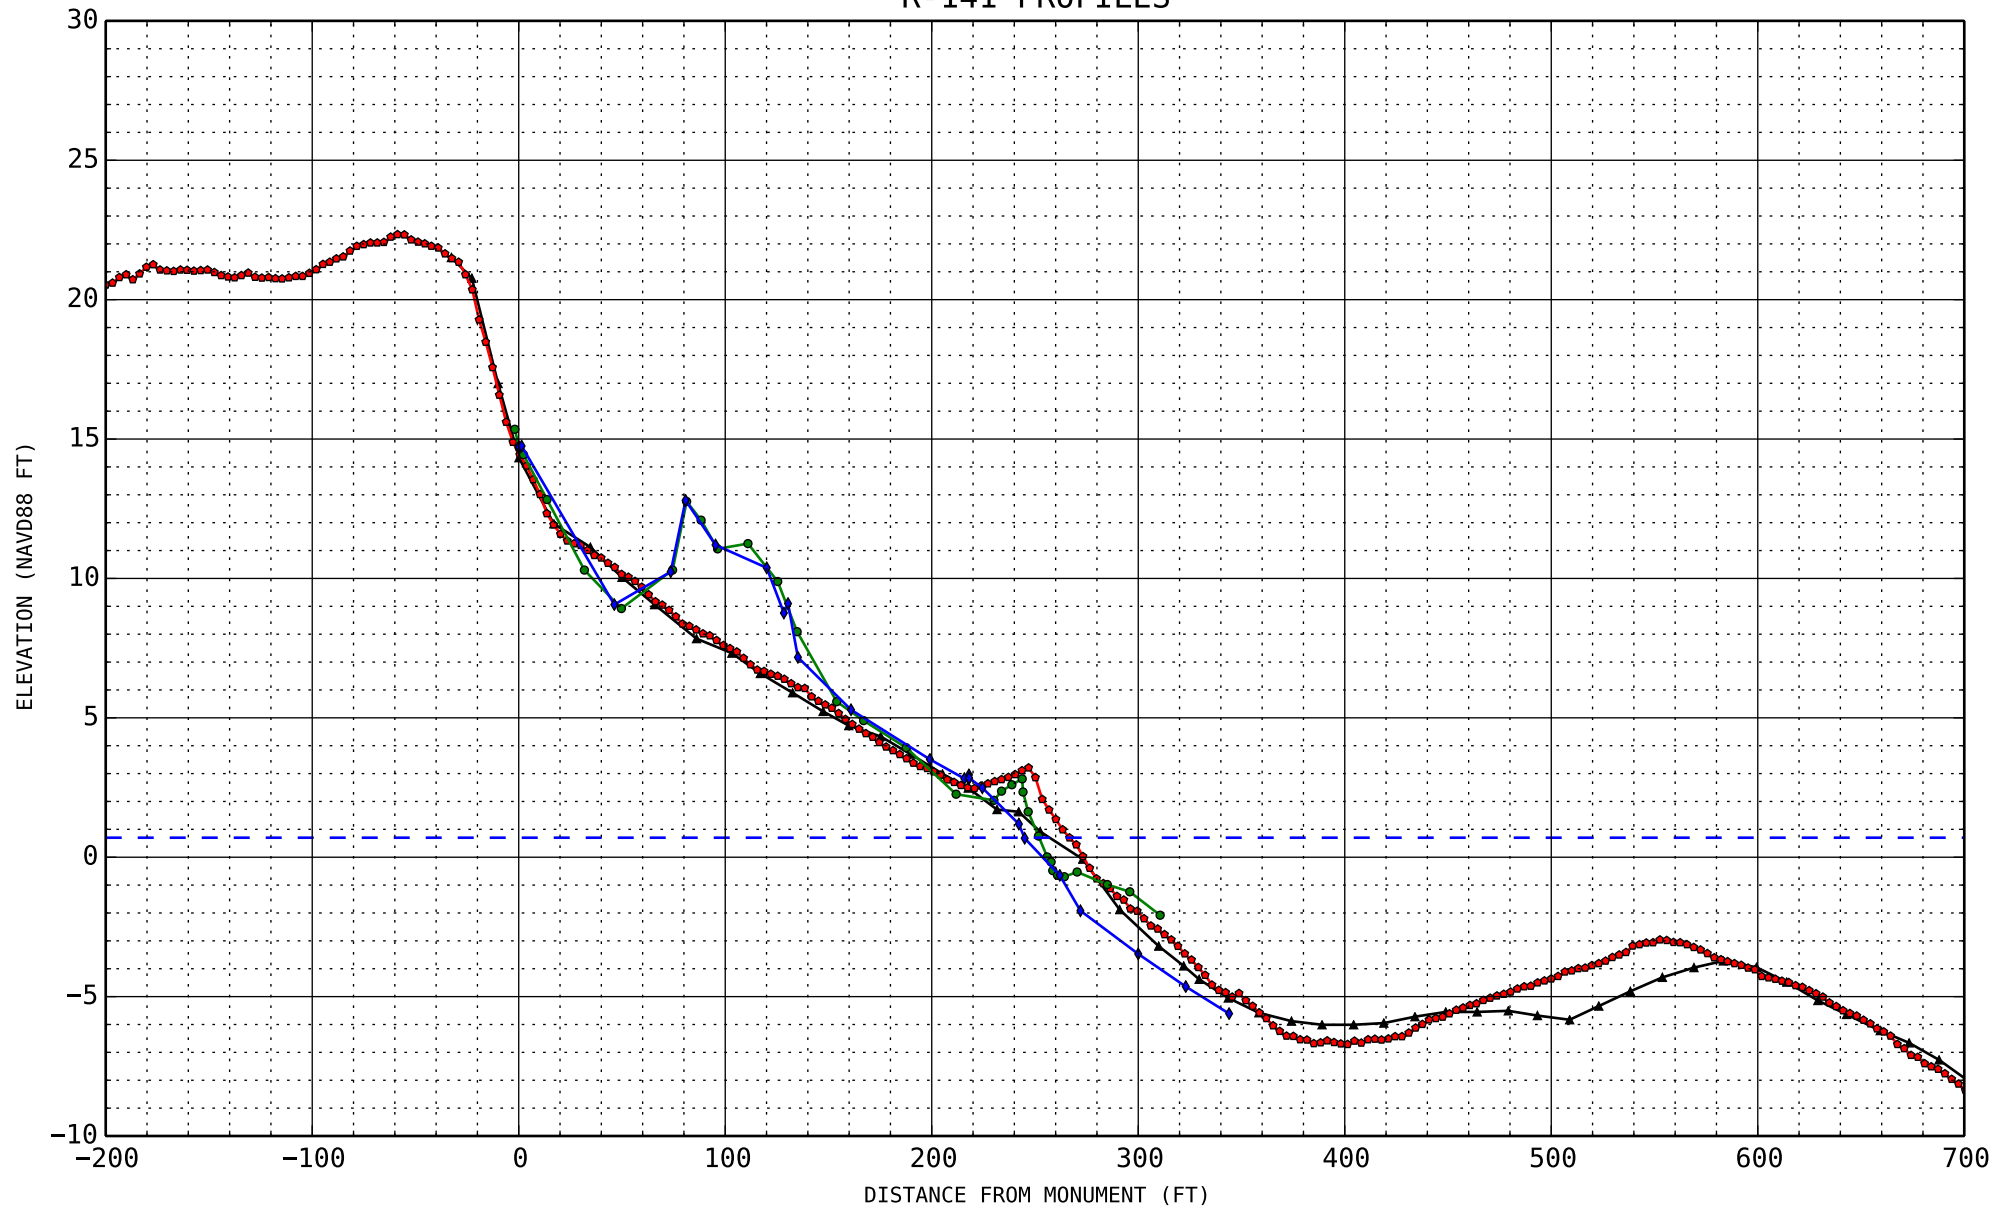
# R-141 PROFILES

- ▲ 2018-DEC MONITORING BY DEW
- 2018-OCT MONITORING BY USACE-LIDAR
- 2016-OCT MONITORING BY DEP
- ◆ 2013-SEP MONITORING BY DEP
- - - MHW CONTOUR (0.7 FT)

RANGE: R-141  
EST DATE: JAN1973  
SURVEY DATE: 18DEC18  
AZIMUTH: 225.0

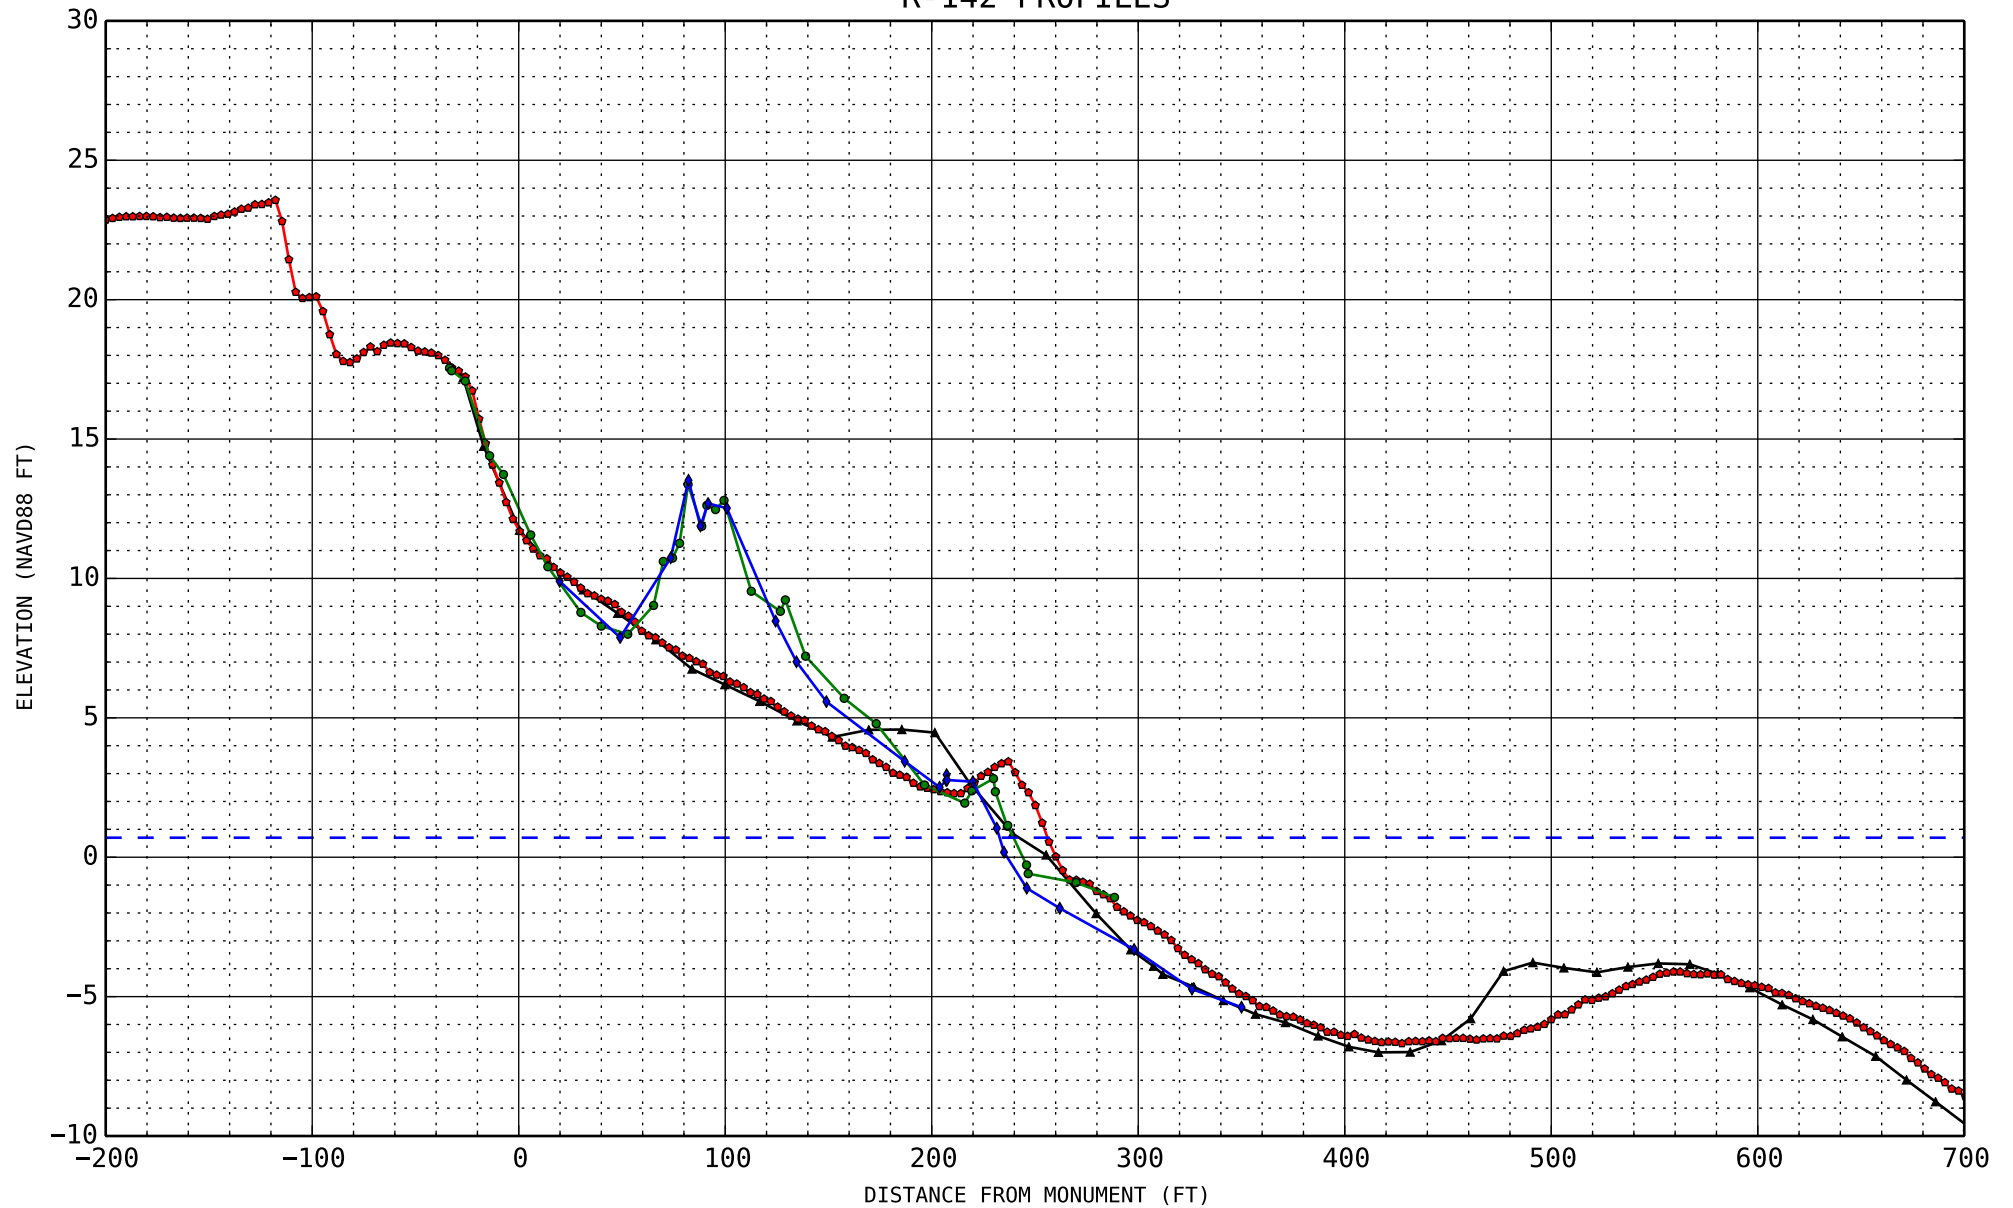
# R-142 PROFILES

- ▲ 2018-DEC MONITORING BY DEW
- 2018-OCT MONITORING BY USACE-LIDAR
- 2016-OCT MONITORING BY DEP
- ◆ 2013-SEP MONITORING BY DEP
- - - MHW CONTOUR (0.7 FT)

RANGE: R-142  
EST DATE: JAN1973  
SURVEY DATE: 18DEC18  
AZIMUTH: 225.0

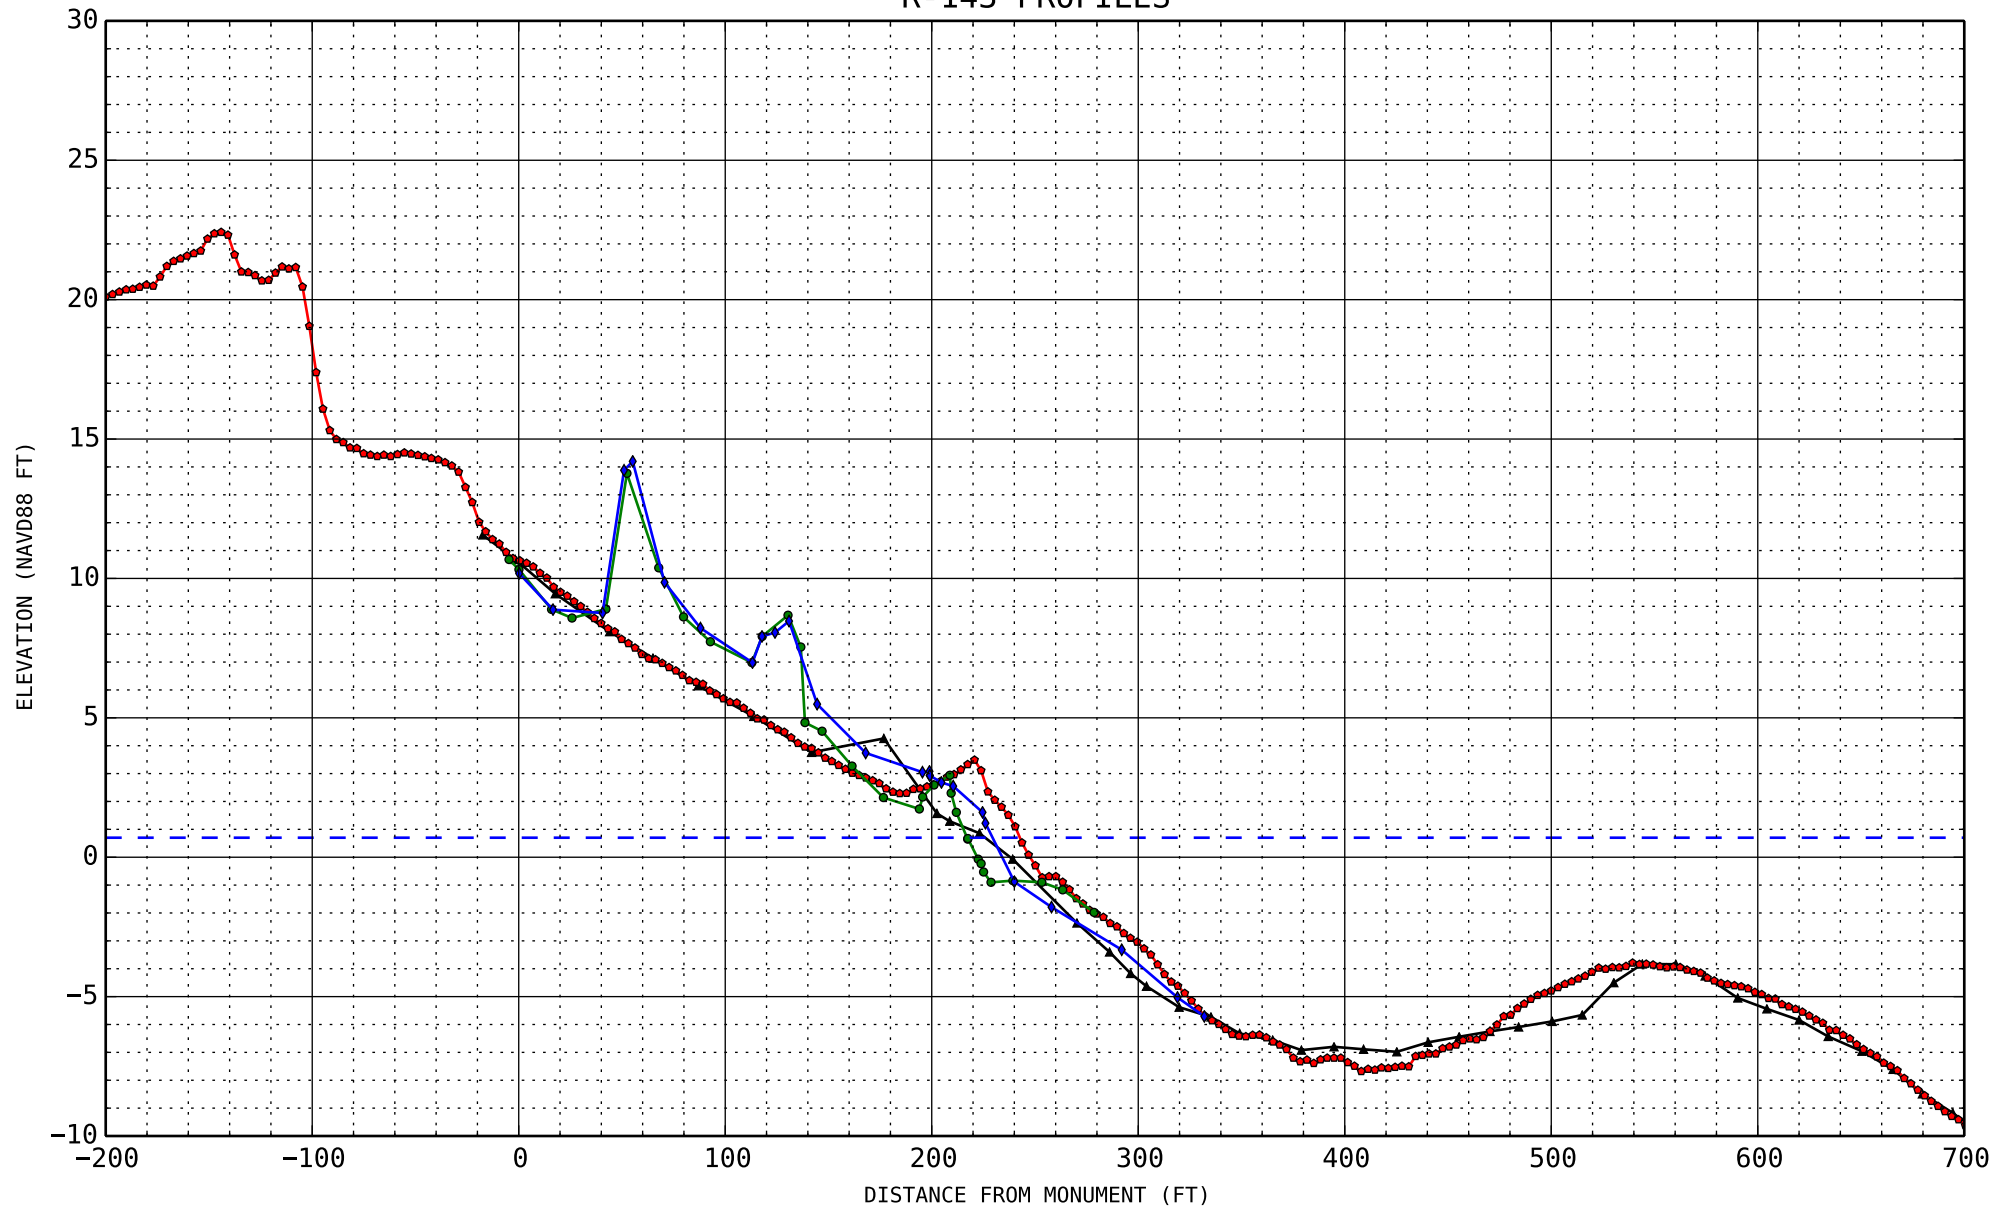
# R-143 PROFILES

- ▲ 2018-DEC MONITORING BY DEW
- 2018-OCT MONITORING BY USACE-LIDAR
- 2016-OCT MONITORING BY DEP
- ◆ 2013-SEP MONITORING BY DEP
- - - MHW CONTOUR (0.7 FT)

RANGE: R-143  
EST DATE: JAN1973  
SURVEY DATE: 18DEC18  
AZIMUTH: 225.0

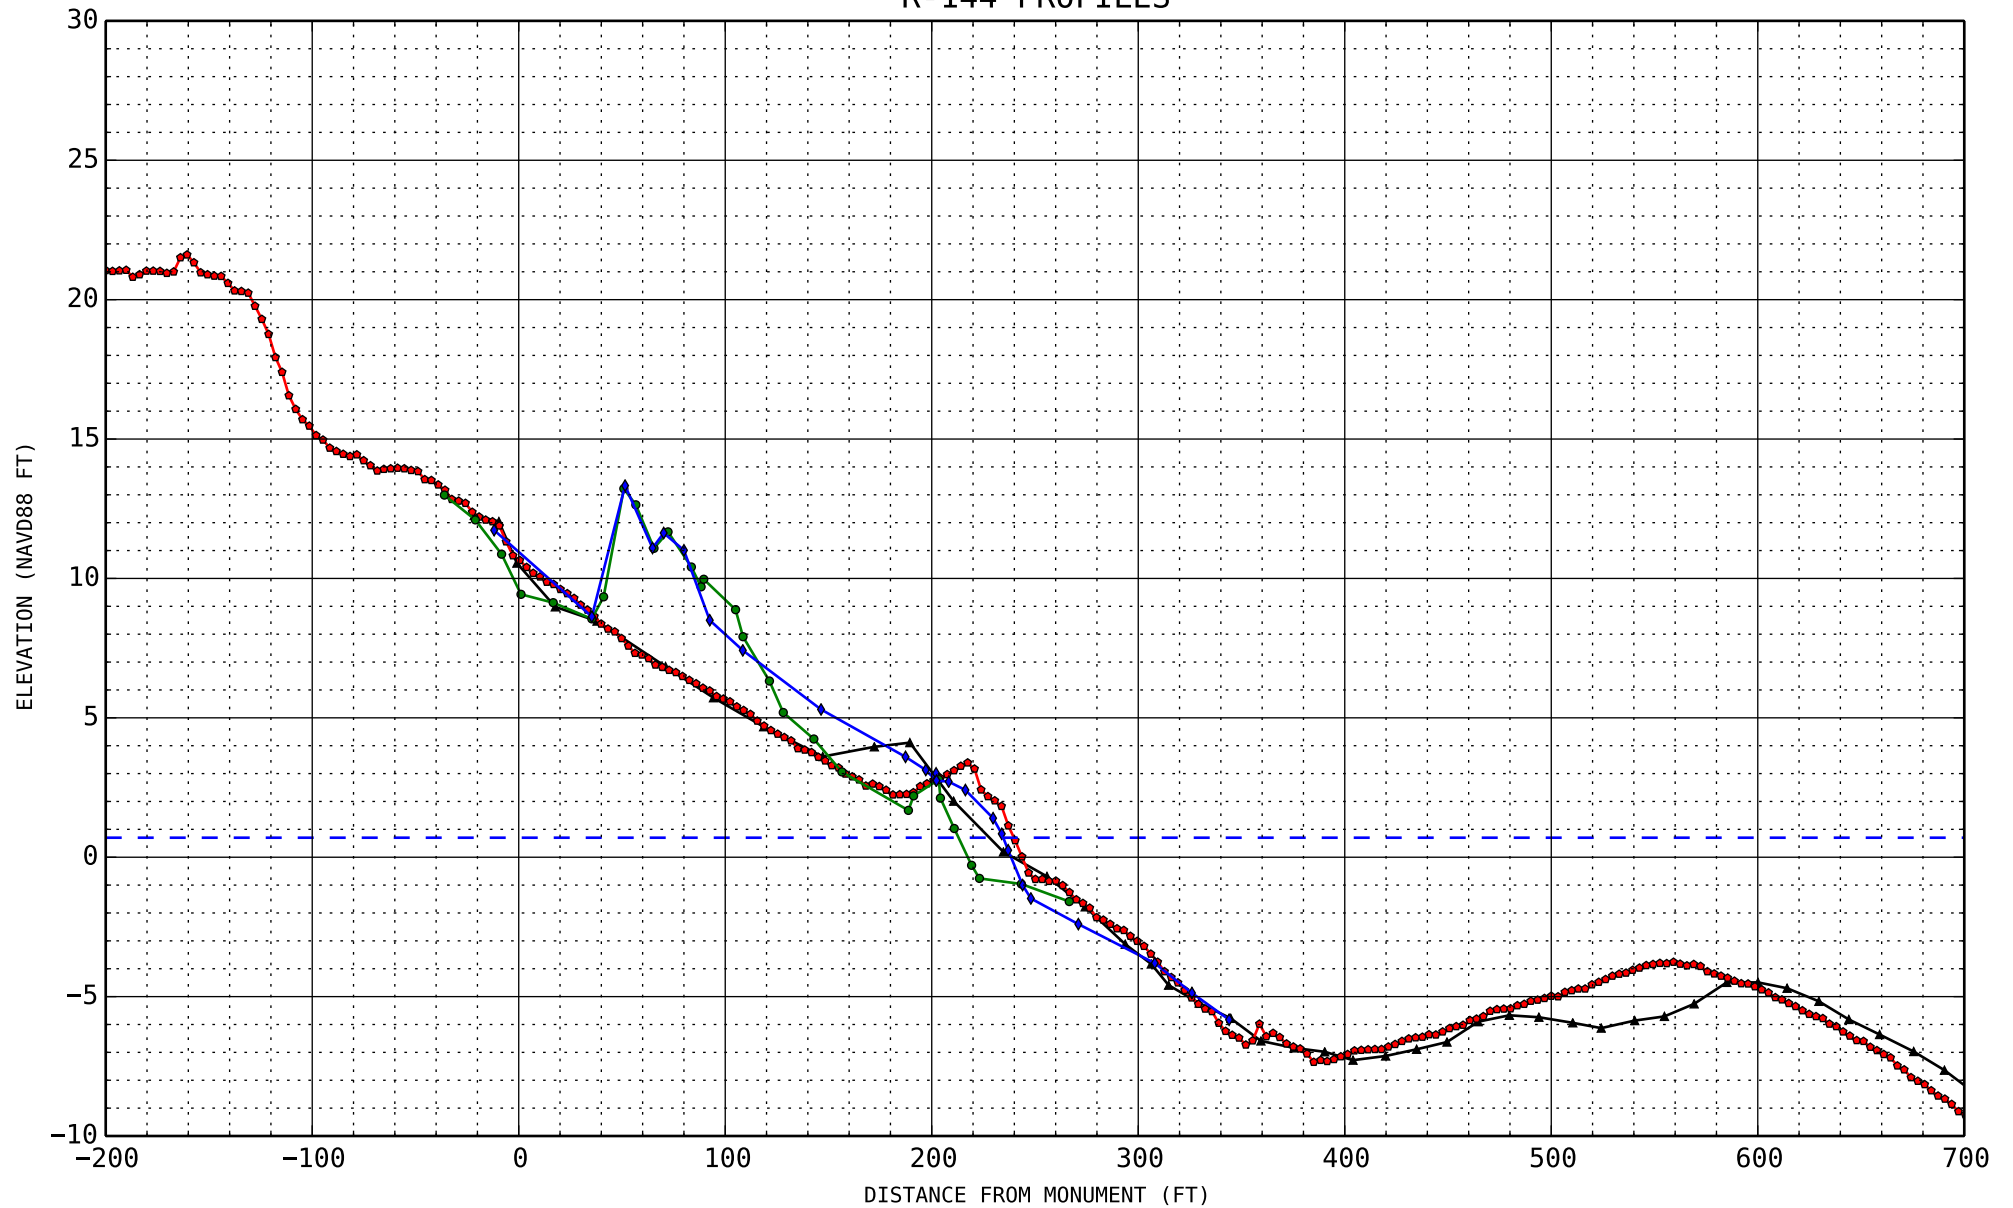
# R-144 PROFILES

- ▲ 2018-DEC MONITORING BY DEW
- 2018-OCT MONITORING BY USACE-LIDAR
- 2016-OCT MONITORING BY DEP
- ◆ 2013-SEP MONITORING BY DEP
- - - MHW CONTOUR (0.7 FT)

RANGE: R-144  
EST DATE: JAN1973  
SURVEY DATE: 18DEC18  
AZIMUTH: 225.0
