# R-17 PROFILES

OKALOOSA  
PROGRAM SUPPORT GIS  
DIVISION OF WATER RESOURCE MANAGEMENT  
FLORIDA DEPARTMENT OF ENVIRONMENTAL PROTECTION

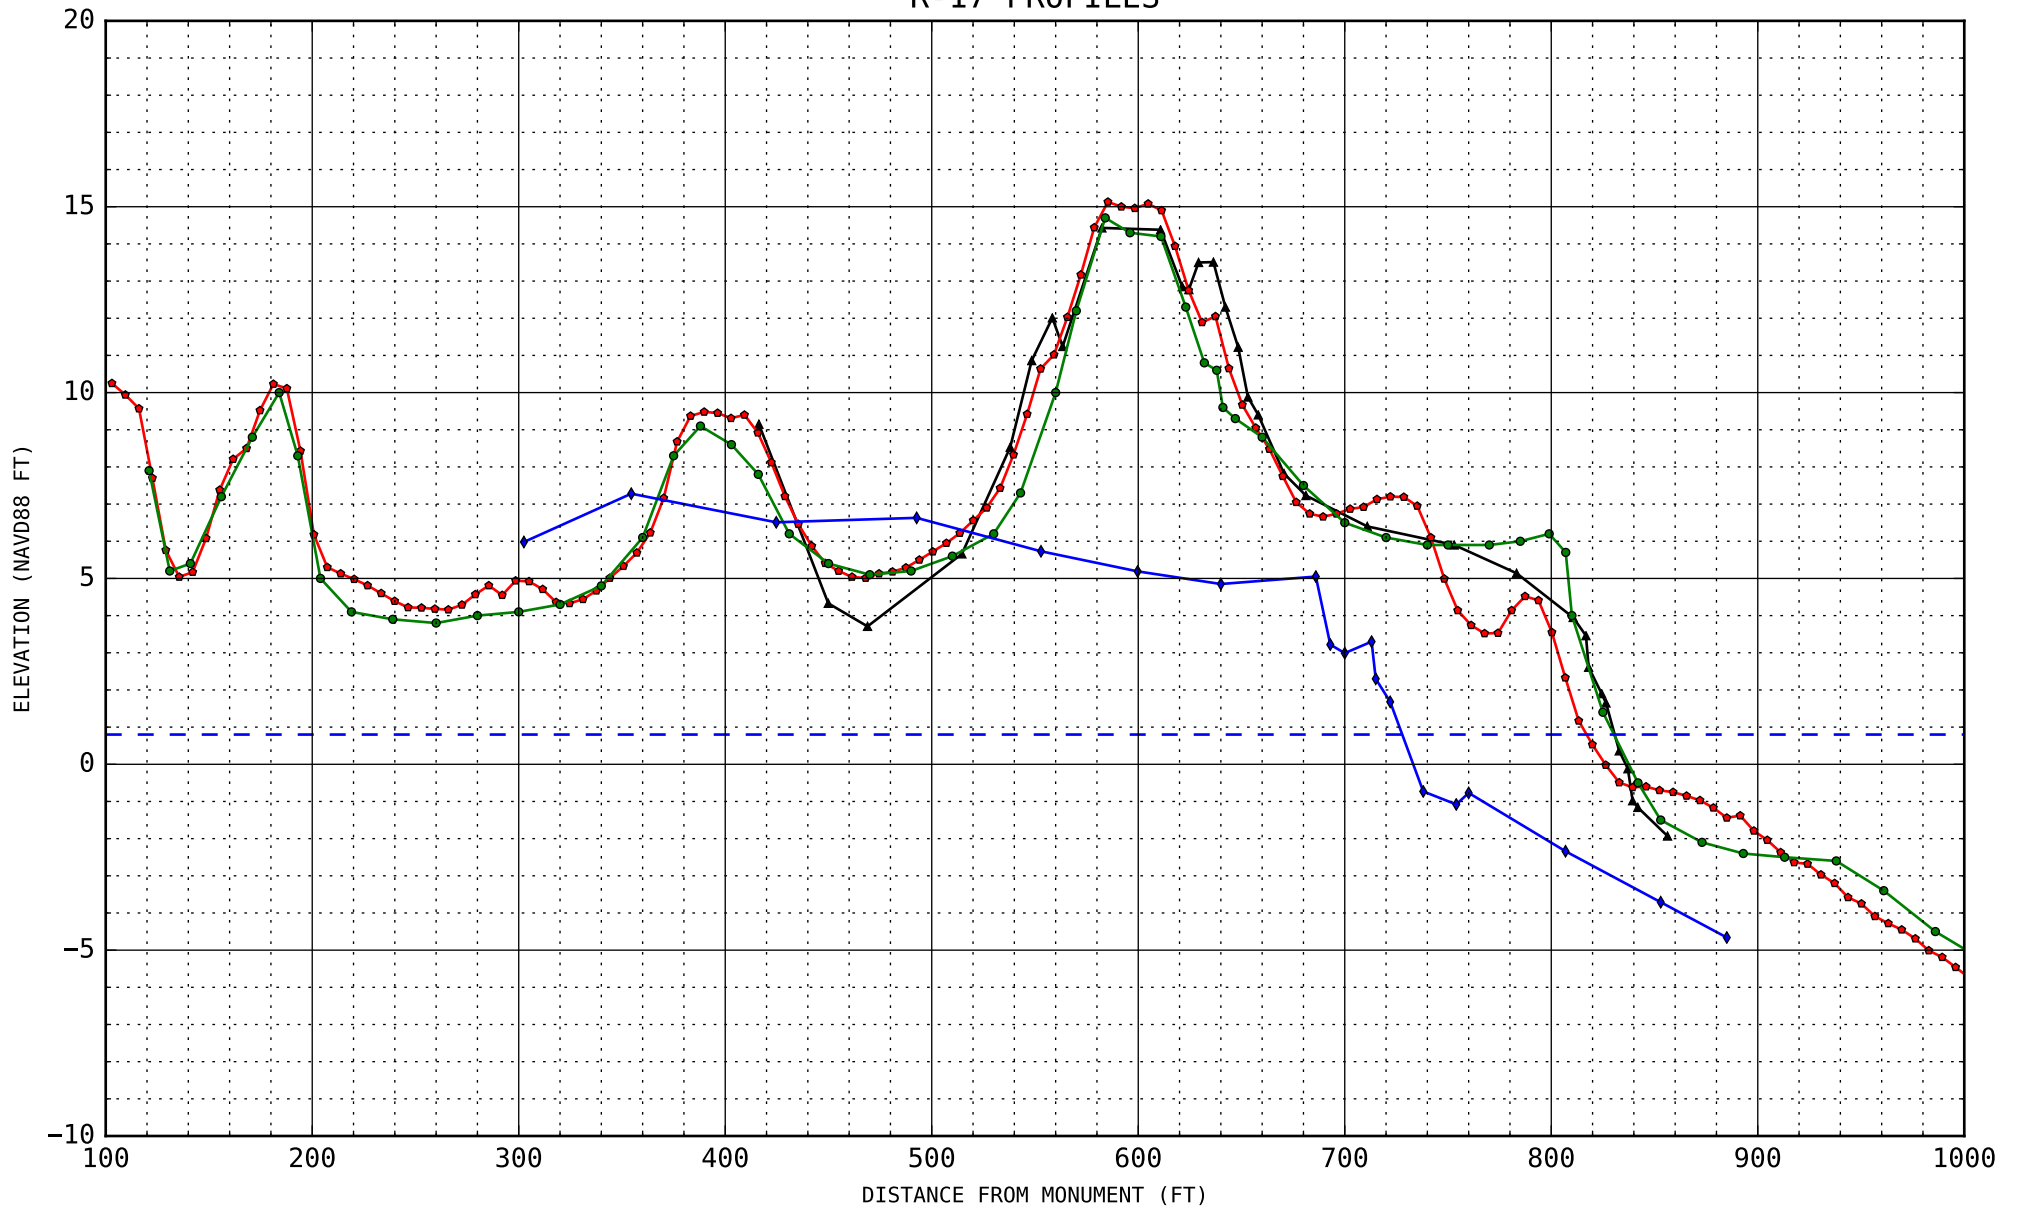
- ▲ 2019-APR CONDITION BY DEP
- 2016-SEP MONITORING BY USACE-LIDAR
- 2014-JUL MONITORING BY MAE
- ◆ 2008-JUN MONITORING BY DEP
- - - MHW CONTOUR (0.8 FT)

RANGE: R-17  
EST DATE: OCT1995  
SURVEY DATE: 03APR19  
AZIMUTH: 190.0

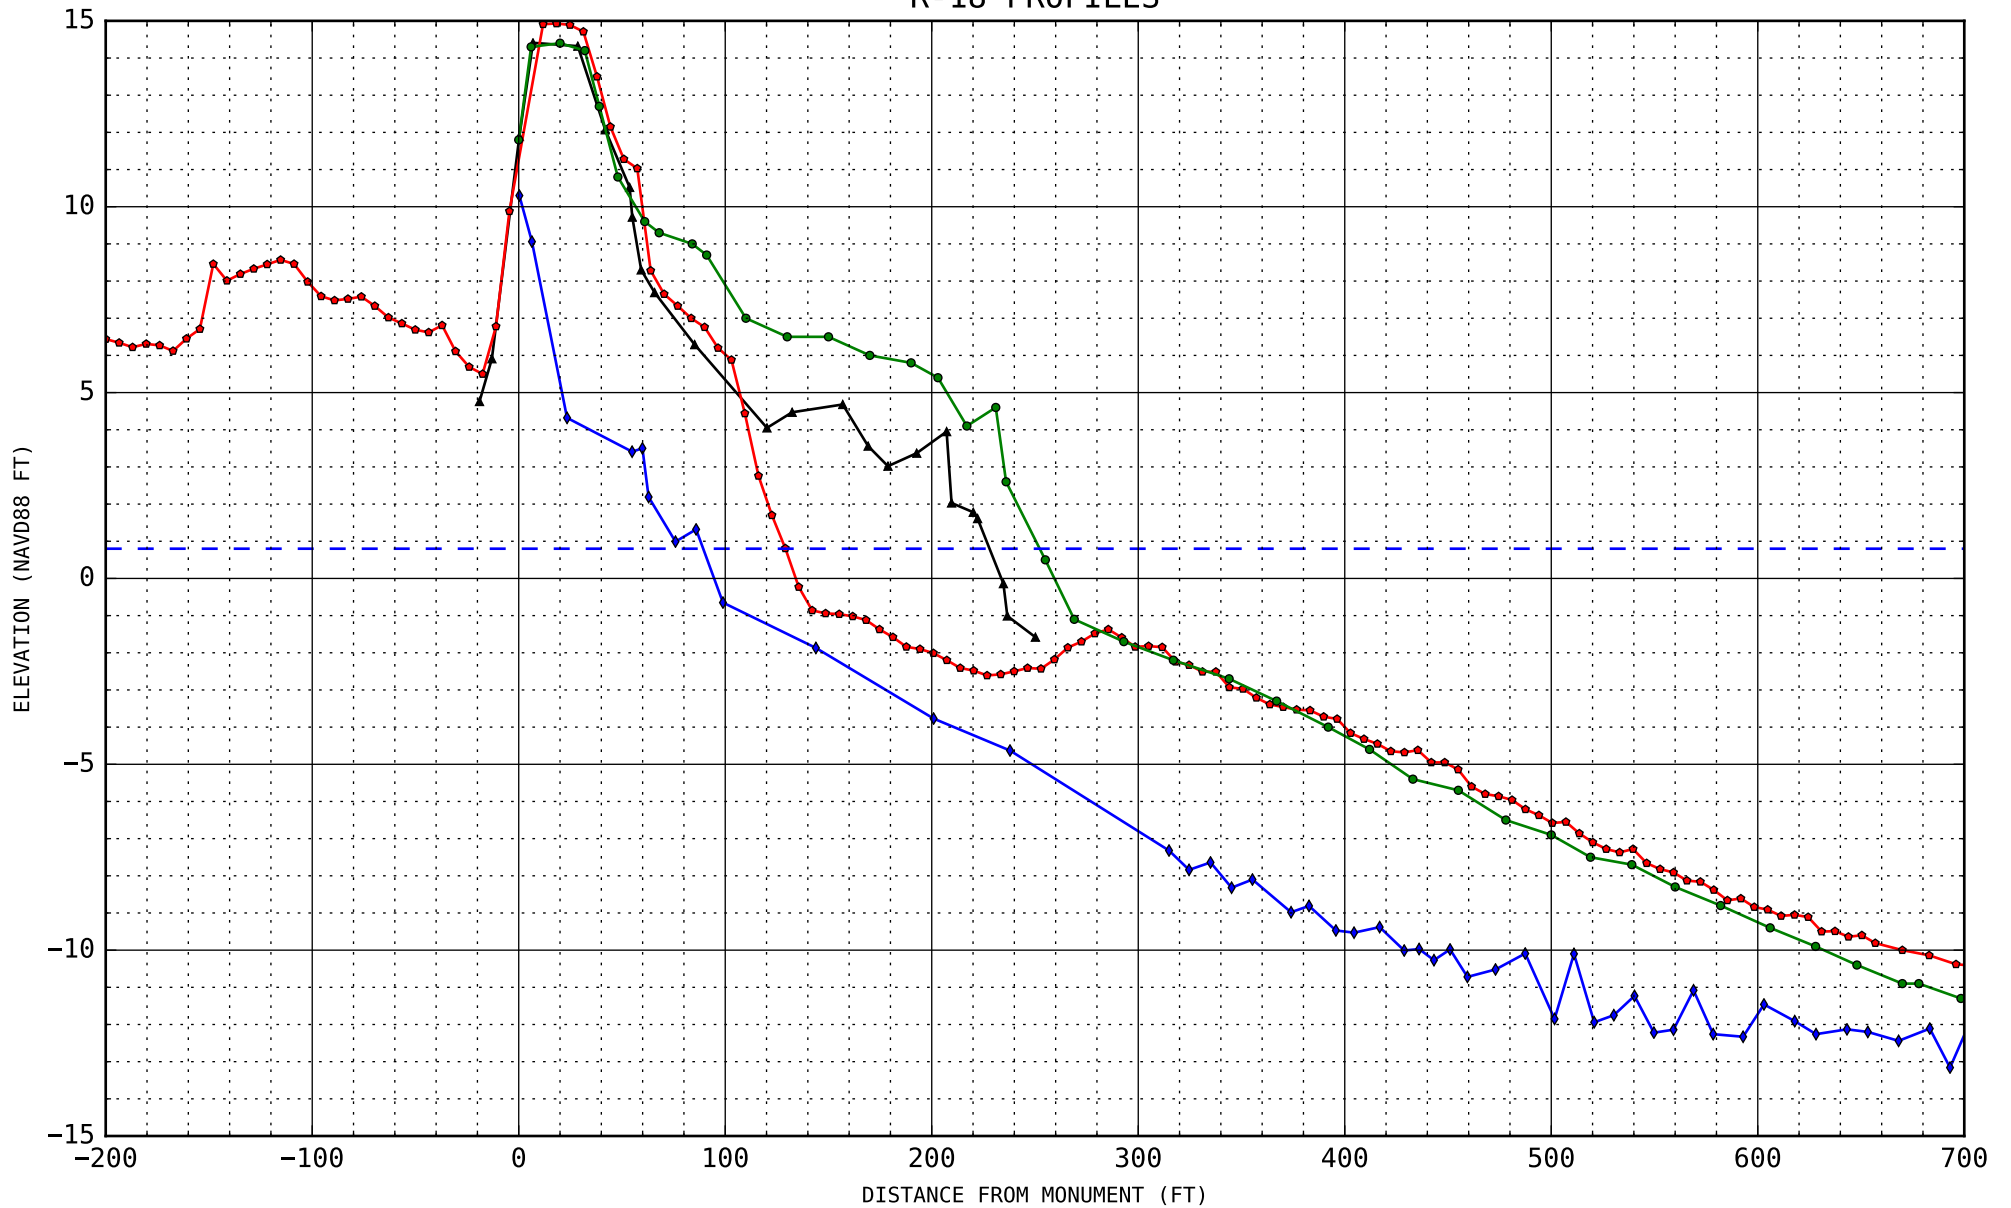
# R-18 PROFILES

- ▲ 2019-APR CONDITION BY DEP
- 2016-SEP MONITORING BY USACE-LIDAR
- 2014-JUL MONITORING BY MAE
- ◆ 2008-JUN MONITORING BY DEP
- - - MHW CONTOUR (0.8 FT)

RANGE: R-18  
EST DATE: OCT1995  
SURVEY DATE: 03APR19  
AZIMUTH: 190.0

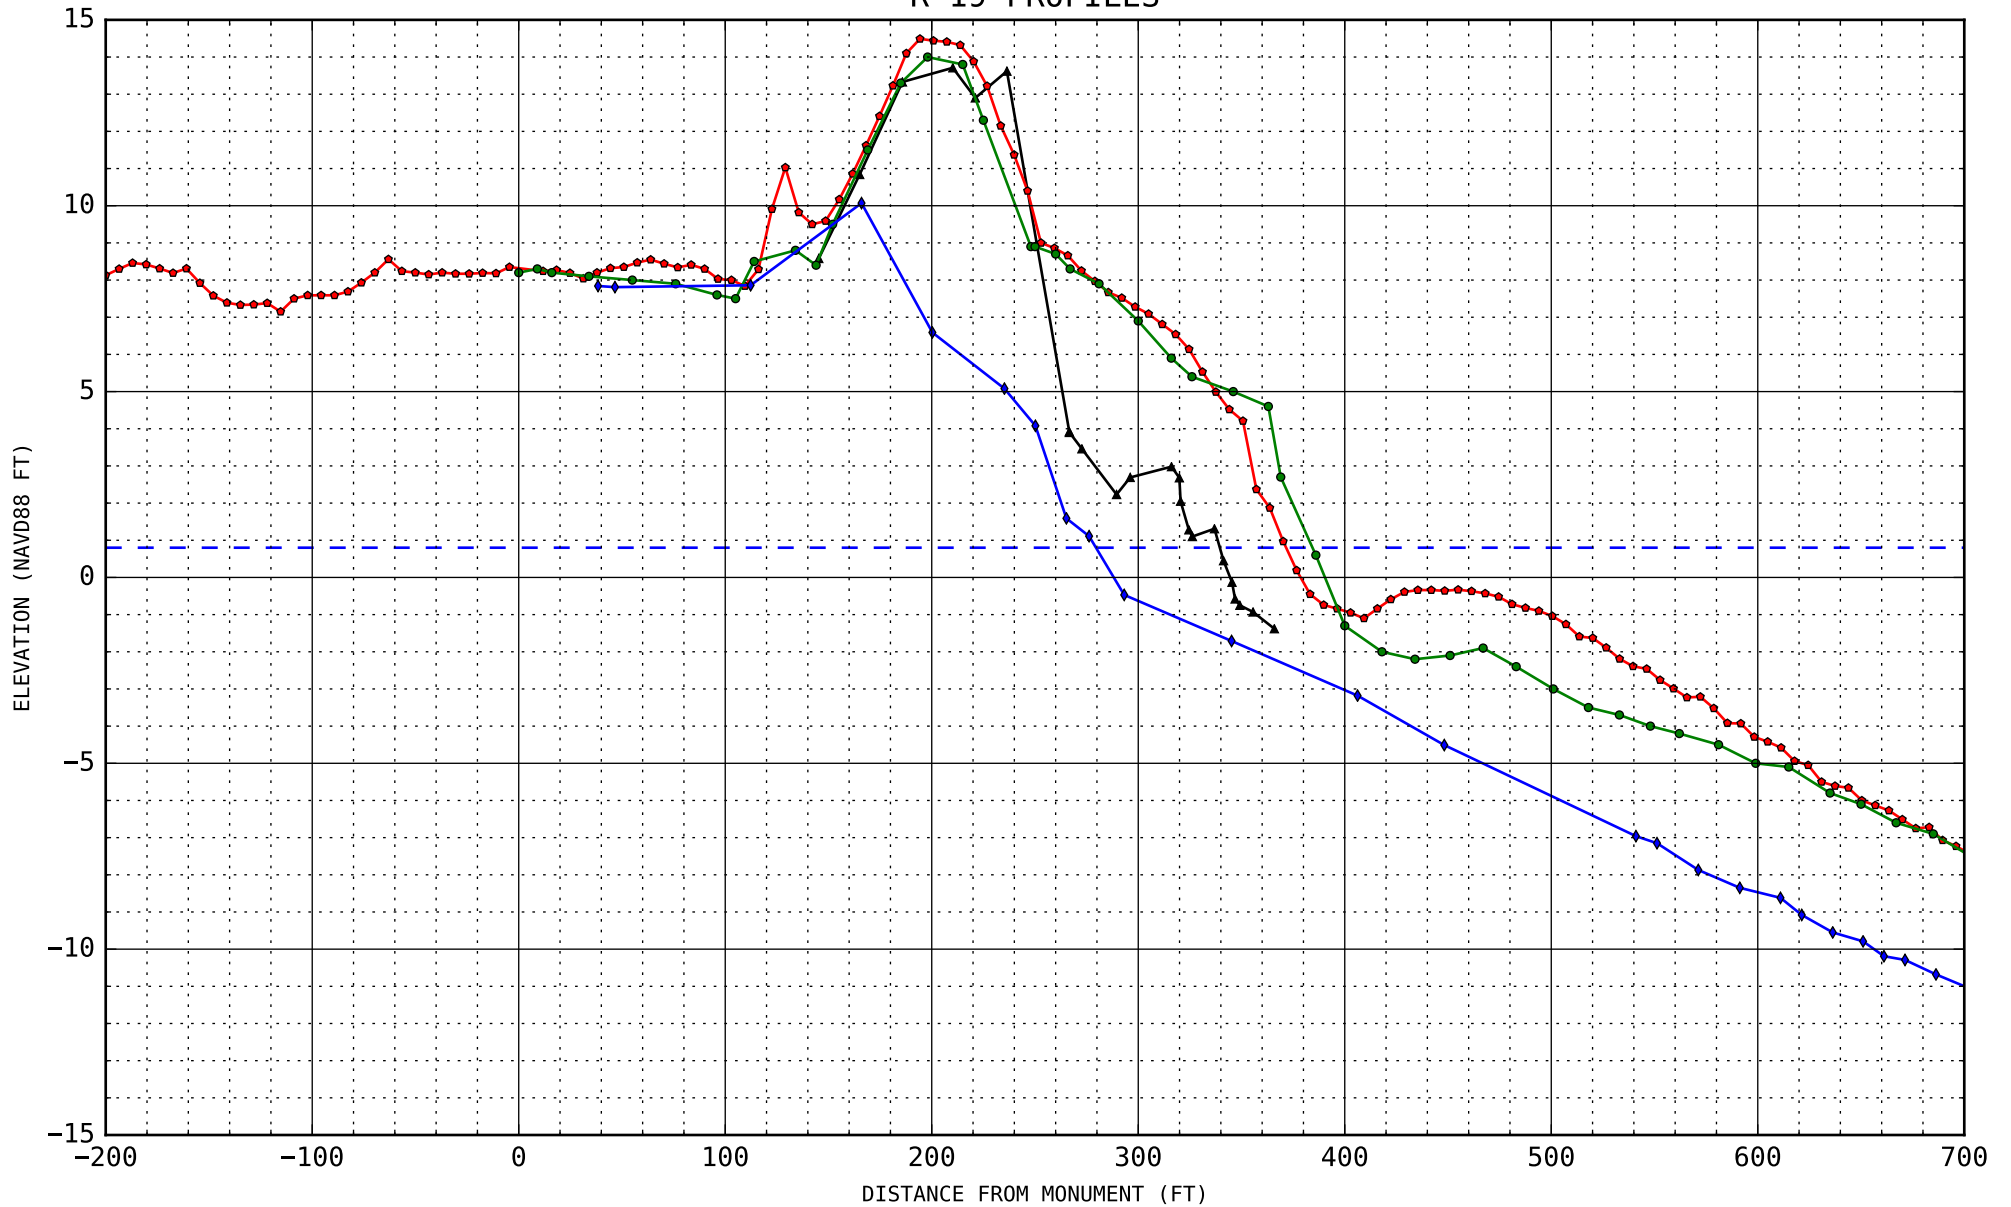
# R-19 PROFILES

- ▲ 2019-APR CONDITION BY DEP
- 2016-SEP MONITORING BY USACE-LIDAR
- 2014-JUL MONITORING BY MAE
- ◆ 2008-JUN MONITORING BY DEP
- - - MHW CONTOUR (0.8 FT)

RANGE: R-19  
EST DATE: MAR1989  
SURVEY DATE: 03APR19  
AZIMUTH: 190.0

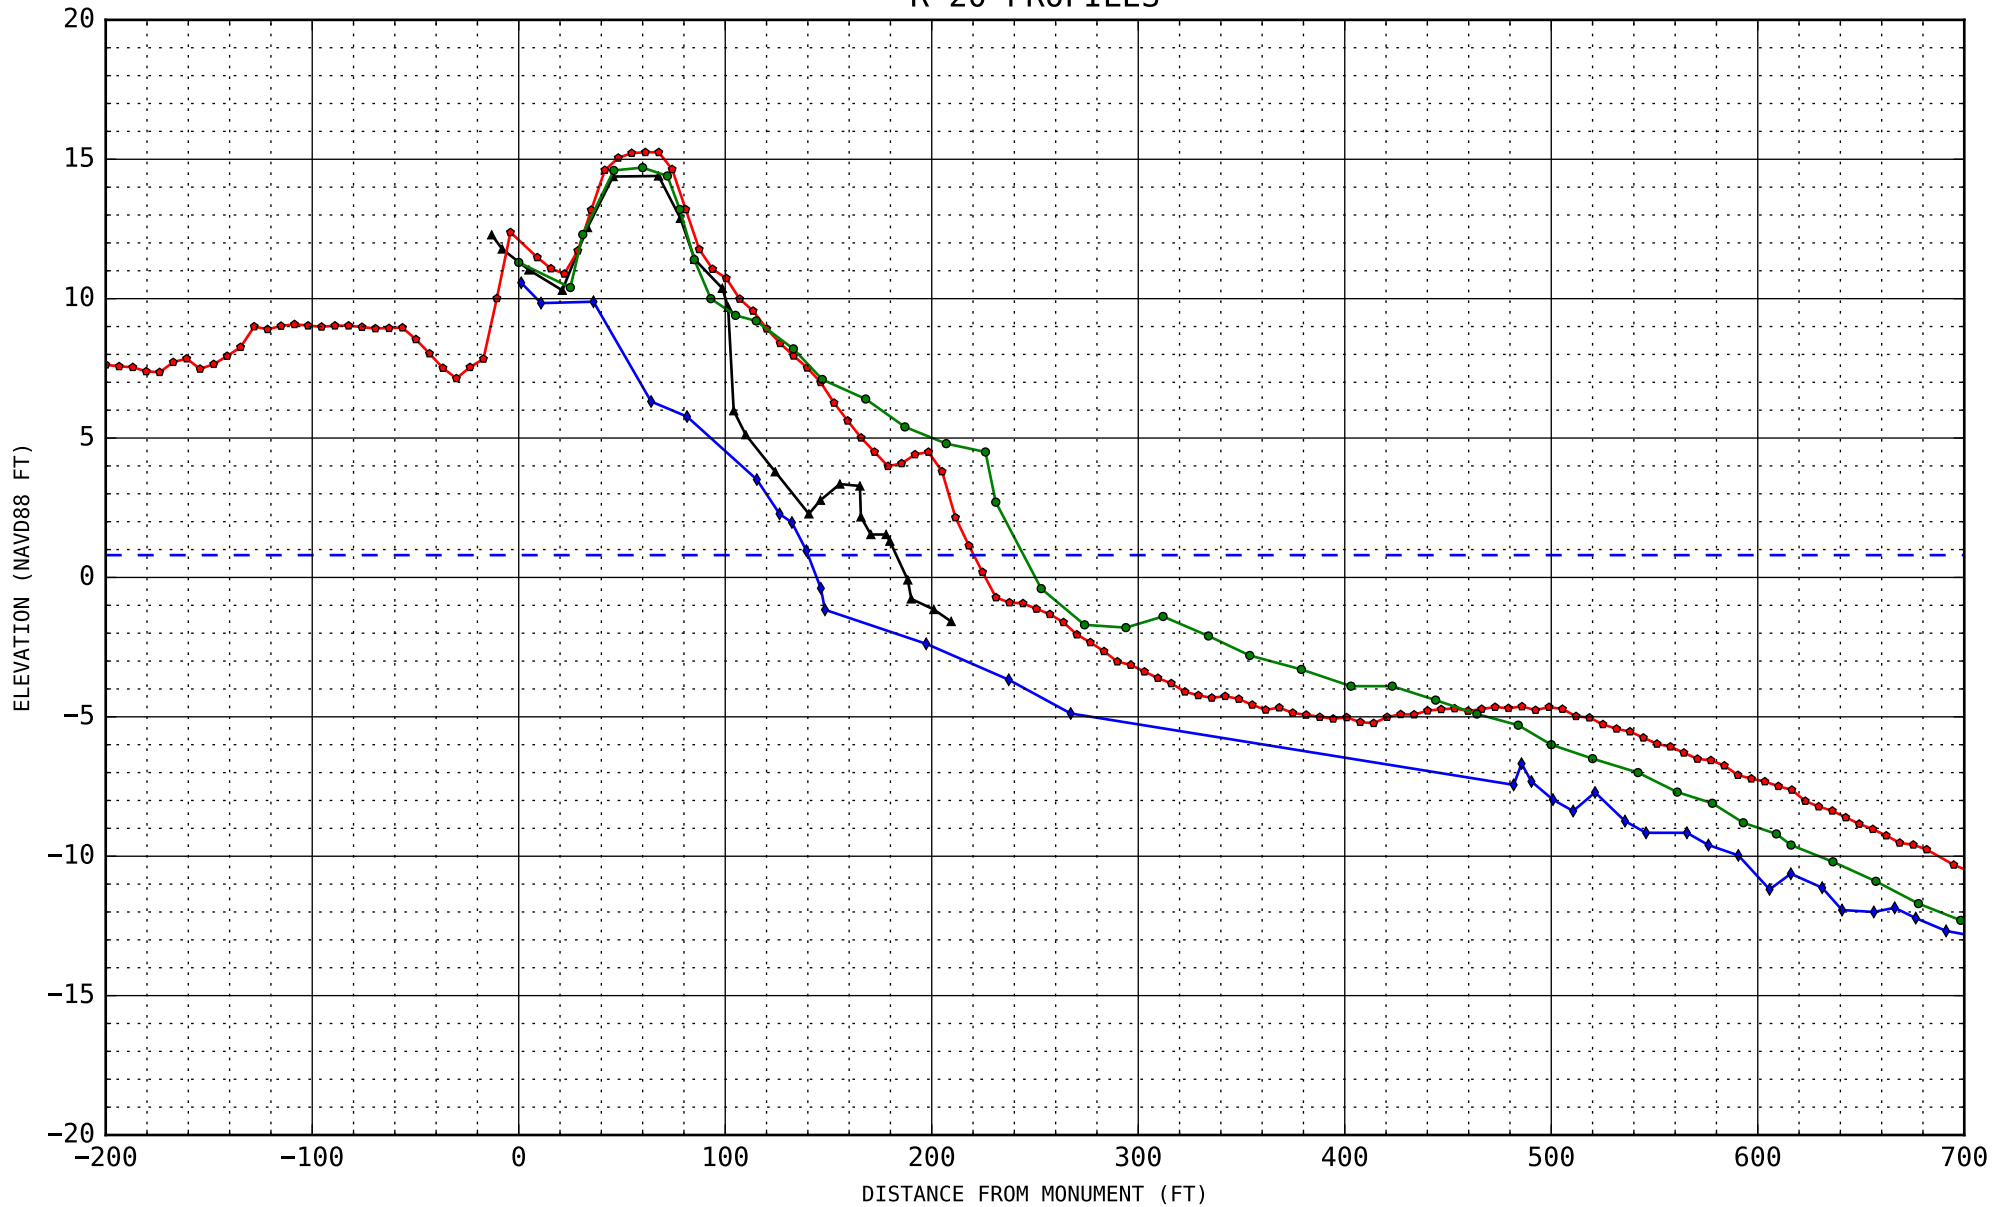
# R-20 PROFILES

- ▲ 2019-APR CONDITION BY DEP
- 2016-SEP MONITORING BY USACE-LIDAR
- 2014-JUL MONITORING BY MAE
- ◆ 2008-JUN MONITORING BY DEP
- - - MHW CONTOUR (0.8 FT)

RANGE: R-20  
EST DATE: OCT1973  
SURVEY DATE: 03APR19  
AZIMUTH: 175.0

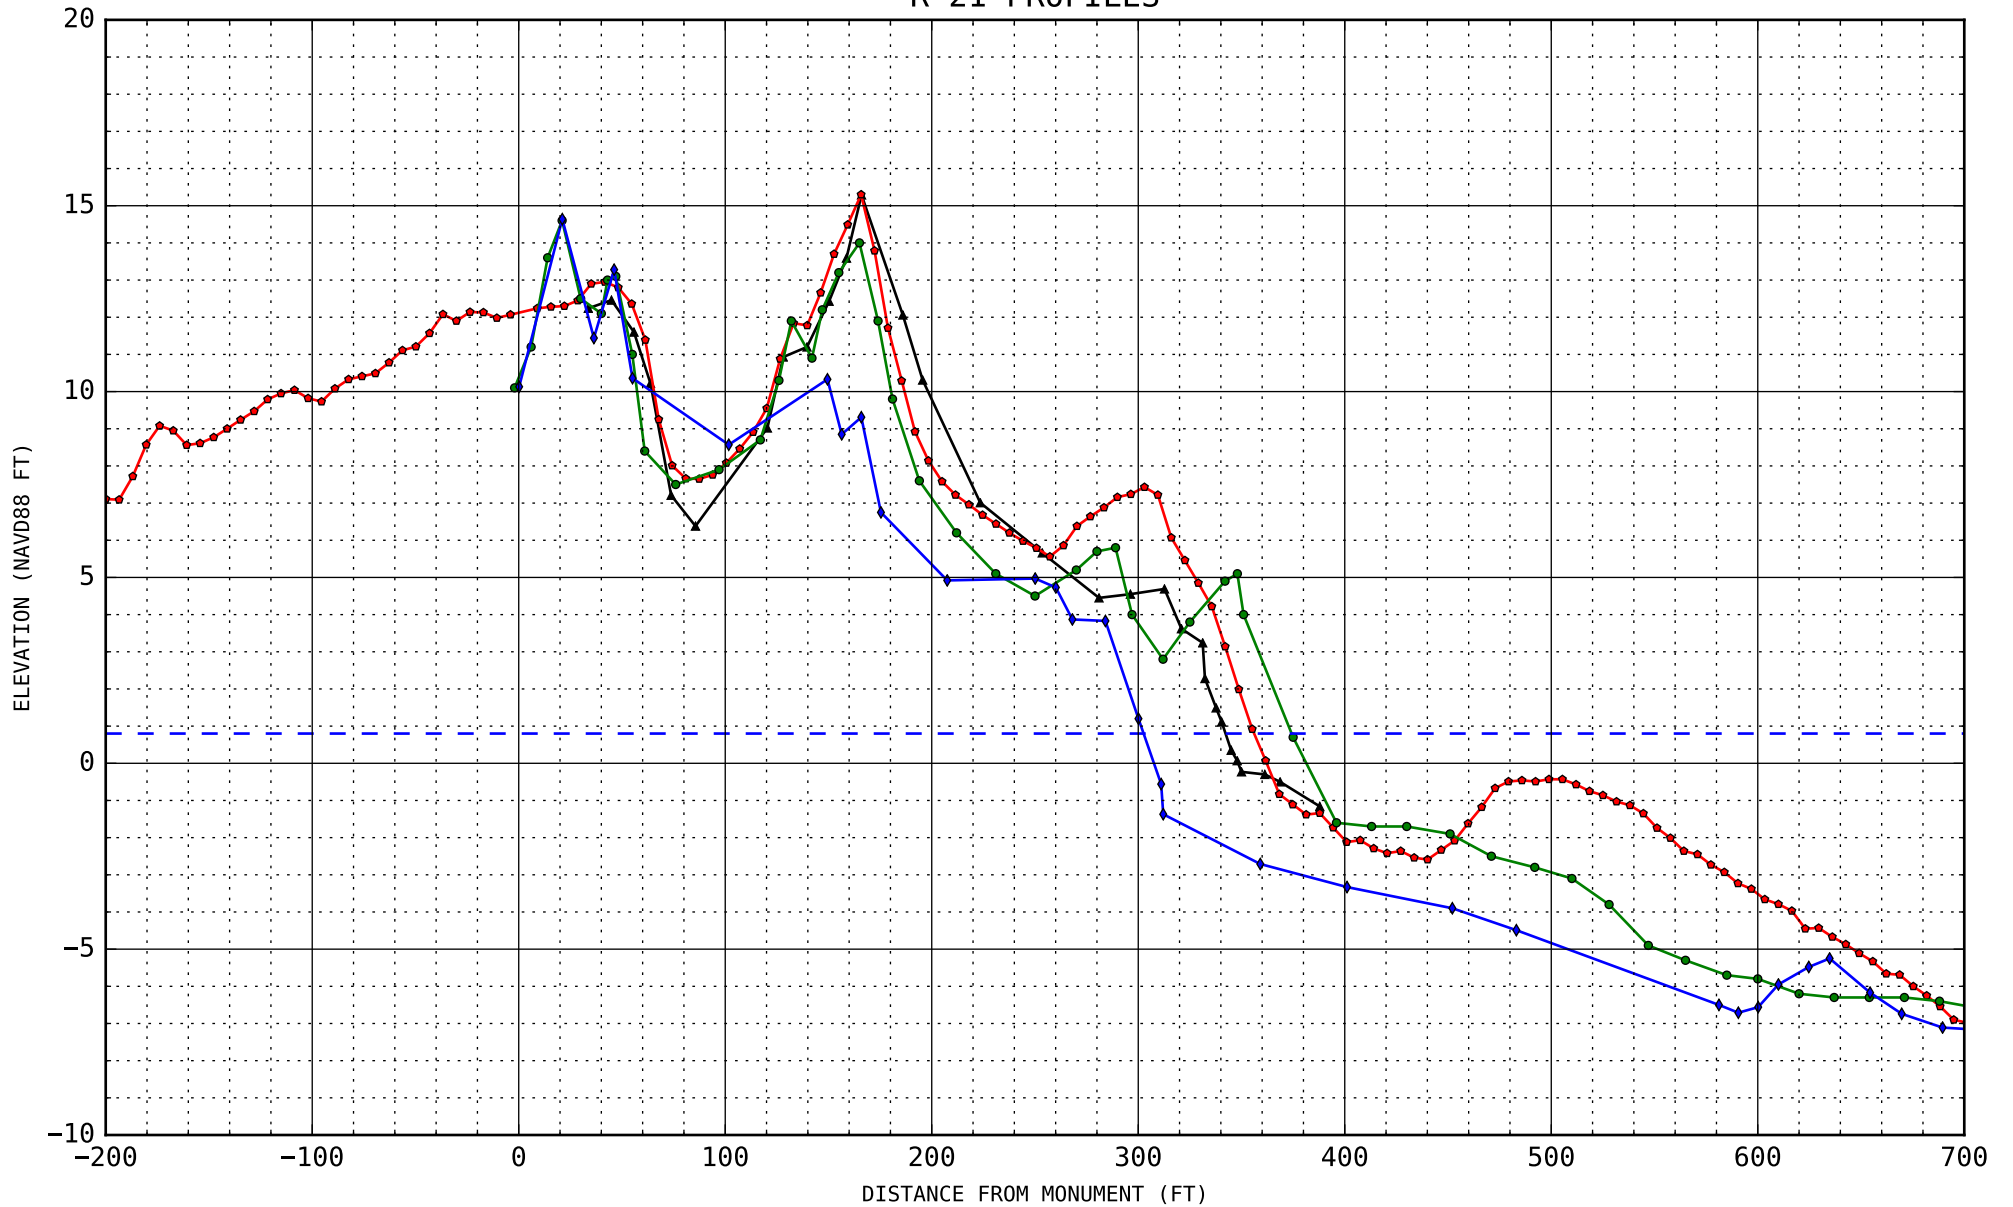
# R-21 PROFILES

- ▲ 2019-APR CONDITION BY DEP
- 2016-SEP MONITORING BY USACE-LIDAR
- 2014-JUL MONITORING BY MAE
- ◆ 2008-JUN MONITORING BY DEP
- - - MHW CONTOUR (0.8 FT)

RANGE: R-21  
EST DATE: OCT1973  
SURVEY DATE: 03APR19  
AZIMUTH: 175.0

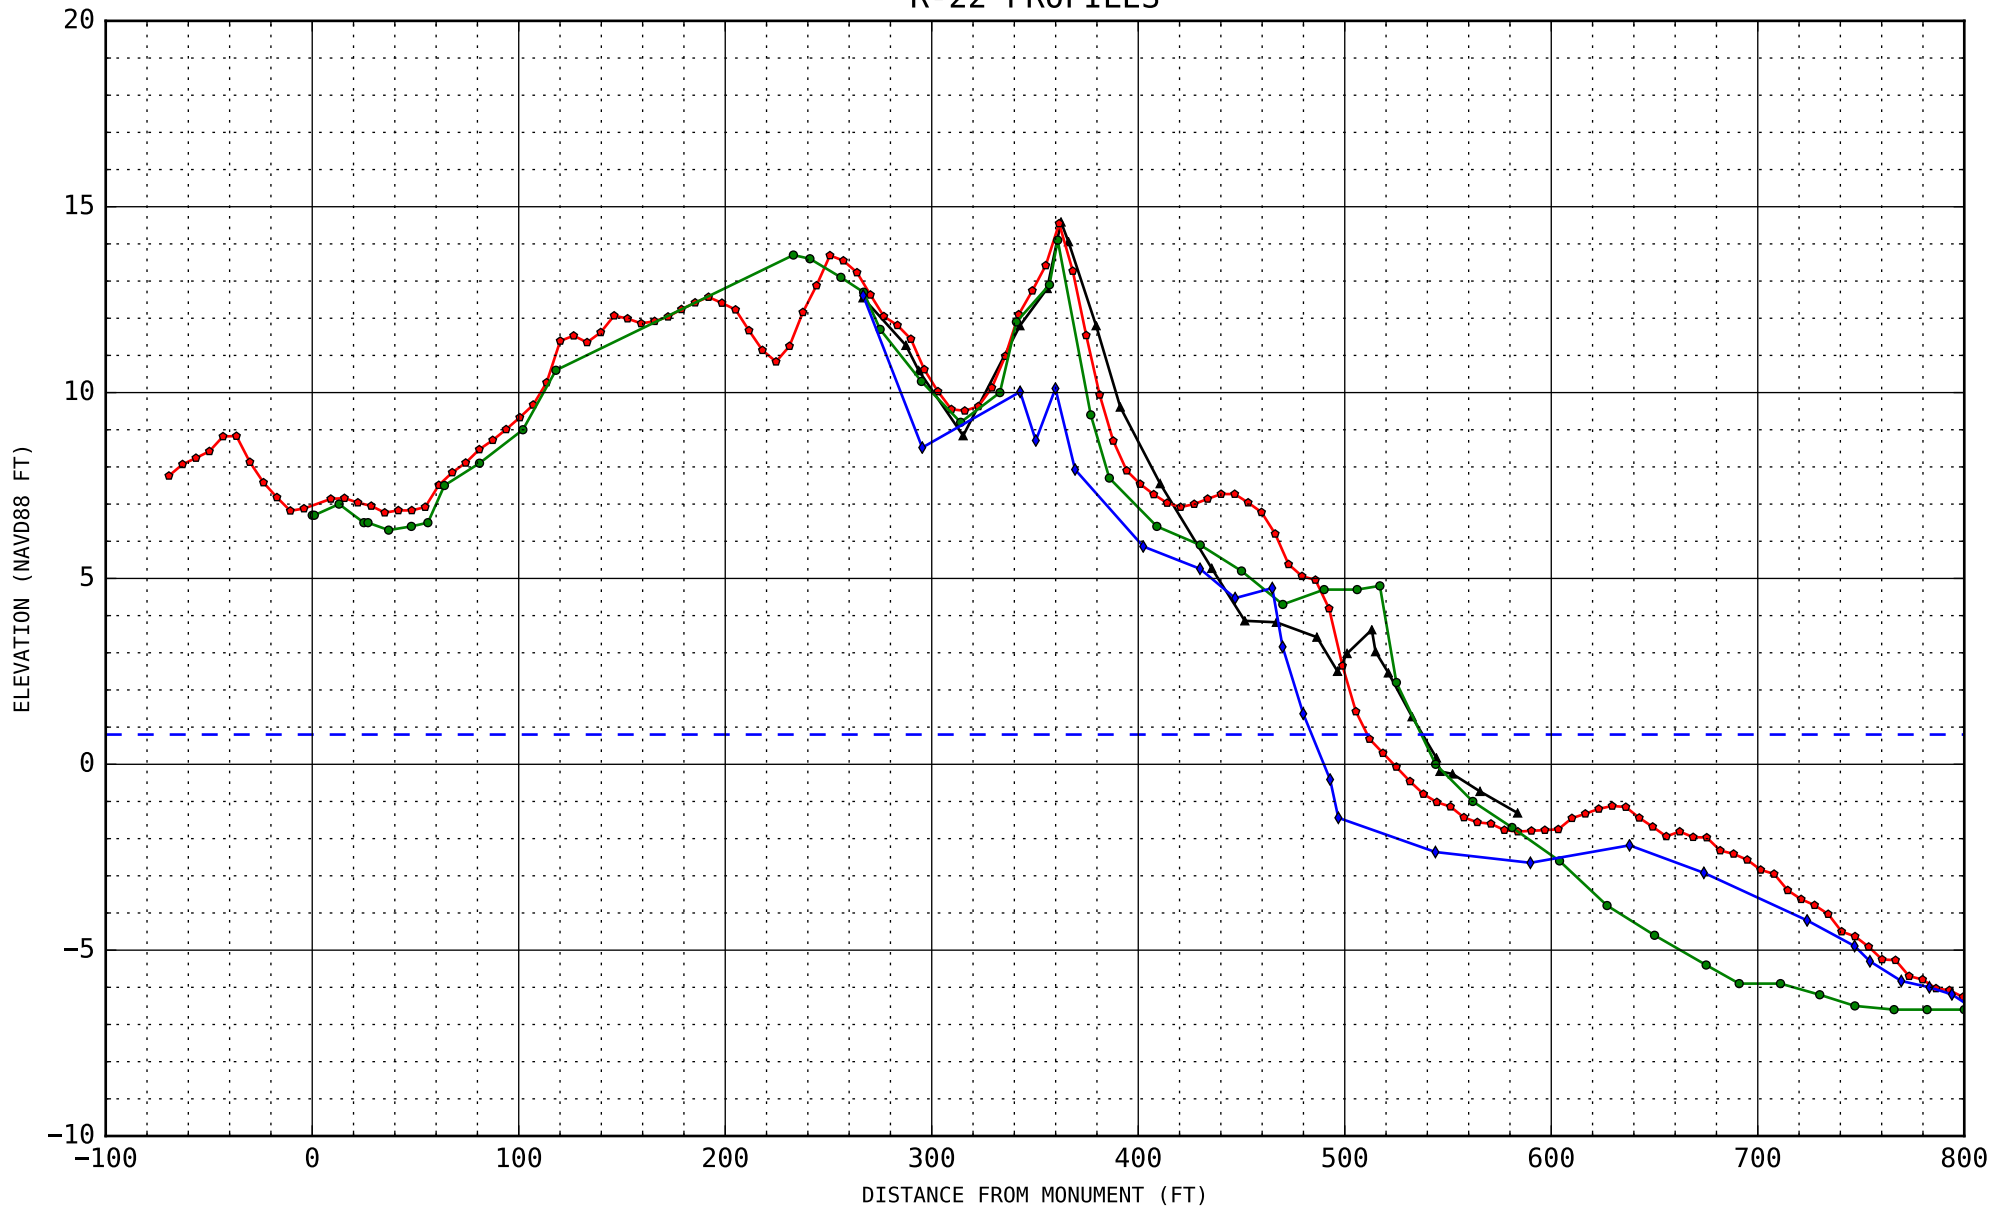
# R-22 PROFILES

- ▲ 2019-APR CONDITION BY DEP
- 2016-SEP MONITORING BY USACE-LIDAR
- 2014-JUL MONITORING BY MAE
- ◆ 2008-JUN MONITORING BY DEP
- - - MHW CONTOUR (0.8 FT)

RANGE: R-22  
EST DATE: OCT1995  
SURVEY DATE: 03APR19  
AZIMUTH: 175.0

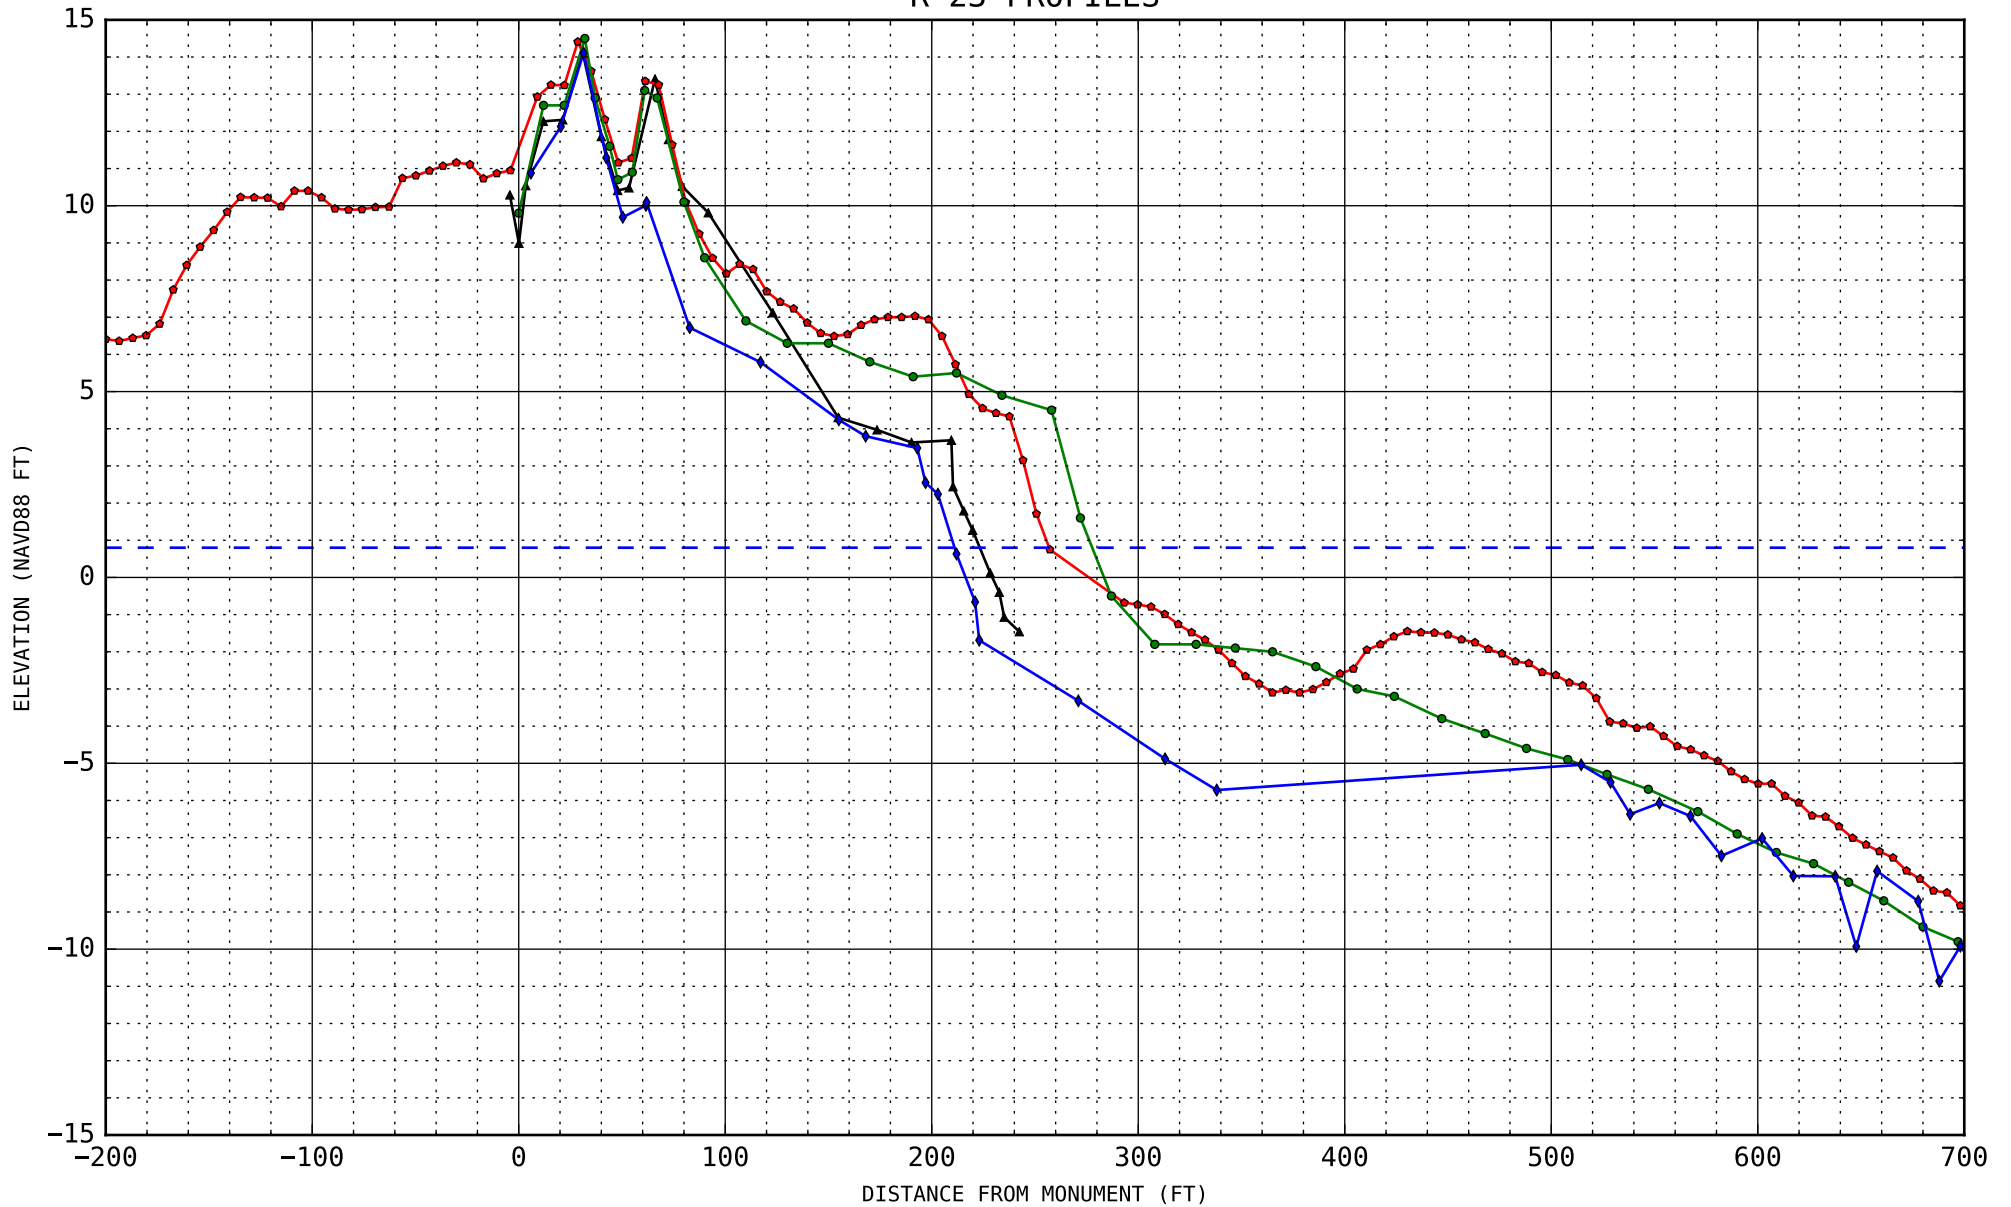
# R-23 PROFILES

- ▲ 2019-APR CONDITION BY DEP
- 2016-SEP MONITORING BY USACE-LIDAR
- 2014-JUL MONITORING BY MAE
- ◆ 2008-JUN MONITORING BY DEP
- - - MHW CONTOUR (0.8 FT)

RANGE: R-23  
EST DATE: OCT1995  
SURVEY DATE: 03APR19  
AZIMUTH: 175.0

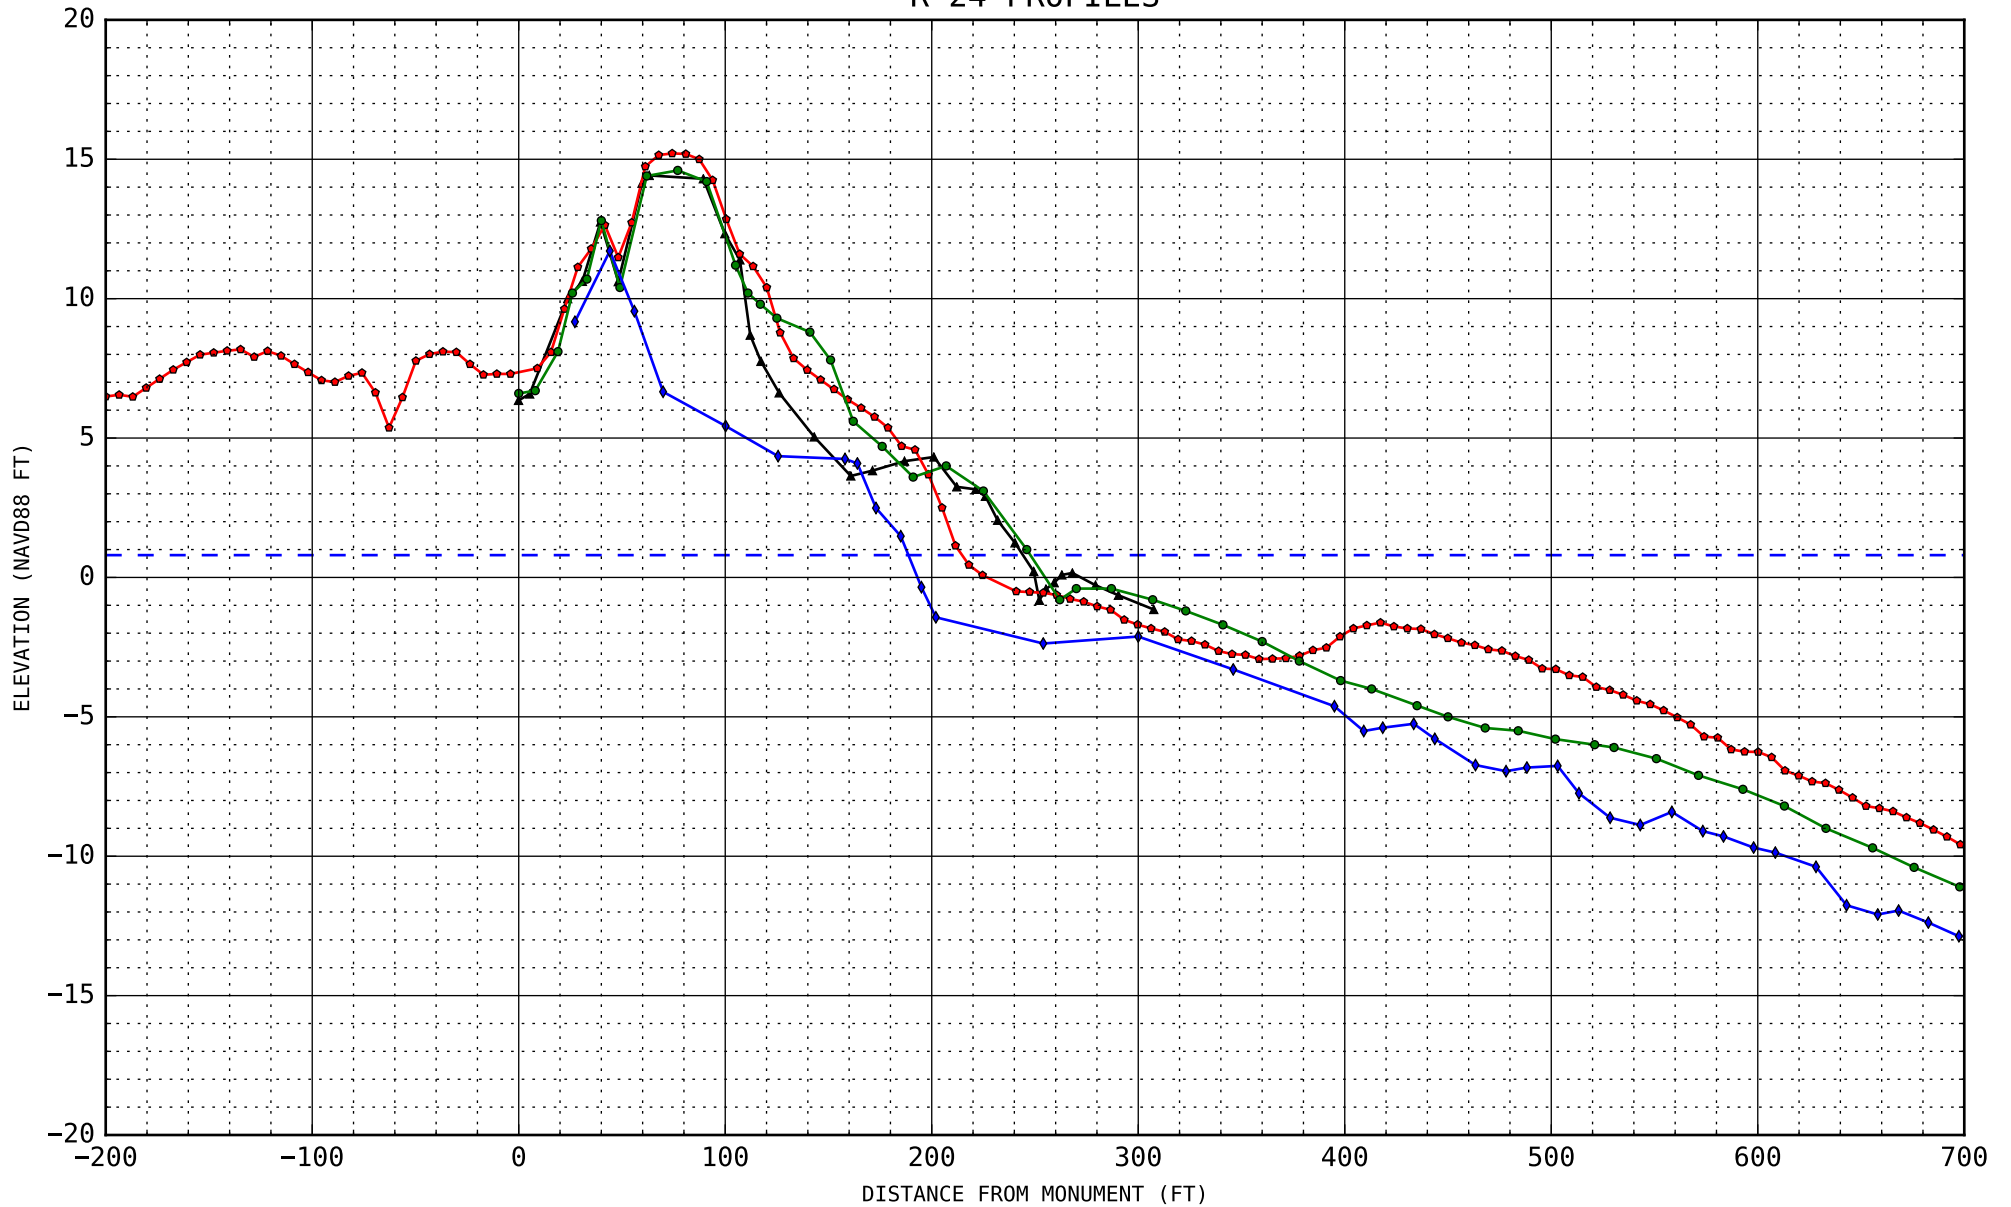
# R-24 PROFILES

- ▲ 2019-APR CONDITION BY DEP
- 2016-SEP MONITORING BY USACE-LIDAR
- 2014-JUL MONITORING BY MAE
- ◆ 2008-JUN MONITORING BY DEP
- - - MHW CONTOUR (0.8 FT)

RANGE: R-24  
EST DATE: M&E1997  
SURVEY DATE: 03APR19  
AZIMUTH: 175.0

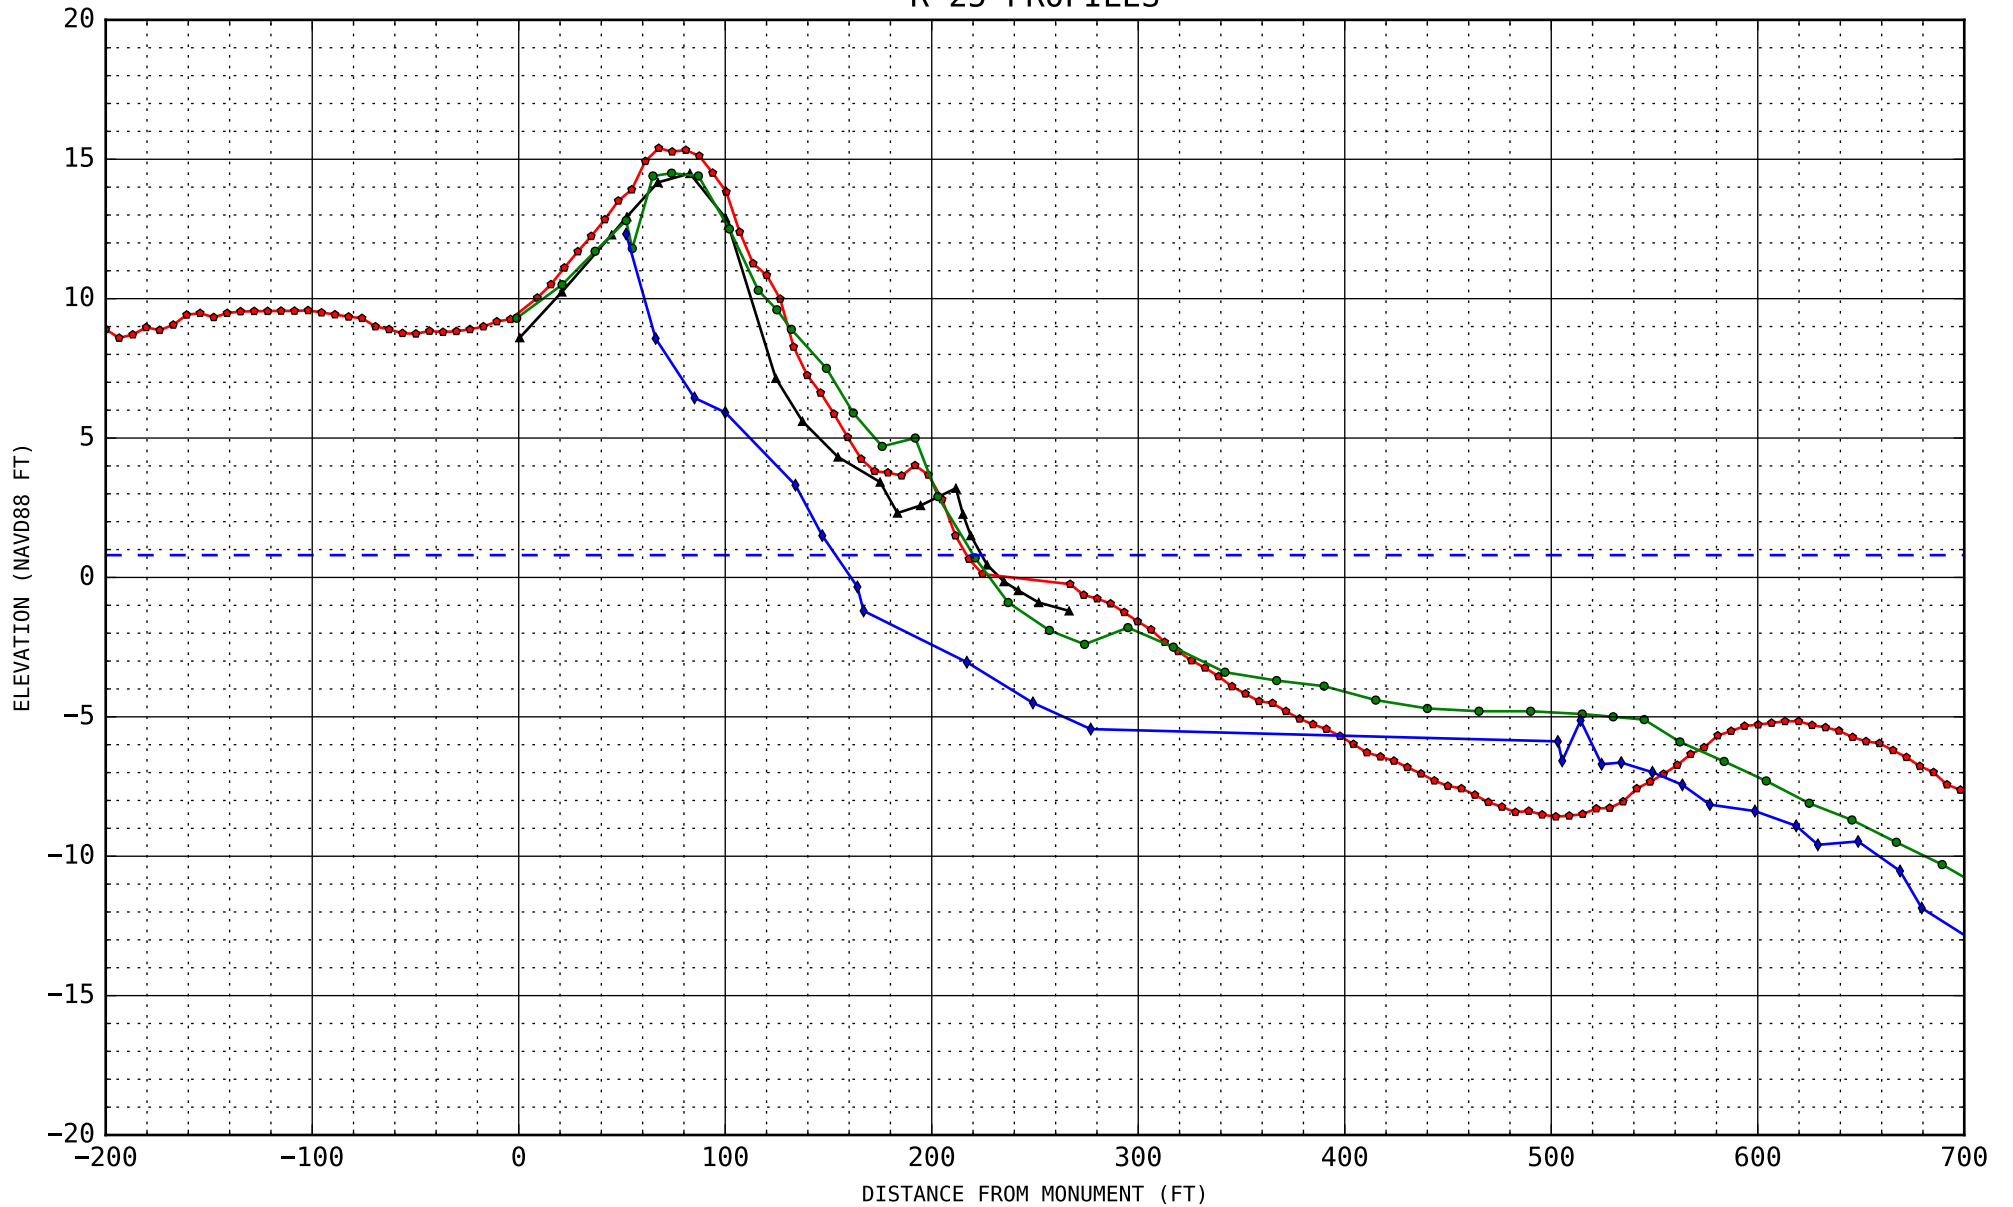
# R-25 PROFILES

- ▲ 2019-APR CONDITION BY DEP
- 2016-SEP MONITORING BY USACE-LIDAR
- 2014-JUL MONITORING BY MAE
- ◆ 2008-JUN MONITORING BY DEP
- - - MHW CONTOUR (0.8 FT)

RANGE: R-25  
EST DATE: OCT1995  
SURVEY DATE: 03APR19  
AZIMUTH: 175.0
