# R-17 PROFILES

OKALOOSA  
PROGRAM SUPPORT GIS  
DIVISION OF WATER RESOURCE MANAGEMENT  
FLORIDA DEPARTMENT OF ENVIRONMENTAL PROTECTION

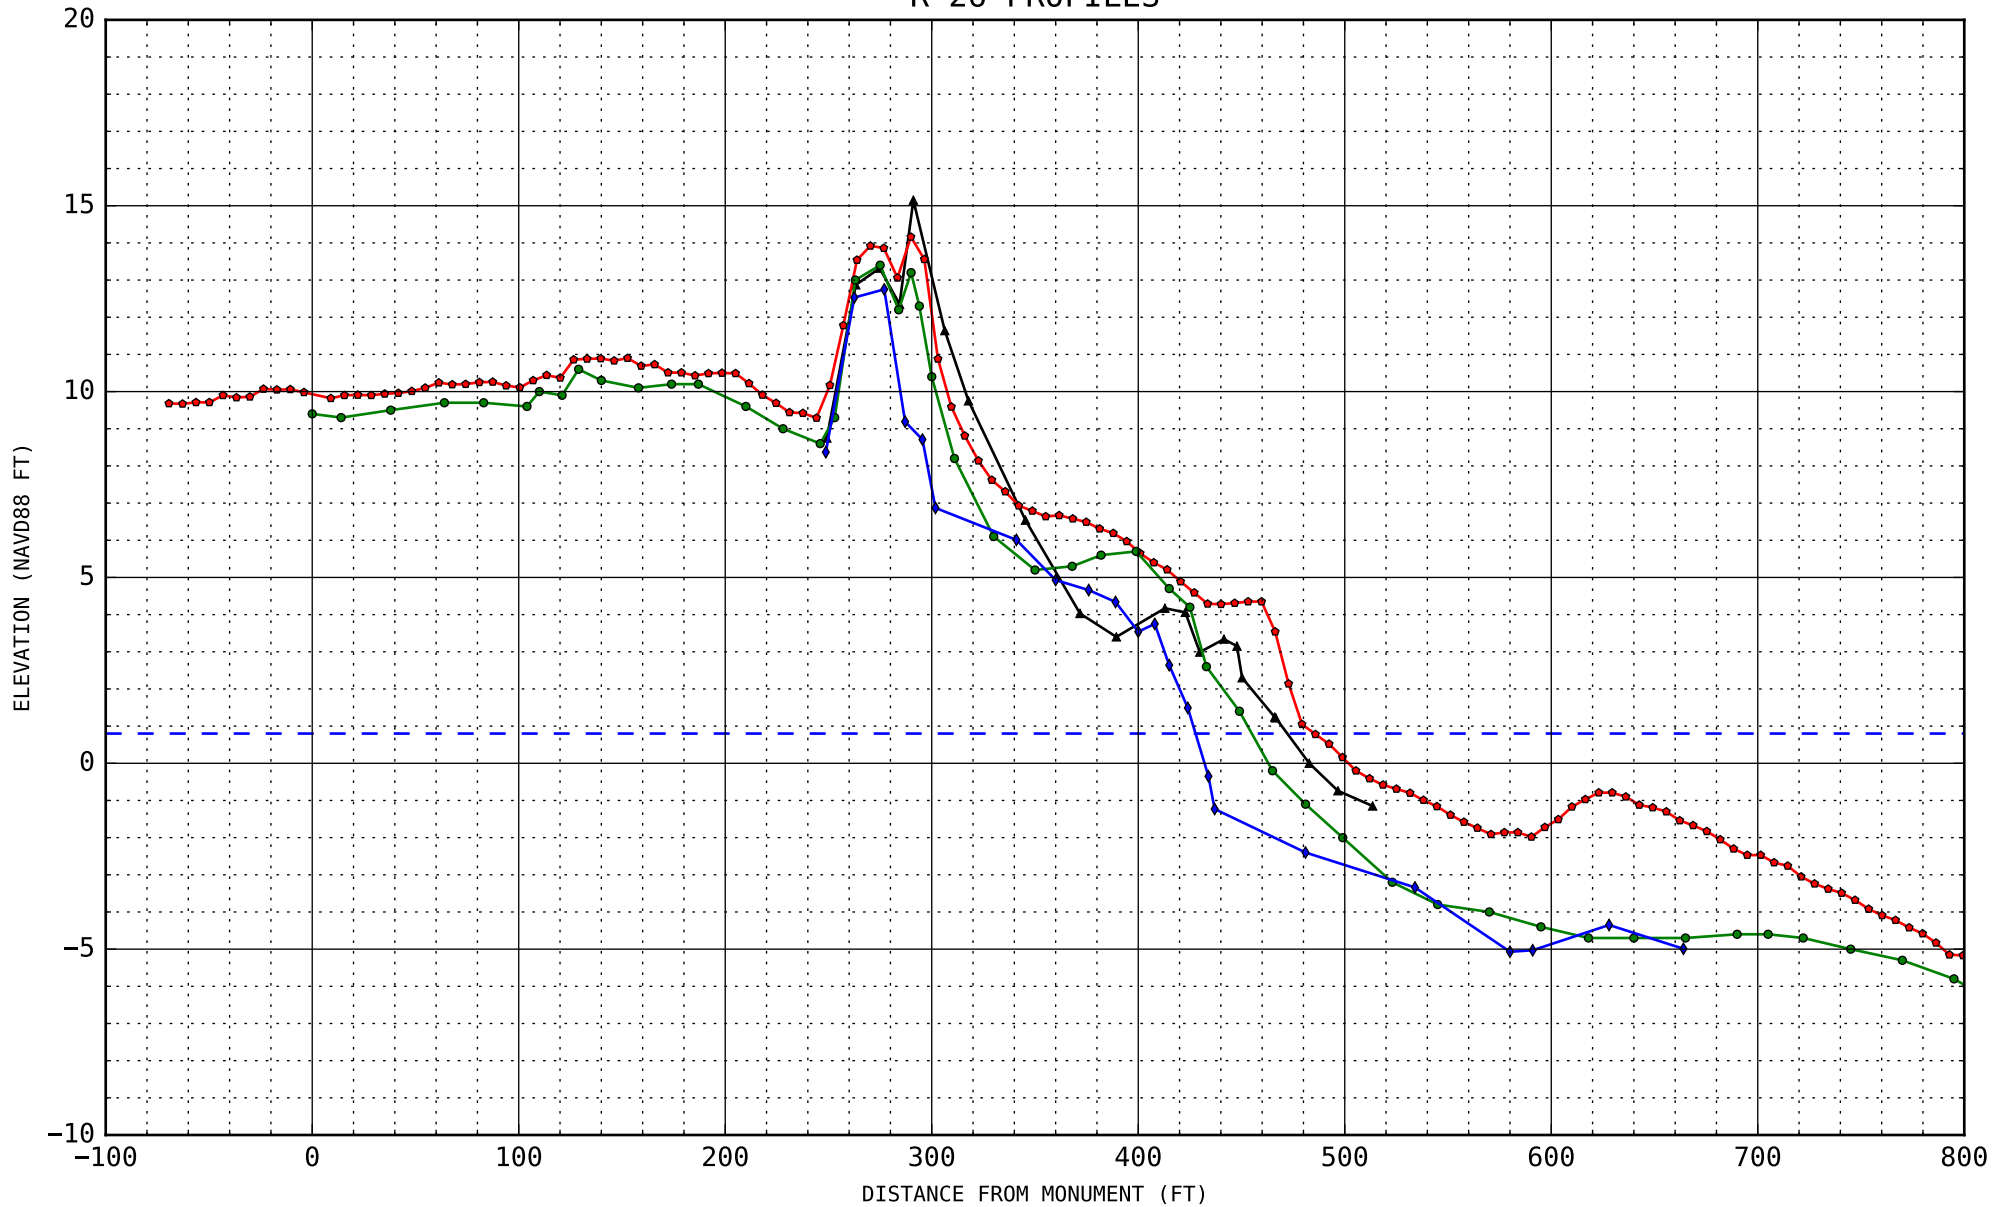
# R-26 PROFILES

- ▲ 2019-APR CONDITION BY DEP
- 2016-SEP MONITORING BY USACE-LIDAR
- 2014-JUL MONITORING BY MAE
- ◆ 2008-JUN MONITORING BY DEP
- - - MHW CONTOUR (0.8 FT)

RANGE: R-26  
EST DATE: OCT1995  
SURVEY DATE: 03APR19  
AZIMUTH: 175.0

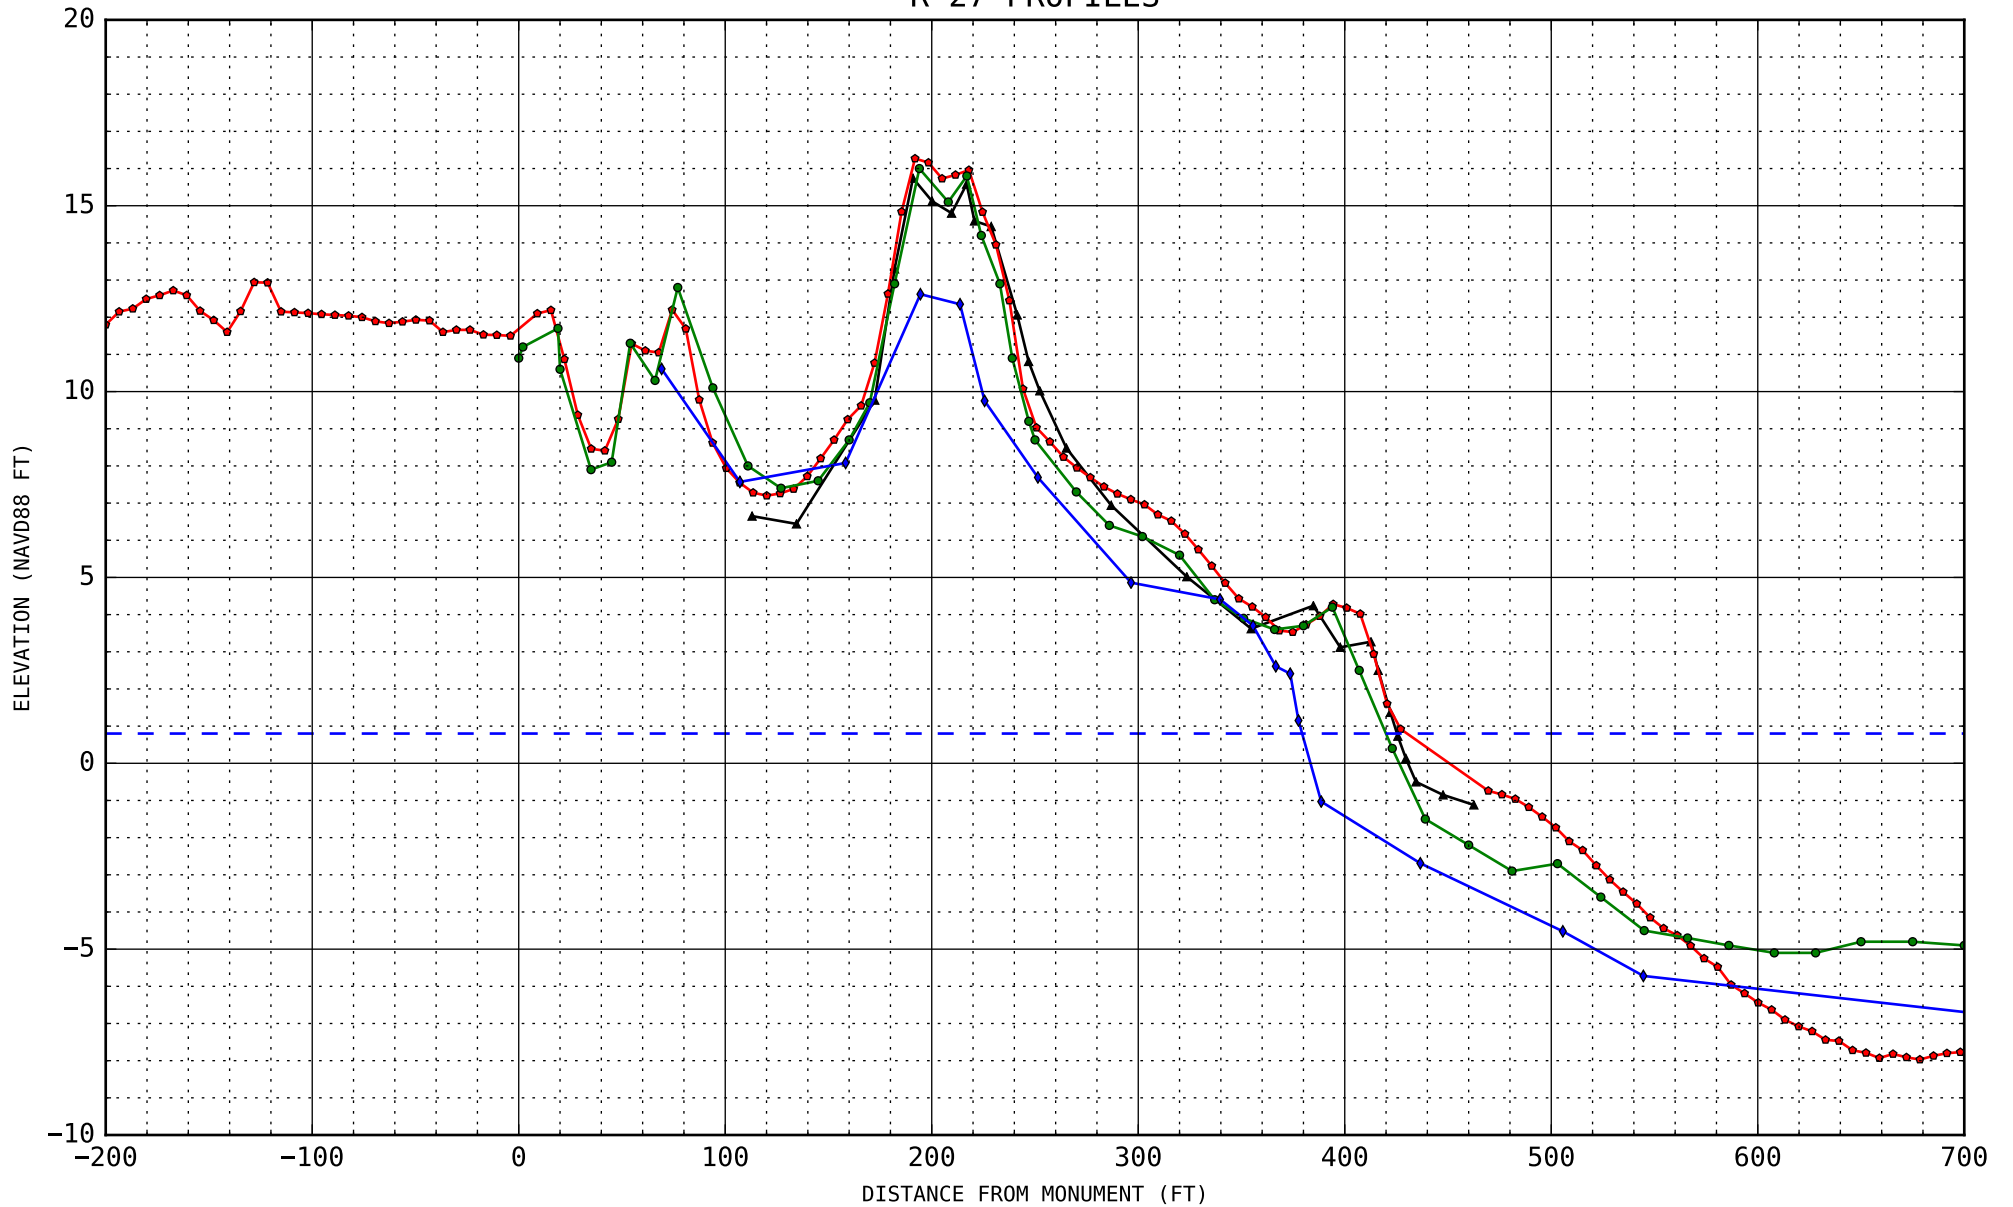
# R-27 PROFILES

- ▲ 2019-APR CONDITION BY DEP
- 2016-SEP MONITORING BY USACE-LIDAR
- 2014-JUL MONITORING BY MAE
- ◆ 2008-JUN MONITORING BY DEP
- - - MHW CONTOUR (0.8 FT)

RANGE: R-27  
EST DATE: MAR1989  
SURVEY DATE: 03APR19  
AZIMUTH: 175.0

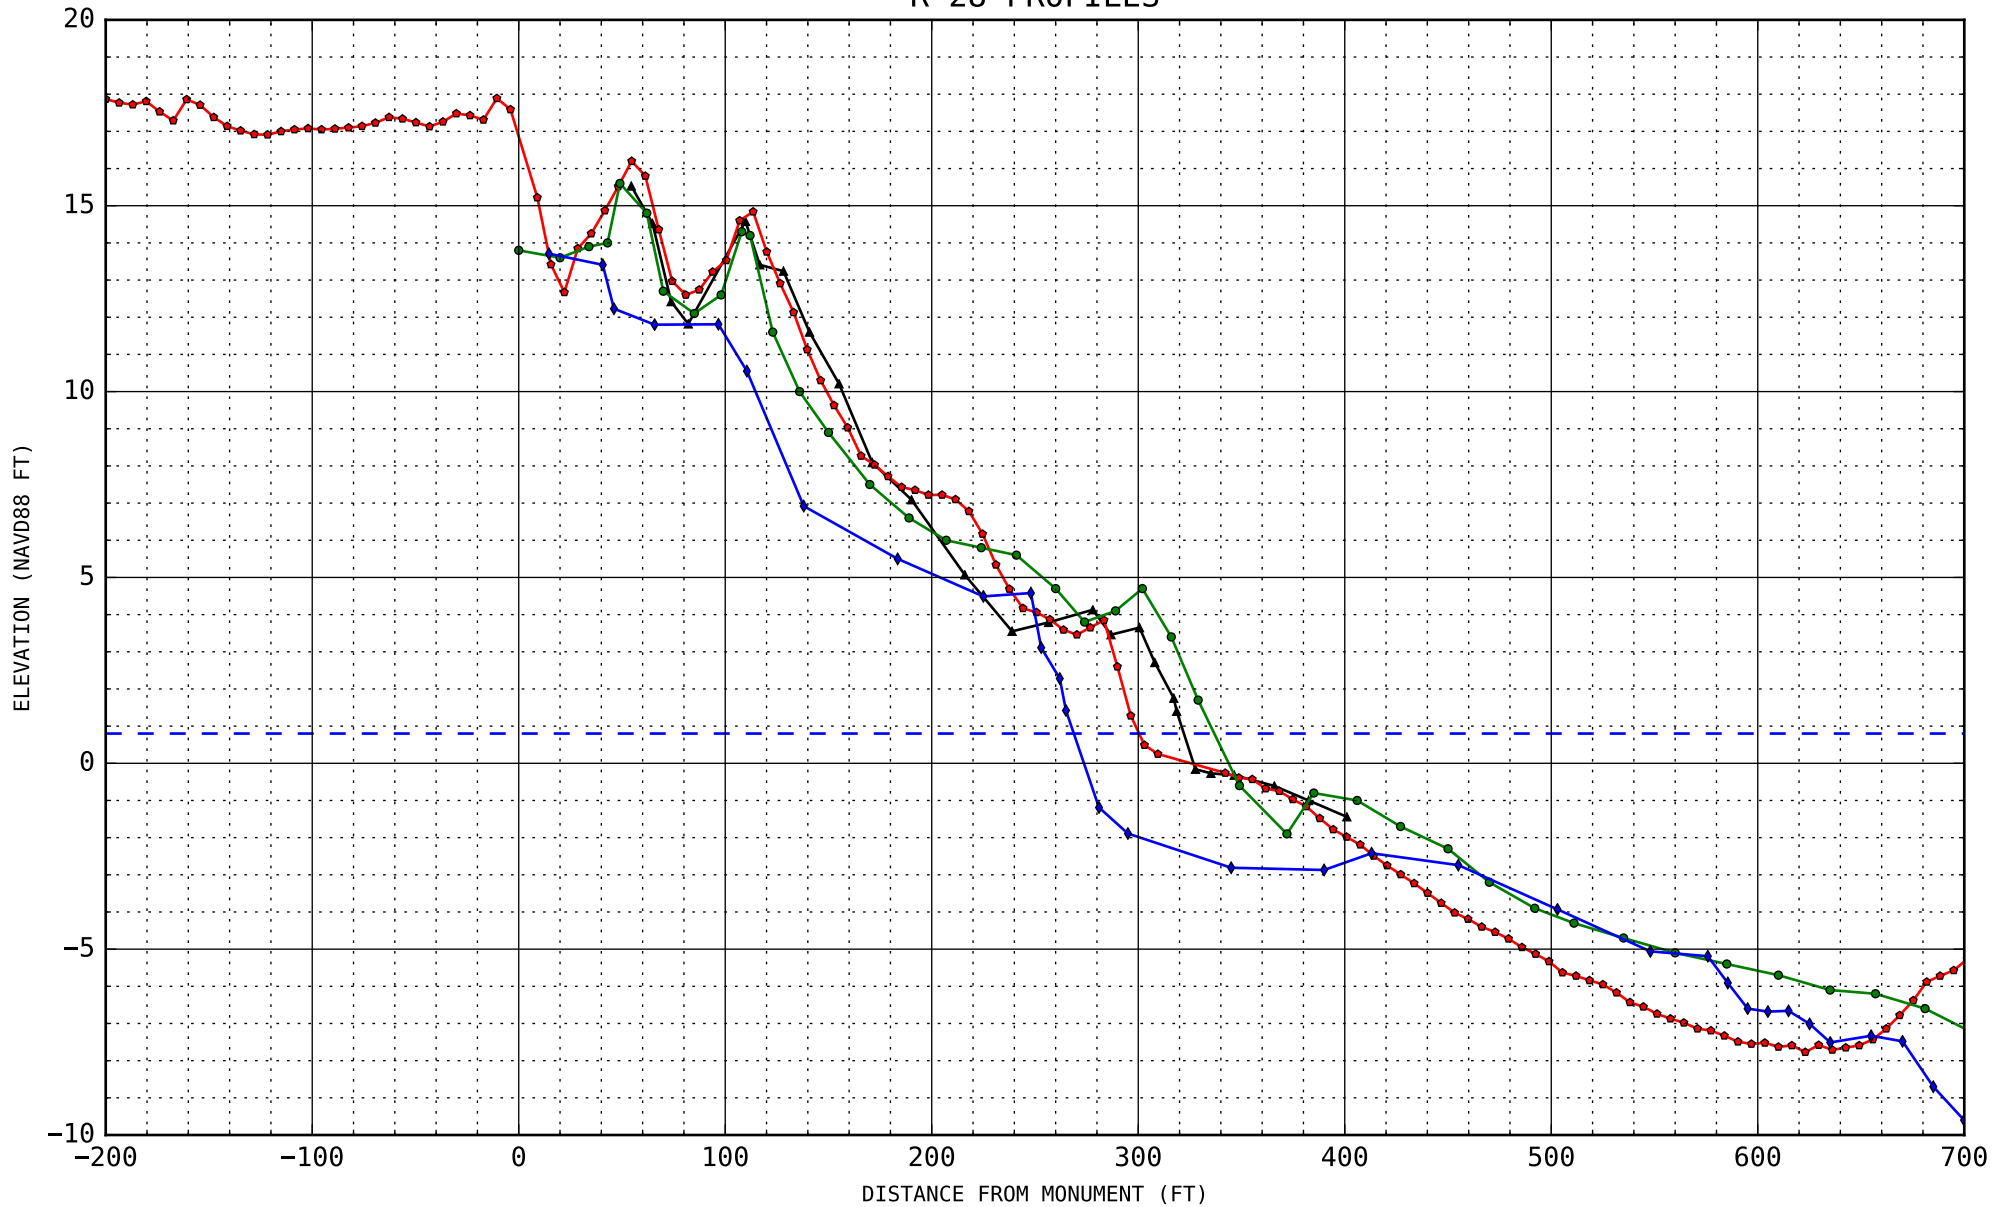
# R-28 PROFILES

- ▲ 2019-APR CONDITION BY DEP
- 2016-SEP MONITORING BY USACE-LIDAR
- 2014-JUL MONITORING BY MAE
- ◆ 2008-JUN MONITORING BY DEP
- - - MHW CONTOUR (0.8 FT)

RANGE: R-28  
EST DATE: OCT1995  
SURVEY DATE: 03APR19  
AZIMUTH: 175.0

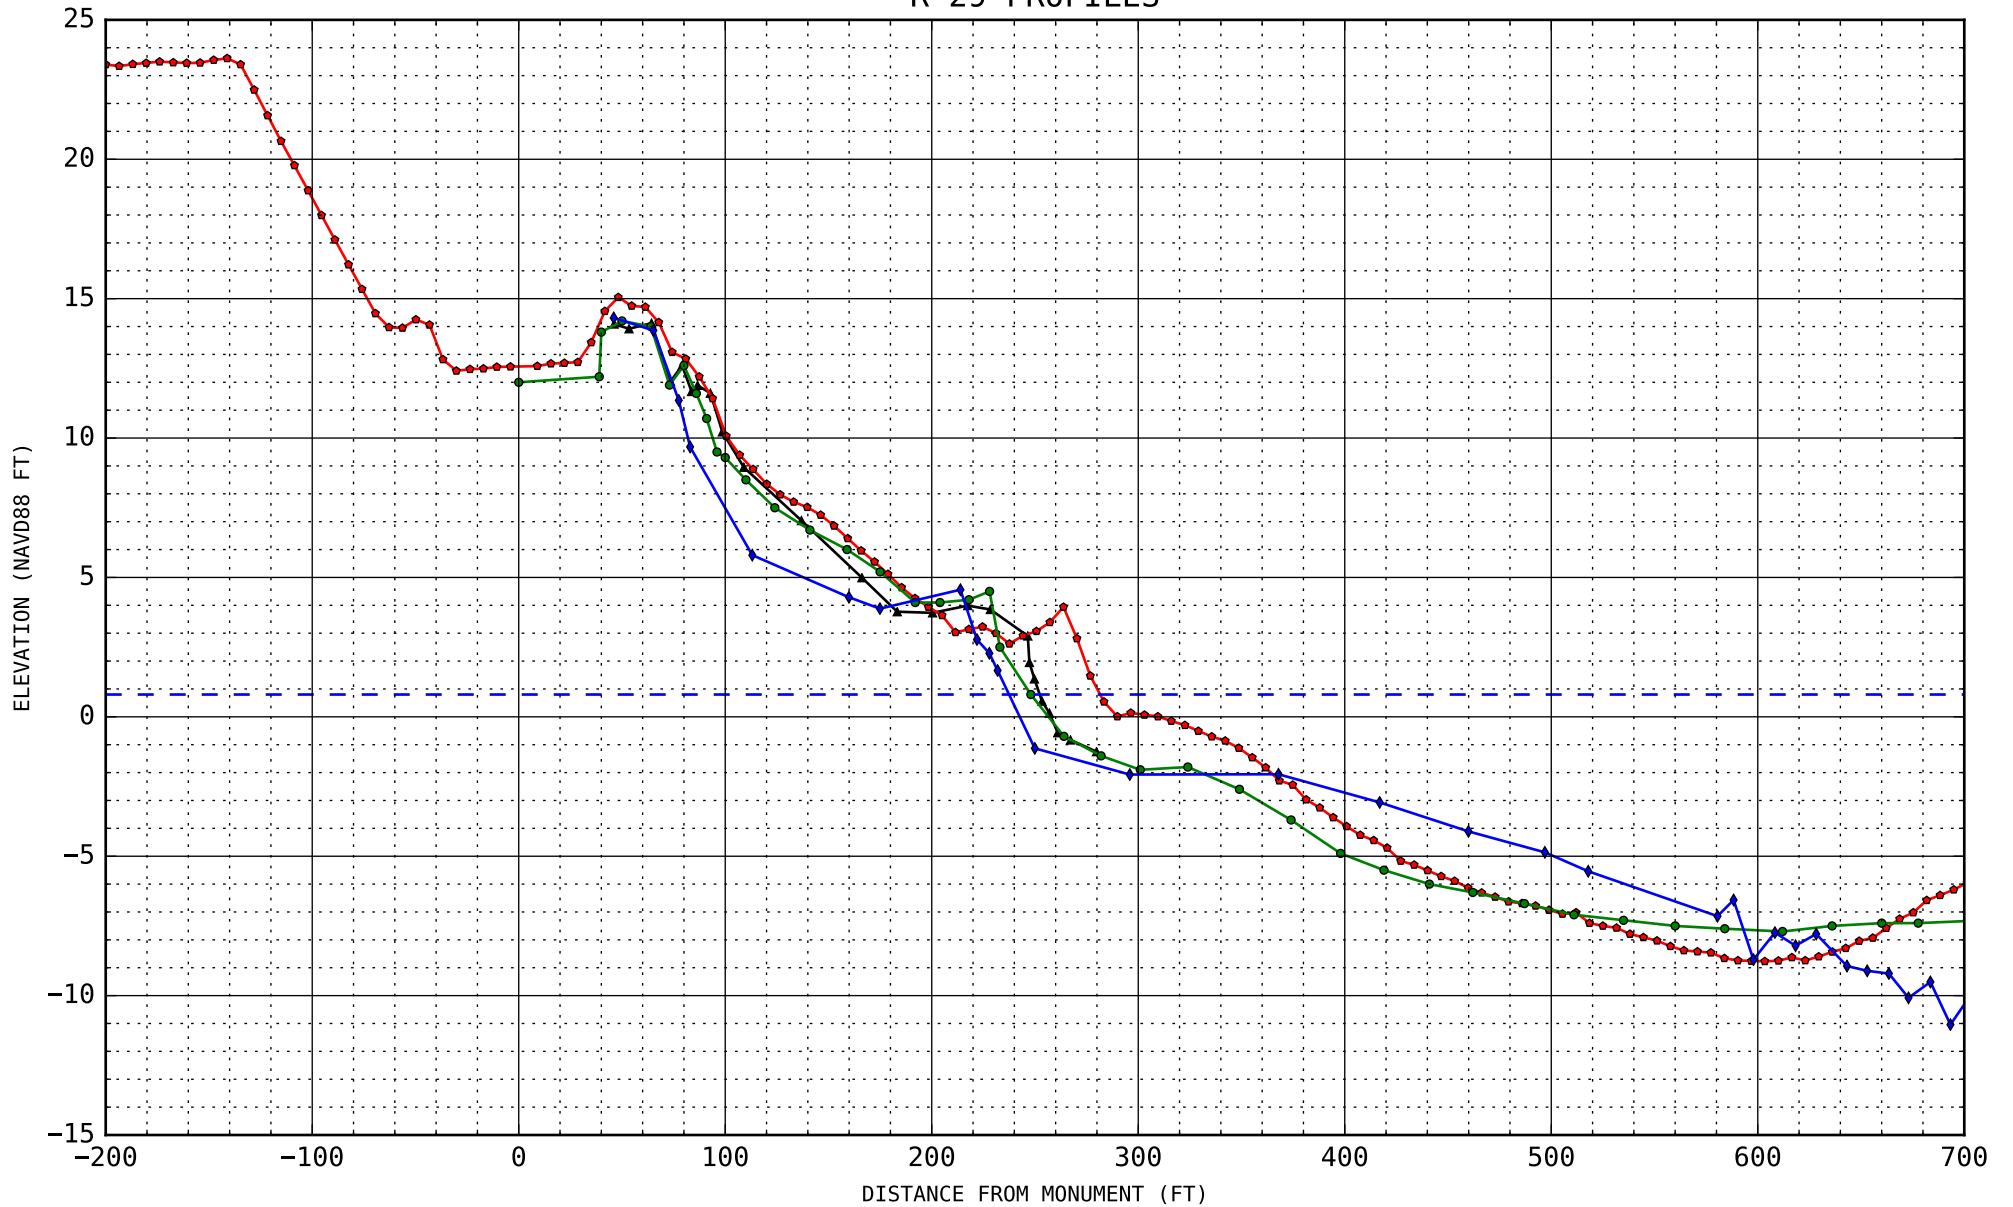
# R-29 PROFILES

- ▲ 2019-APR CONDITION BY DEP
- 2016-SEP MONITORING BY USACE-LIDAR
- 2014-JUL MONITORING BY MAE
- ◆ 2008-JUN MONITORING BY DEP
- - - MHW CONTOUR (0.8 FT)

RANGE: R-29  
EST DATE: M&E1997  
SURVEY DATE: 03APR19  
AZIMUTH: 175.0

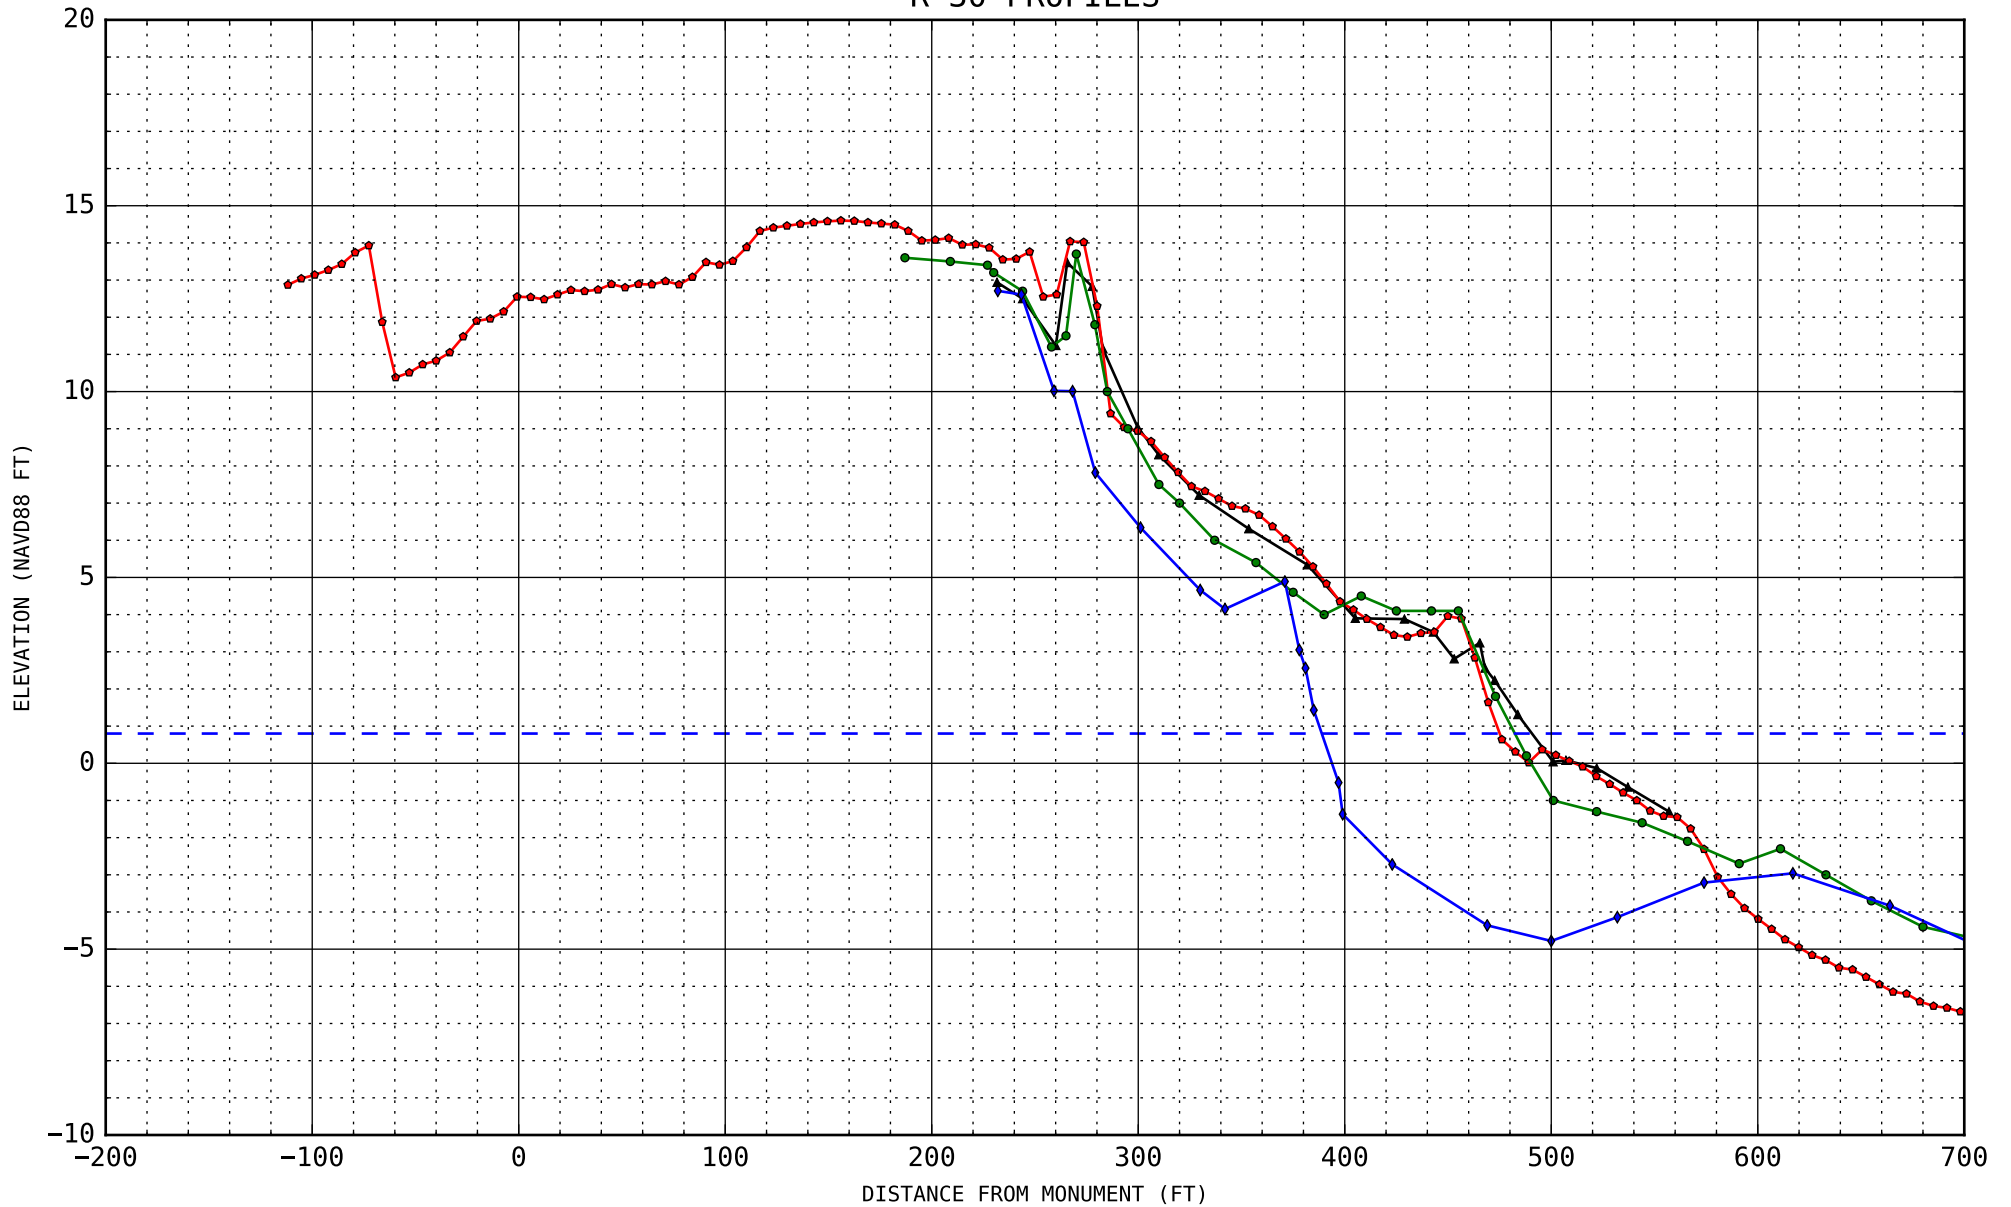
# R-30 PROFILES

- ▲ 2019-APR CONDITION BY DEP
- 2016-SEP MONITORING BY USACE-LIDAR
- 2014-JUL MONITORING BY MAE
- ◆ 2008-JUN MONITORING BY DEP
- - - MHW CONTOUR (0.8 FT)

RANGE: R-30  
EST DATE: OCT1995  
SURVEY DATE: 03APR19  
AZIMUTH: 175.0

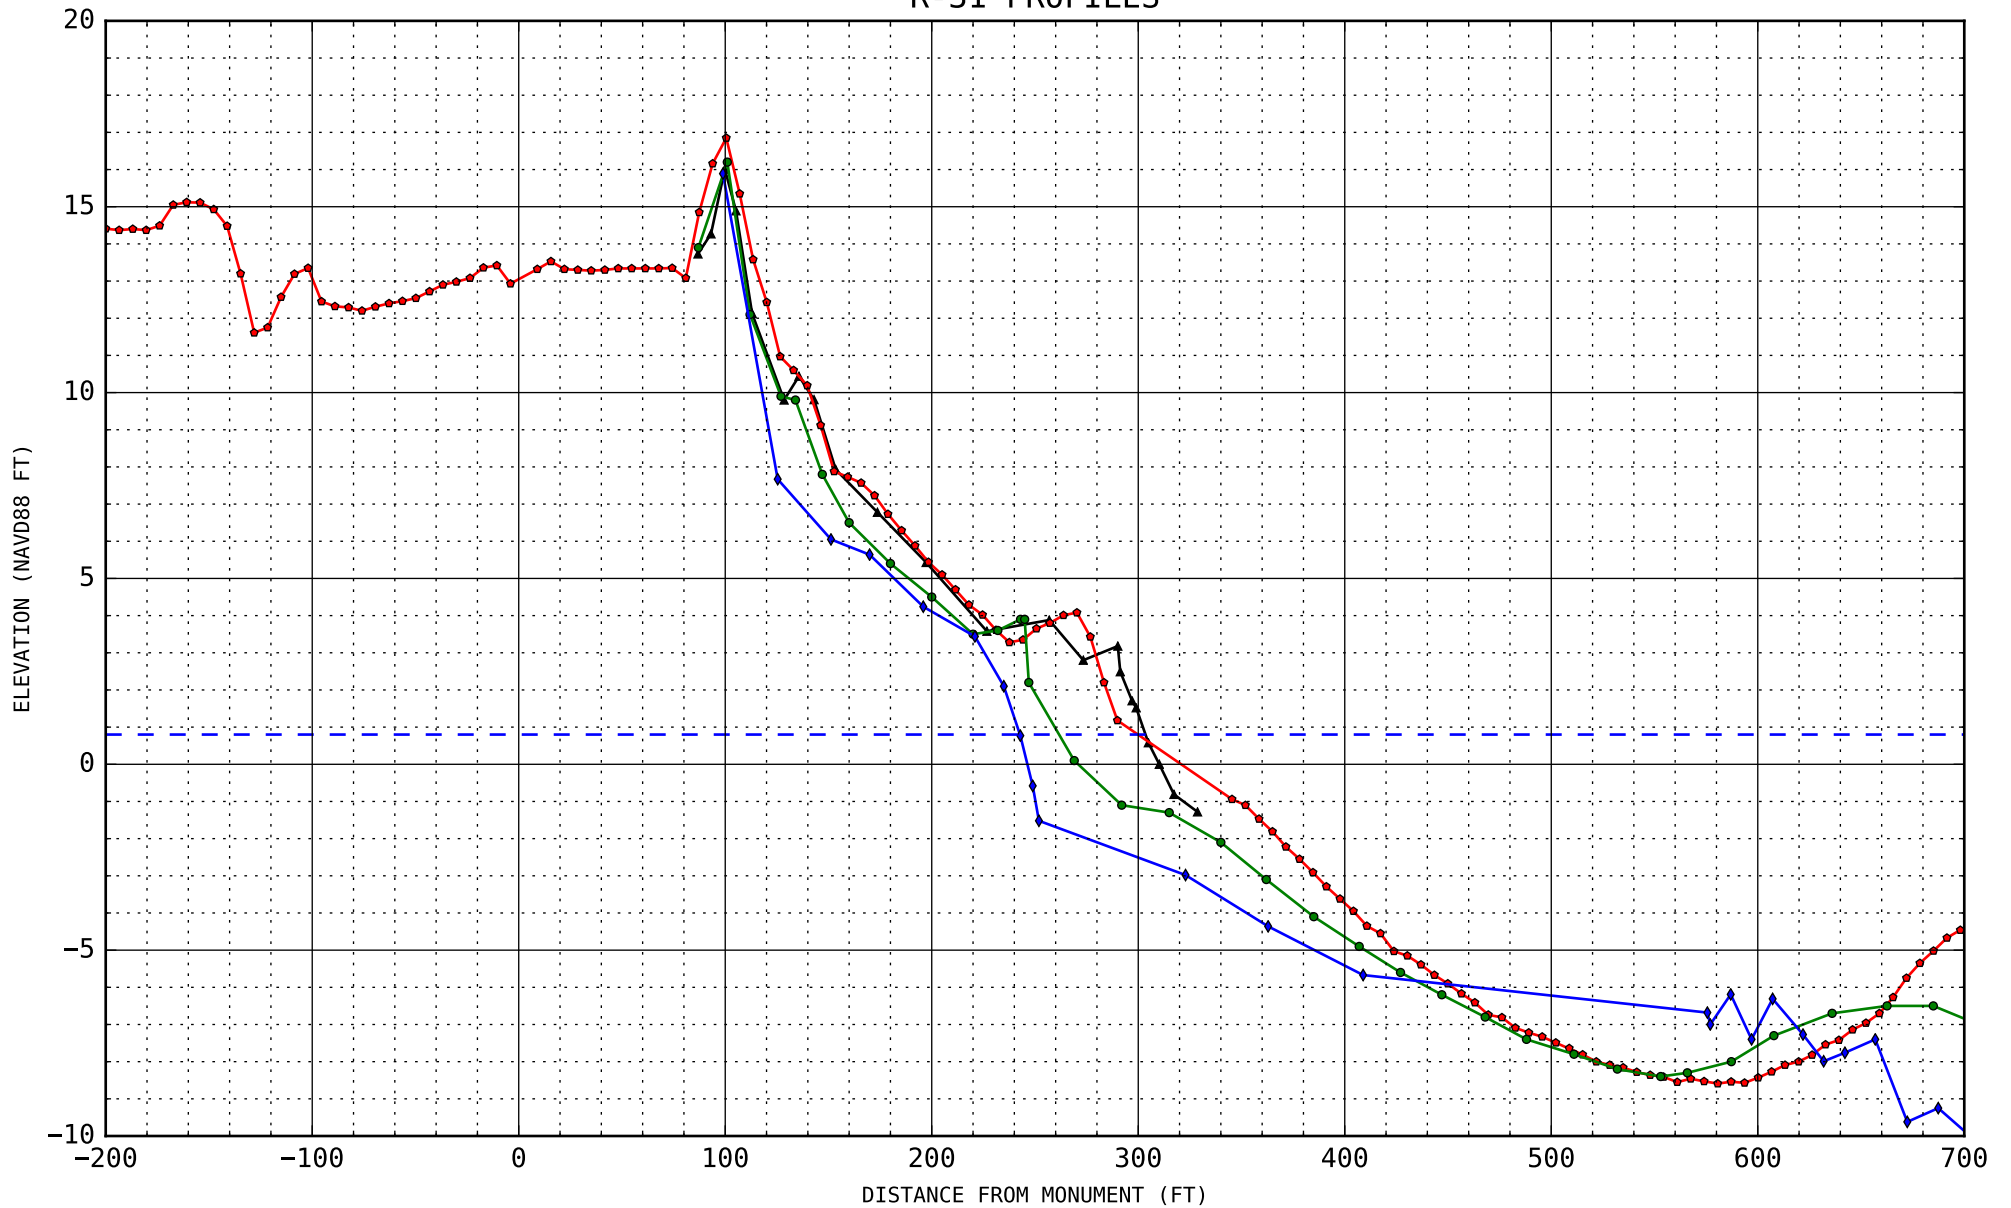
# R-31 PROFILES

- ▲ 2019-APR CONDITION BY DEP
- 2016-SEP MONITORING BY USACE-LIDAR
- 2014-JUL MONITORING BY MAE
- ◆ 2008-JUN MONITORING BY DEP
- - - MHW CONTOUR (0.8 FT)

RANGE: R-31  
EST DATE: M&E1997  
SURVEY DATE: 03APR19  
AZIMUTH: 175.0

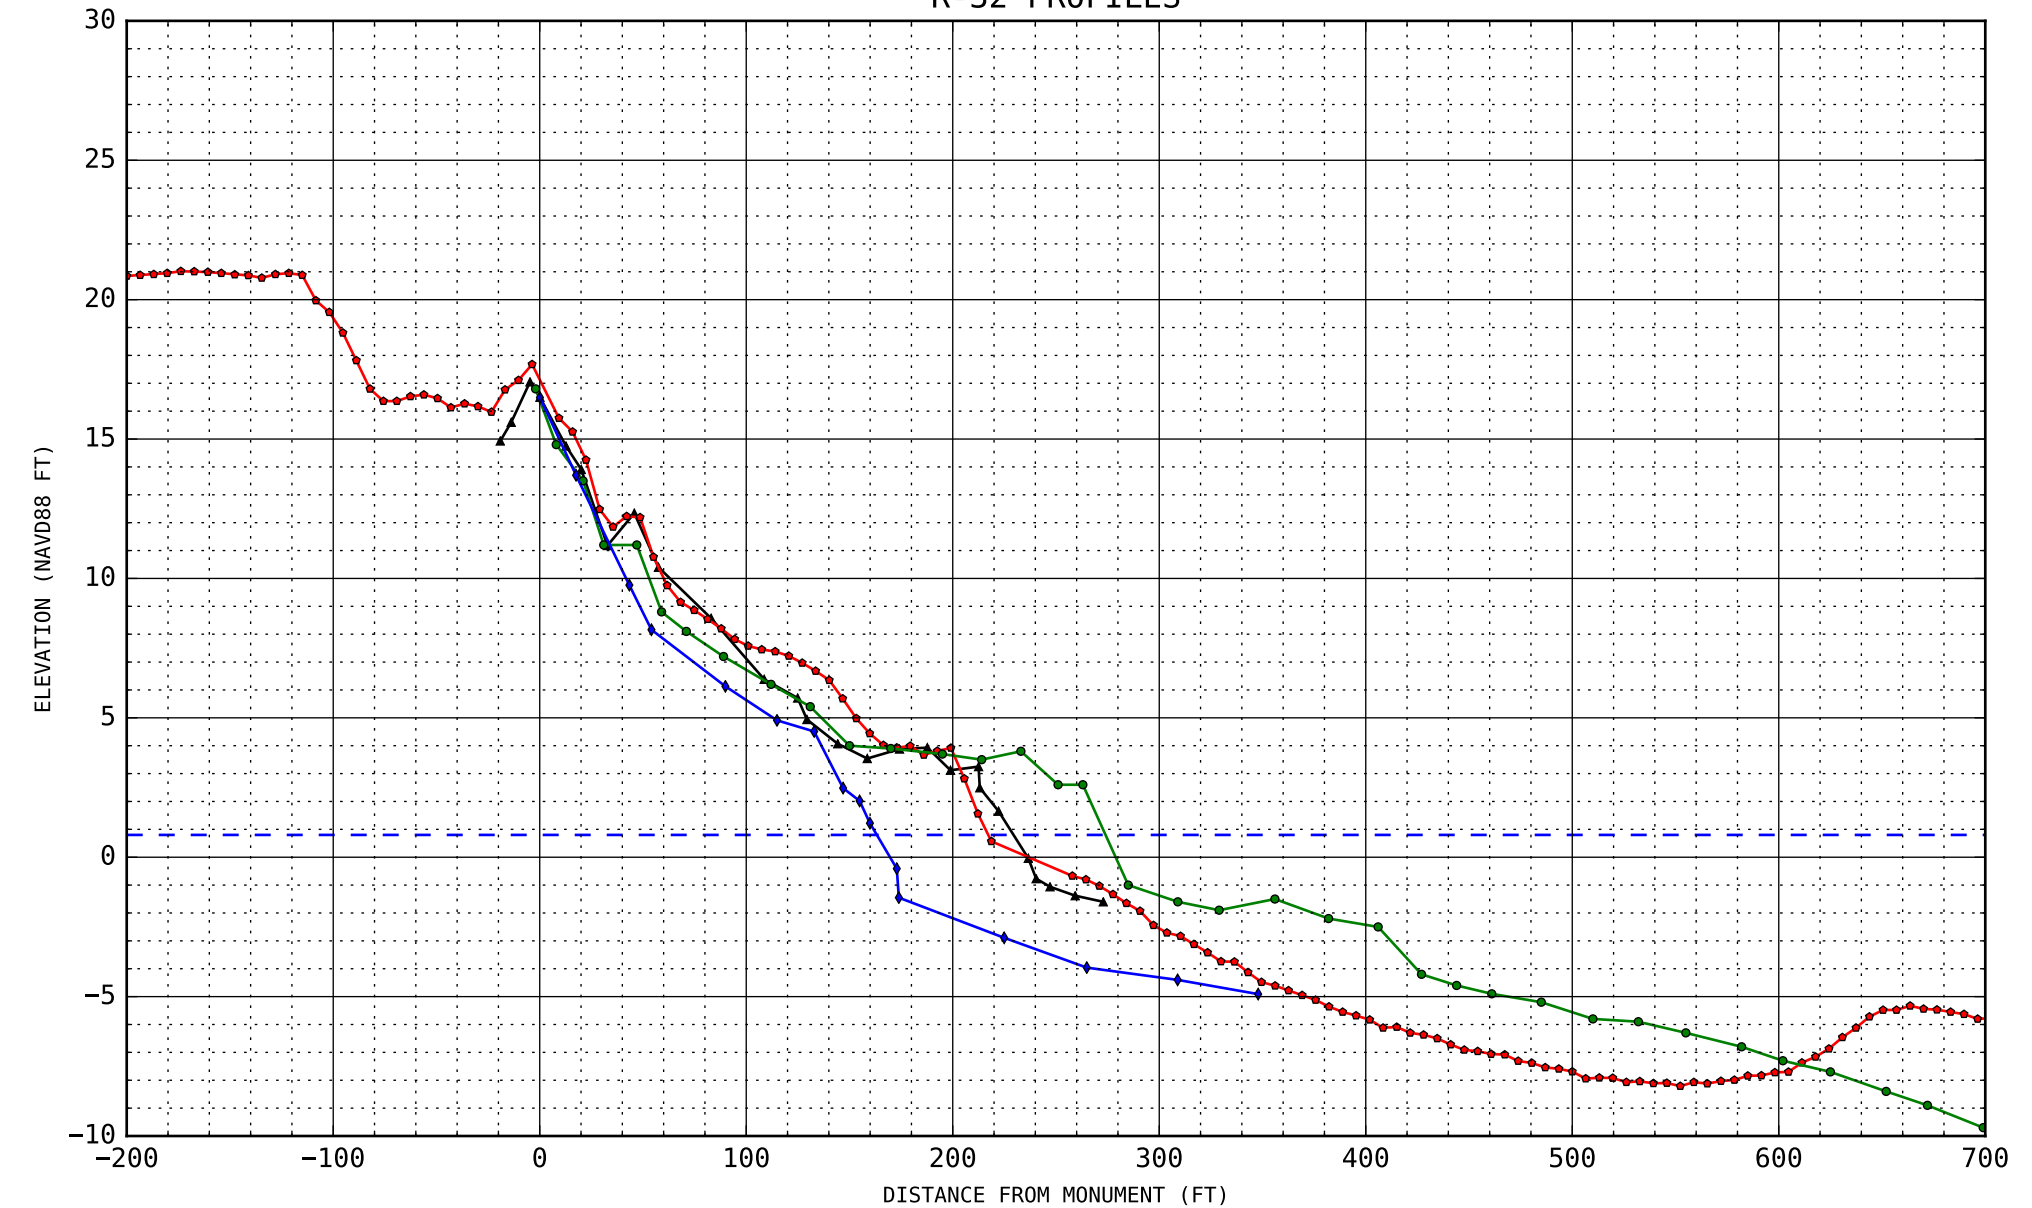
# R-32 PROFILES

- ▲ 2019-APR CONDITION BY DEP
- 2016-SEP MONITORING BY USACE-LIDAR
- 2014-JUL MONITORING BY MAE
- ◆ 2008-JUN MONITORING BY DEP
- - - MHW CONTOUR (0.8 FT)

RANGE: R-32  
EST DATE: OCT1995  
SURVEY DATE: 03APR19  
AZIMUTH: 180.0

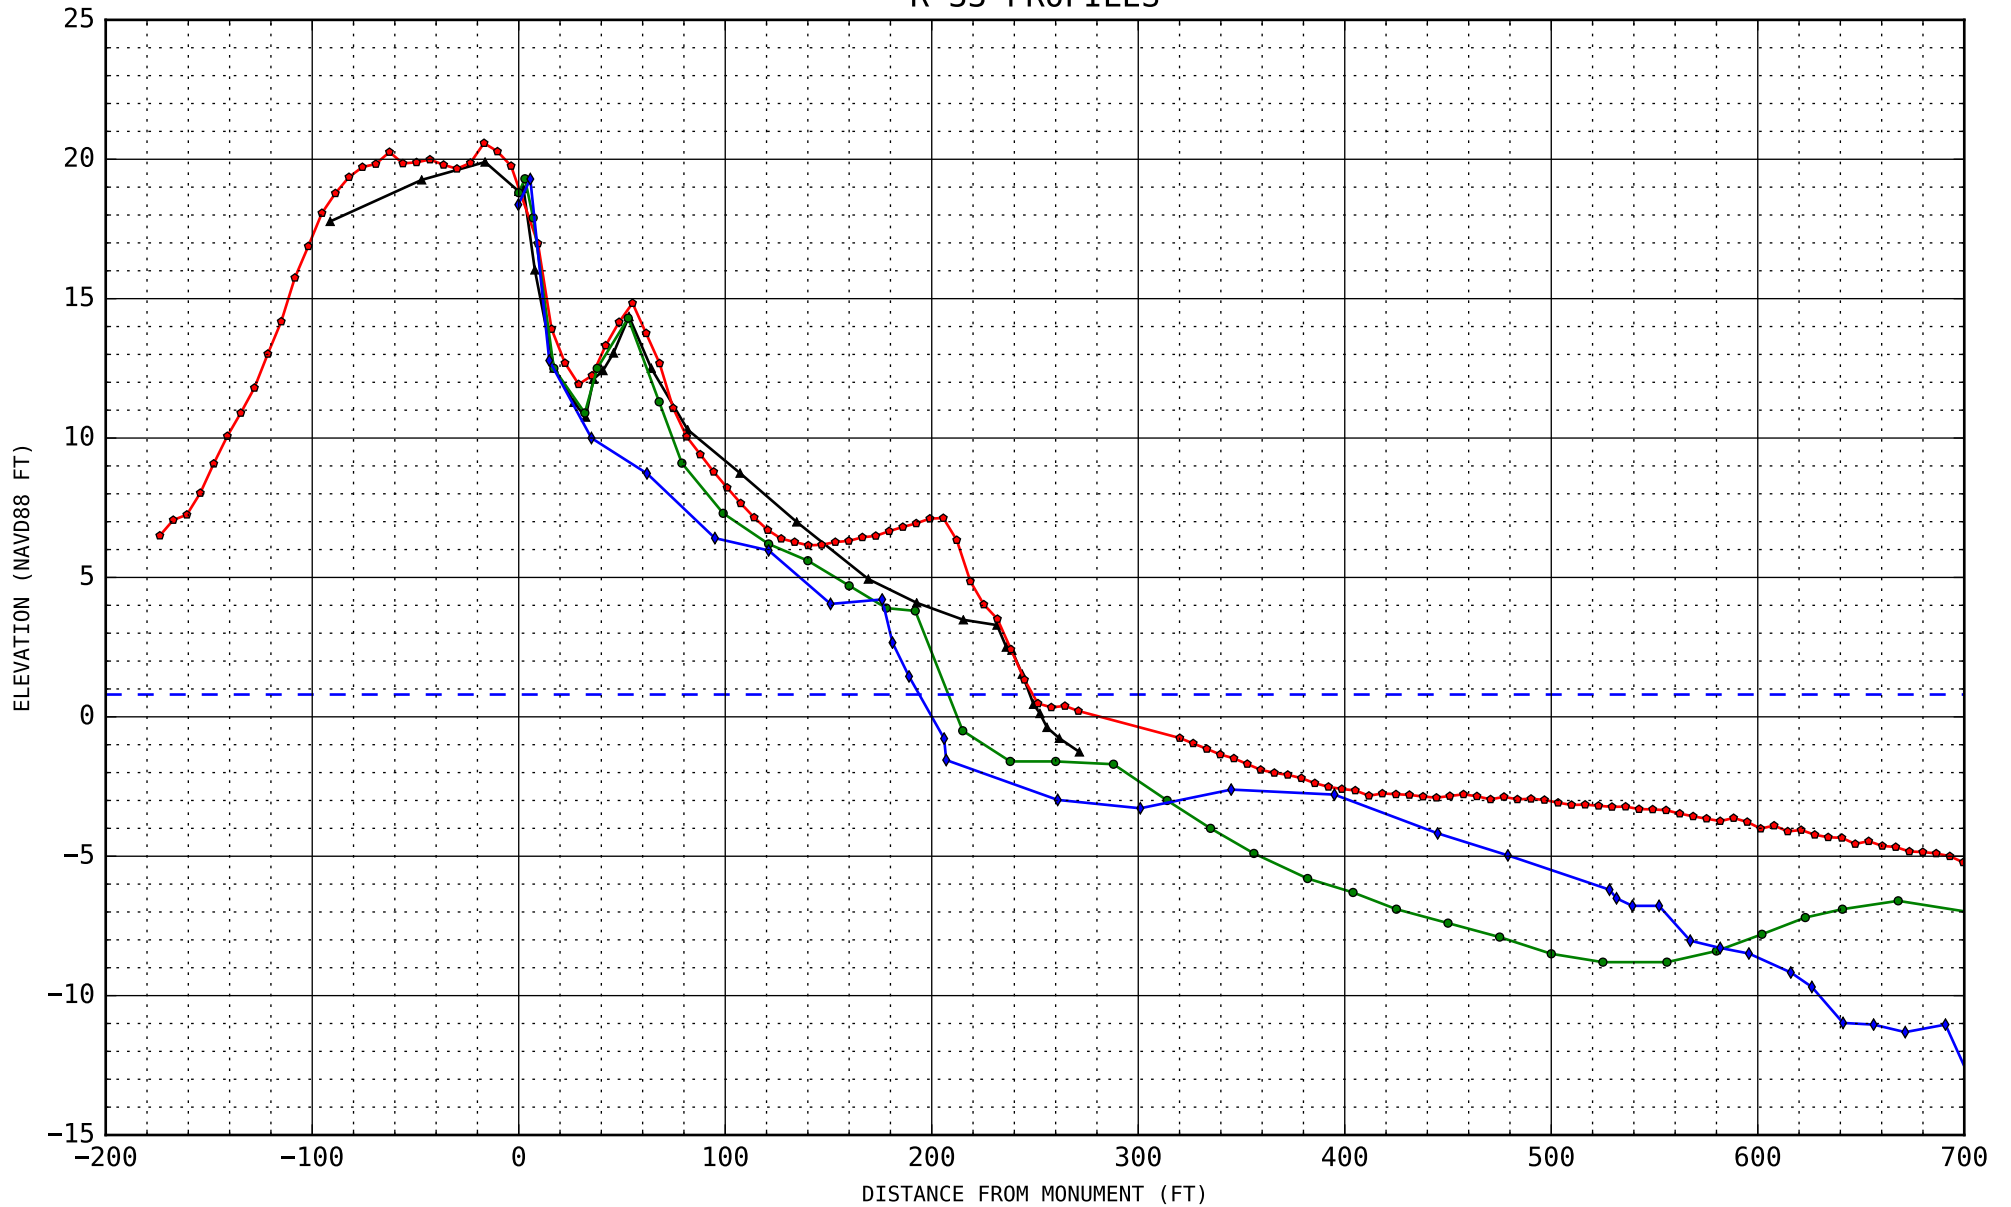
# R-33 PROFILES

- ▲ 2019-APR CONDITION BY DEP
- 2016-SEP MONITORING BY USACE-LIDAR
- 2014-JUL MONITORING BY MAE
- ◆ 2008-JUN MONITORING BY DEP
- - - MHW CONTOUR (0.8 FT)

RANGE: R-33  
EST DATE: OCT1995  
SURVEY DATE: 03APR19  
AZIMUTH: 180.0

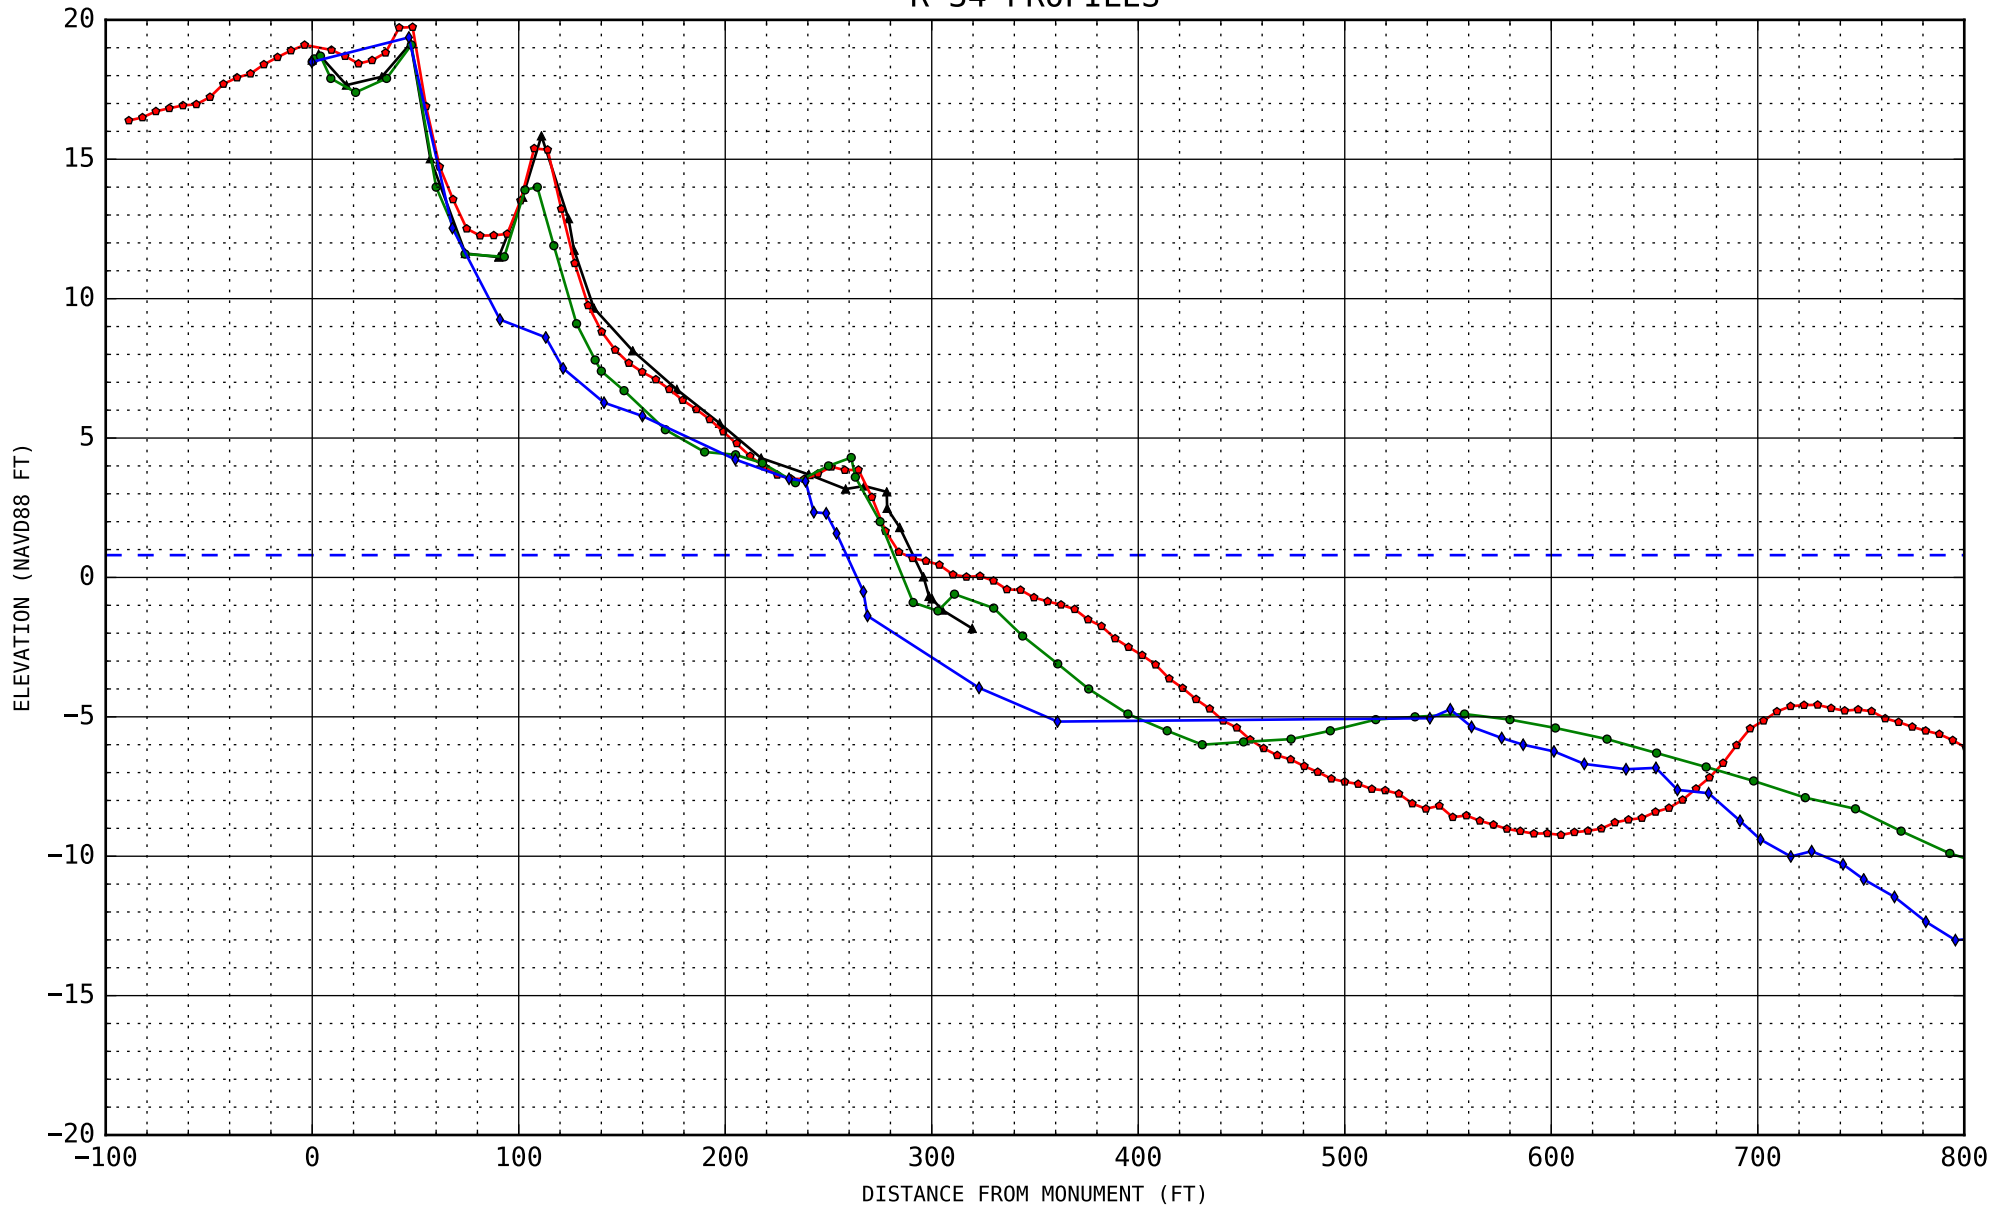
# R-34 PROFILES

- ▲ 2019-APR CONDITION BY DEP
- 2016-SEP MONITORING BY USACE-LIDAR
- 2014-JUL MONITORING BY MAE
- ◆ 2008-JUN MONITORING BY DEP
- - - MHW CONTOUR (0.8 FT)

RANGE: R-34  
EST DATE: OCT1995  
SURVEY DATE: 03APR19  
AZIMUTH: 180.0
