# R-17 PROFILES

OKALOOSA  
PROGRAM SUPPORT GIS  
DIVISION OF WATER RESOURCE MANAGEMENT  
FLORIDA DEPARTMENT OF ENVIRONMENTAL PROTECTION

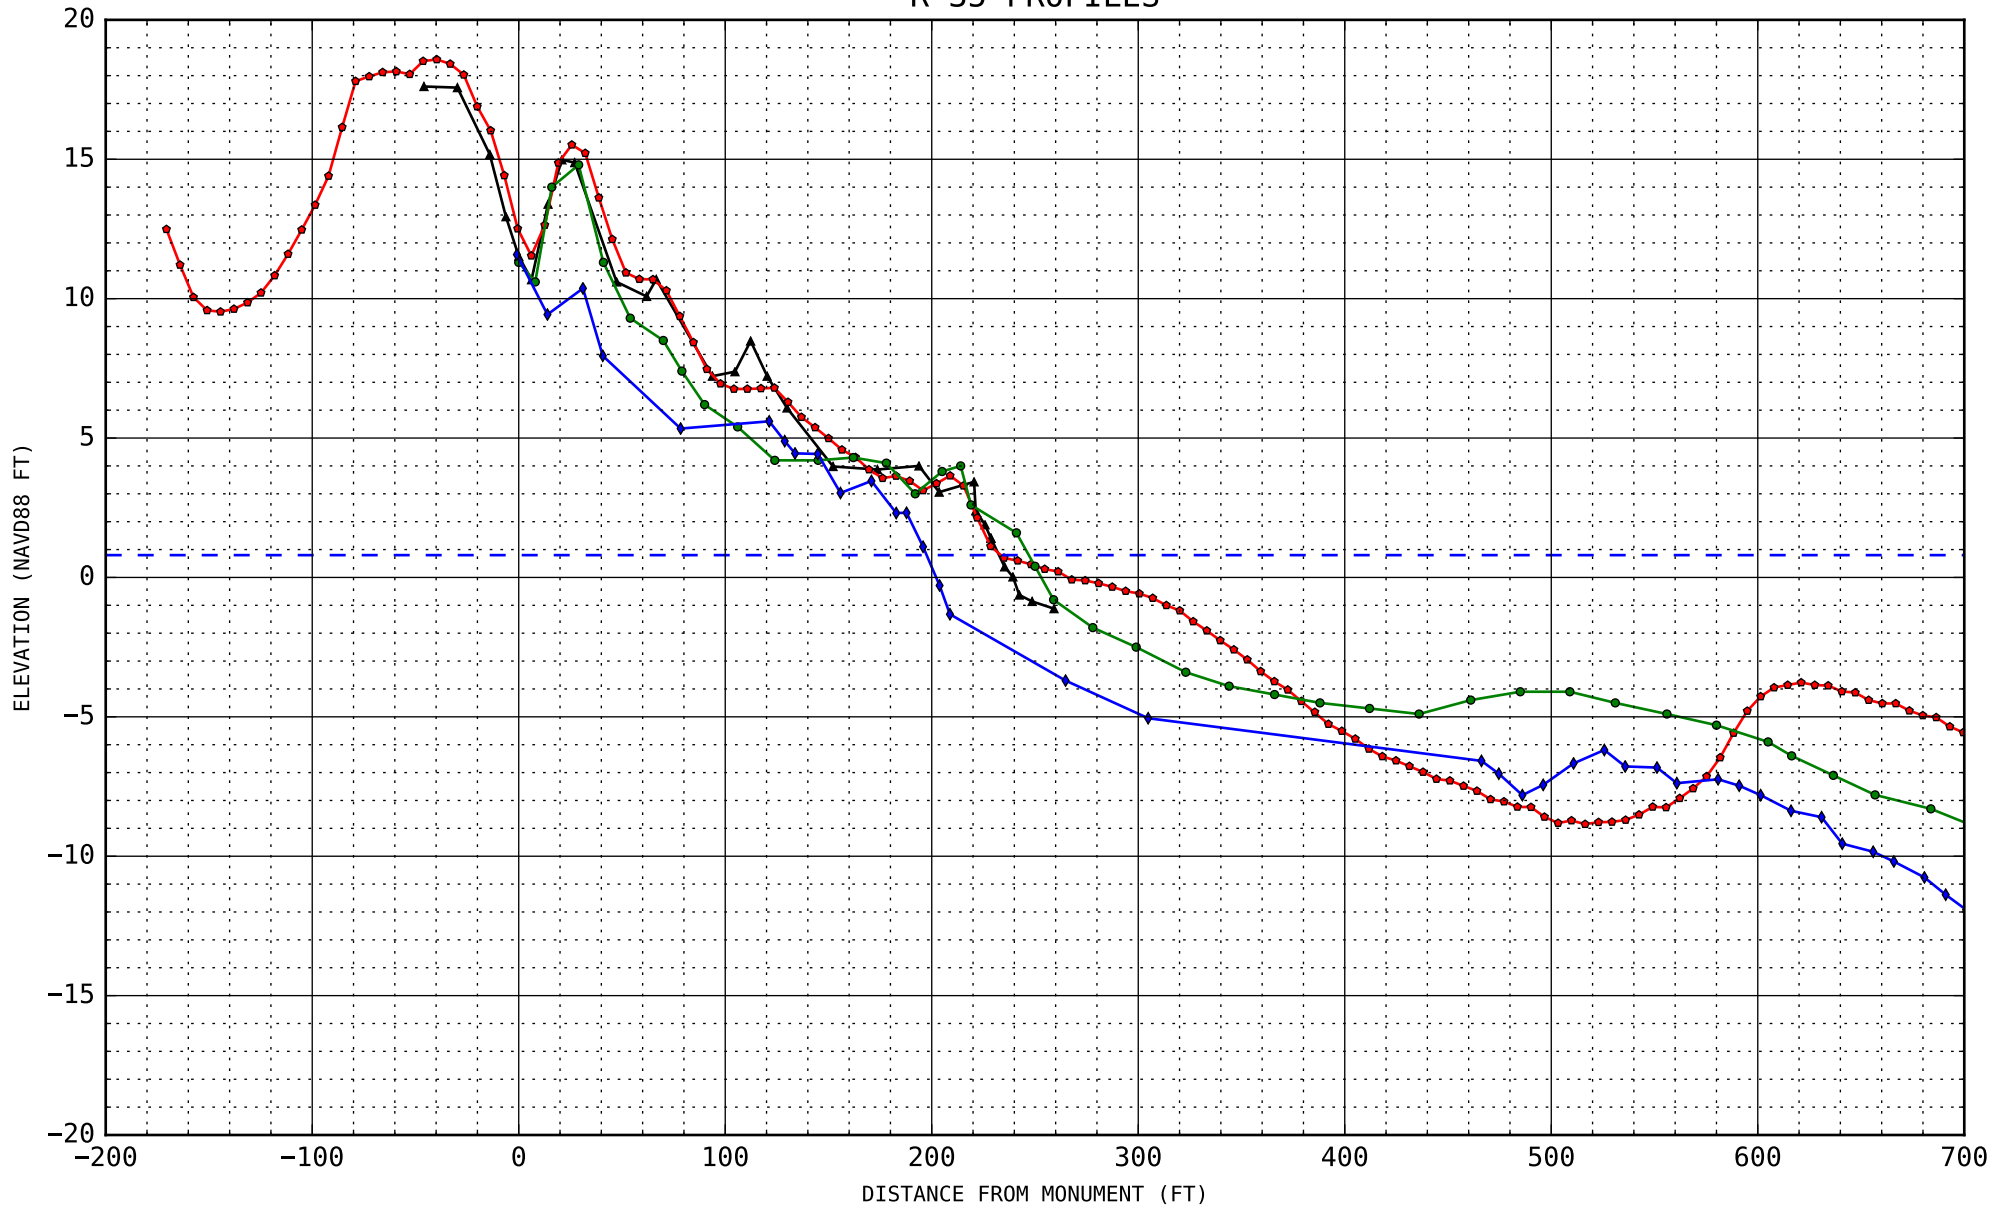
# R-35 PROFILES

- ▲ 2019-APR CONDITION BY DEP
- 2016-SEP MONITORING BY USACE-LIDAR
- 2014-JUL MONITORING BY MAE
- ◆ 2008-JUN MONITORING BY DEP
- - - MHW CONTOUR (0.8 FT)

RANGE: R-35  
EST DATE: OCT1973  
SURVEY DATE: 03APR19  
AZIMUTH: 180.0

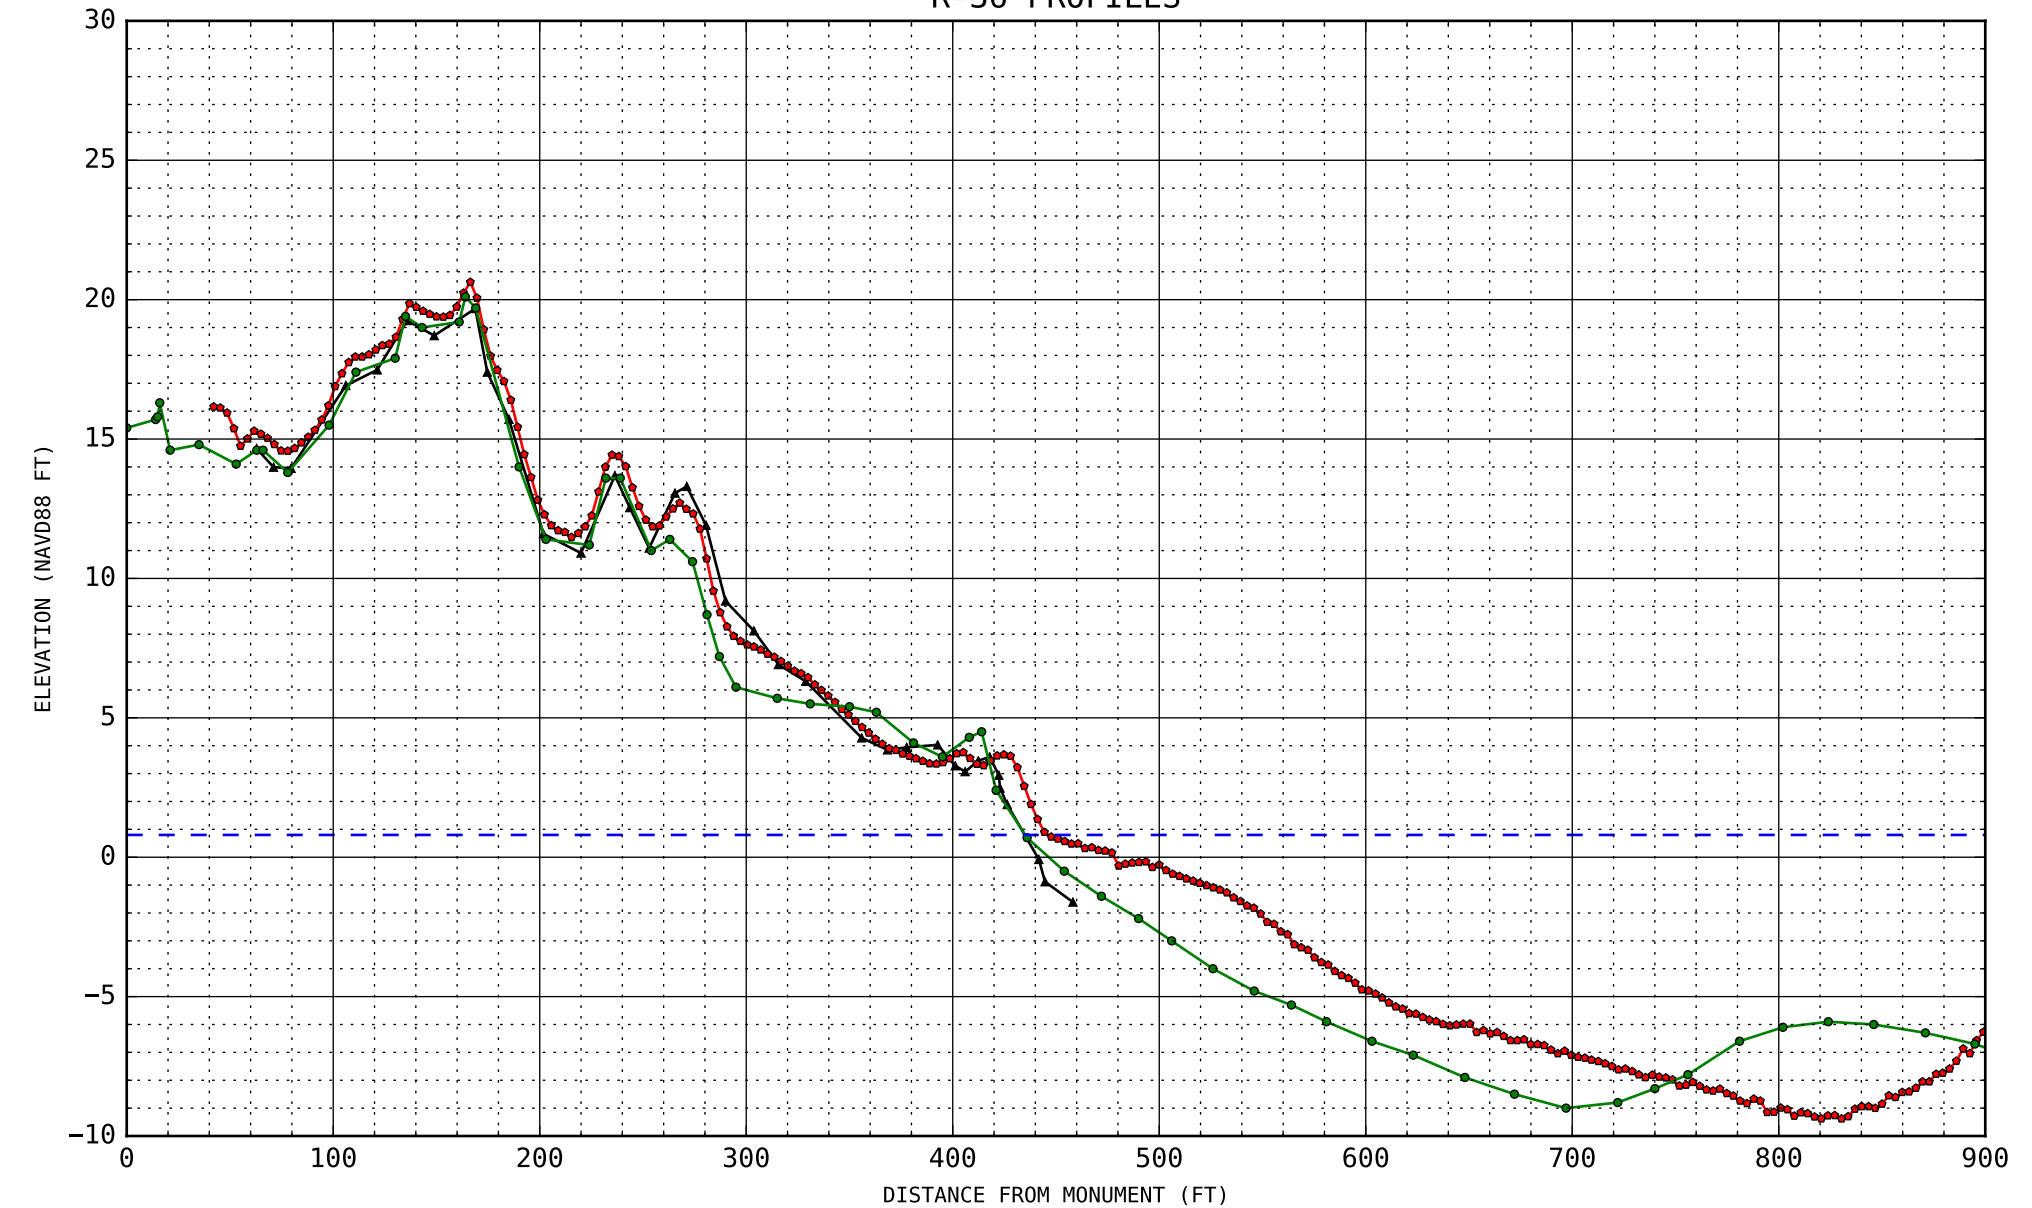
# R-36 PROFILES

- ▲ 2019-APR CONDITION BY DEP
- 2016-SEP MONITORING BY USACE-LIDAR
- 2014-JUL MONITORING BY MAE
- - - MHW CONTOUR (0.8 FT)

RANGE: R-36  
EST DATE: OCT1995  
SURVEY DATE: 03APR19  
AZIMUTH: 180.0
