# R-230 PROFILES

LEE  
 COASTAL ENGINEERING AND GEOLOGY PROGRAM  
 OFFICE OF RESILIENCE AND COASTAL PROTECTION  
 FLORIDA DEPARTMENT OF ENVIRONMENTAL PROTECTION

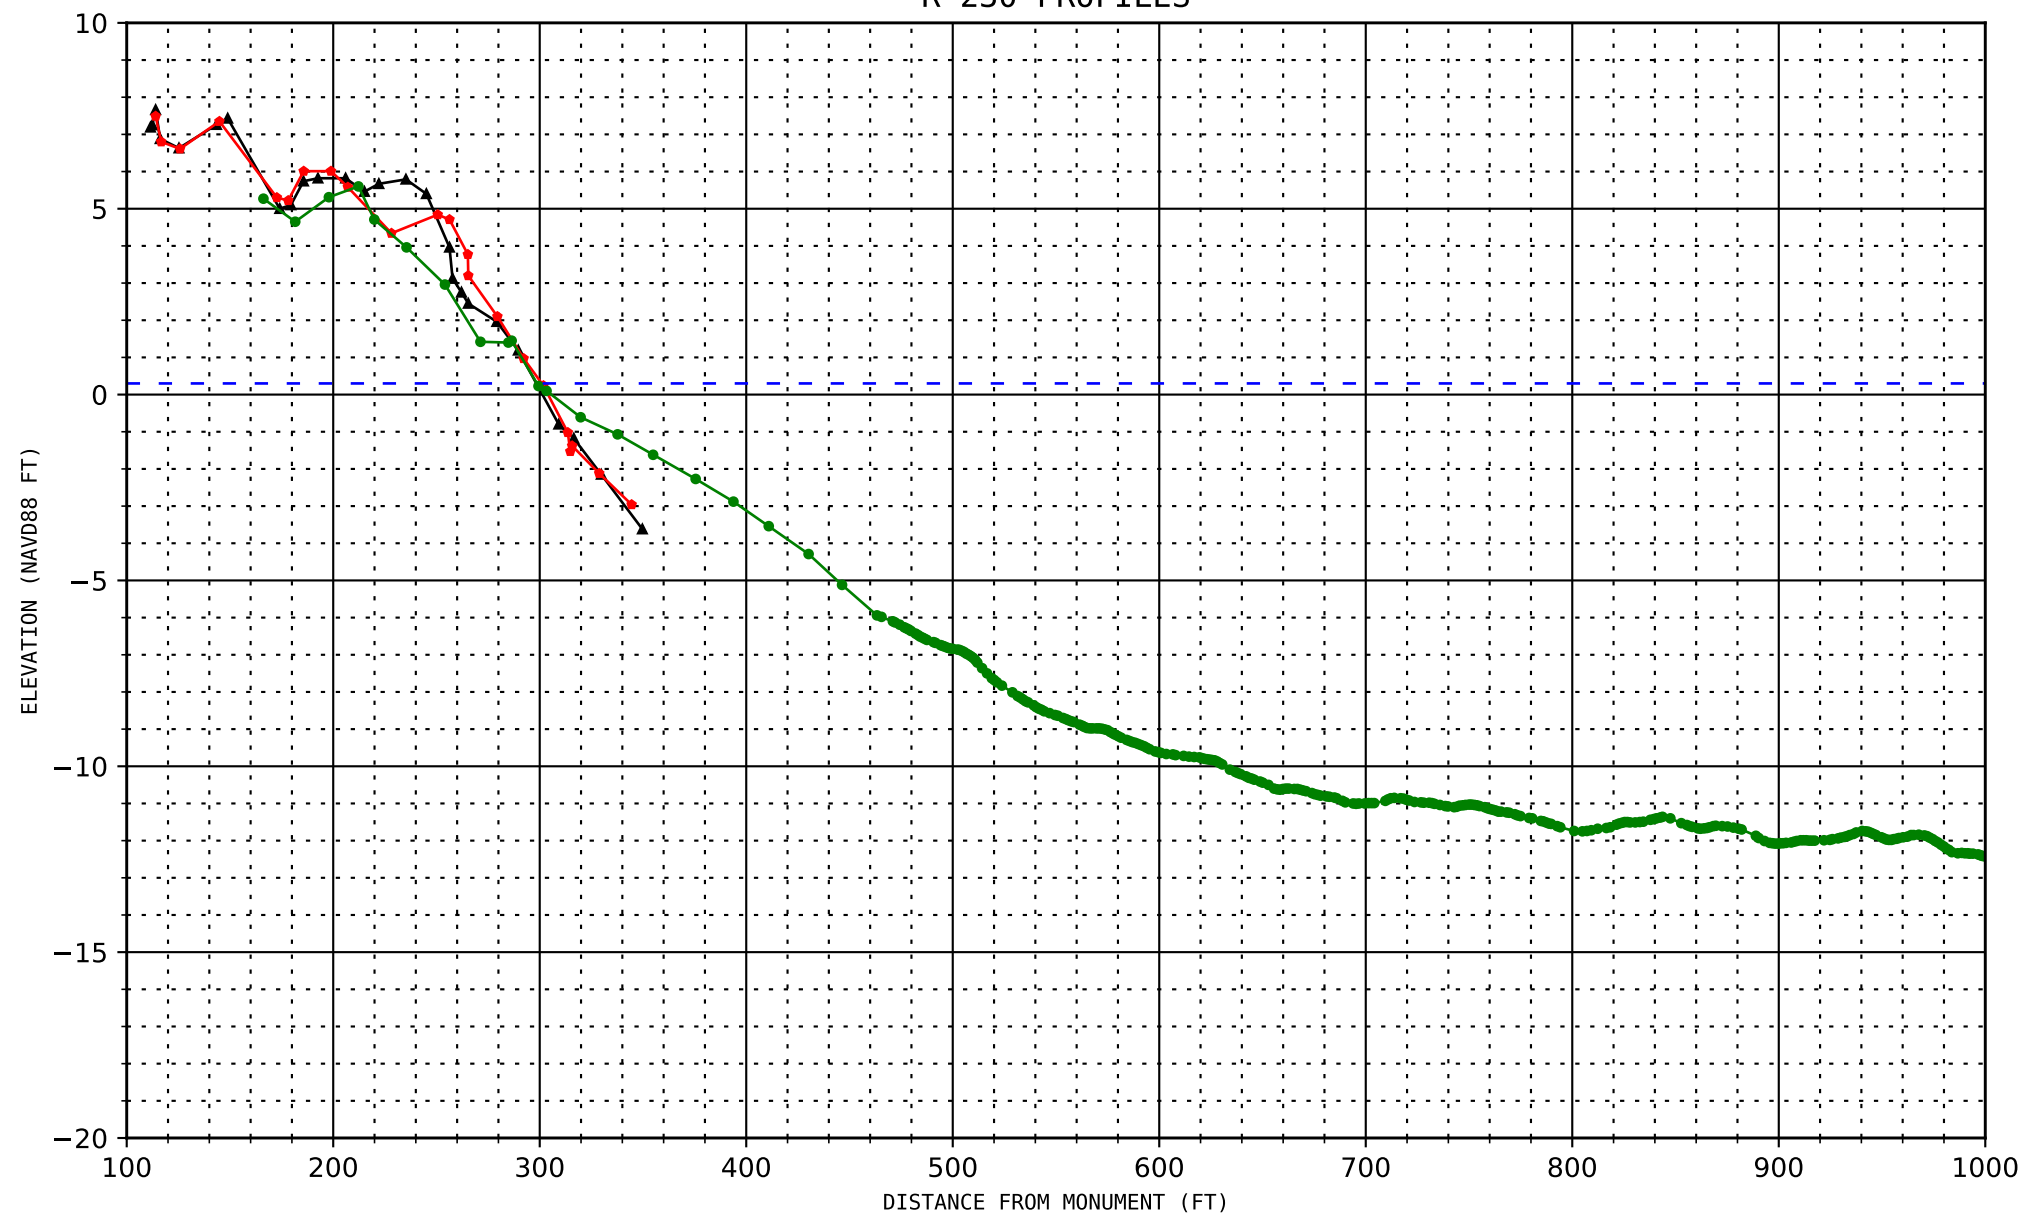
—▲— 2021-MAY CONDITION BY DEP  
 —●— 2018-APR MONITORING BY DEP  
 —●— 2015-JAN POST-C BY CEC  
 - - - MHW CONTOUR (0.3 FT)

RANGE: R-230  
 EST DATE: JAN1982  
 SURVEY DATE: 18JUN21  
 AZIMUTH: 250.0

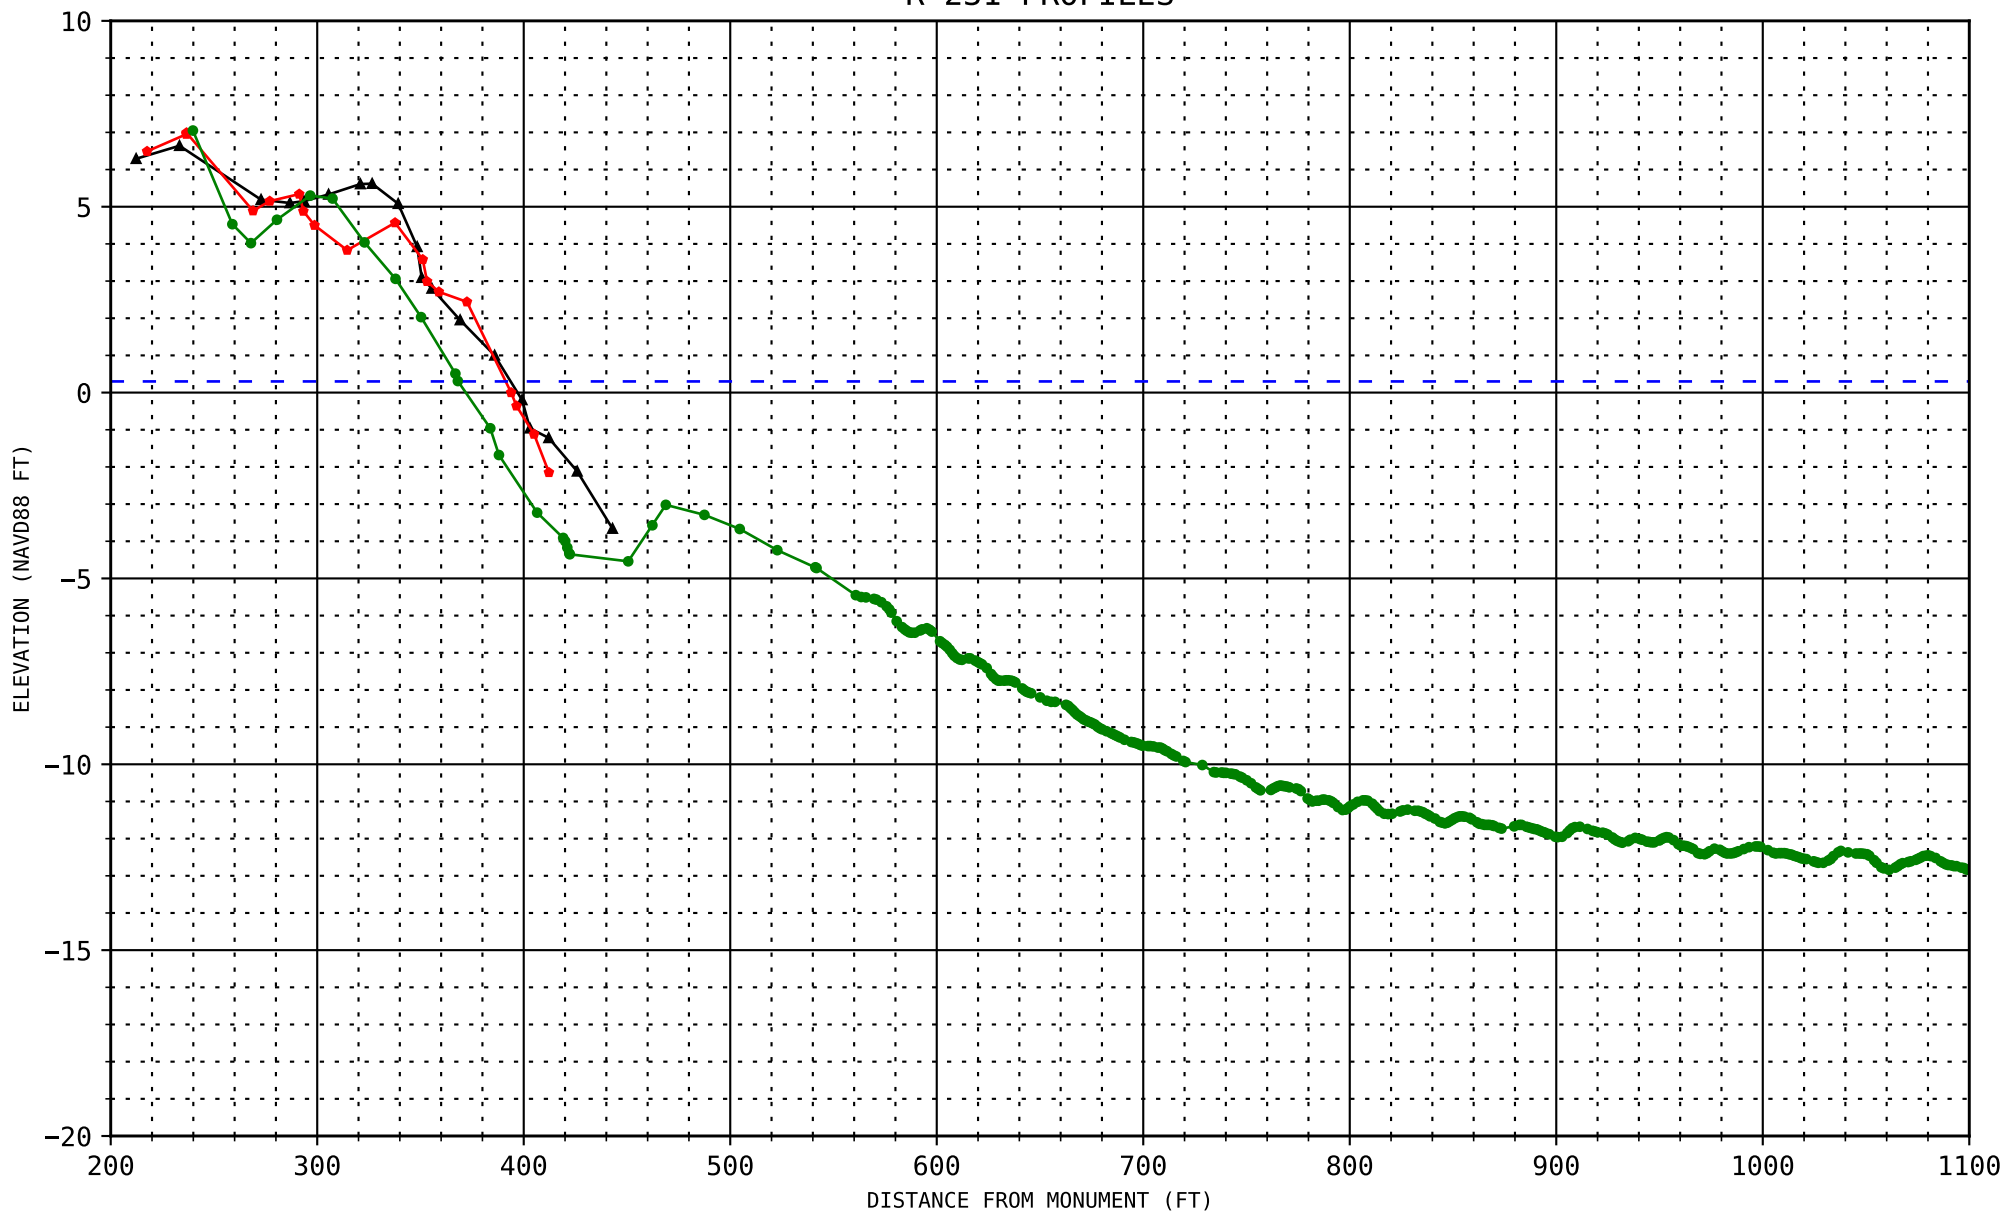
# R-231 PROFILES

- ▲— 2021-MAY CONDITION BY DEP
- 2018-APR MONITORING BY DEP
- 2015-JAN POST-C BY CEC
- - - MHW CONTOUR (0.3 FT)

RANGE: R-231  
 EST DATE: JAN1982  
 SURVEY DATE: 18JUN21  
 AZIMUTH: 245.0

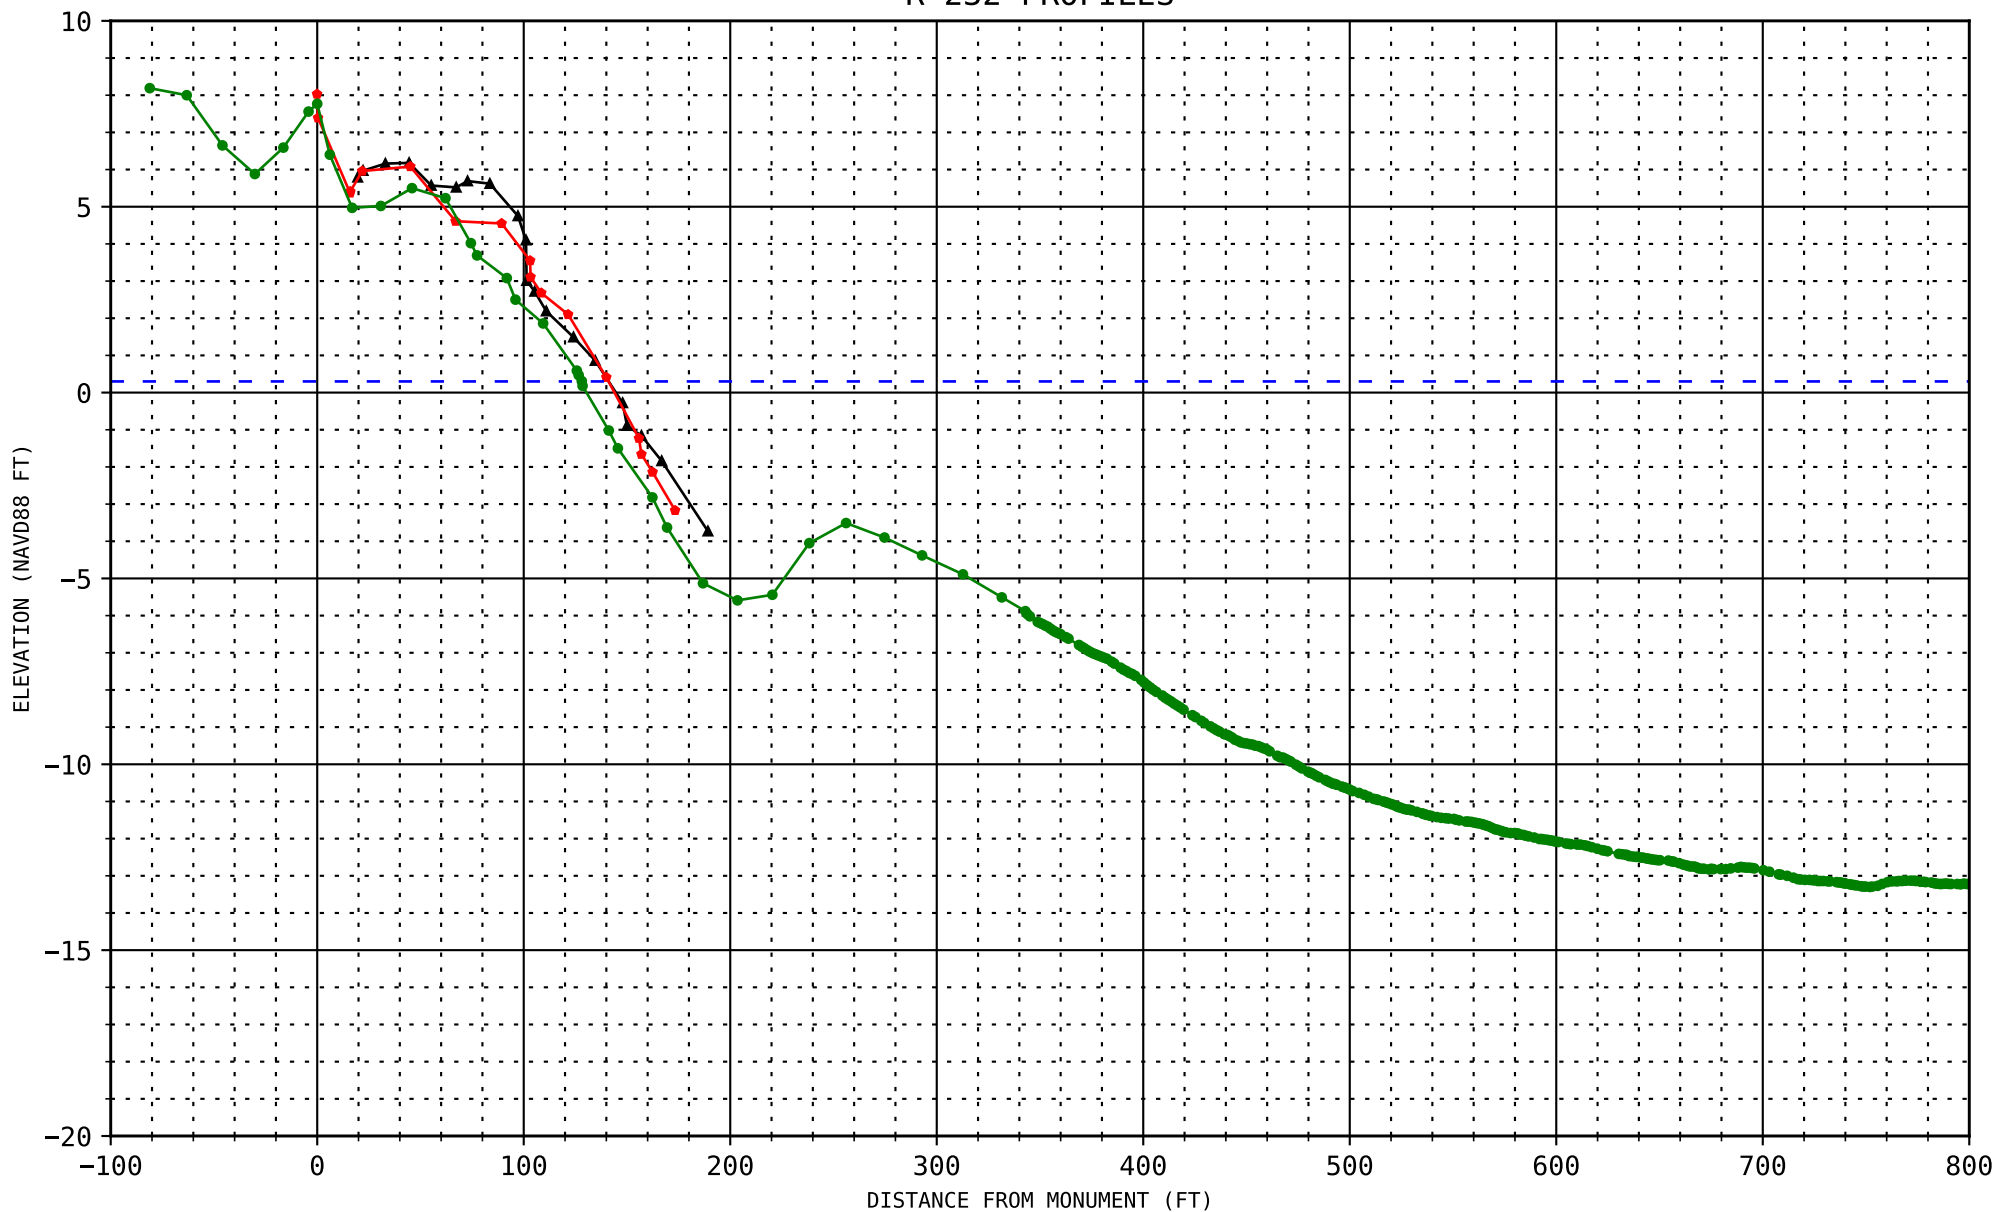
# R-232 PROFILES

—▲— 2021-MAY CONDITION BY DEP  
 —●— 2018-APR MONITORING BY DEP  
 —●— 2015-JAN POST-C BY CEC  
 - - - MHW CONTOUR (0.3 FT)

RANGE: R-232  
 EST DATE: APR2001  
 SURVEY DATE: 18JUN21  
 AZIMUTH: 242.0

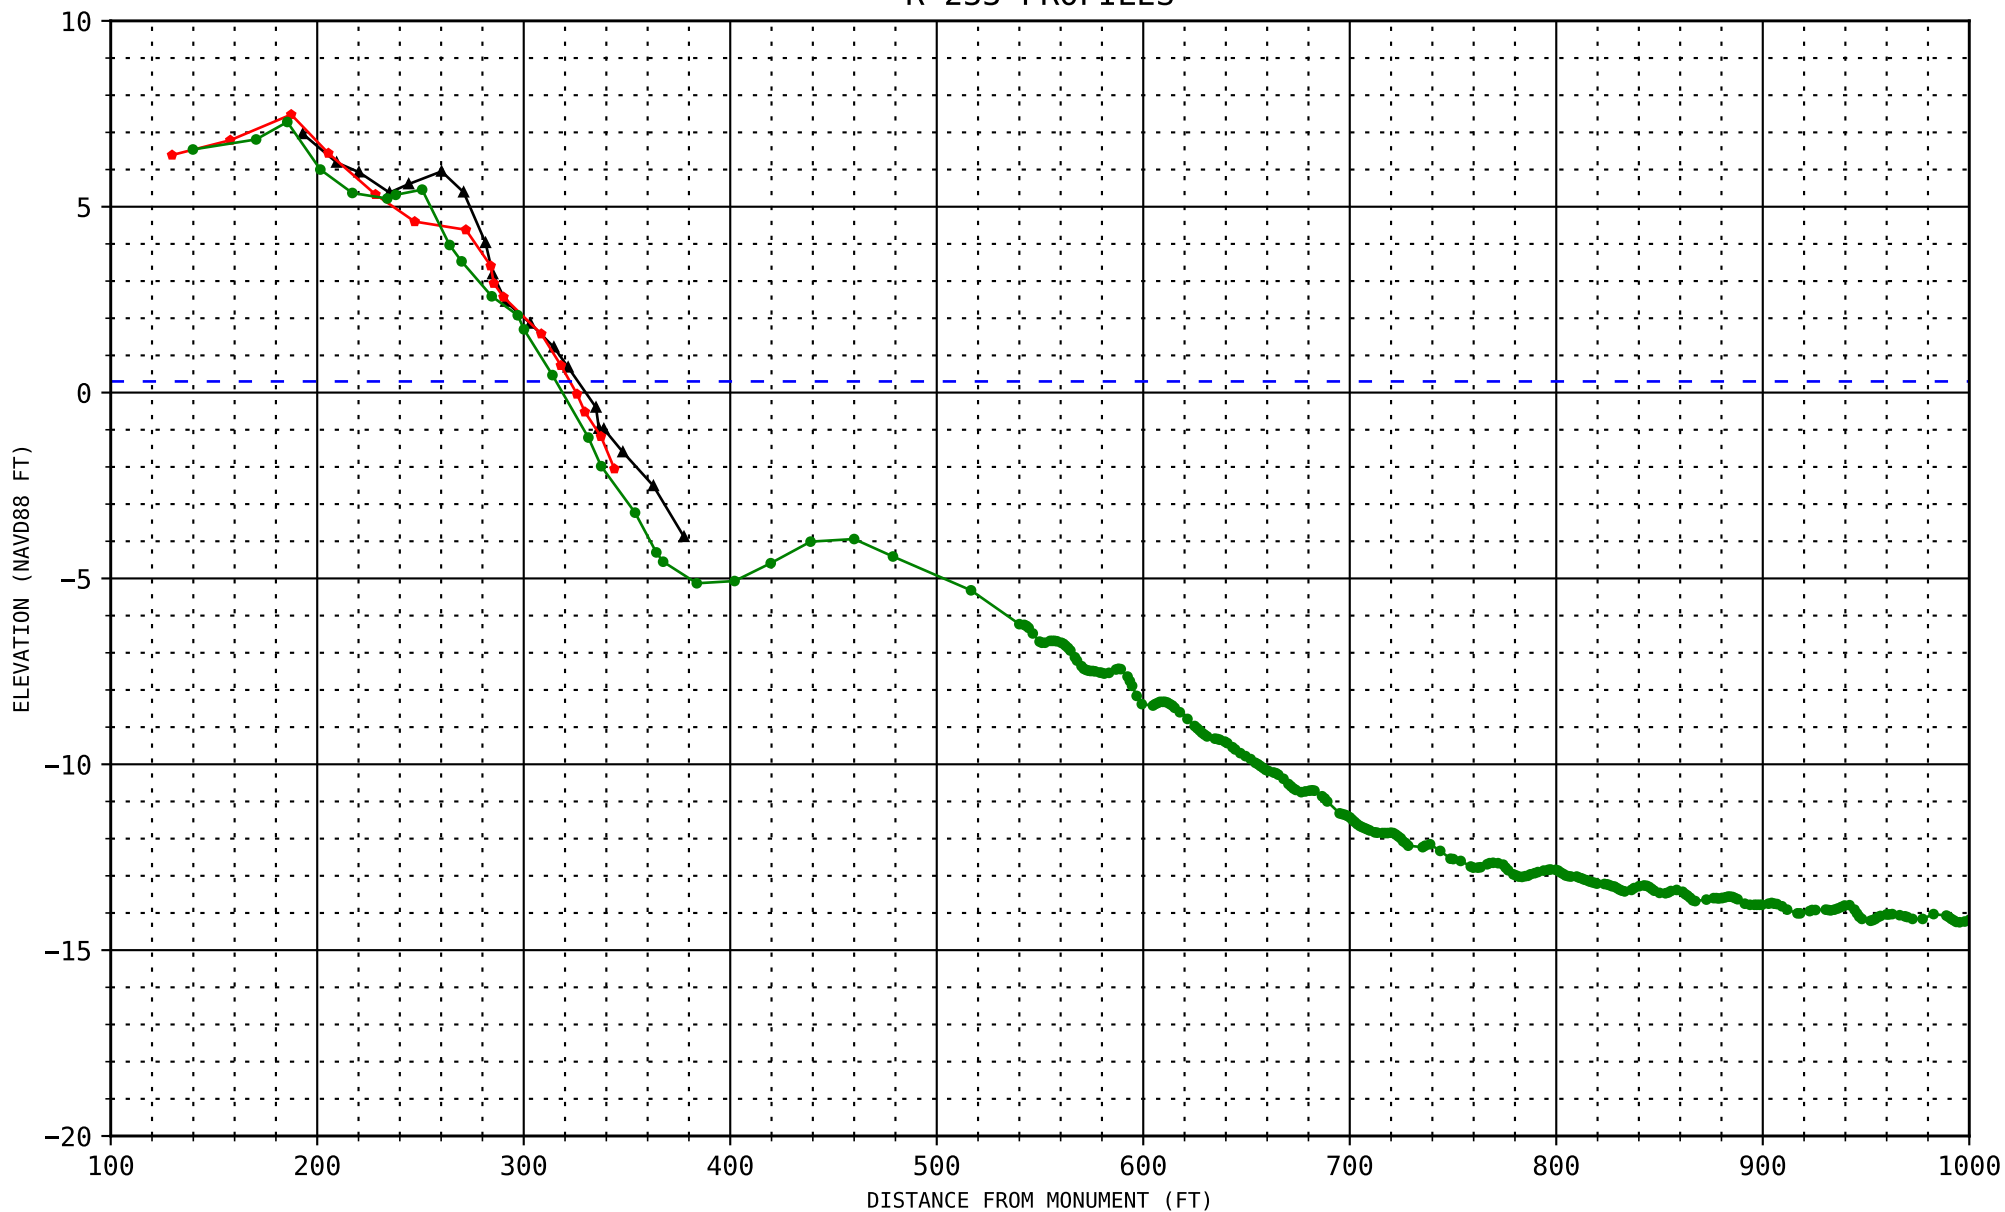
# R-233 PROFILES

—▲— 2021-MAY CONDITION BY DEP  
 —●— 2018-APR MONITORING BY DEP  
 —●— 2015-JAN POST-C BY CEC  
 - - - MHW CONTOUR (0.3 FT)

RANGE: R-233  
 EST DATE: JAN1982  
 SURVEY DATE: 18JUN21  
 AZIMUTH: 247.0

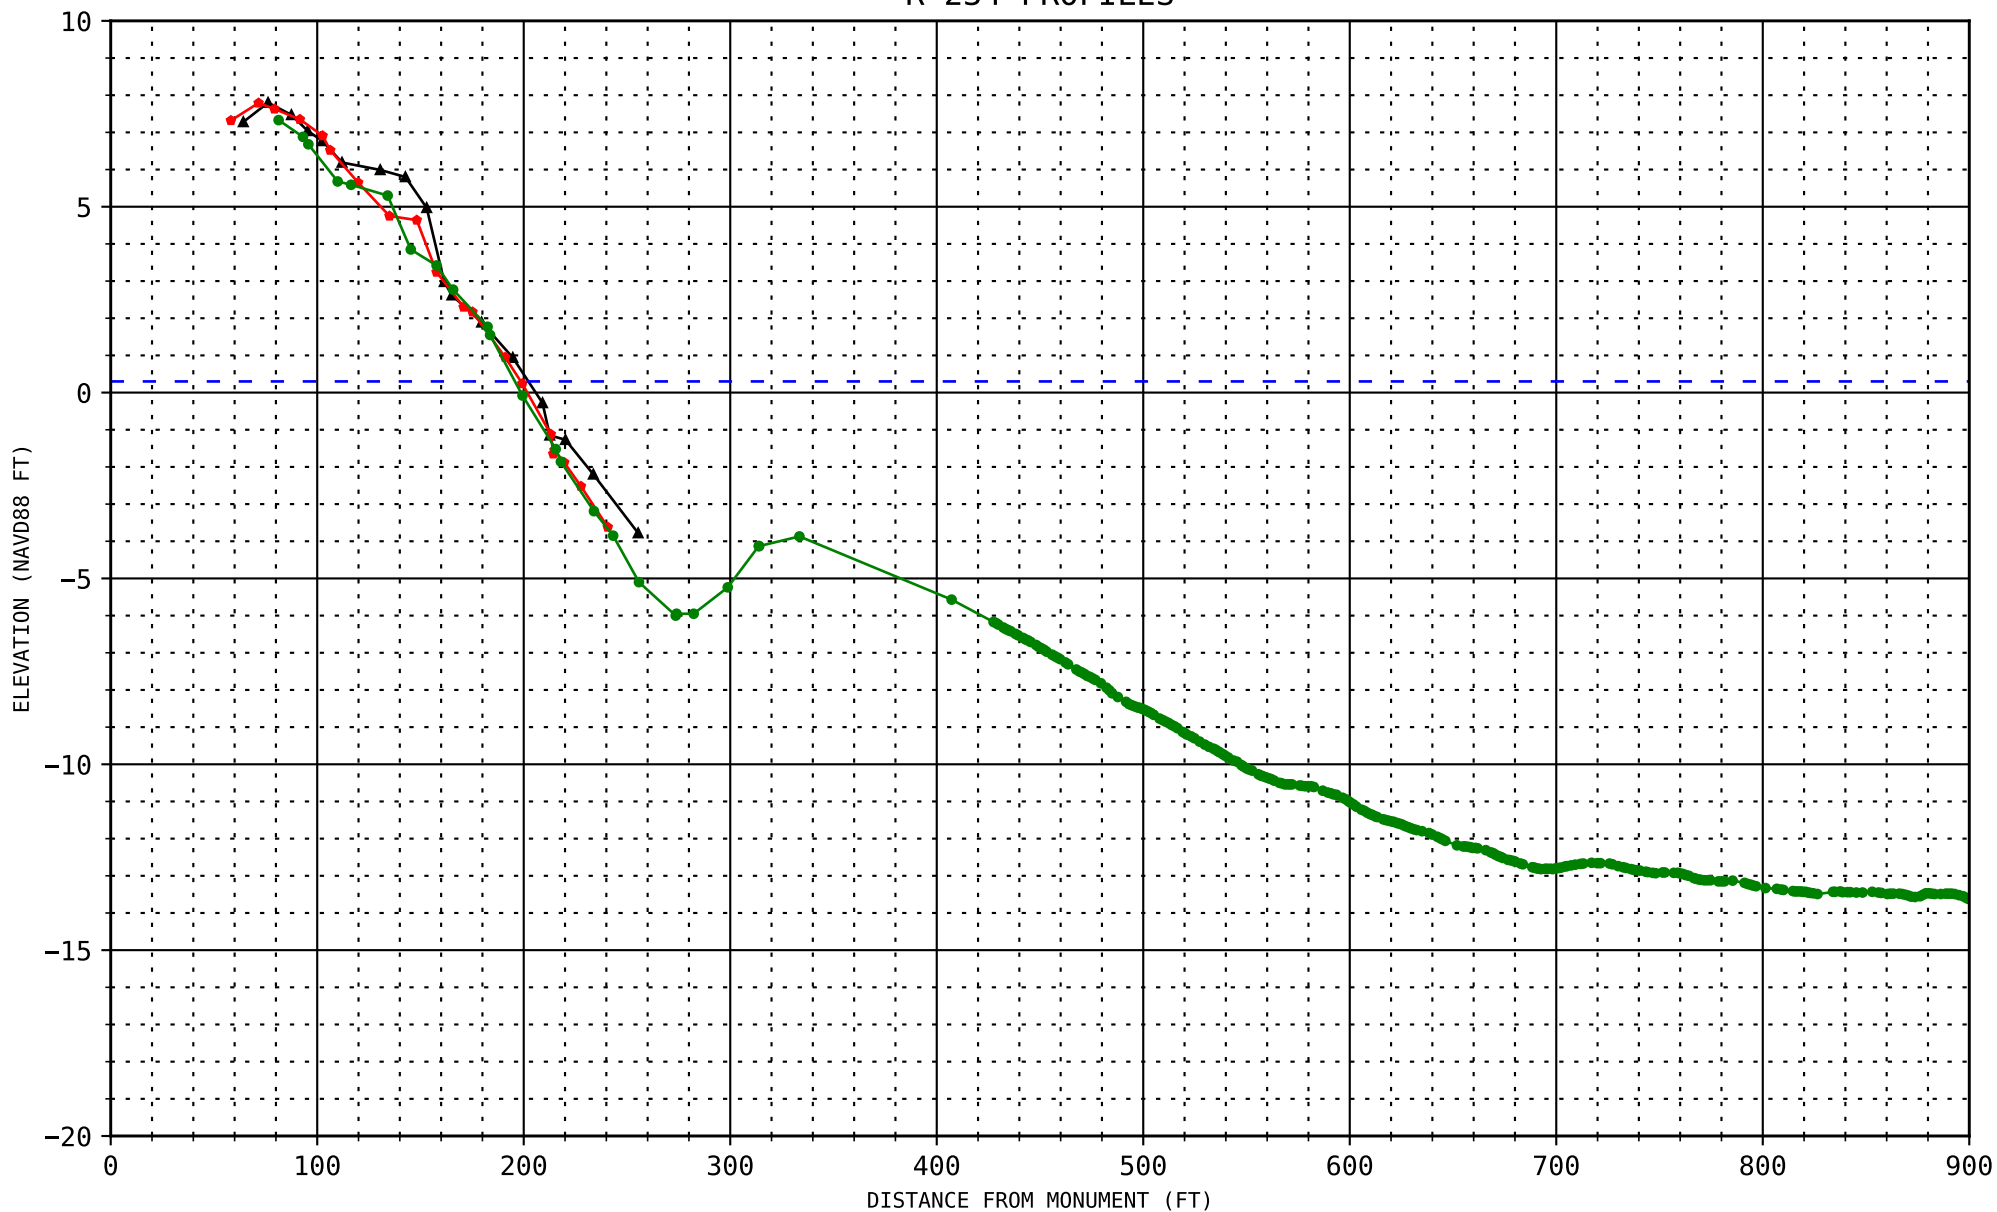
# R-234 PROFILES

- ▲— 2021-MAY CONDITION BY DEP
- 2018-APR MONITORING BY DEP
- 2015-JAN POST-C BY CEC
- - - MHW CONTOUR (0.3 FT)

RANGE: R-234  
EST DATE: AUG1988  
SURVEY DATE: 18JUN21  
AZIMUTH: 255.0

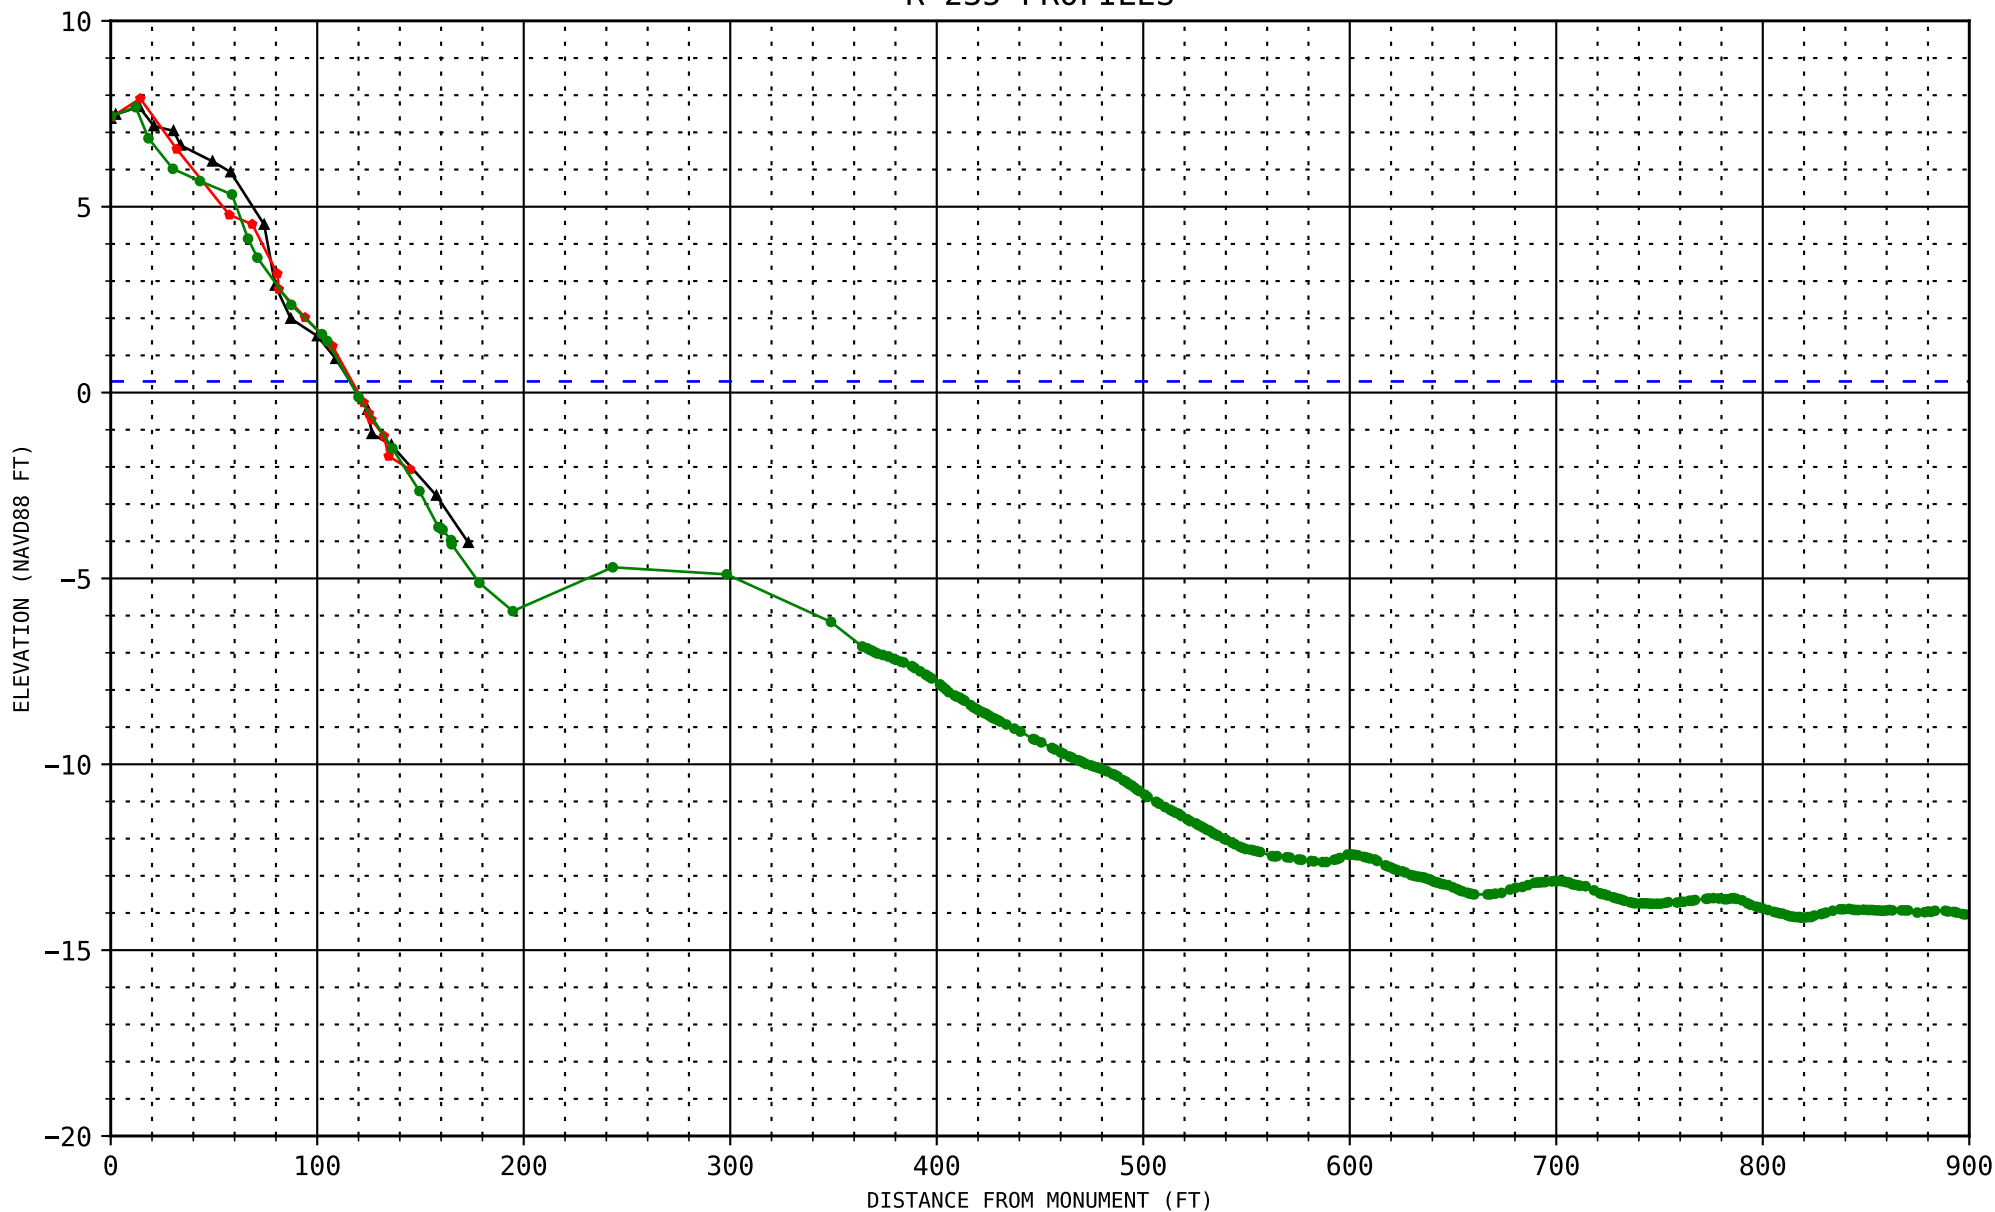
# R-235 PROFILES

- ▲— 2021-MAY CONDITION BY DEP
- 2018-APR MONITORING BY DEP
- 2015-JAN POST-C BY CEC
- - - MHW CONTOUR (0.3 FT)

RANGE: R-235  
 EST DATE: APR2001  
 SURVEY DATE: 18JUN21  
 AZIMUTH: 250.0

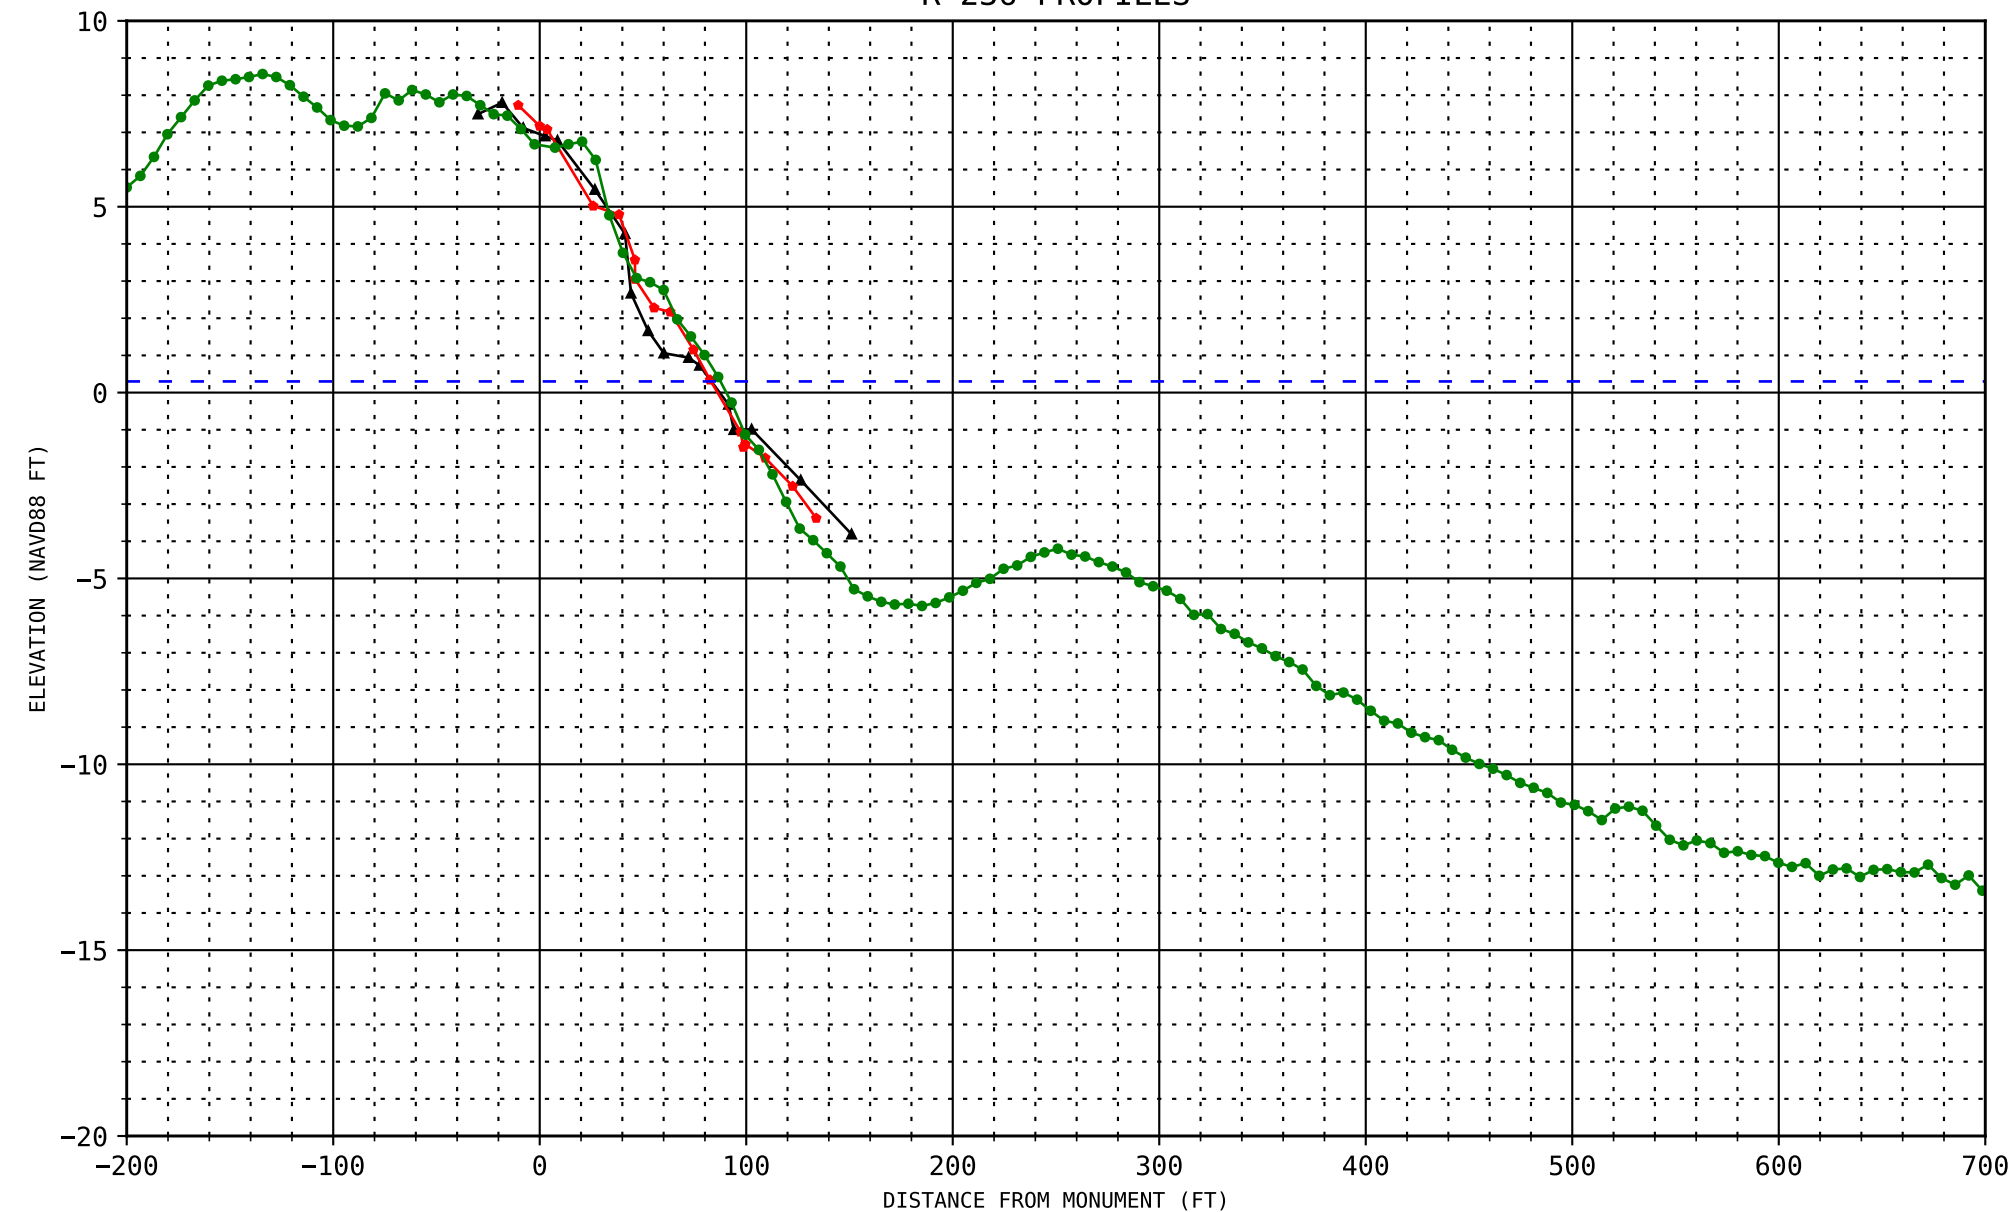
# R-236 PROFILES

▲ 2021-MAY CONDITION BY DEP  
 ● 2018-APR MONITORING BY DEP  
 ● 2015-JUN MONITORING BY USACE-LIDAR  
 - - - MHW CONTOUR (0.3 FT)

RANGE: R-236  
 EST DATE: APR2001  
 SURVEY DATE: 18JUN21  
 AZIMUTH: 255.0

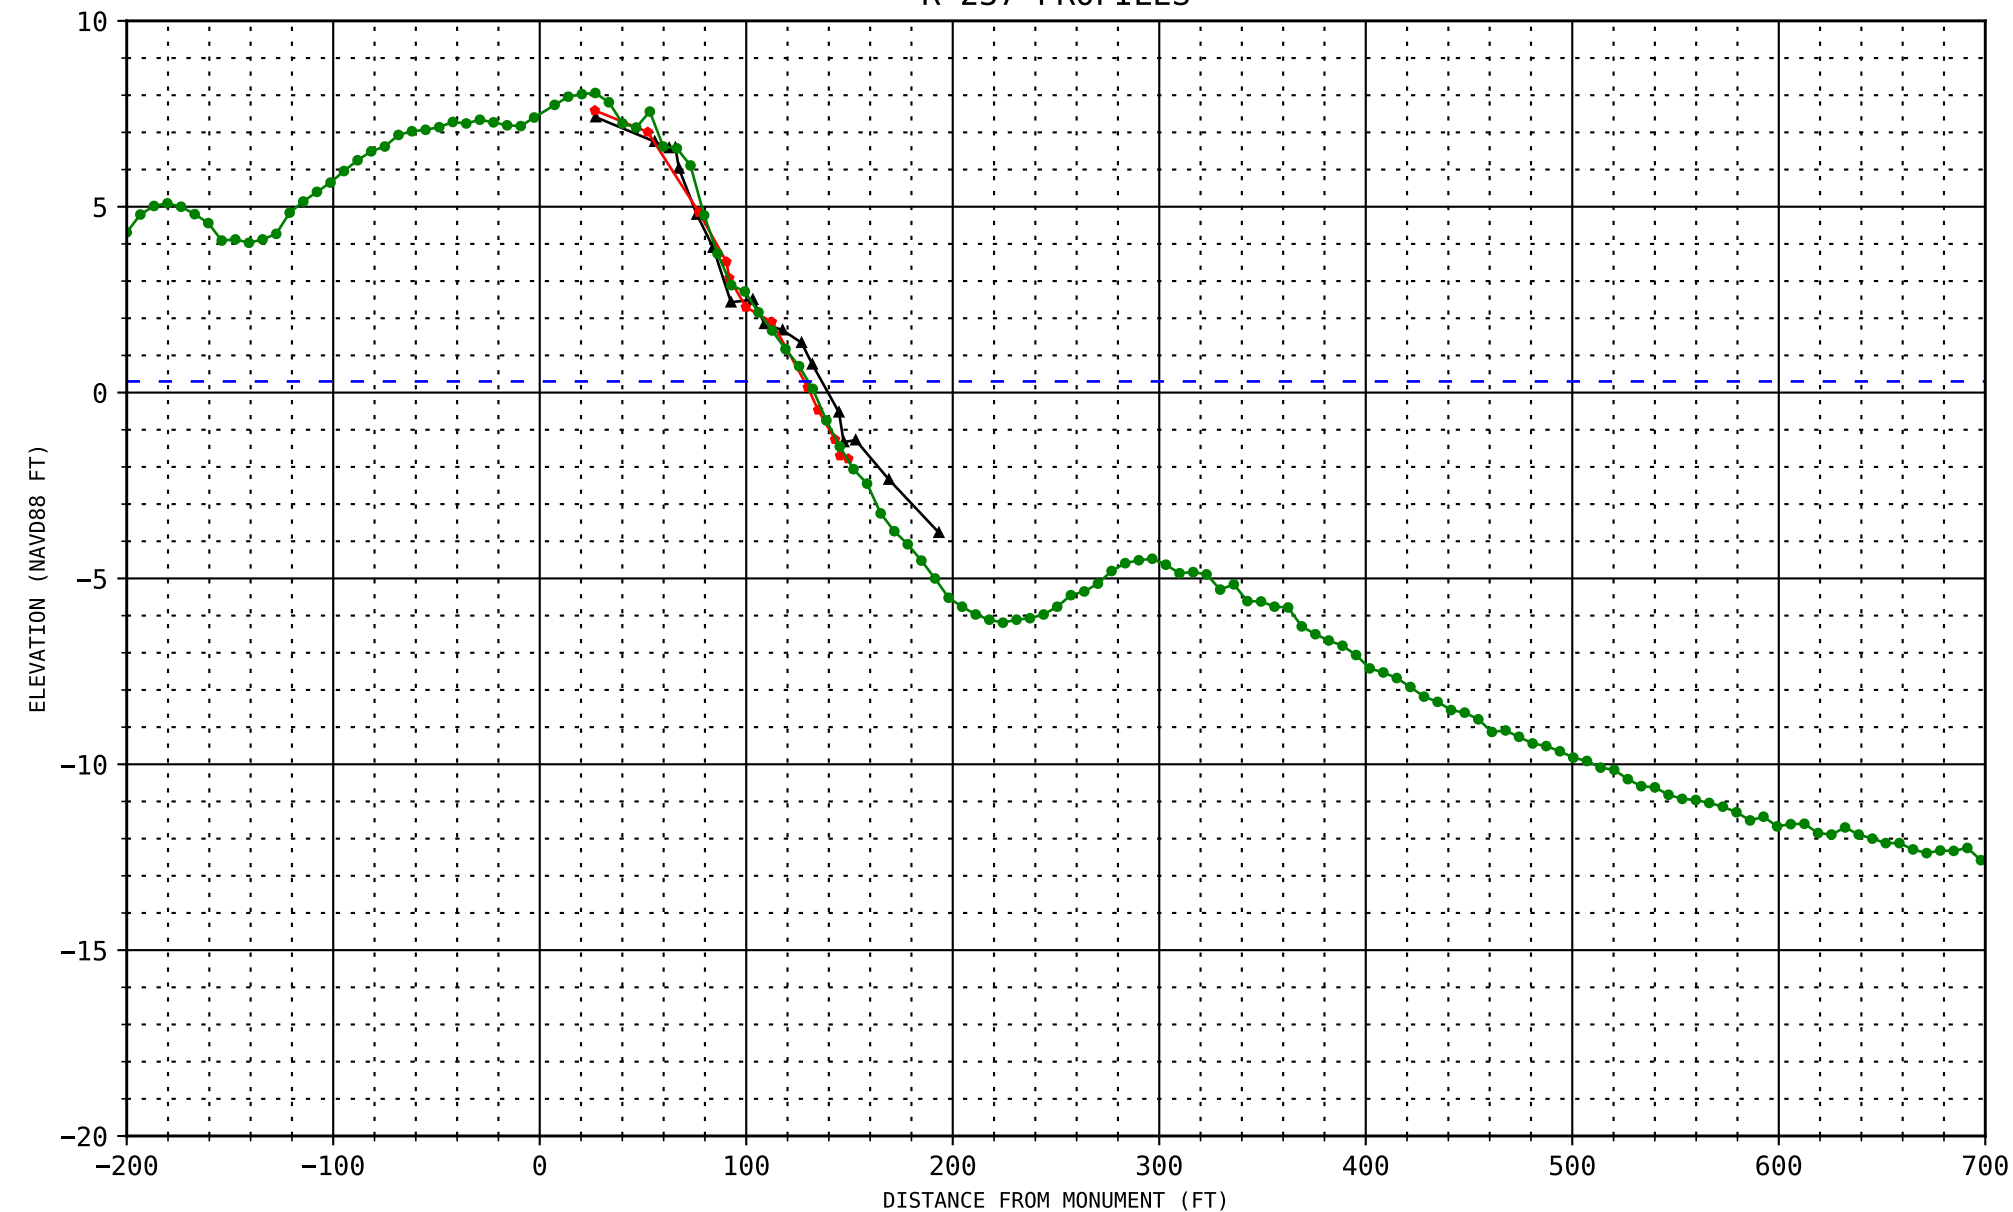
# R-237 PROFILES

▲ 2021-MAY CONDITION BY DEP  
 ● 2018-APR MONITORING BY DEP  
 ● 2015-JUN MONITORING BY USACE-LIDAR  
 - - - MHW CONTOUR (0.3 FT)

RANGE: R-237  
 EST DATE: JAN1974  
 SURVEY DATE: 18JUN21  
 AZIMUTH: 247.0

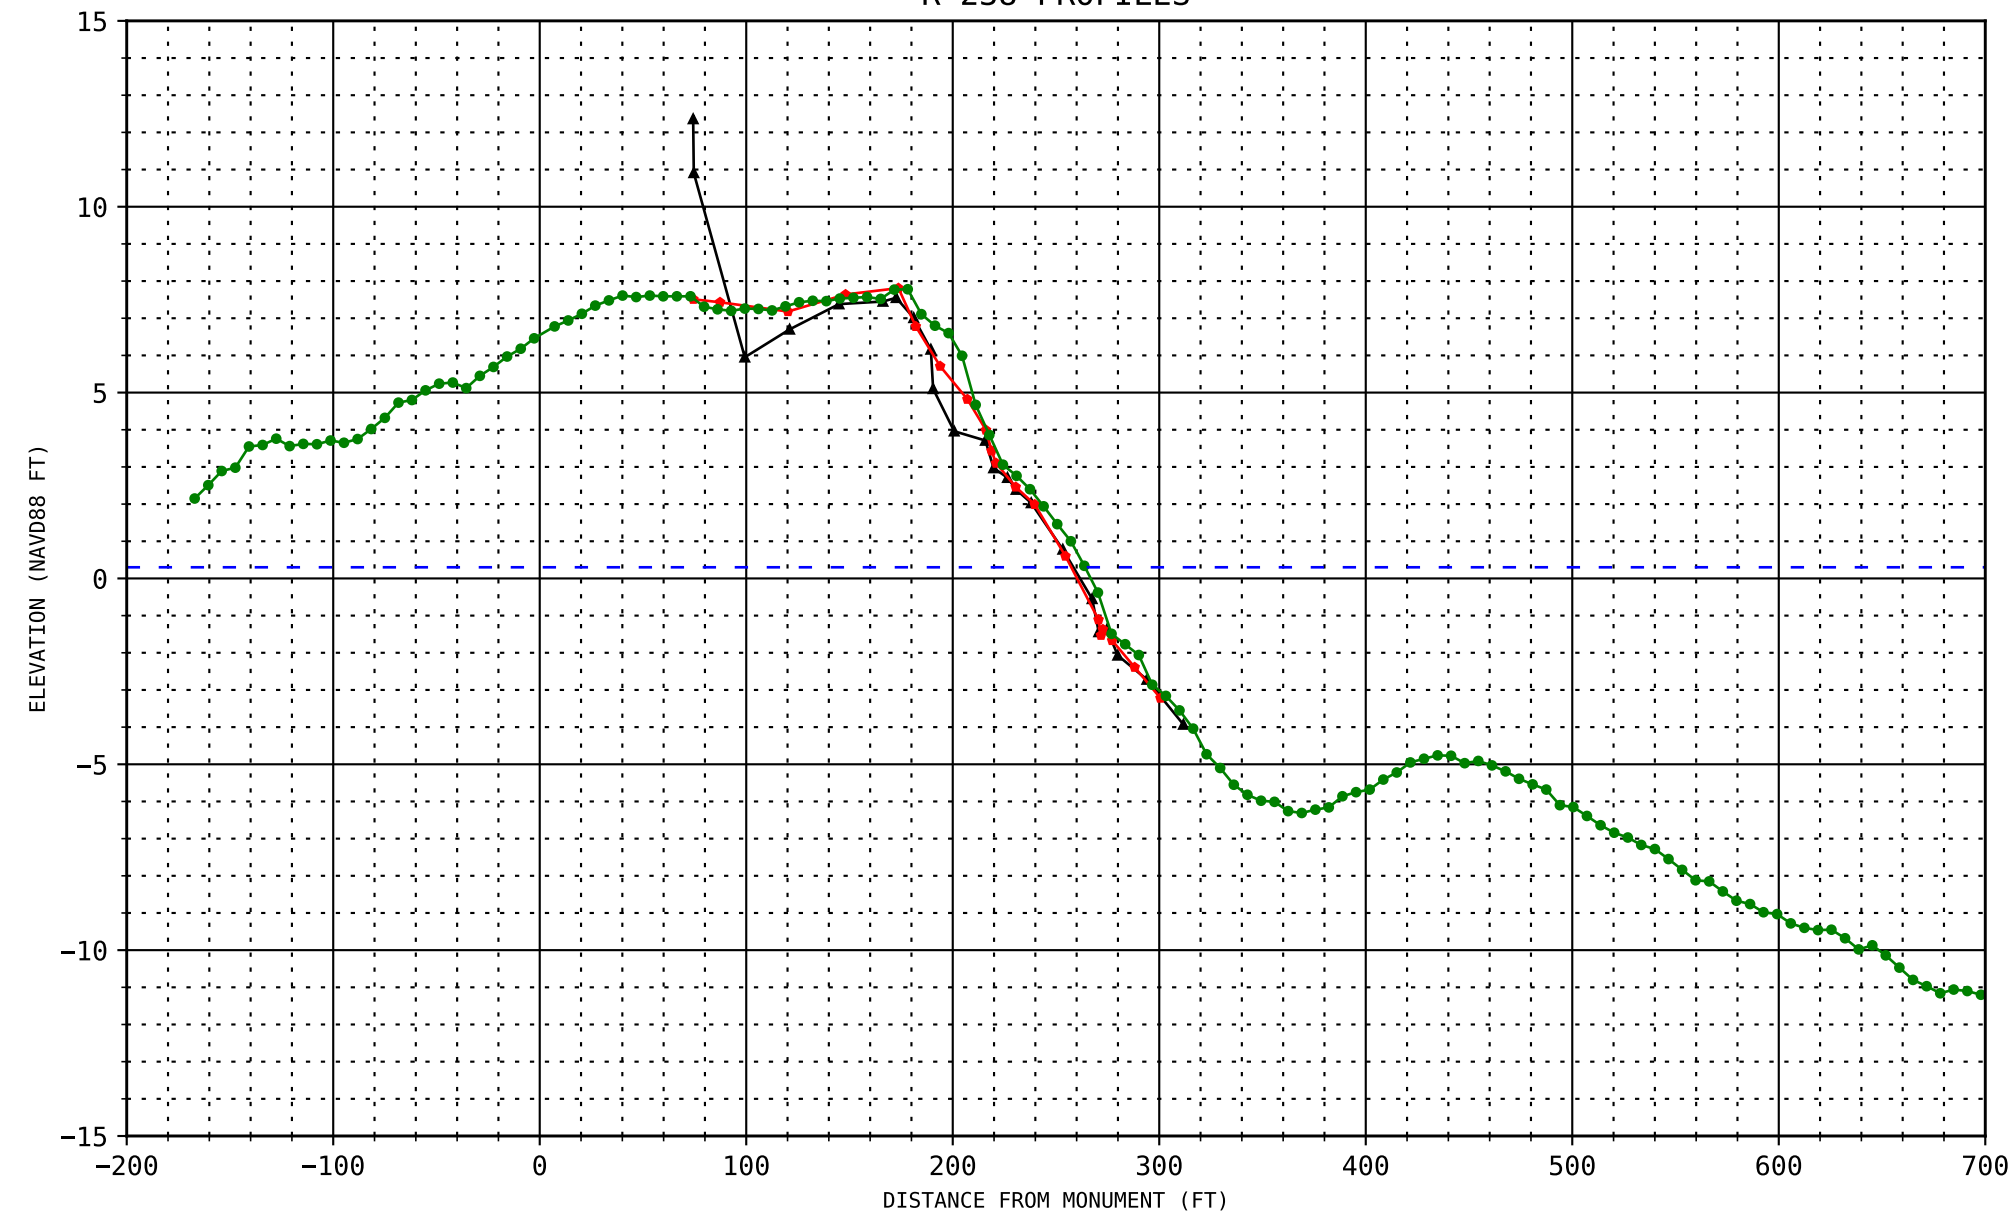
# R-238 PROFILES

▲ 2021-MAY CONDITION BY DEP  
 ● 2018-APR MONITORING BY DEP  
 ● 2015-JUN MONITORING BY USACE-LIDAR  
 - - - MHW CONTOUR (0.3 FT)

RANGE: R-238  
 EST DATE: JAN1982  
 SURVEY DATE: 18JUN21  
 AZIMUTH: 250.0
