# R-230 PROFILES

LEE  
 COASTAL ENGINEERING AND GEOLOGY PROGRAM  
 OFFICE OF RESILIENCE AND COASTAL PROTECTION  
 FLORIDA DEPARTMENT OF ENVIRONMENTAL PROTECTION

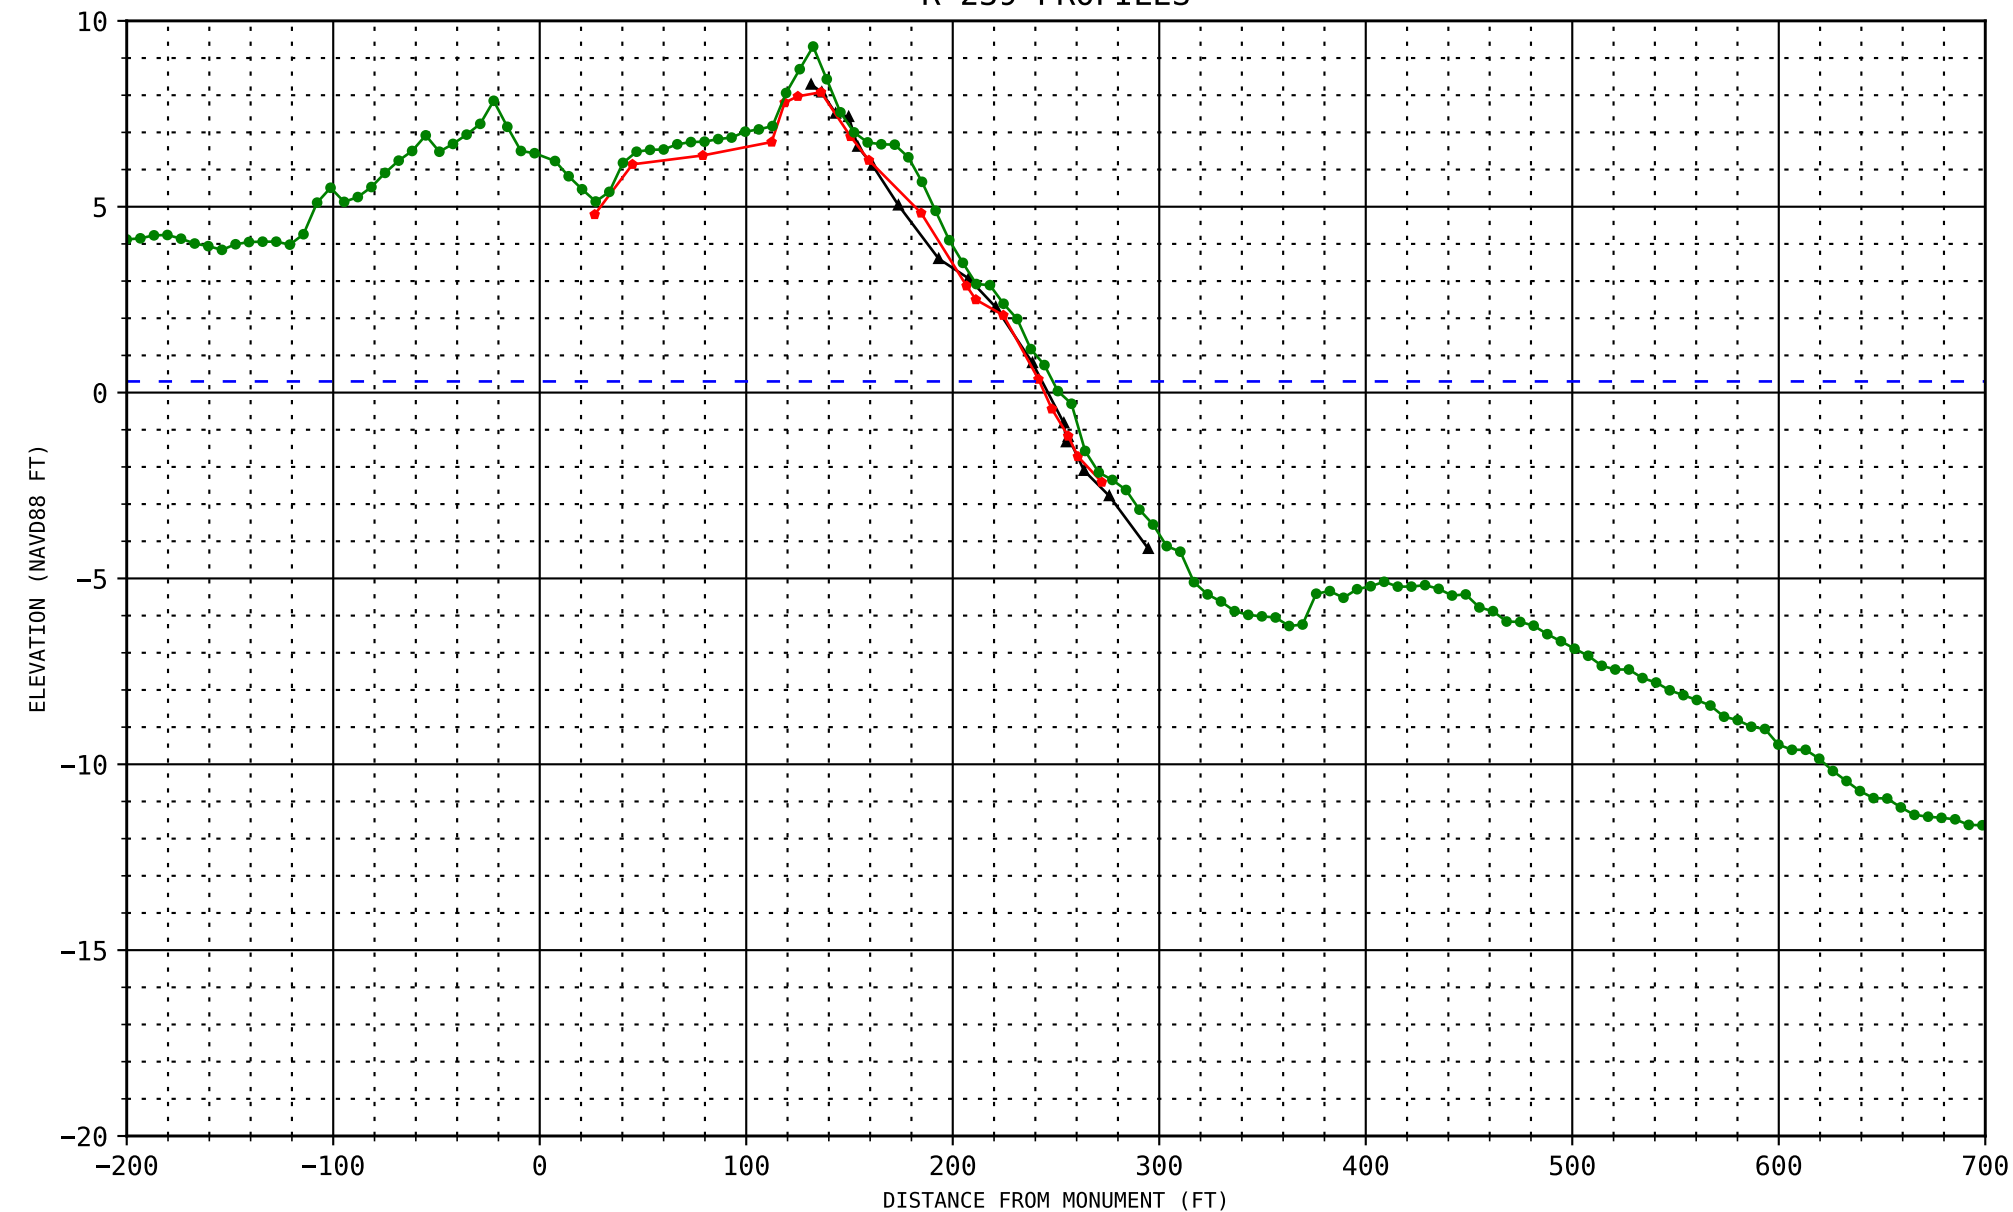
# R-239 PROFILES

▲ 2021-MAY CONDITION BY DEP  
 ● 2018-APR MONITORING BY DEP  
 ● 2015-JUN MONITORING BY USACE-LIDAR  
 - - - MHW CONTOUR (0.3 FT)

RANGE: R-239  
 EST DATE: JAN1982  
 SURVEY DATE: 18JUN21  
 AZIMUTH: 255.0
