T-1 PROFILES

| ● 2017-JUL MONITORING BY HSS | PROGRAM SUPPORT GIS | EST DATE: MECM |
| ● 2014-JUN CONDITION BY ARC | DIVISION OF WATER RESOURCE MANAGEMENT | SURVEY DATE: 27JUN19 |

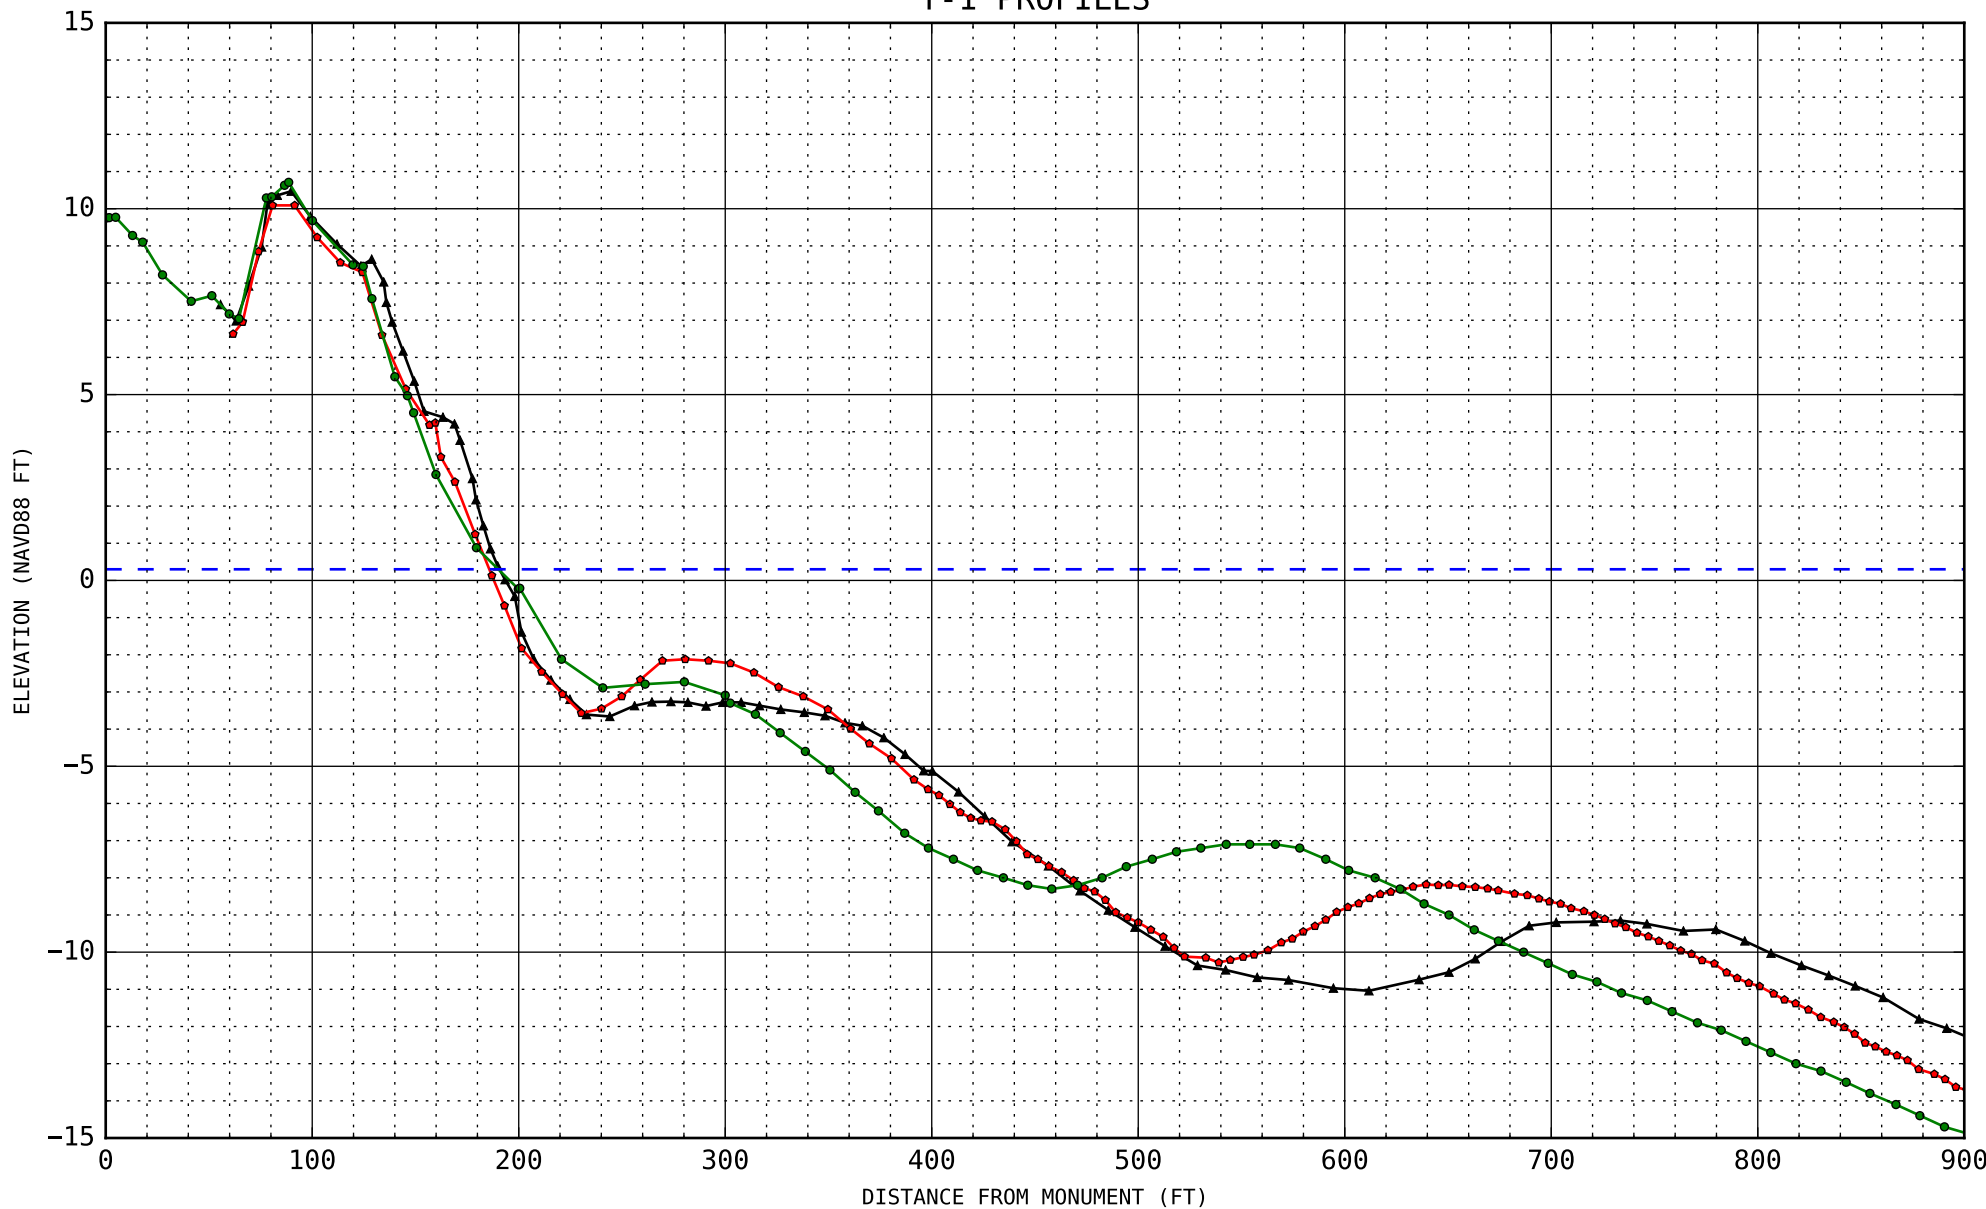
| ▲ 2019-JUN MONITORING BY HSS | SARASOTA | RANGE: T-1 |
| - - - MHW CONTOUR (0.3 FT) | FLORIDA DEPARTMENT OF ENVIRONMENTAL PROTECTION | AZIMUTH: 240.0 |

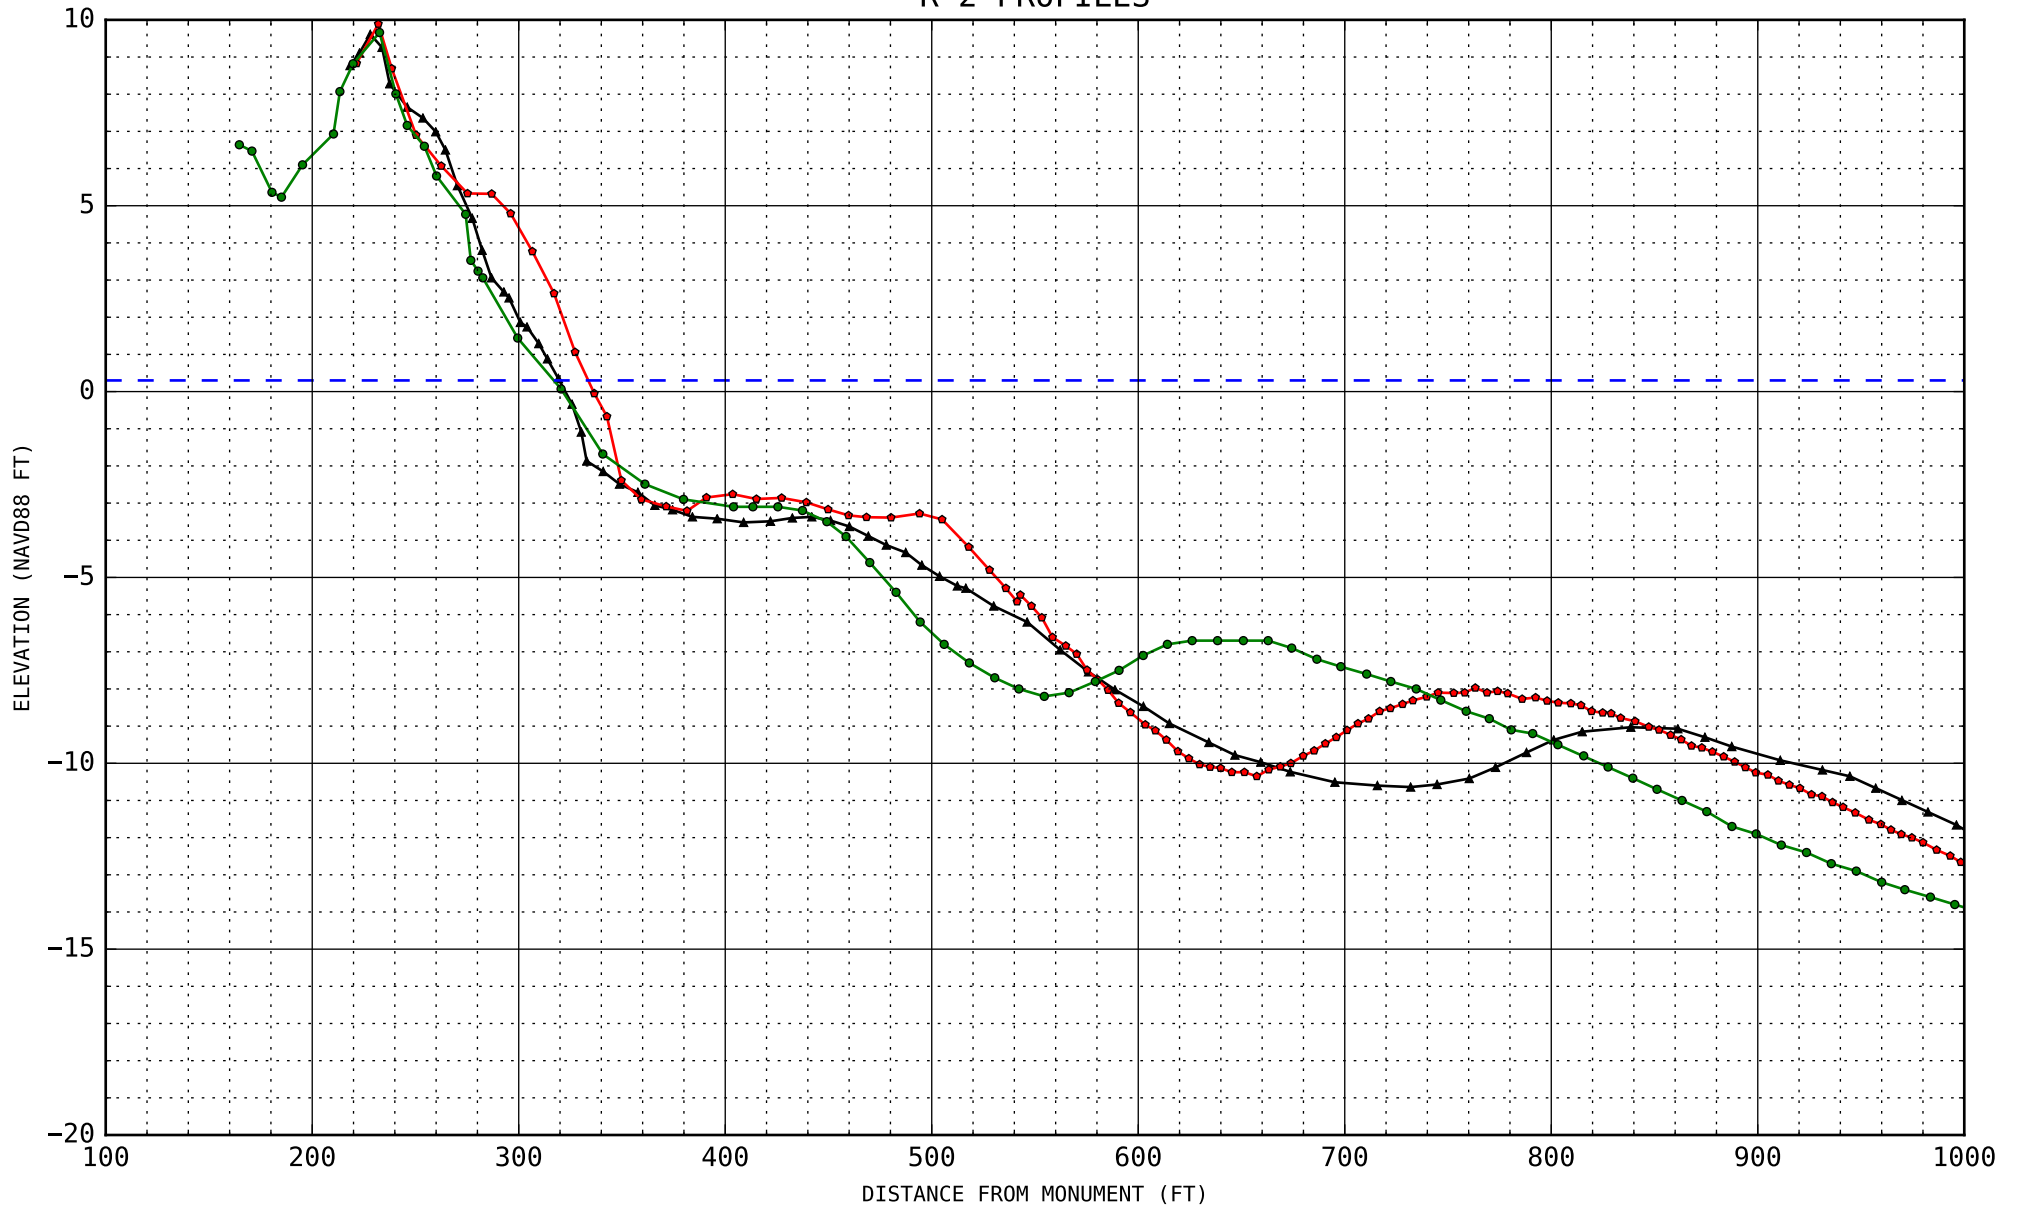
# R-2 PROFILES

▲—▲ 2019-JUN MONITORING BY HSS  
 ●—● 2017-JUL MONITORING BY HSS  
 ●—● 2014-JUN CONDITION BY ARC  
 - - - MHW CONTOUR (0.3 FT)

RANGE: R-2  
 EST DATE: DNR1986  
 SURVEY DATE: 27JUN19  
 AZIMUTH: 240.0

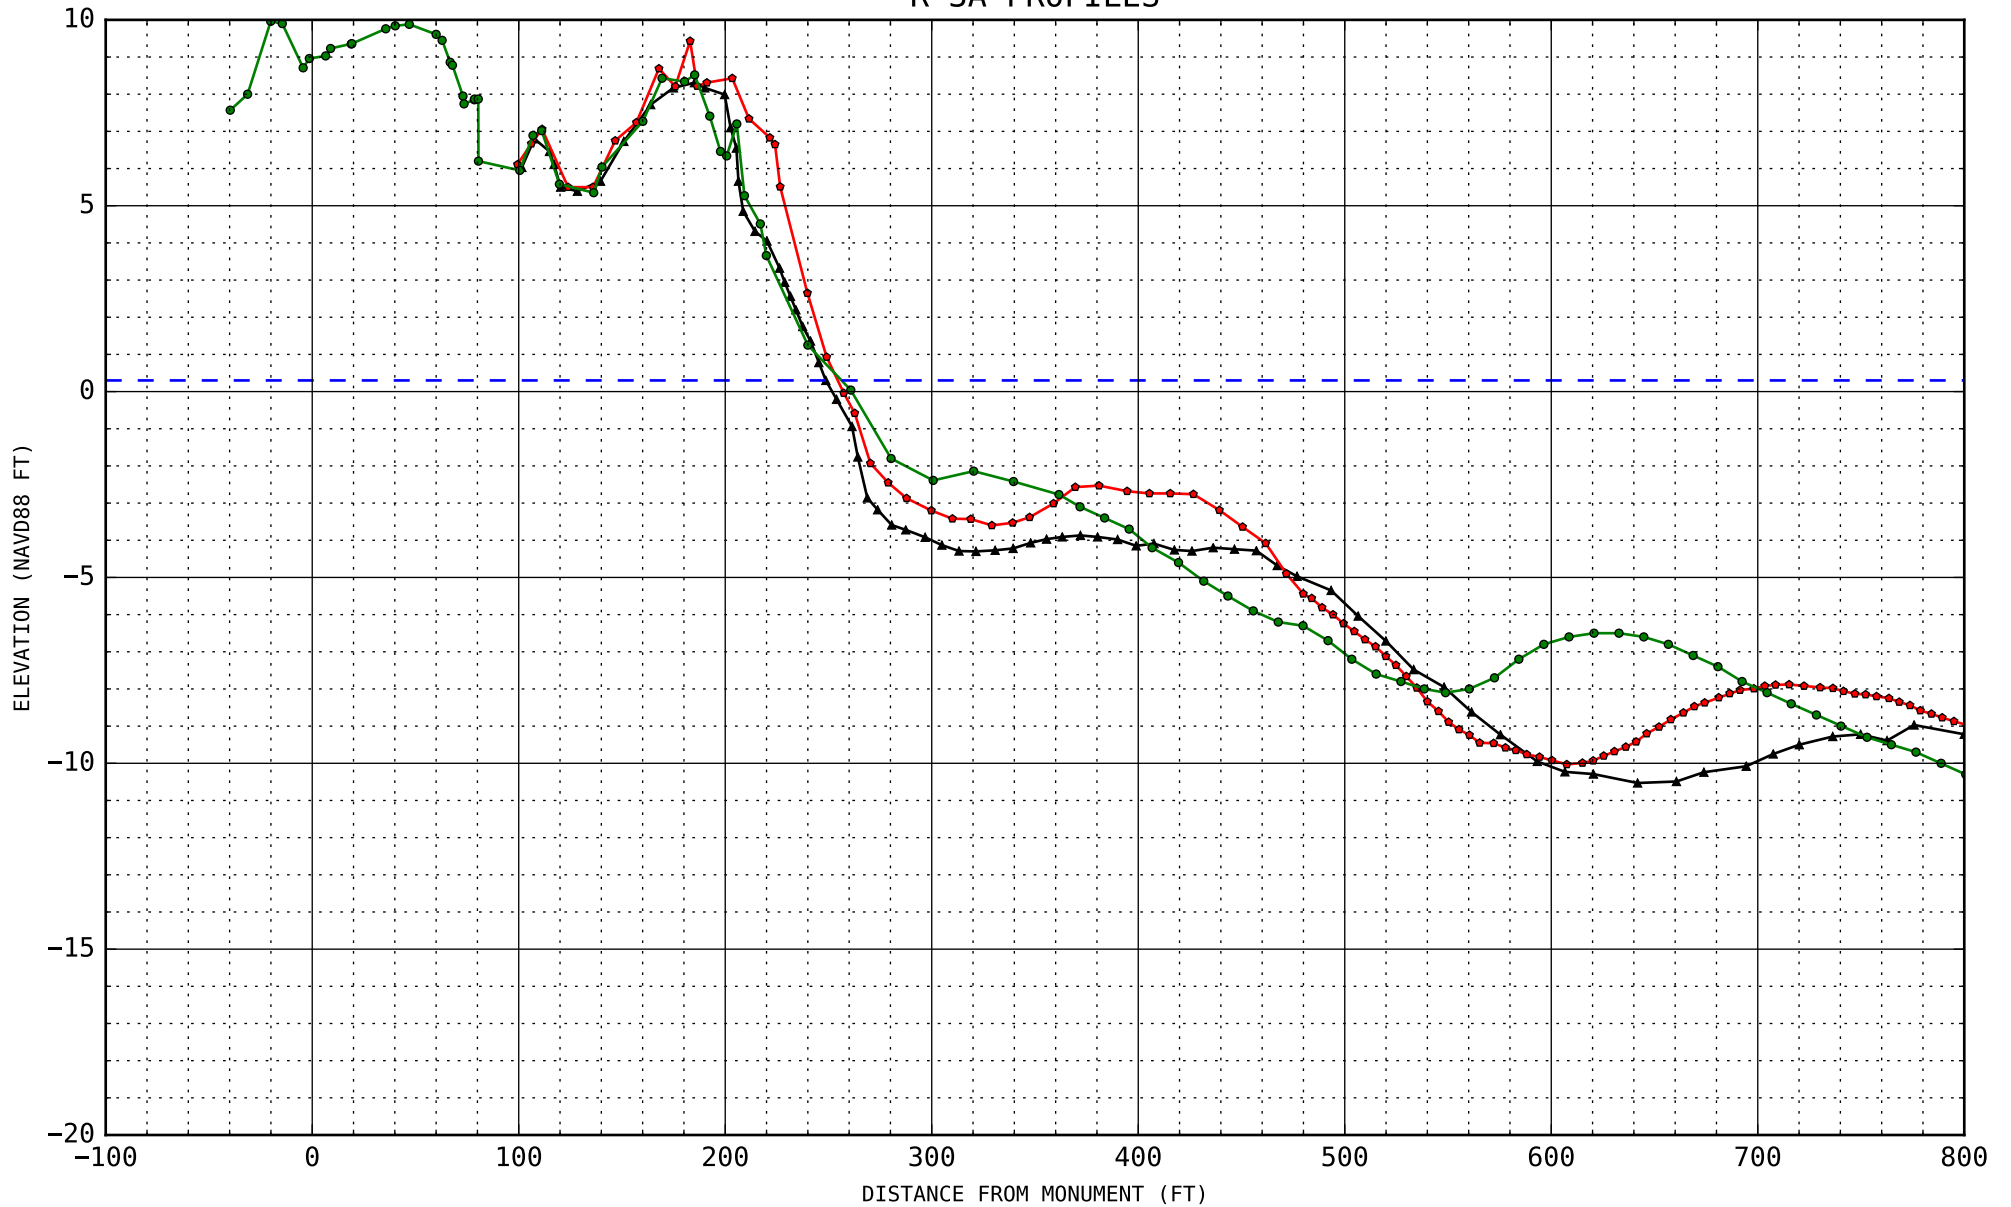
# R-3A PROFILES

▲ 2019-JUN MONITORING BY HSS  
 ● 2017-JUL MONITORING BY HSS  
 ● 2014-JUN CONDITION BY ARC  
 - - - MHW CONTOUR (0.3 FT)

RANGE: R-3A  
 EST DATE: JAN1985  
 SURVEY DATE: 27JUN19  
 AZIMUTH: 240.0

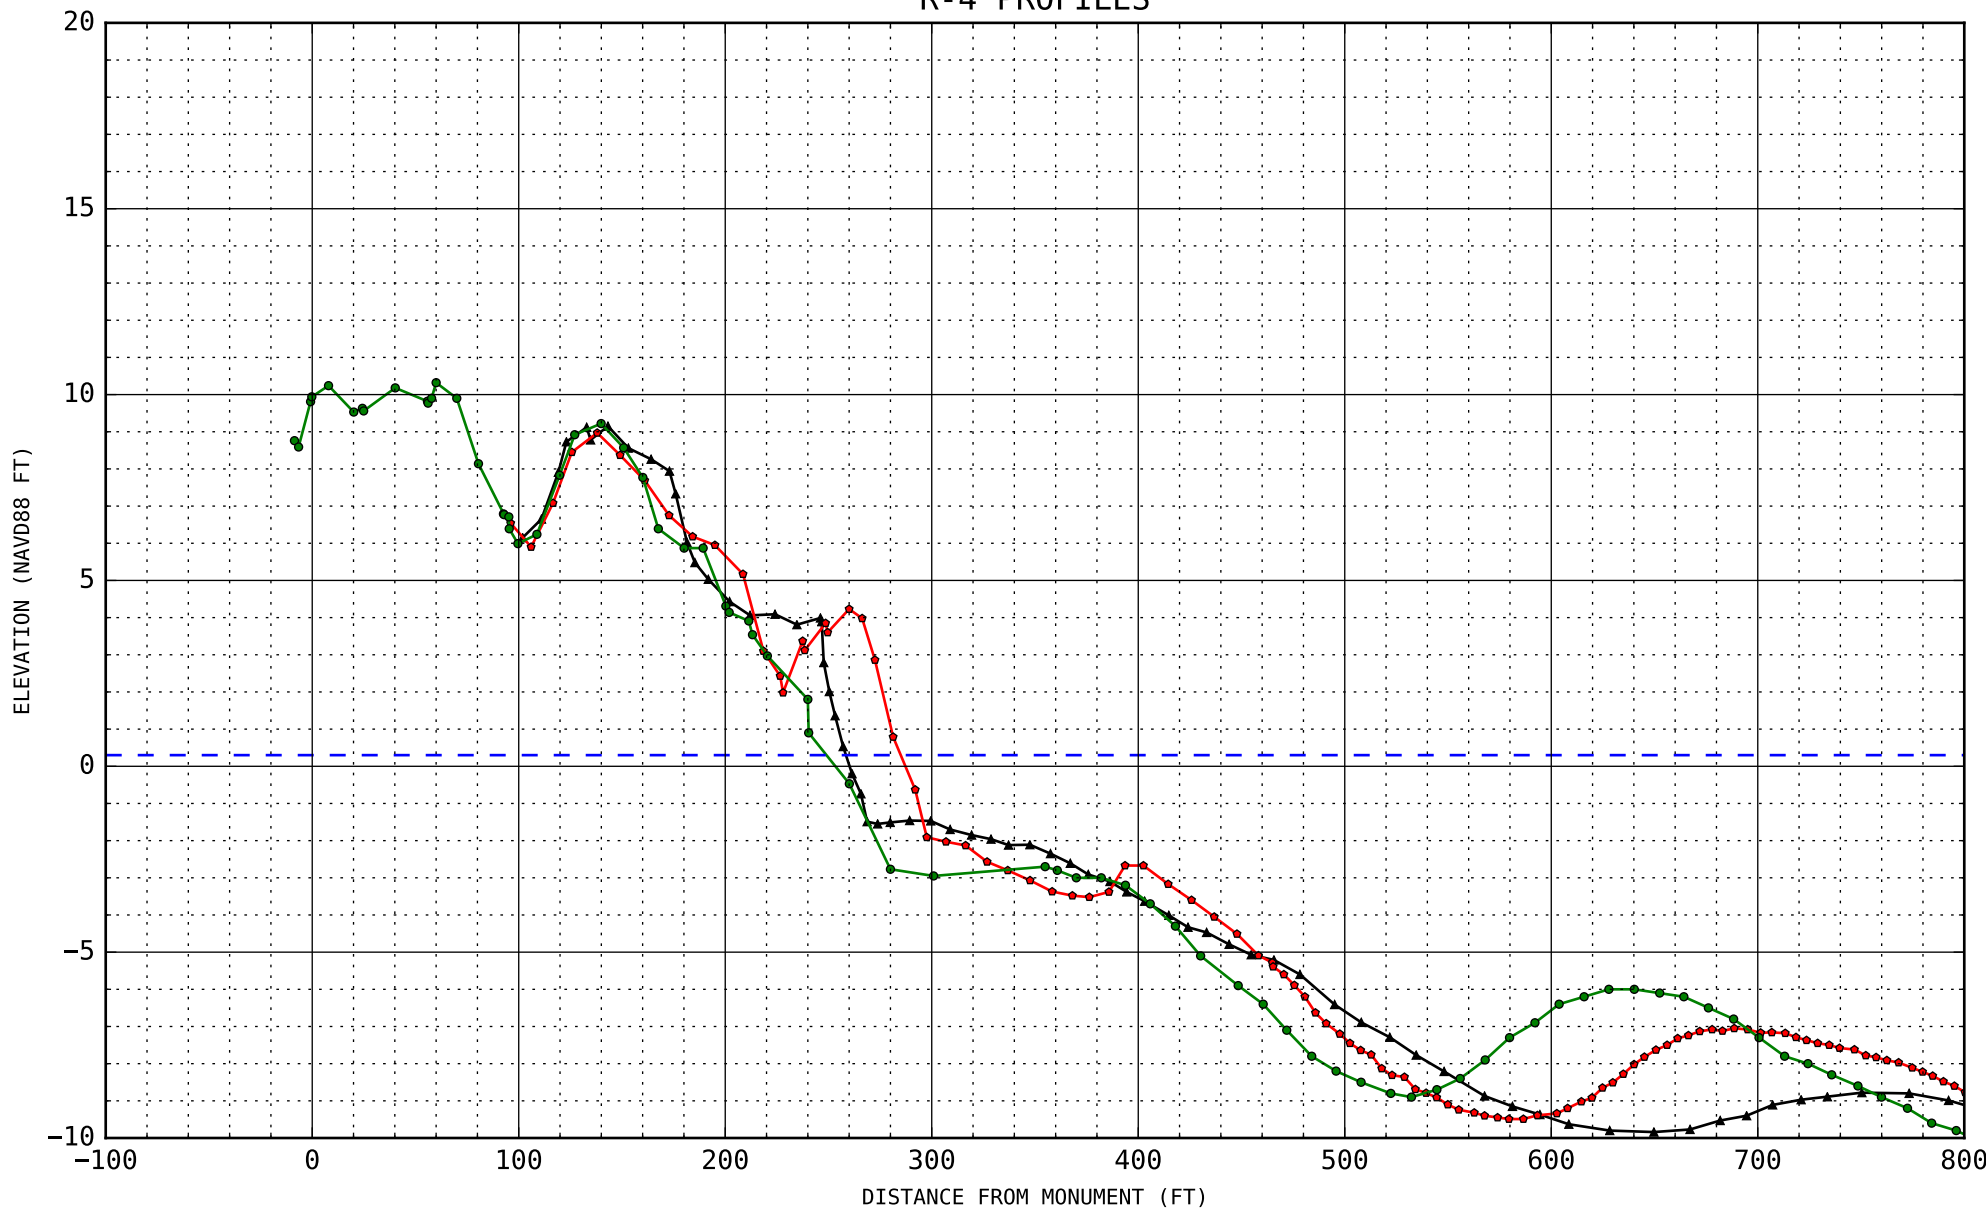
R-4 PROFILES

| ▲ | 2019-JUN MONITORING BY HSS | SARASOTA<br>PROGRAM SUPPORT GIS<br>DIVISION OF WATER RESOURCE MANAGEMENT<br>FLORIDA DEPARTMENT OF ENVIRONMENTAL PROTECTION | RANGE: | R-4 |
| ● | 2017-JUL MONITORING BY HSS | | EST DATE: | APR1987 |
| ● | 2014-JUN CONDITION BY ARC | | SURVEY DATE: | 27JUN19 |
| - - - | MHW CONTOUR (0.3 FT) | | AZIMUTH: | 240.0 |

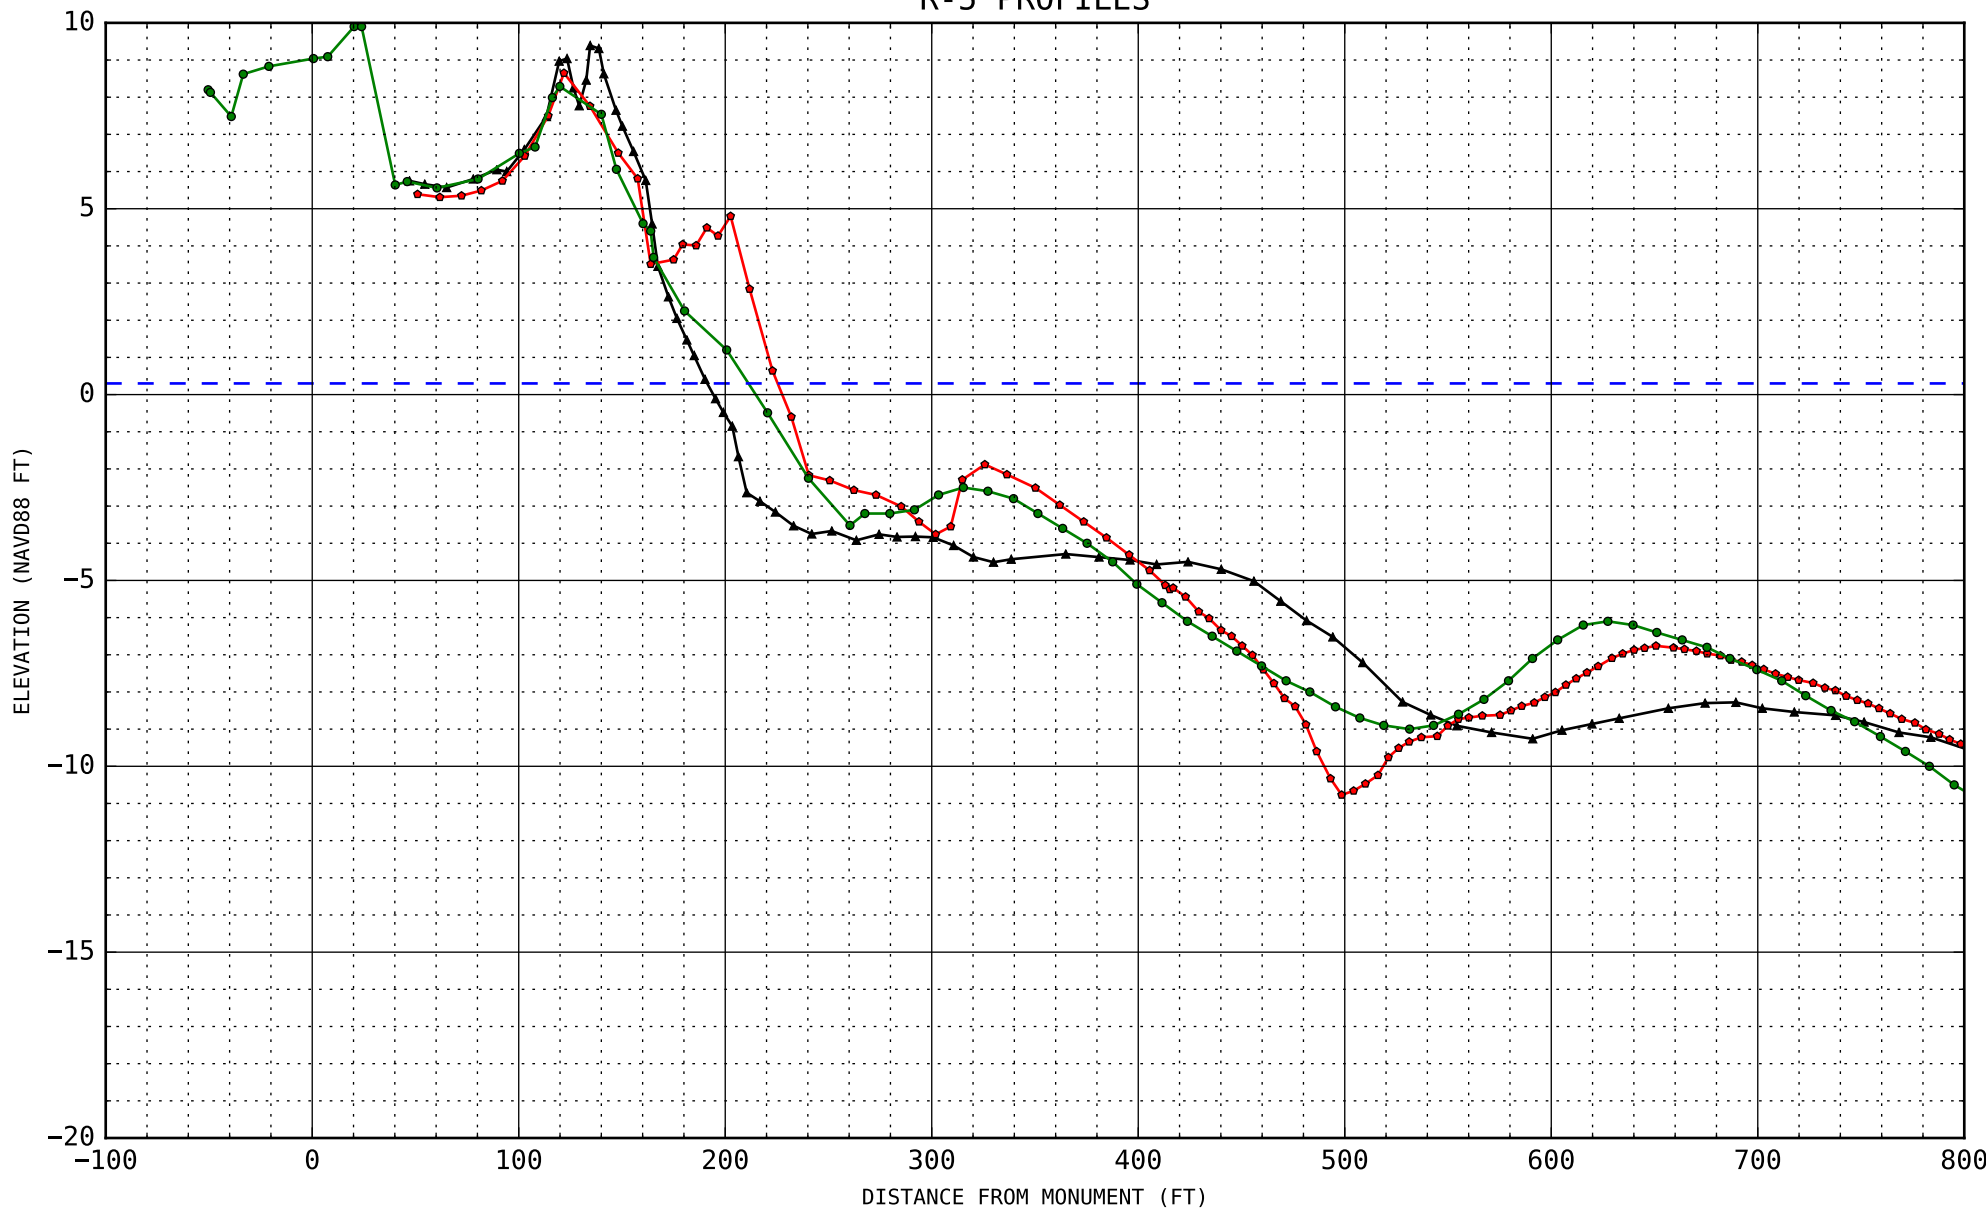
R-5 PROFILES

| ▲ 2019-JUN MONITORING BY HSS | SARASOTA | RANGE: R-5 |
| ● 2017-JUL MONITORING BY HSS | PROGRAM SUPPORT GIS | EST DATE: MECM |
| ● 2014-JUN CONDITION BY ARC | DIVISION OF WATER RESOURCE MANAGEMENT | SURVEY DATE: 27JUN19 |
| - - - MHW CONTOUR (0.3 FT) | FLORIDA DEPARTMENT OF ENVIRONMENTAL PROTECTION | AZIMUTH: 240.0 |

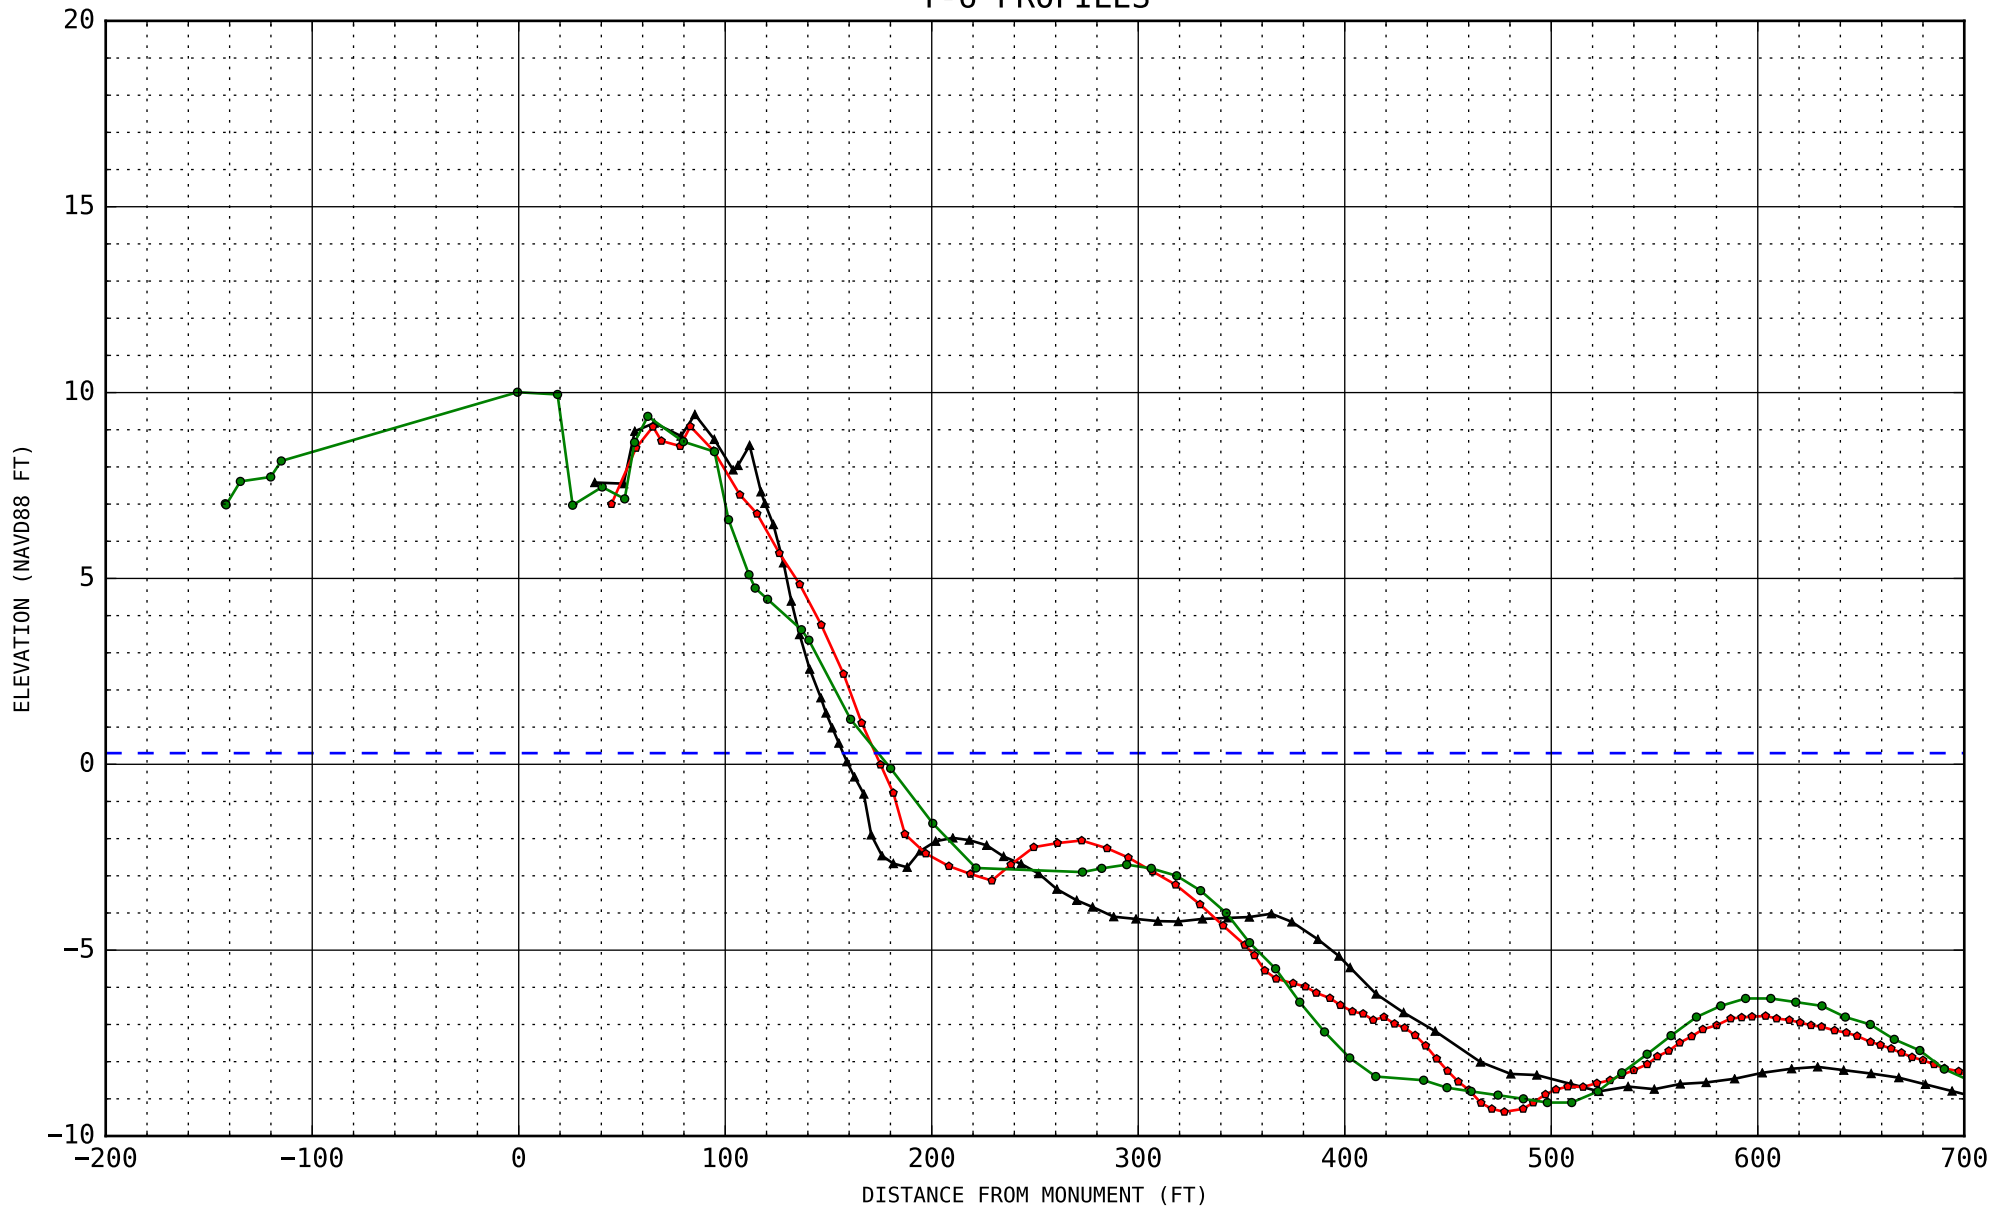
# T-6 PROFILES

- ▲ 2019-JUN MONITORING BY HSS
- 2017-JUL MONITORING BY HSS
- 2014-JUN CONDITION BY ARC
- - - MHW CONTOUR (0.3 FT)

RANGE: T-6  
 EST DATE: MECM  
 SURVEY DATE: 27JUN19  
 AZIMUTH: 240.0

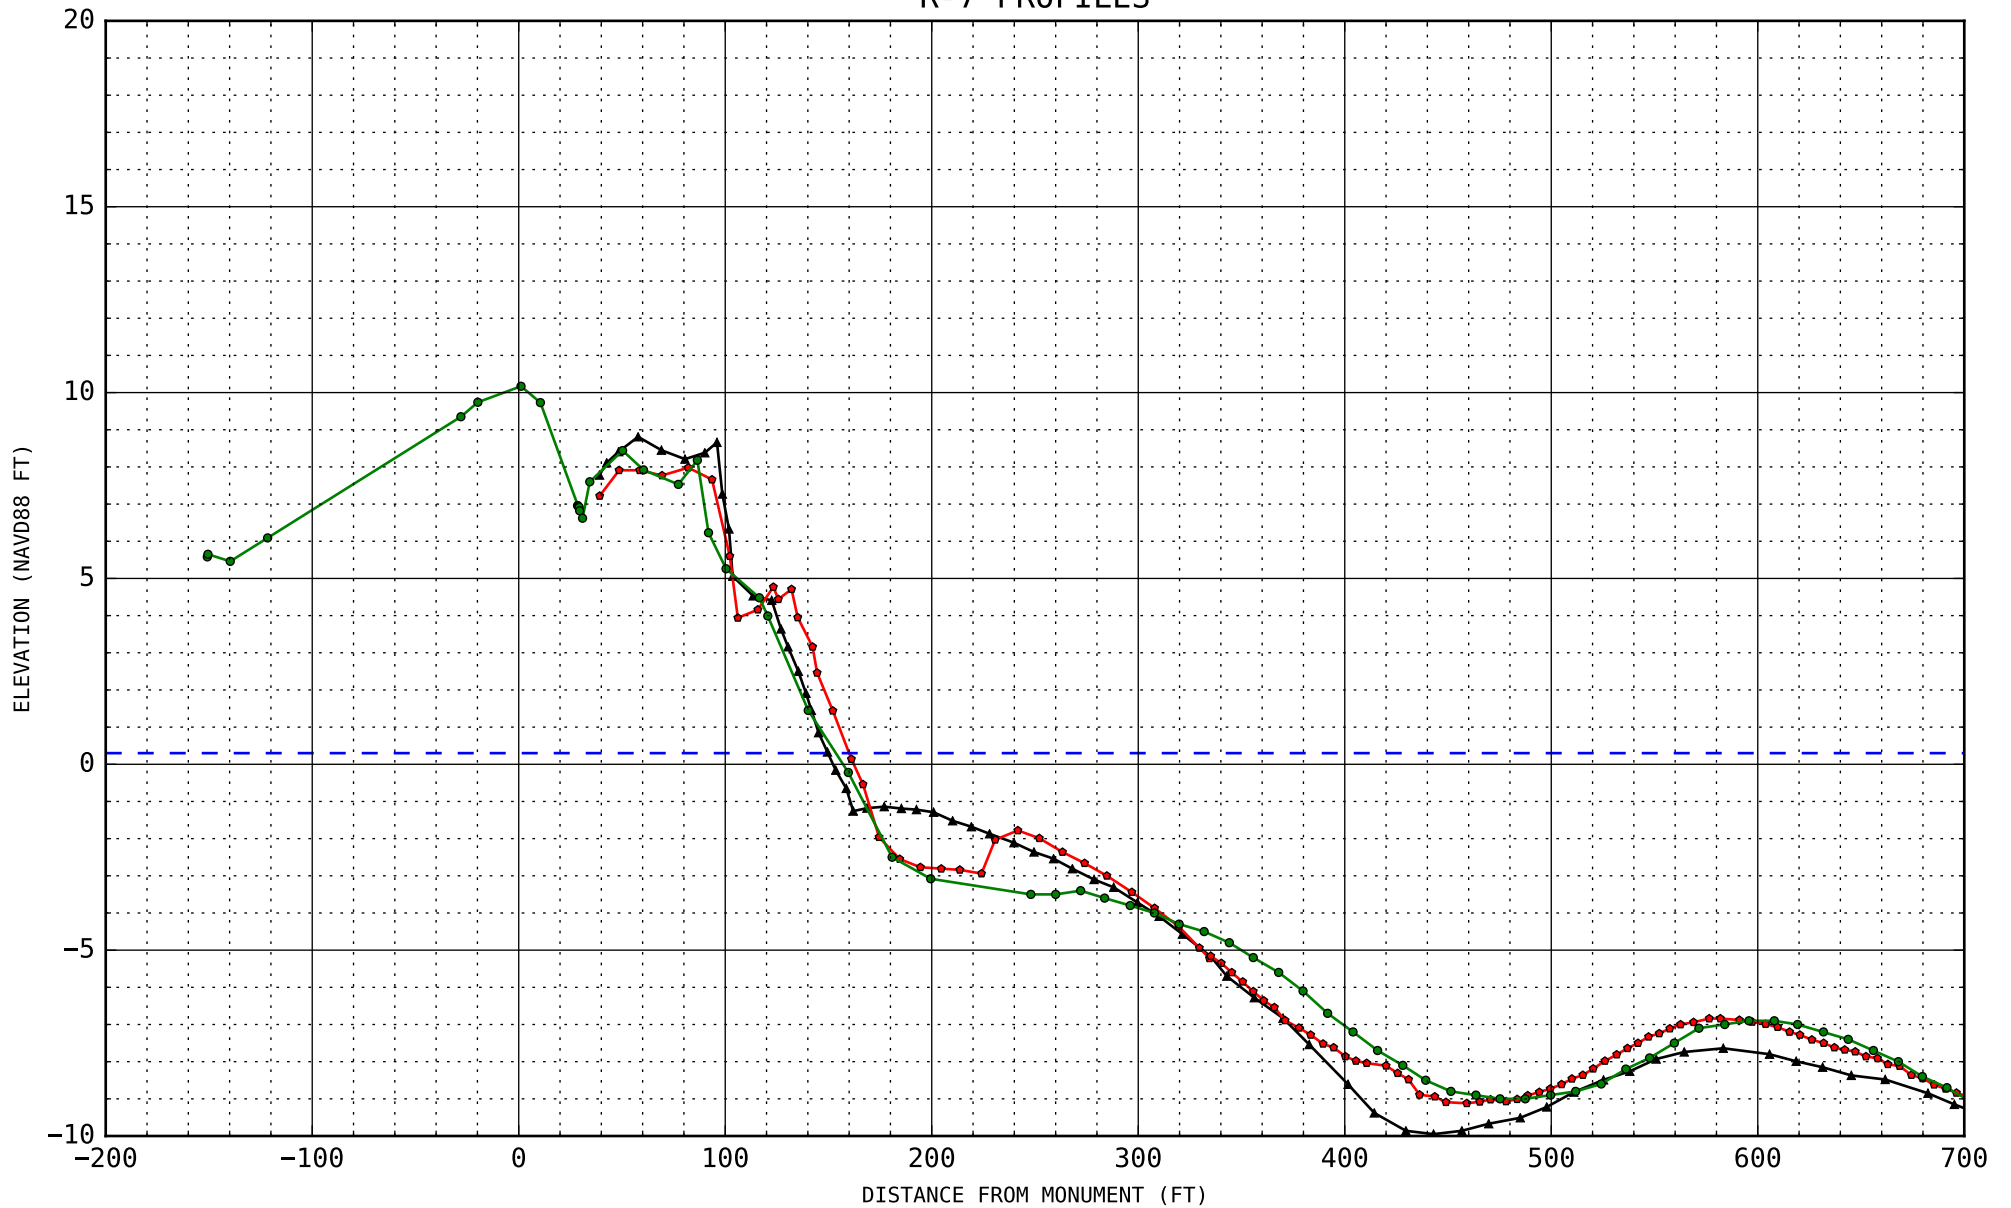
# R-7 PROFILES

- ▲ 2019-JUN MONITORING BY HSS
- 2017-JUL MONITORING BY HSS
- 2014-JUN CONDITION BY ARC
- - - MHW CONTOUR (0.3 FT)

RANGE: R-7  
EST DATE: MECM  
SURVEY DATE: 27JUN19  
AZIMUTH: 240.0

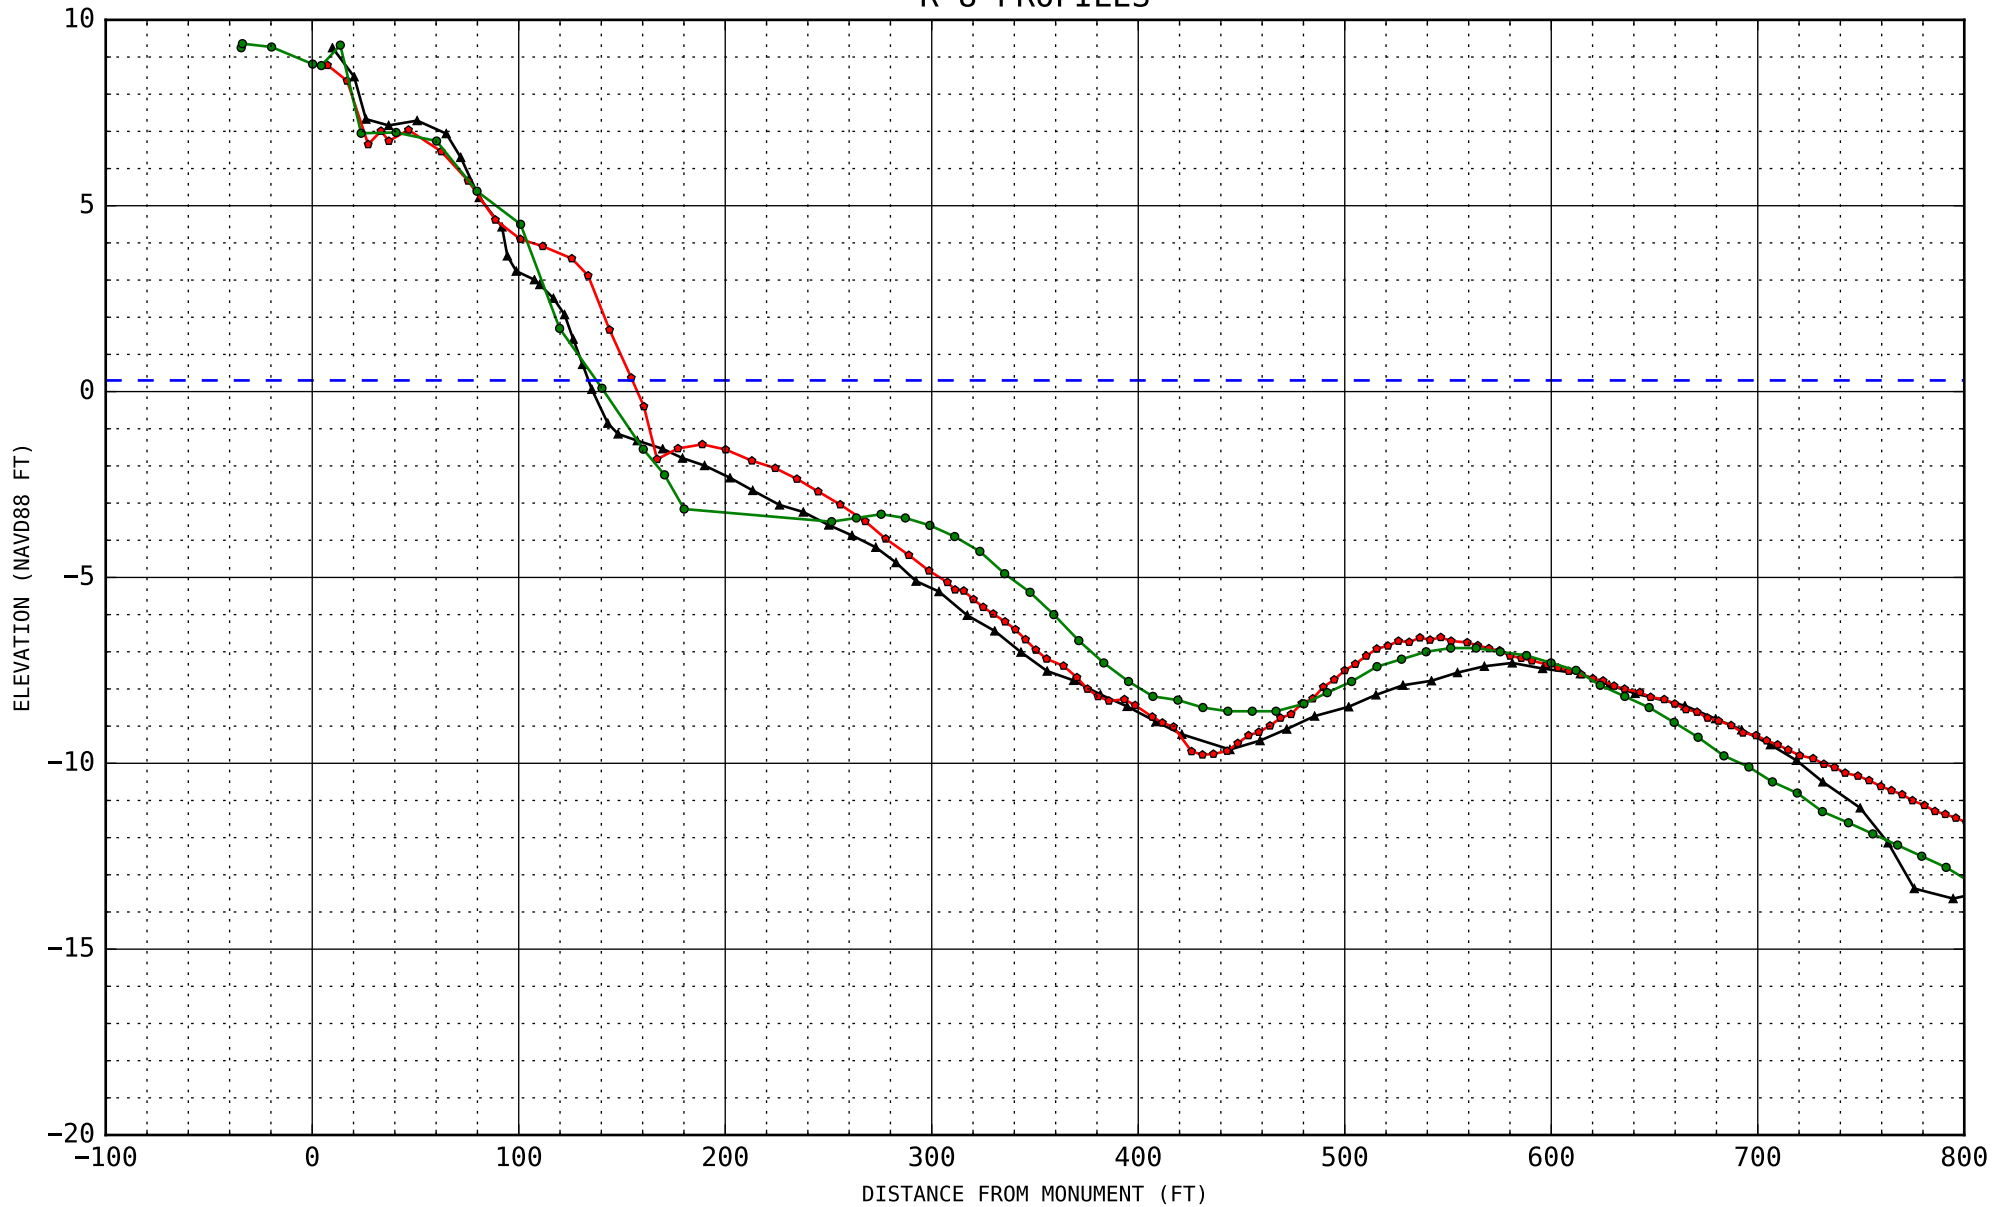
# R-8 PROFILES

- ▲ 2019-JUN MONITORING BY HSS
- 2017-JUL MONITORING BY HSS
- 2014-JUN CONDITION BY ARC
- - - MHW CONTOUR (0.3 FT)

RANGE: R-8  
 EST DATE: MAR1974  
 SURVEY DATE: 27JUN19  
 AZIMUTH: 235.0

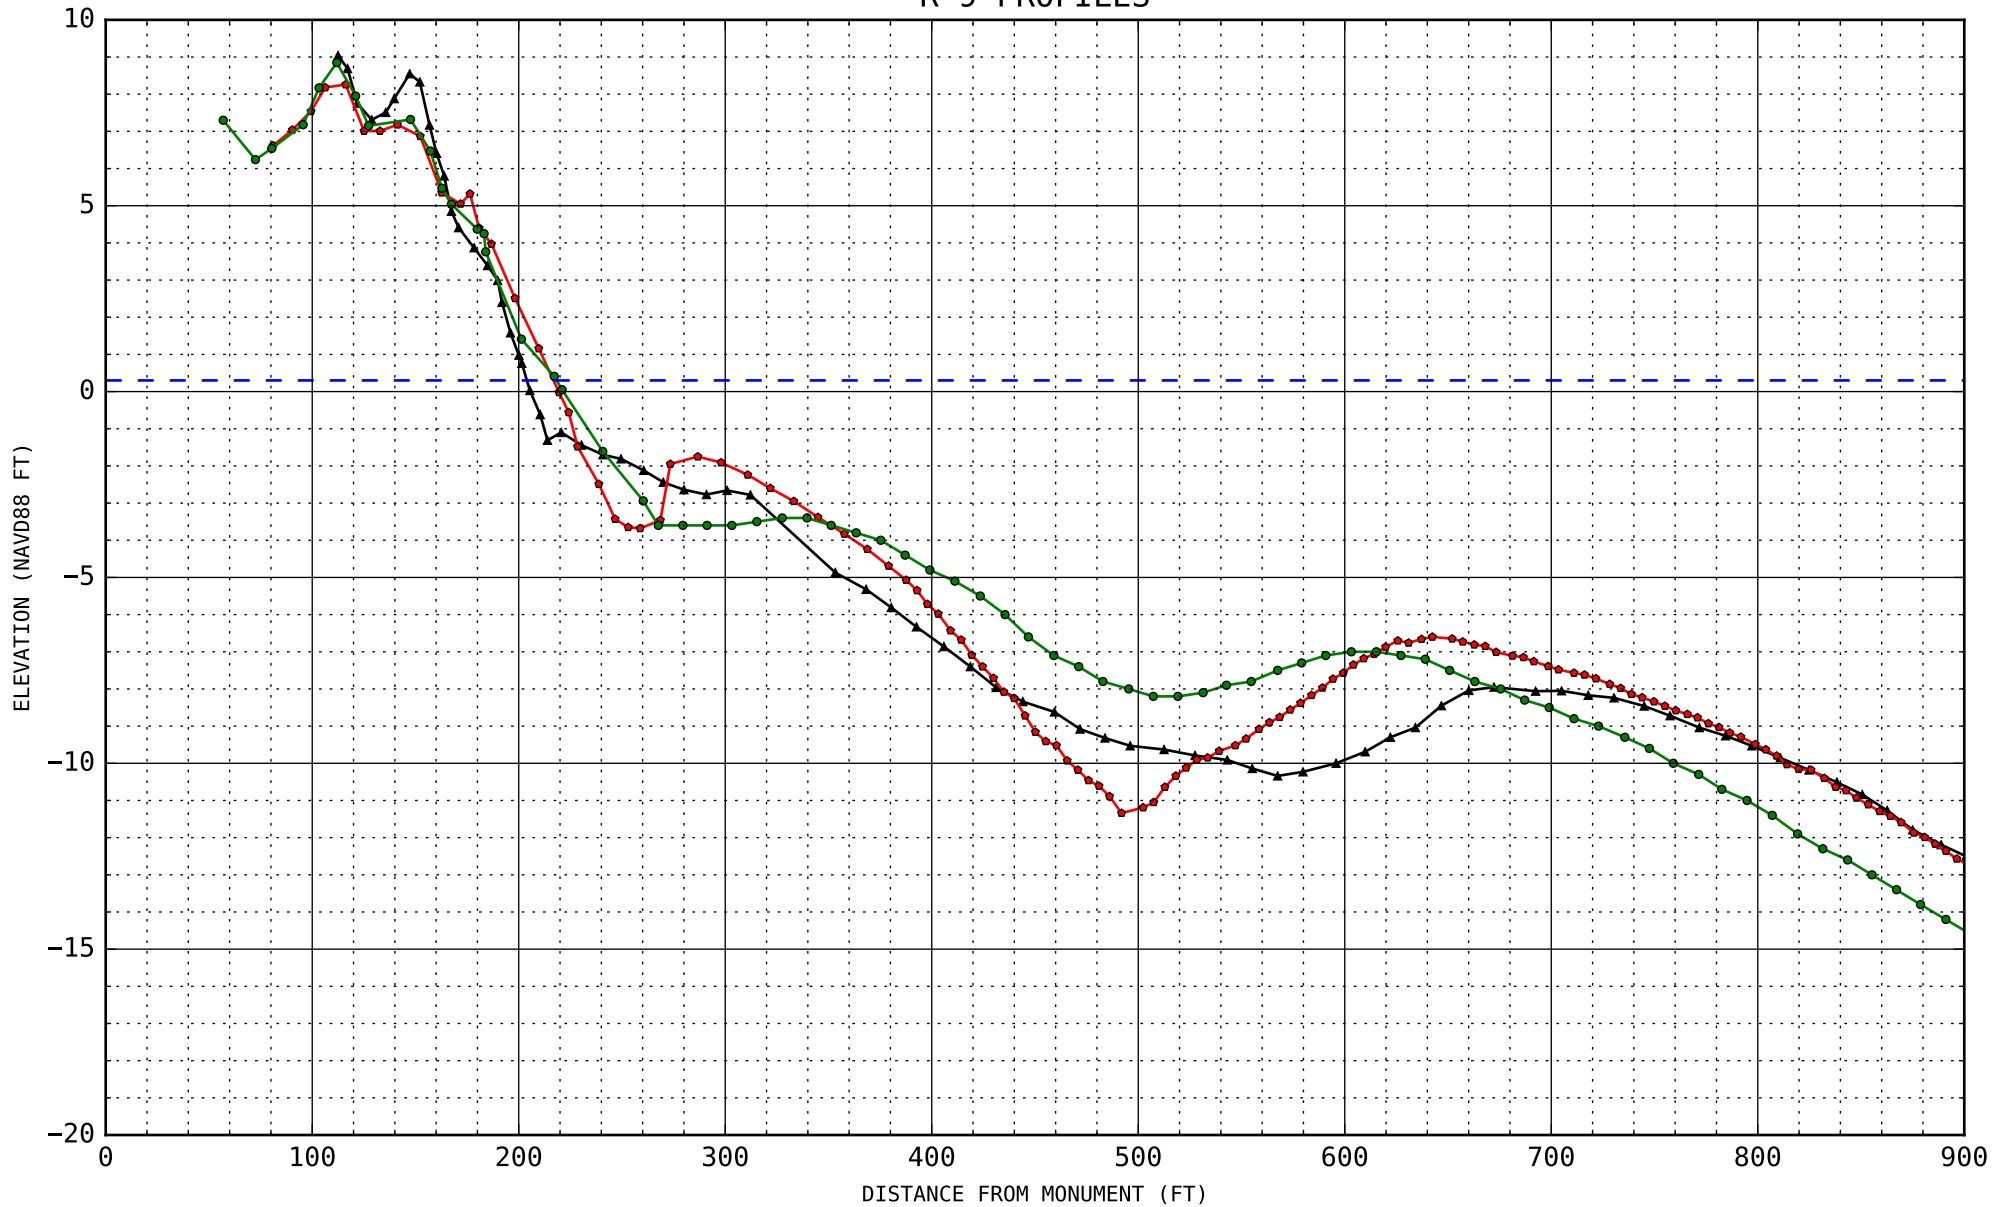
# R-9 PROFILES

- ▲ 2019-JUN MONITORING BY HSS
- 2017-JUL MONITORING BY HSS
- 2014-JUN CONDITION BY ARC
- - - MHW CONTOUR (0.3 FT)

RANGE: R-9  
EST DATE: MAR1974  
SURVEY DATE: 27JUN19  
AZIMUTH: 235.0
