T-1 PROFILES

| ● 2017-JUL MONITORING BY HSS | PROGRAM SUPPORT GIS | EST DATE: MECM |
| ● 2014-JUN CONDITION BY ARC | DIVISION OF WATER RESOURCE MANAGEMENT | SURVEY DATE: 27JUN19 |

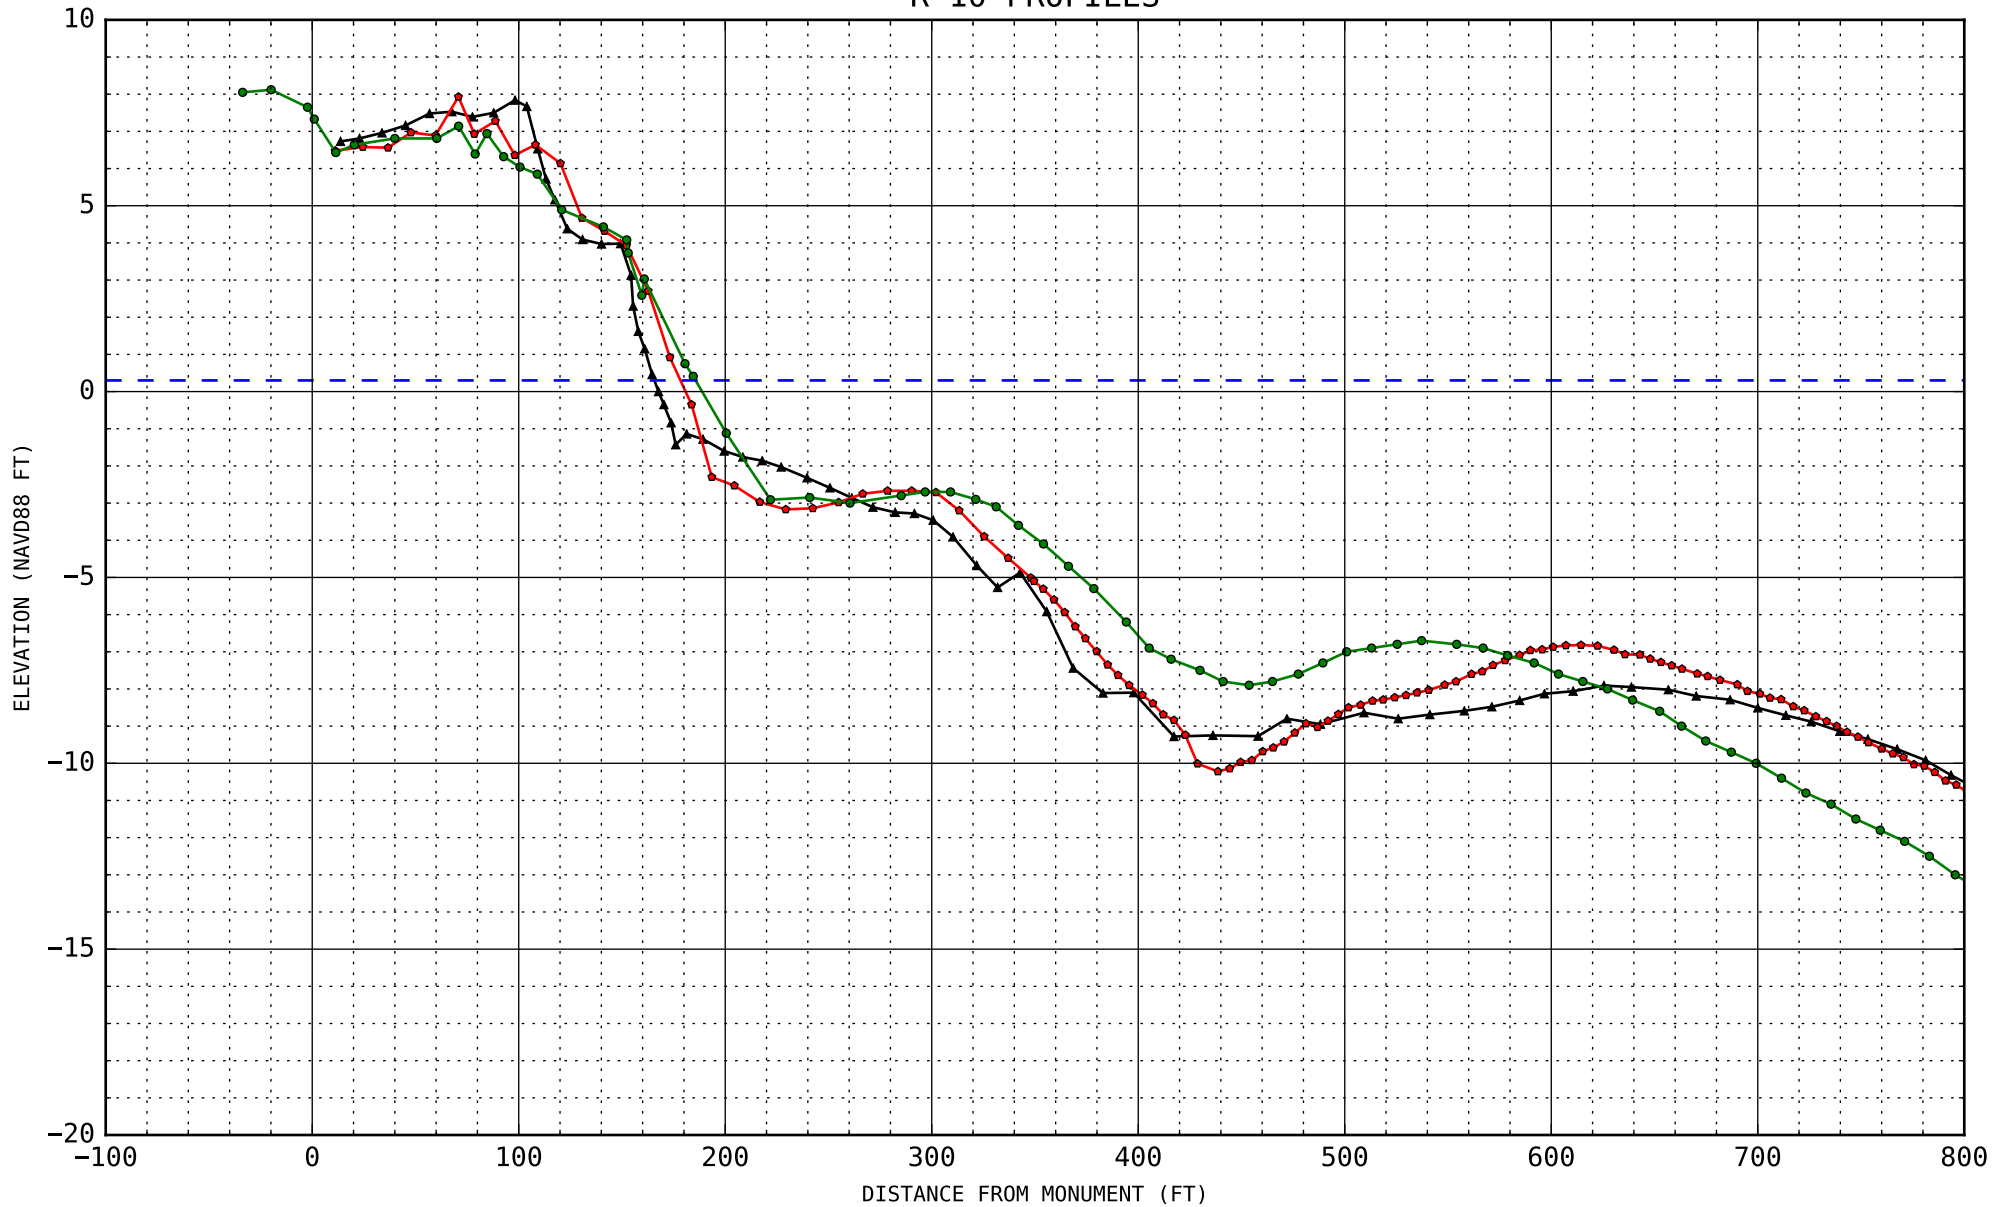
# R-10 PROFILES

- ▲ 2019-JUN MONITORING BY HSS
- 2017-JUL MONITORING BY HSS
- 2014-JUN CONDITION BY ARC
- - - MHW CONTOUR (0.3 FT)

RANGE: R-10  
EST DATE: MECM  
SURVEY DATE: 27JUN19  
AZIMUTH: 235.0

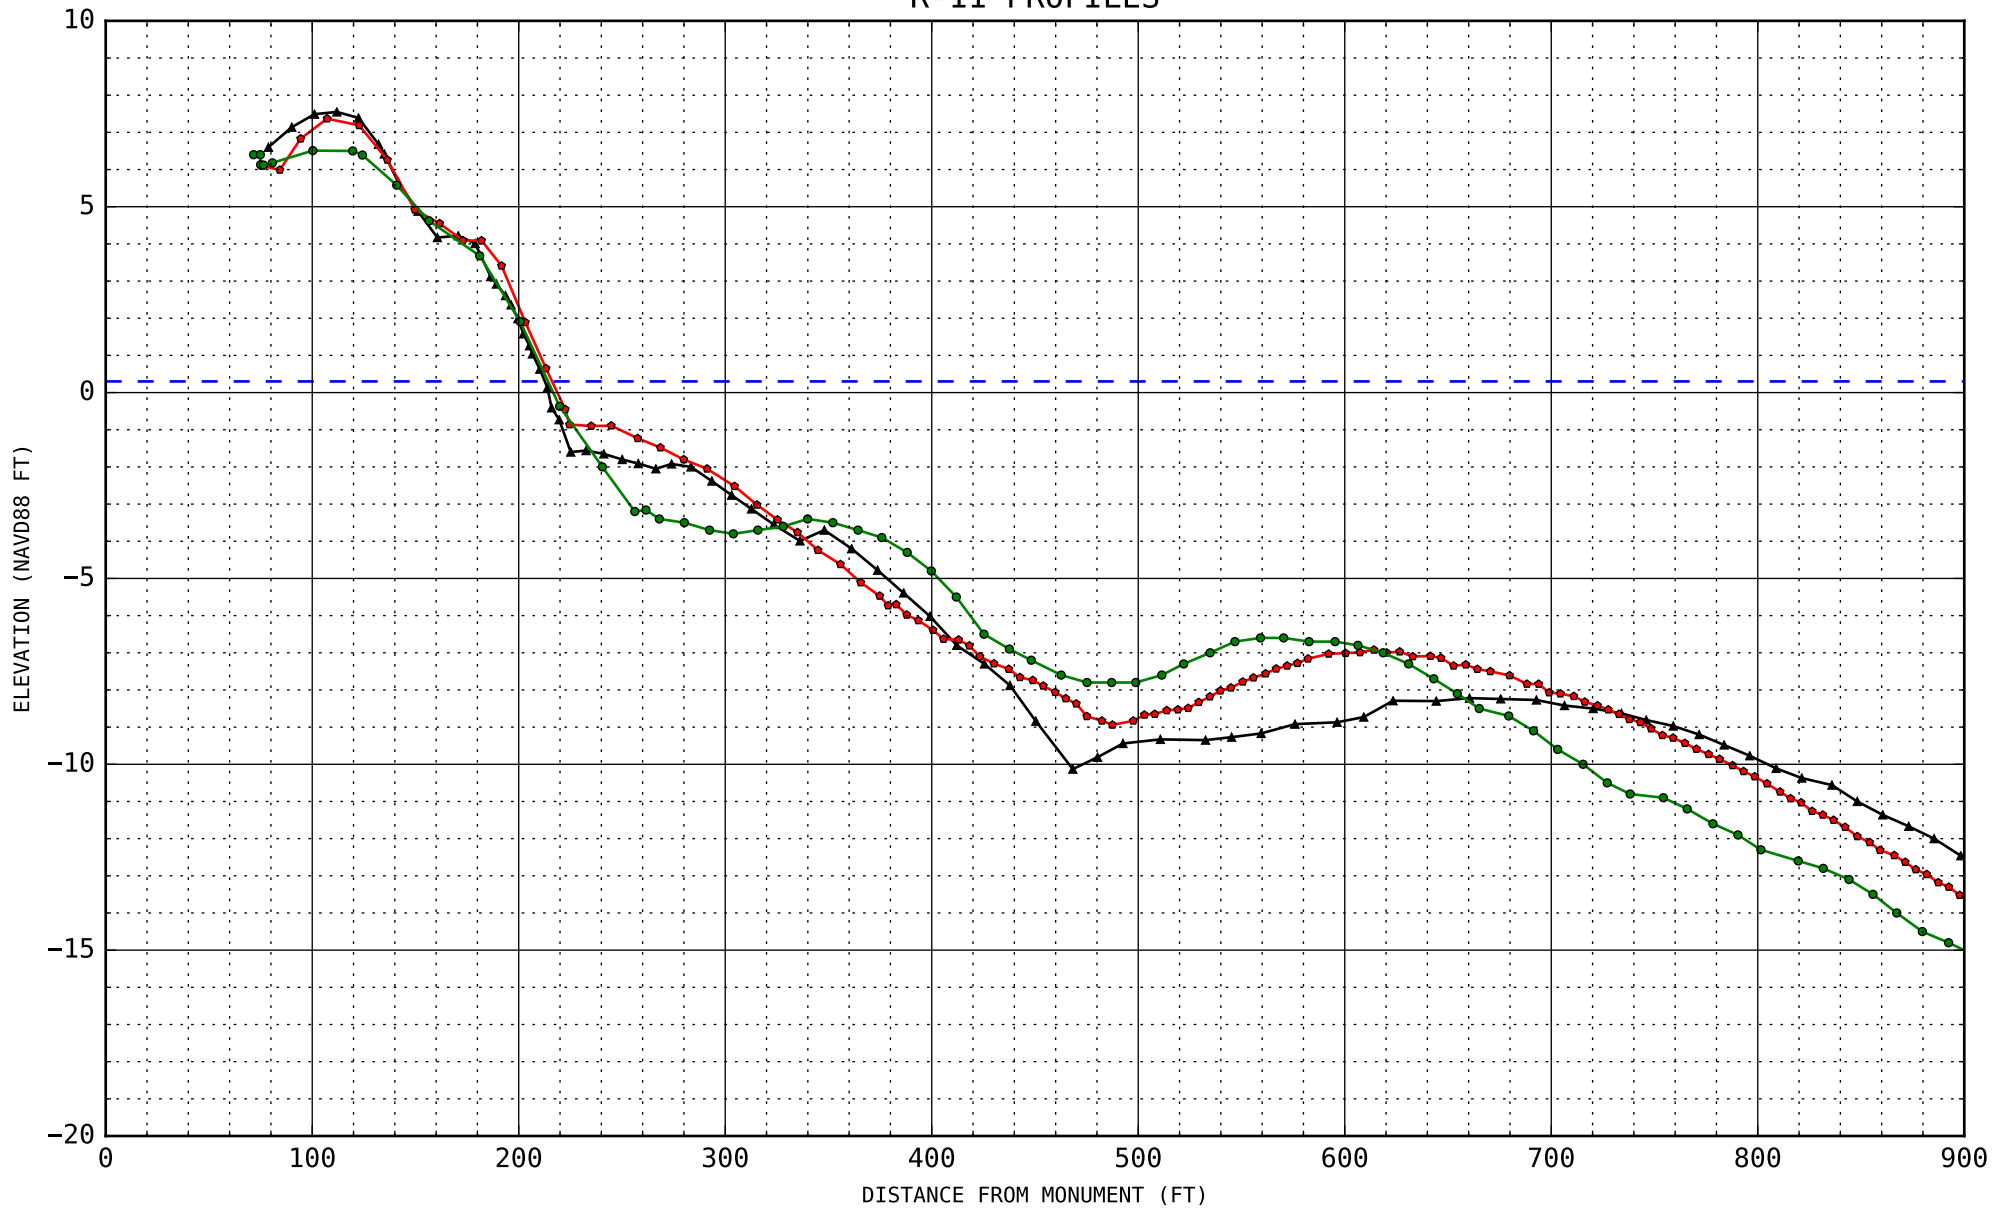
# R-11 PROFILES

▲ 2019-JUN MONITORING BY HSS  
 ● 2017-JUL MONITORING BY HSS  
 ● 2014-JUN CONDITION BY ARC  
 - - - MHW CONTOUR (0.3 FT)

RANGE: R-11  
 EST DATE: APR1987  
 SURVEY DATE: 28JUN19  
 AZIMUTH: 235.0

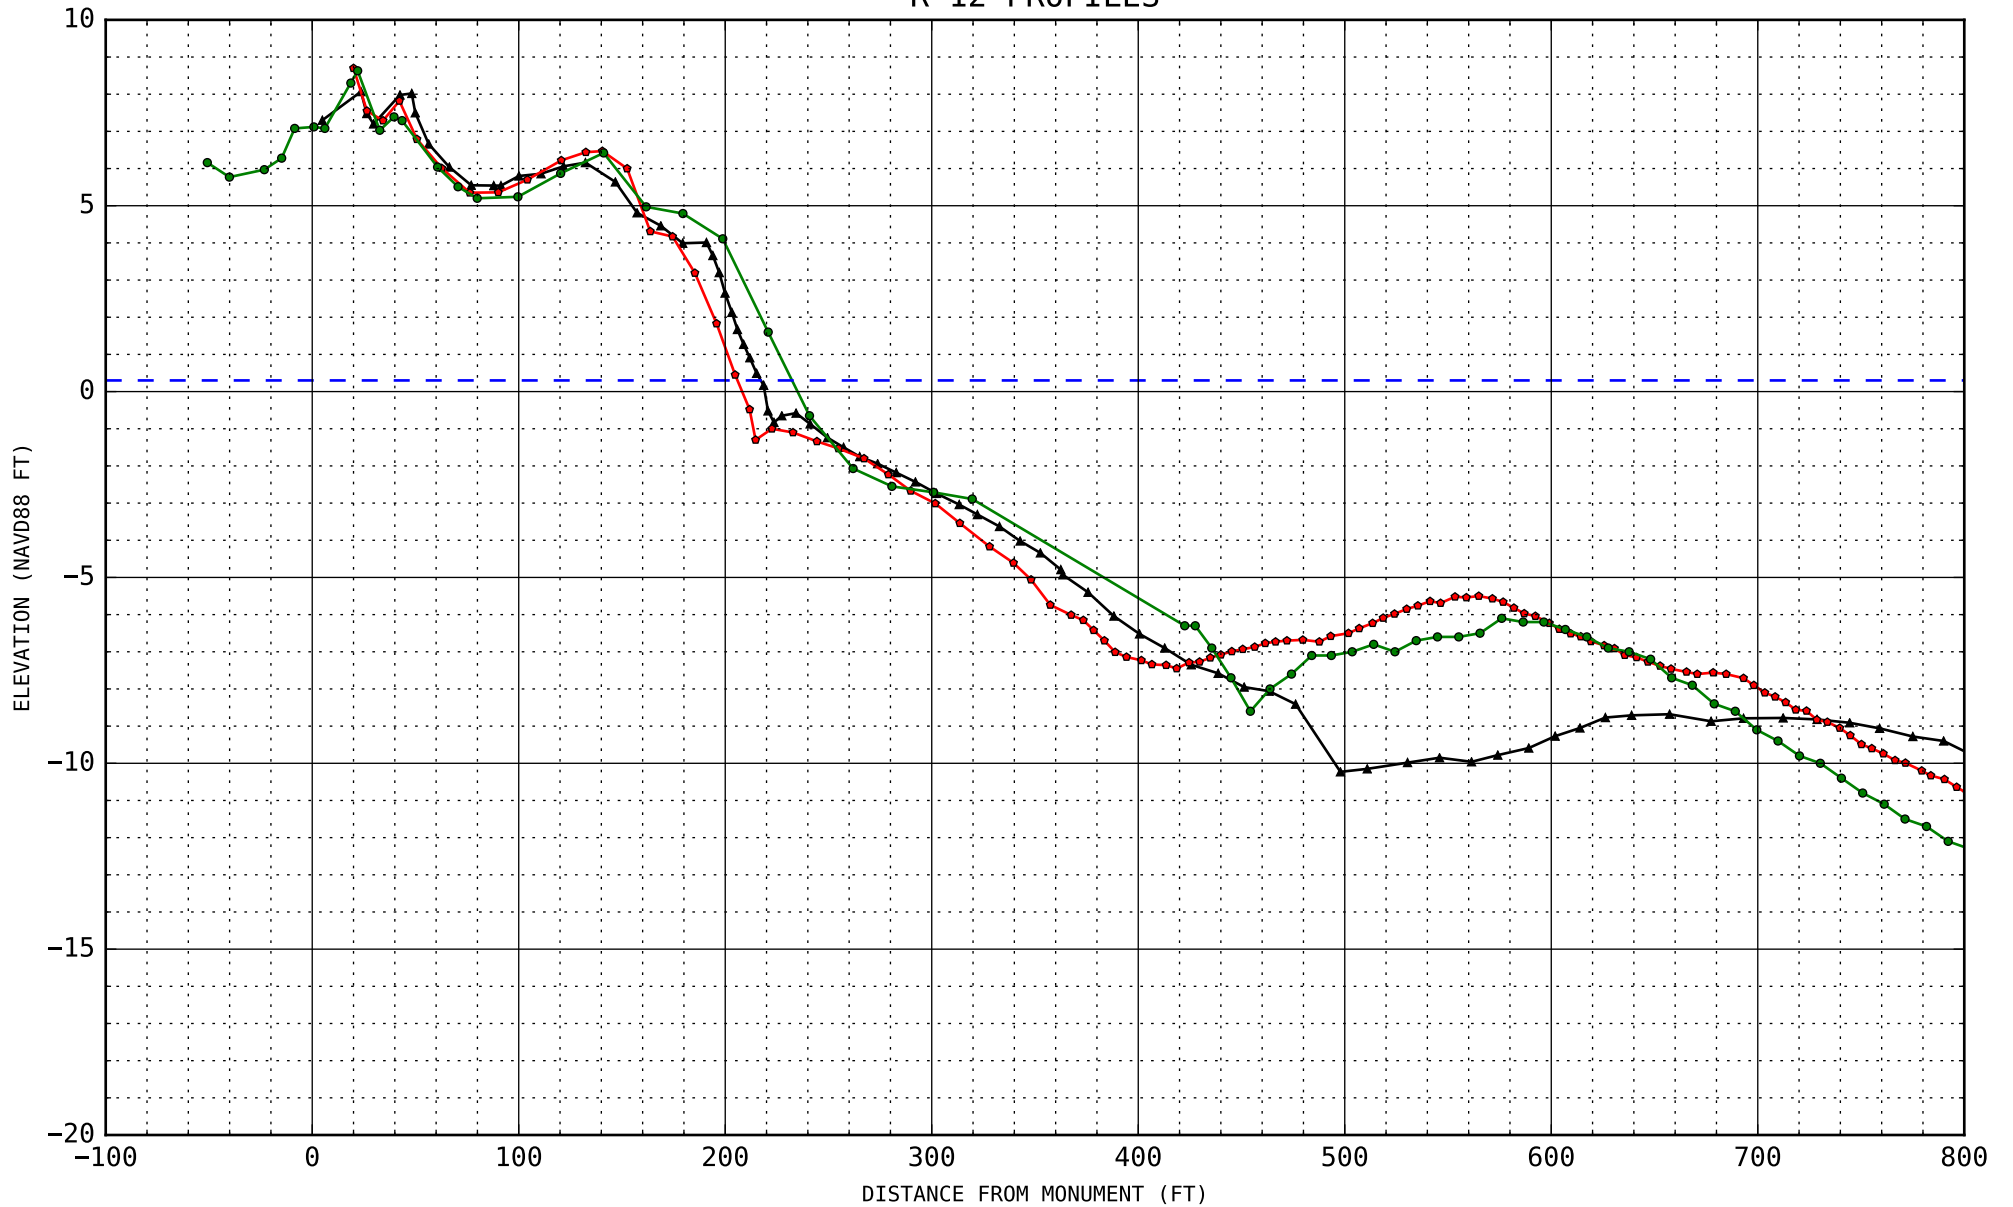
# R-12 PROFILES

- ▲ 2019-JUN MONITORING BY HSS
- 2017-JUL MONITORING BY HSS
- 2014-JUN CONDITION BY ARC
- - - MHW CONTOUR (0.3 FT)

RANGE: R-12  
EST DATE: JAN1985  
SURVEY DATE: 28JUN19  
AZIMUTH: 235.0

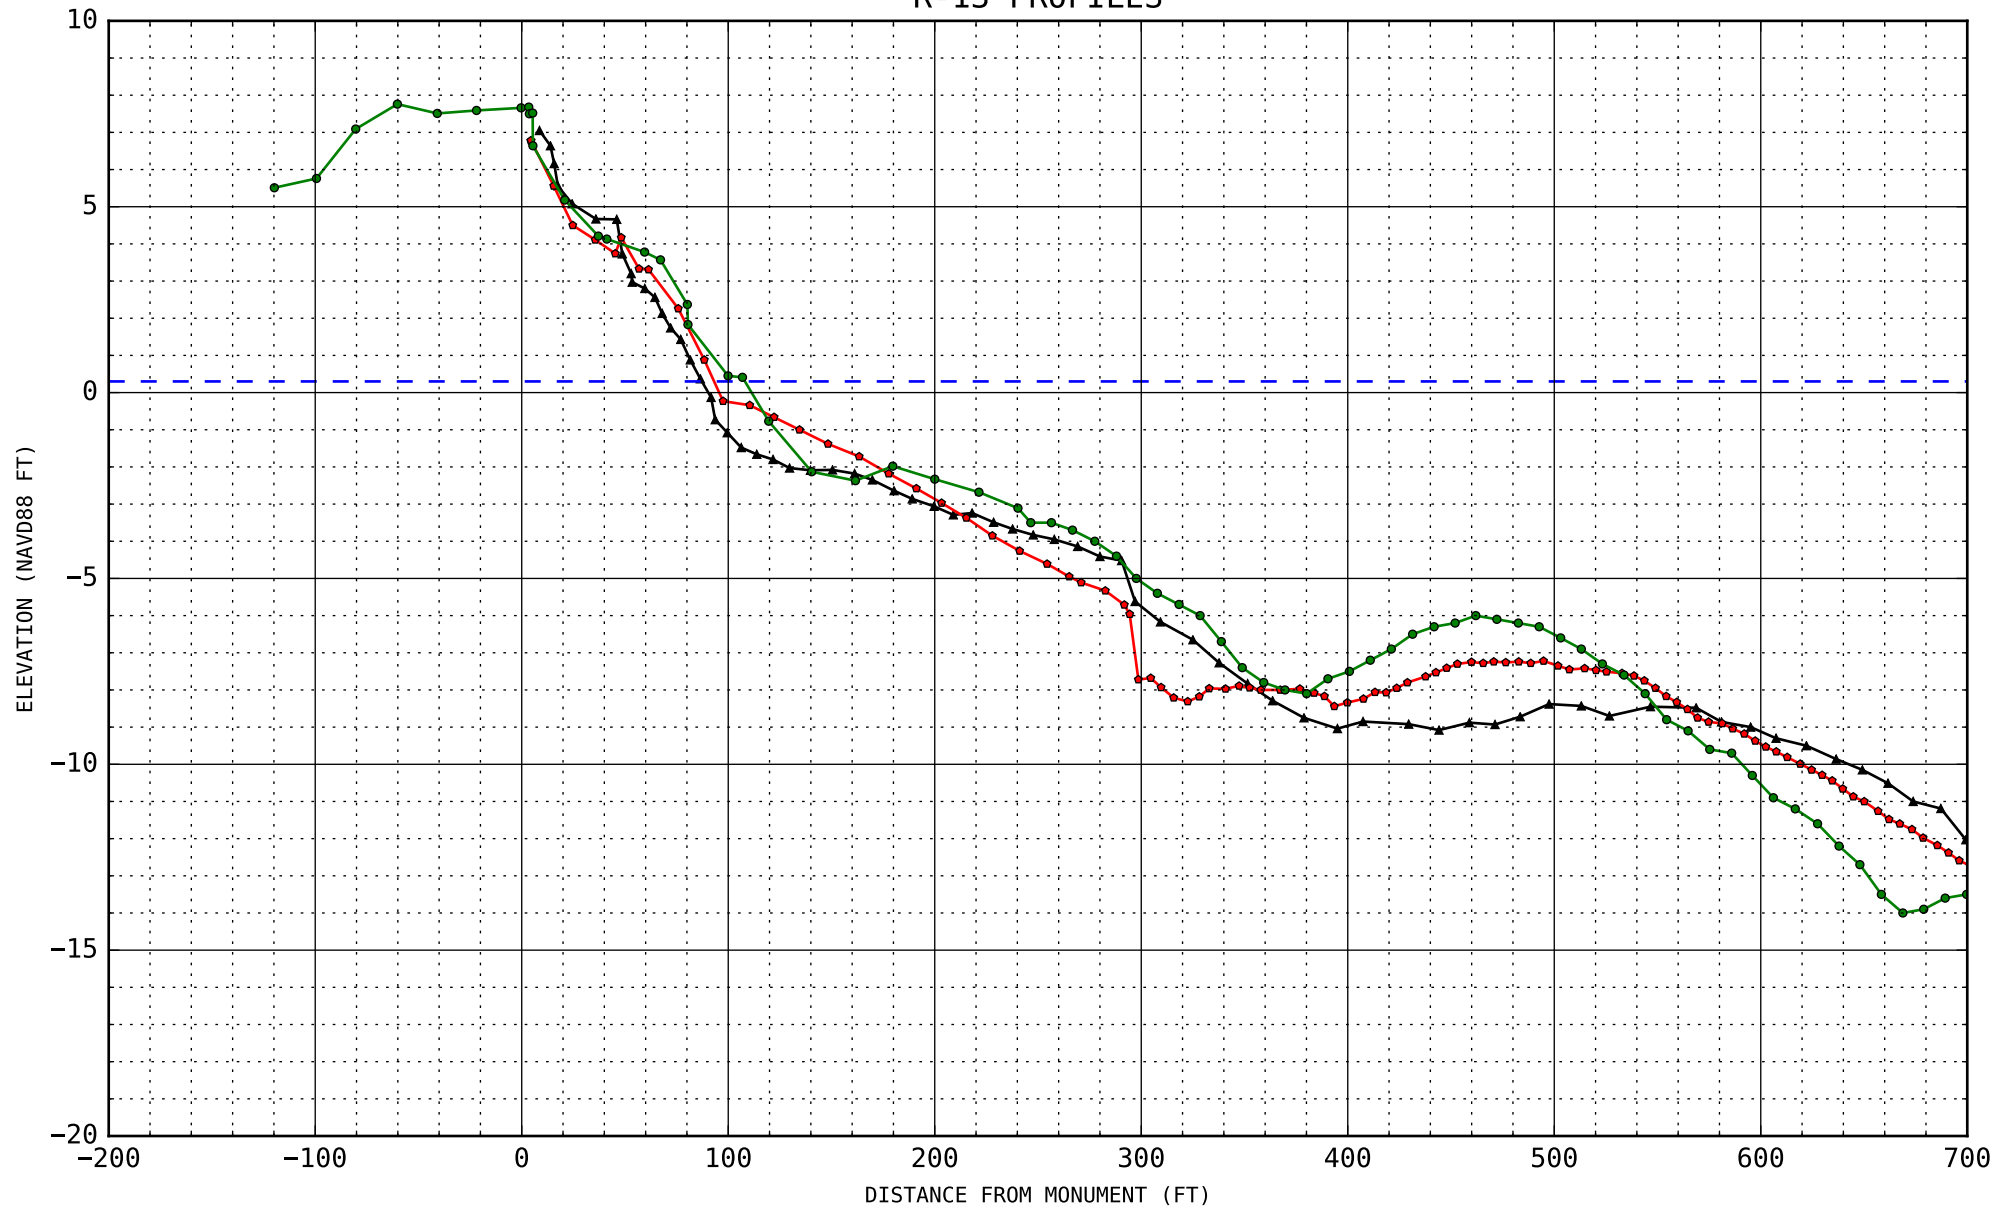
# R-13 PROFILES

▲ 2019-JUN MONITORING BY HSS  
 ● 2017-JUL MONITORING BY HSS  
 ● 2014-JUN CONDITION BY ARC  
 - - - MHW CONTOUR (0.3 FT)

RANGE: R-13  
 EST DATE: SABE124  
 SURVEY DATE: 28JUN19  
 AZIMUTH: 235.0

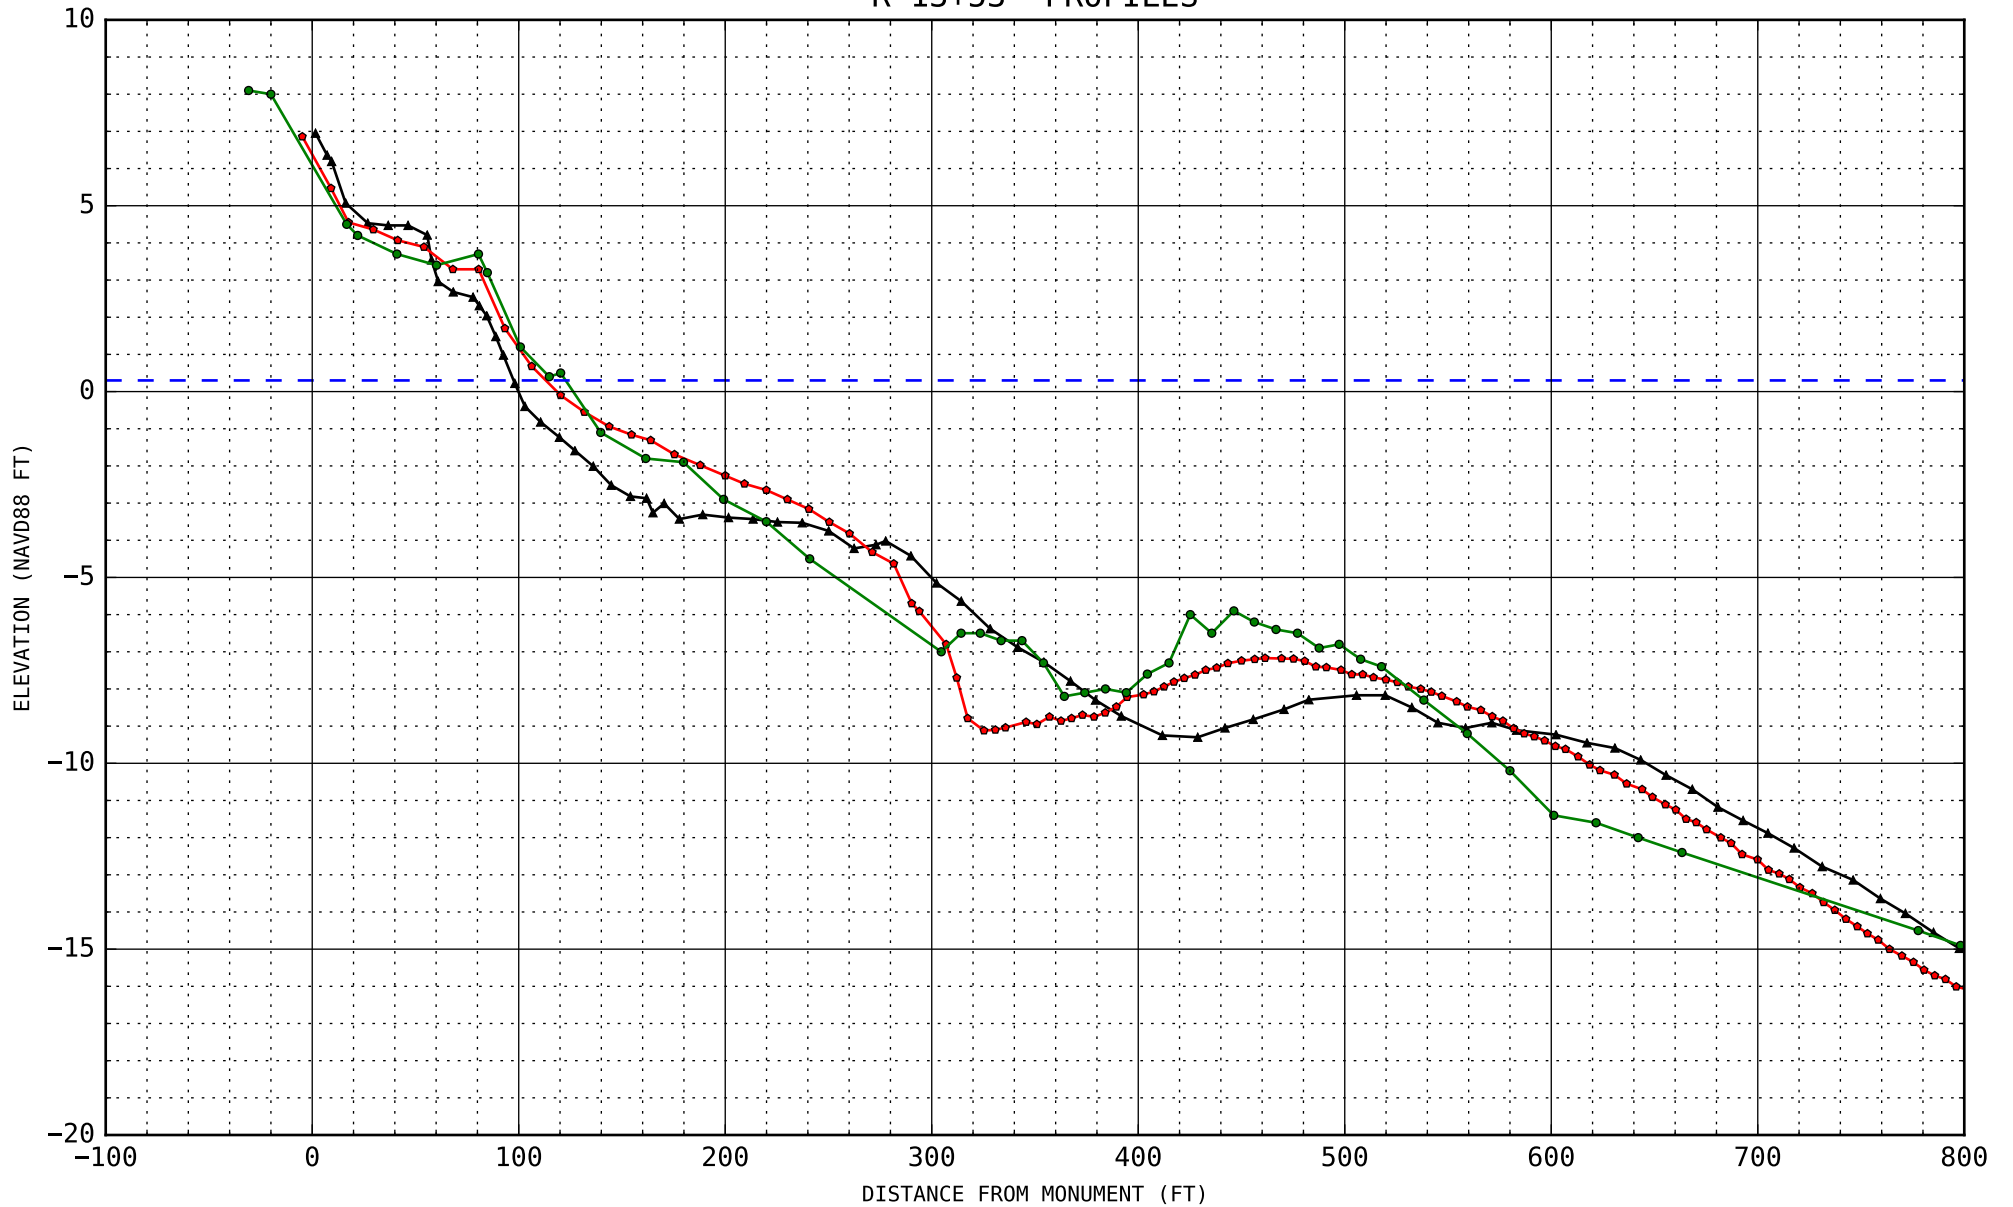
# R-13+53- PROFILES

▲ 2019-JUN MONITORING BY HSS  
 ● 2017-JUL MONITORING BY HSS  
 ● 2014-JUN CONDITION BY ARC  
 - - - MHW CONTOUR (0.3 FT)

RANGE: R-13+53-  
 EST DATE: 0REFPT  
 SURVEY DATE: 28JUN19  
 AZIMUTH: 231.0

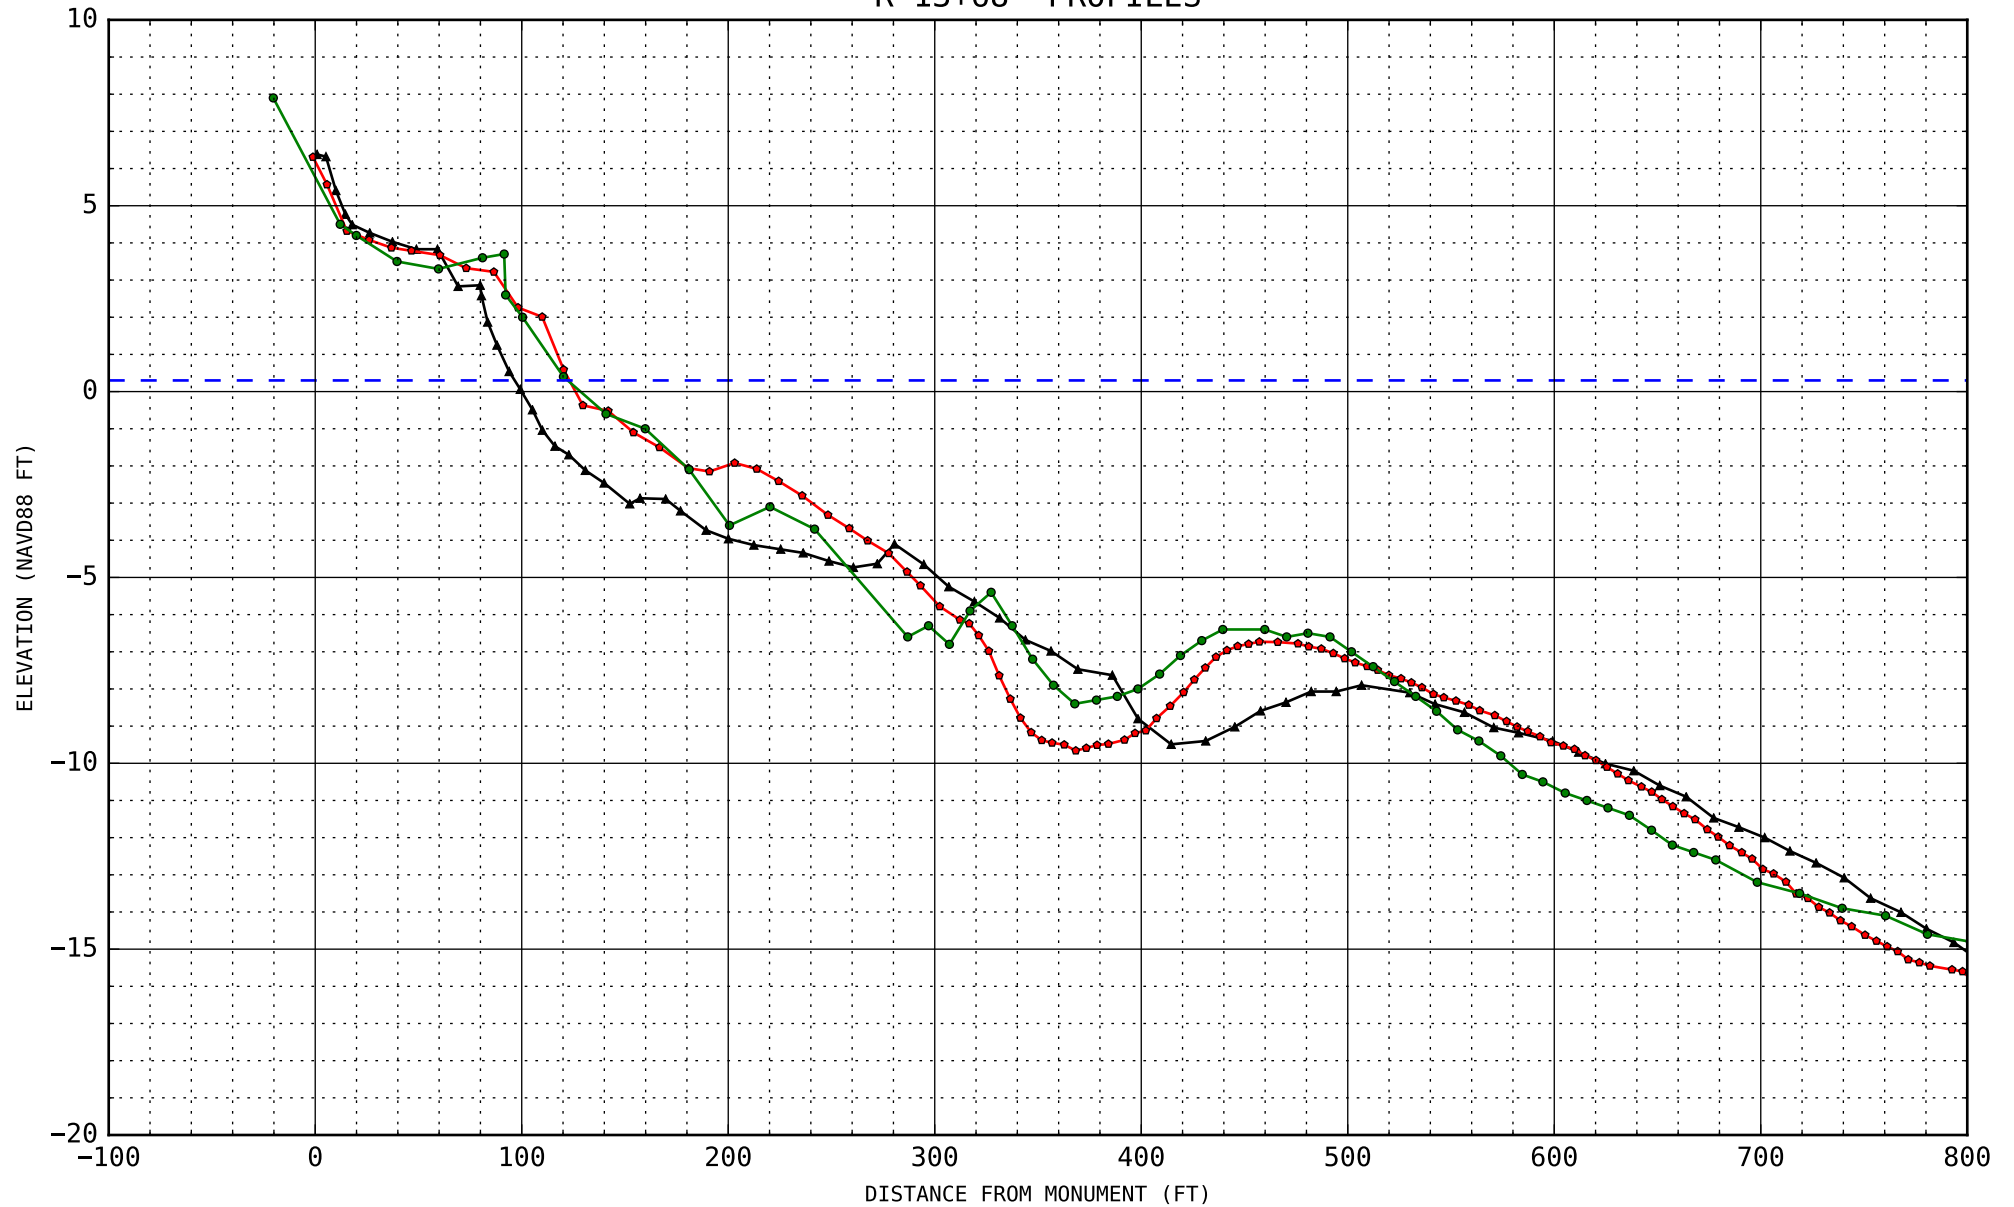
# R-13+68- PROFILES

2019-JUN MONITORING BY HSS  
 2017-JUL MONITORING BY HSS  
 2014-JUN CONDITION BY ARC  
 MHW CONTOUR (0.3 FT)

RANGE: R-13+68-  
 EST DATE: 0REFPT  
 SURVEY DATE: 28JUN19  
 AZIMUTH: 231.0

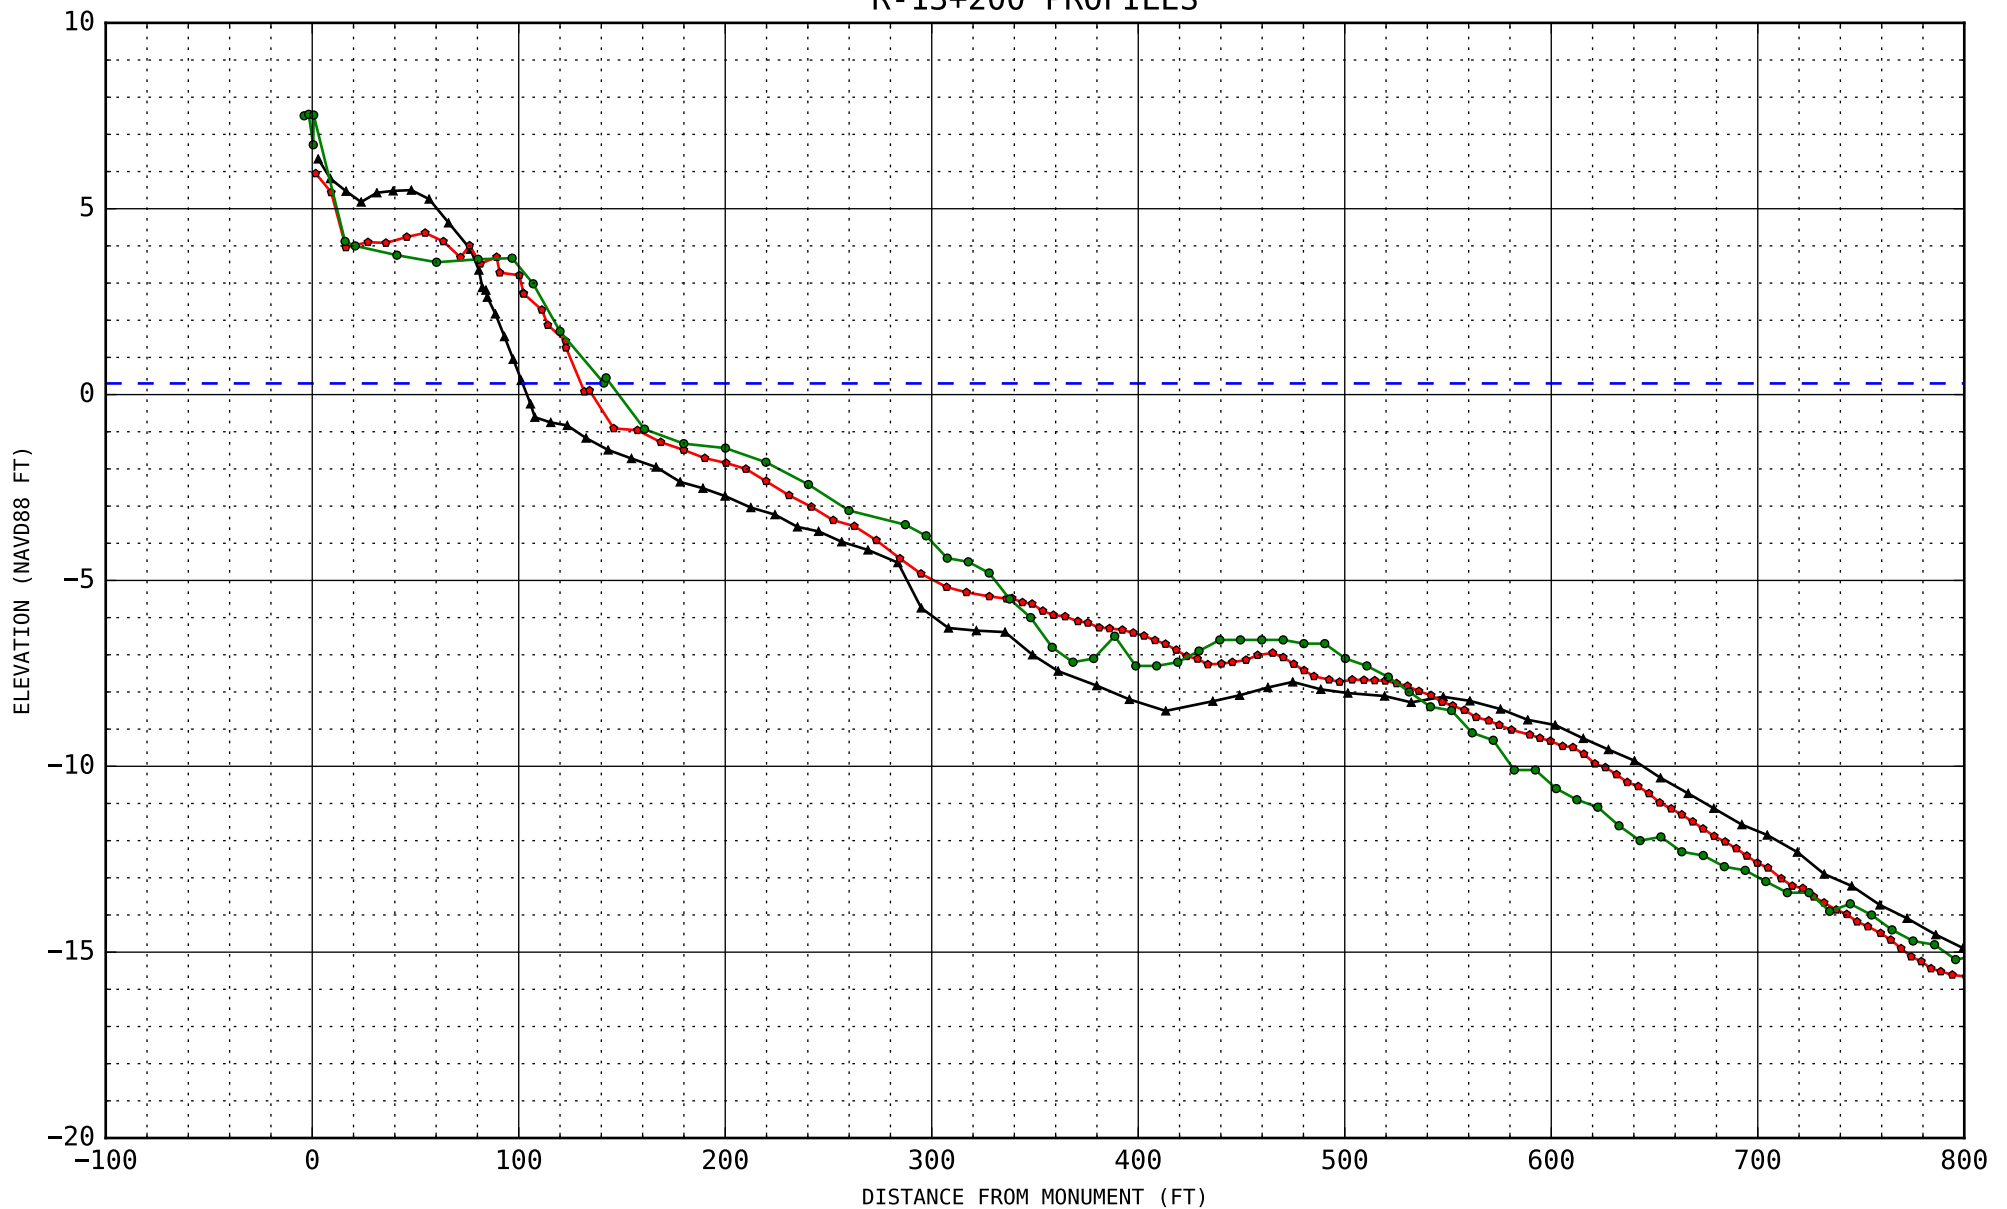
# R-13+200 PROFILES

| <p>▲ 2019-JUN MONITORING BY HSS</p> <p>● 2017-JUL MONITORING BY HSS</p> <p>● 2014-JUN CONDITION BY ARC</p> <p>-- MHW CONTOUR (0.3 FT)</p> | <p>SARASOTA</p> <p>PROGRAM SUPPORT GIS</p> <p>DIVISION OF WATER RESOURCE MANAGEMENT</p> <p>FLORIDA DEPARTMENT OF ENVIRONMENTAL PROTECTION</p> | <p>RANGE: R-13+200</p> <p>EST DATE: REFPT</p> <p>SURVEY DATE: 28JUN19</p> <p>AZIMUTH: 235.0</p> |

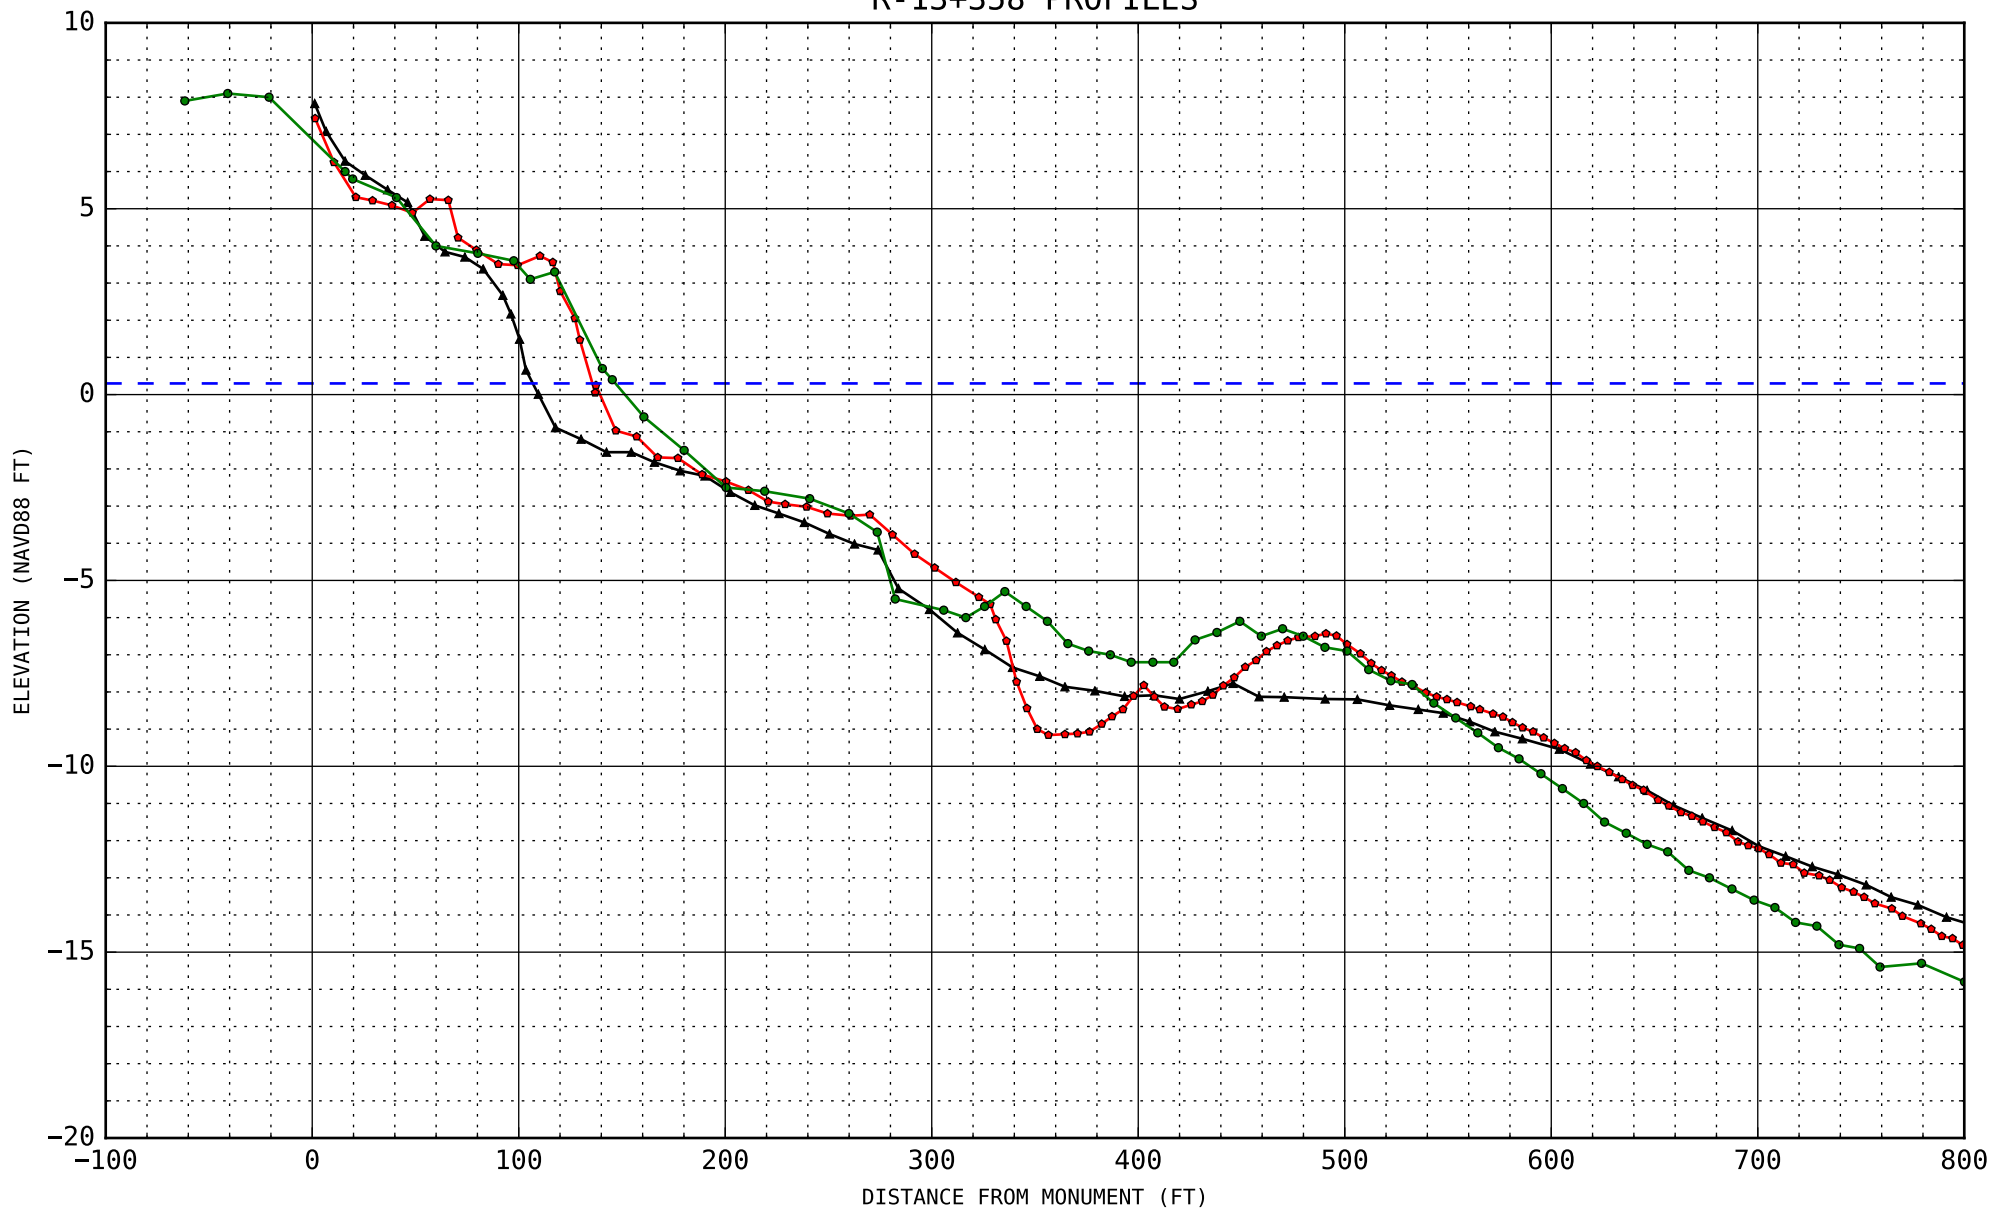
# R-13+358 PROFILES

2019-JUN MONITORING BY HSS  
 2017-JUL MONITORING BY HSS  
 2014-JUN CONDITION BY ARC  
 MHW CONTOUR (0.3 FT)

RANGE: R-13+358  
 EST DATE: -0REFPT  
 SURVEY DATE: 28JUN19  
 AZIMUTH: 227.0

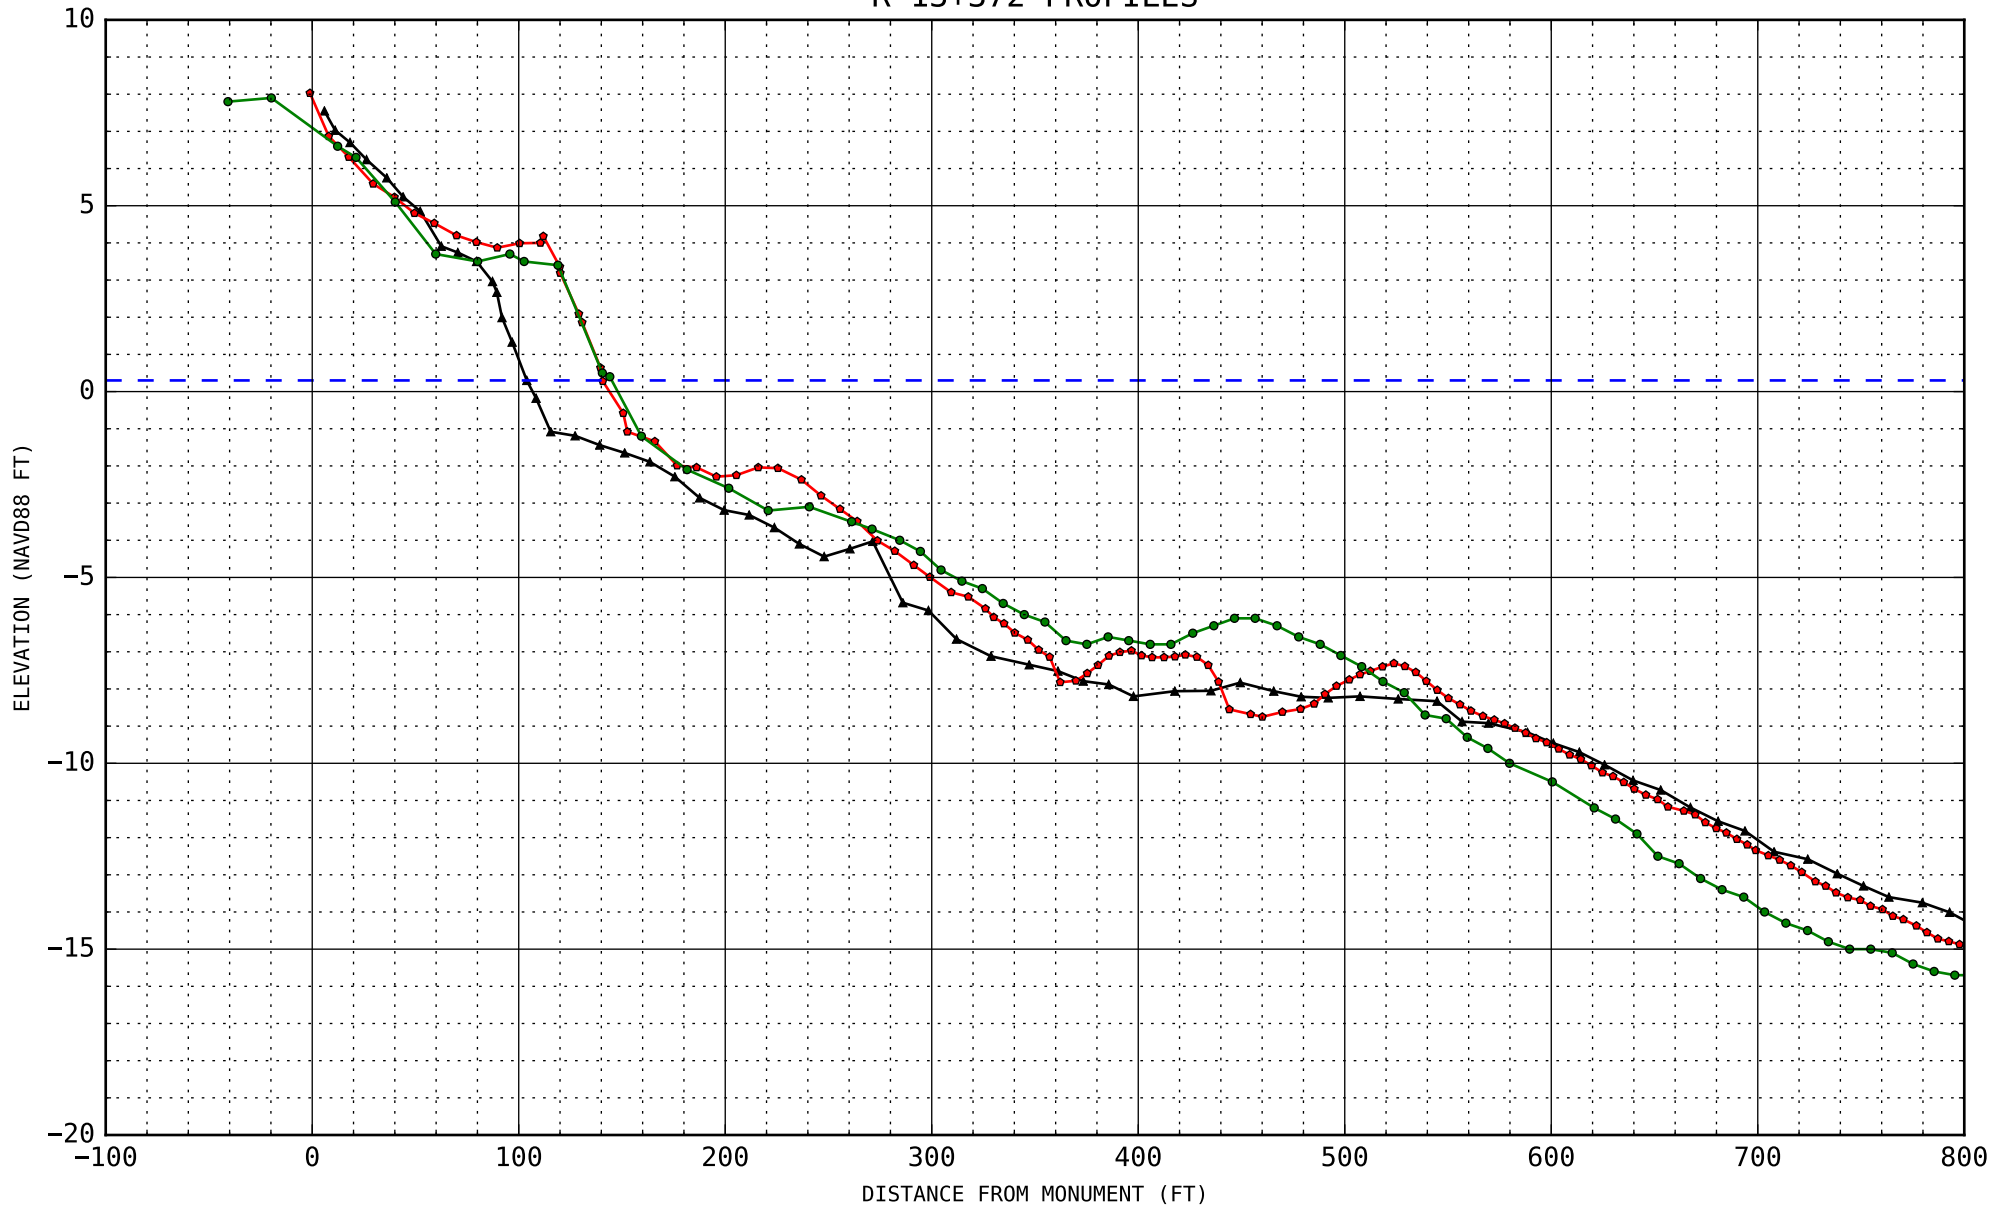
# R-13+372 PROFILES

- ▲ 2019-JUN MONITORING BY HSS
- 2017-JUL MONITORING BY HSS
- 2014-JUN CONDITION BY ARC
- - - MHW CONTOUR (0.3 FT)

RANGE: R-13+372  
EST DATE: -0REFPT  
SURVEY DATE: 28JUN19  
AZIMUTH: 227.0
