T-1 PROFILES

| ● 2017-JUL MONITORING BY HSS | PROGRAM SUPPORT GIS | EST DATE: MECM |
| ● 2014-JUN CONDITION BY ARC | DIVISION OF WATER RESOURCE MANAGEMENT | SURVEY DATE: 27JUN19 |

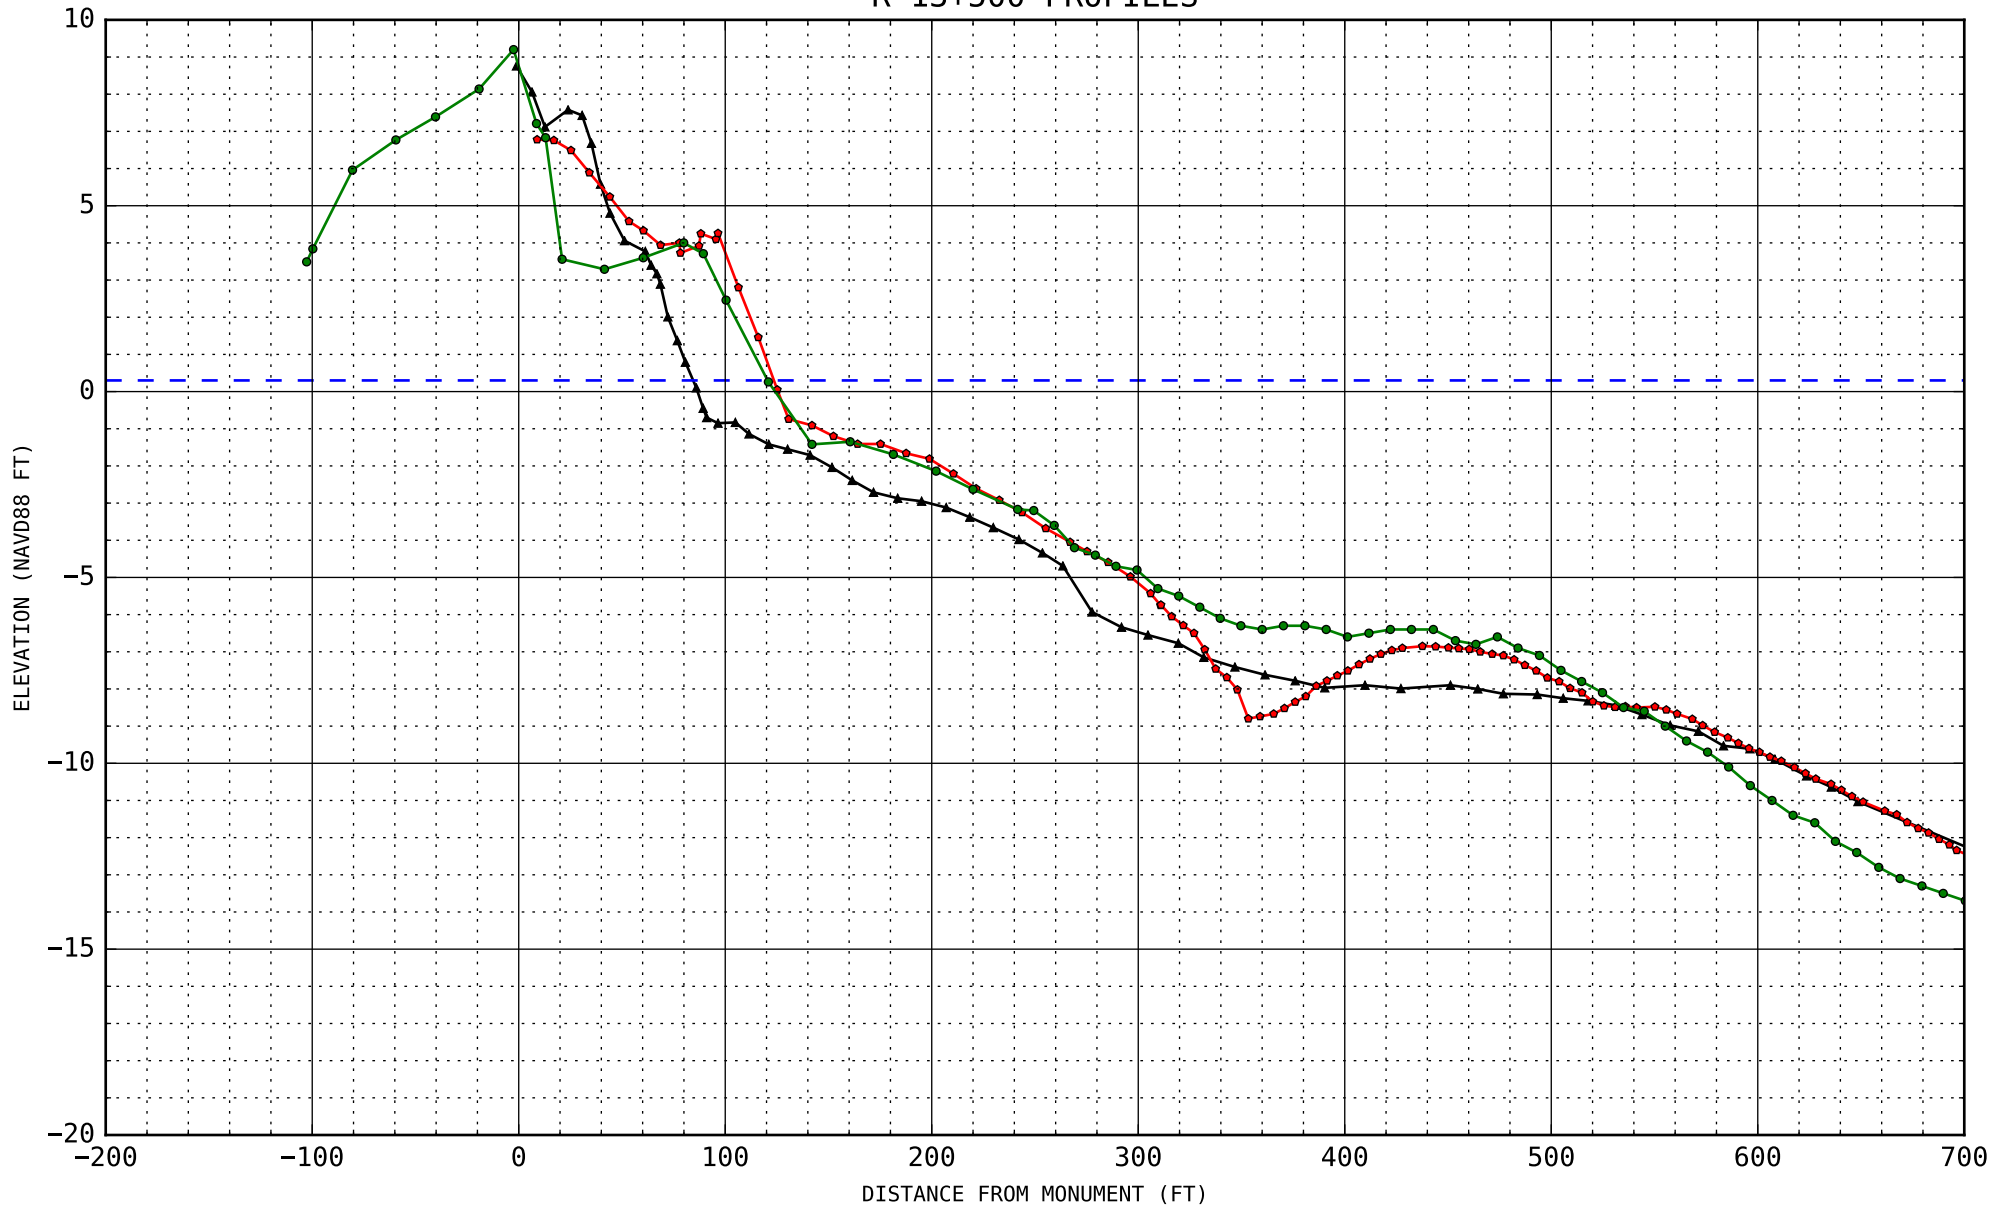
# R-13+500 PROFILES

▲—▲ 2019-JUN MONITORING BY HSS  
 ●—● 2017-JUL MONITORING BY HSS  
 ●—● 2014-JUN CONDITION BY ARC  
 - - - MHW CONTOUR (0.3 FT)

RANGE: R-13+500  
 EST DATE: CPEDISK  
 SURVEY DATE: 28JUN19  
 AZIMUTH: 235.0

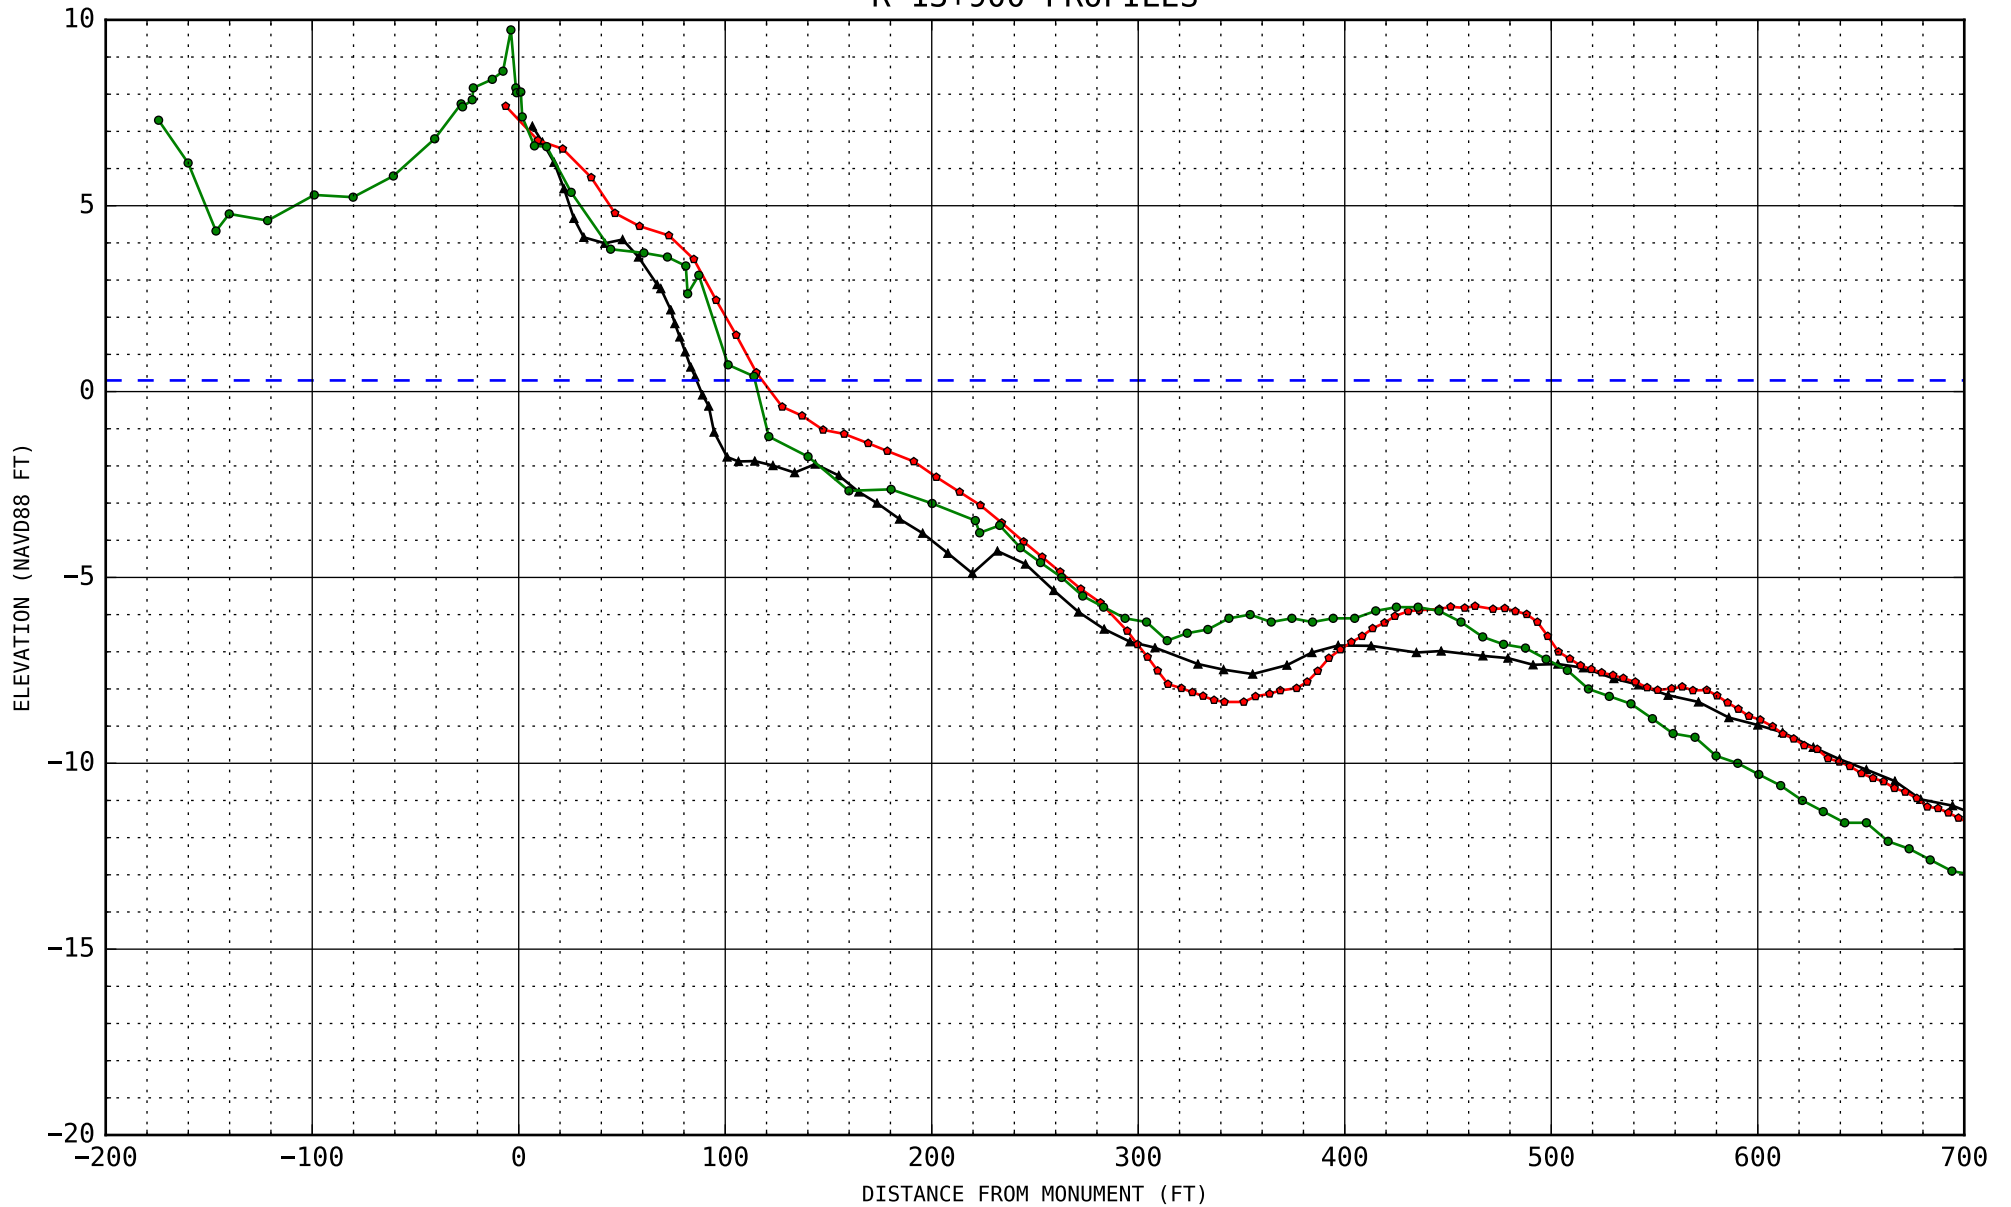
# R-13+900 PROFILES

RANGE: R-13+900  
 EST DATE: REFPT  
 SURVEY DATE: 28JUN19  
 AZIMUTH: 235.0

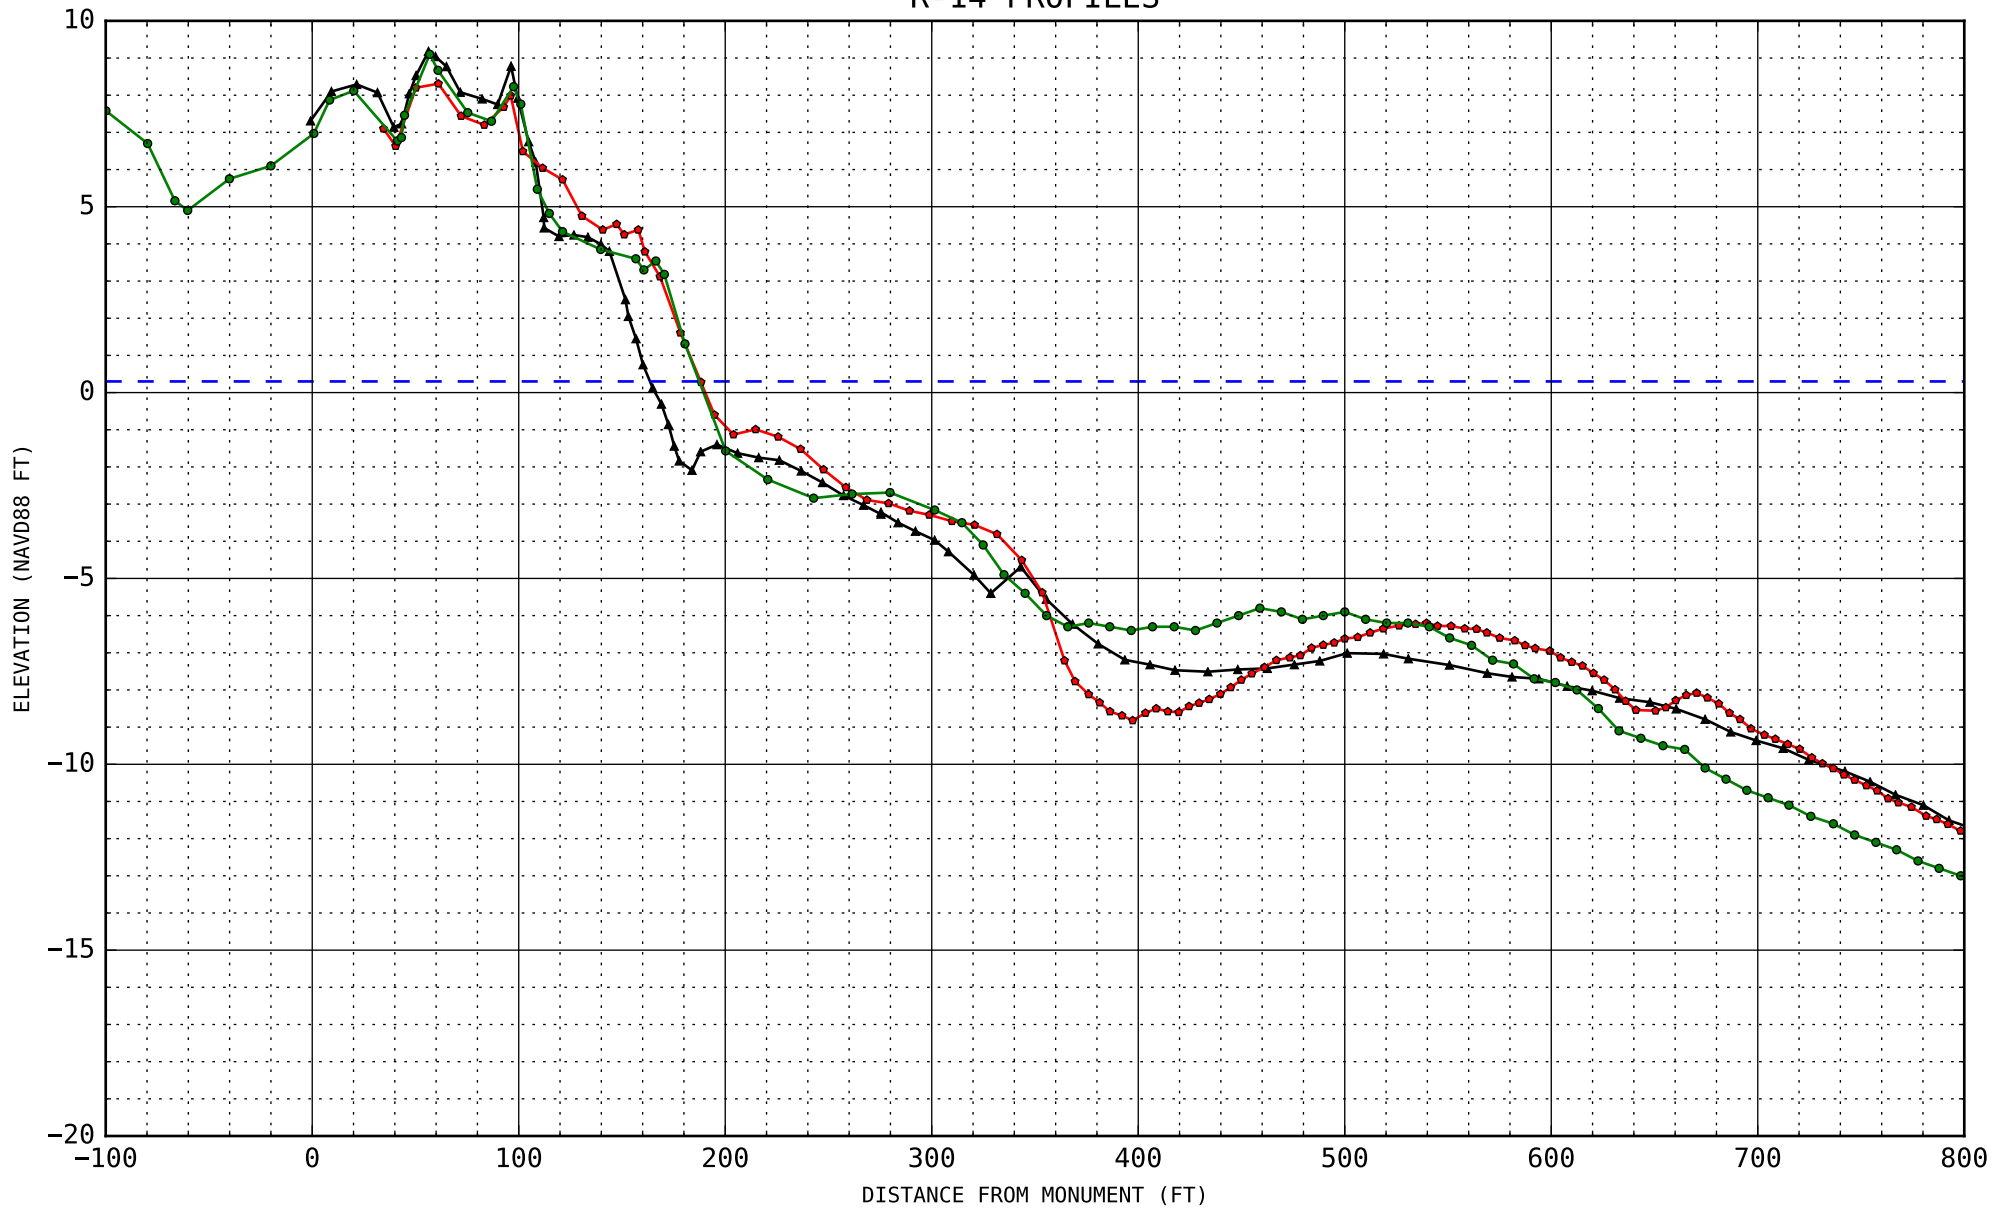
# R-14 PROFILES

2019-JUN MONITORING BY HSS  
 2017-JUL MONITORING BY HSS  
 2014-JUN CONDITION BY ARC  
 MHW CONTOUR (0.3 FT)

RANGE: R-14  
 EST DATE: MAR1974  
 SURVEY DATE: 28JUN19  
 AZIMUTH: 235.0

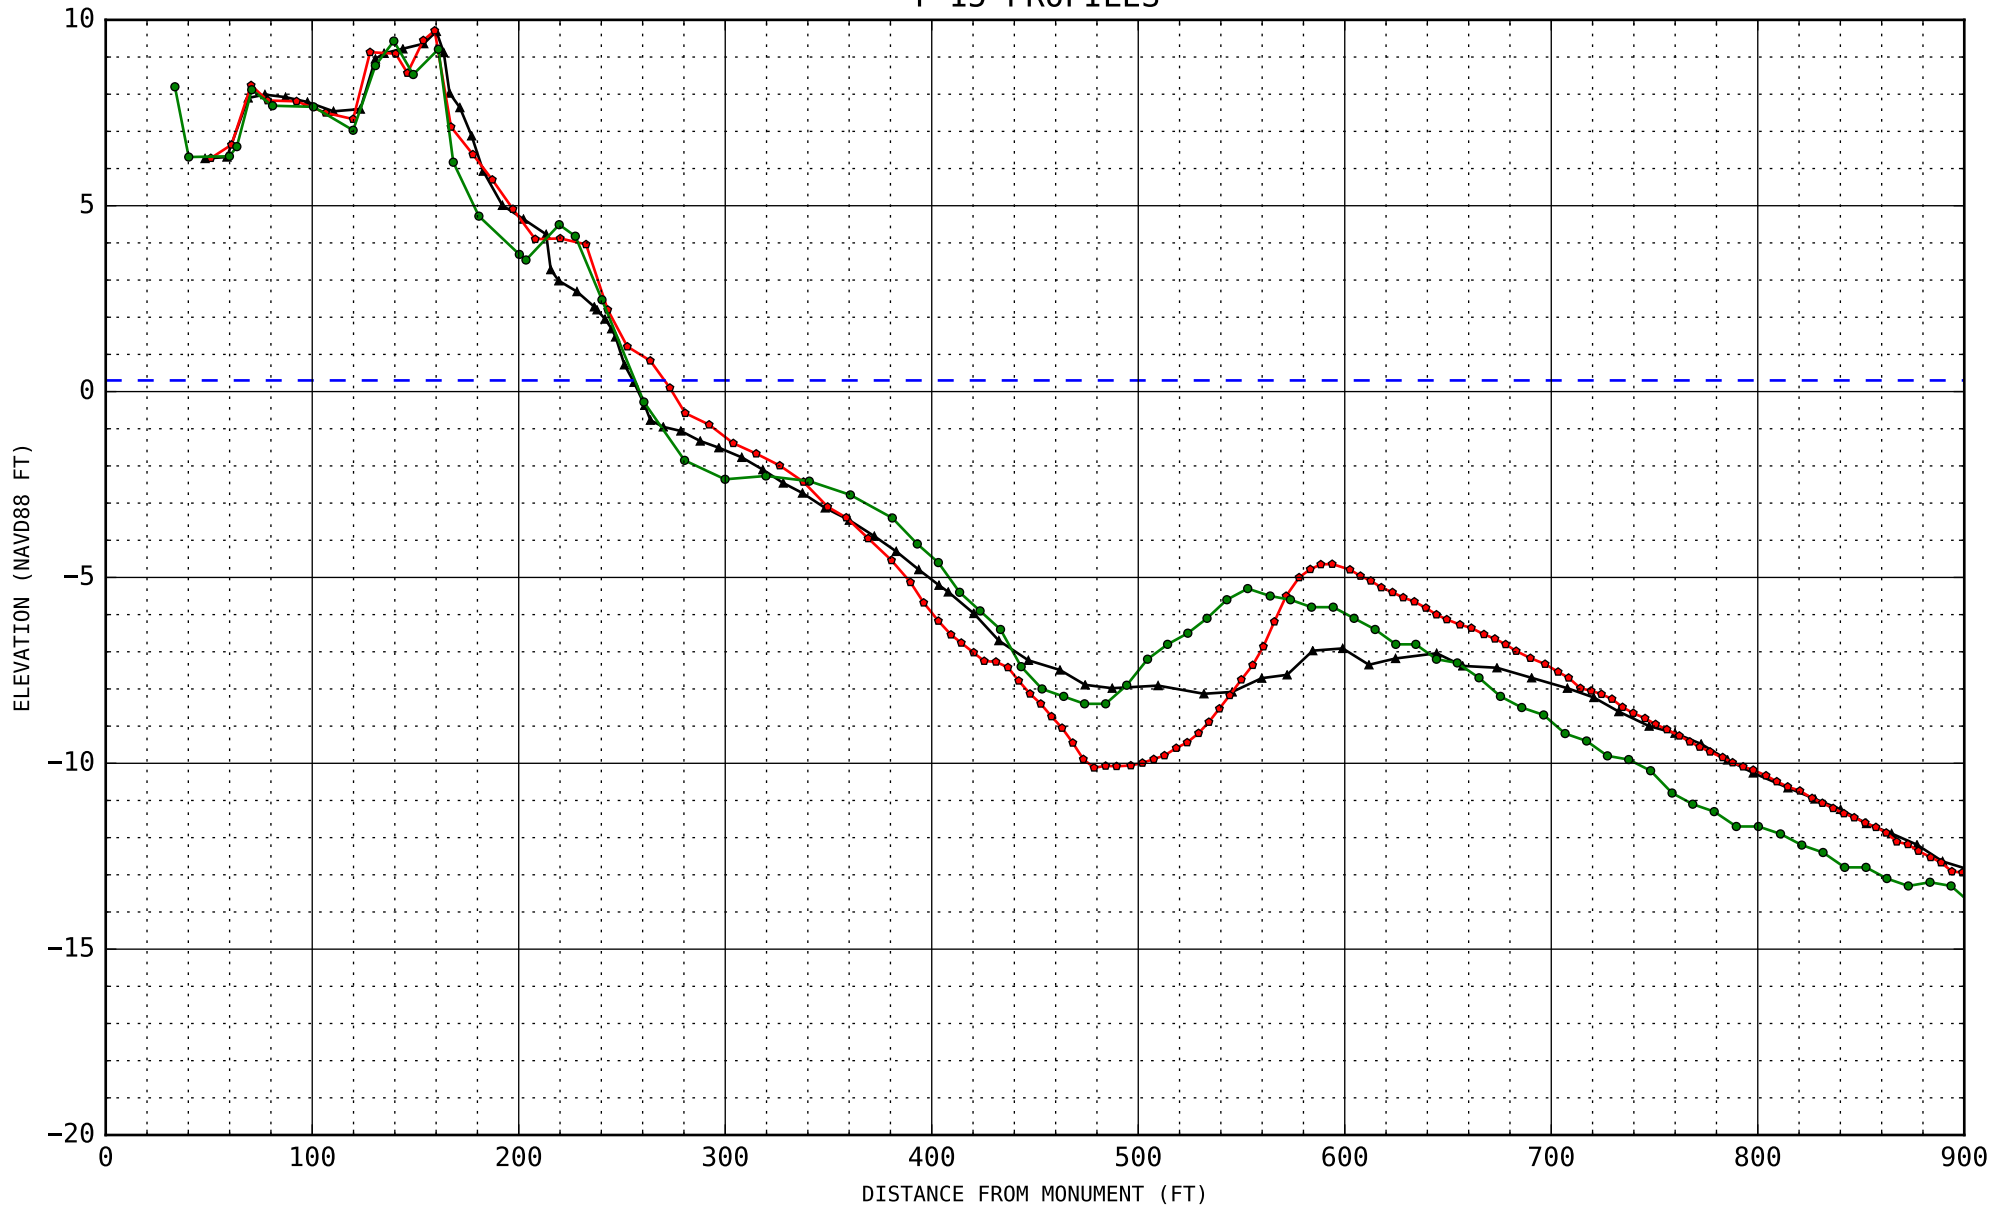
# T-15 PROFILES

- ▲ 2019-JUN MONITORING BY HSS
- 2017-JUL MONITORING BY HSS
- 2014-JUN CONDITION BY ARC
- - - MHW CONTOUR (0.3 FT)

RANGE: T-15  
 EST DATE: JUN1977  
 SURVEY DATE: 28JUN19  
 AZIMUTH: 235.0

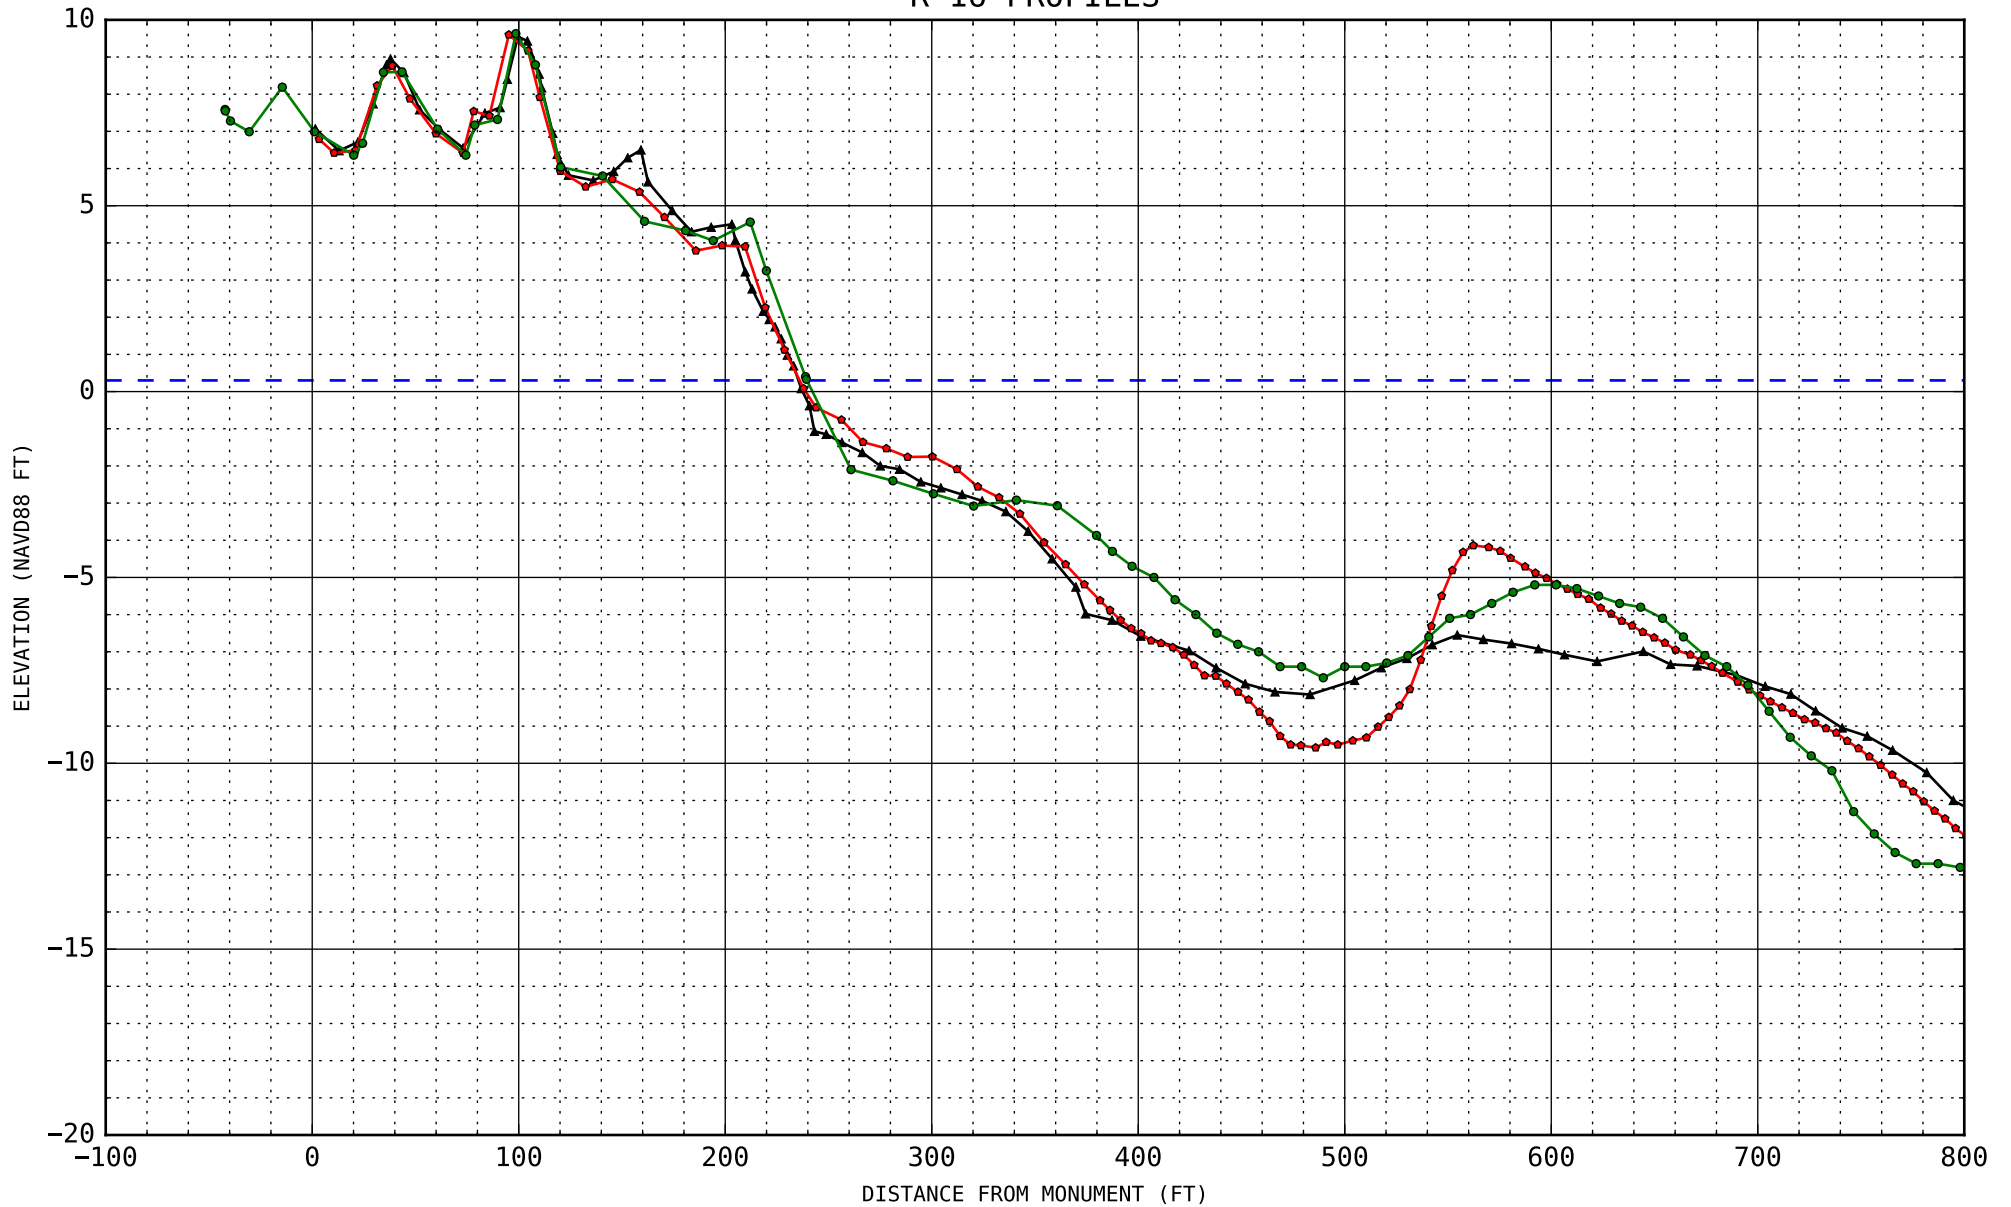
# R-16 PROFILES

| <p>▲ 2019-JUN MONITORING BY HSS</p> <p>● 2017-JUL MONITORING BY HSS</p> <p>● 2014-JUN CONDITION BY ARC</p> <p>- - - MHW CONTOUR (0.3 FT)</p> | <p>SARASOTA</p> <p>PROGRAM SUPPORT GIS</p> <p>DIVISION OF WATER RESOURCE MANAGEMENT</p> <p>FLORIDA DEPARTMENT OF ENVIRONMENTAL PROTECTION</p> | <p>RANGE: R-16</p> <p>EST DATE: CPE1993</p> <p>SURVEY DATE: 28JUN19</p> <p>AZIMUTH: 235.0</p> |

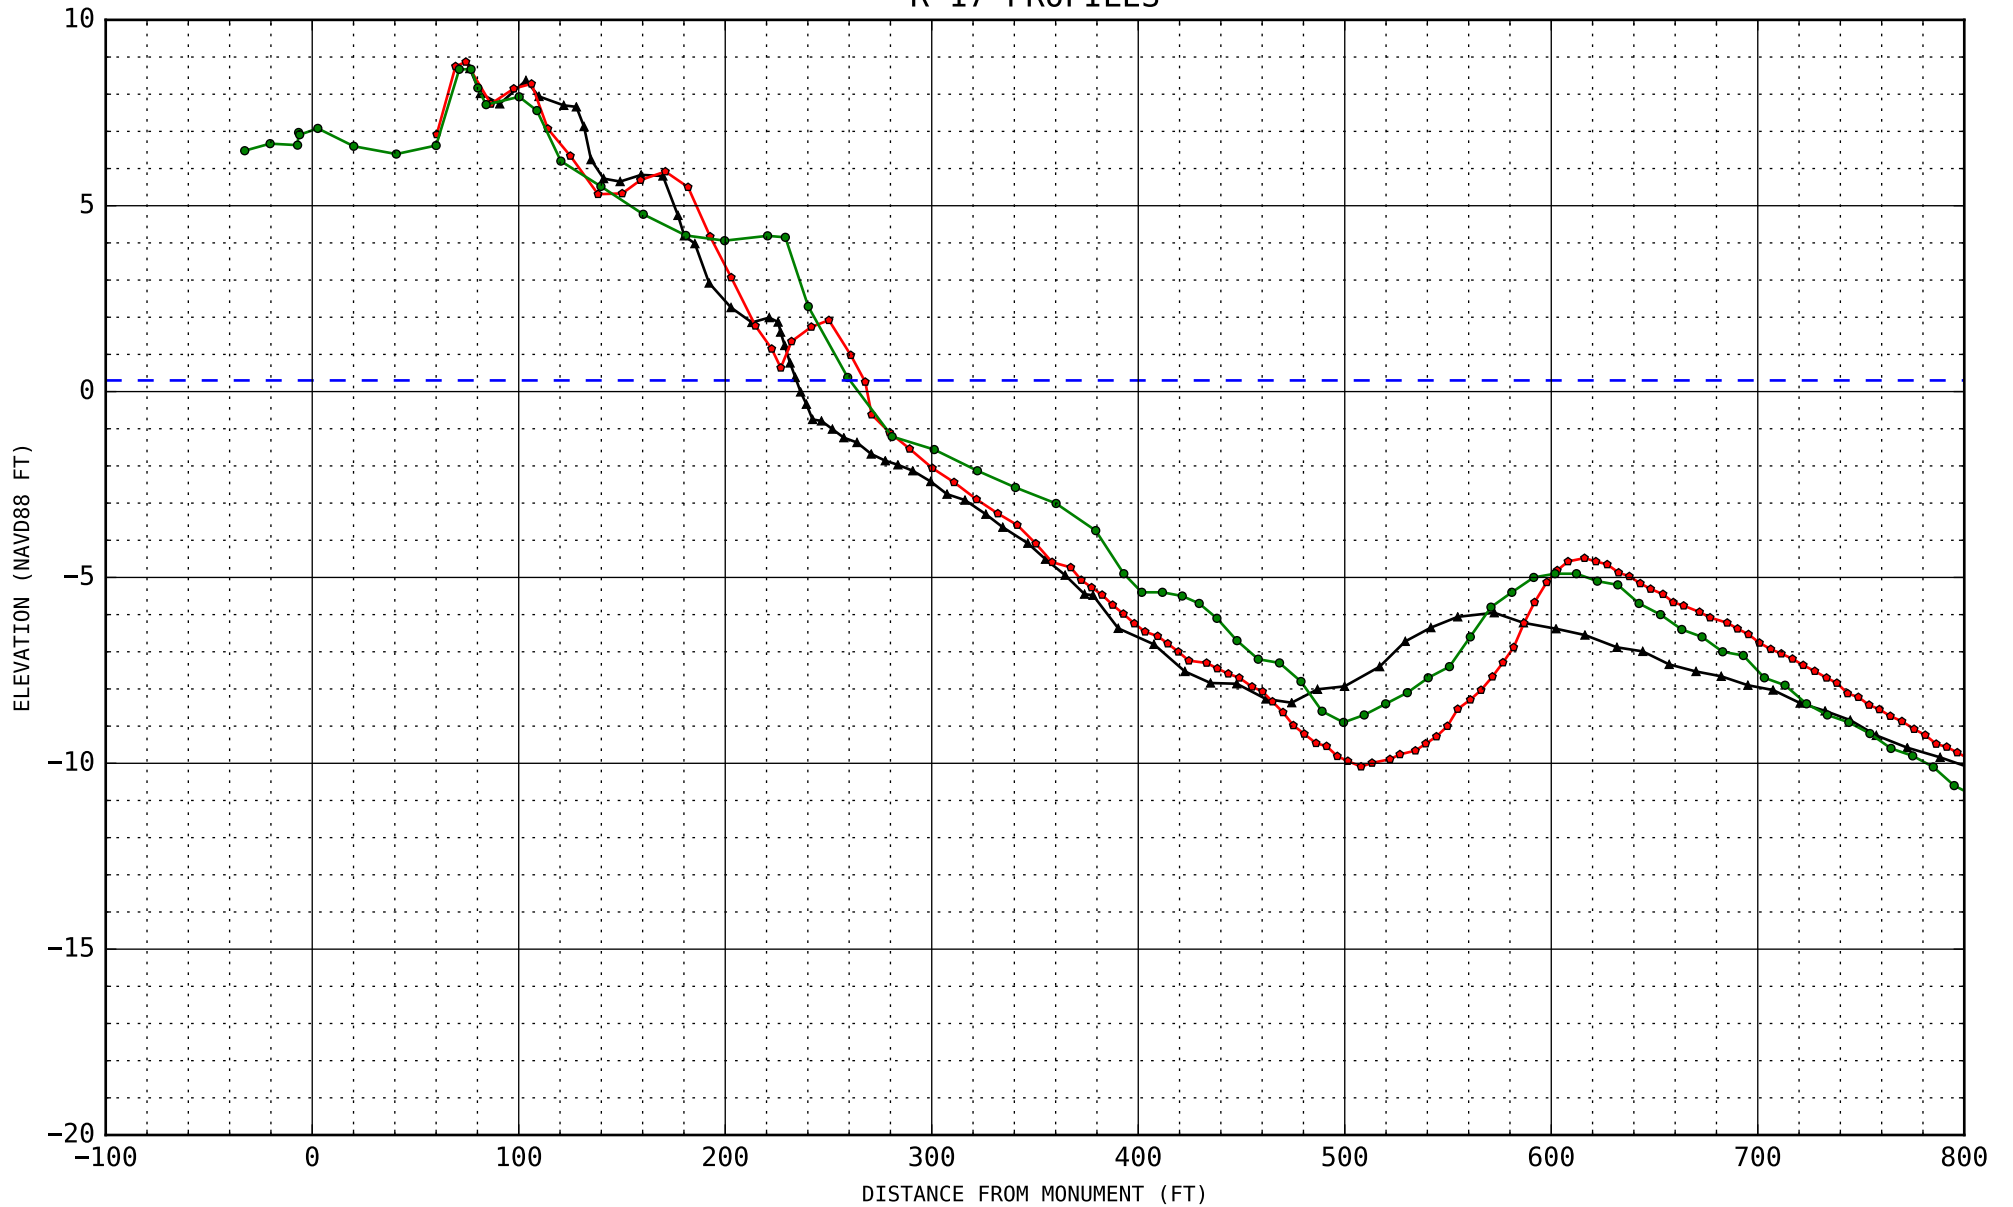
# R-17 PROFILES

- ▲ 2019-JUN MONITORING BY HSS
- 2017-JUL MONITORING BY HSS
- 2014-JUN CONDITION BY ARC
- - - MHW CONTOUR (0.3 FT)

RANGE: R-17  
 EST DATE: JAN1985  
 SURVEY DATE: 28JUN19  
 AZIMUTH: 235.0

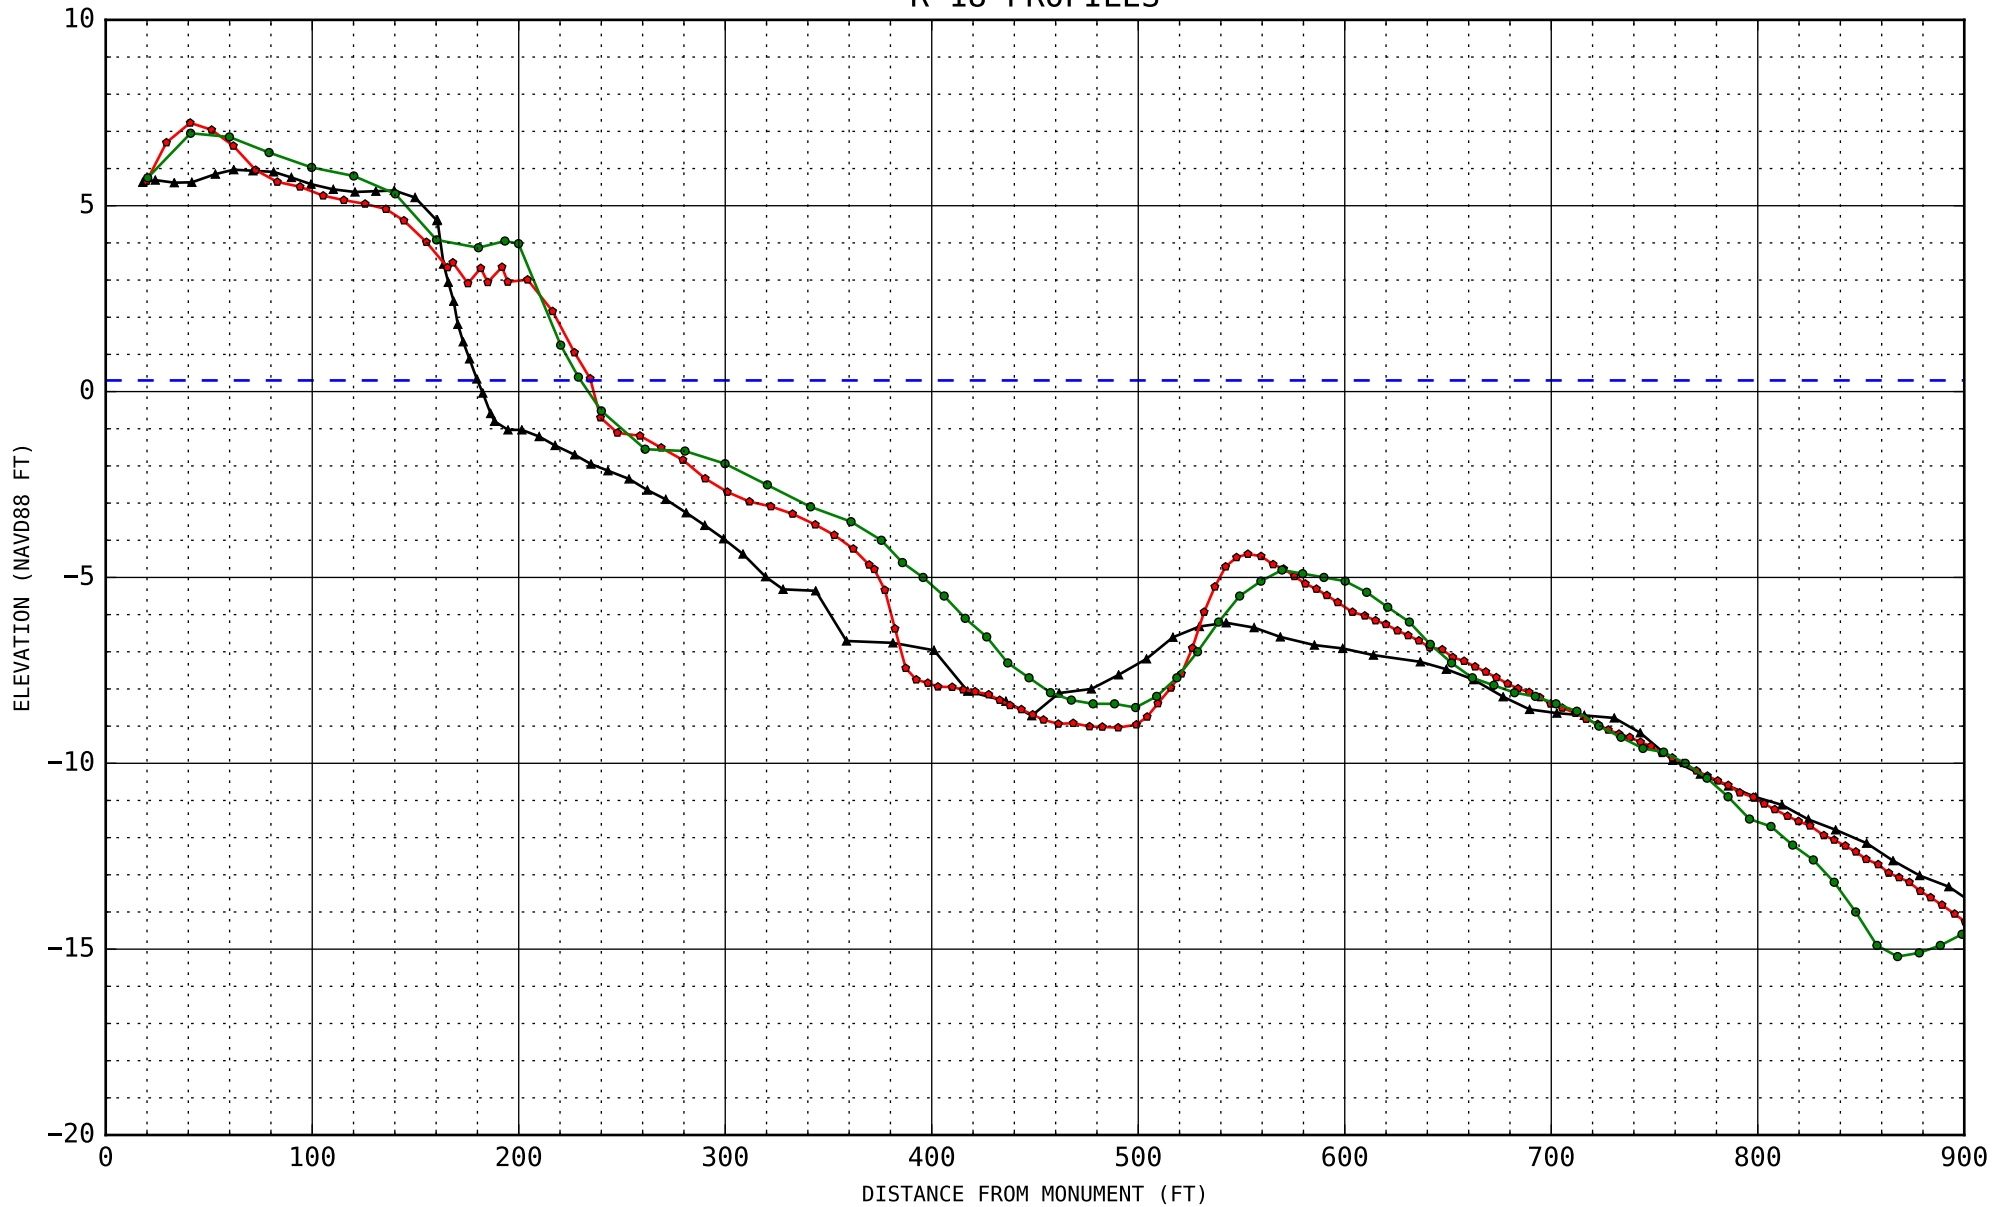
# R-18 PROFILES

- ▲ 2019-JUN MONITORING BY HSS
- 2017-JUL MONITORING BY HSS
- 2014-JUN CONDITION BY ARC
- - - MHW CONTOUR (0.3 FT)

RANGE: R-18  
EST DATE: APR1987  
SURVEY DATE: 28JUN19  
AZIMUTH: 230.0

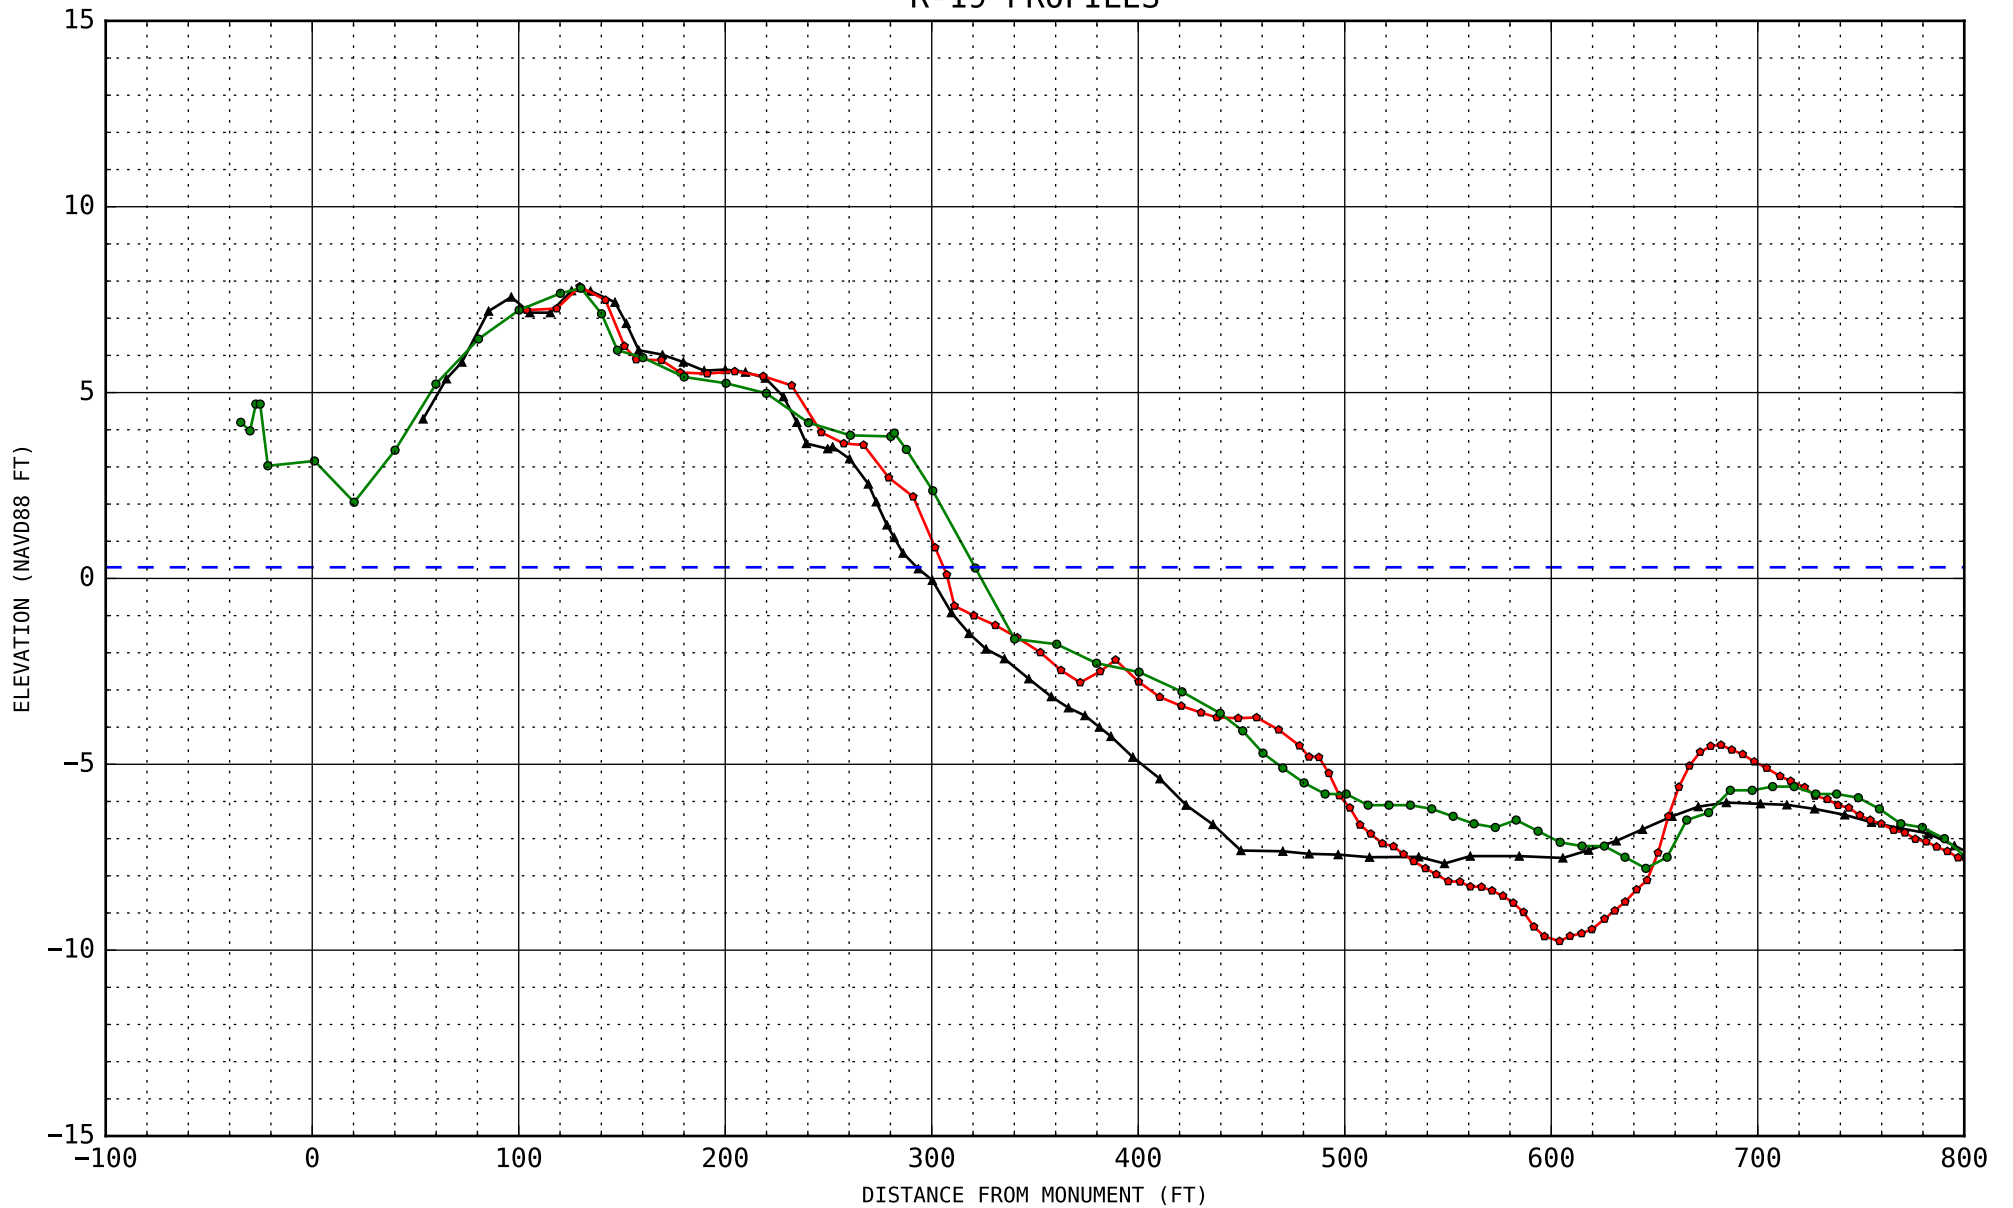
# R-19 PROFILES

- ▲ 2019-JUN MONITORING BY HSS
- 2017-JUL MONITORING BY HSS
- 2014-JUN CONDITION BY ARC
- - - MHW CONTOUR (0.3 FT)

RANGE: R-19  
EST DATE: JAN1985  
SURVEY DATE: 01JUL19  
AZIMUTH: 230.0

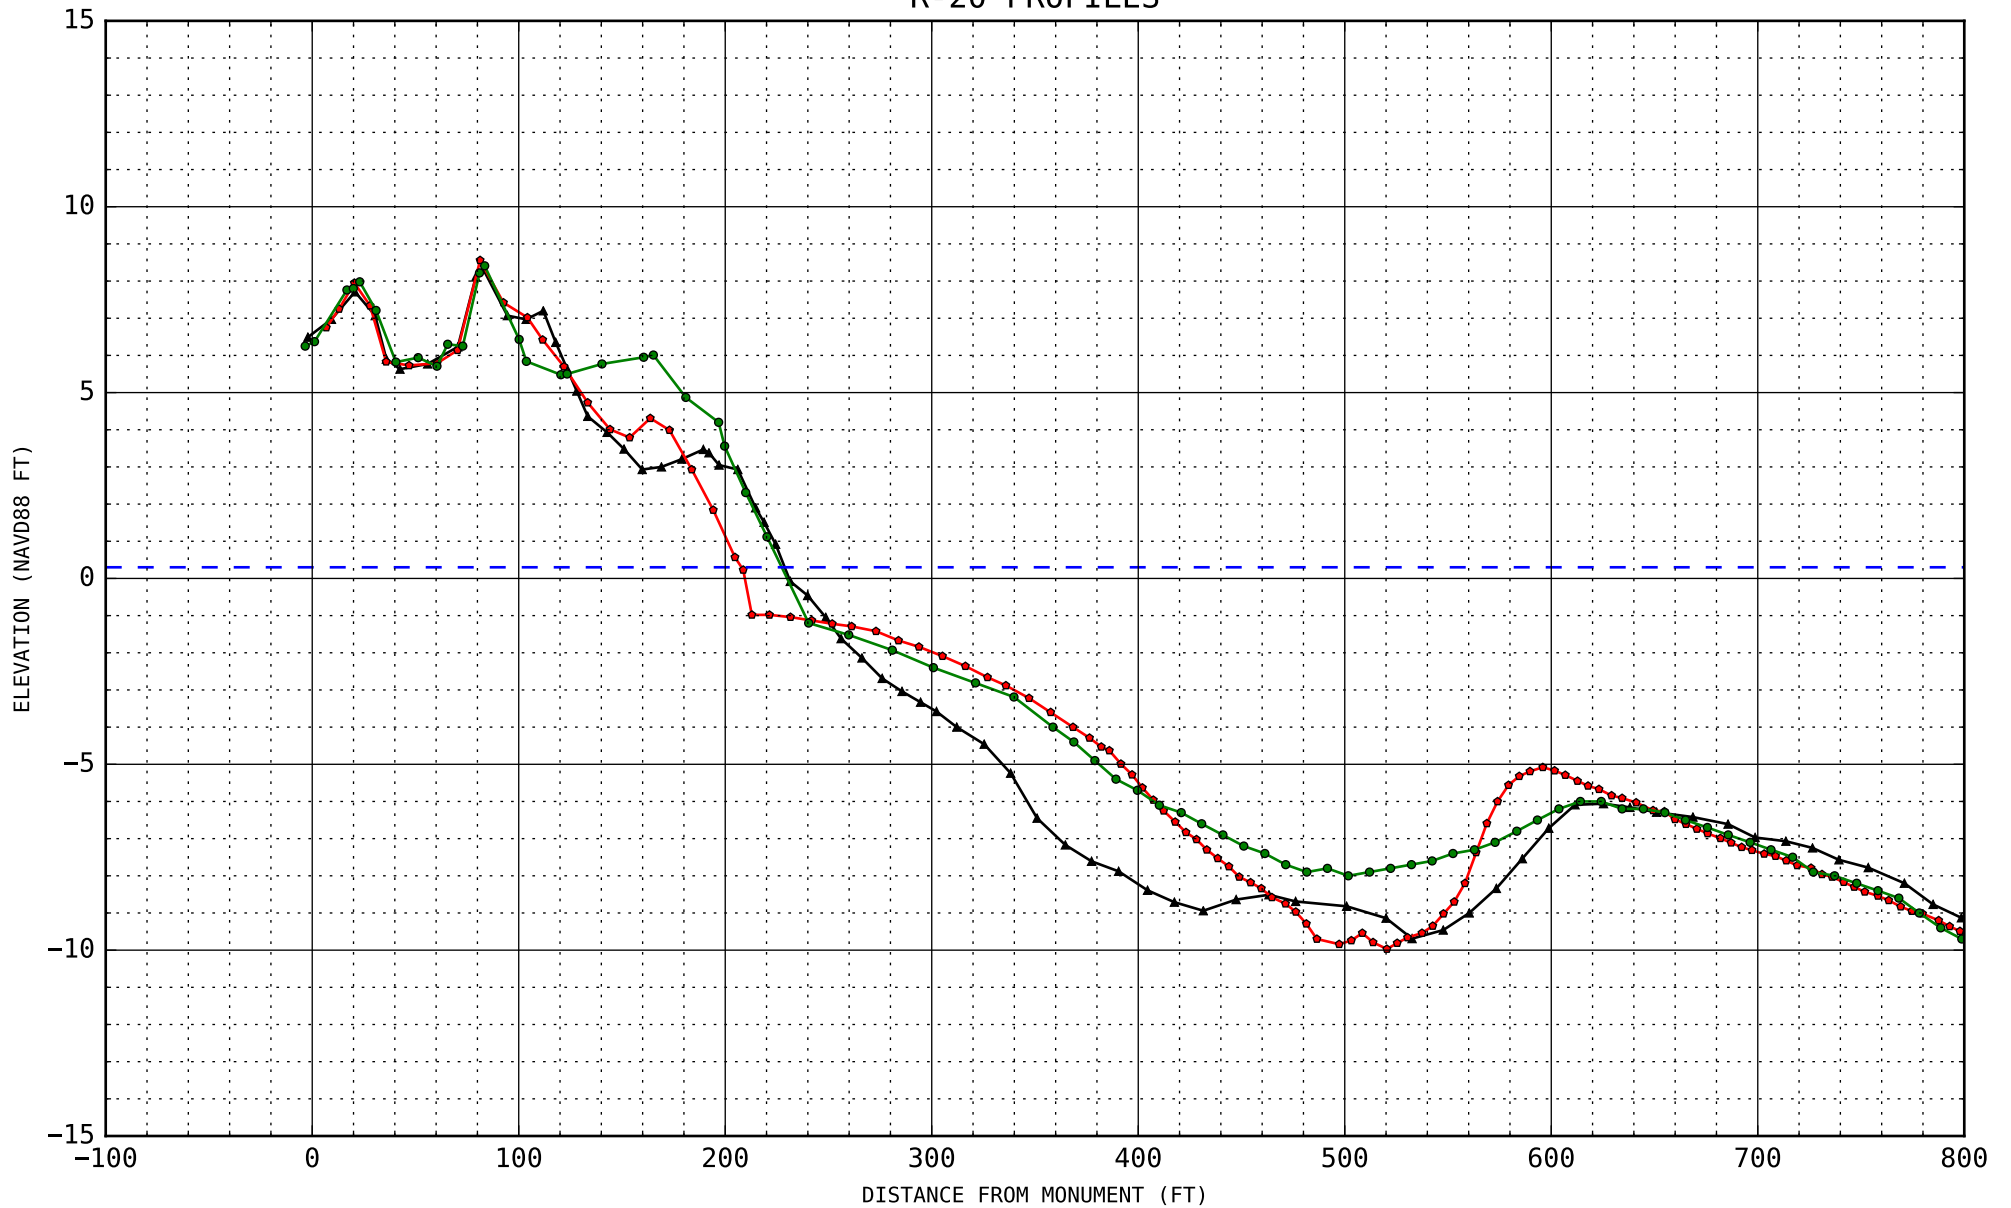
# R-20 PROFILES

▲ 2019-JUN MONITORING BY HSS  
 ● 2017-JUL MONITORING BY HSS  
 ● 2014-JUN CONDITION BY ARC  
 - - - MHW CONTOUR (0.3 FT)

RANGE: R-20  
 EST DATE: SSCCM  
 SURVEY DATE: 01JUL19  
 AZIMUTH: 230.0
