T-1 PROFILES

| ● 2017-JUL MONITORING BY HSS | PROGRAM SUPPORT GIS | EST DATE: MECM |
| ● 2014-JUN CONDITION BY ARC | DIVISION OF WATER RESOURCE MANAGEMENT | SURVEY DATE: 27JUN19 |

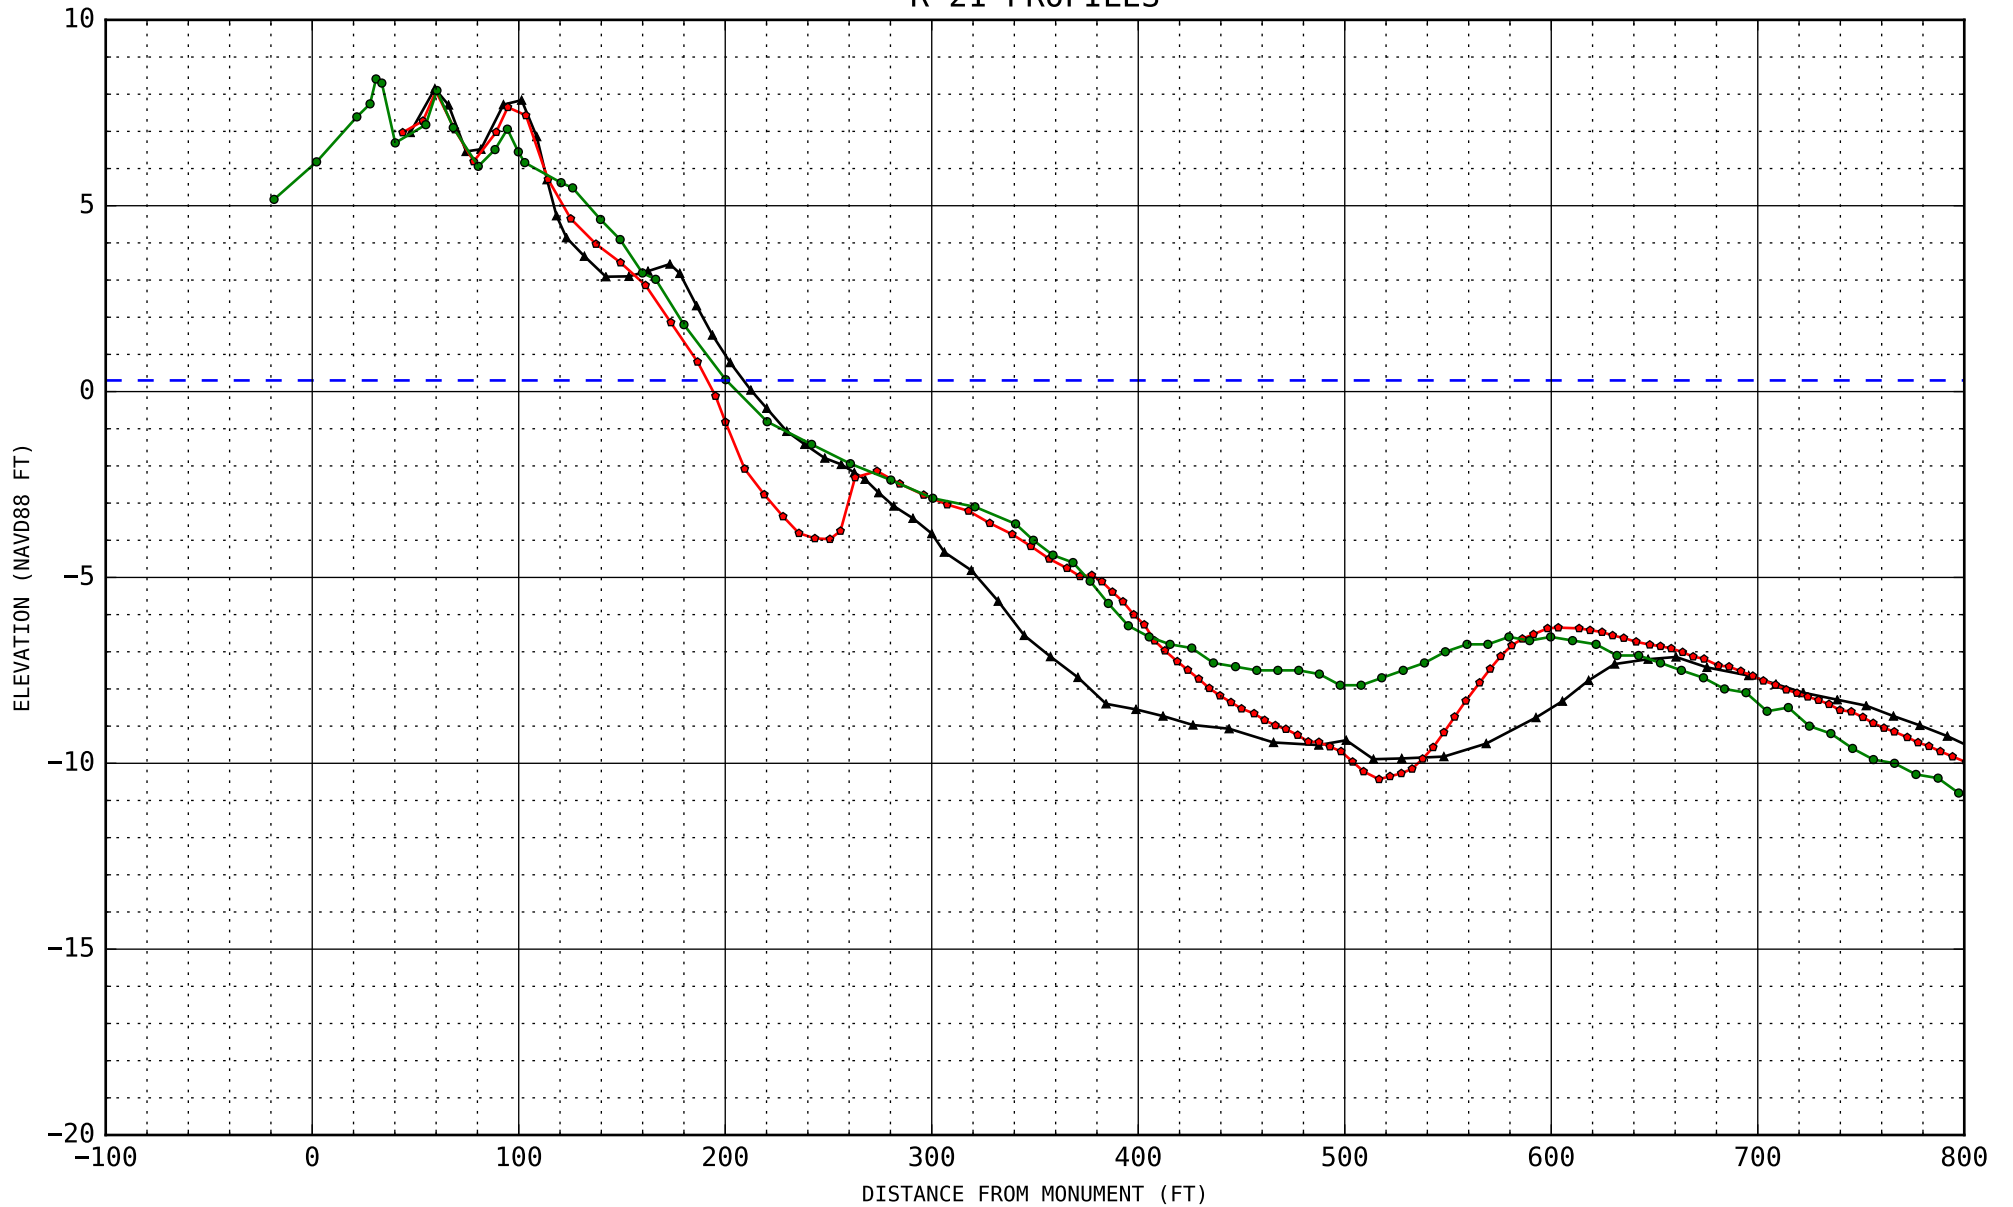
# R-21 PROFILES

- ▲ 2019-JUN MONITORING BY HSS
- 2017-JUL MONITORING BY HSS
- 2014-JUN CONDITION BY ARC
- - - MHW CONTOUR (0.3 FT)

RANGE: R-21  
EST DATE: JAN1985  
SURVEY DATE: 01JUL19  
AZIMUTH: 230.0

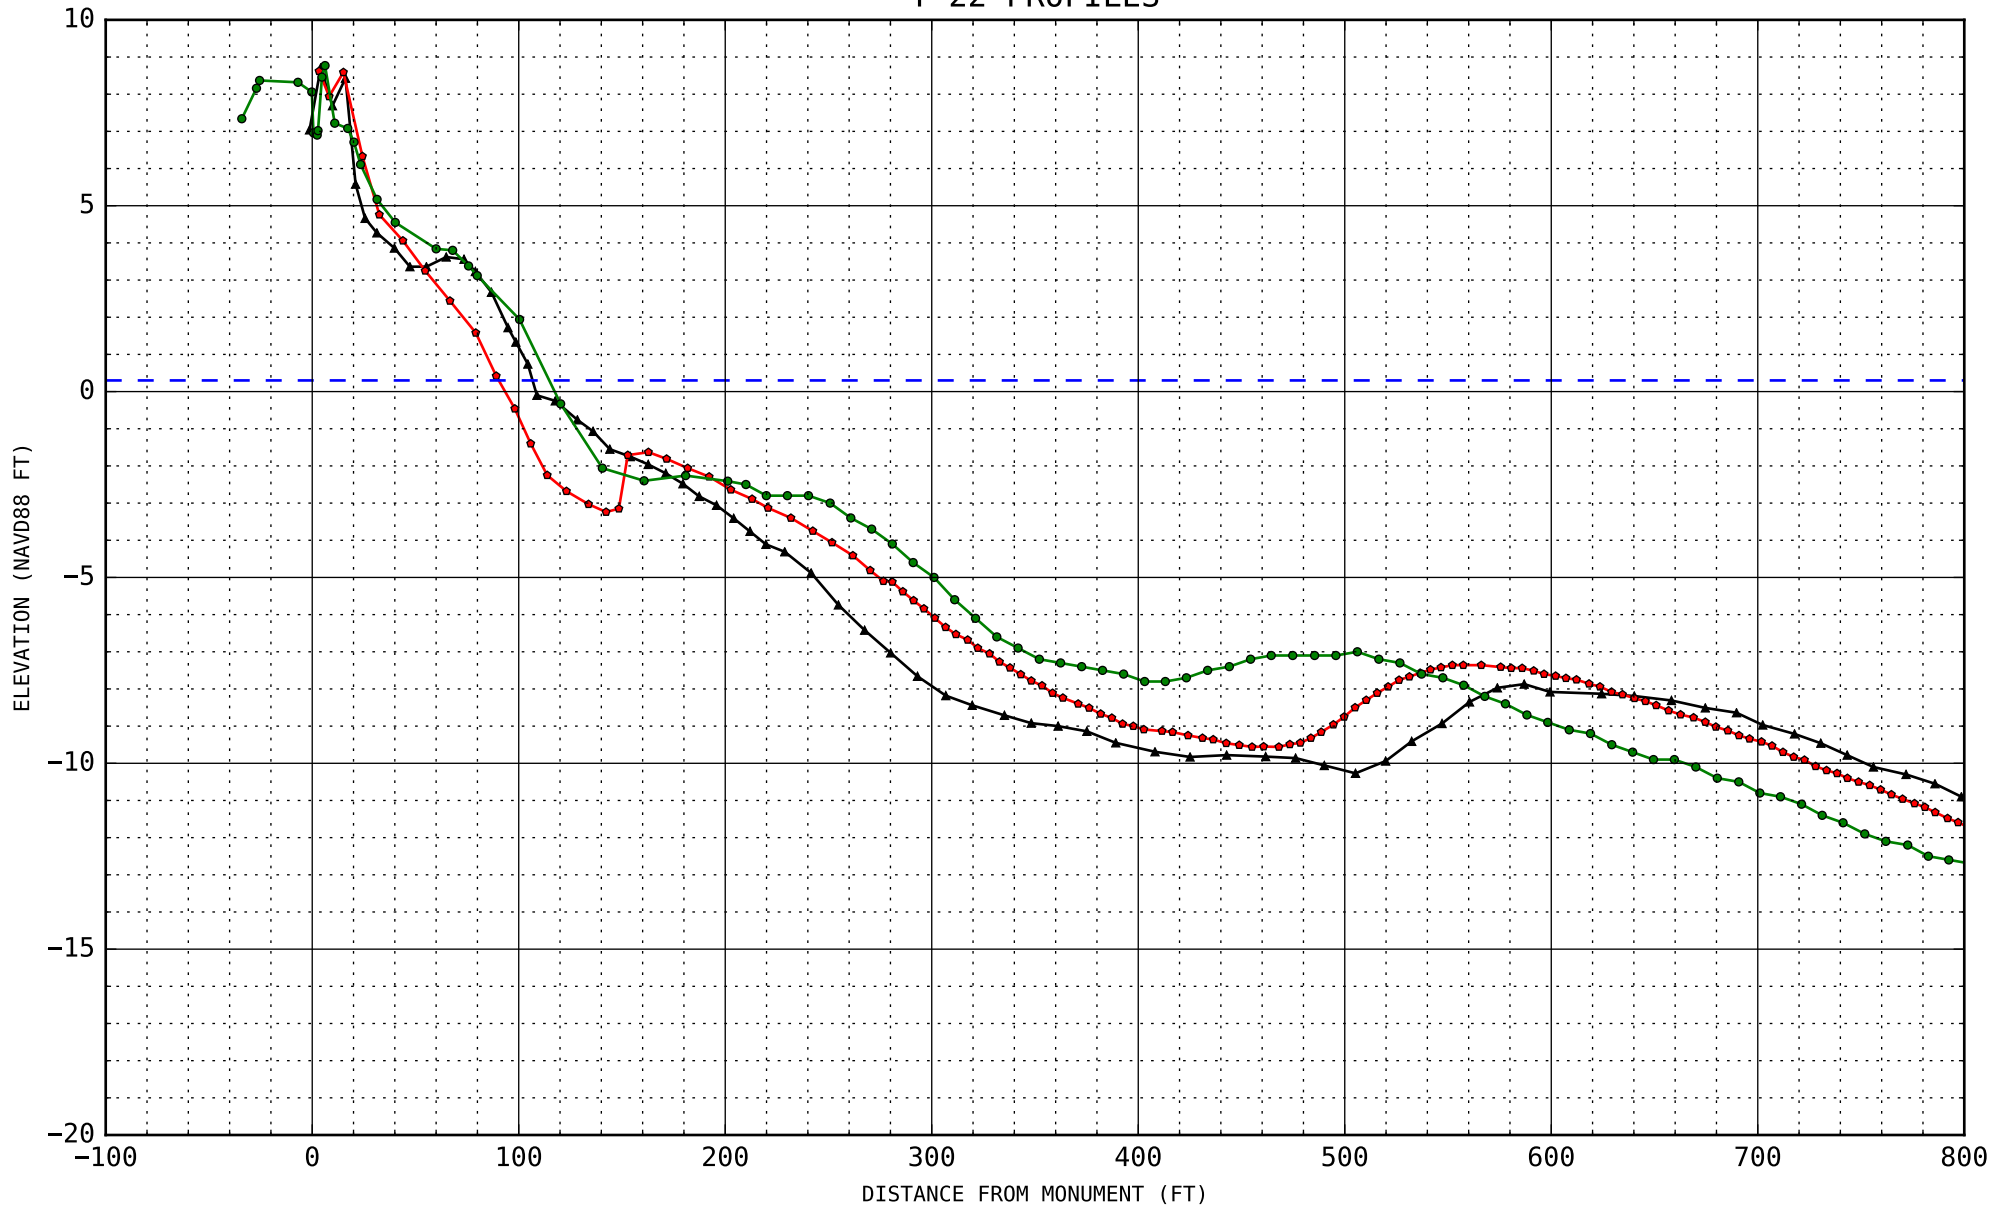
# T-22 PROFILES

- ▲ 2019-JUN MONITORING BY HSS
- 2017-JUL MONITORING BY HSS
- 2014-JUN CONDITION BY ARC
- - - MHW CONTOUR (0.3 FT)

RANGE: T-22  
EST DATE: CPEDISK  
SURVEY DATE: 01JUL19  
AZIMUTH: 230.0

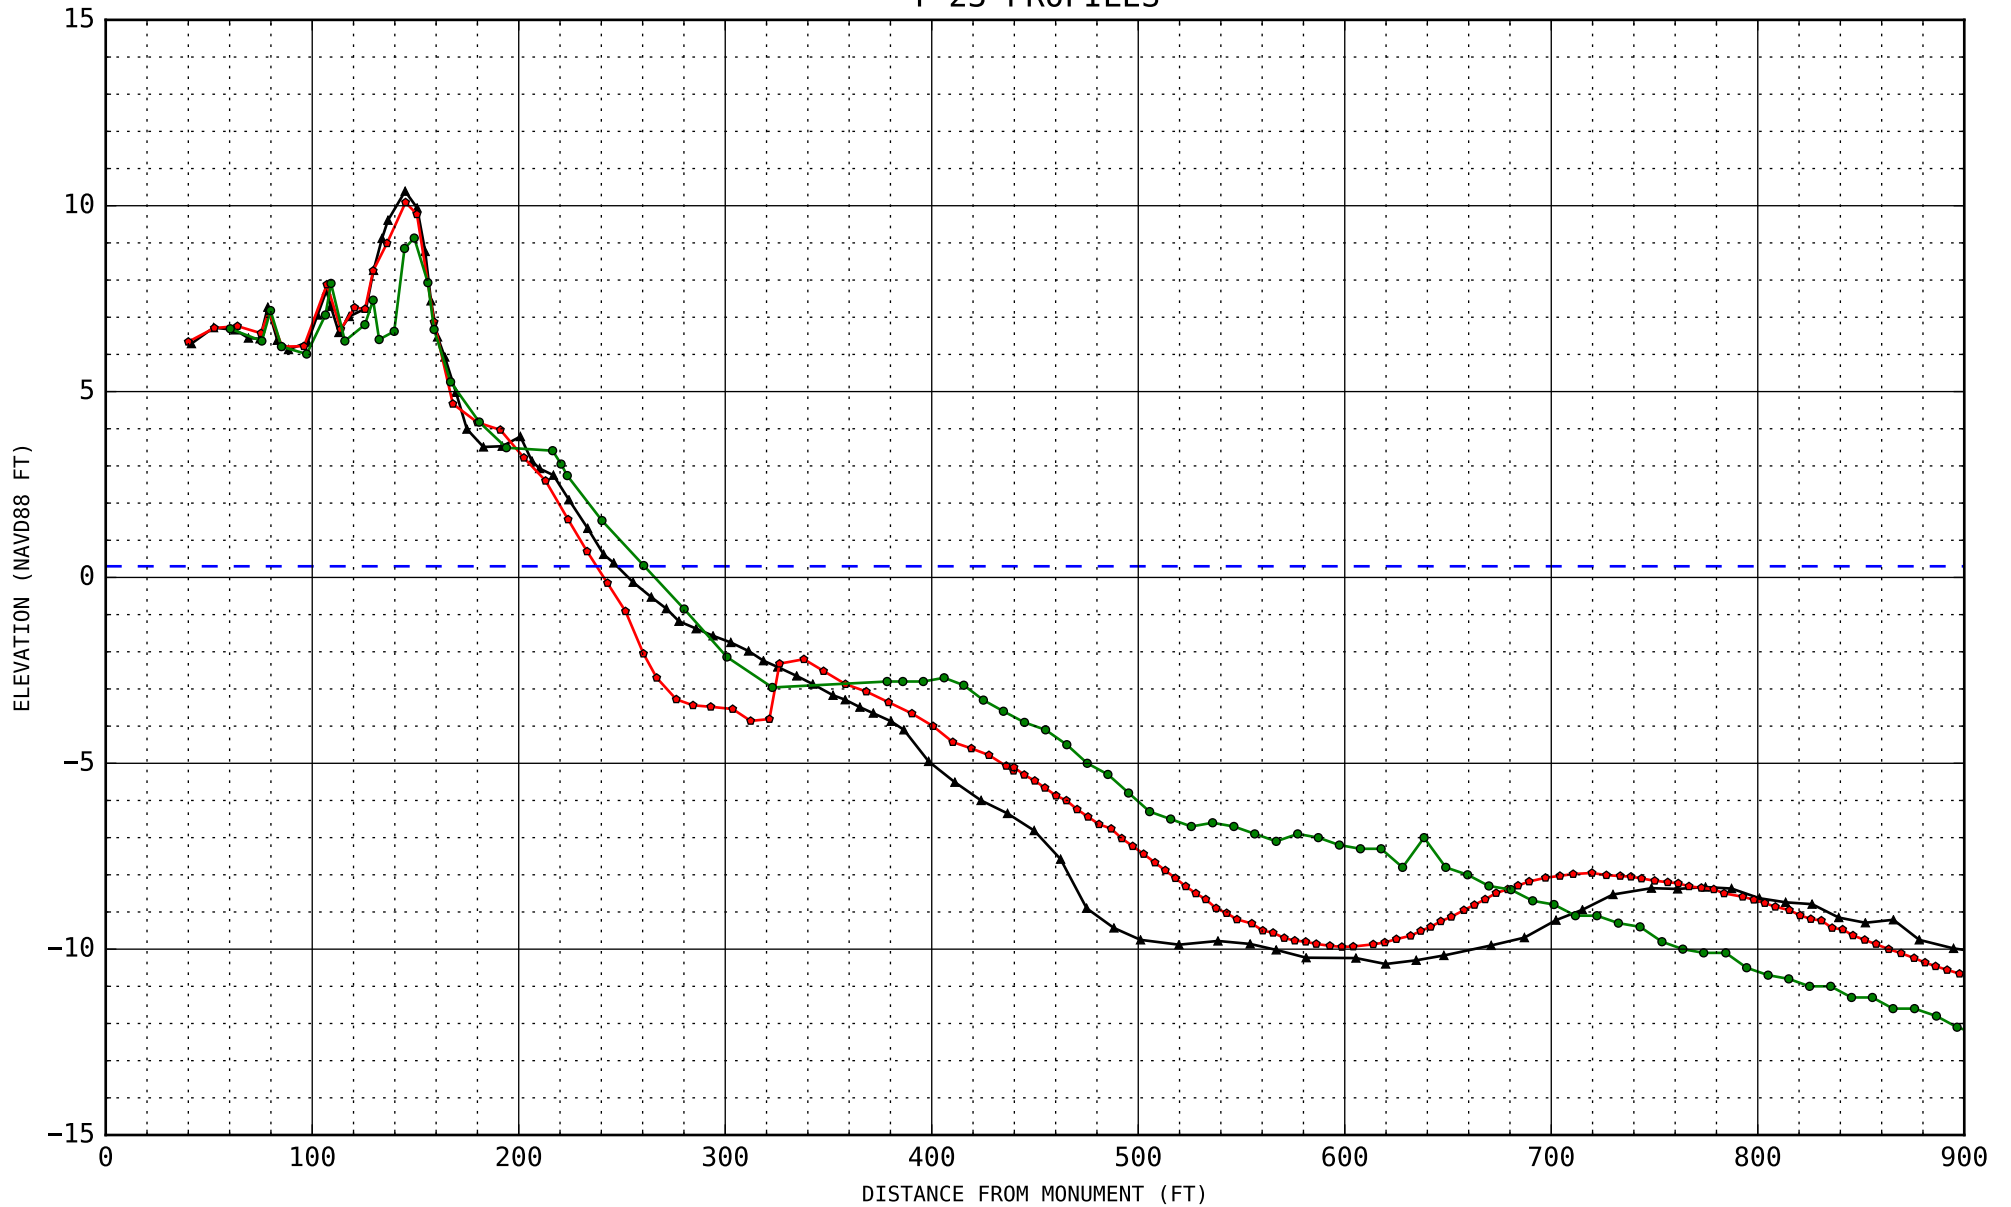
# T-23 PROFILES

▲ 2019-JUN MONITORING BY HSS  
 ● 2017-JUL MONITORING BY HSS  
 ● 2014-JUN CONDITION BY ARC  
 - - - MHW CONTOUR (0.3 FT)

RANGE: T-23  
 EST DATE: JUN1977  
 SURVEY DATE: 01JUL19  
 AZIMUTH: 230.0

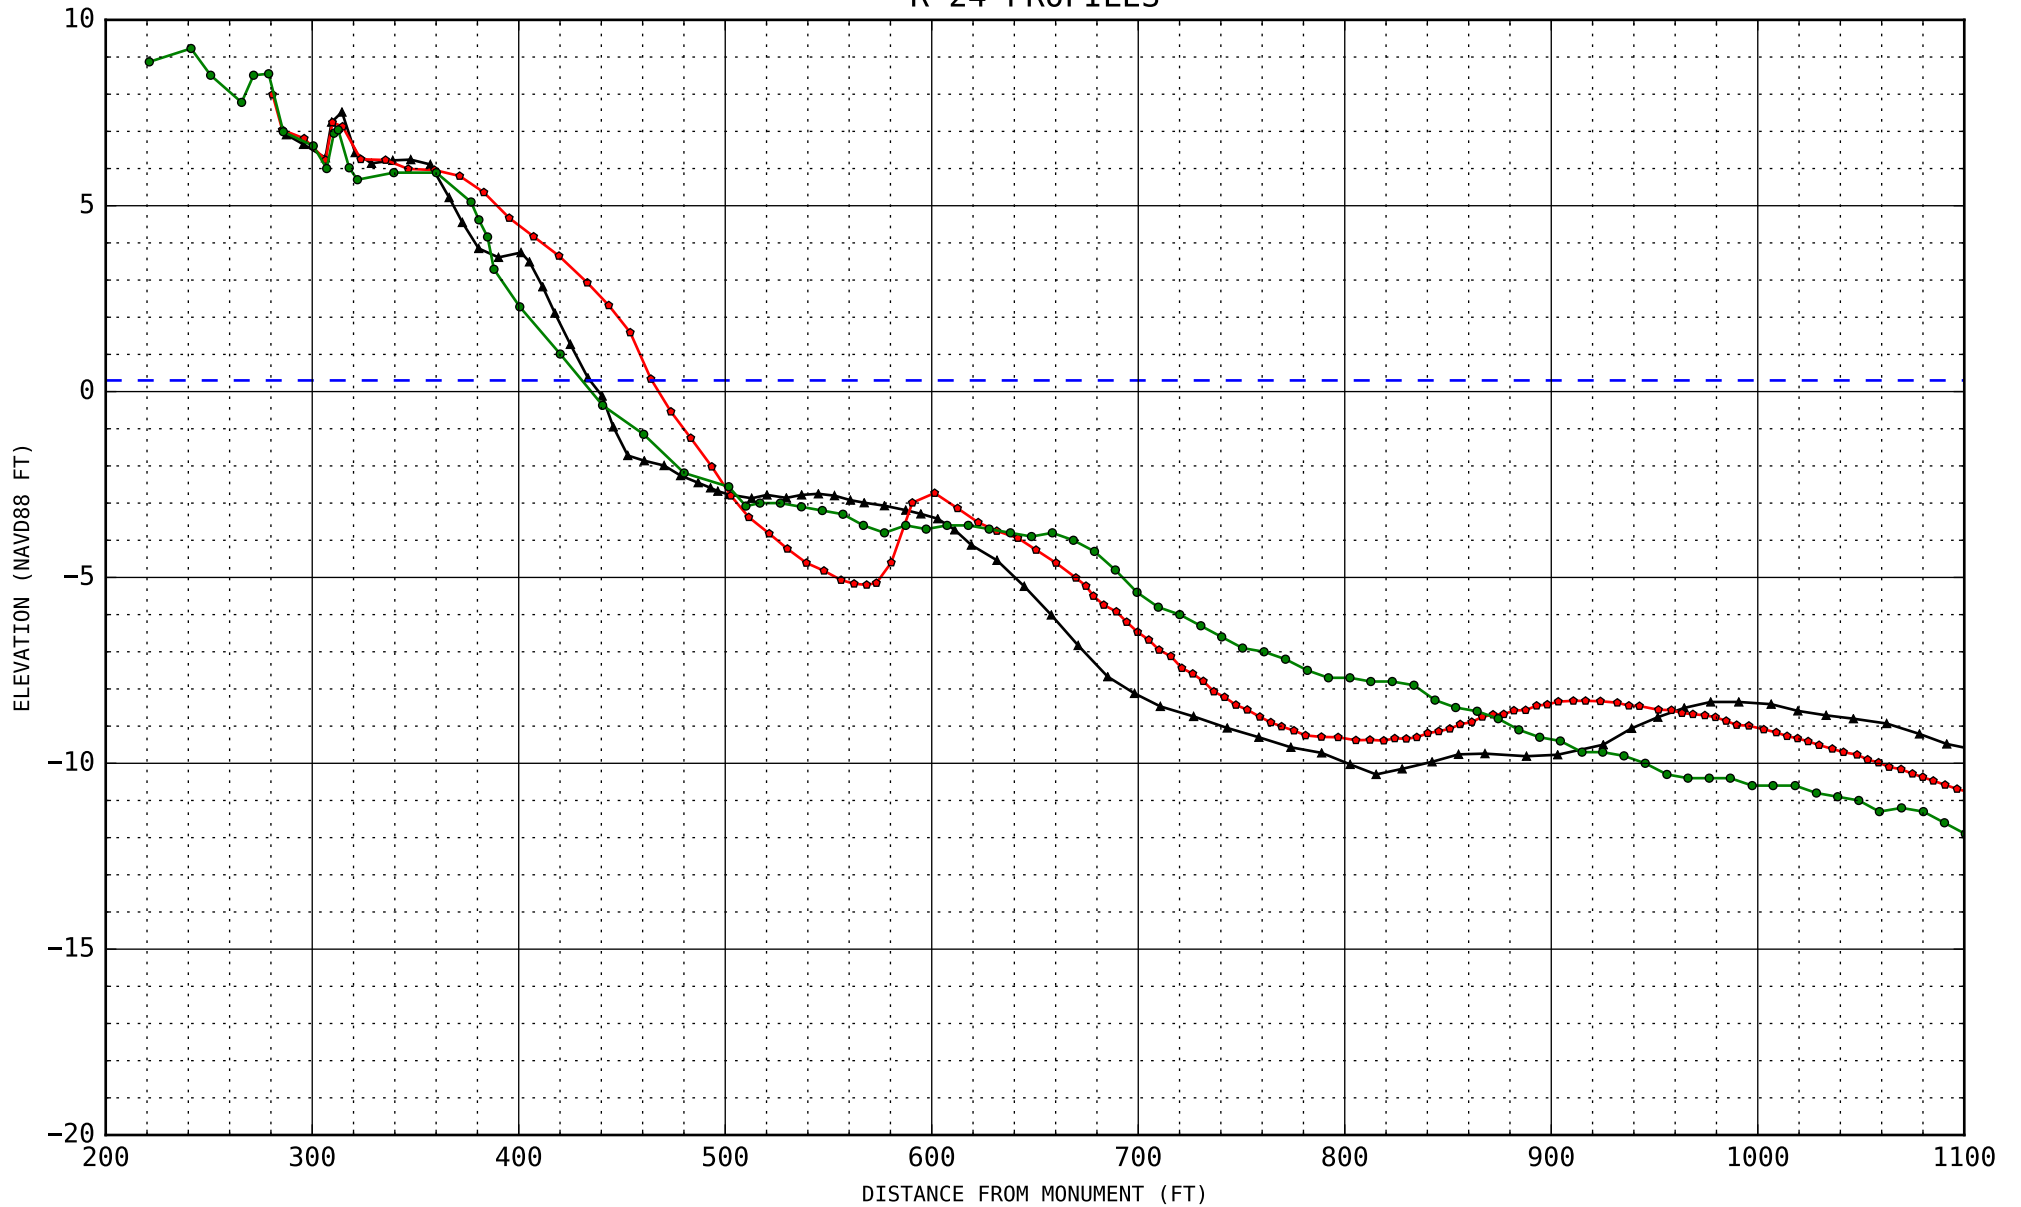
# R-24 PROFILES

▲ 2019-JUN MONITORING BY HSS  
 ● 2017-JUL MONITORING BY HSS  
 ● 2014-JUN CONDITION BY ARC  
 - - - MHW CONTOUR (0.3 FT)

RANGE: R-24  
 EST DATE: DNR1985  
 SURVEY DATE: 01JUL19  
 AZIMUTH: 230.0

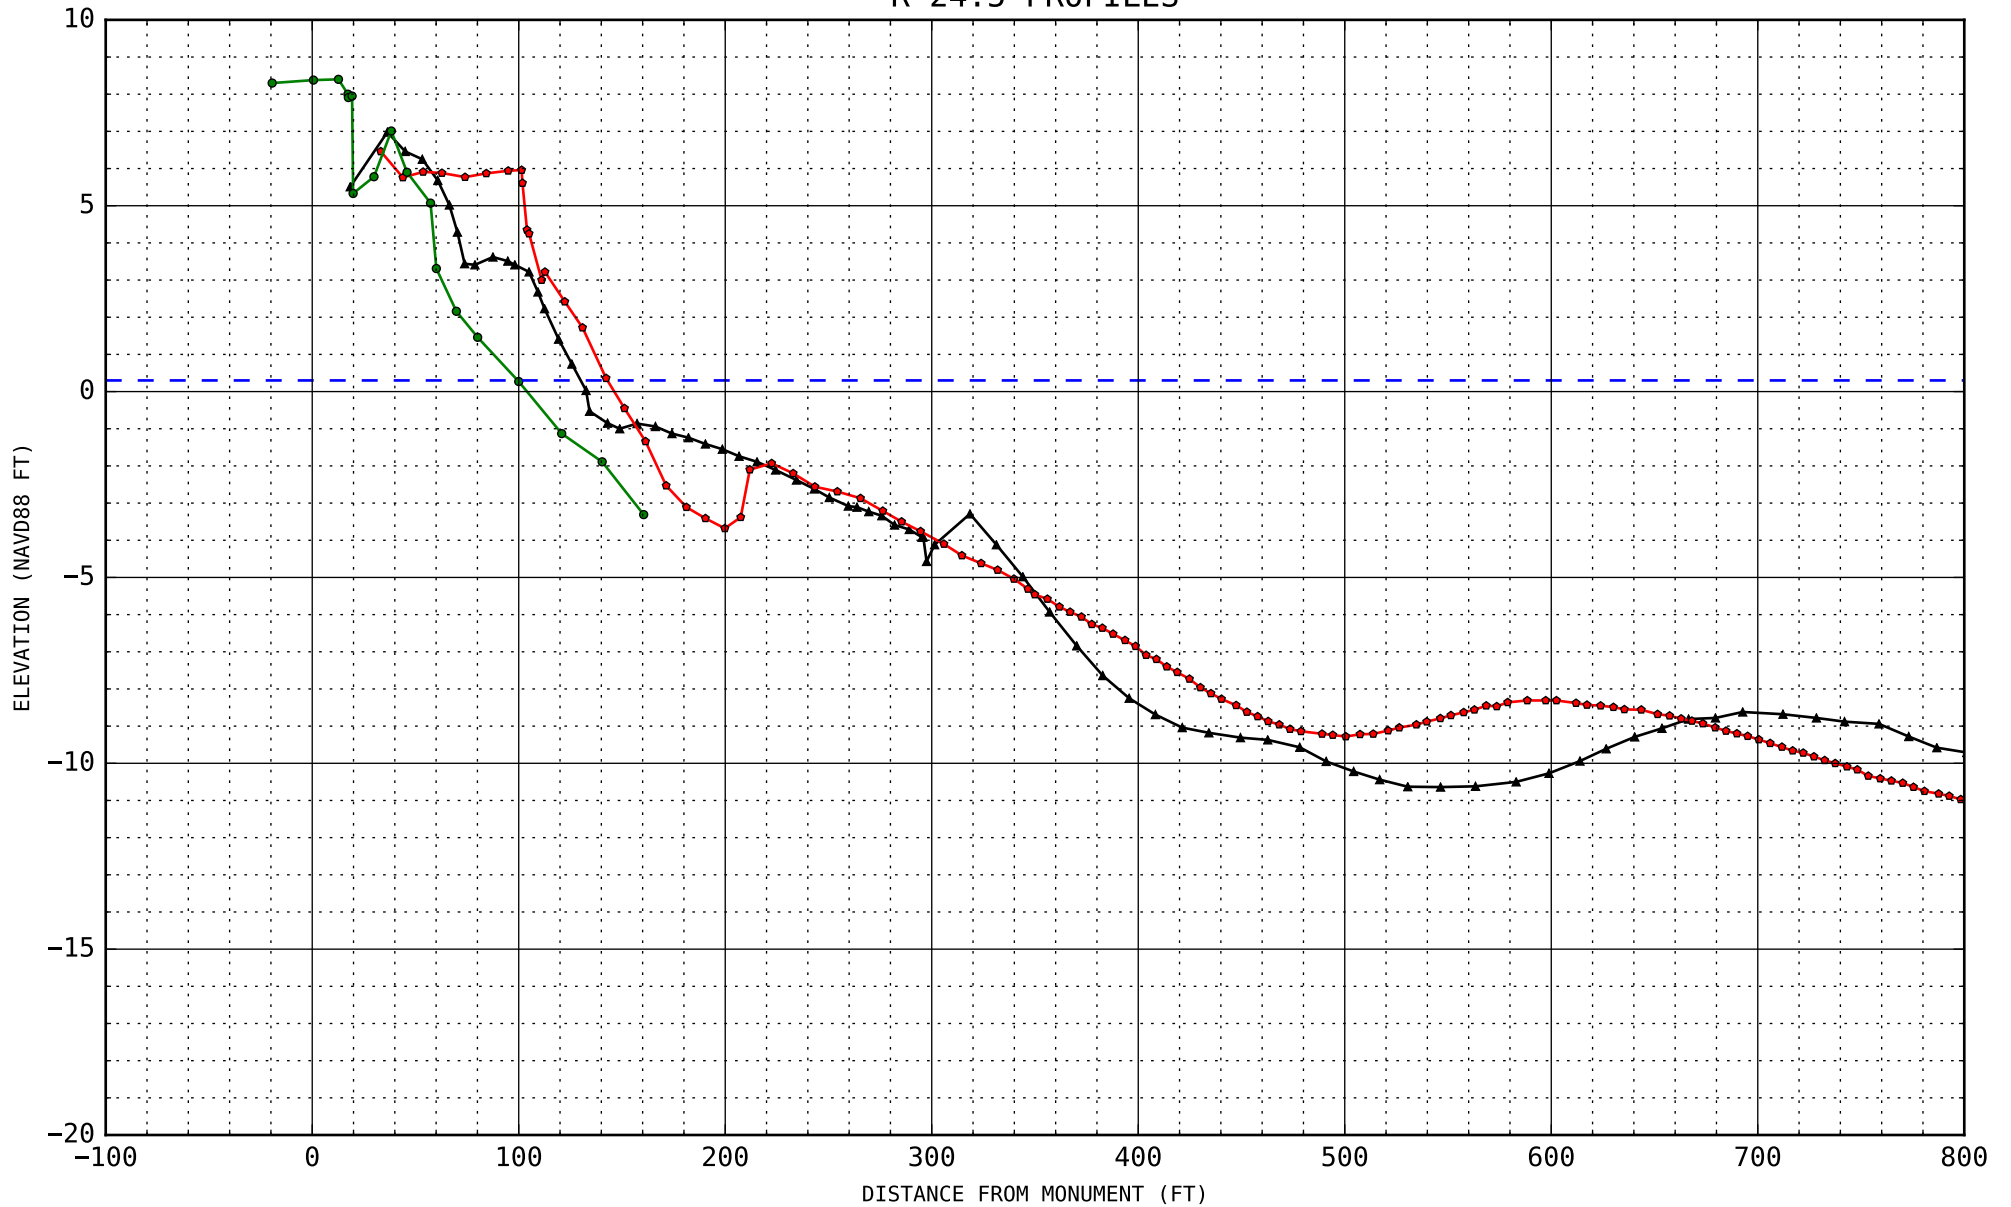
# R-24.5 PROFILES

▲ 2019-JUN MONITORING BY HSS  
 ● 2017-JUL MONITORING BY HSS  
 ● 2014-JUN CONDITION BY ARC  
 - - - MHW CONTOUR (0.3 FT)

RANGE: R-24.5  
 EST DATE: ARC2014  
 SURVEY DATE: 01JUL19  
 AZIMUTH: 230.0

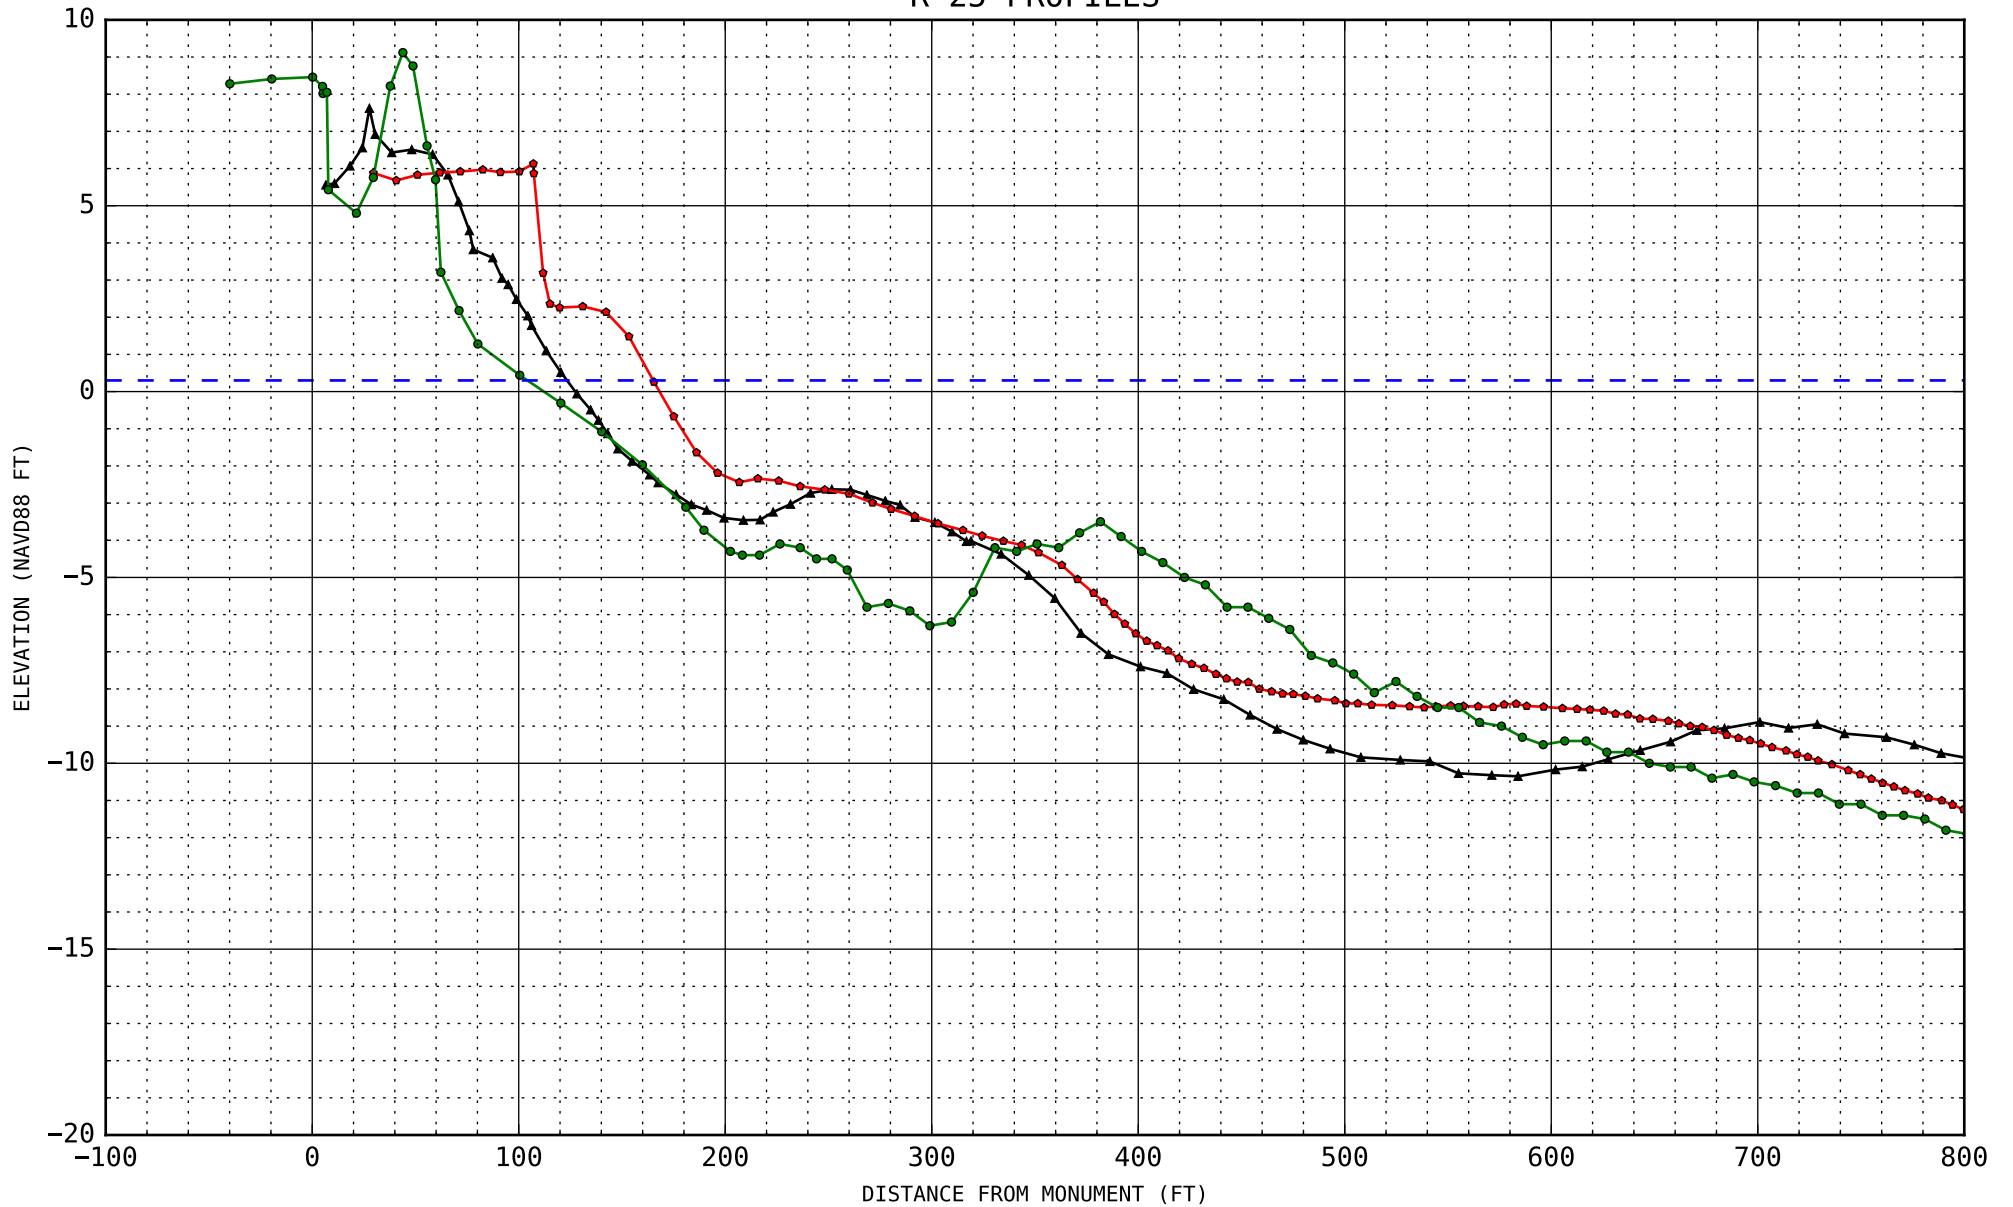
# R-25 PROFILES

▲ 2019-JUN MONITORING BY HSS  
 ● 2017-JUL MONITORING BY HSS  
 ● 2014-JUN CONDITION BY ARC  
 - - - MHW CONTOUR (0.3 FT)

RANGE: R-25  
 EST DATE: JAN1985  
 SURVEY DATE: 01JUL19  
 AZIMUTH: 230.0

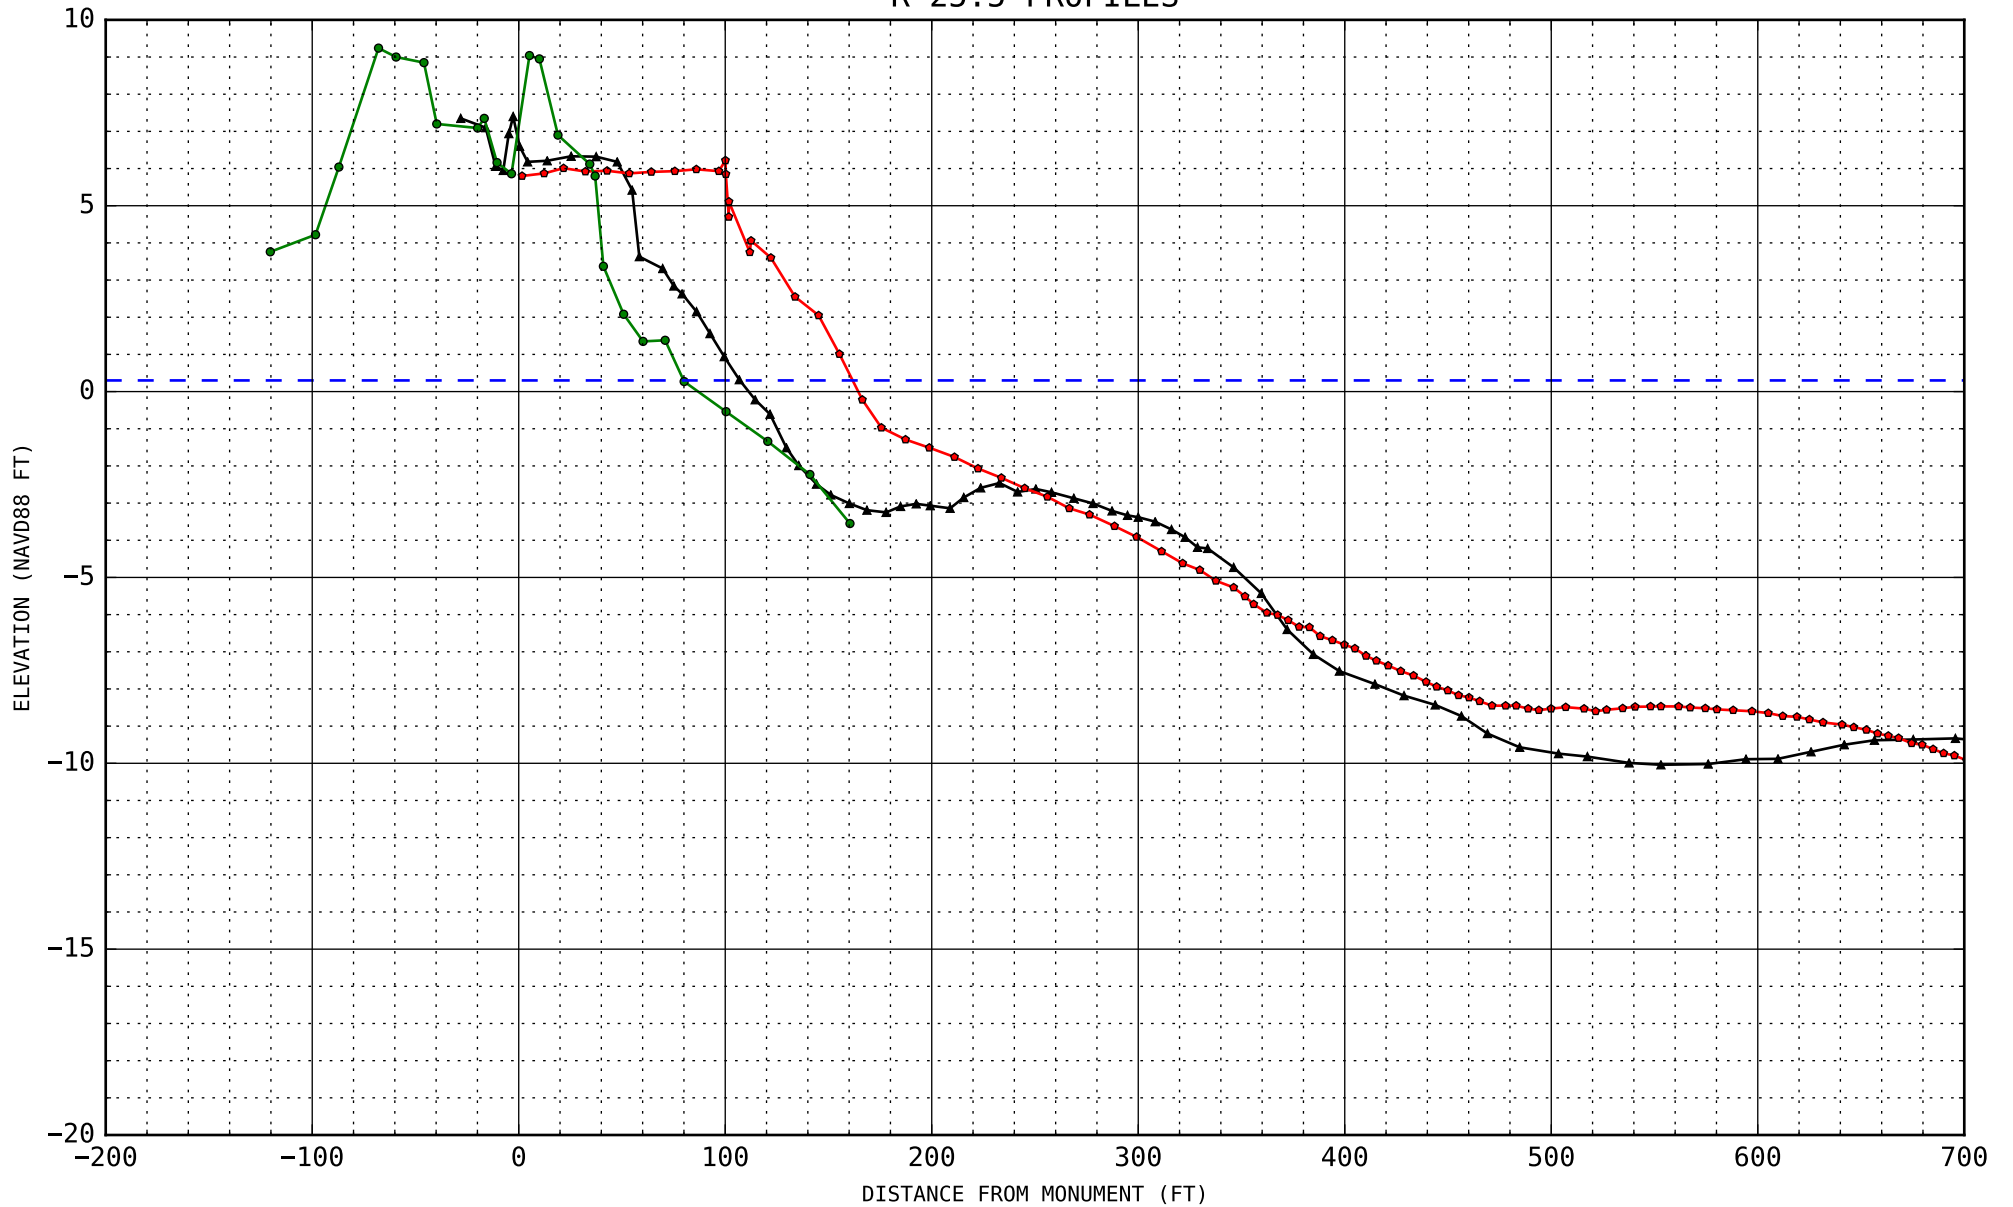
# R-25.5 PROFILES

▲ 2019-JUN MONITORING BY HSS  
 ● 2017-JUL MONITORING BY HSS  
 ● 2014-JUN CONDITION BY ARC  
 - - - MHW CONTOUR (0.3 FT)

RANGE: R-25.5  
 EST DATE: ARC2014  
 SURVEY DATE: 01JUL19  
 AZIMUTH: 230.0

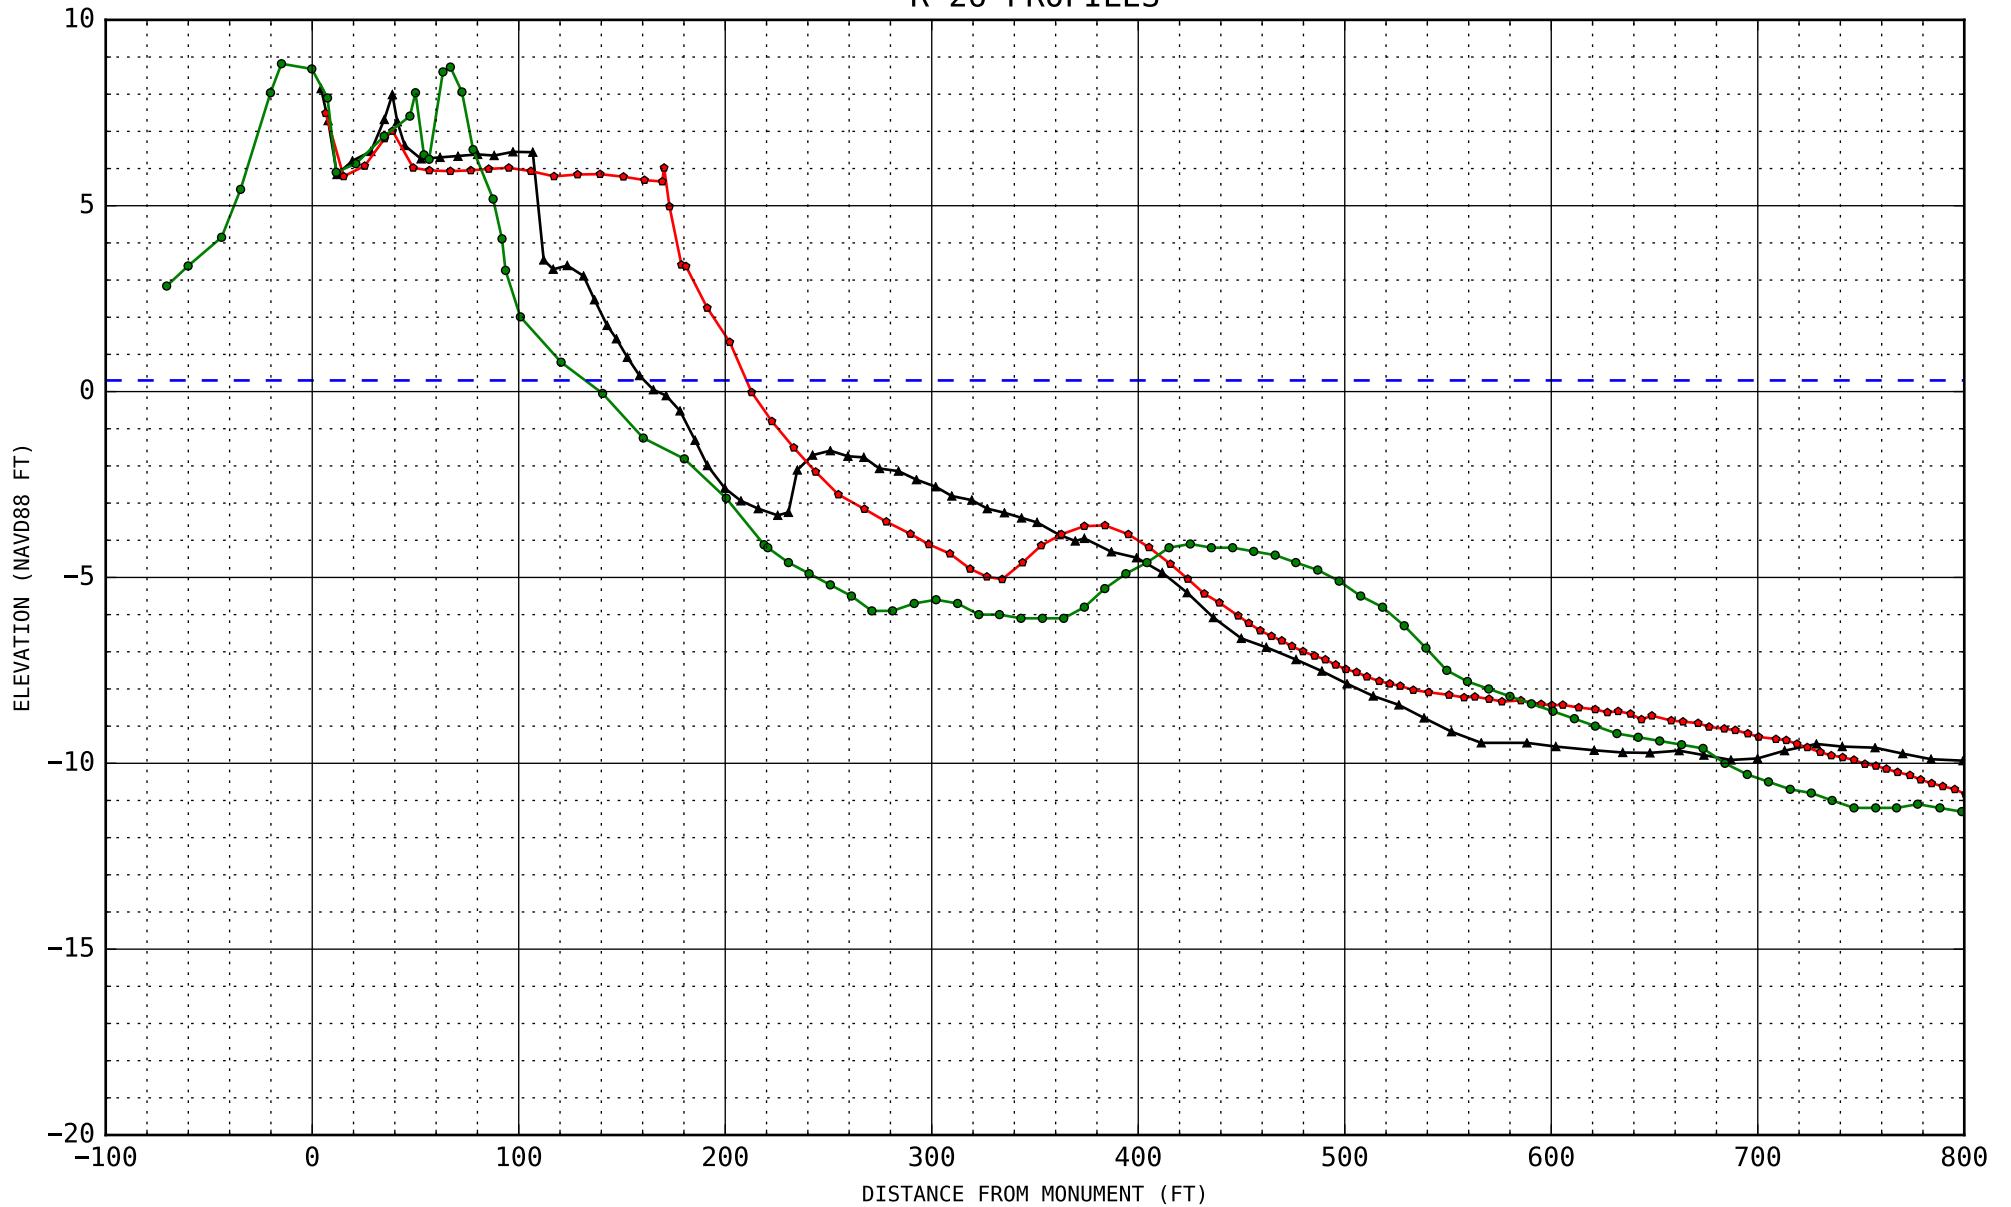
# R-26 PROFILES

- ▲ 2019-JUN MONITORING BY HSS
- 2017-JUL MONITORING BY HSS
- 2014-JUN CONDITION BY ARC
- - - MHW CONTOUR (0.3 FT)

RANGE: R-26  
EST DATE: JAN1985  
SURVEY DATE: 01JUL19  
AZIMUTH: 230.0

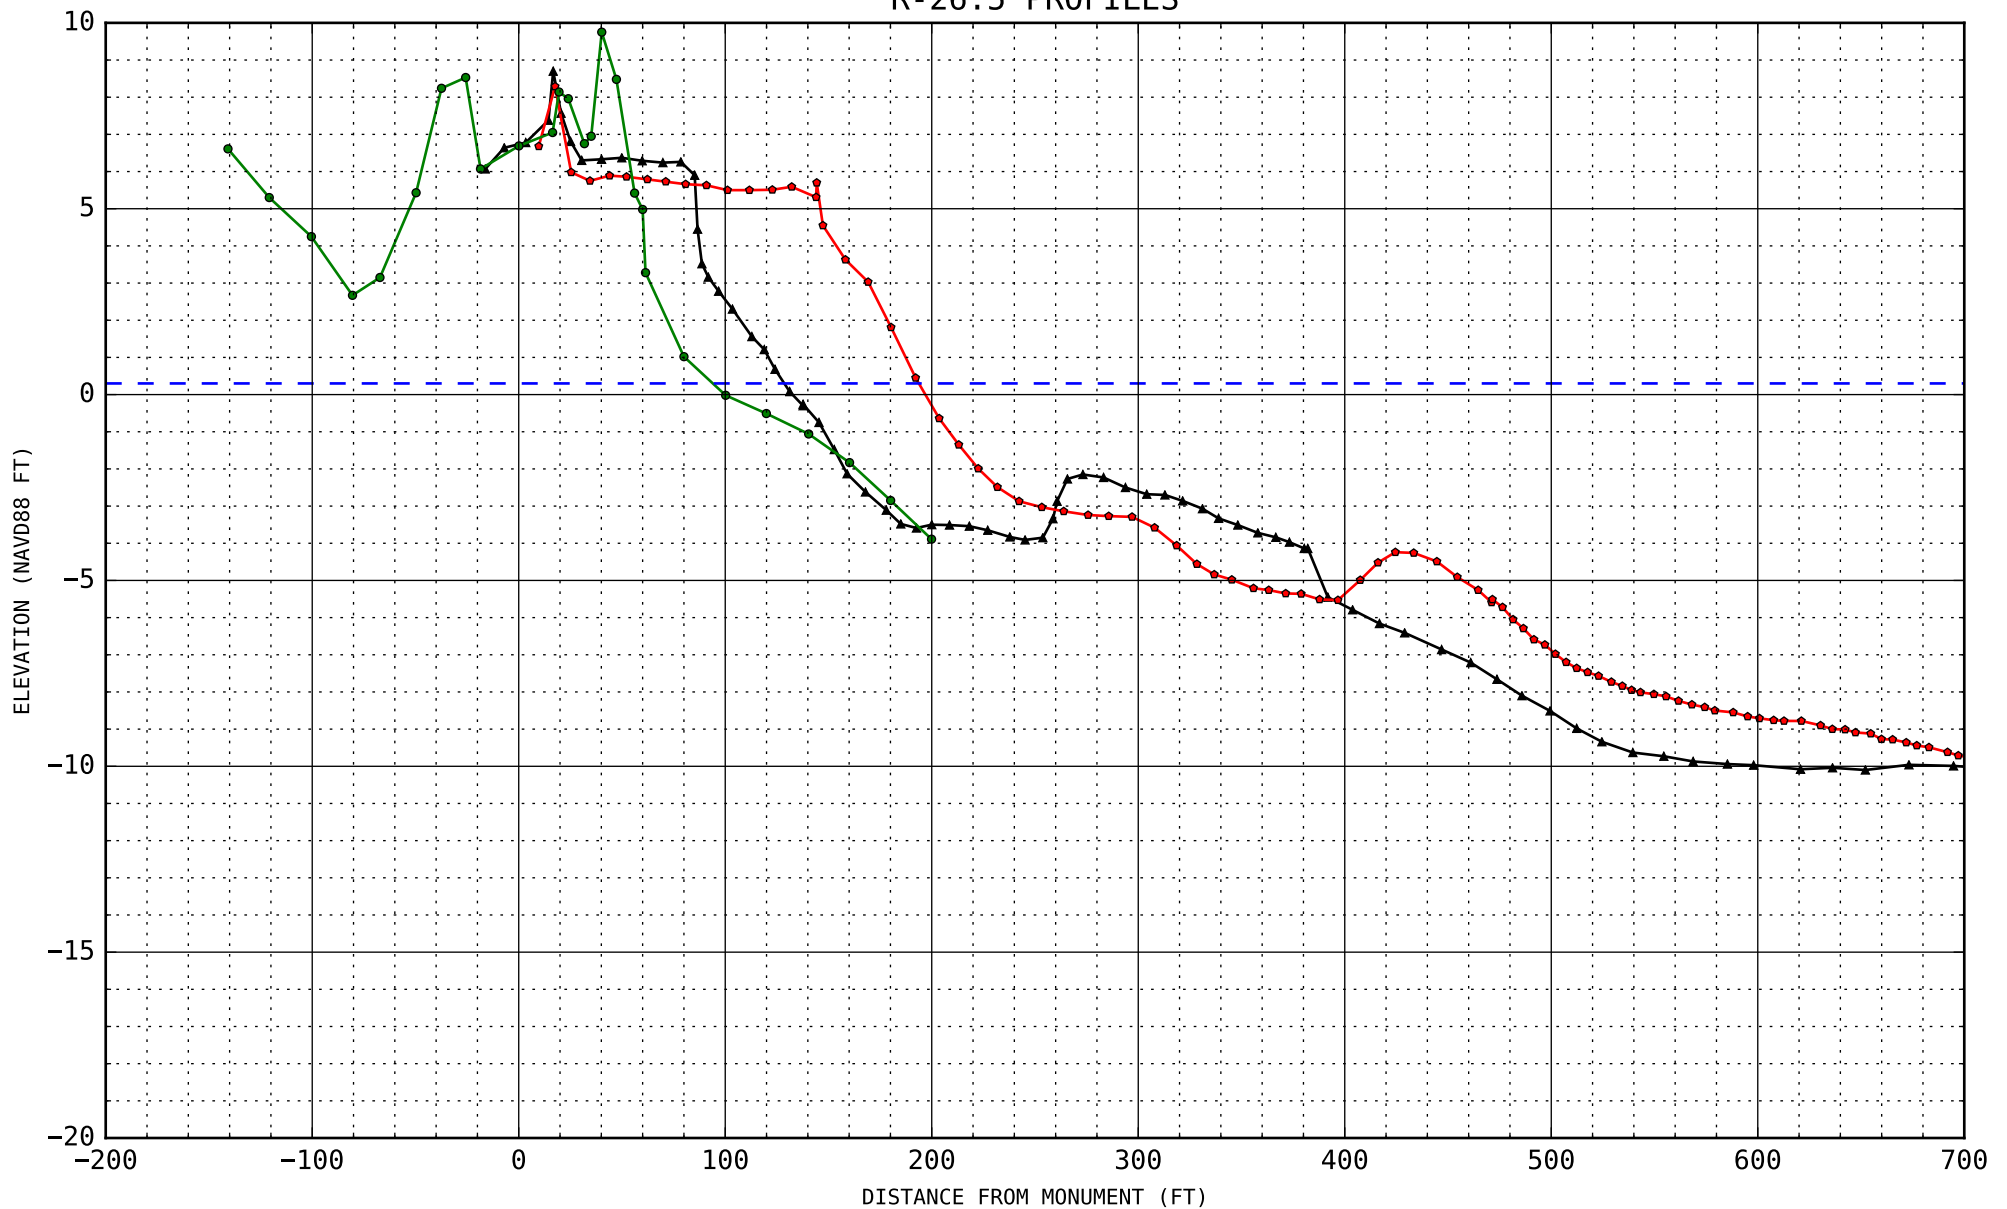
# R-26.5 PROFILES

| <p>▲ 2019-JUN MONITORING BY HSS</p> <p>● 2017-JUL MONITORING BY HSS</p> <p>● 2014-JUN CONDITION BY ARC</p> <p>-- MHW CONTOUR (0.3 FT)</p> | <p>SARASOTA</p> <p>PROGRAM SUPPORT GIS</p> <p>DIVISION OF WATER RESOURCE MANAGEMENT</p> <p>FLORIDA DEPARTMENT OF ENVIRONMENTAL PROTECTION</p> | <p>RANGE: R-26.5</p> <p>EST DATE: ARC2014</p> <p>SURVEY DATE: 01JUL19</p> <p>AZIMUTH: 230.0</p> |
