T-1 PROFILES

| ● 2017-JUL MONITORING BY HSS | PROGRAM SUPPORT GIS | EST DATE: MECM |
| ● 2014-JUN CONDITION BY ARC | DIVISION OF WATER RESOURCE MANAGEMENT | SURVEY DATE: 27JUN19 |

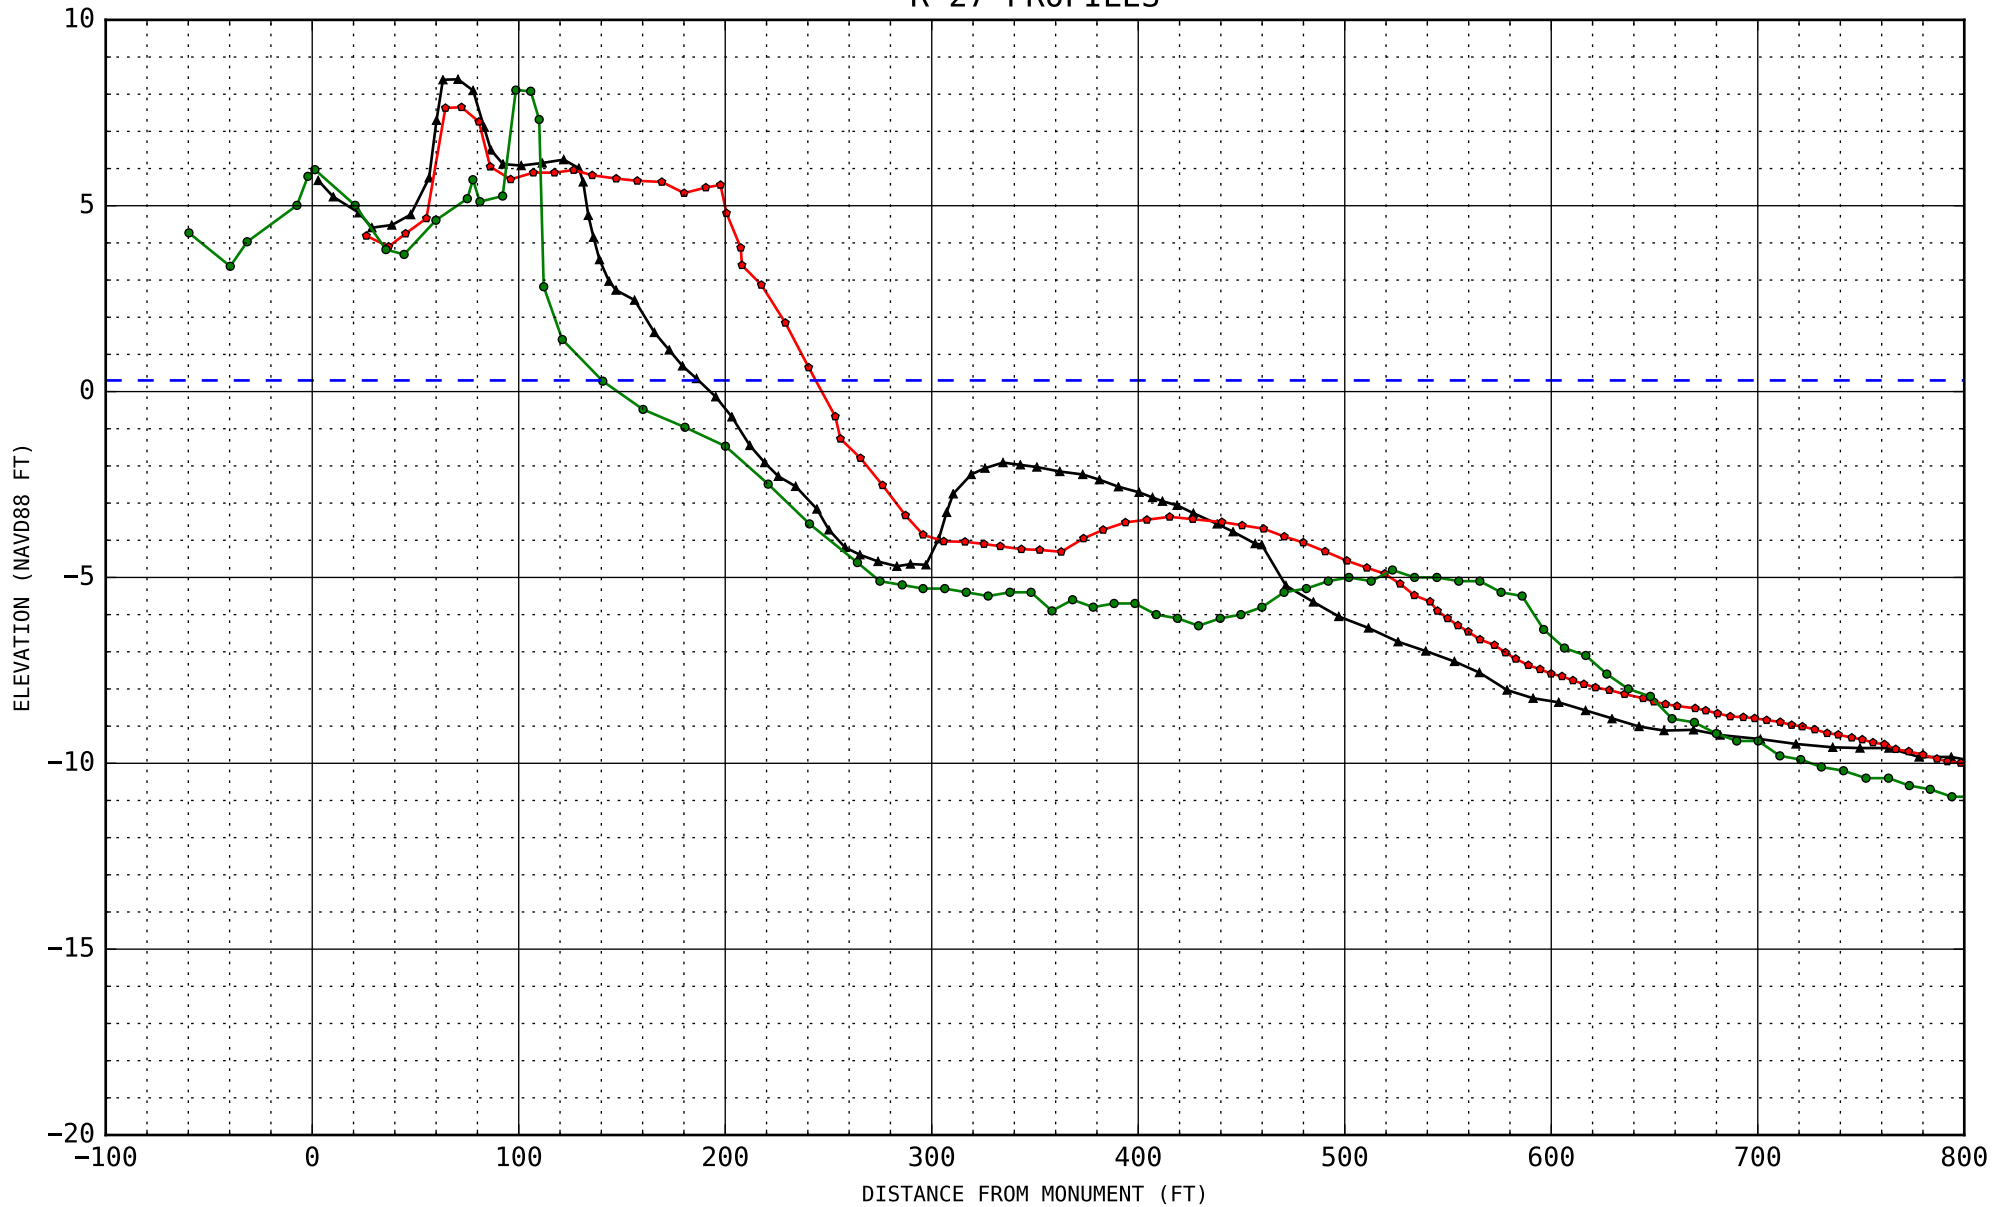
# R-27 PROFILES

- ▲ 2019-JUN MONITORING BY HSS
- 2017-JUL MONITORING BY HSS
- 2014-JUN CONDITION BY ARC
- - - MHW CONTOUR (0.3 FT)

RANGE: R-27  
EST DATE: MAR1974  
SURVEY DATE: 01JUL19  
AZIMUTH: 230.0

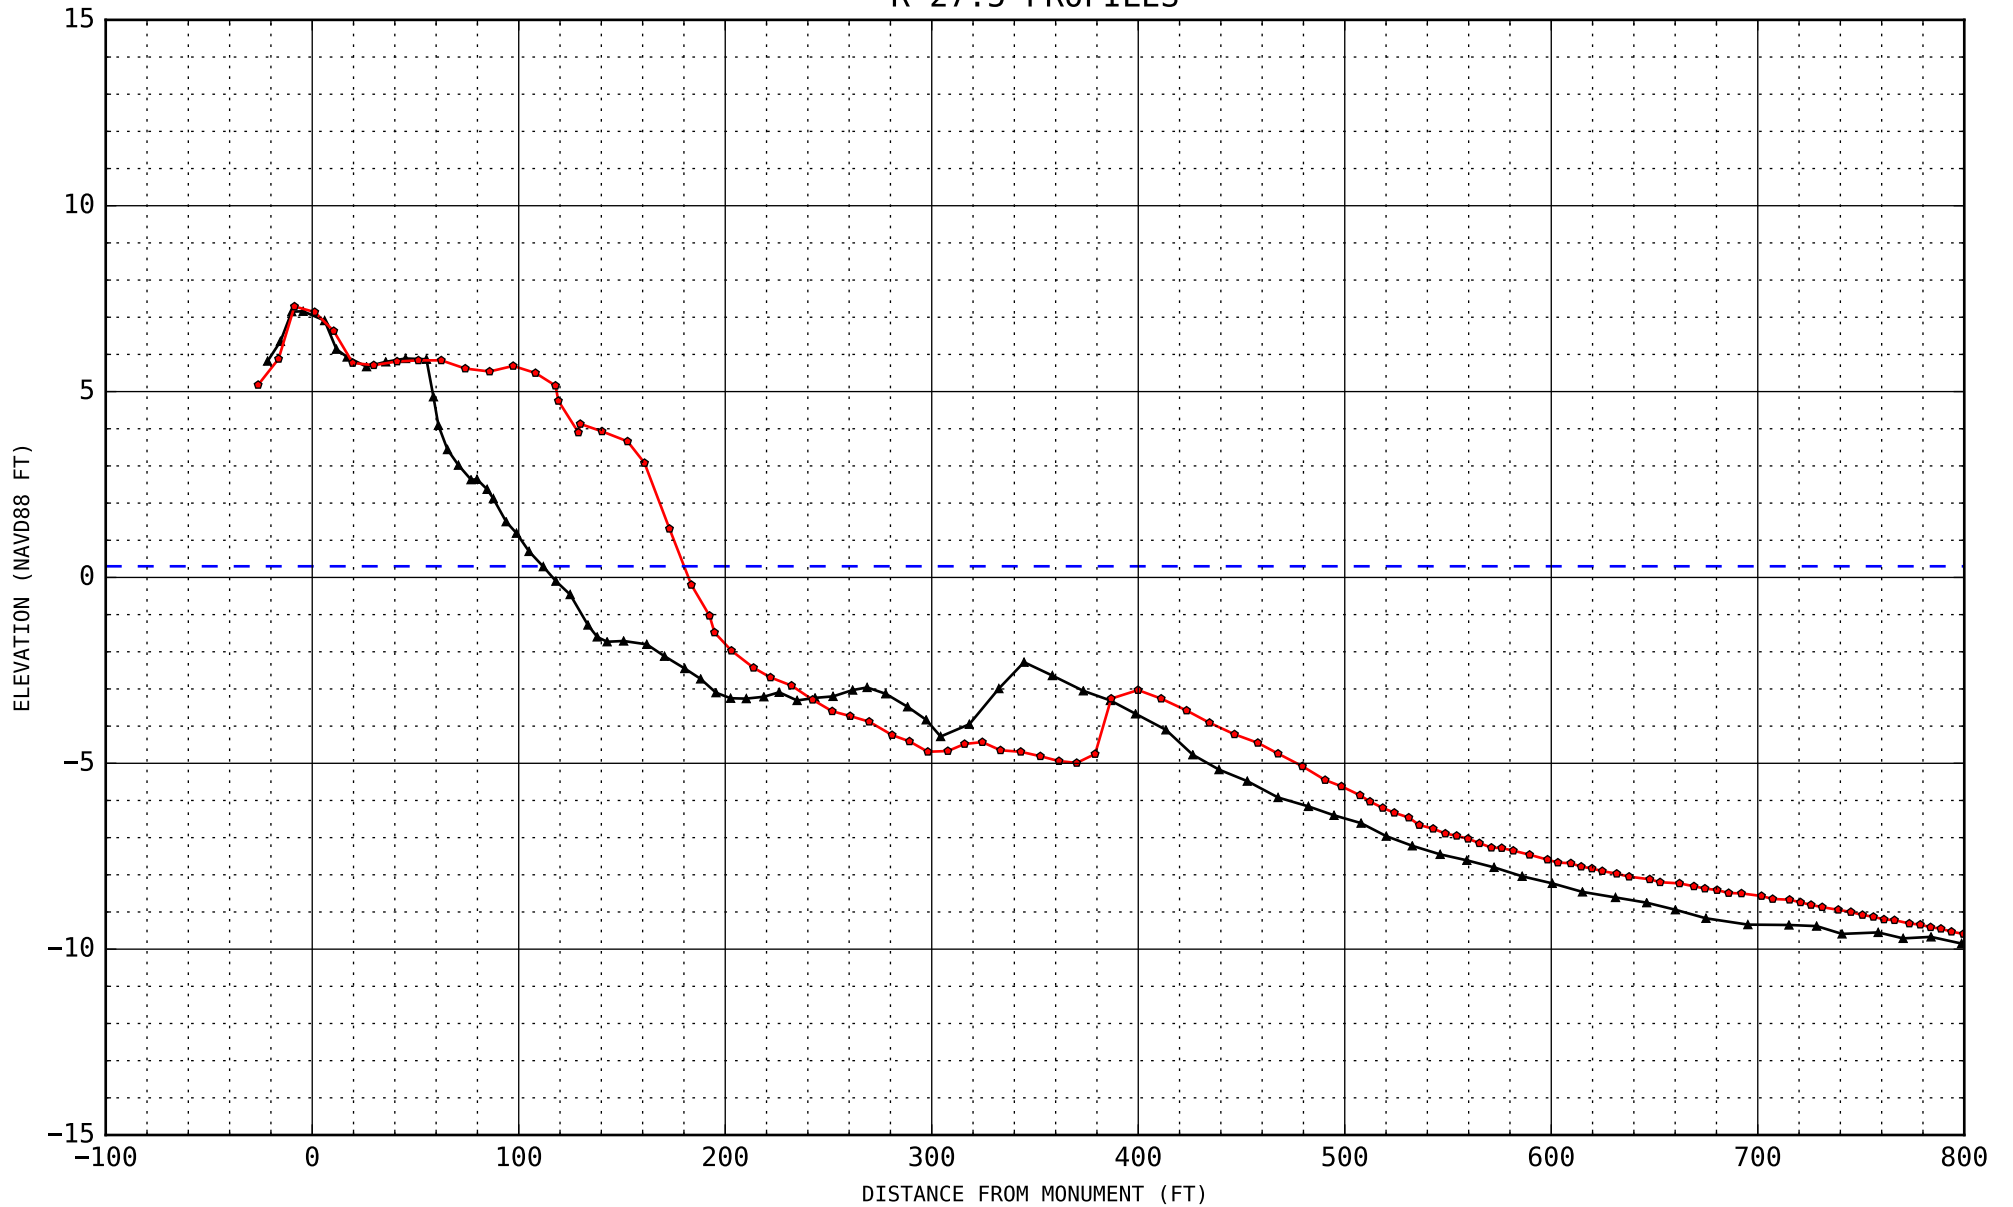
# R-27.5 PROFILES

- ▲ 2019-JUN MONITORING BY HSS
- 2017-JUL MONITORING BY HSS
- - - MHW CONTOUR (0.3 FT)

RANGE: R-27.5  
 EST DATE: ARC2014  
 SURVEY DATE: 01JUL19  
 AZIMUTH: 230.0

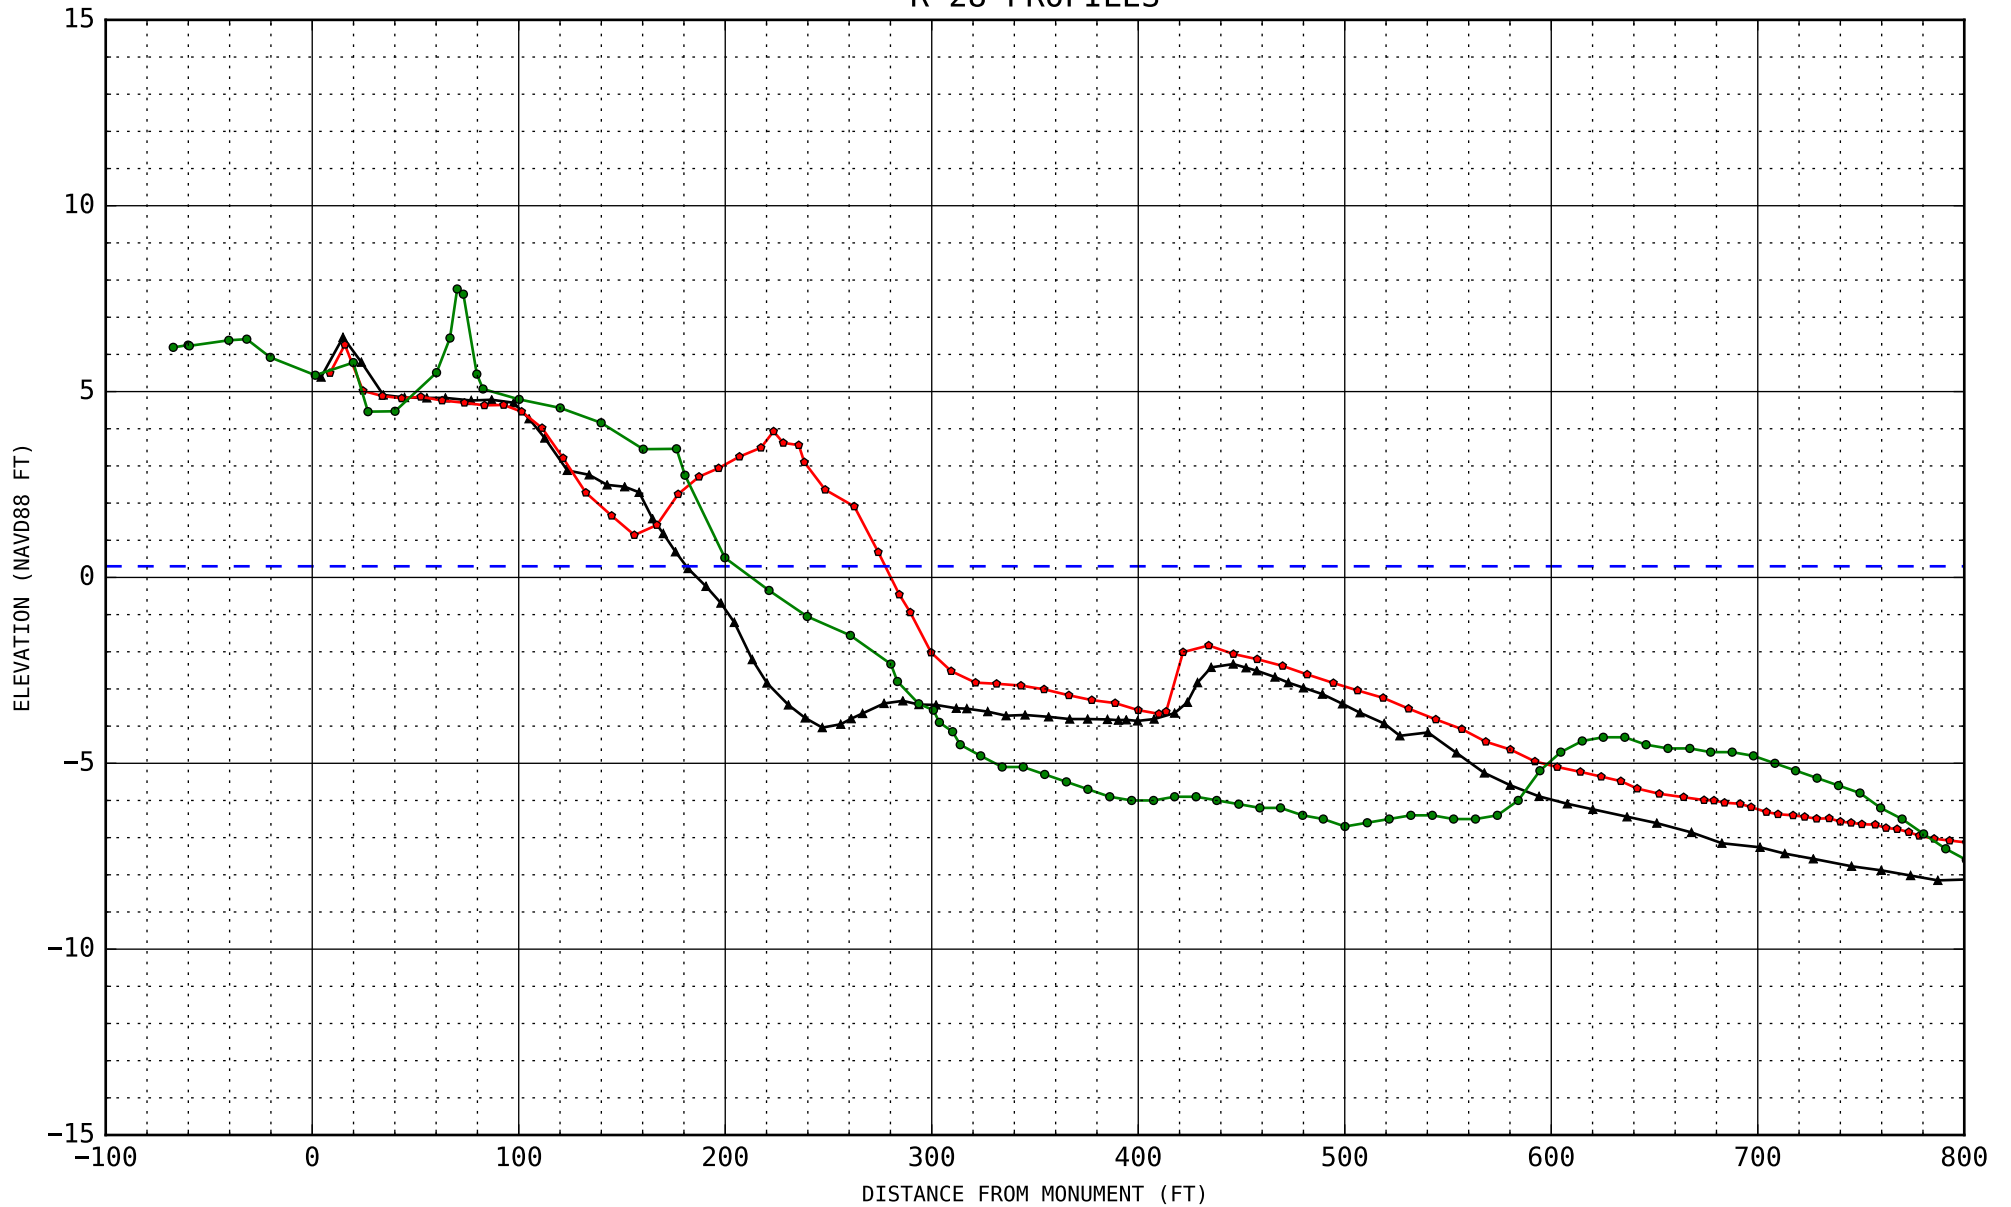
# R-28 PROFILES

- ▲ 2019-JUN MONITORING BY HSS
- 2017-JUL MONITORING BY HSS
- 2014-JUN CONDITION BY ARC
- - - MHW CONTOUR (0.3 FT)

RANGE: R-28  
EST DATE: JAN1985  
SURVEY DATE: 01JUL19  
AZIMUTH: 230.0

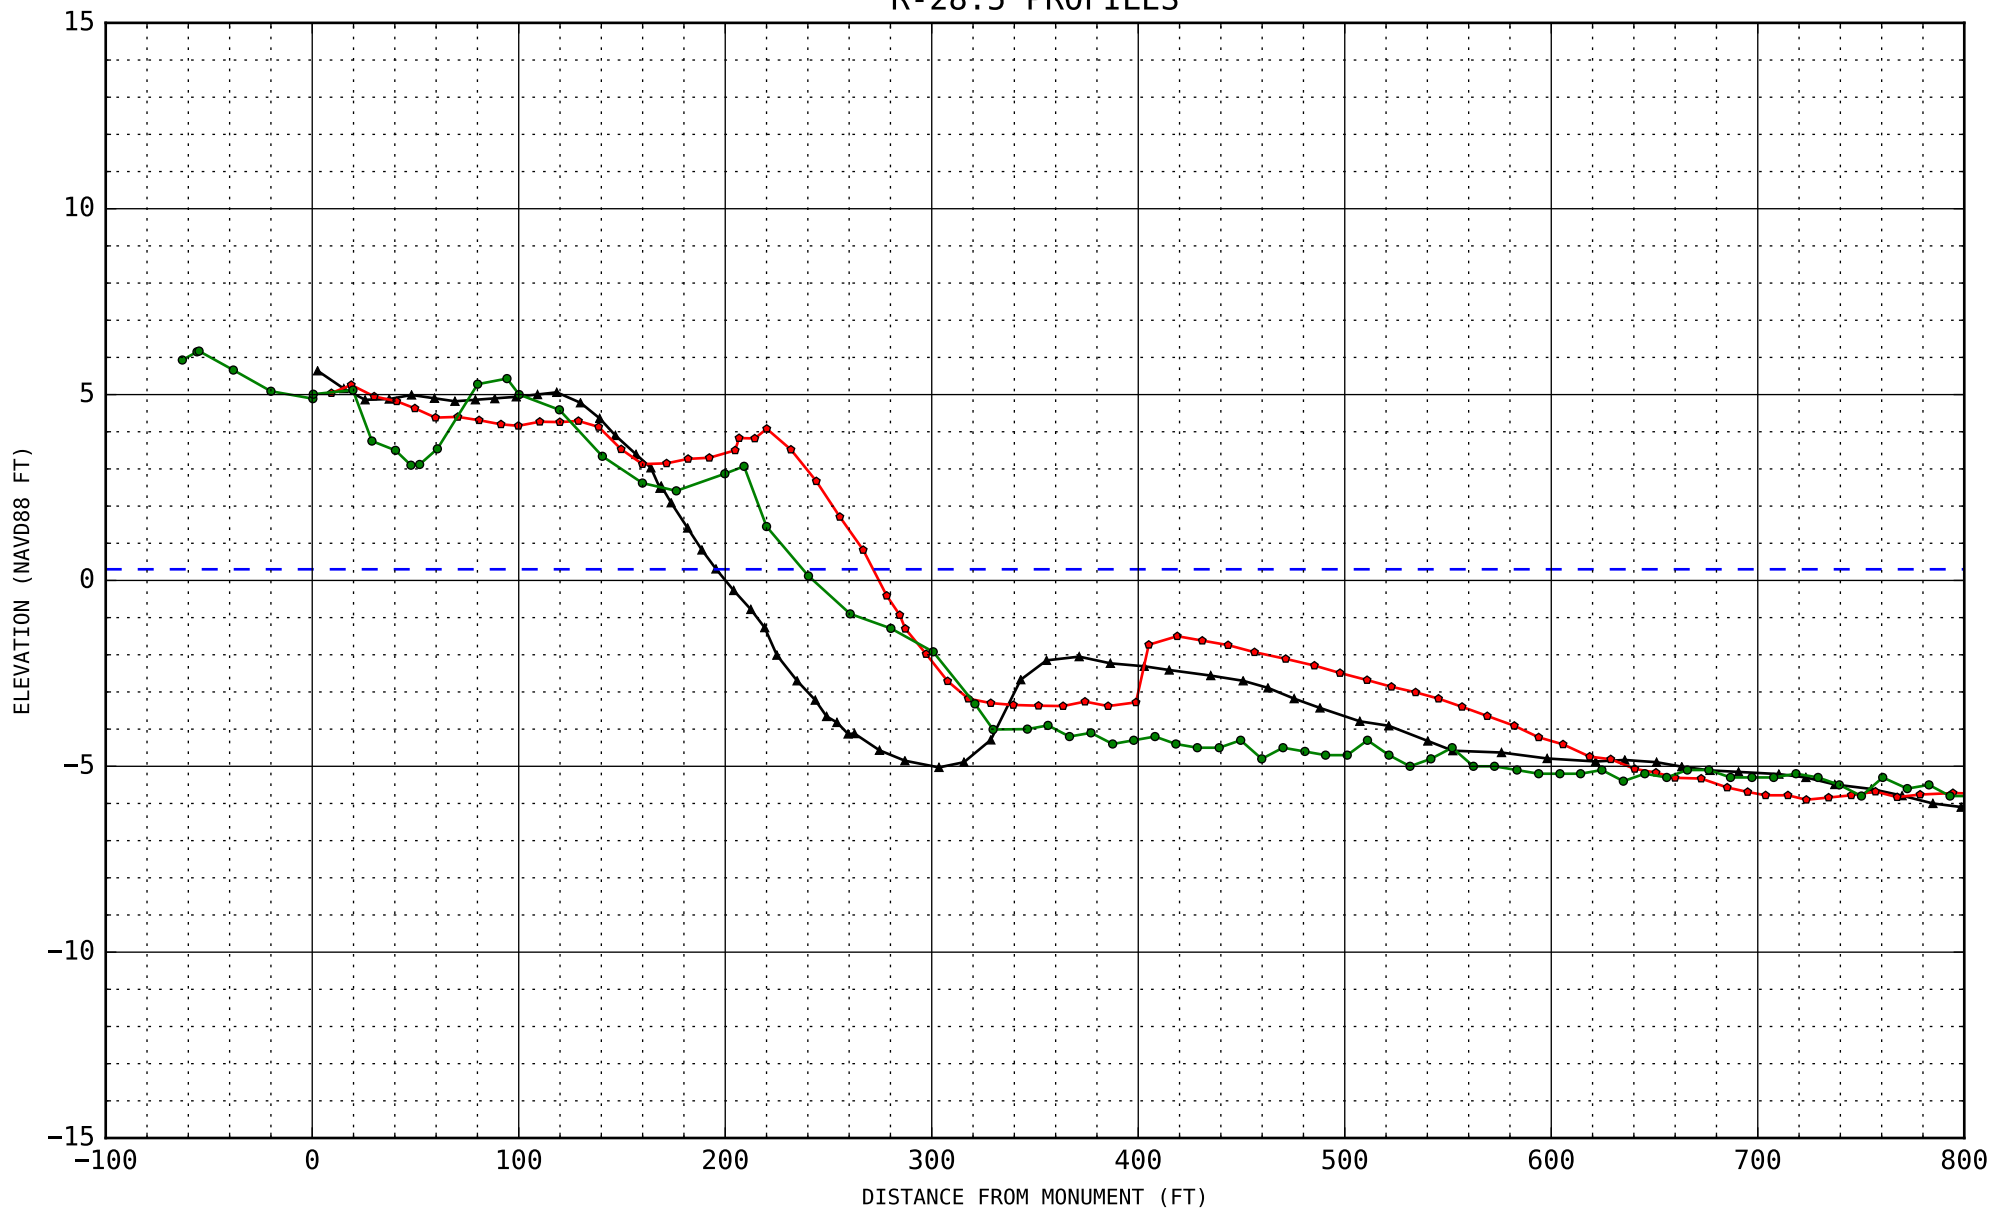
# R-28.5 PROFILES

| <p>▲ 2019-JUN MONITORING BY HSS</p> <p>● 2017-JUL MONITORING BY HSS</p> <p>● 2014-JUN CONDITION BY ARC</p> <p>-- MHW CONTOUR (0.3 FT)</p> | <p>SARASOTA<br/>PROGRAM SUPPORT GIS<br/>DIVISION OF WATER RESOURCE MANAGEMENT<br/>FLORIDA DEPARTMENT OF ENVIRONMENTAL PROTECTION</p> | <p>RANGE: R-28.5<br/>EST DATE: MECM<br/>SURVEY DATE: 01JUL19<br/>AZIMUTH: 230.0</p> |

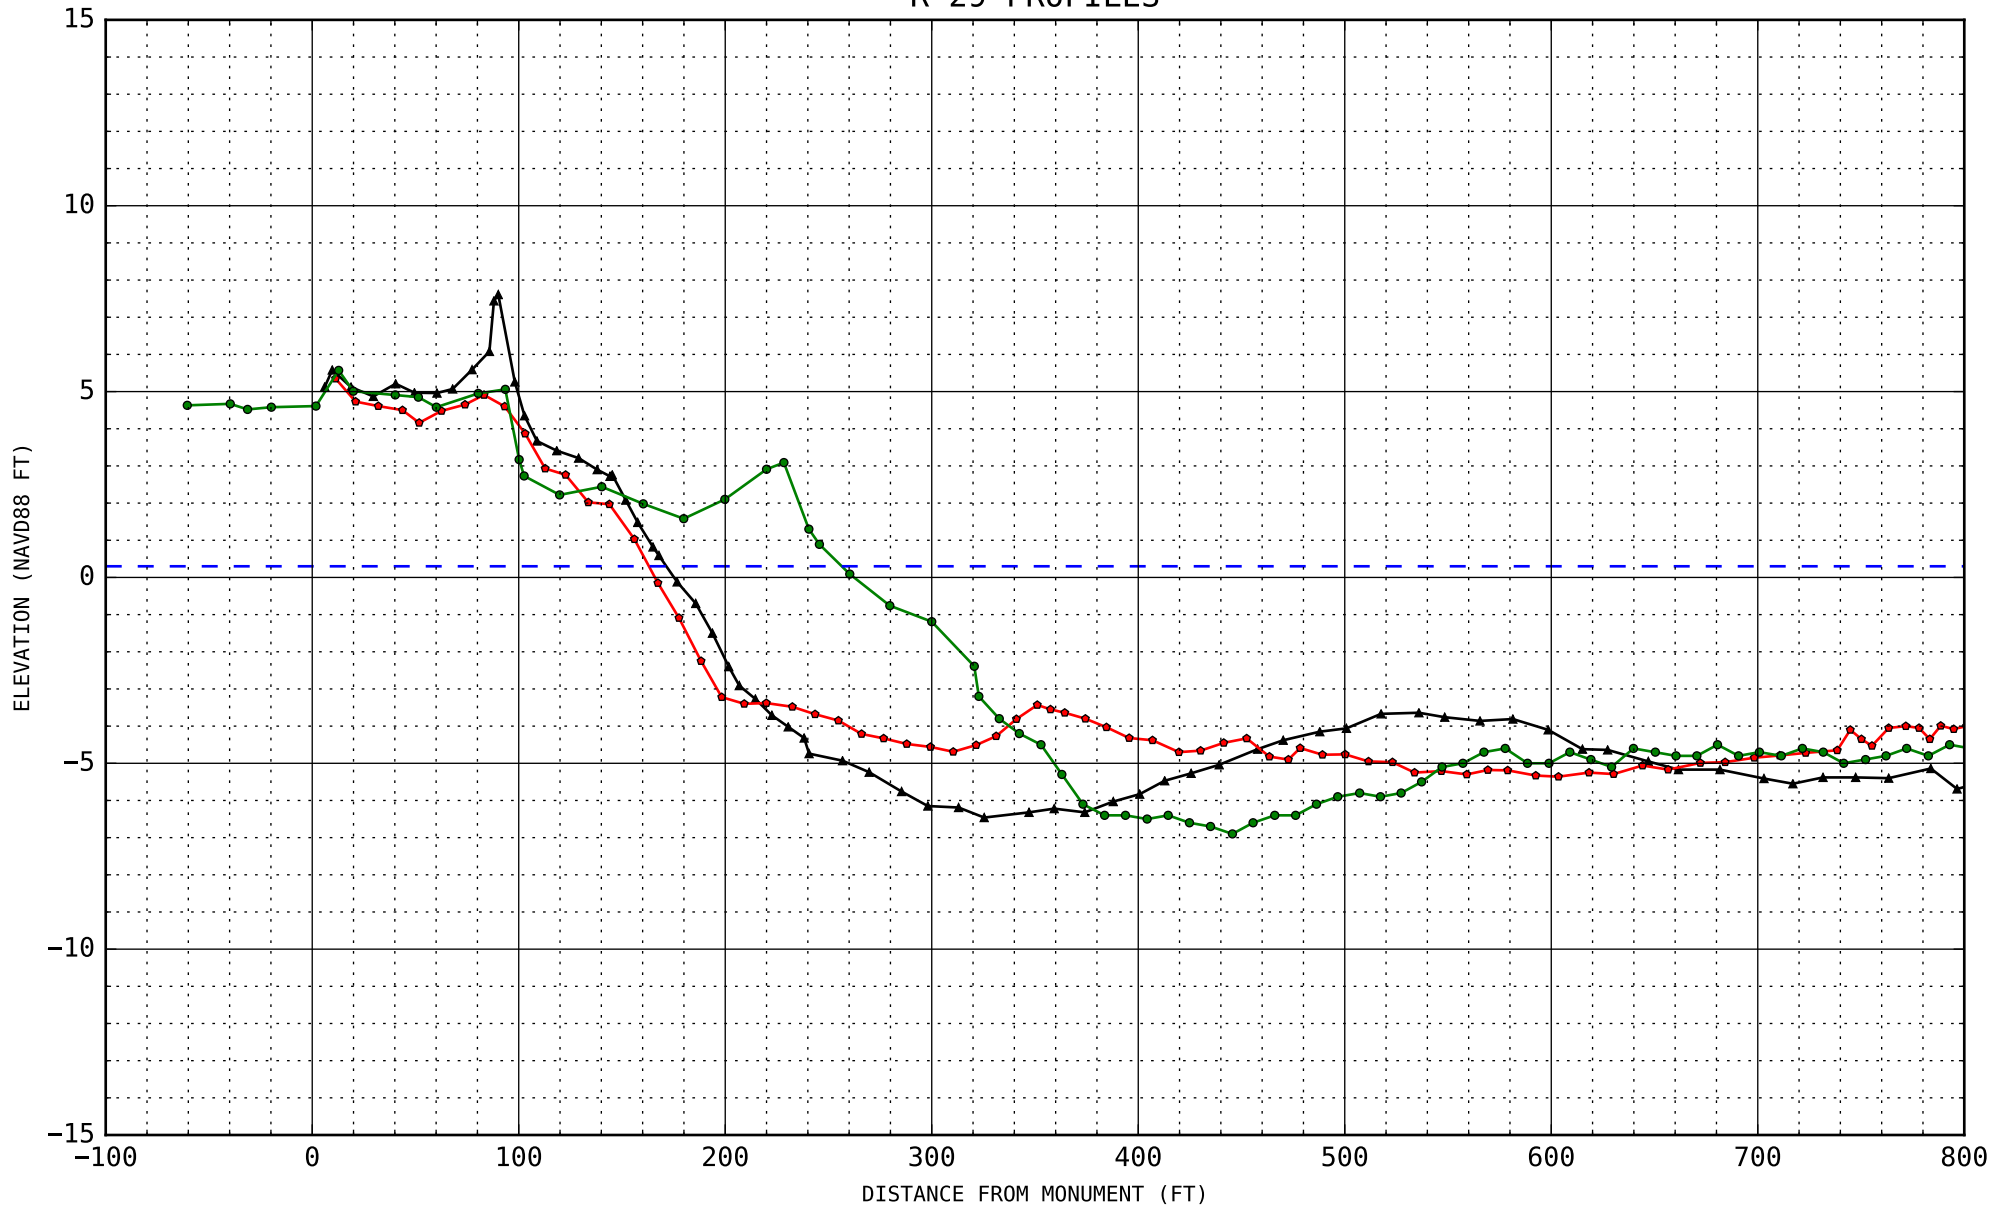
# R-29 PROFILES

▲ 2019-JUN MONITORING BY HSS  
 ● 2017-JUL MONITORING BY HSS  
 ● 2014-JUN CONDITION BY ARC  
 - - - MHW CONTOUR (0.3 FT)

RANGE: R-29  
 EST DATE: CPEIRC  
 SURVEY DATE: 01JUL19  
 AZIMUTH: 215.0
