# R-34 PROFILES

ST LUCIE  
 COASTAL ENGINEERING AND GEOLOGY PROGRAM  
 OFFICE OF RESILIENCE AND COASTAL PROTECTION  
 FLORIDA DEPARTMENT OF ENVIRONMENTAL PROTECTION

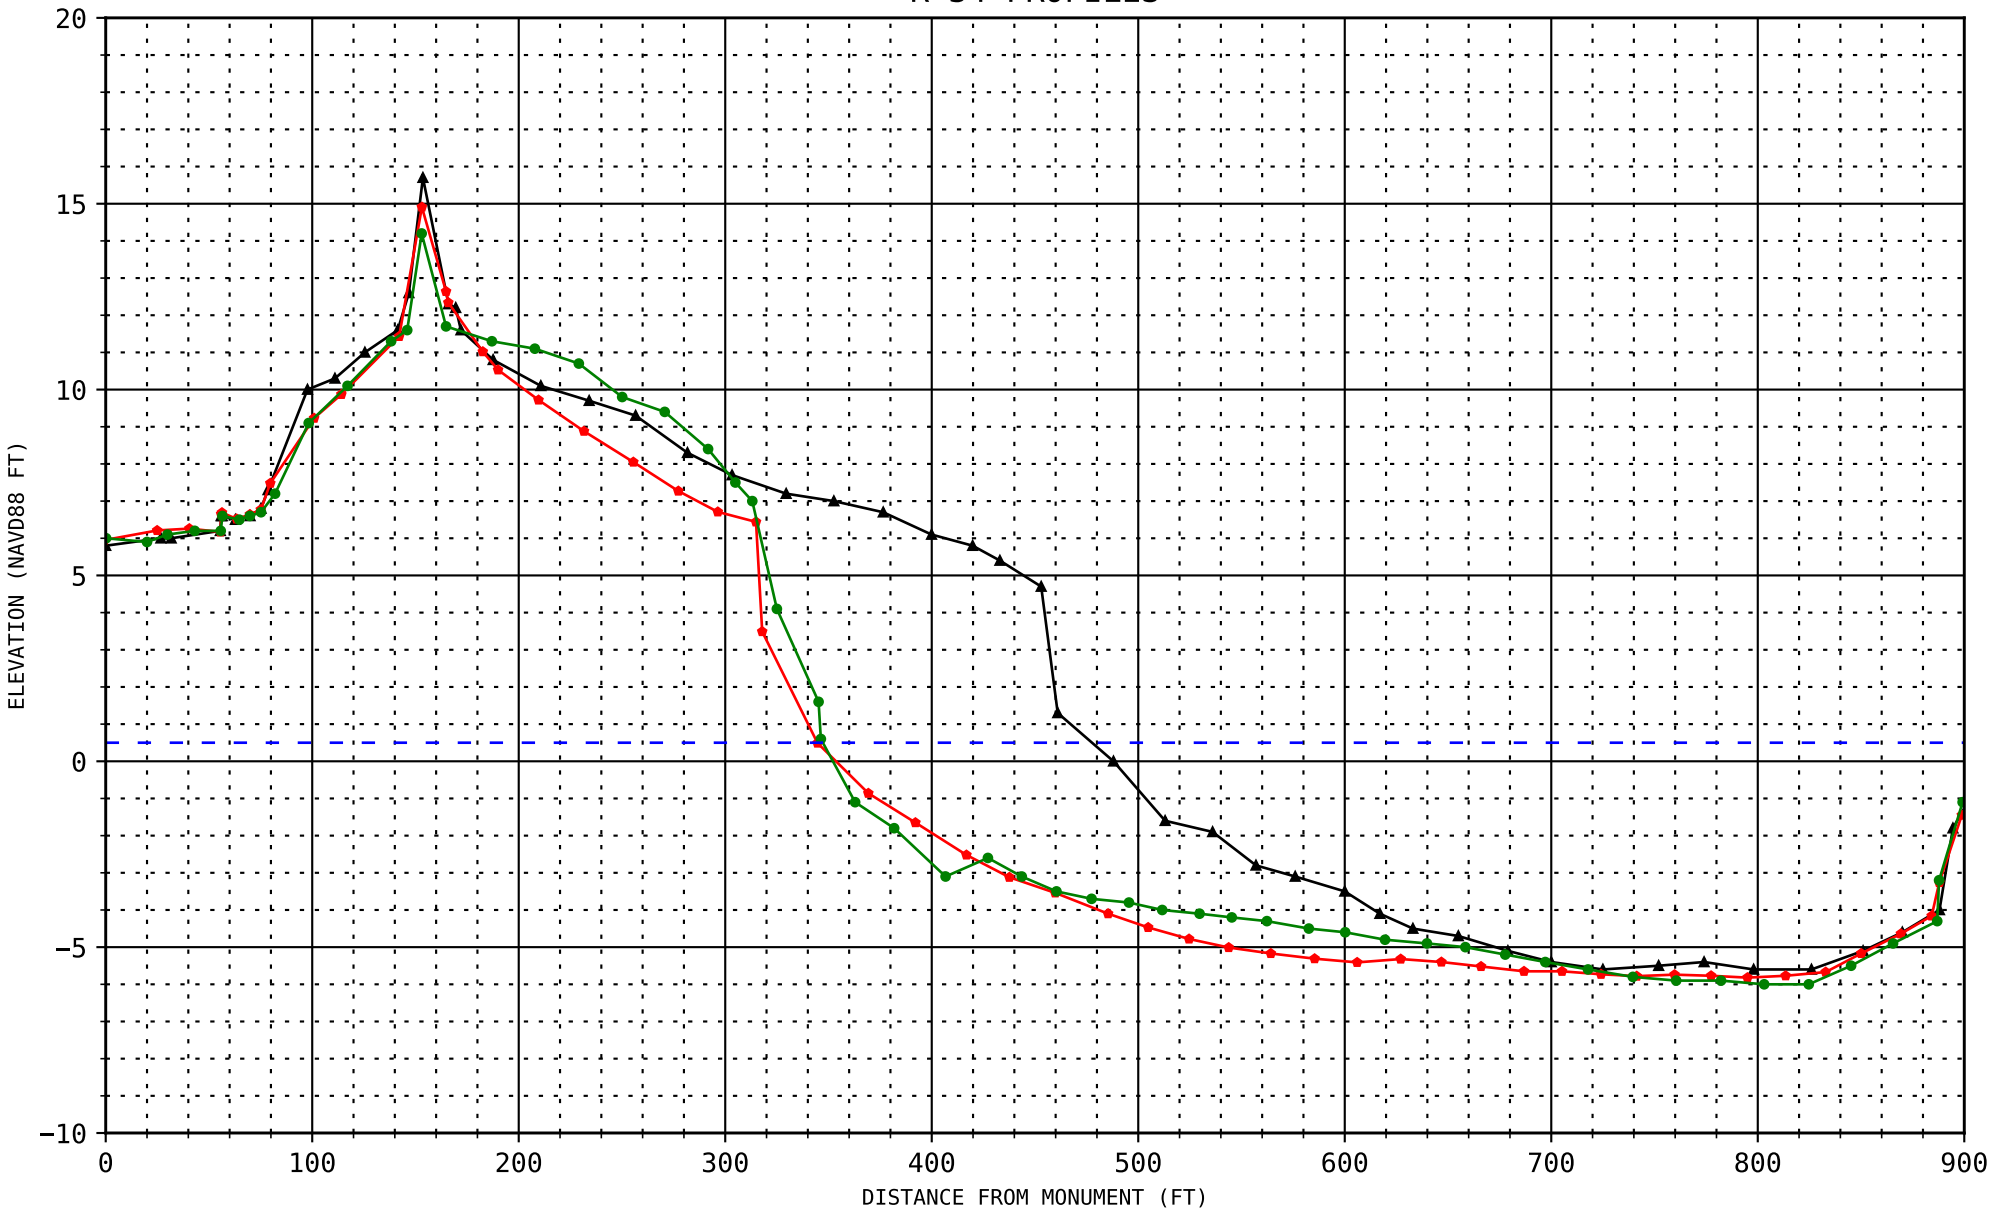
| <p> —▲— 2021-JUN MONITORING BY MAE<br/> —●— 2020-JUN MONITORING BY MAE<br/> —●— 20219-JUN 12-MONTHS BY MAE<br/> - - - MHW CONTOUR (0.5 FT) </p> | <p> ST LUCIE<br/> COASTAL ENGINEERING AND GEOLOGY PROGRAM<br/> OFFICE OF RESILIENCE AND COASTAL PROTECTION<br/> FLORIDA DEPARTMENT OF ENVIRONMENTAL PROTECTION </p> | <p> RANGE: R-34<br/> EST DATE: JAN1972<br/> SURVEY DATE: 03JUN21<br/> AZIMUTH: 70.0 </p> |

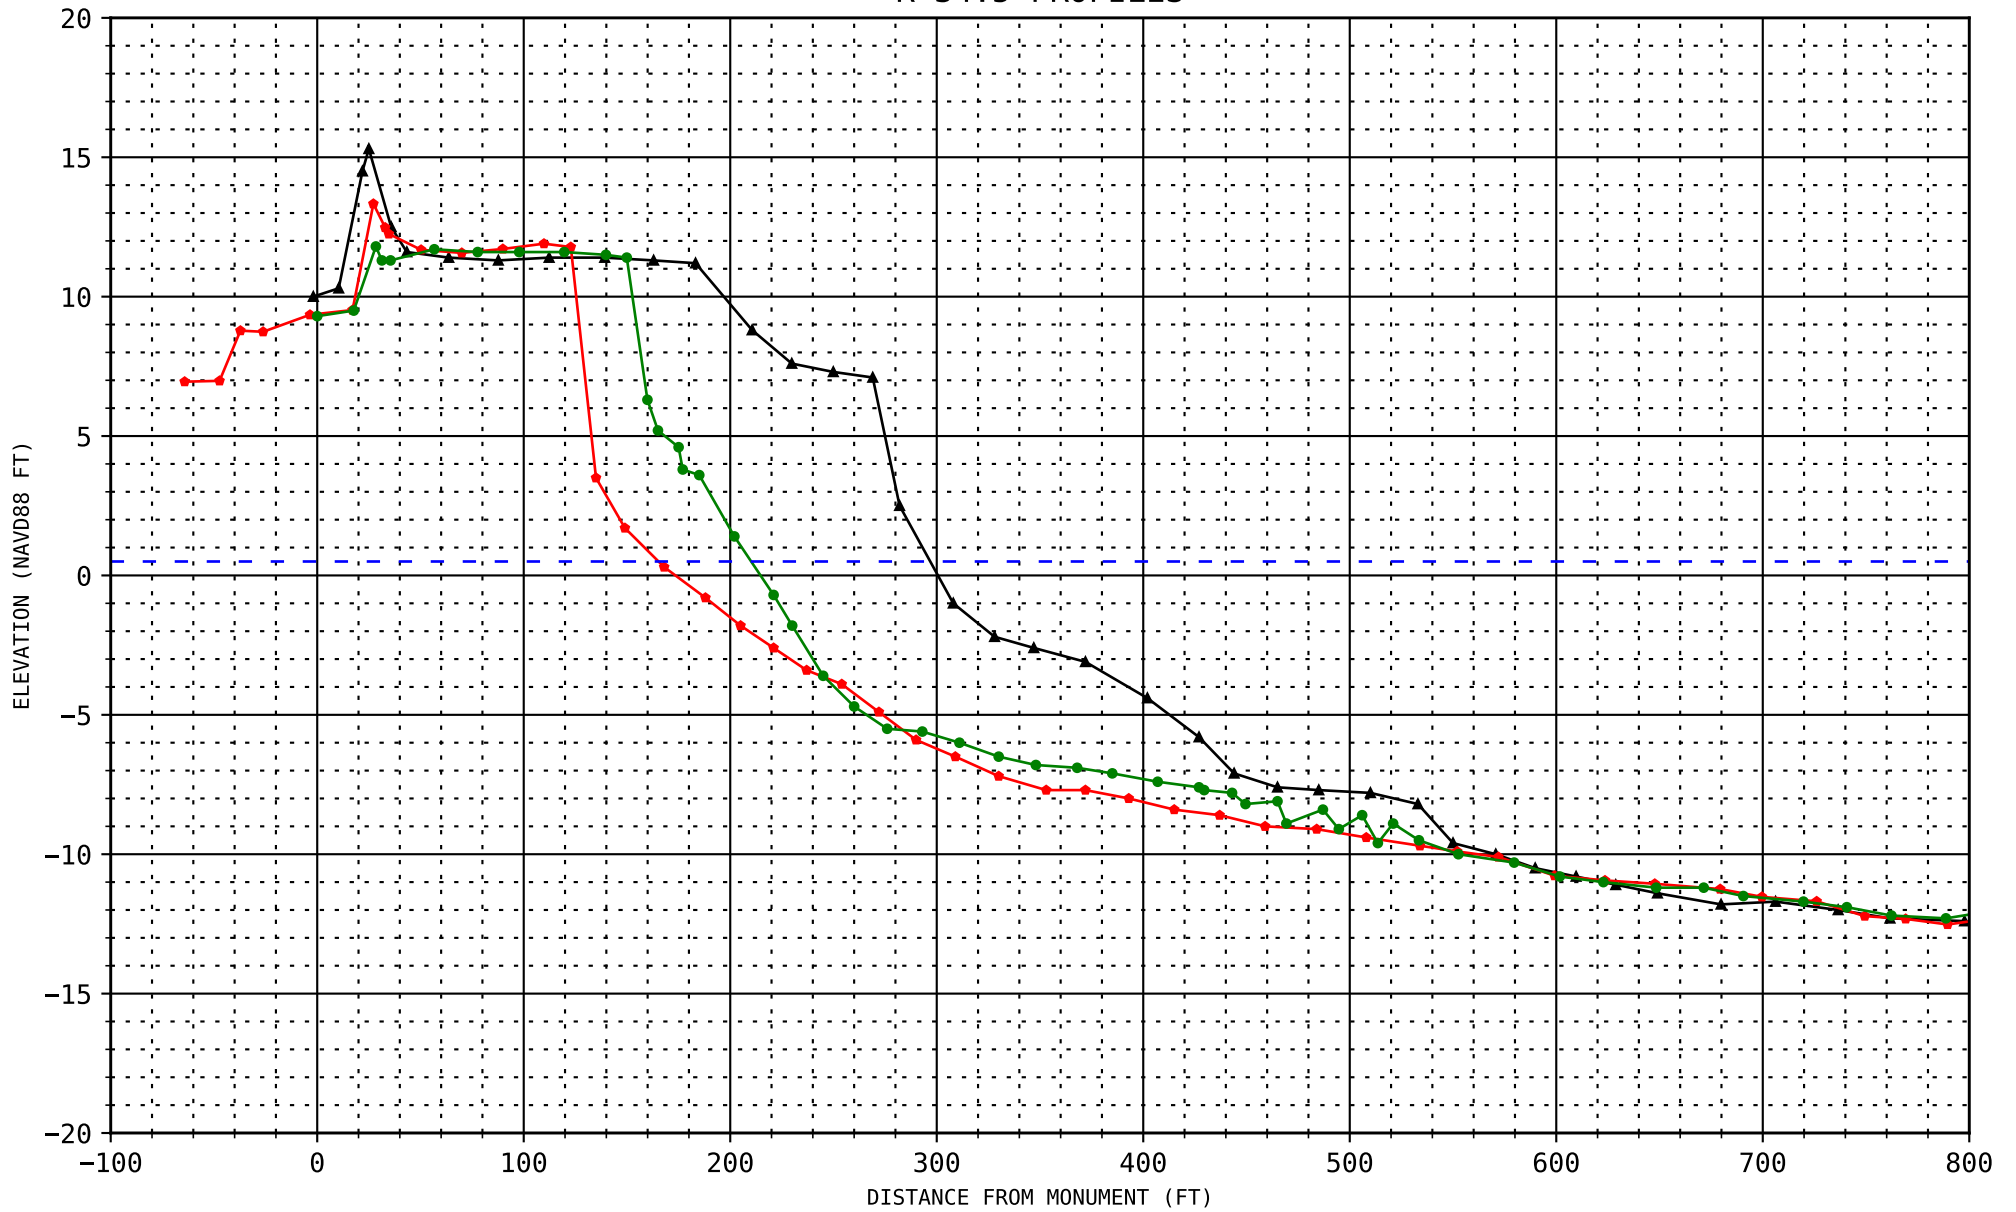
# R-34.5 PROFILES

—▲— 2021-JUN MONITORING BY MAE  
 —●— 2020-JUN MONITORING BY MAE  
 —●— 2019-JUN 12-MONTHS BY MAE  
 - - - MHW CONTOUR (0.5 FT)

RANGE: R-34.5  
 EST DATE: M&E2001  
 SURVEY DATE: 03JUN21  
 AZIMUTH: 70.0

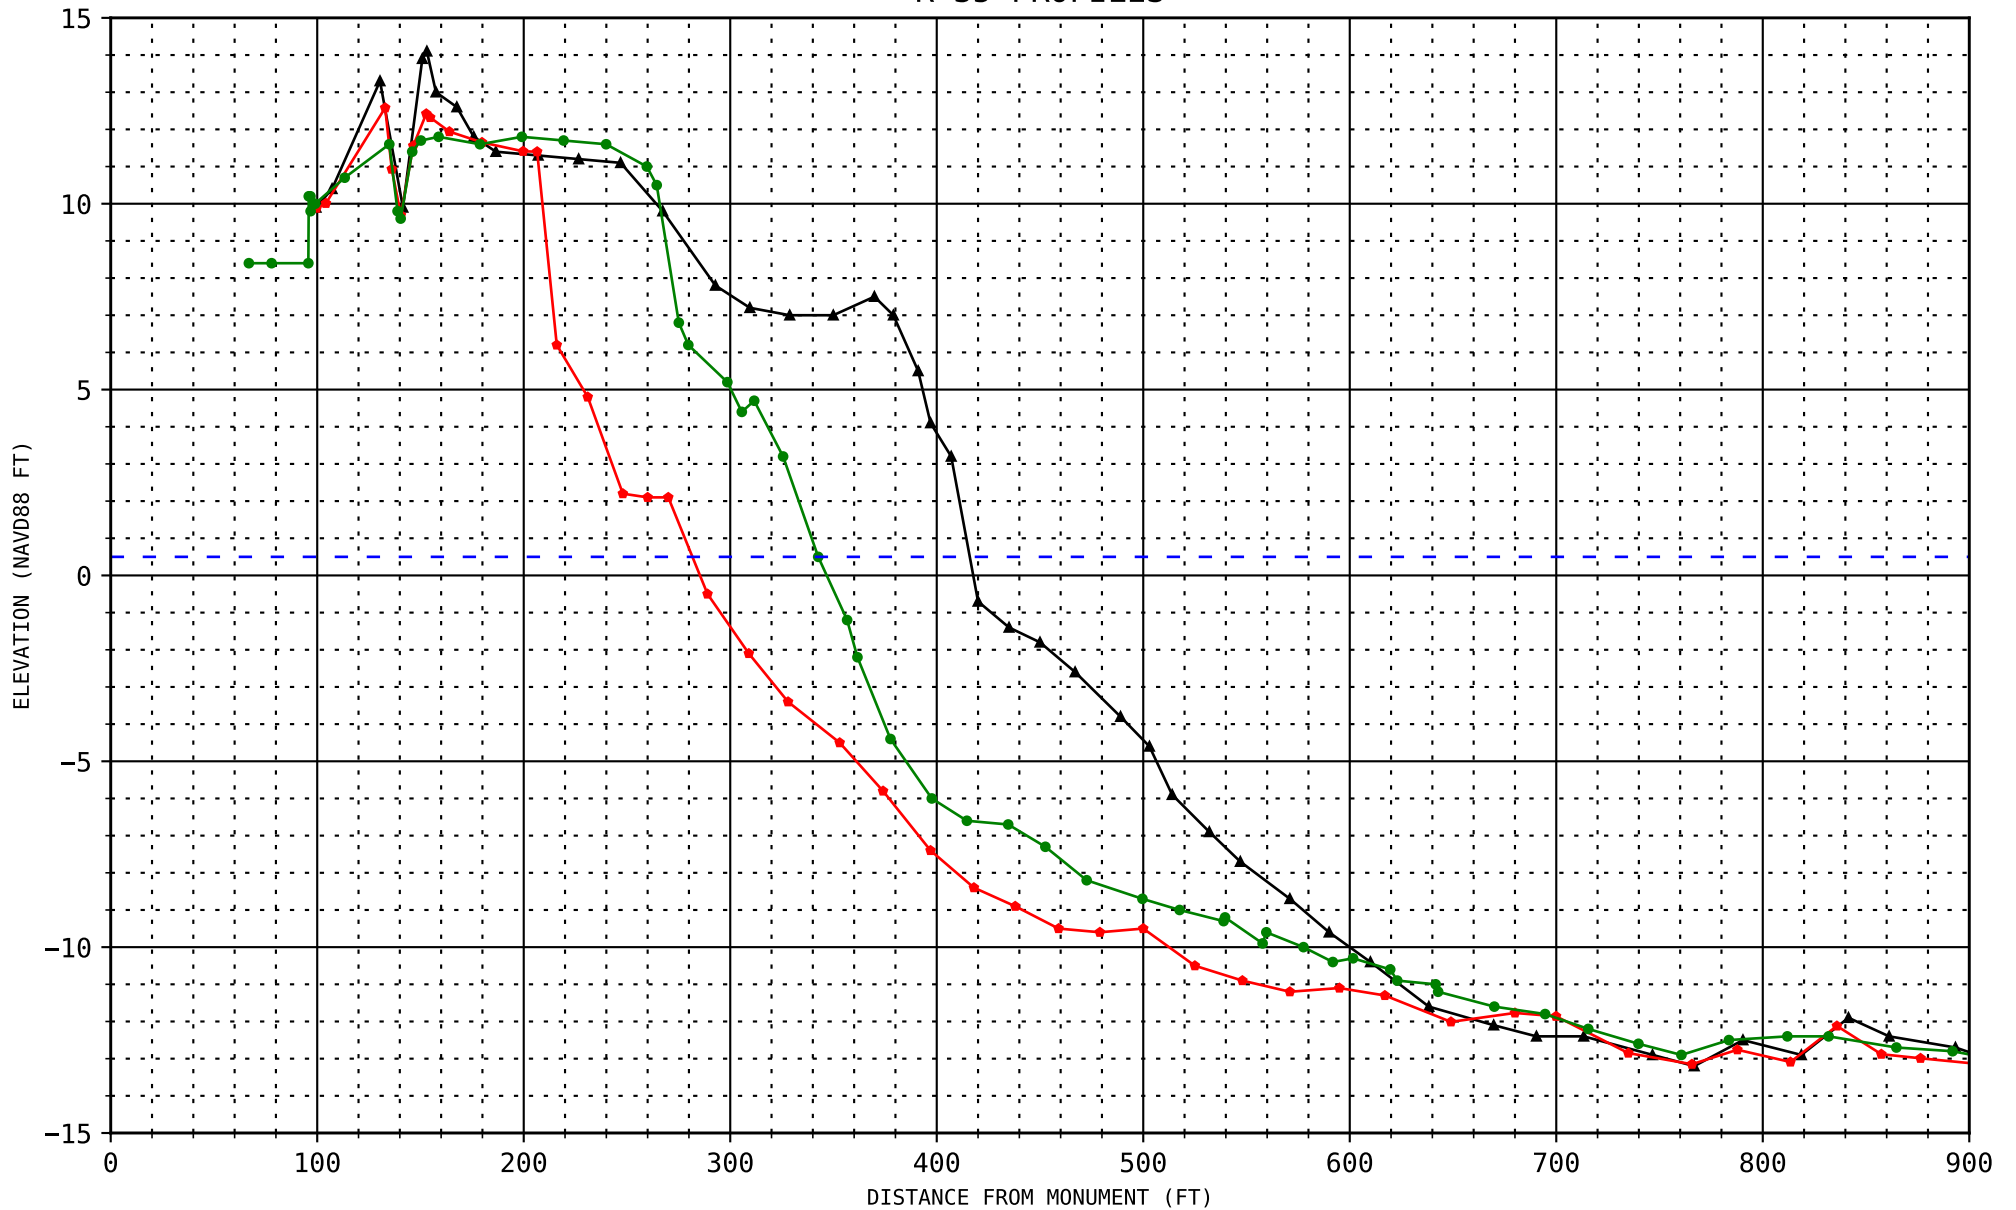
# R-35 PROFILES

| <p> ▲ 2021-JUN MONITORING BY MAE<br/> ● 2020-JUN MONITORING BY MAE<br/> ● 2019-JUN 12-MONTHS BY MAE<br/> - - - MHW CONTOUR (0.5 FT) </p> | <p> ST LUCIE<br/> COASTAL ENGINEERING AND GEOLOGY PROGRAM<br/> OFFICE OF RESILIENCE AND COASTAL PROTECTION<br/> FLORIDA DEPARTMENT OF ENVIRONMENTAL PROTECTION </p> | <p> RANGE: R-35<br/> EST DATE: COE1997<br/> SURVEY DATE: 03JUN21<br/> AZIMUTH: 70.0 </p> |

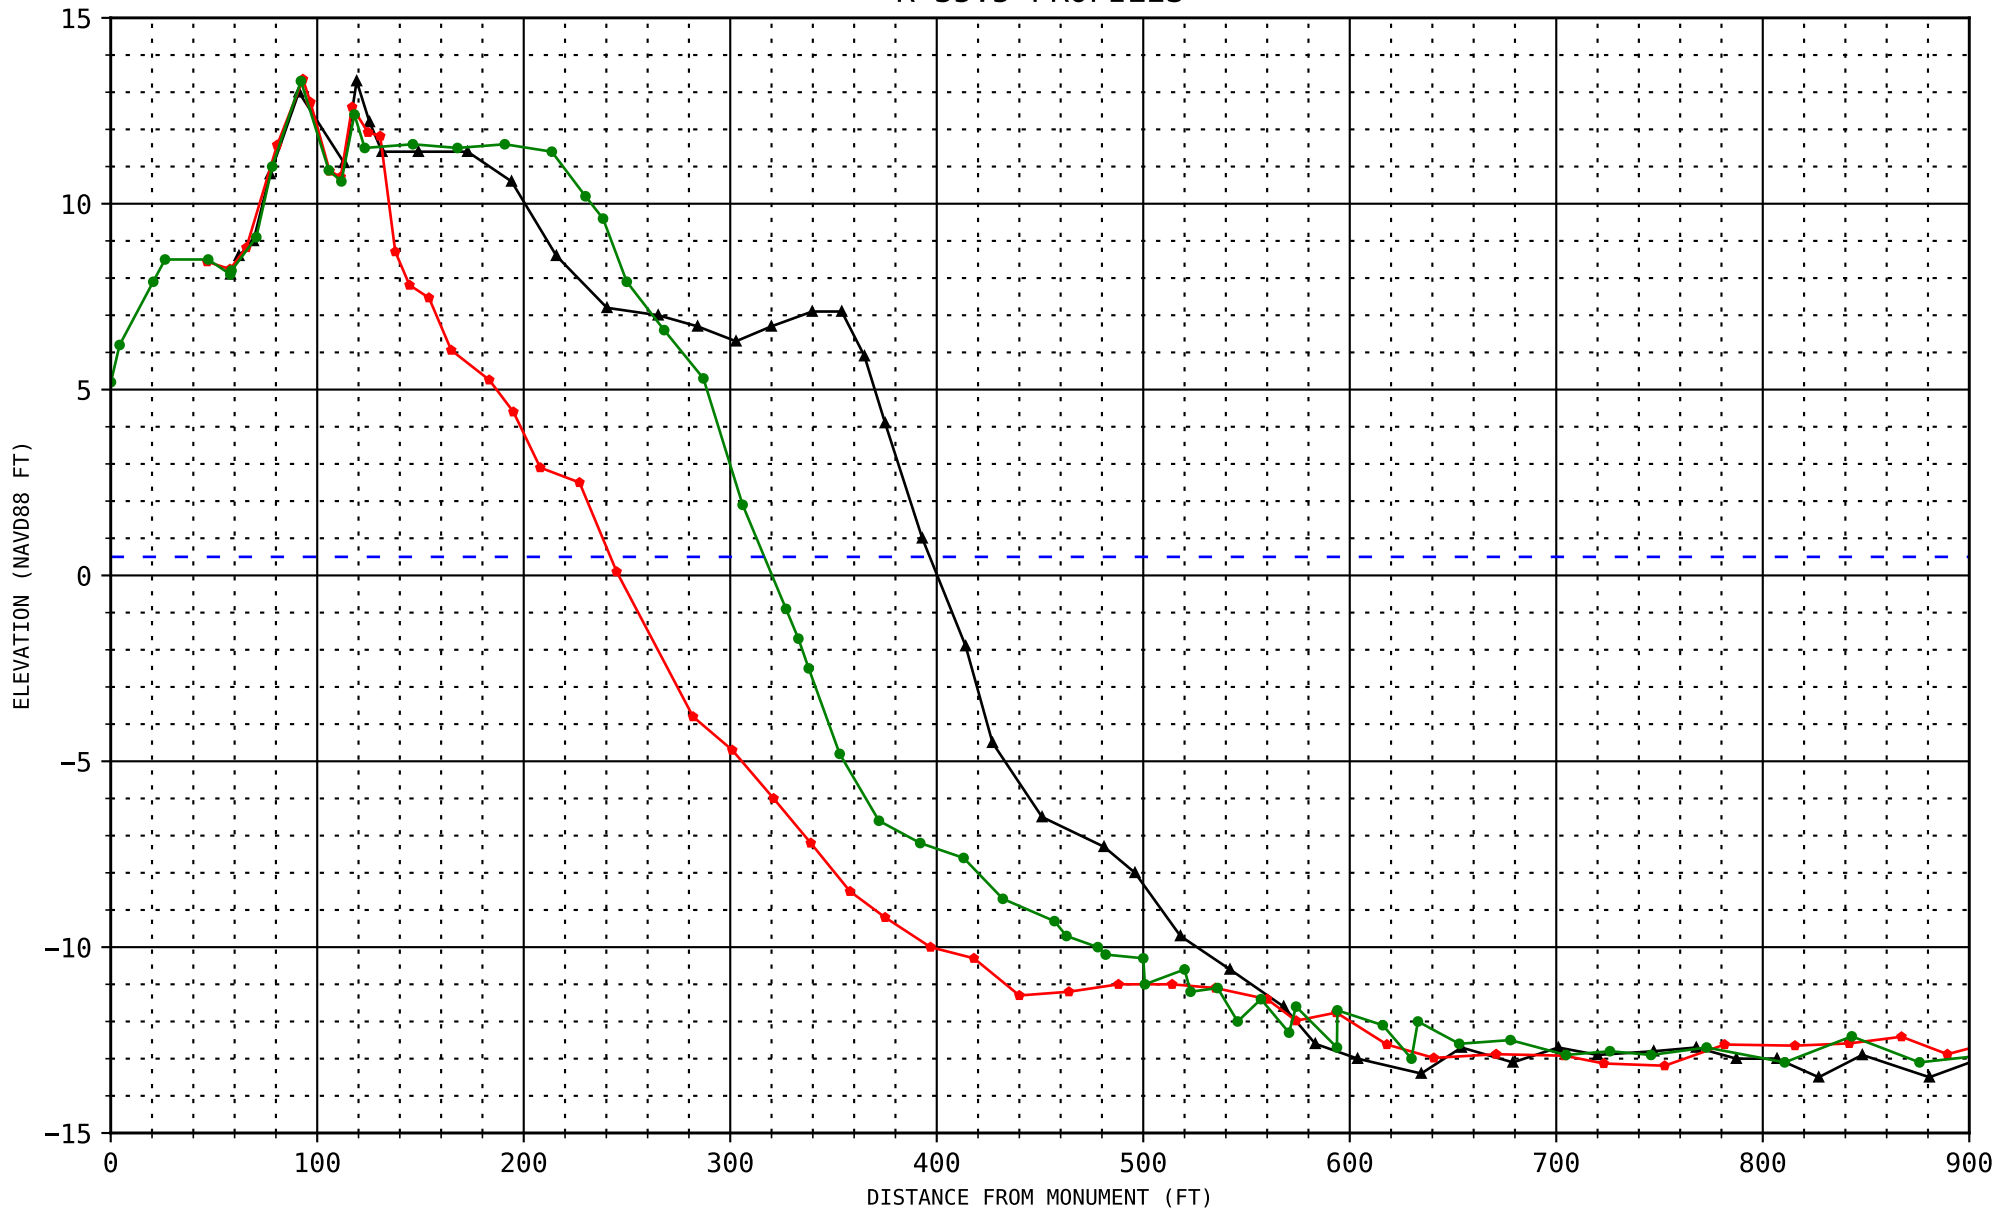
# R-35.5 PROFILES

RANGE: R-35.5  
EST DATE: COE1979  
SURVEY DATE: 03JUN21  
AZIMUTH: 70.0

—▲— 2021-JUN MONITORING BY MAE  
—●— 2020-JUN MONITORING BY MAE  
—●— 2019-JUN 12-MONTHS BY MAE  
- - - MHW CONTOUR (0.5 FT)

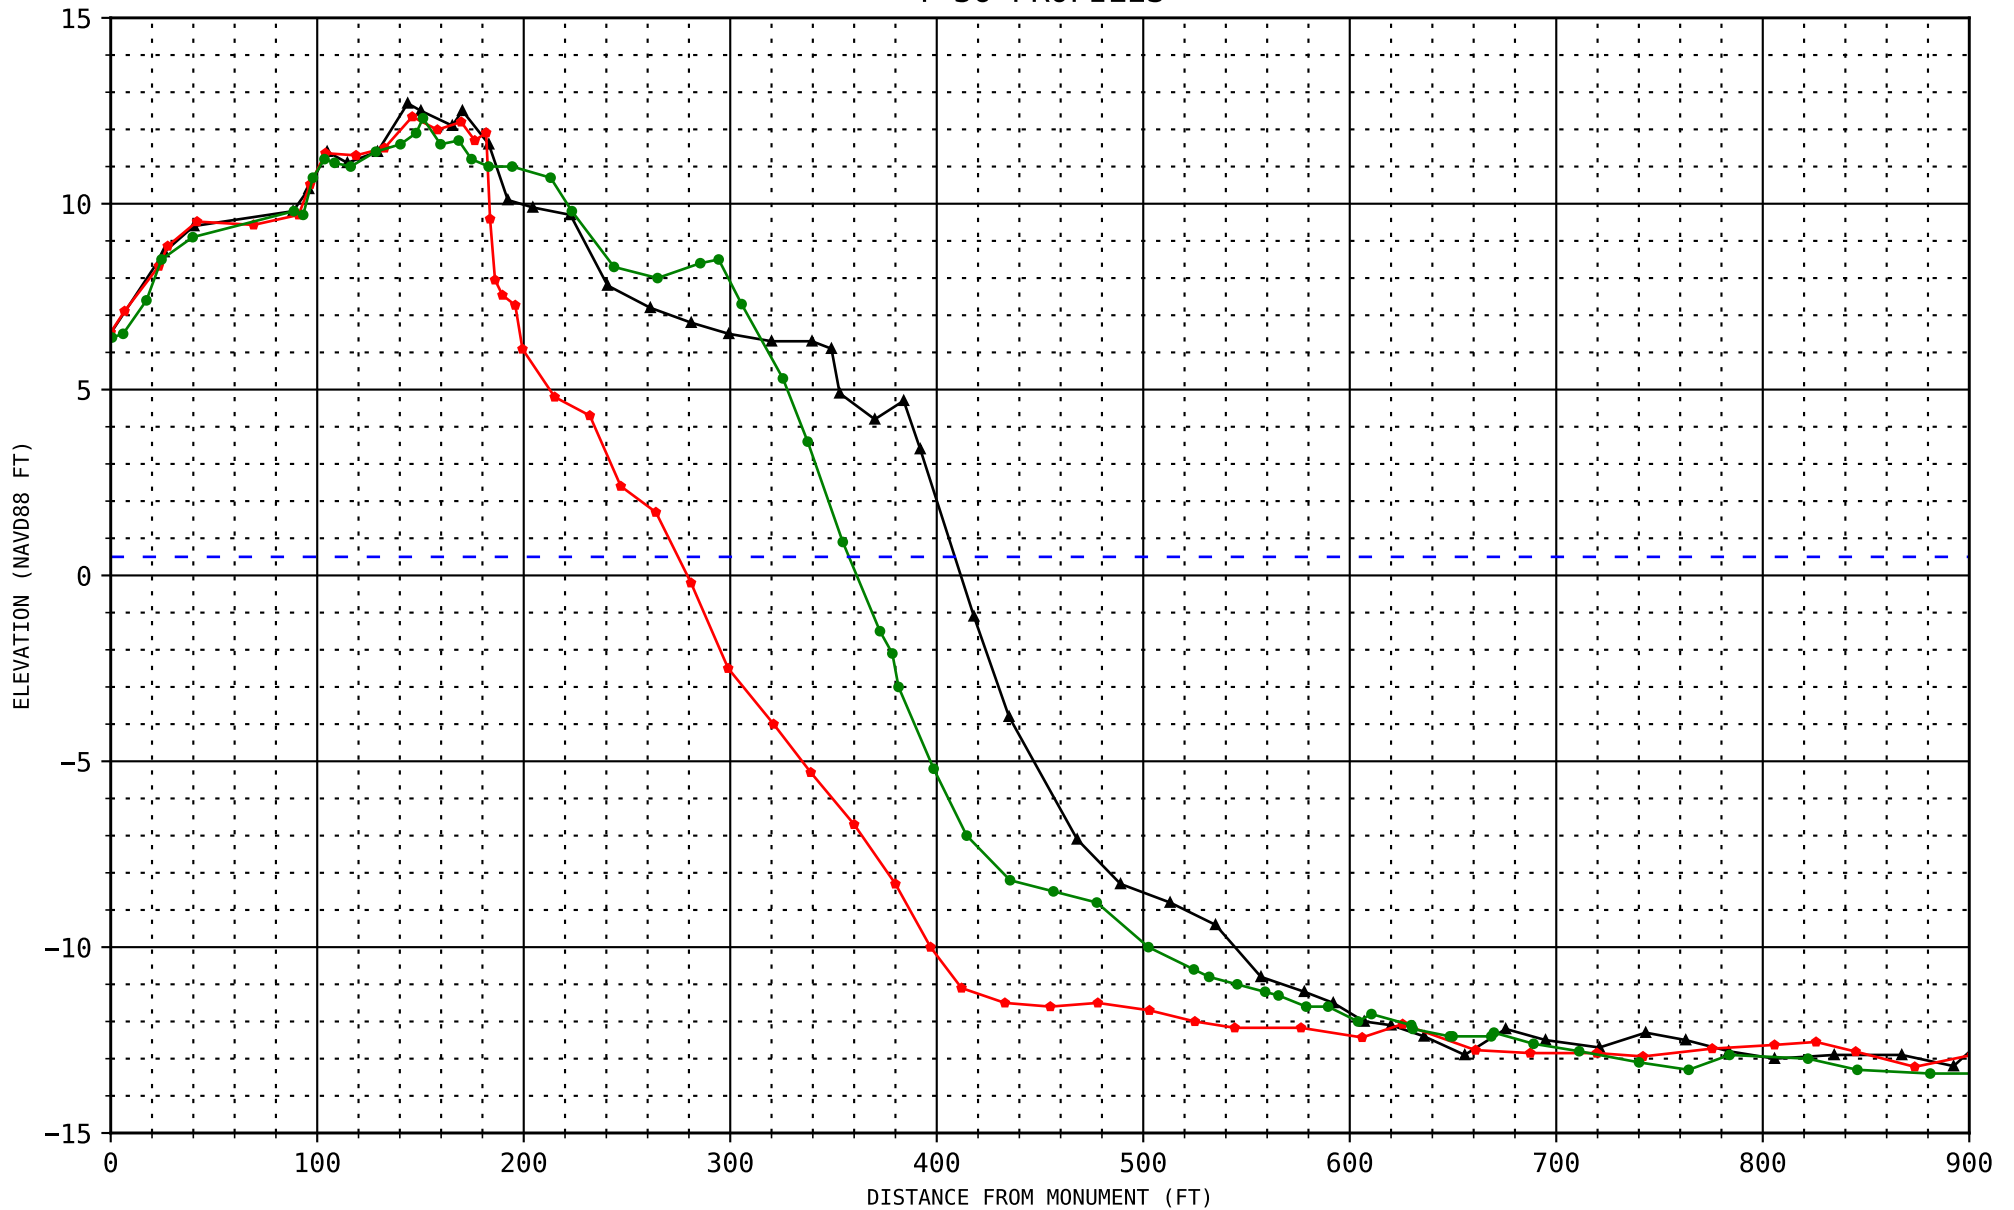
# T-36 PROFILES

—▲— 2021-JUN MONITORING BY MAE  
 —●— 2020-JUN MONITORING BY MAE  
 —●— 2019-JUN 12-MONTHS BY MAE  
 - - - MHW CONTOUR (0.5 FT)

RANGE: T-36  
 EST DATE: JUL1977  
 SURVEY DATE: 03JUN21  
 AZIMUTH: 70.0

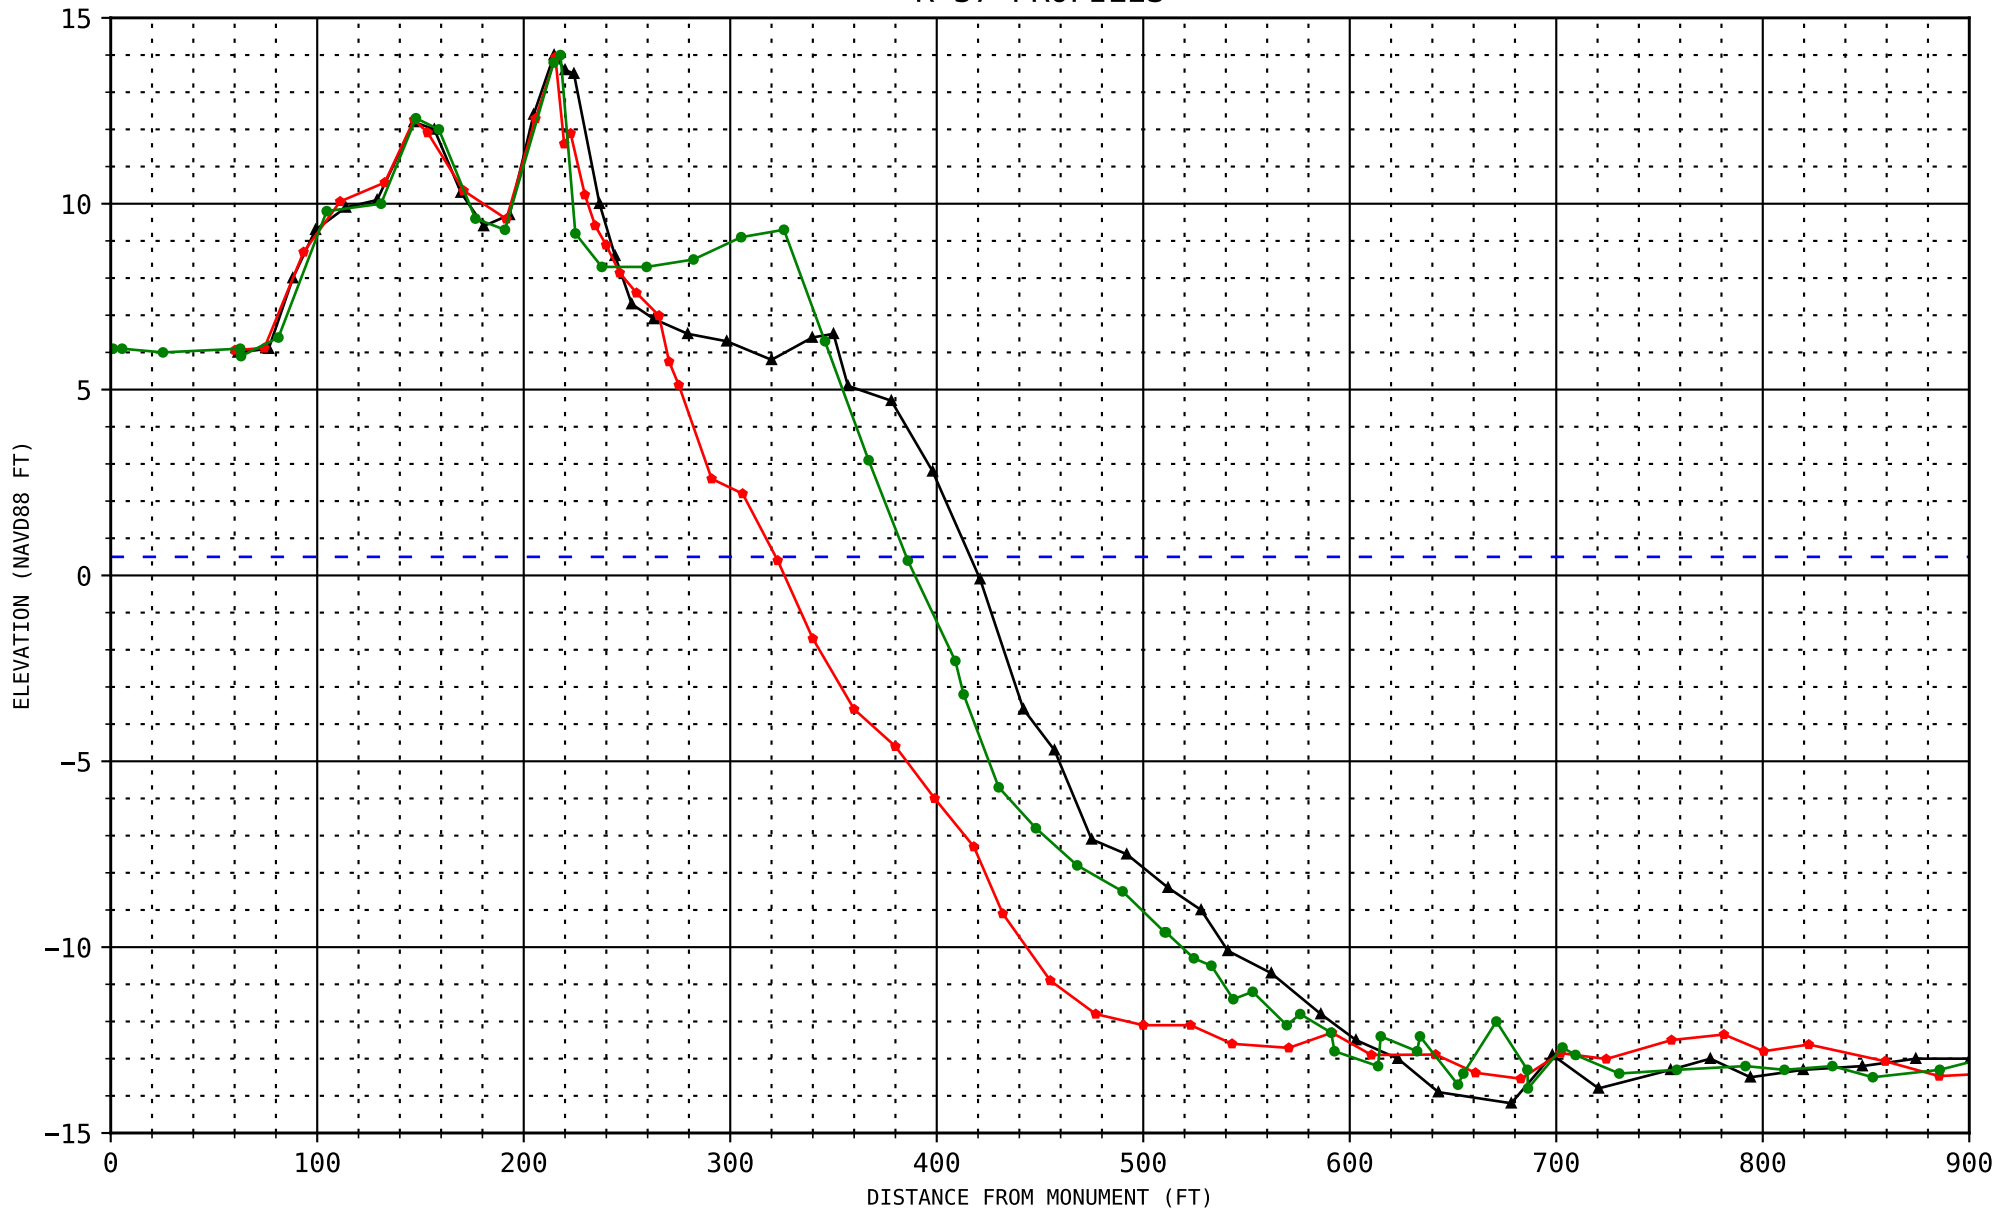
# R-37 PROFILES

- ▲— 2021-JUN MONITORING BY MAE
- 2020-JUN MONITORING BY MAE
- 2019-JUN 12-MONTHS BY MAE
- - - MHW CONTOUR (0.5 FT)

RANGE: R-37  
 EST DATE: COE1979  
 SURVEY DATE: 01JUN21  
 AZIMUTH: 70.0

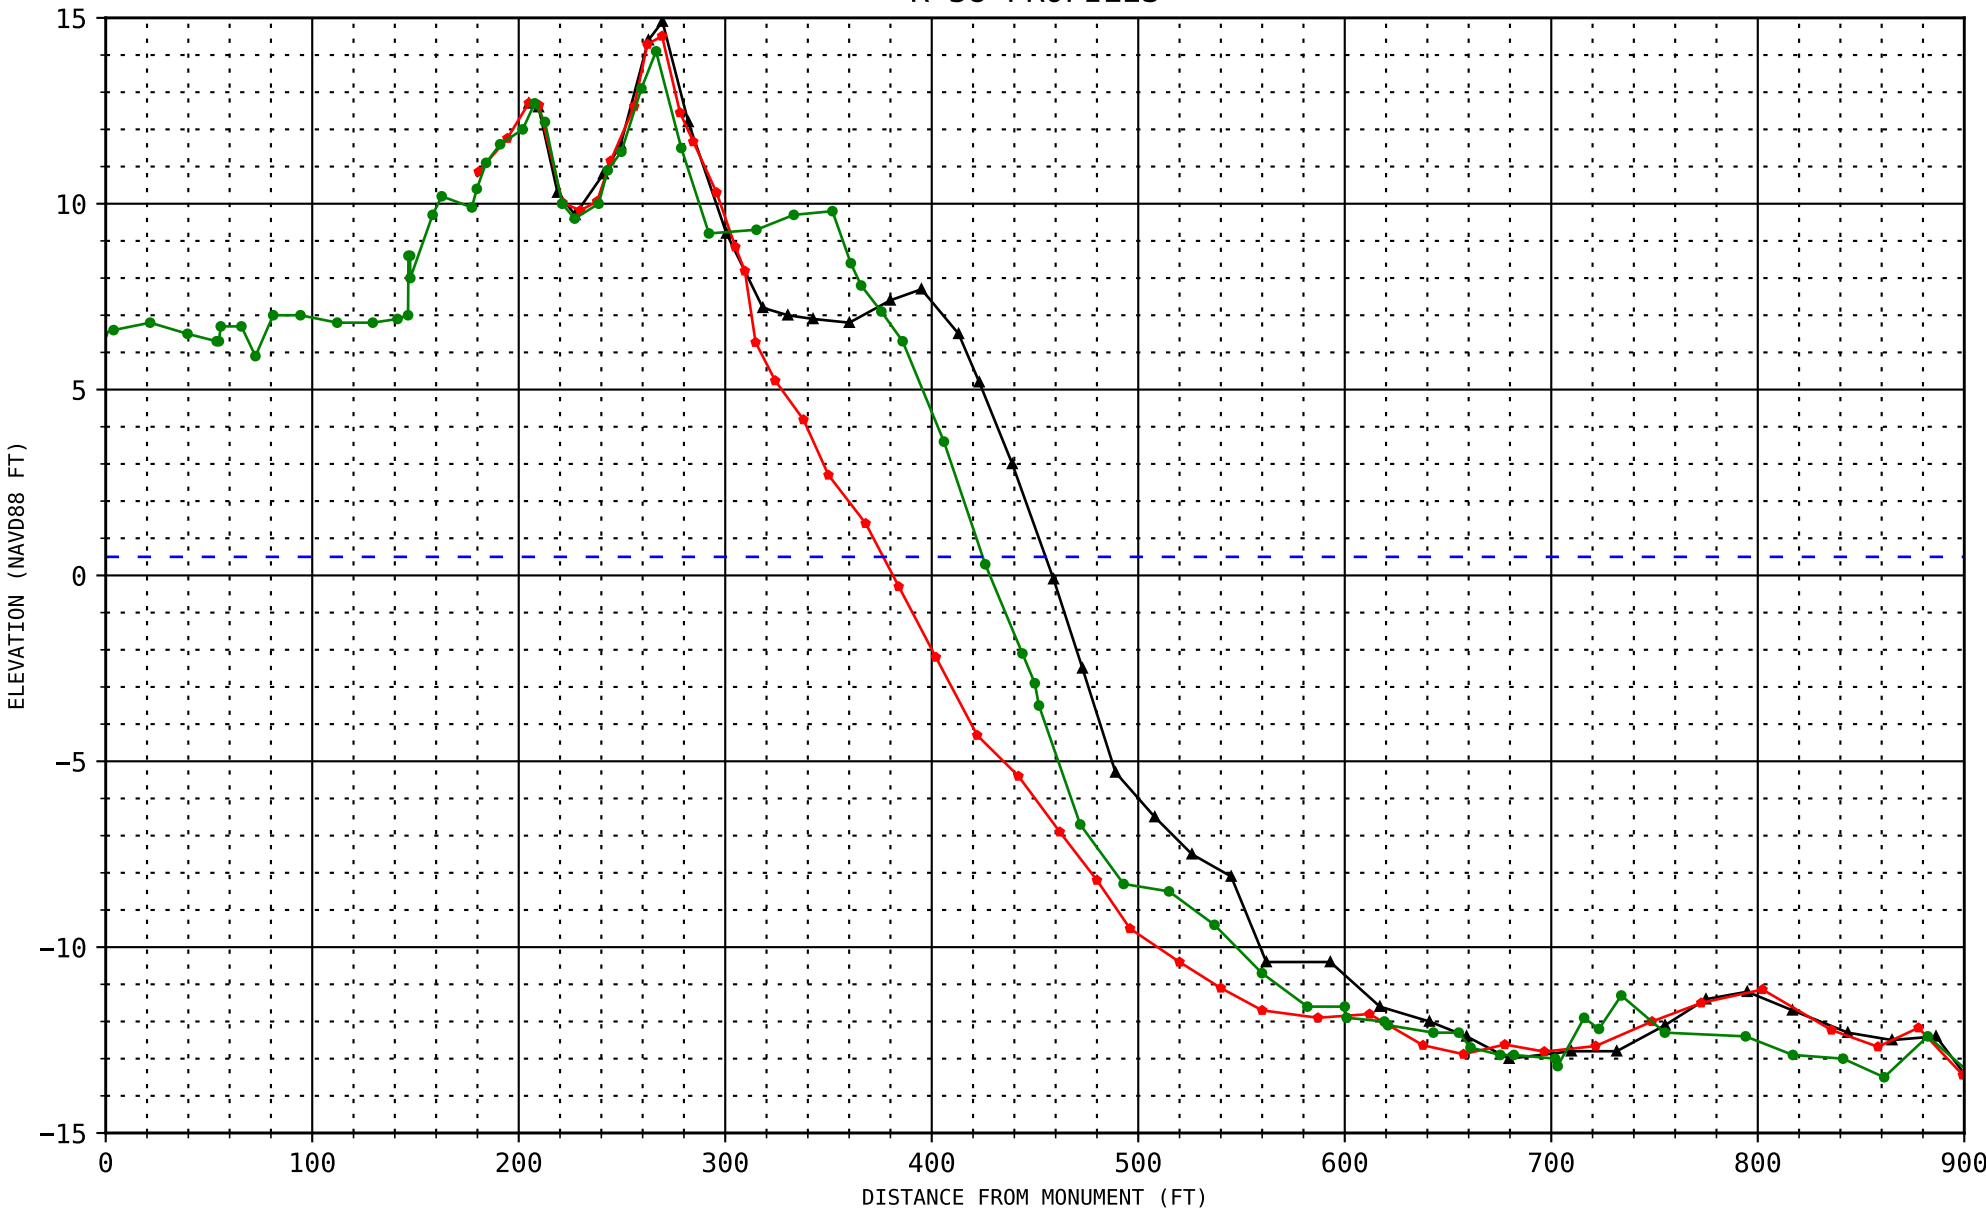
# R-38 PROFILES

—▲— 2021-JUN MONITORING BY MAE  
 —●— 2020-JUN MONITORING BY MAE  
 —●— 2019-JUN 12-MONTHS BY MAE  
 - - - MHW CONTOUR (0.5 FT)

RANGE: R-38  
 EST DATE: COE1984  
 SURVEY DATE: 01JUN21  
 AZIMUTH: 70.0

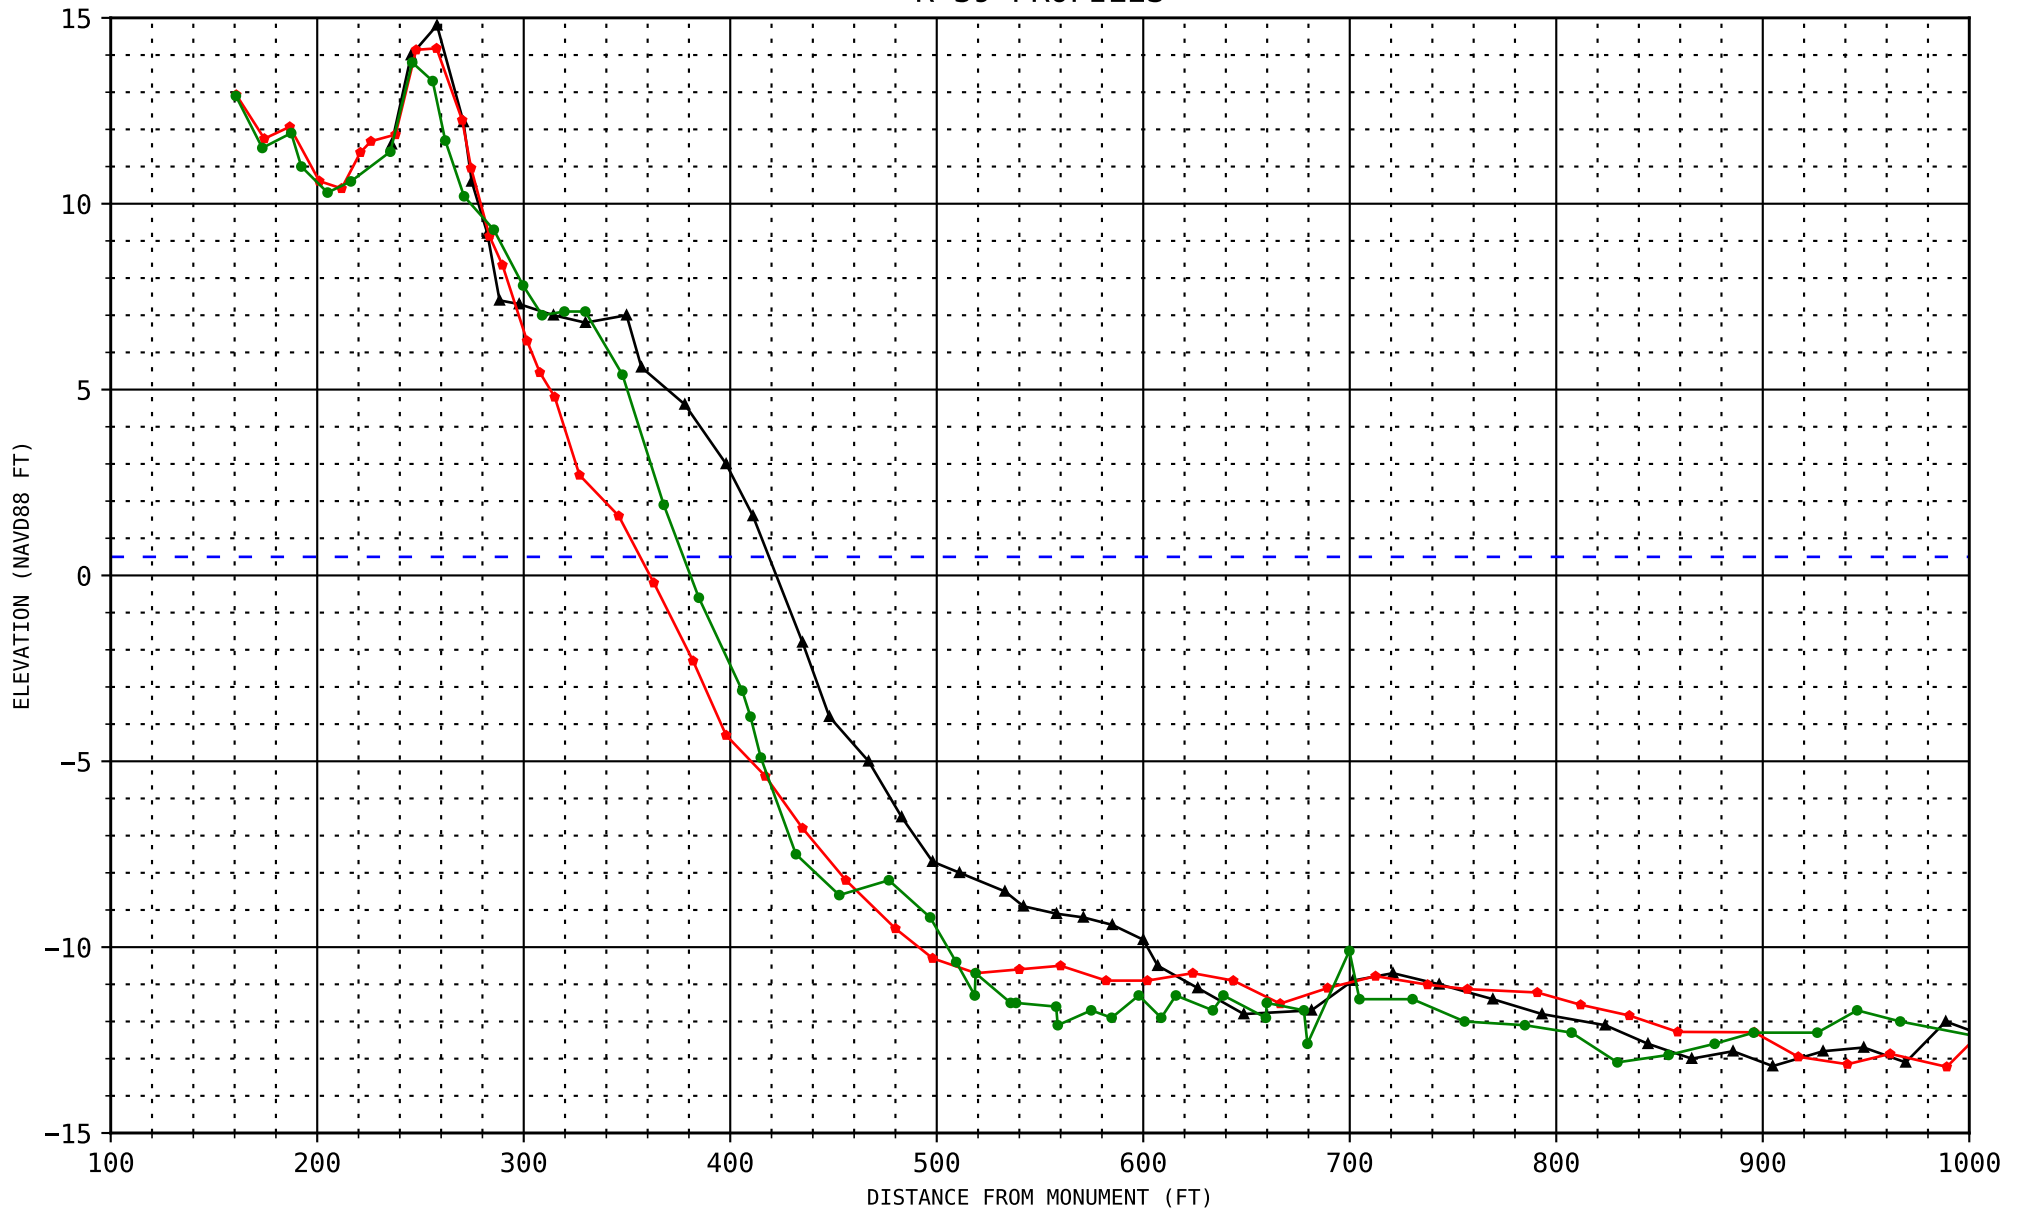
# R-39 PROFILES

—▲— 2021-JUN MONITORING BY MAE  
 —●— 2020-JUN MONITORING BY MAE  
 —●— 2019-JUN 12-MONTHS BY MAE  
 - - - MHW CONTOUR (0.5 FT)

RANGE: R-39  
 EST DATE: JAN1972  
 SURVEY DATE: 01JUN21  
 AZIMUTH: 70.0

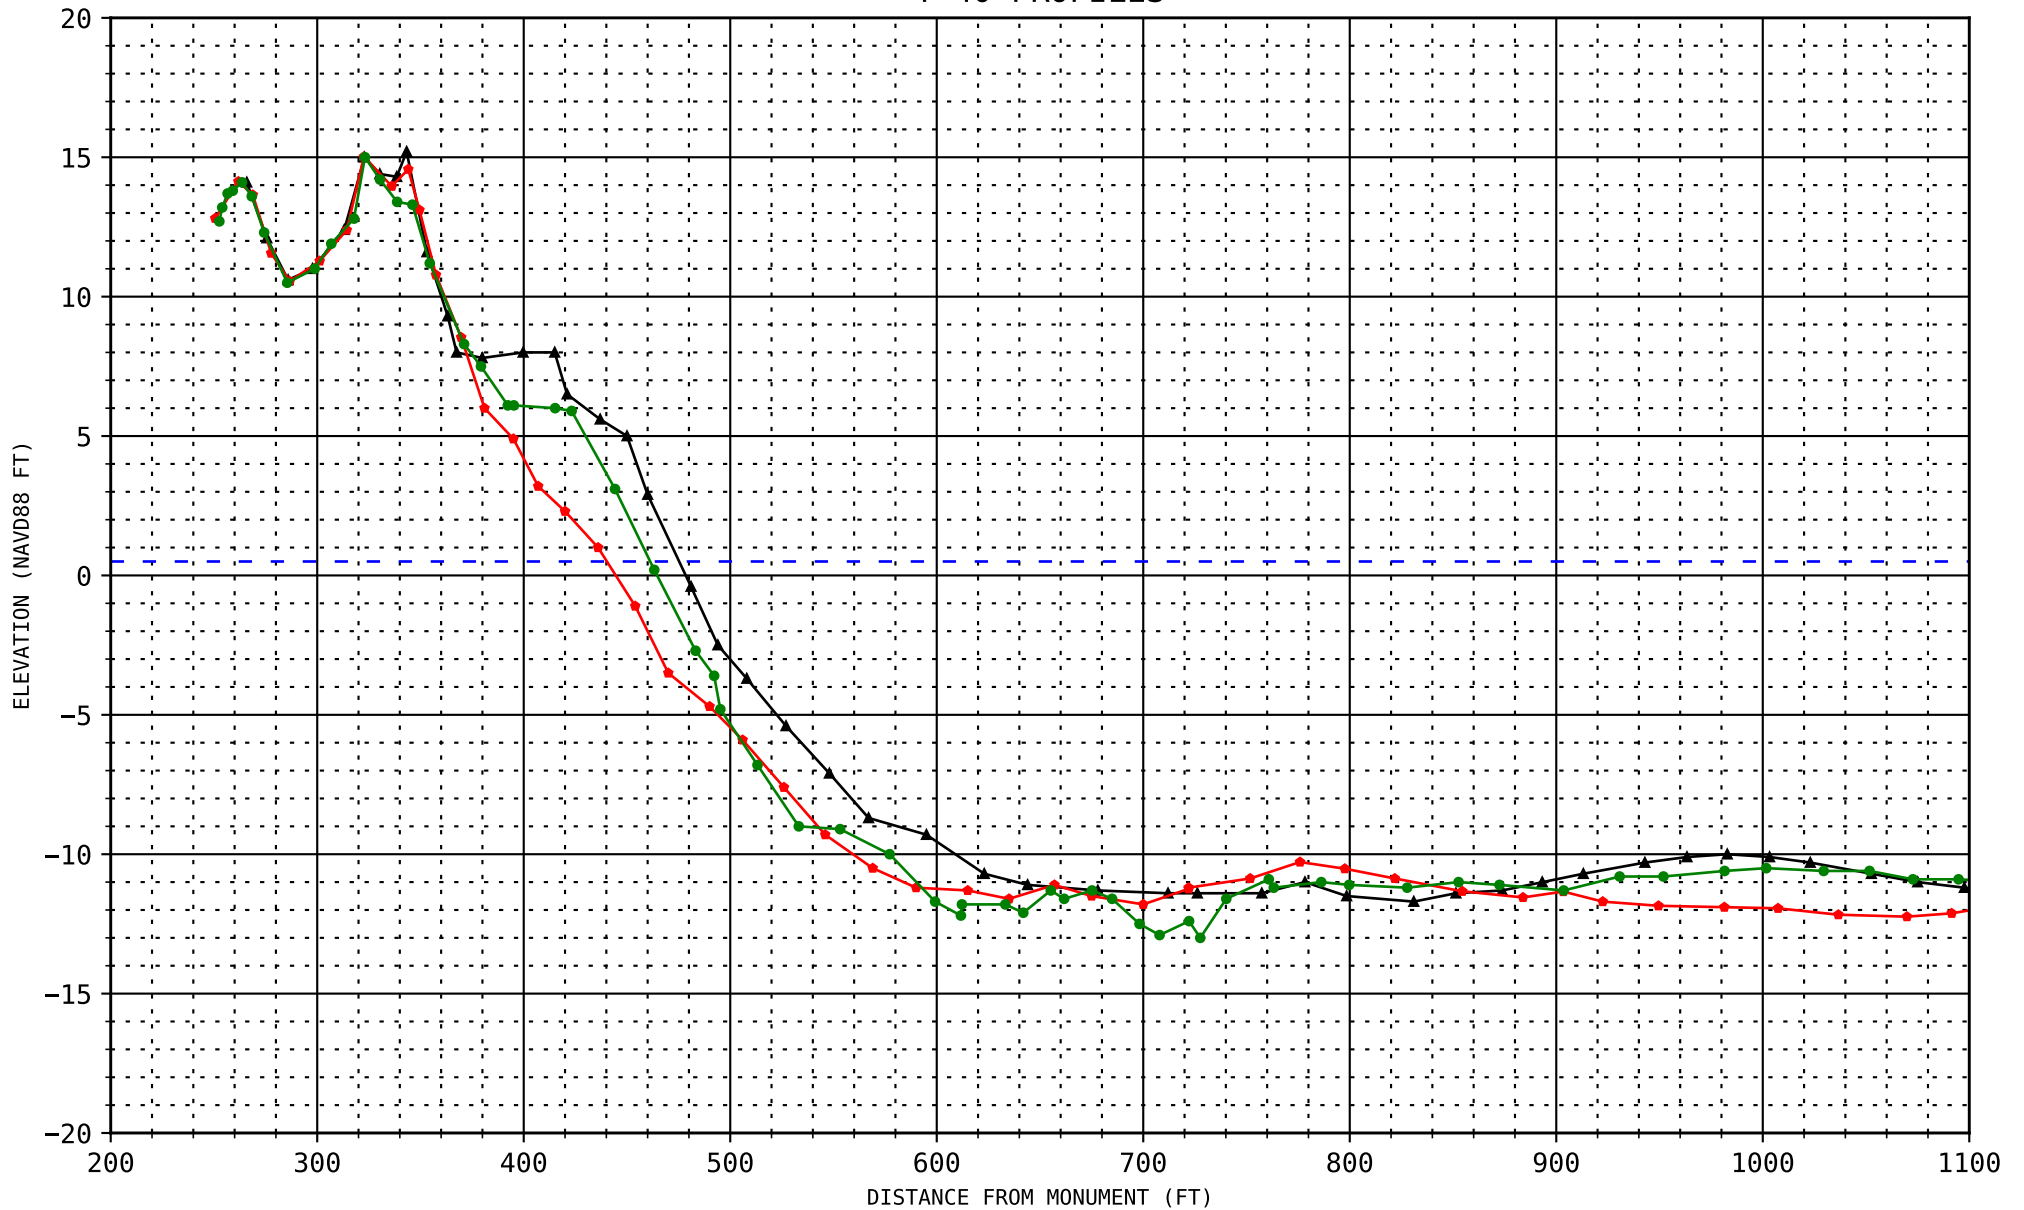
# T-40 PROFILES

—▲— 2021-JUN MONITORING BY MAE  
 —●— 2020-JUN MONITORING BY MAE  
 —●— 2019-JUN 12-MONTHS BY MAE  
 - - - MHW CONTOUR (0.5 FT)

RANGE: T-40  
 EST DATE: JUL1977  
 SURVEY DATE: 01JUN21  
 AZIMUTH: 70.0
