# R-34 PROFILES

ST LUCIE  
 COASTAL ENGINEERING AND GEOLOGY PROGRAM  
 OFFICE OF RESILIENCE AND COASTAL PROTECTION  
 FLORIDA DEPARTMENT OF ENVIRONMENTAL PROTECTION

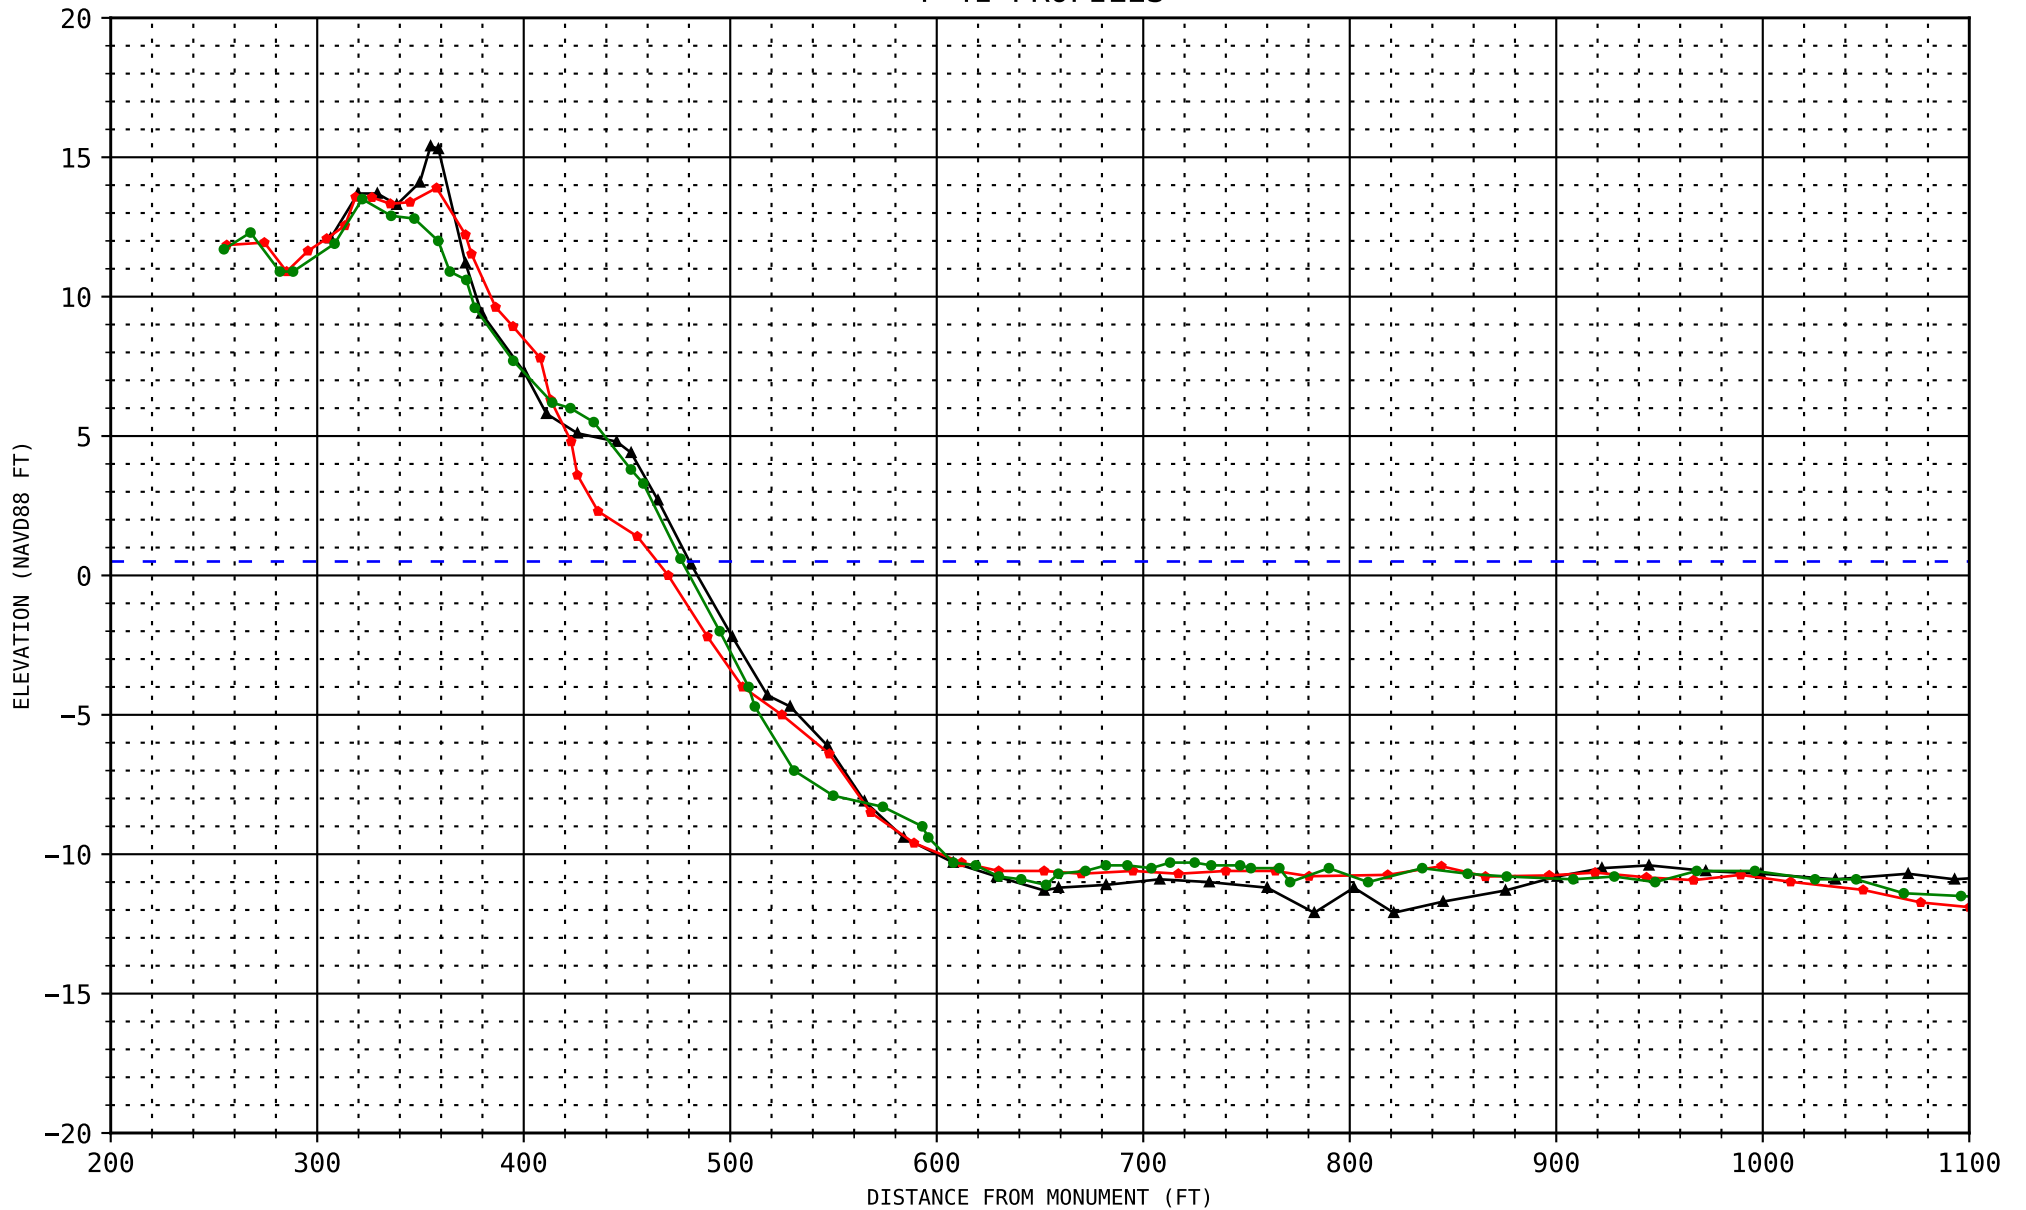
# T-41 PROFILES

—▲— 2021-JUN MONITORING BY MAE  
 —◆— 2020-JUN MONITORING BY MAE  
 —●— 2019-JUN 12-MONTHS BY MAE  
 - - - MHW CONTOUR (0.5 FT)

RANGE: T-41  
 EST DATE: JUL1977  
 SURVEY DATE: 01JUN21  
 AZIMUTH: 70.0

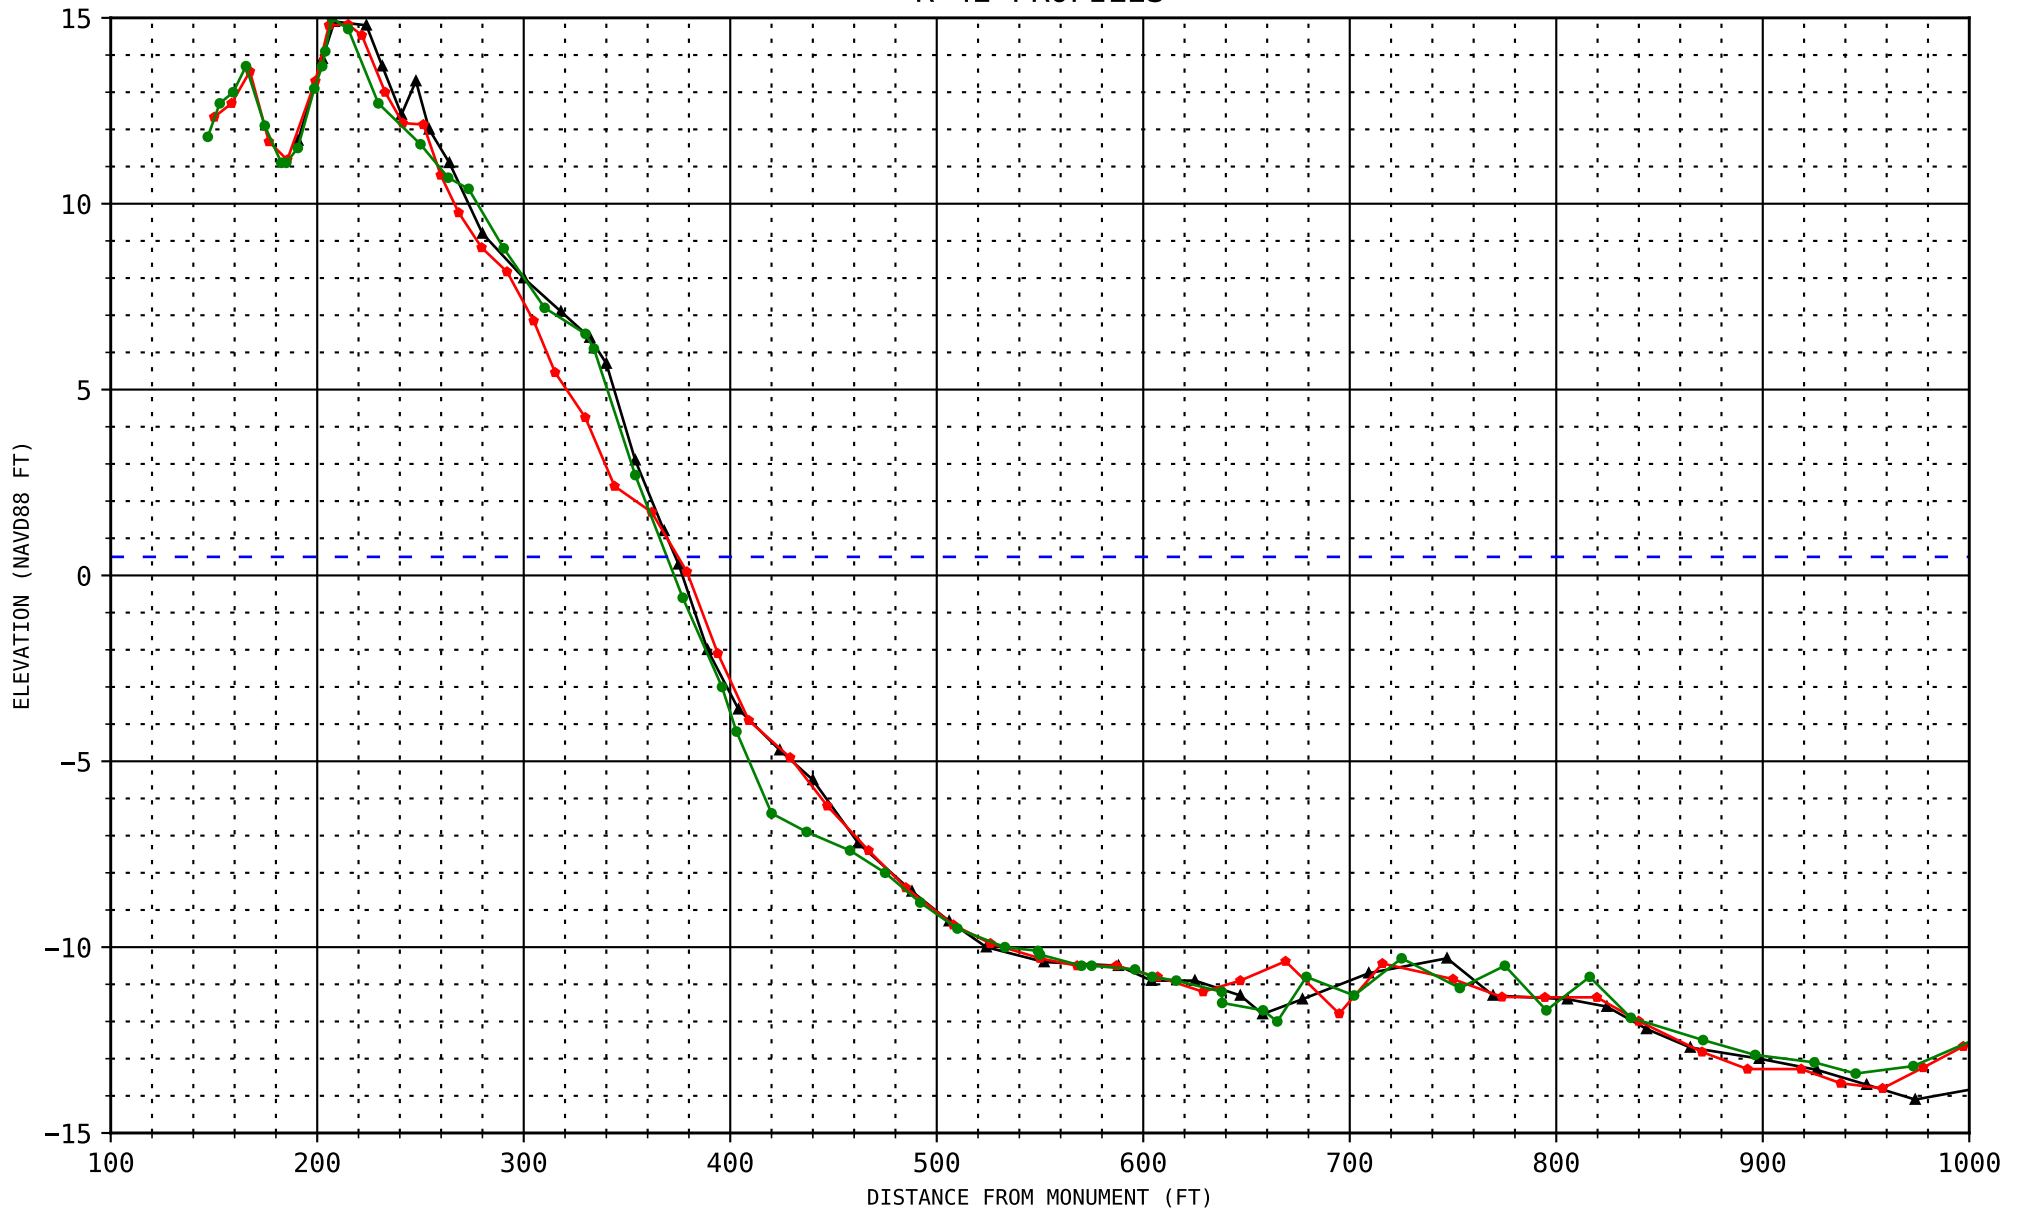
# R-42 PROFILES

—▲— 2021-JUN MONITORING BY MAE  
 —●— 2020-JUN MONITORING BY MAE  
 —●— 2019-JUN 12-MONTHS BY MAE  
 - - - MHW CONTOUR (0.5 FT)

RANGE: R-42  
 EST DATE: JAN1972  
 SURVEY DATE: 01JUN21  
 AZIMUTH: 70.0

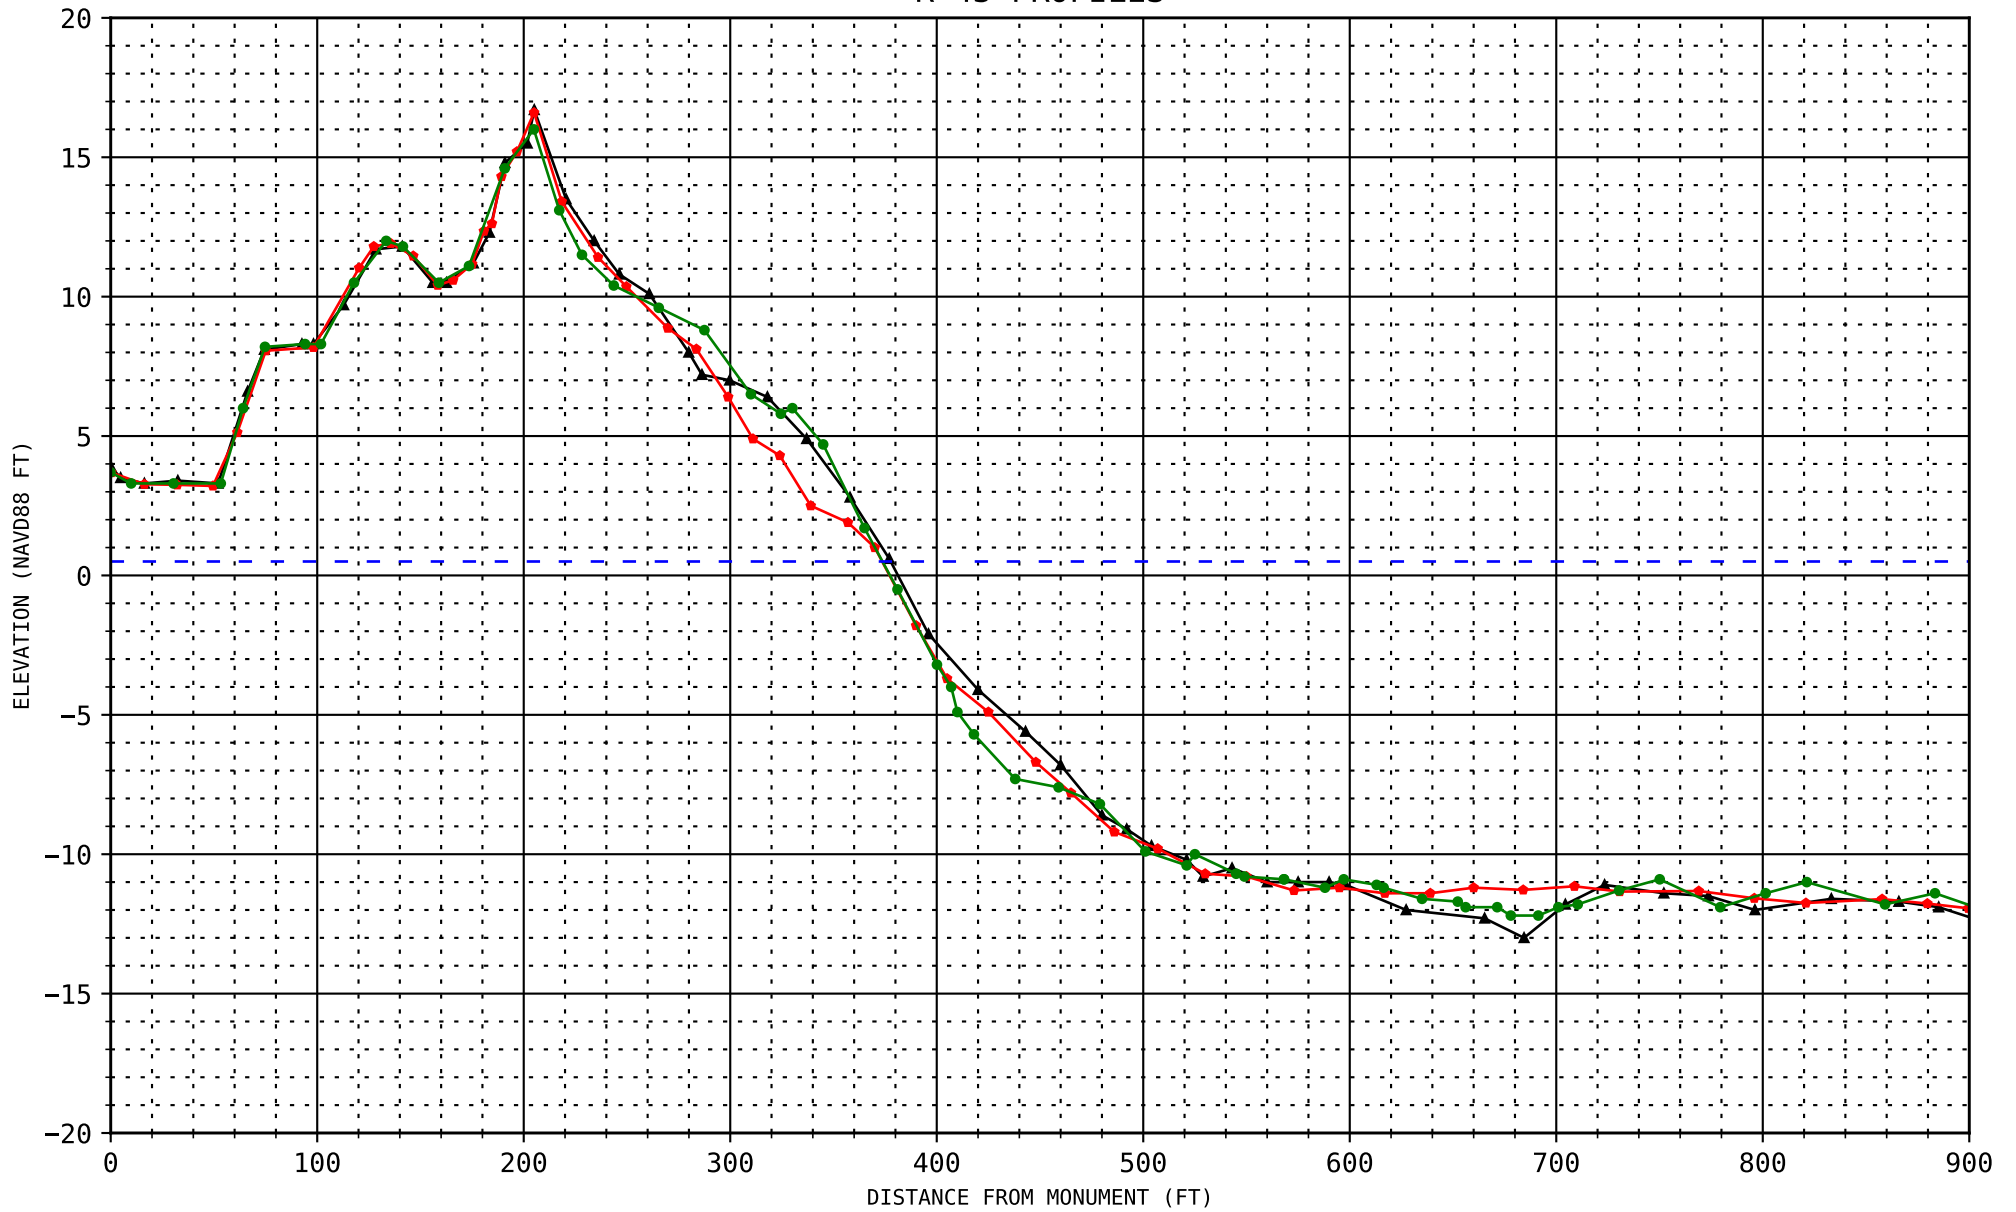
# R-43 PROFILES

—▲— 2021-JUN MONITORING BY MAE  
 —●— 2020-JUN MONITORING BY MAE  
 —●— 2019-JUN 12-MONTHS BY MAE  
 - - - MHW CONTOUR (0.5 FT)

RANGE: R-43  
 EST DATE: JUN1997  
 SURVEY DATE: 01JUN21  
 AZIMUTH: 70.0

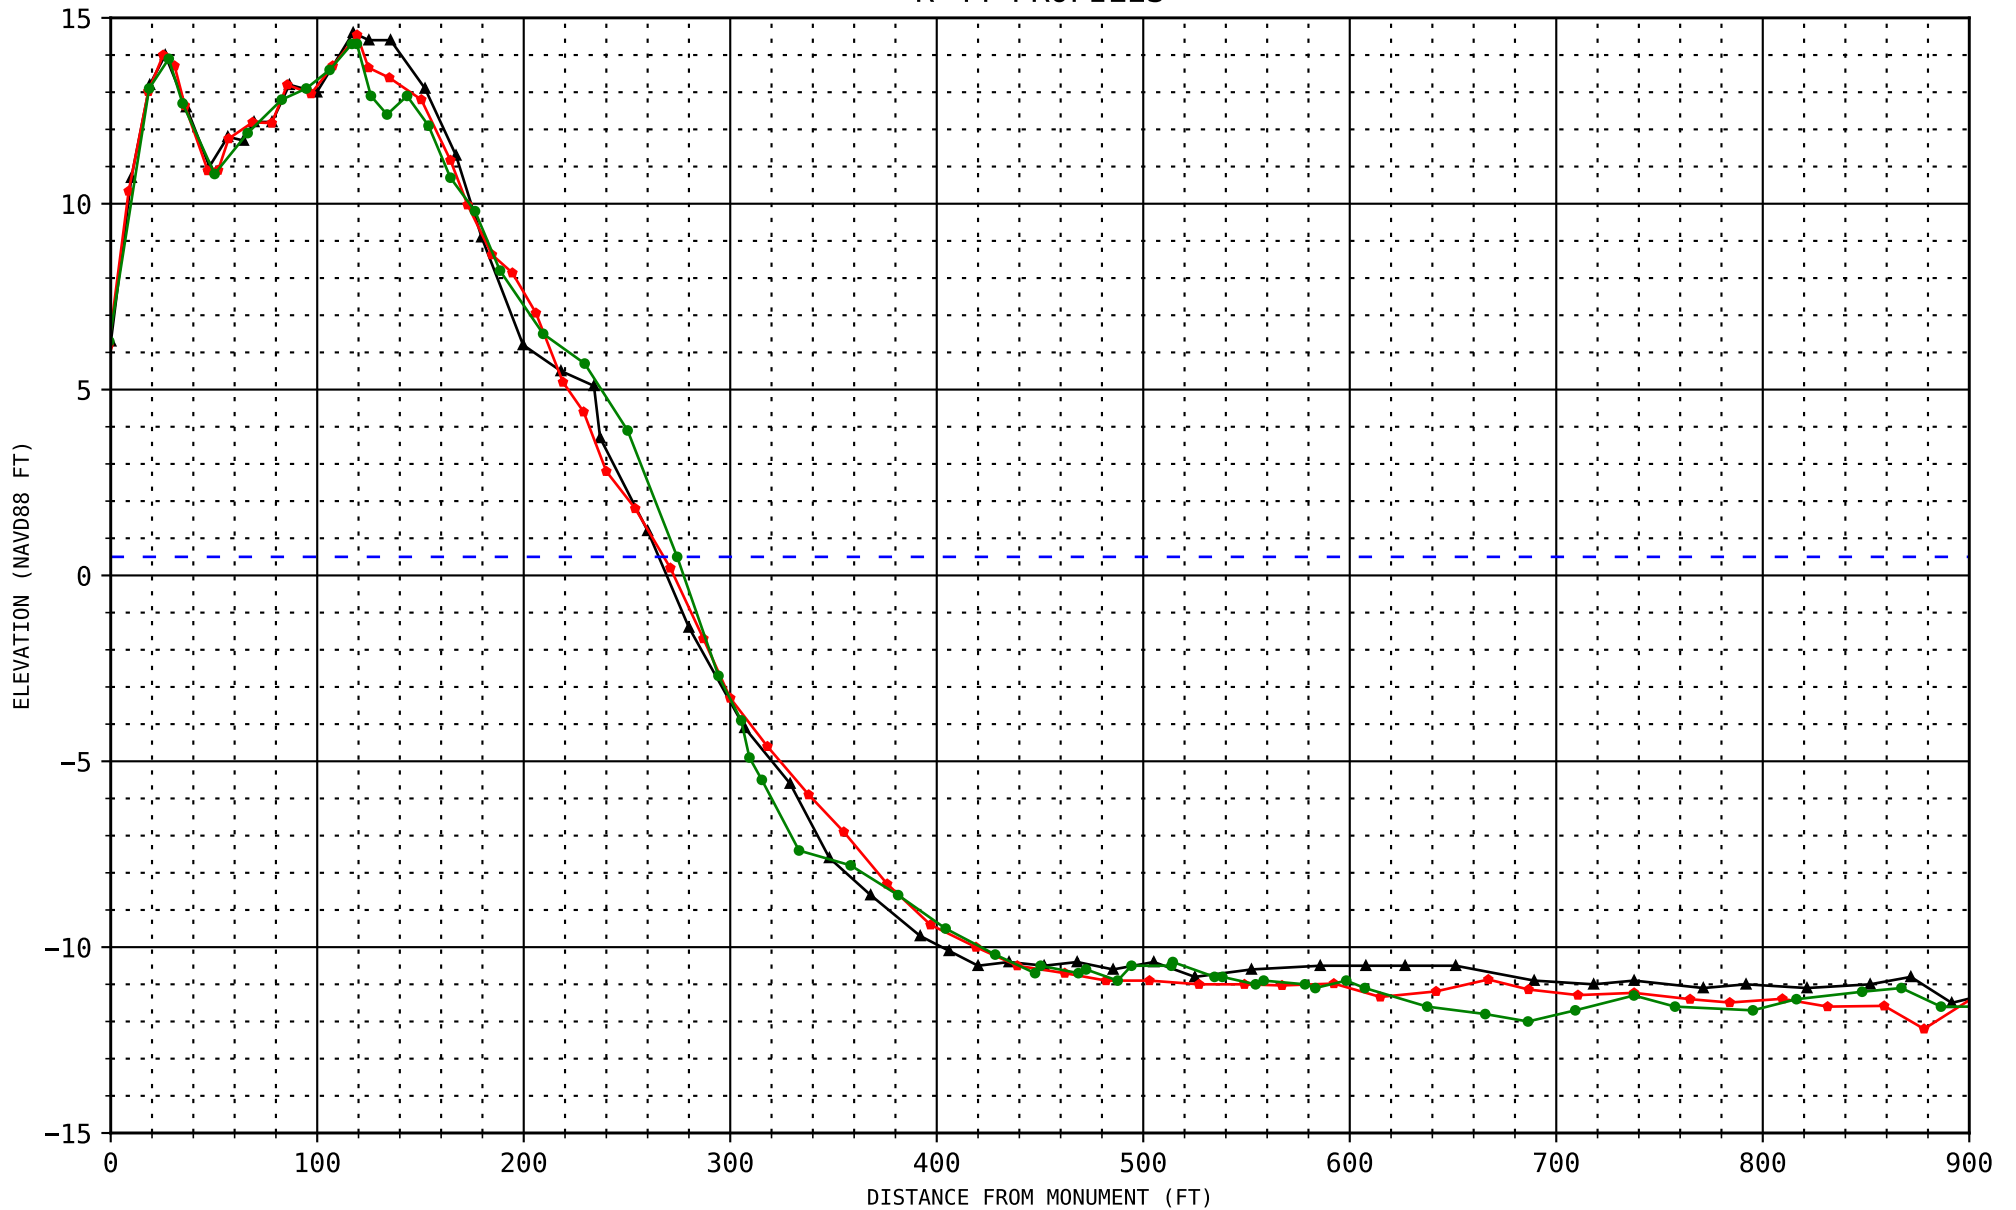
# R-44 PROFILES

—▲— 2021-JUN MONITORING BY MAE  
 —●— 2020-JUN MONITORING BY MAE  
 —●— 2019-JUN 12-MONTHS BY MAE  
 - - - MHW CONTOUR (0.5 FT)

RANGE: R-44  
 EST DATE: FEB1983  
 SURVEY DATE: 01JUN21  
 AZIMUTH: 70.0

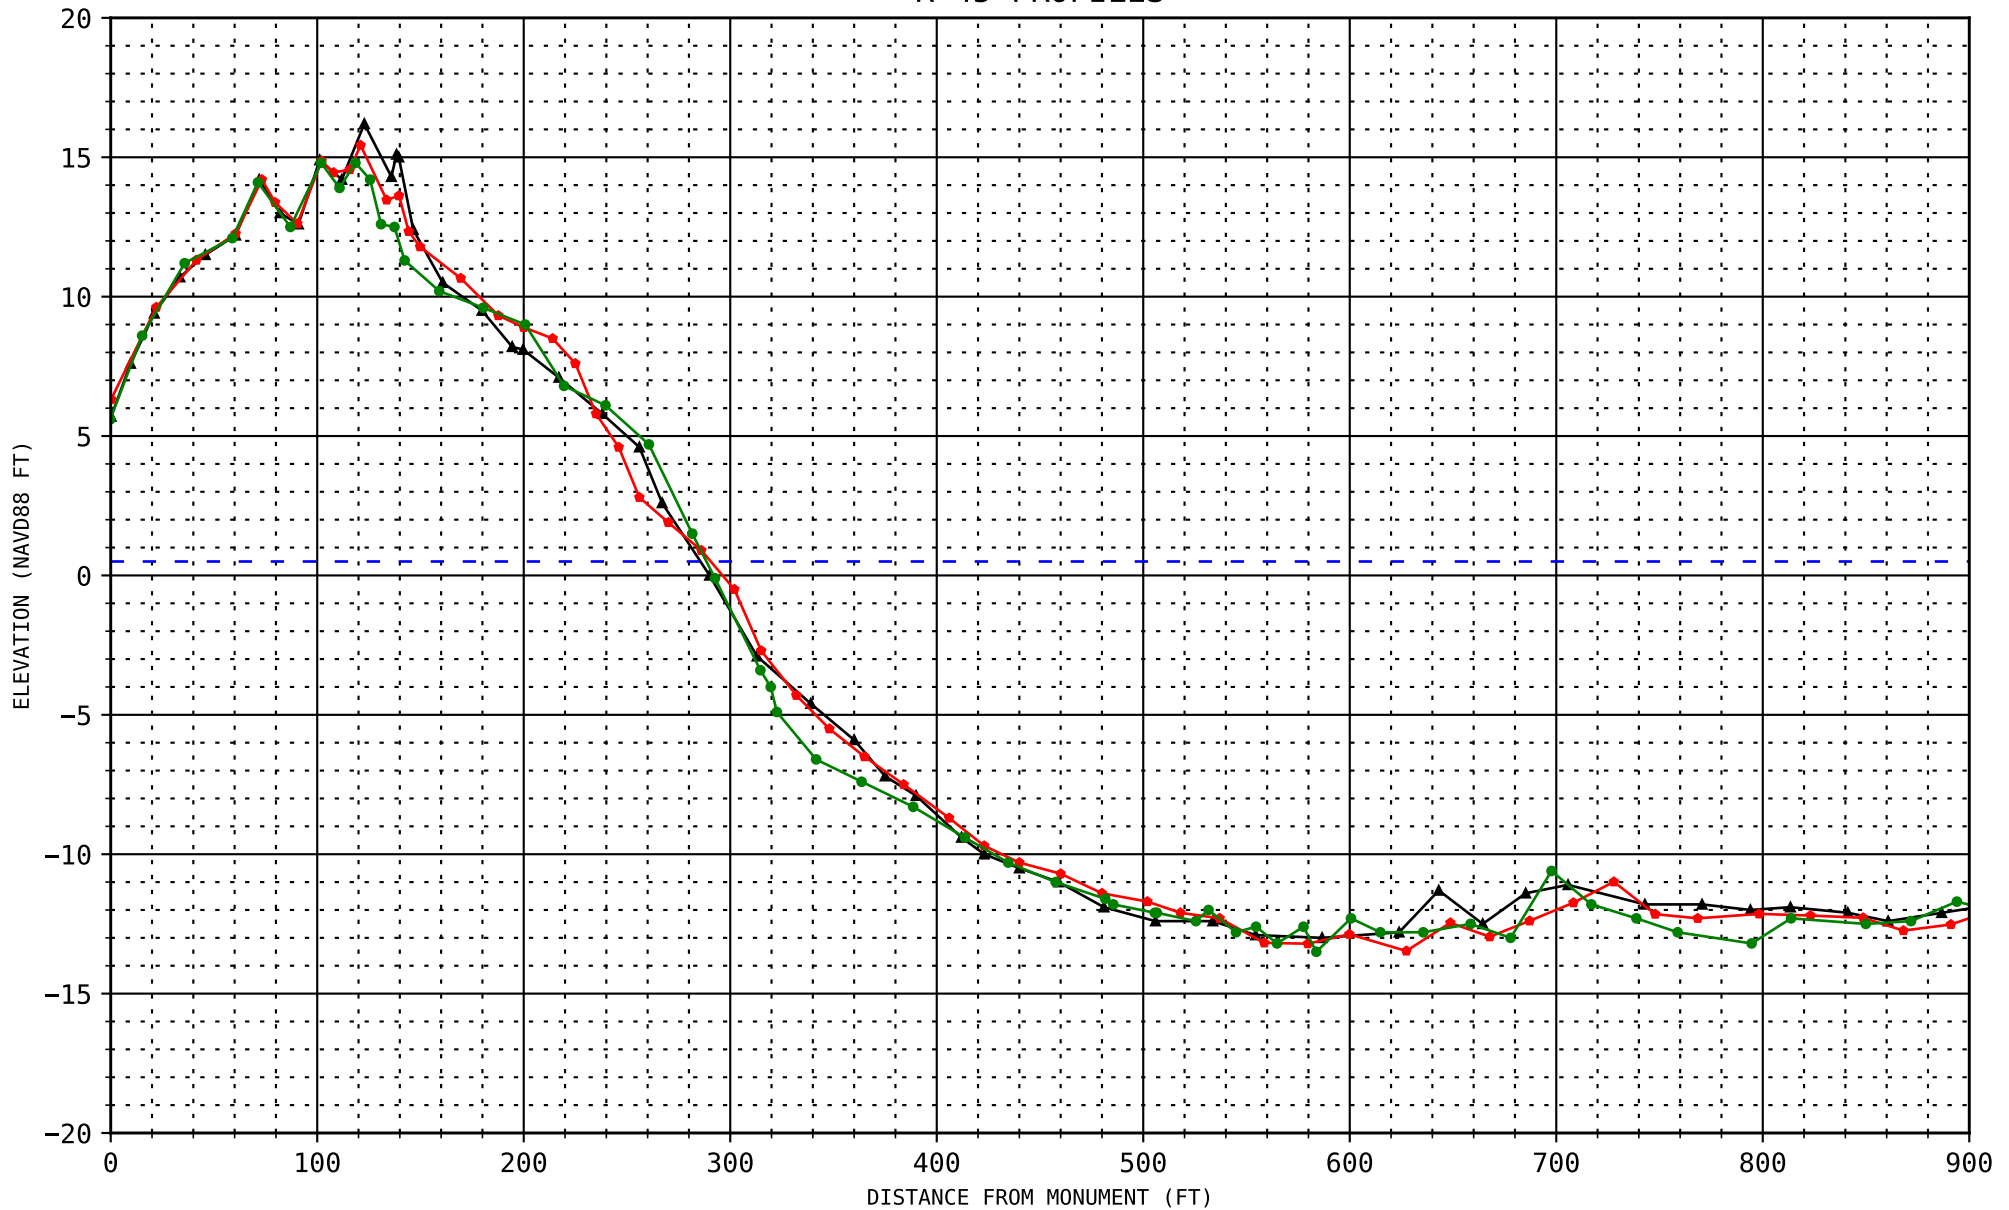
# R-45 PROFILES

—▲— 2021-JUN MONITORING BY MAE  
 —●— 2020-JUN MONITORING BY MAE  
 —●— 2019-JUN 12-MONTHS BY MAE  
 - - - MHW CONTOUR (0.5 FT)

RANGE: R-45  
 EST DATE: COE1994  
 SURVEY DATE: 01JUN21  
 AZIMUTH: 70.0

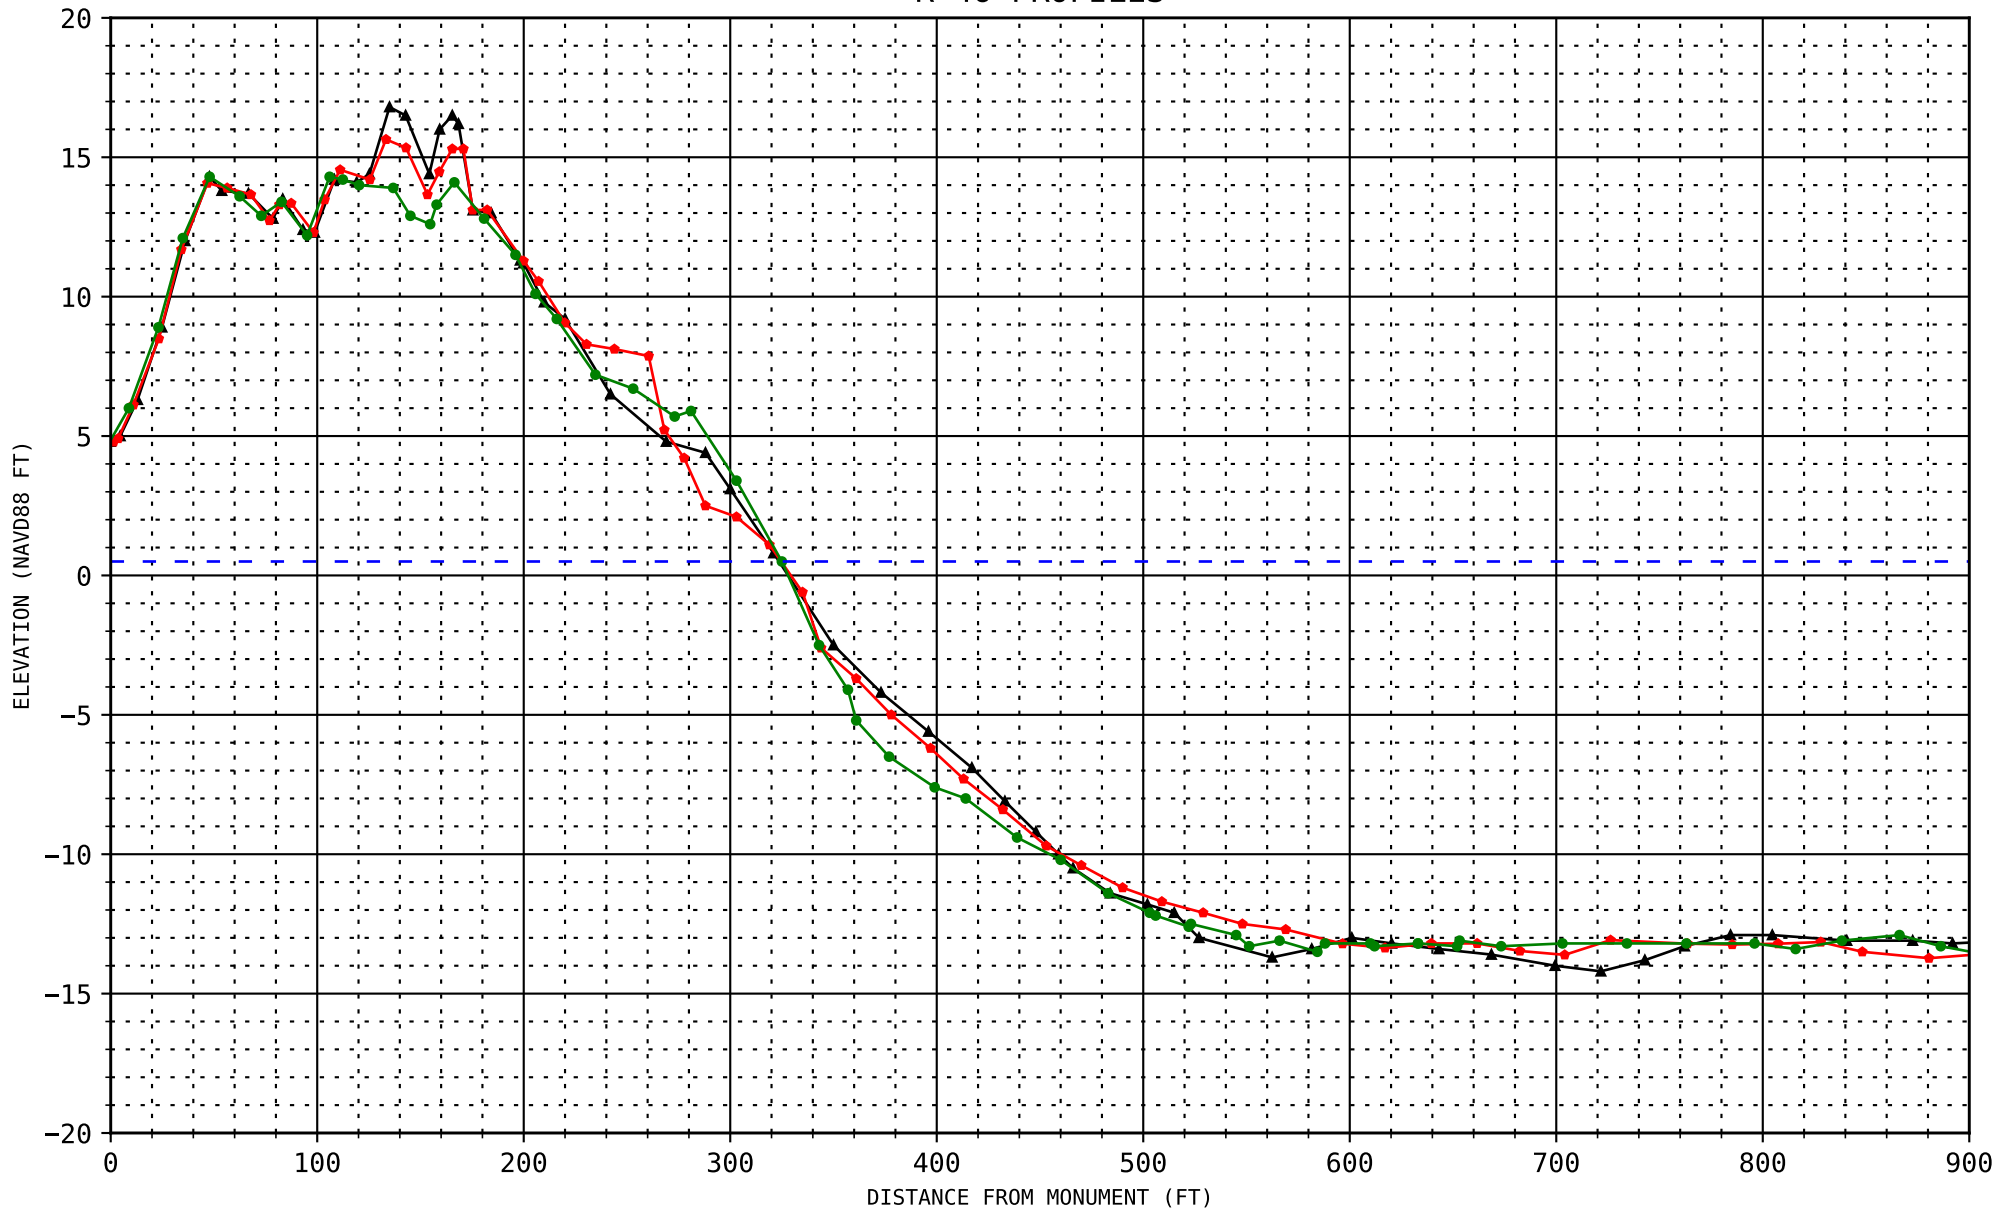
# R-46 PROFILES

| <p> —▲— 2021-JUN MONITORING BY MAE<br/> —●— 2020-JUN MONITORING BY MAE<br/> —●— 2019-JUN 12-MONTHS BY MAE<br/> - - - MHW CONTOUR (0.5 FT) </p> | <p> ST LUCIE<br/> COASTAL ENGINEERING AND GEOLOGY PROGRAM<br/> OFFICE OF RESILIENCE AND COASTAL PROTECTION<br/> FLORIDA DEPARTMENT OF ENVIRONMENTAL PROTECTION </p> | <p> RANGE: R-46<br/> EST DATE: SEP1986<br/> SURVEY DATE: 01JUN21<br/> AZIMUTH: 70.0 </p> |
