# ***CRITICALLY ERODED BEACHES IN FLORIDA***

Updated, April 2007

**BUREAU OF BEACHES AND COASTAL SYSTEMS  
DIVISION OF WATER RESOURCE MANAGEMENT  
DEPARTMENT OF ENVIRONMENTAL PROTECTION  
STATE OF FLORIDA**

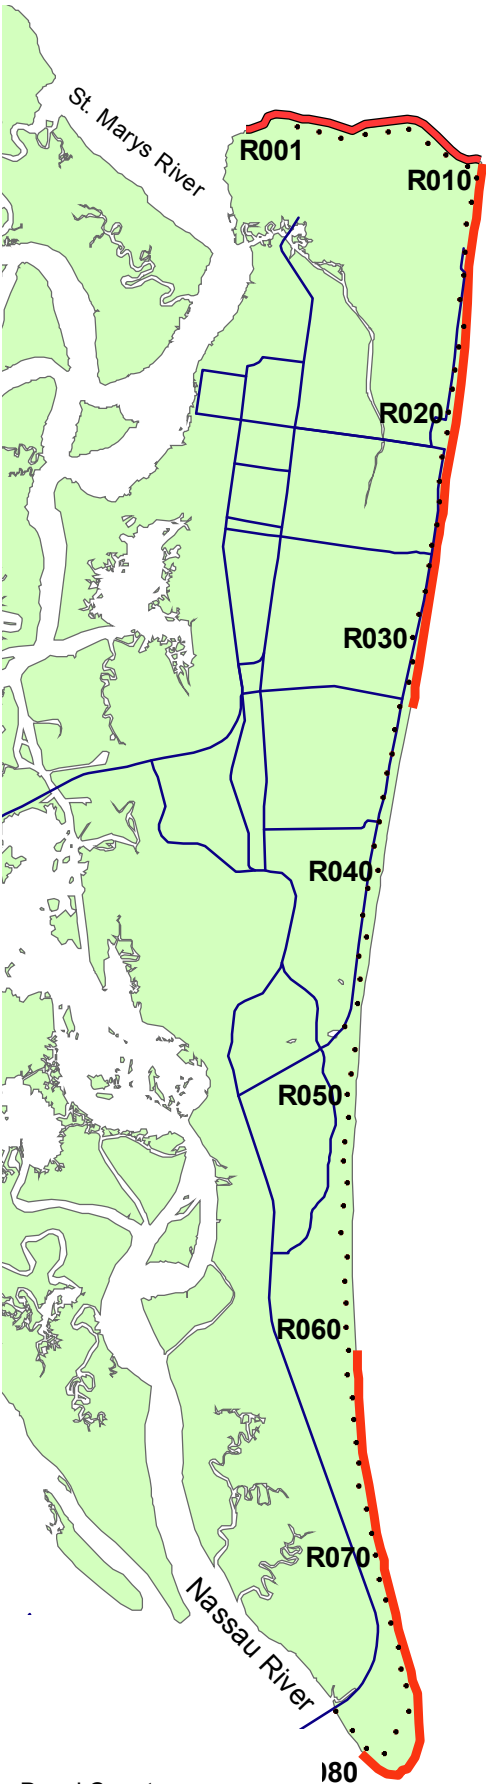
The southern 3.1 miles of Atlantic Ocean fronting beaches of Amelia Island (R61-R80) are critically eroded threatening development and recreational interests. A beach restoration project has been constructed along much of this area. A terminal groin has been constructed at R80 and a nearshore breakwater has been constructed south of R75.

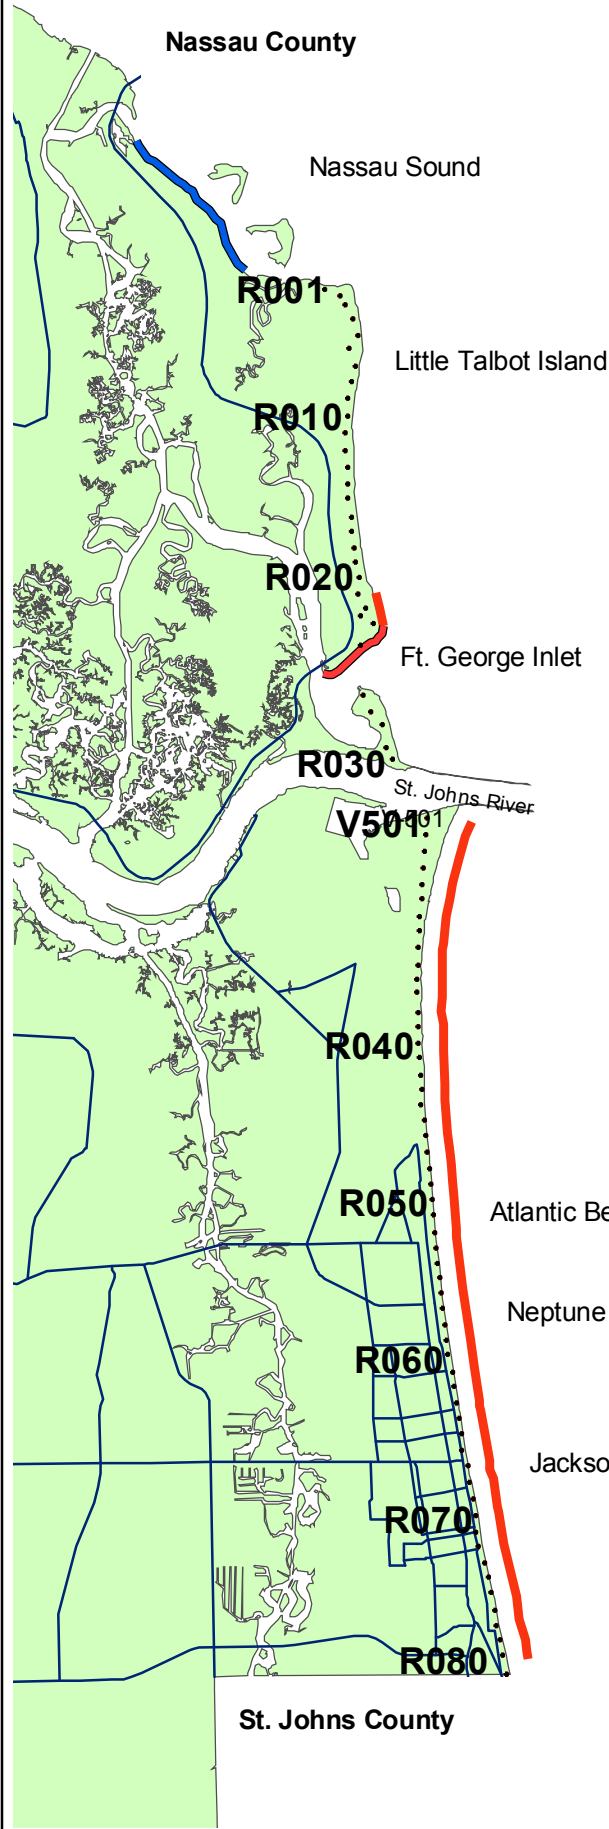
| Duval County | |

The southern 0.3 mile of Atlantic Ocean fronting beach on Little Talbot Island (R21-R23) is critically eroded, as is the 0.7 mile along Ft. George Inlet (R23-AIA Bridge). These critically eroded beach and inlet shoreline areas, resulting from the northward migration of Ft. George Inlet, are experiencing a threat to recreational interests at Little Talbot Island State Park and State Road AIA.

The southern 10.1 miles of Atlantic Ocean fronting beaches in Duval County (V501-R80) are designated as critically eroded due to past threats to development and recreational interests. This area is part of a beach restoration project, which is continually maintained.

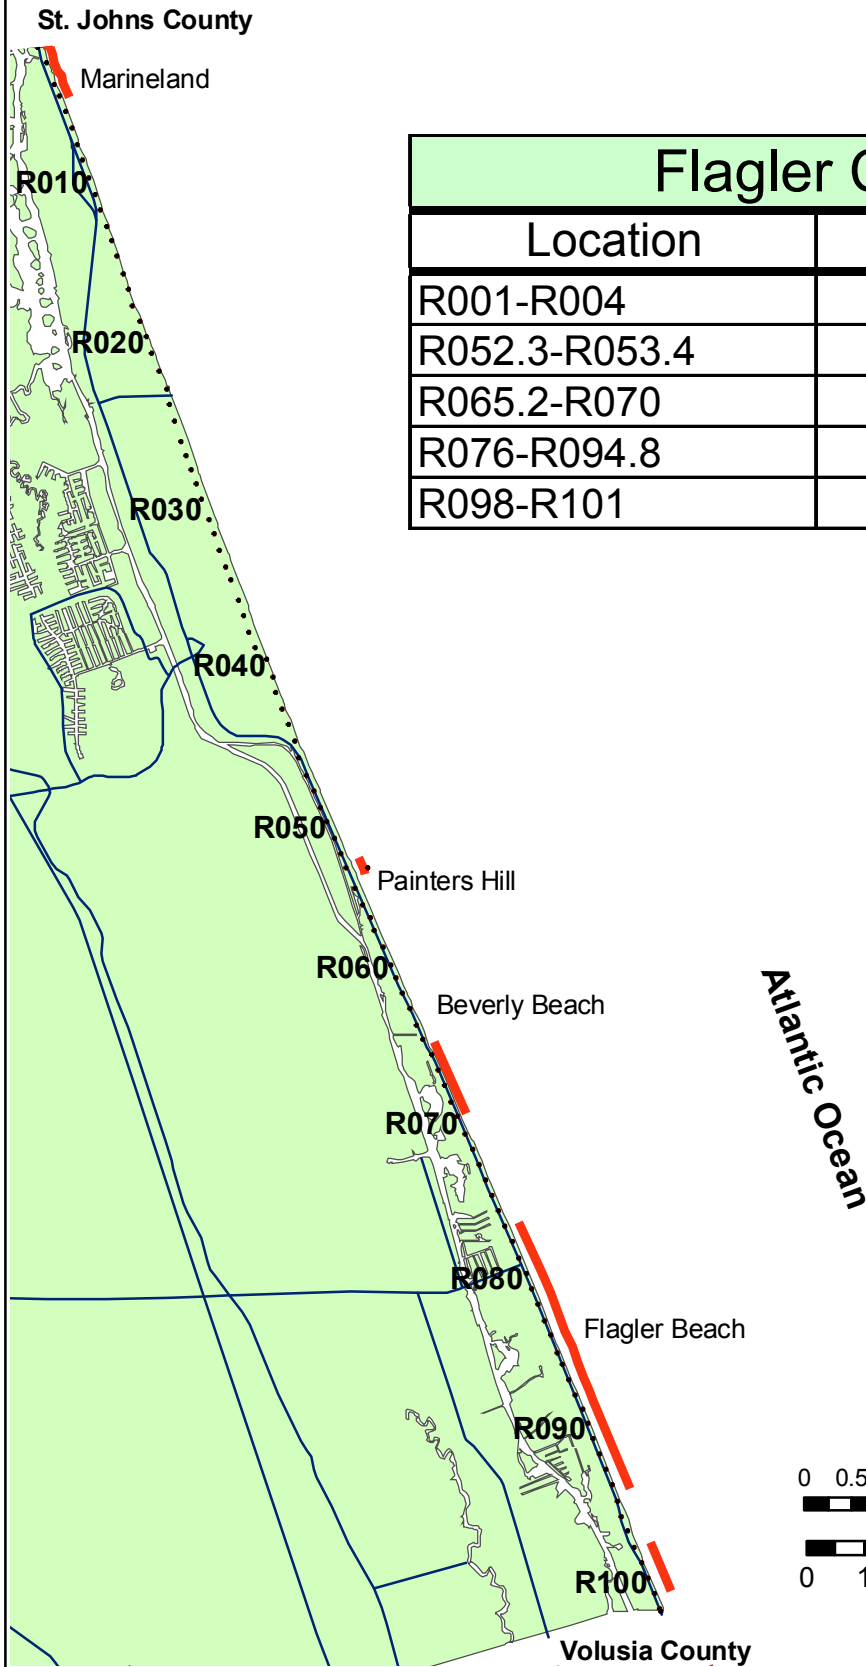
| Flagler County | |

Erosion at the northern 0.6 mile of beach (R1-R4) is threatening development and recreational interests at Marineland. This area has a rock revetment and coquina rock groins. Following storm damage by Hurricane Floyd in 1999, the revetment was restored and a new revetment constructed to the south at a more landward alignment with dune restoration.

A small segment of erosion (0.1 mile) in Painter's Hill (R52.3-R53.4) threatens development. Following severe erosion caused by Tropical Storm Gabrielle in 2001, vertical seawalls were constructed.

A 0.9-mile segment of erosion at the north Flagler Beach city limits (R65.2-R70) and 3.3 miles of erosion along southern Flagler Beach (R76-R94.8) threatens State Road A1A. Much of this southern area has a rock revetment.

A 0.5-mile segment of erosion at the south end of the county (R98-R101) threatens State Road A1A.

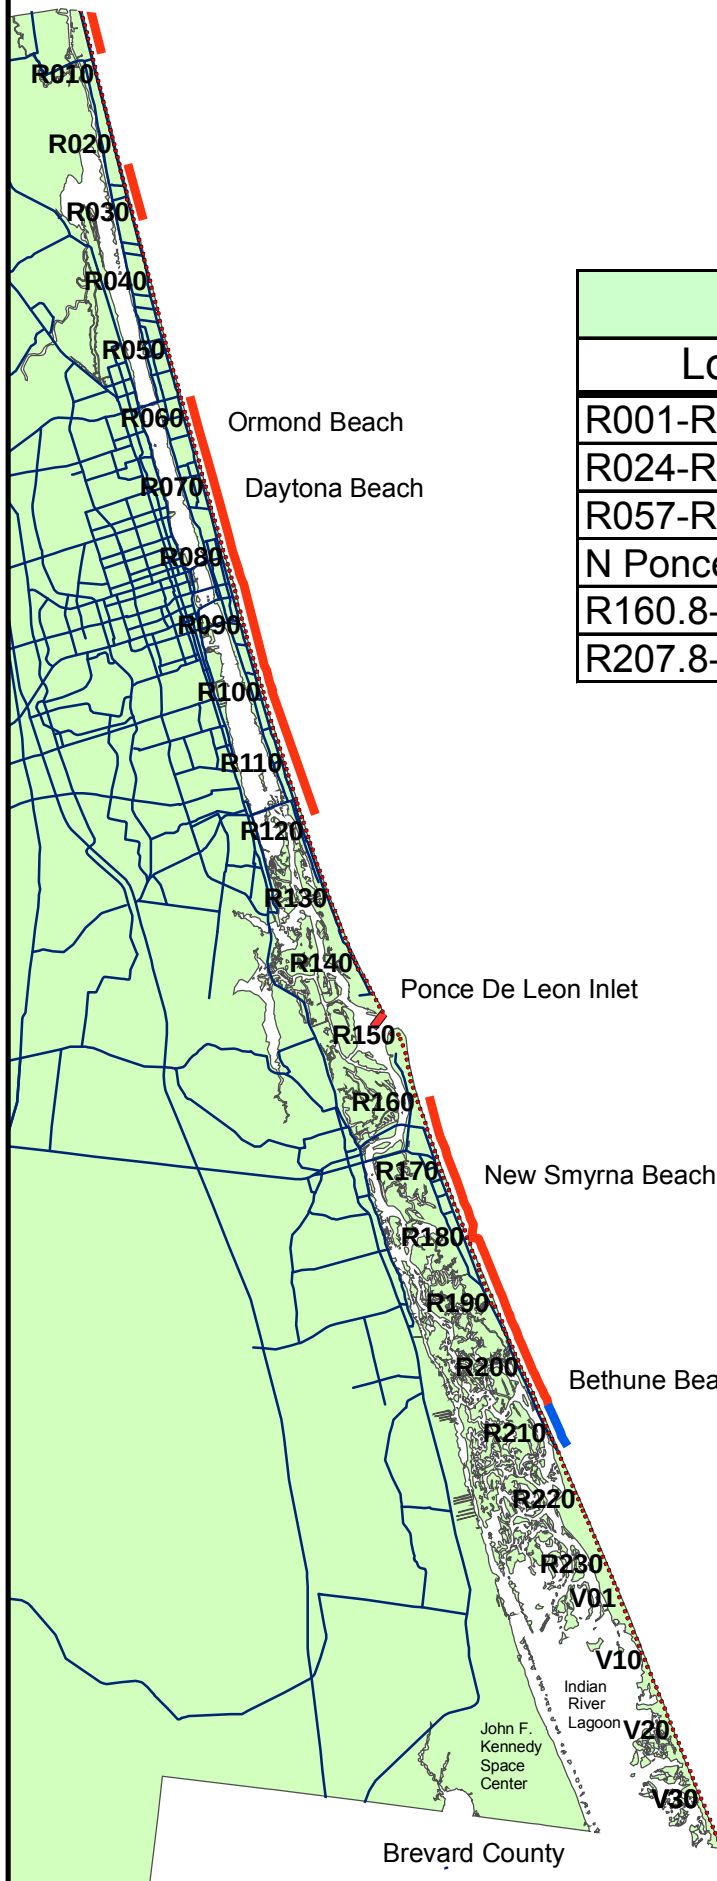
| Volusia County | |

A 1.1-mile segment of the Canaveral National Seashore (R207.8-R214) south of Bethune Beach is also eroded without any threatened interests at this time.

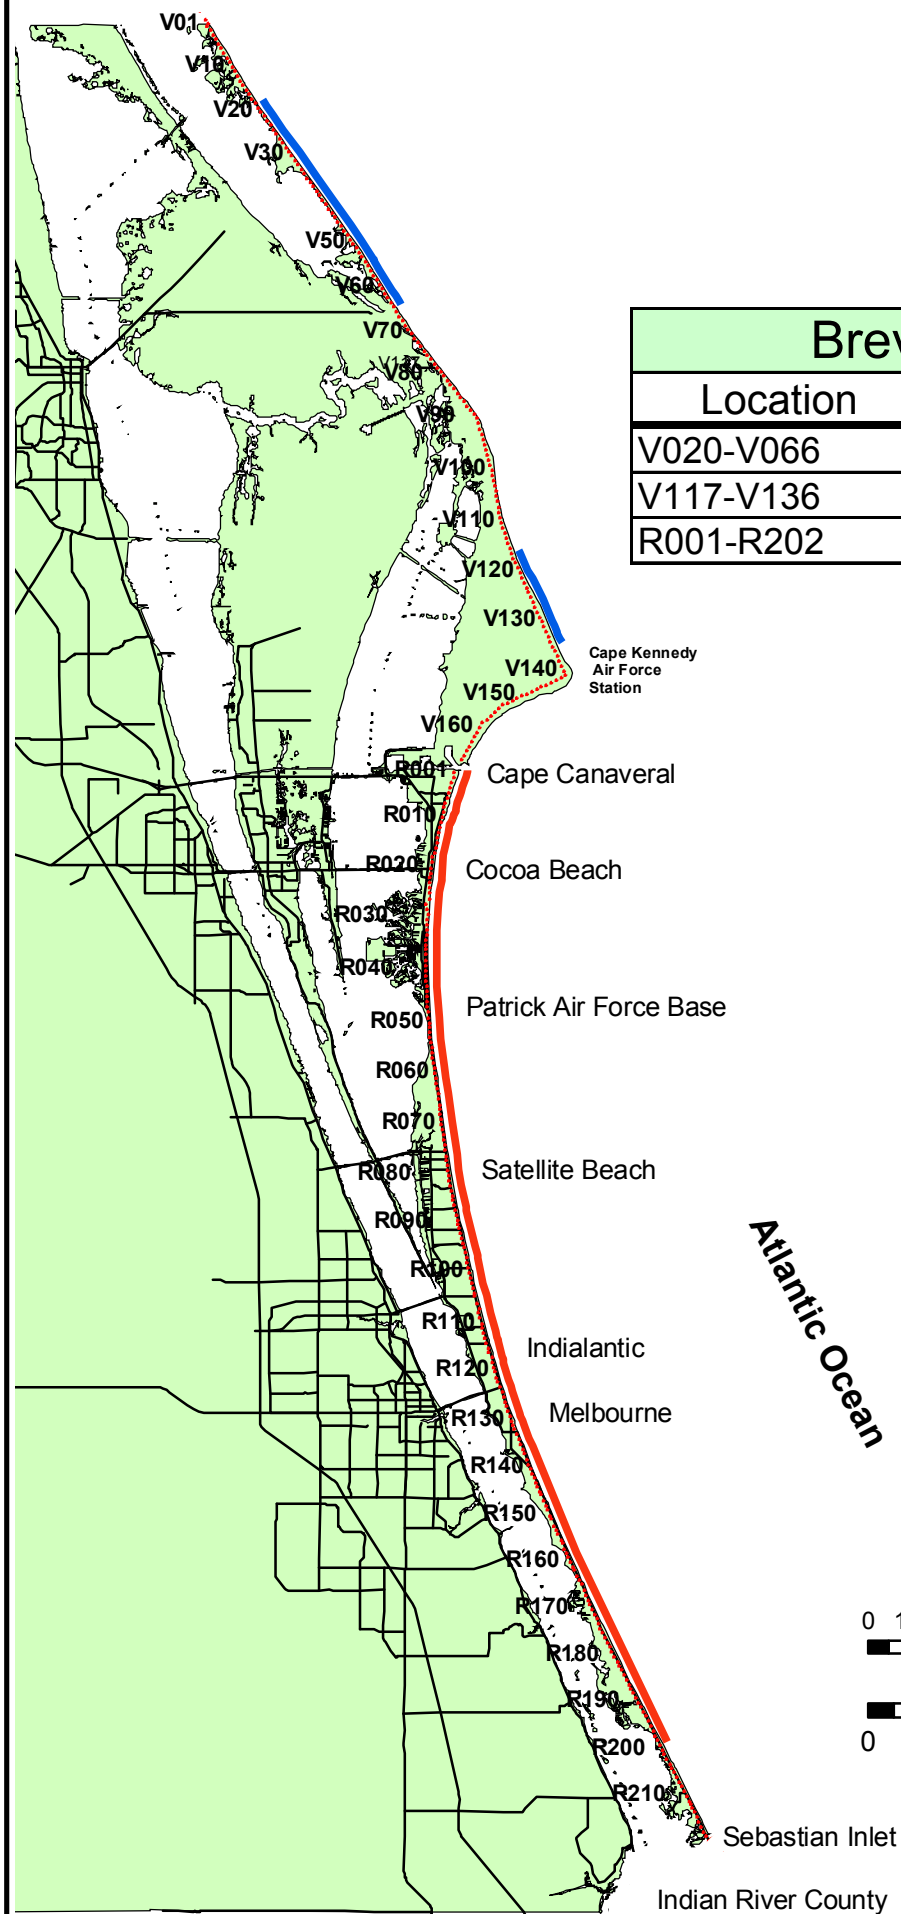
| Brevard County | |

From Canaveral Inlet extending 36.5 miles to the south is a long coastal segment (R1-R202) designated as critically eroded. Threatened are development, recreational interests, and wildlife habitat. Beach restoration projects have been conducted in Canaveral, Cocoa Beach, Patrick Air Force Base, Indiatlantic, and Melbourne Beach.

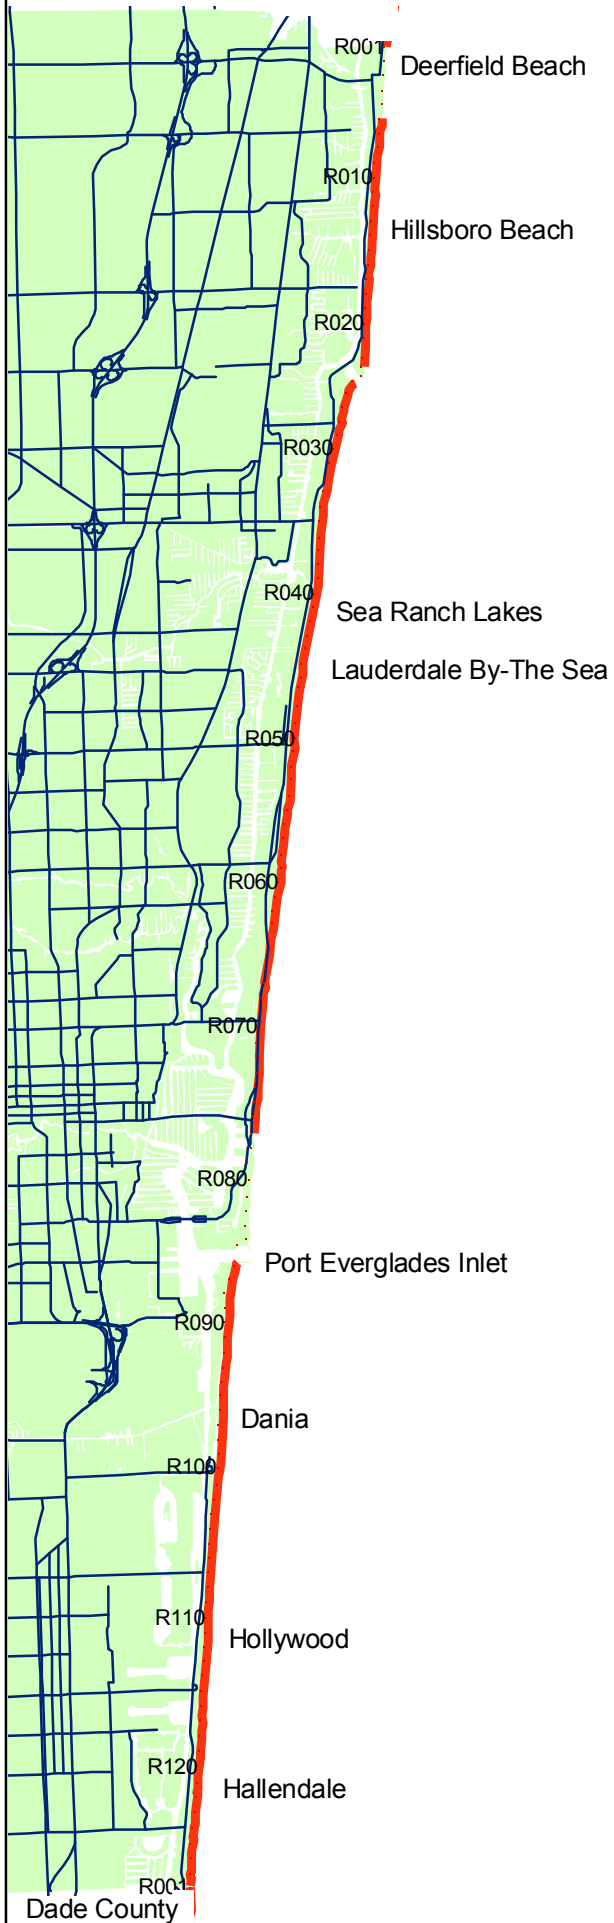
| Broward County | |

South of Hillsboro Inlet and extending for 10 miles along Pompano Beach, Sea Ranch Lakes, Lauderdale-by-the-Sea, and Ft. Lauderdale is a continuous critically eroded area (R25-R77) that threatens development and recreational interests including State Road A1A. A beach restoration project has been constructed at Pompano Beach and inlet sand transfer is ongoing immediately south of Hillsboro Inlet. Numerous bulkheads and retaining walls also exist along this stretch of coast. Beach restoration is being conducted throughout this area.

Along the southern 8.1 miles of Broward County south of Port Everglades Entrance is a critically eroded area (R86-R128) that threatens recreational interests at John U. Lloyd State Park and development and recreational interests along the communities of Dania, Hollywood, and Hallandale. Beach restoration projects are ongoing at J.U. Lloyd State Park and at Hollywood and Hallandale. Seawalls also exist along the private development.

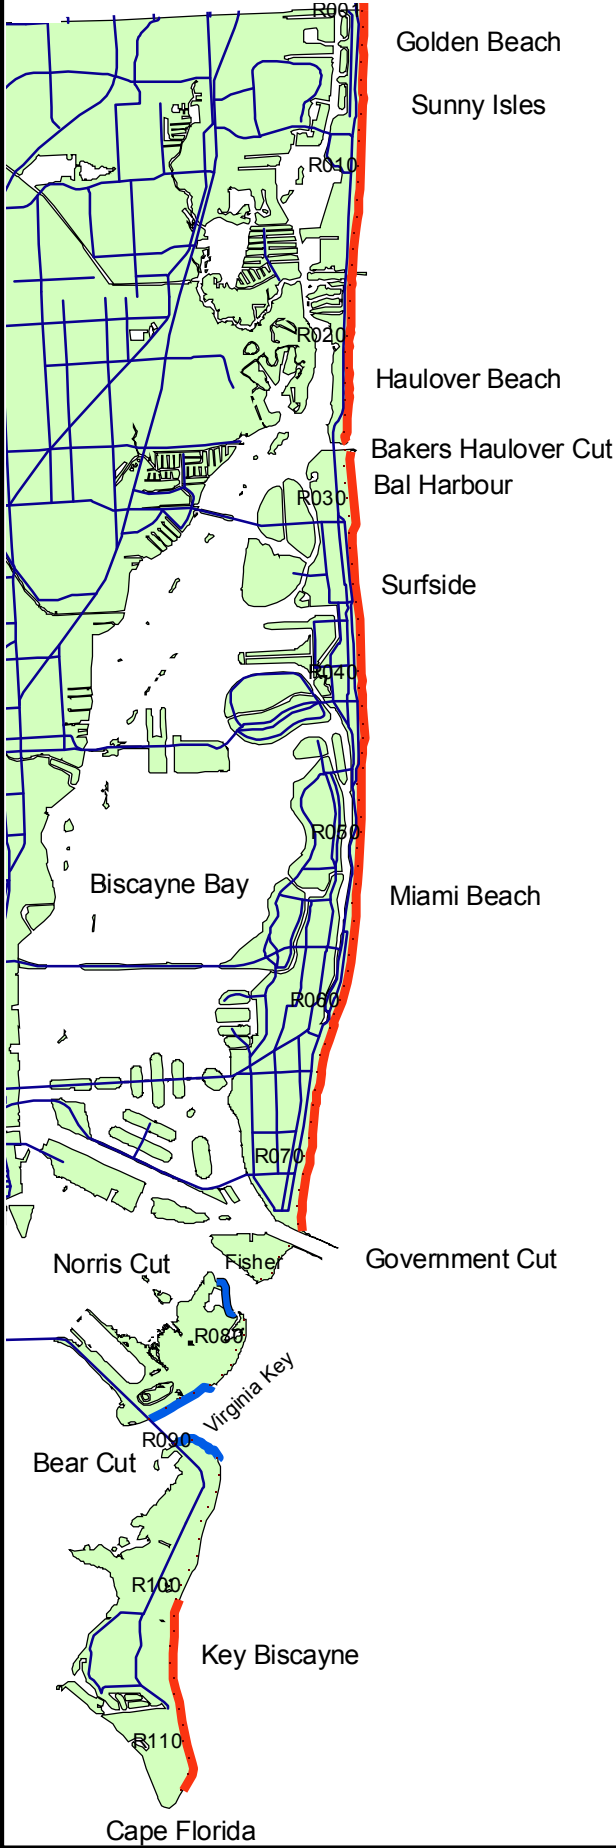
| Dade County | |

The northern end of Virginia Key along the south shoreline of Norris Cut (0.3 mile) has noncritical inlet shoreline erosion. The southern 0.8-mile of beach on Virginia Key (R84-R88) is also noncritically eroded.

The northern end of Key Biscayne (R89-R92) has 0.6 mile of noncritical erosion, and the southern half of Key Biscayne (R101-R113) has 2.5 miles of critical erosion. The critically eroded area threatens development in the Village of Key Biscayne and recreational interests at Bill Baggs Cape Florida State Park. This segment is a beach restoration project.

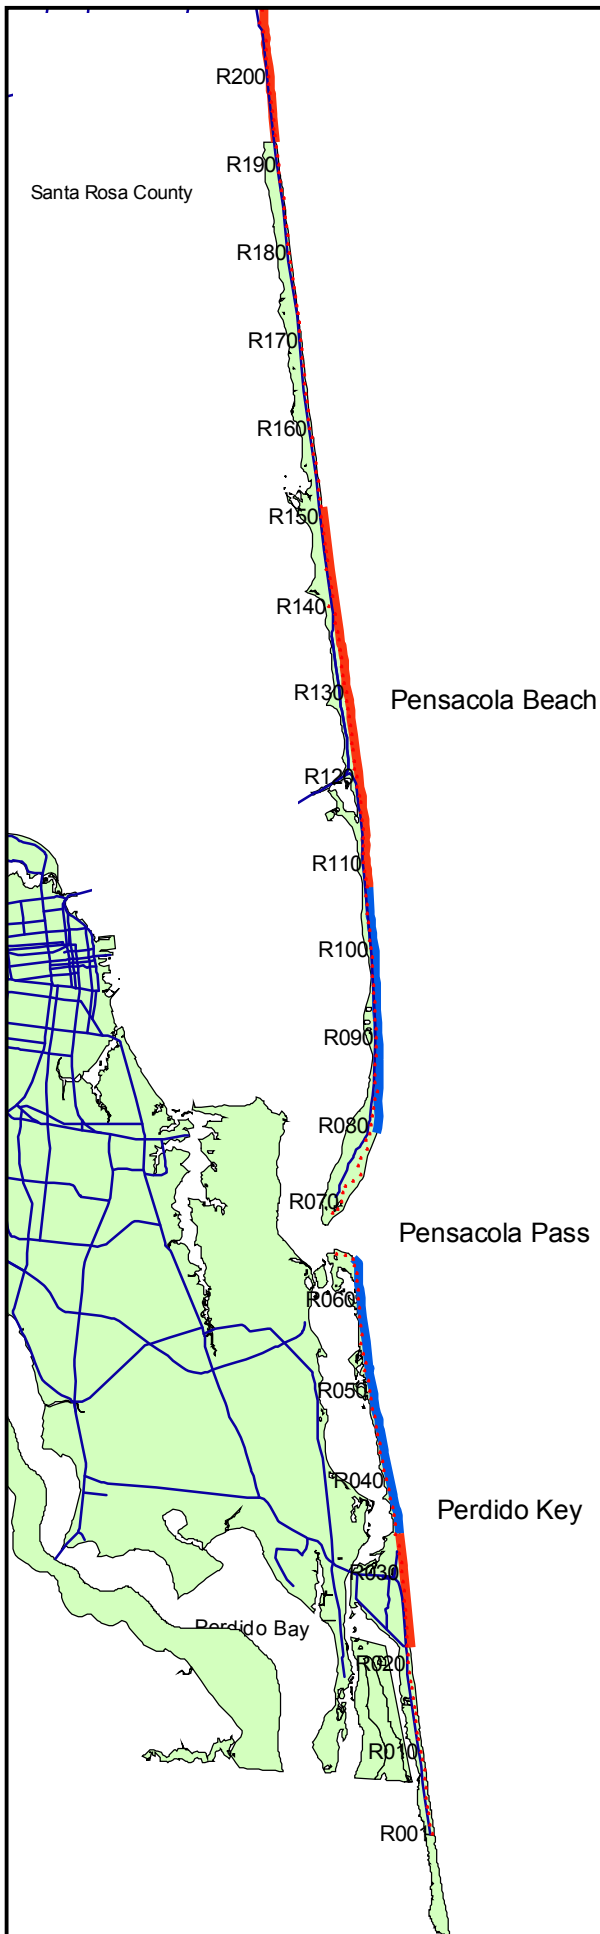
## Escambia County

There are two critically eroded areas (10.7 miles) and two noncritically eroded areas (11.2 miles) in Escambia County.

The entire 8.2-mile length of Pensacola Beach (R107-R151) is critically eroded threatening development and recreational interests. Dune restoration was conducted after the storms of 1995, 1998, 2002, and 2004. Beach restoration was completed in 2003.

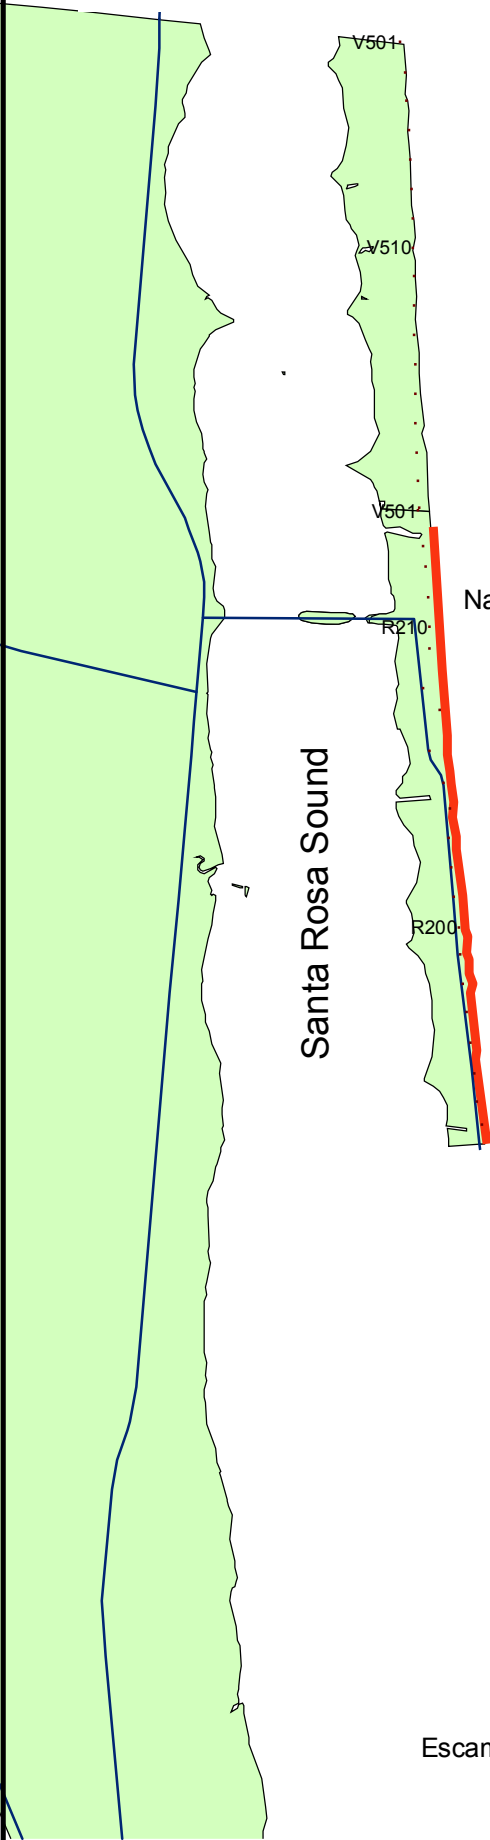
| Santa Rosa County | |

There is one critically eroded area in Santa Rosa County (4.1 miles). The critically eroded area along Navarre Beach (R192.5-R213.5) threatens development and recreational interests. Following hurricanes in 1995 and 1998, dune restoration projects were constructed. A beach restoration project was completed in 2006.

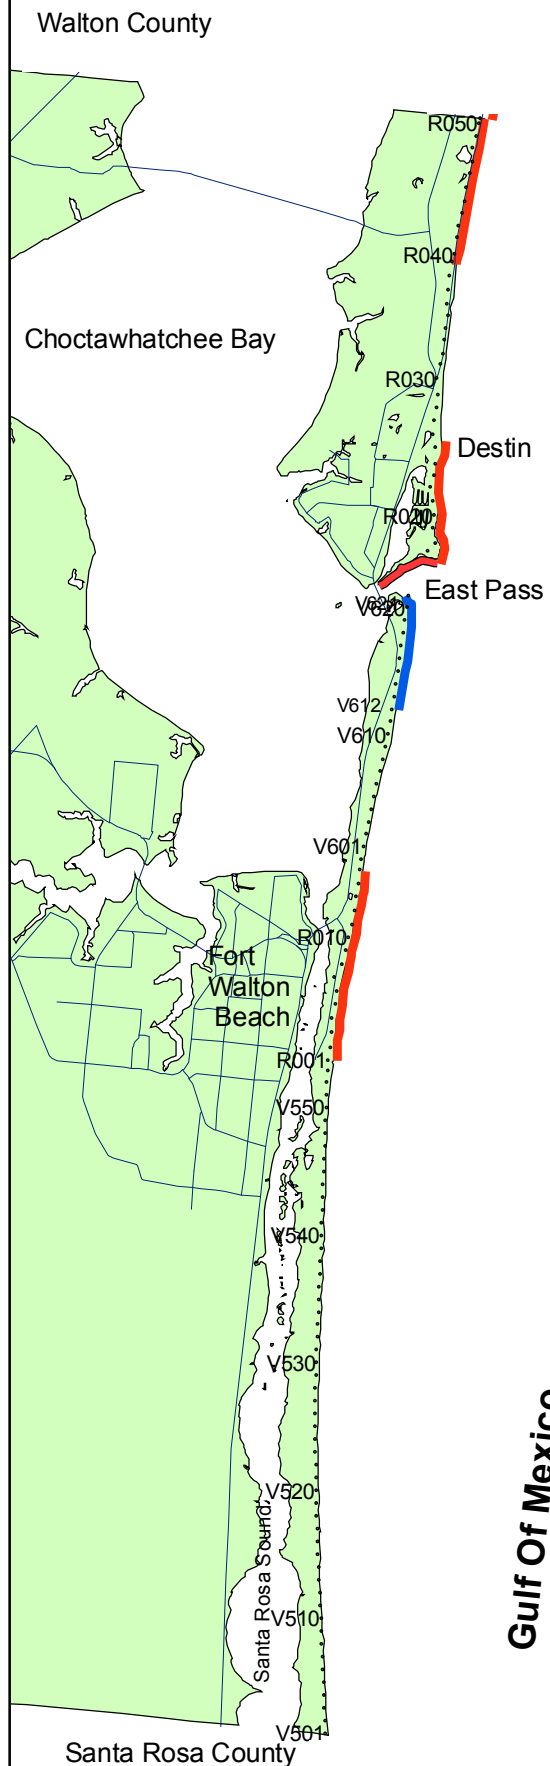
| Okaloosa County | |

The east shoreline of East Pass along Norriego Point is experiencing critical inlet shoreline erosion threatening development and recreational interests. This area has bulkheads and retaining walls in front of private development, and a seawall and boulder mound T-groins along the undeveloped segment to the north.

The western 1.6 miles of Destin (R17-R25.5) is designated critically eroded following the severe impact of the 2005 hurricane season. The eastern 2.1 miles of Destin (R39-R50) is designated critically eroded threatening development and the coastal road. This area is part of a beach restoration project to be constructed in 2007.

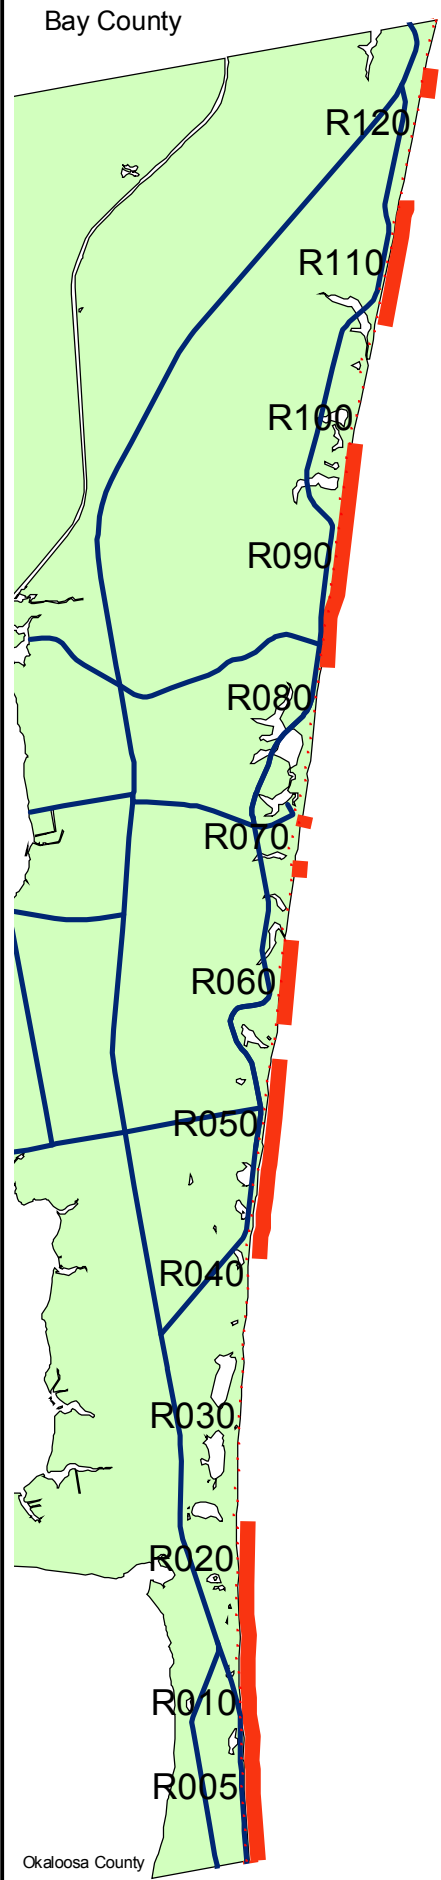
| Walton County | |

A 3.1-mile segment of critical erosion threatens development along Seagrove Beach (R82-R98). To the east along Seacrest Beach, is another 1.8-mile segment (R105.5-R114.7) where development is threatened by erosion of the bluff.

A 0.4-mile segment at Inlet Beach (R122-R124) is designated critically eroded due to its poststorm vulnerability threatening development interests.

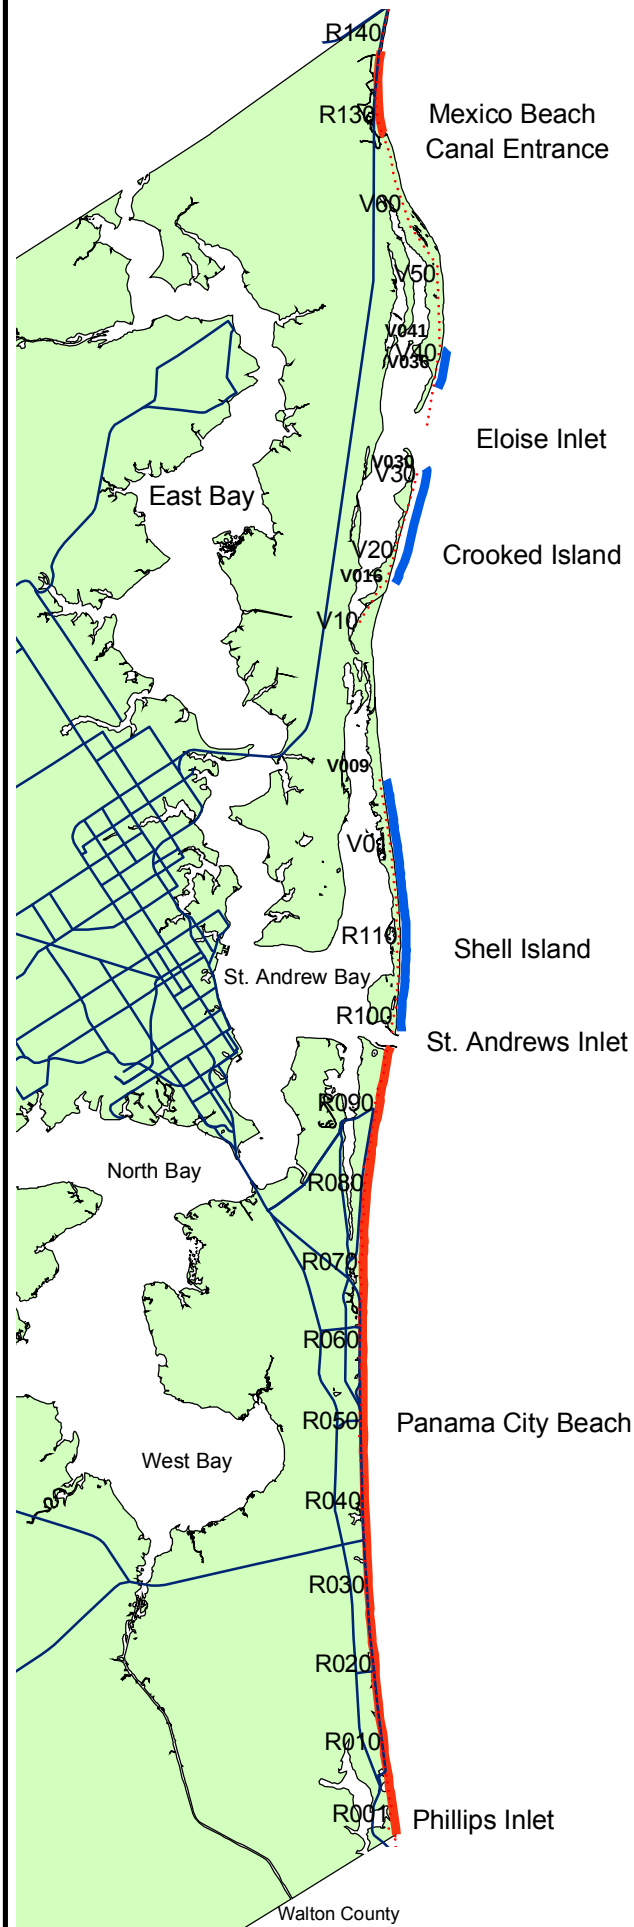
| Bay County | |

On Crooked Island there are two noncritically eroded areas split by Eloise Inlet. The western segment (V16-V30+2000) extends 2.8 miles to the west and the eastern segment (V36-V41) extends 1.2 miles to the east.

The eastern 0.9 miles of Bay County (R127.8-R137.8) along the Town of Mexico Beach is designated critically eroded. Inlet sand transfer is periodically conducted at Mexico Beach Inlet and dune restoration has been conducted following Hurricanes Opal (1995) and Dennis (2005).
