# **Critically Eroded Beaches In Florida**

**Updated June, 2014**

**ENGINEERING, HYDROLOGY, AND GEOLOGY PROGRAM  
DIVISION OF WATER RESOURCE MANAGEMENT  
DEPARTMENT OF ENVIRONMENTAL PROTECTION  
STATE OF FLORIDA**

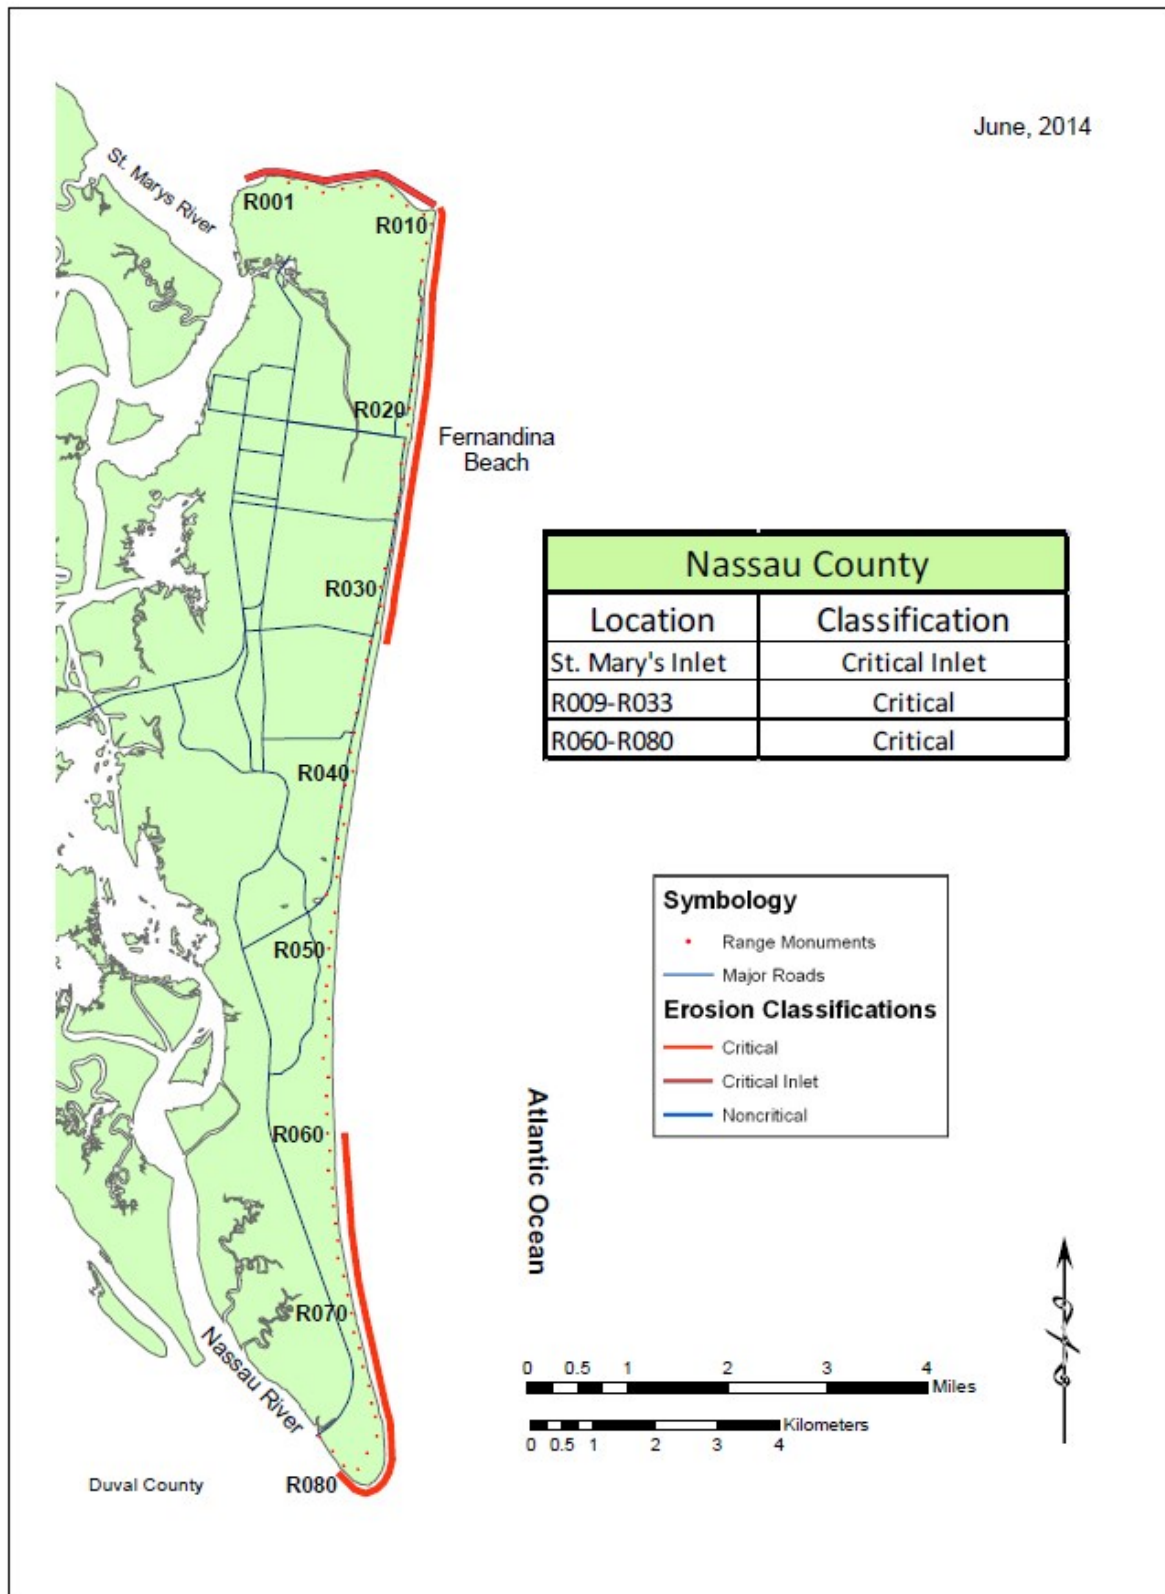
The southern 3.3 miles of Atlantic Ocean fronting beaches of Amelia Island (R60-R80) are critically eroded threatening development and recreational interests. A beach restoration project has been constructed along much of this area. A terminal groin has been constructed at R80 and a nearshore breakwater has been constructed south of R75.

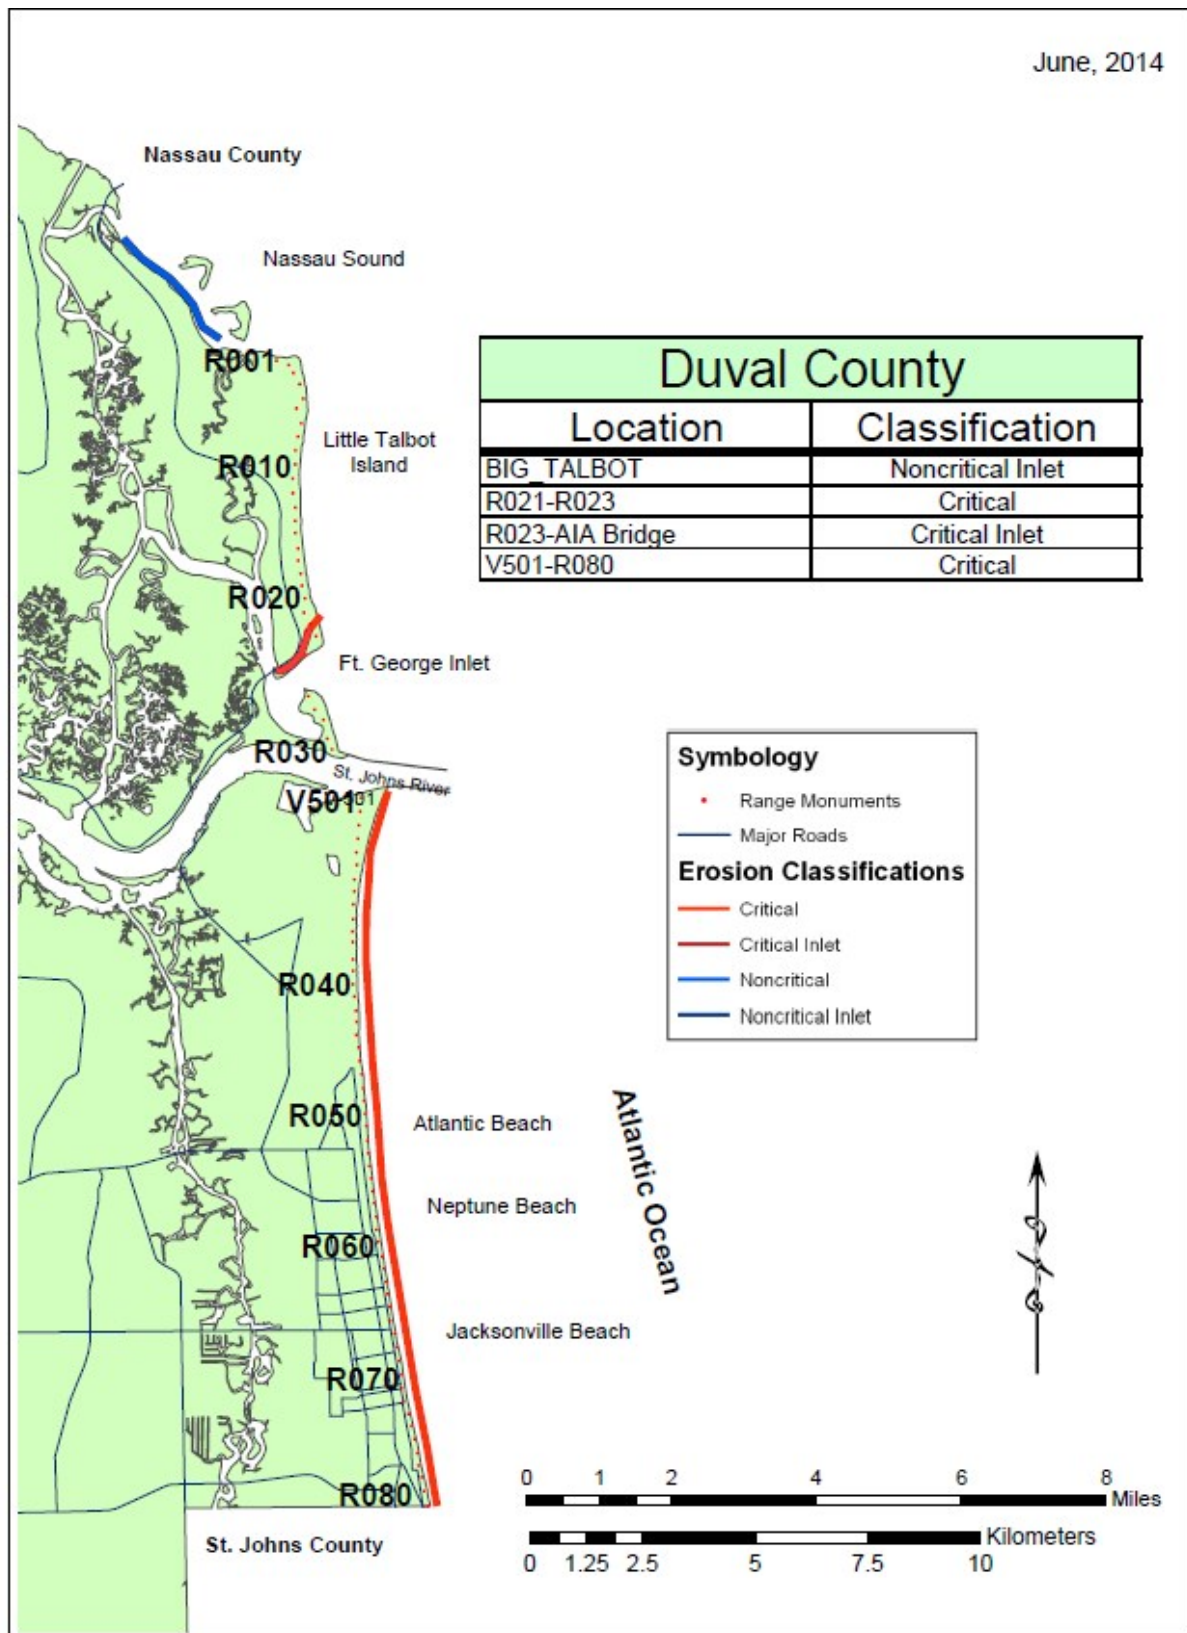
There are two critically eroded beach areas (10.4 miles), one critically eroded inlet shoreline area (0.7 mile), and one non-critically eroded inlet shoreline area (2 miles) in Duval County.

The southern 10.1 miles of Atlantic Ocean fronting beaches in Duval County (V501-R80) are designated as critically eroded due to past threats to development and recreational interests. This area is part of a beach restoration project, which is continually maintained.

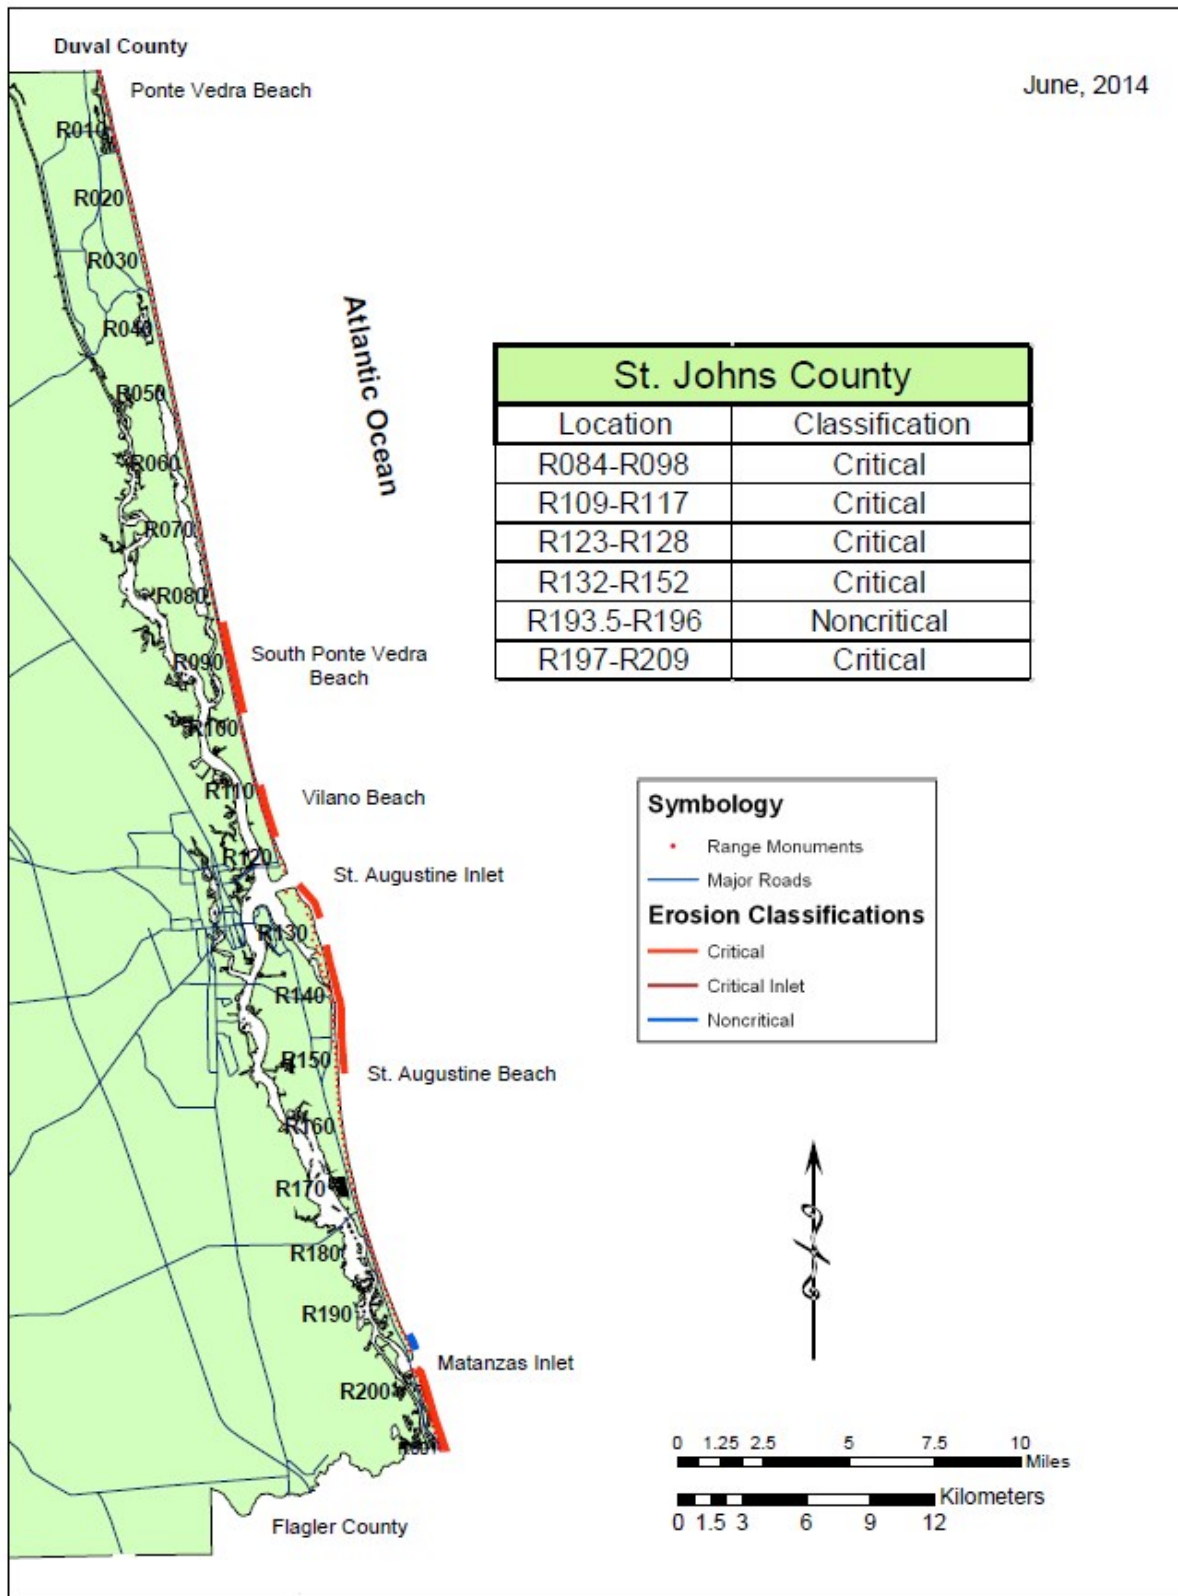
There are five critically eroded areas (11.5 miles) and one non-critically eroded area (0.5 mile) in St. Johns County.

The southern 2.4 miles of St. Johns County beaches (R197-R209) are critically eroded between Matanzas Inlet and the Flagler County line. The northern portion threatens State Road AIA and private development. Although the State Road AIA roadbed has been abandoned along the southern segment, wildlife habitat within the Matanzas River lagoon is being threatened. This area has been nourished from Atlantic Intracoastal Waterway dredge disposal.

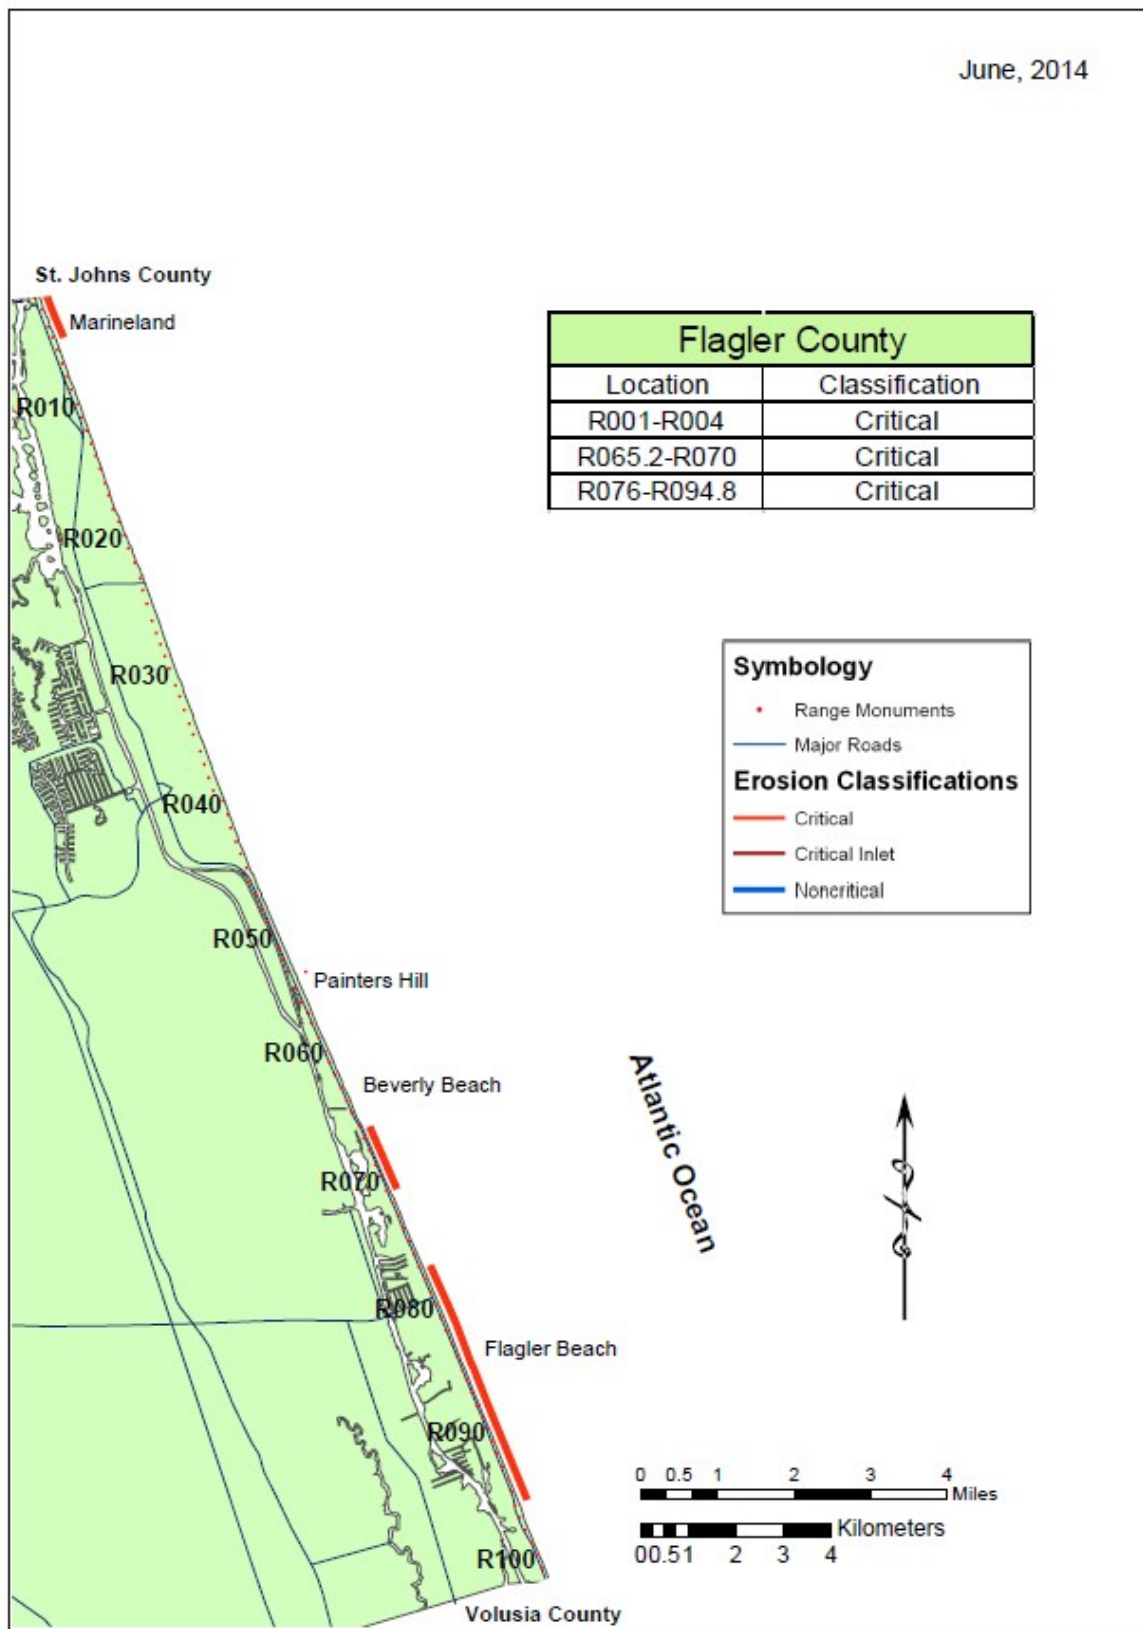
There are three critically eroded areas (4.8 miles) in Flagler County.

Erosion at the northern 0.6 mile of beach (R1-R4) is threatening development and recreational interests at Marineland. This area has a rock revetment and coquina rock groins. Following storm damage by Hurricane Floyd in 1999, the revetment was restored and a new revetment constructed to the south at a more landward alignment with dune restoration.

A 0.9-mile segment of erosion at the north Flagler Beach city limits (R65.2-R70) and 3.3 miles of erosion along southern Flagler Beach (R76-R94.8) threatens State Road A1A. Much of this southern area has a rock revetment.

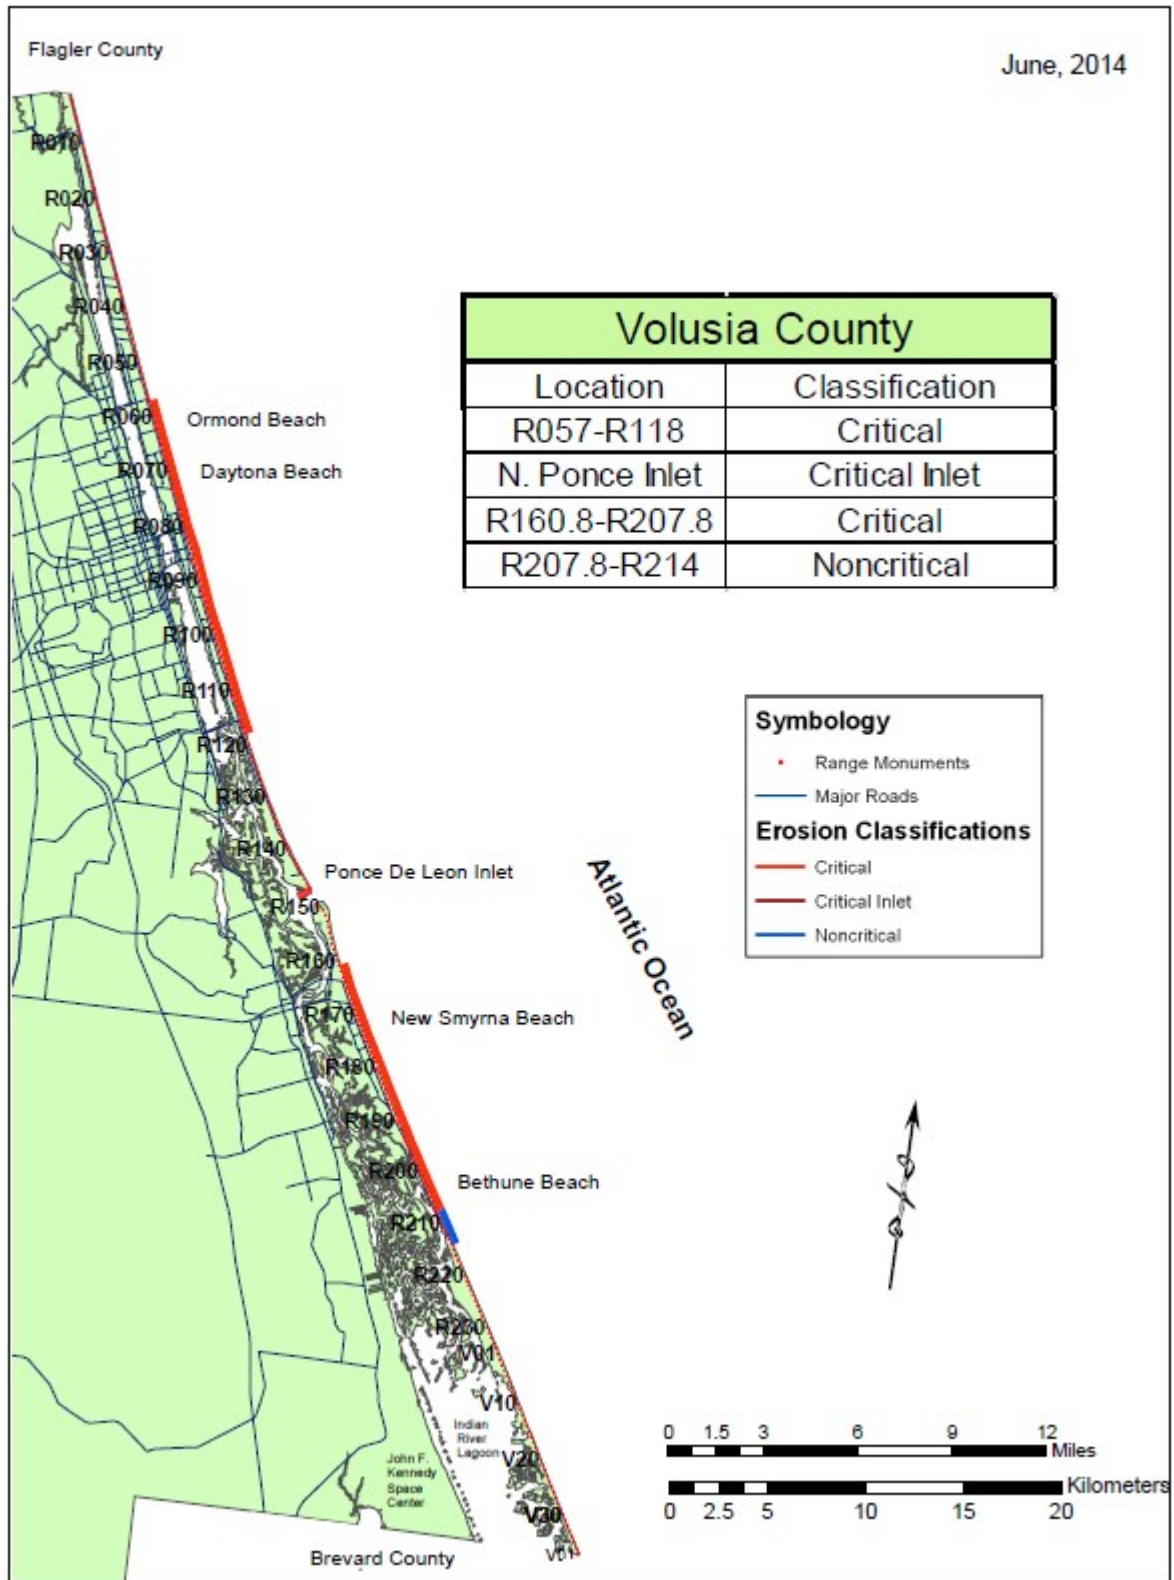
There are two critically eroded beach areas (19.4 miles), one non-critically eroded beach area (1.1 miles), and one critically eroded inlet shoreline area (0.6 mile) in Volusia County.

A 1.1-mile segment of the Canaveral National Seashore (R207.8-R214) south of Bethune Beach is also eroded without any threatened interests at this time.

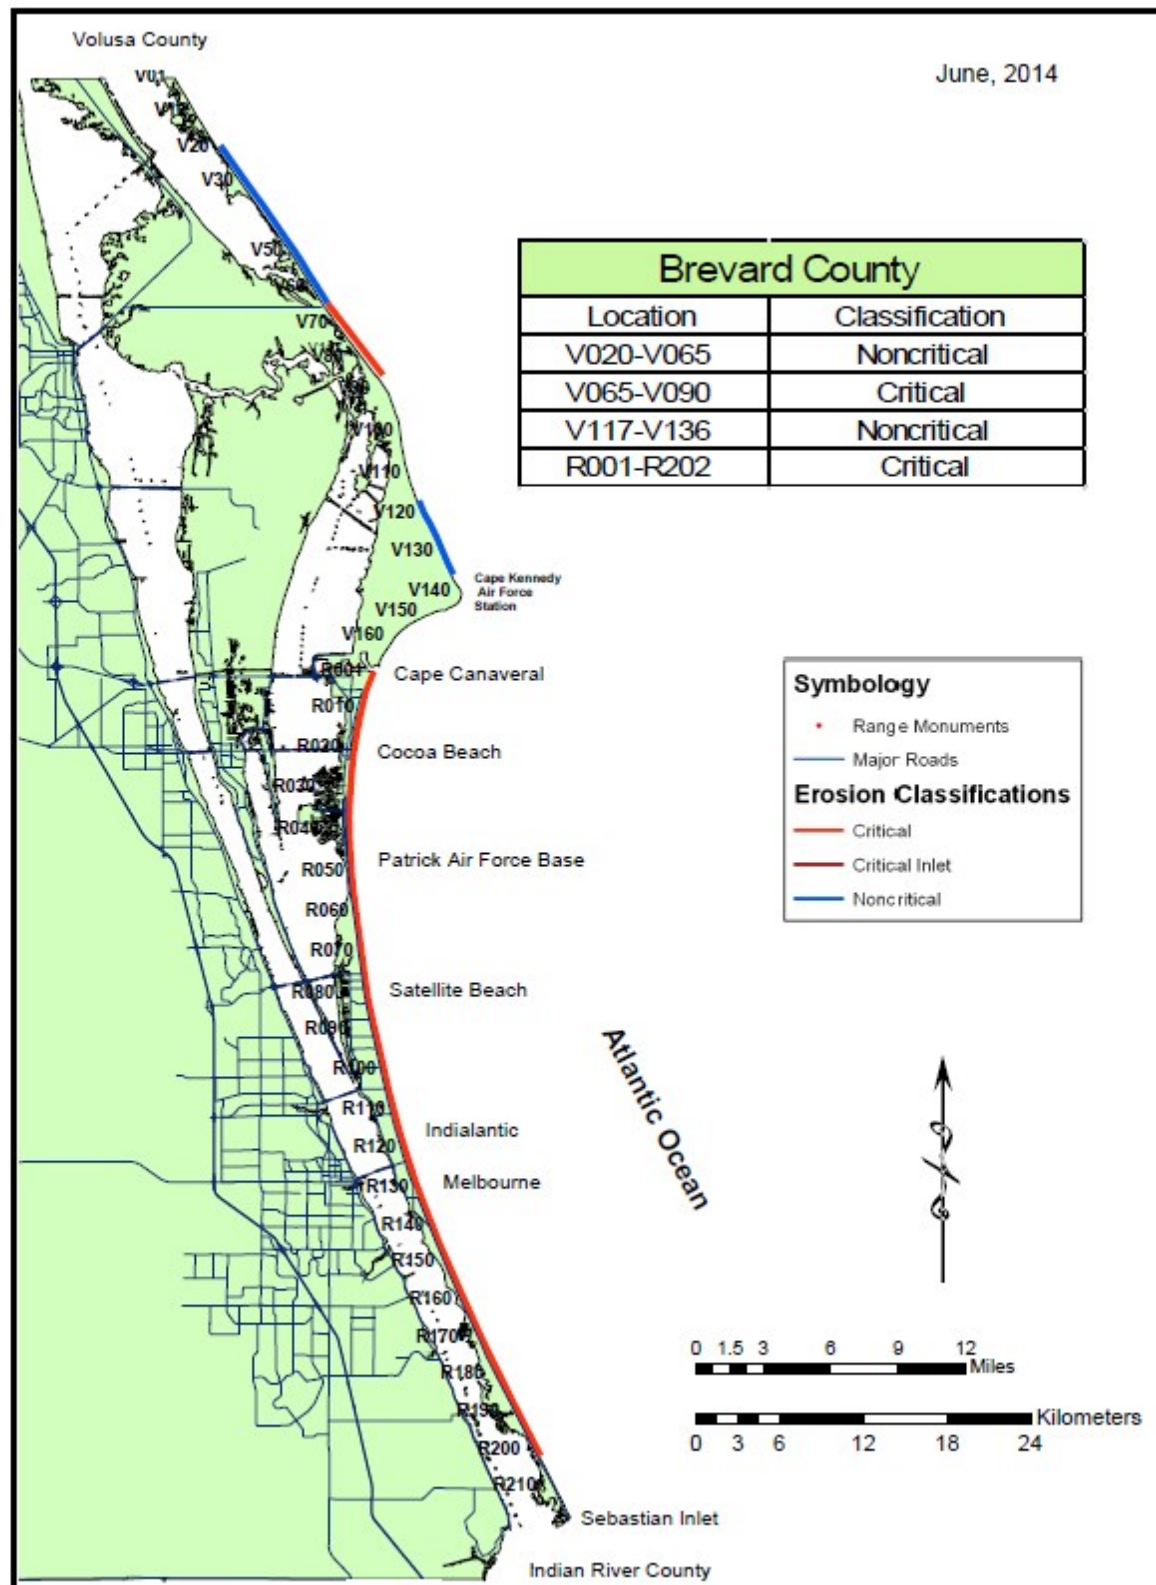
There are two critically eroded areas (41.2 miles) and two non-critically eroded areas (12.1 miles) in Brevard County.

From Canaveral Inlet extending 36.5 miles to the south is a long coastal segment (R1-R202) designated as critically eroded. With the impact of Hurricanes Frances and Jeanne in 2004, the southerly 11.5 miles of this segment became critically eroded. Threatened are development, recreational interests, and wildlife habitat. Beach restoration projects have been conducted in Canaveral, Cocoa Beach, Patrick Air Force Base, Indialantic, and Melbourne Beach.

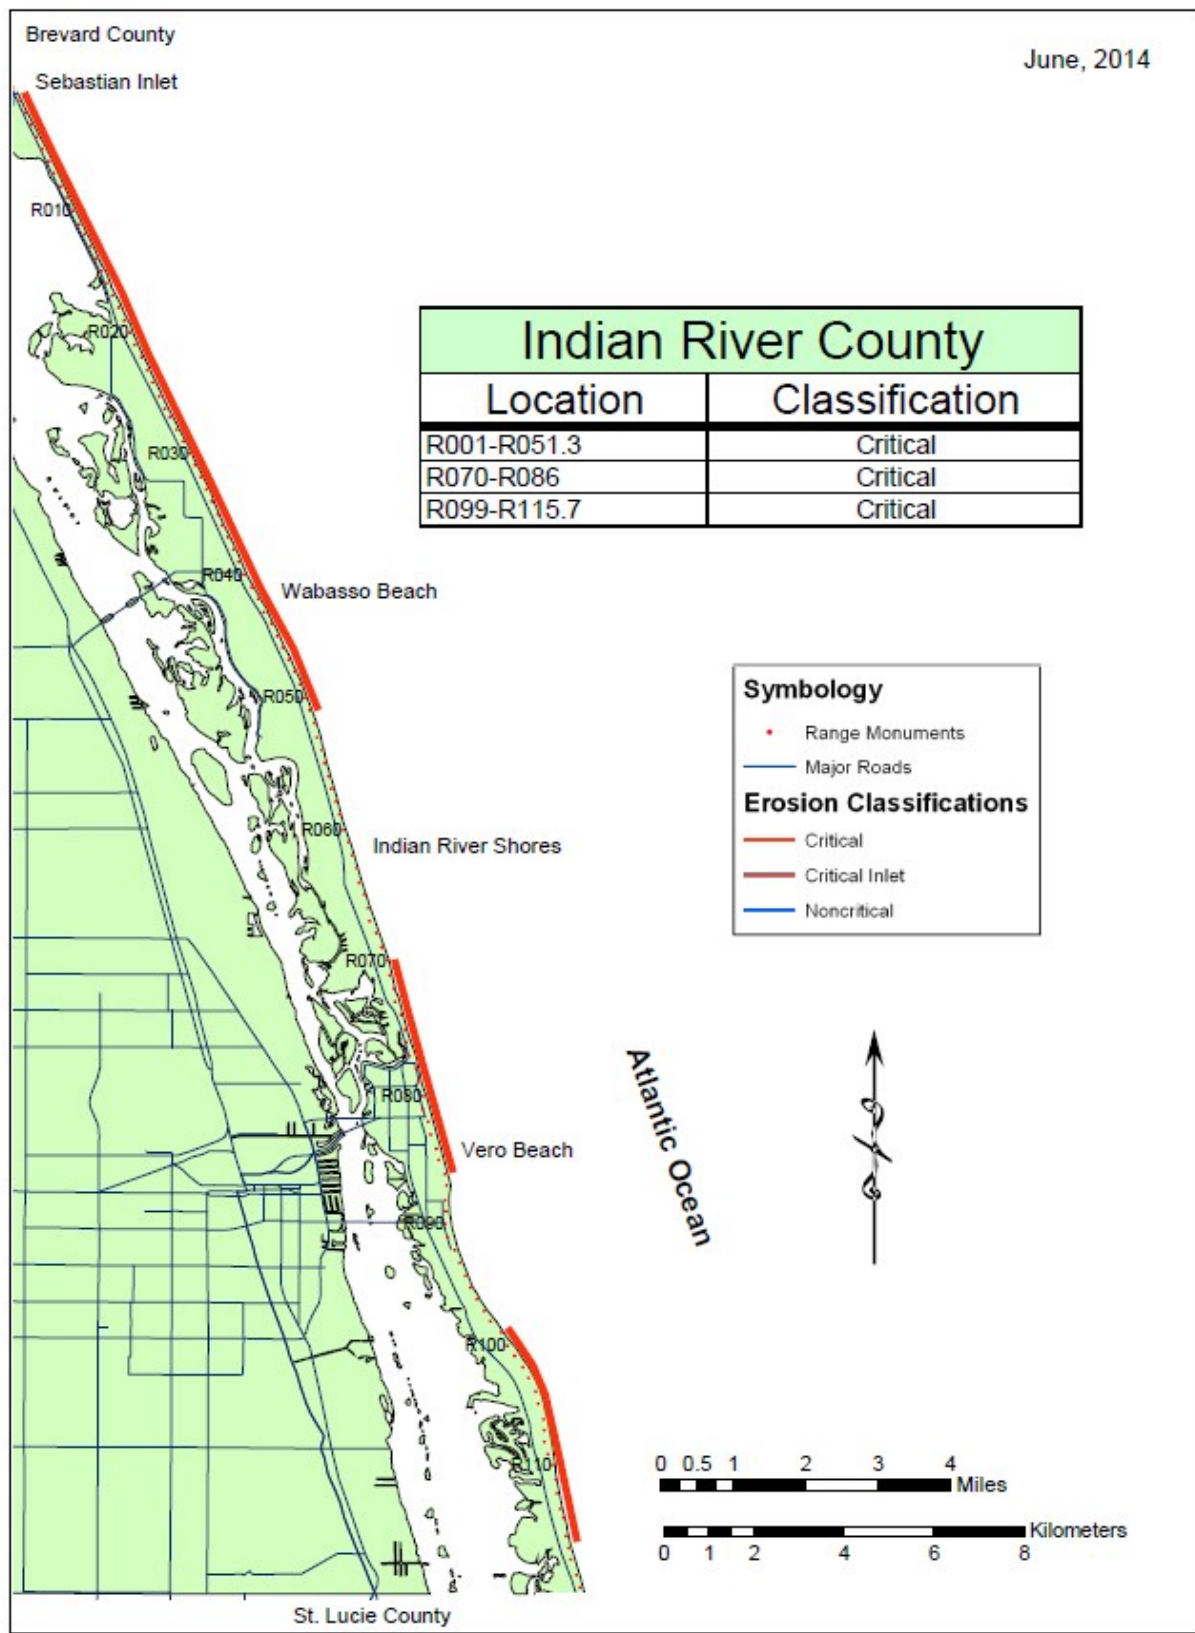
There are three critically eroded areas (15.7 miles) in Indian River County.

In southern Indian River County a 3.1-mile segment (R99-R115.7) is critically eroded threatening development interests. A beach restoration project has been constructed along a portion of this area.

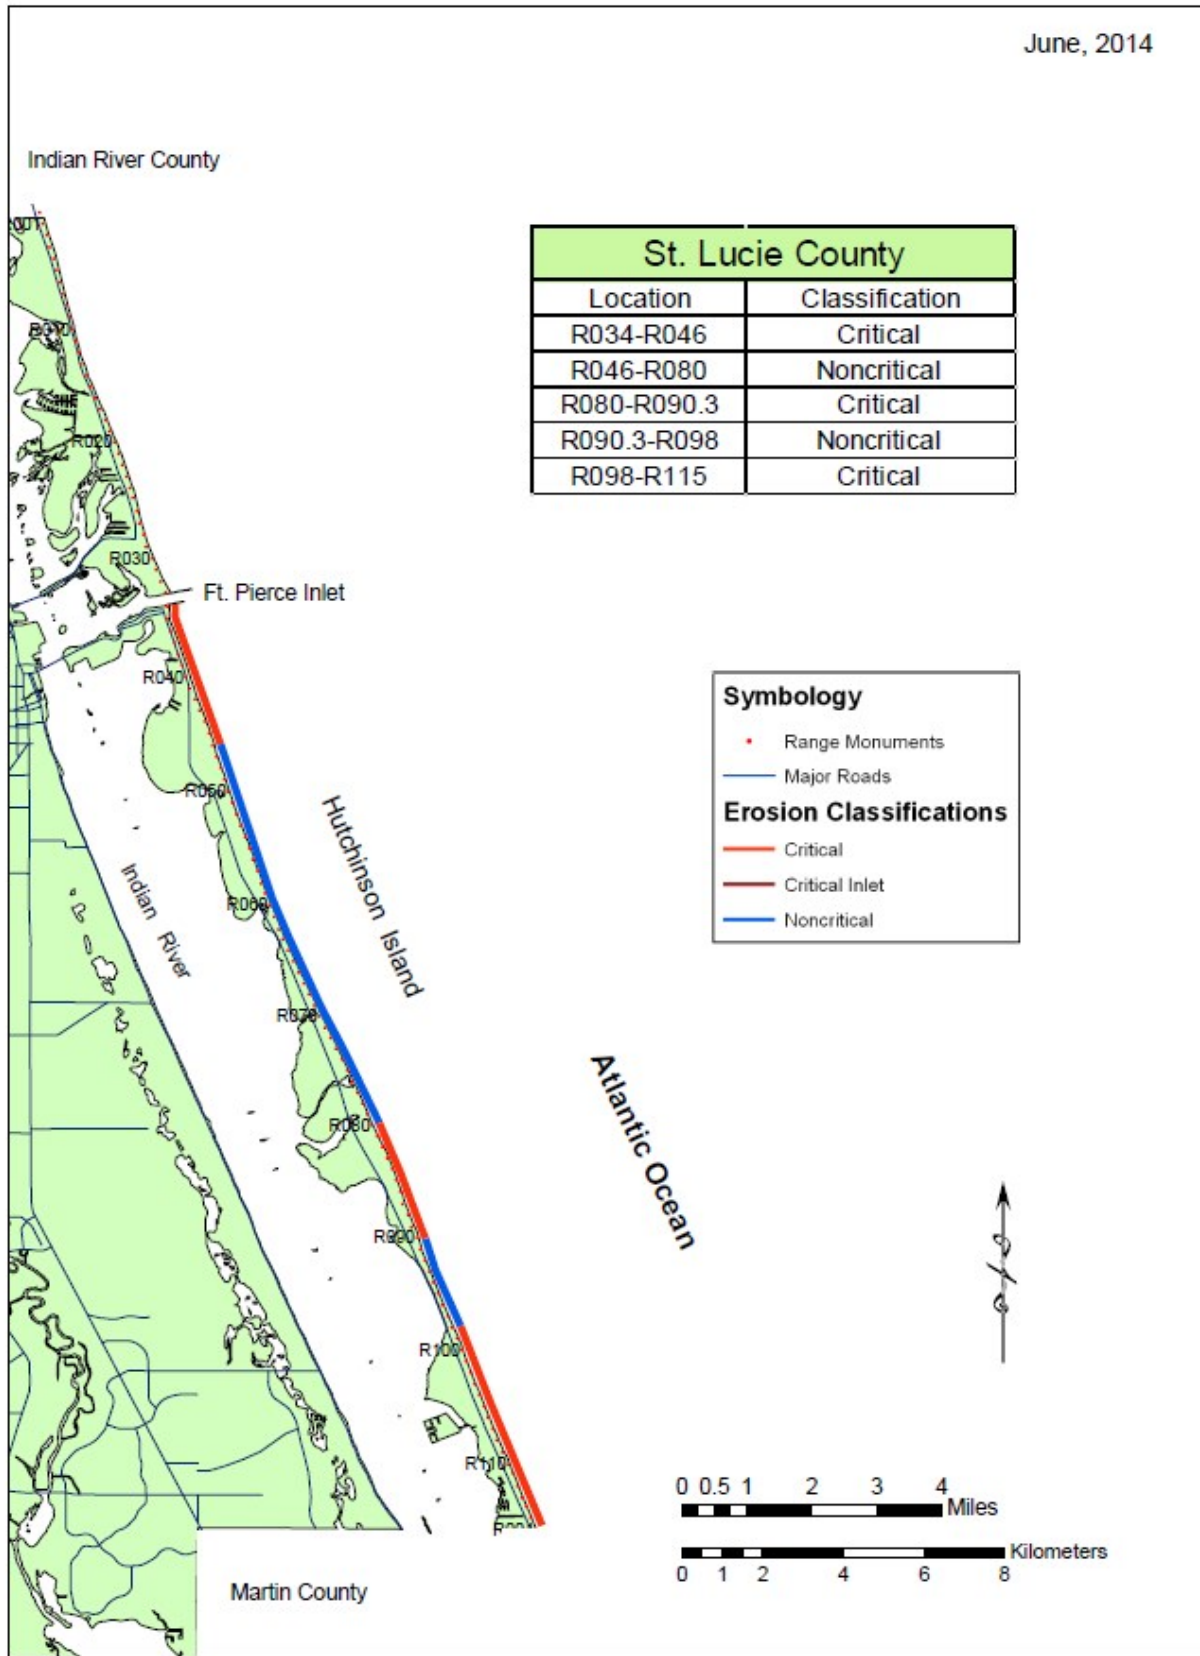
There are three critically eroded areas (7.6 miles) and two non-critically eroded areas (7.9 miles) in St. Lucie County.

The southern 3.4 miles of the county shoreline (R98-R115+1000) is critically eroded with development interests threatened.

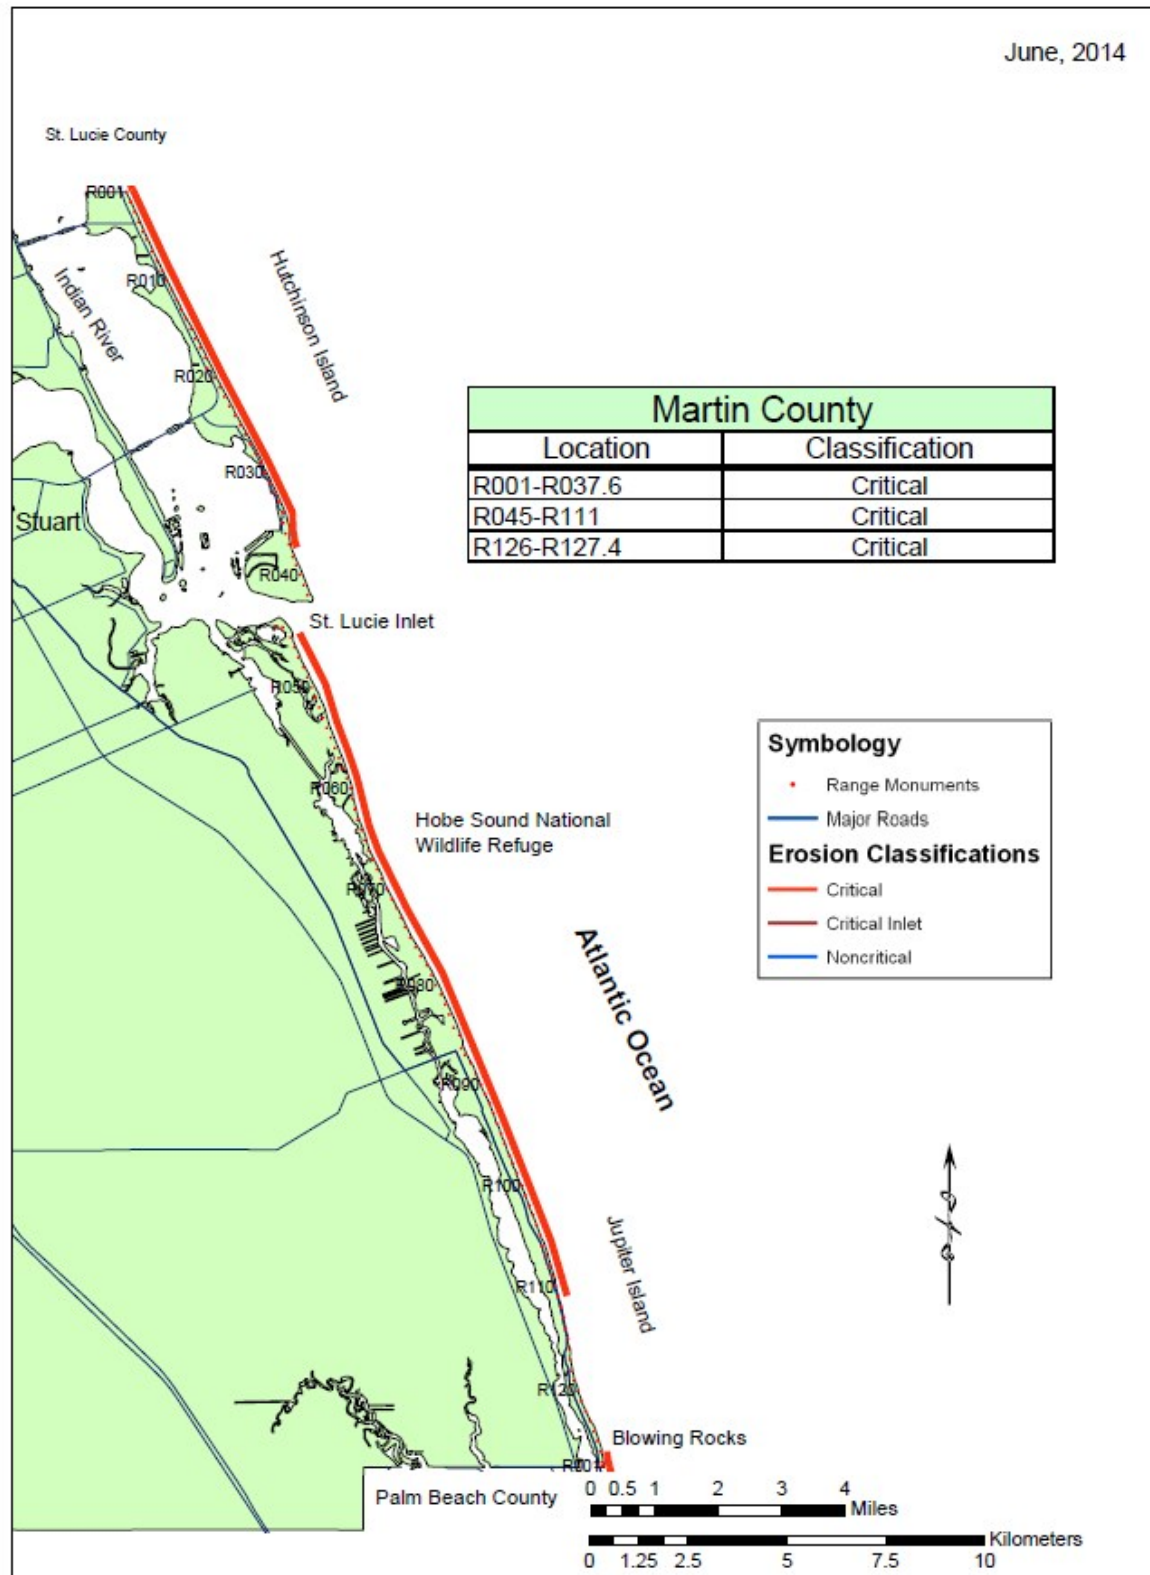
There are three critically eroded areas in Martin County (18 miles.)

South of Blowing Rocks Preserve is another critically eroded area (R126-R127.4) extending 0.2 mile to the Palm Beach County line and threatening private development.

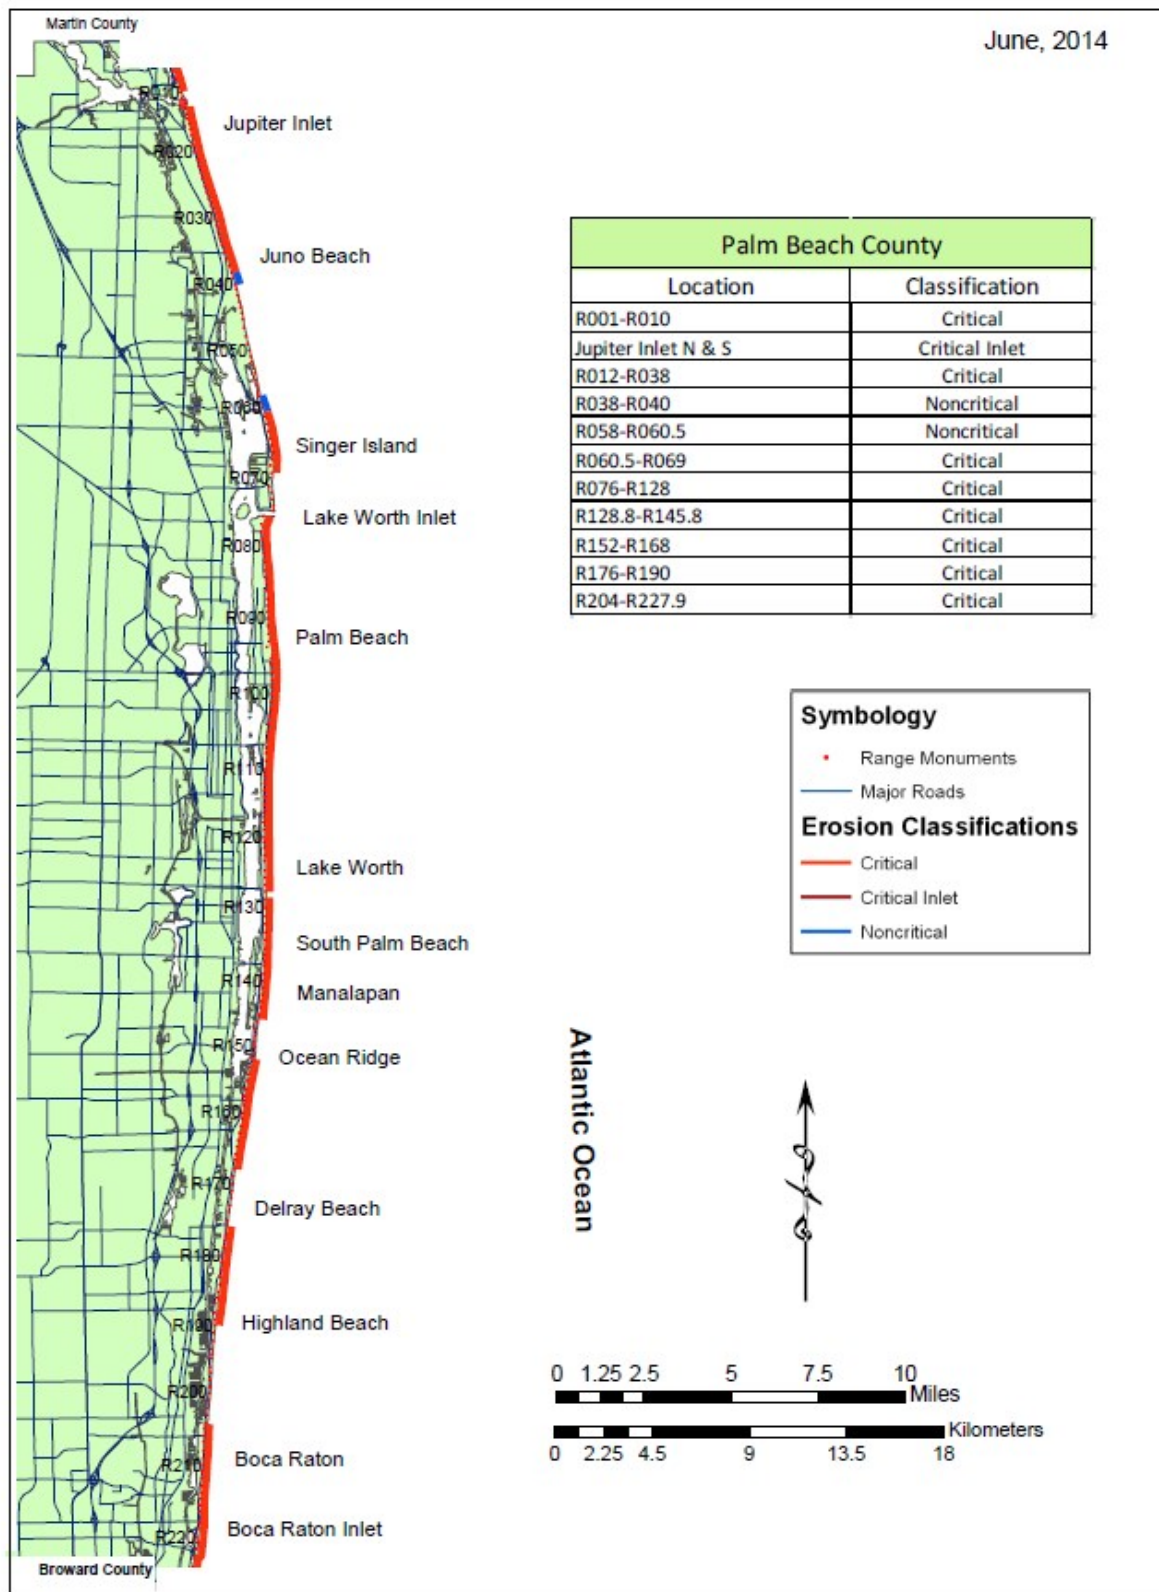
There are eight critically eroded areas (33.6 miles), two non-critically eroded areas (0.9 mile), and one critically eroded inlet shoreline area (0.8 mile) in Palm Beach County.

The City of Boca Raton at the south end of Palm Beach County has critical erosion (R204-R227.9) extending 5.0 miles to the Broward County line, which threatens recreation interests at Spanish River Park, Red Reef Park, and South Inlet Park as well as State Road AIA and private development. Beach restoration has been constructed throughout Boca Raton, and inlet sand transfer and seawalls exist south of Boca Raton Inlet.

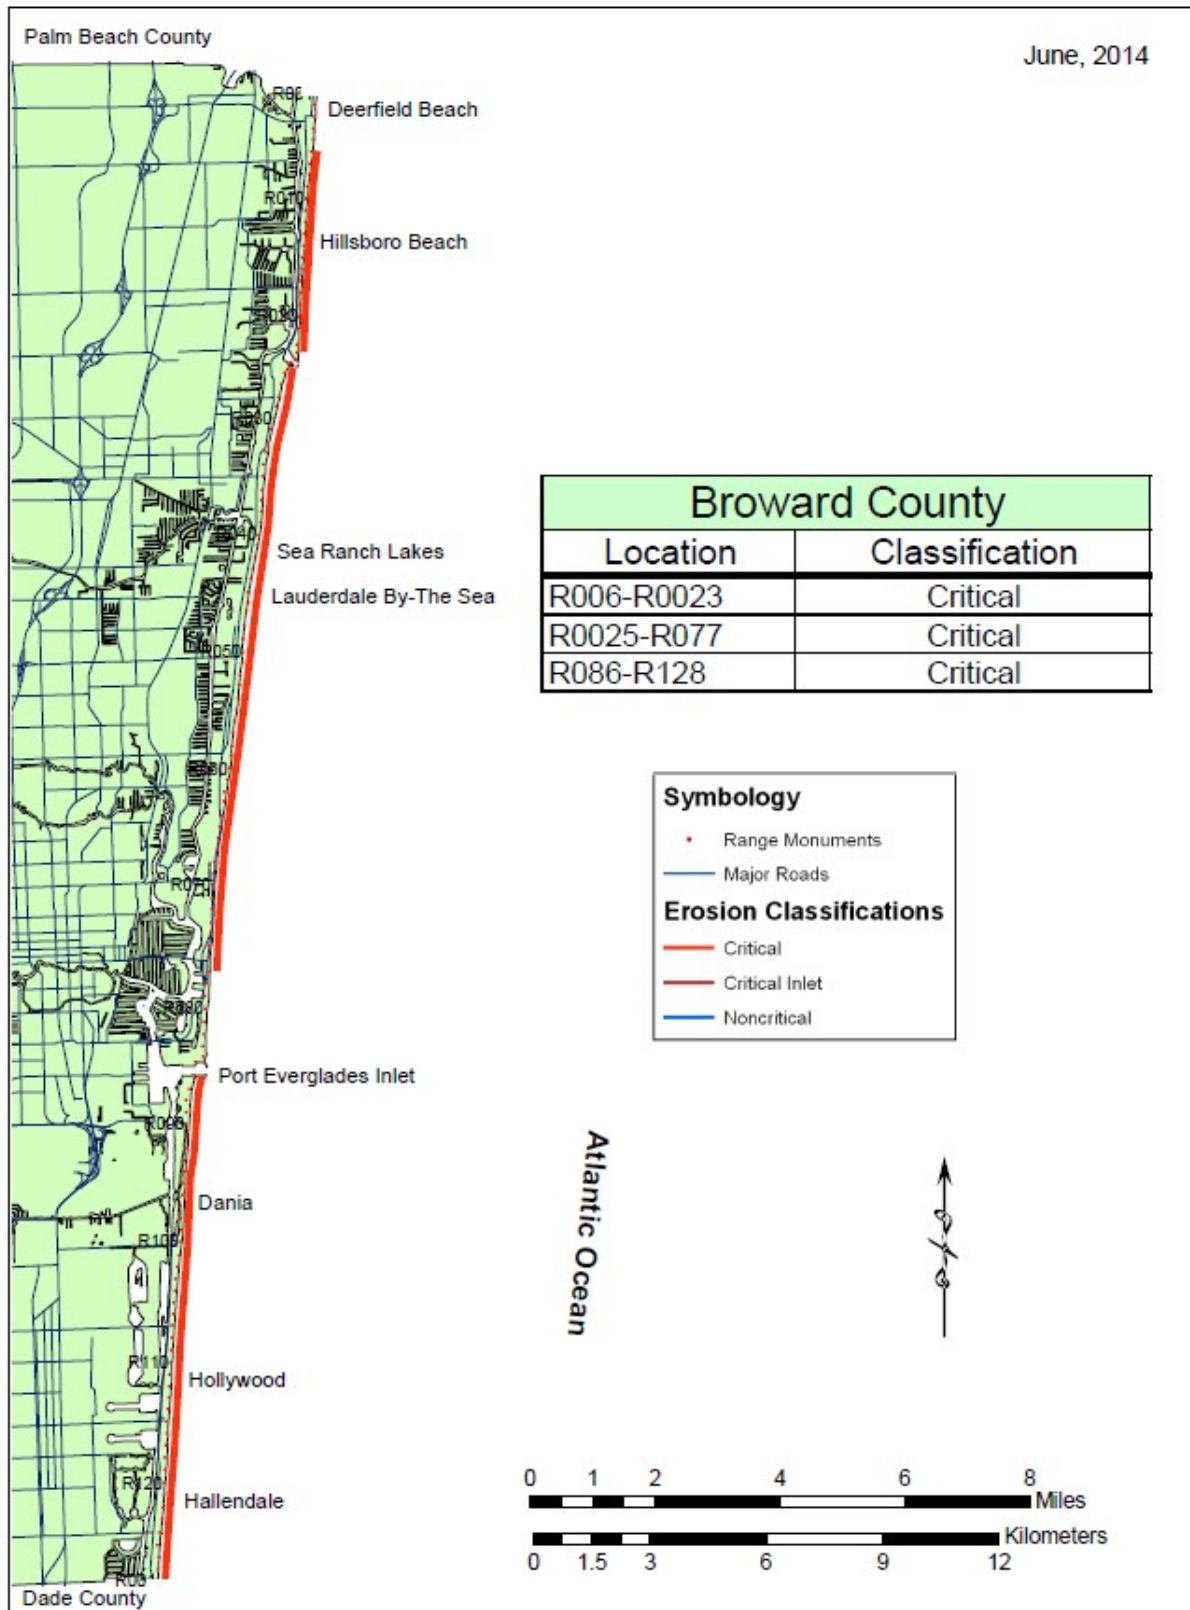
Nearly all of Broward County is critically eroded. Three critical erosion areas (21.3 miles) are specifically identified.

Along the southern 8.1 miles of Broward County south of Port Everglades Entrance is a critically eroded area (R86-R128) that threatens recreational interests at John U. Lloyd State Park and development and recreational interests along the communities of Dania, Hollywood, and Hallandale. Beach restoration projects are ongoing at J.U. Lloyd State Park and at Hollywood and Hallandale. Seawalls also exist along the private development.
