# **Critically Eroded Beaches In Florida**

**Updated June, 2014**

**ENGINEERING, HYDROLOGY, AND GEOLOGY PROGRAM  
DIVISION OF WATER RESOURCE MANAGEMENT  
DEPARTMENT OF ENVIRONMENTAL PROTECTION  
STATE OF FLORIDA**

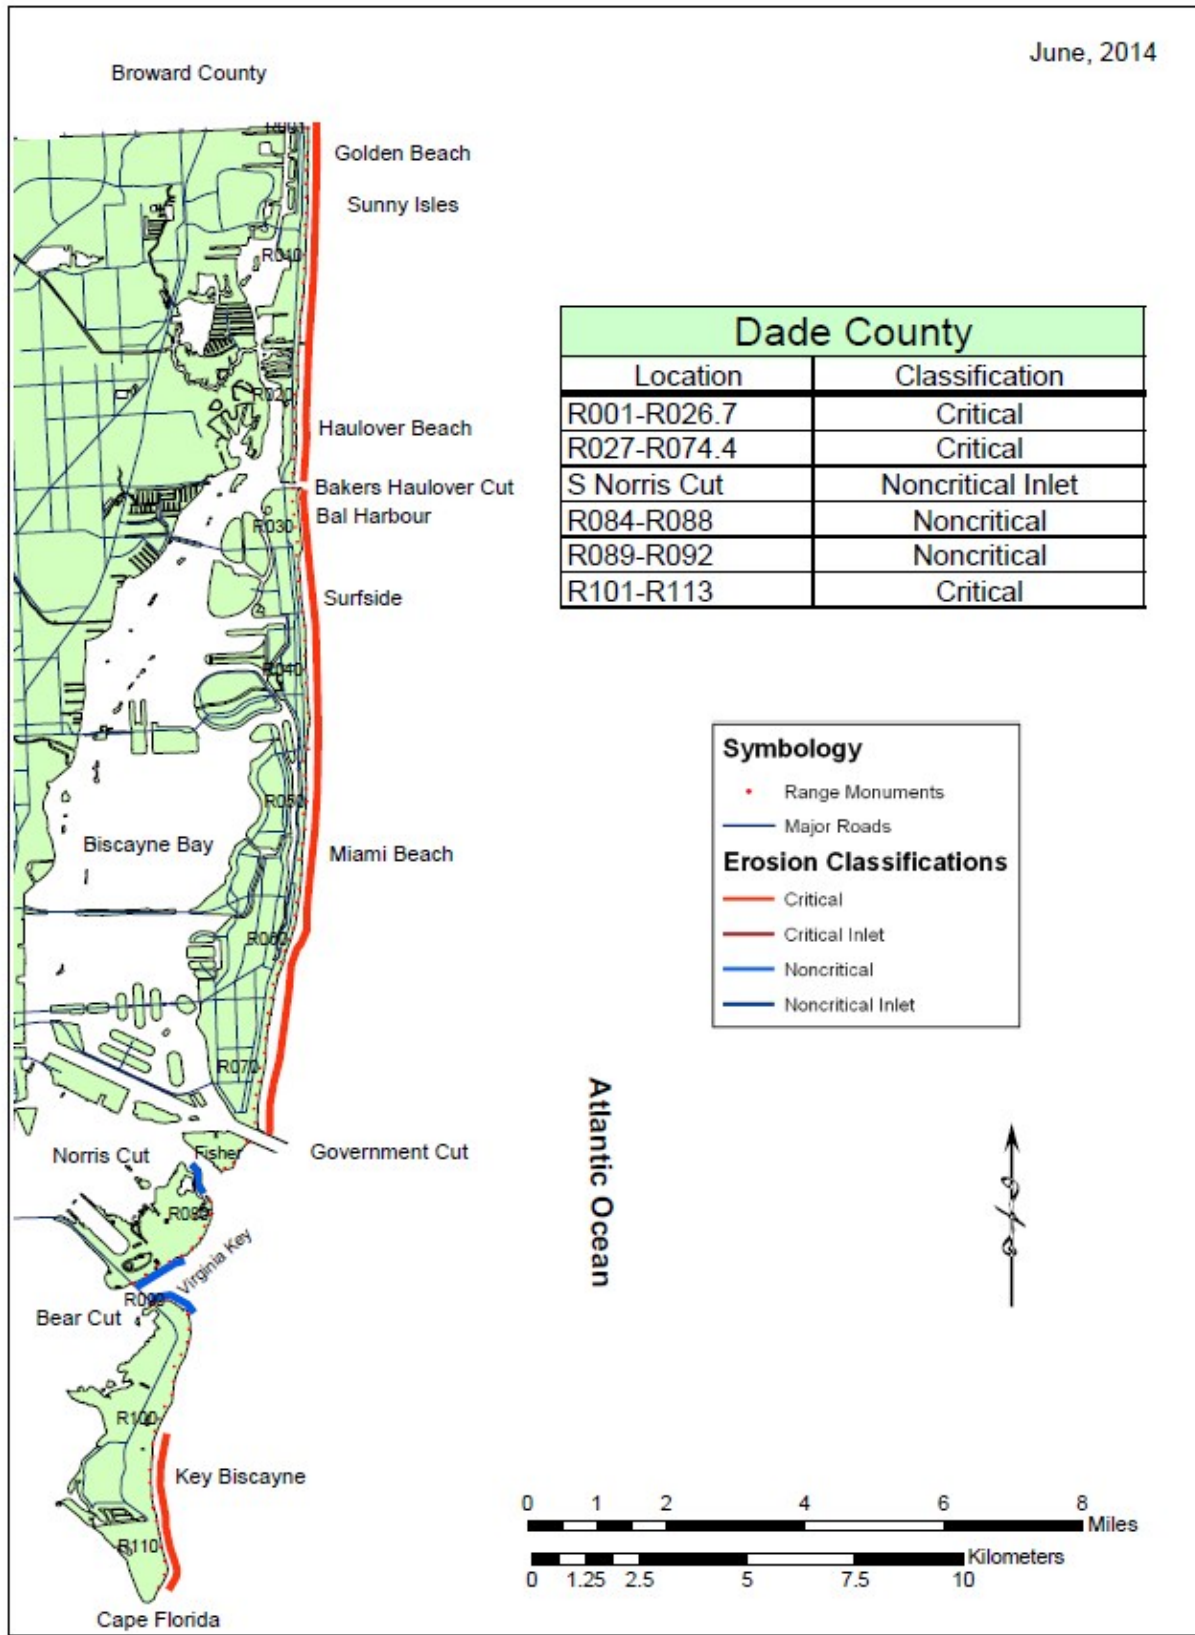
Most of Dade County's barrier island coast north of Cape Florida is critically eroded. The erosion is identified by three critically eroded areas (17 miles), two non-critically eroded areas (1.4 miles), and one non-critically eroded inlet shoreline area (0.3 mile).

The northern end of Key Biscayne (R89-R92) has 0.6 mile of non-critical erosion, and the southern half of Key Biscayne (R101-R113) has 2.5 miles of critical erosion. The critically eroded area threatens development in the Village of Key Biscayne and recreational interests at Bill Baggs Cape Florida State Park. This segment is a beach restoration project.

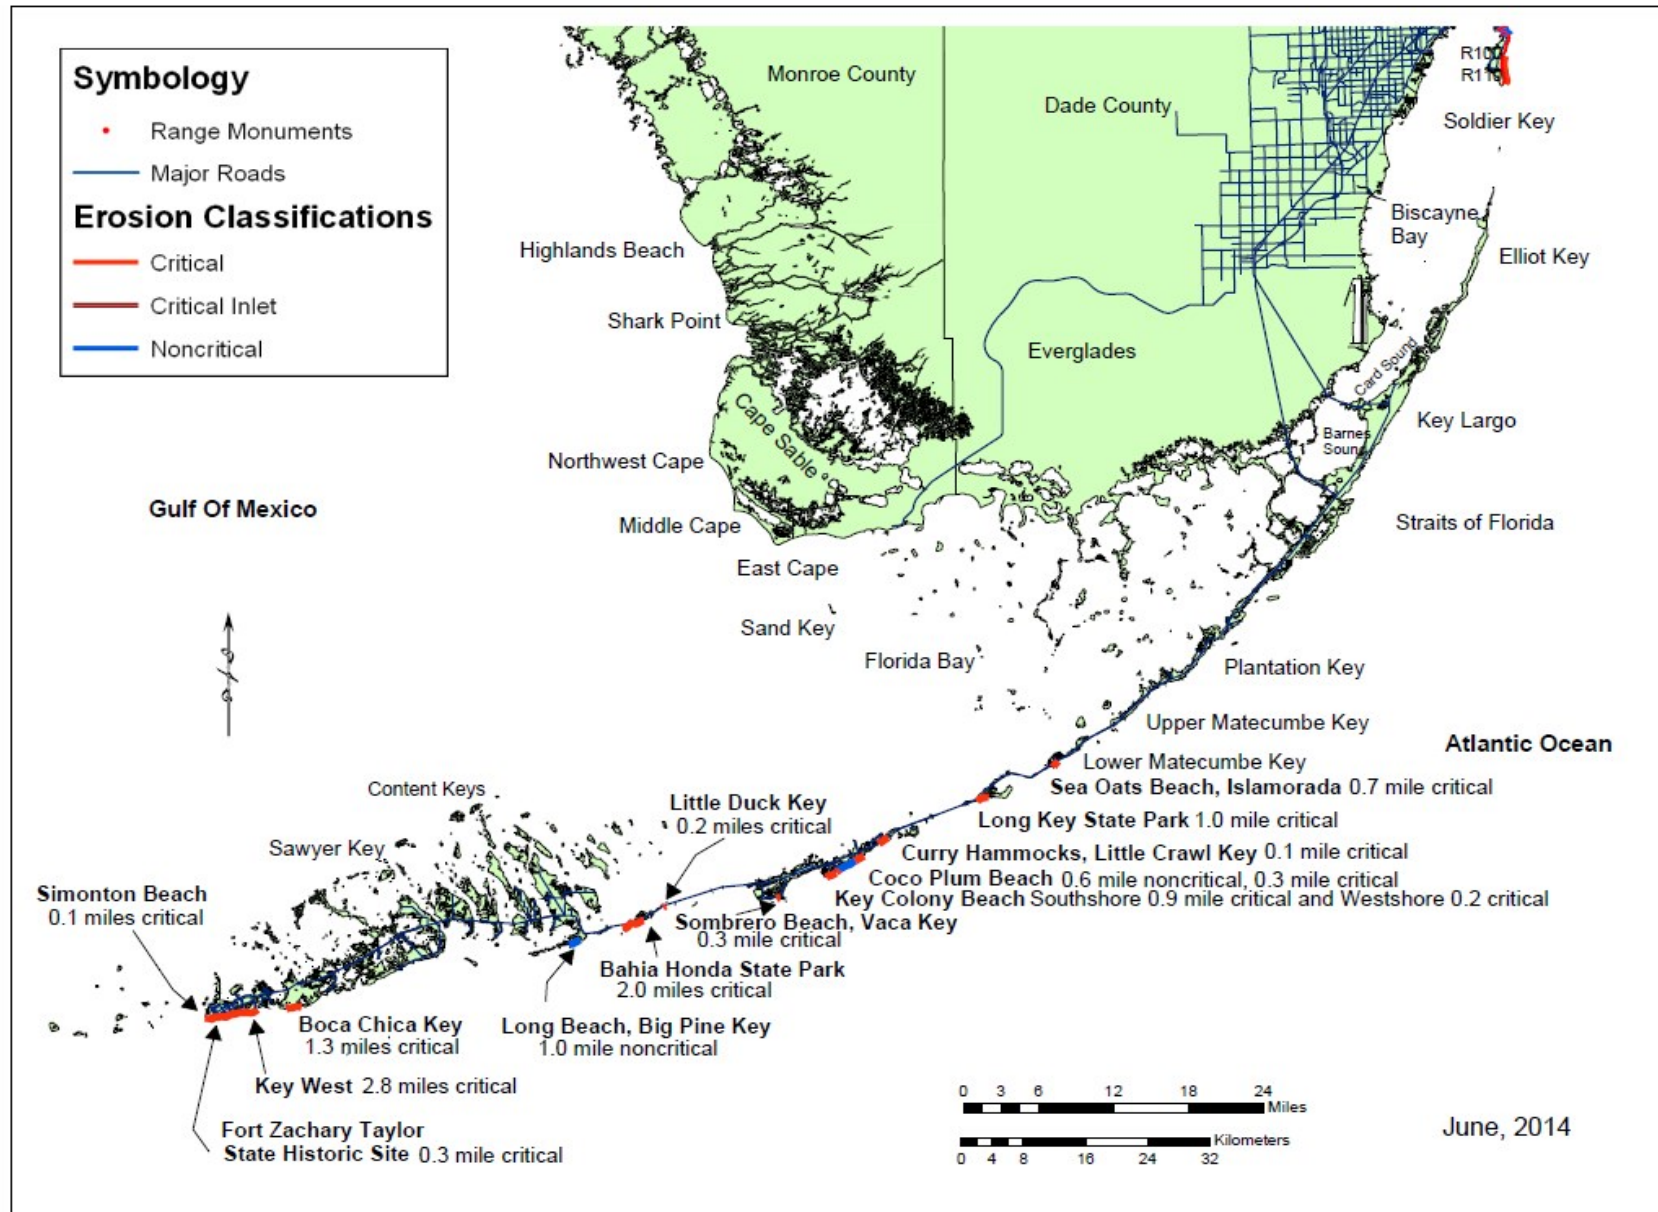
There are 13 critically eroded beach areas (10.2 miles) and two non-critically eroded beach areas (1.6 miles) along the Florida Keys fronting on the Straits of Florida and Gulf of Mexico between Key Largo and Key West. The distal sand keys west of Key West including Woman Key, Boca Grande Key, the Marquesas Keys, and the Tortugas Keys, also have beach erosion conditions that have not been adequately studied for inclusion in this report. Also not included at this time are the mainland beaches of Key McLaughlin and Cape Sable that front on the Gulf of Mexico. These beaches sustained severe erosion conditions due to Hurricane Wilma in 2005.

The distal sand keys west of Key West are known to have erosion areas; however, insufficient data is currently available. Particularly susceptible to erosion conditions are Woman Key, Boca Grande Key, the Marquesas Keys, and the Tortugas Keys. Cape Sable and Key McLaughlin on the mainland coast of Monroe County fronting the Gulf of Mexico were severely impacted by Hurricane Wilma in 2005. These areas are now being monitored by aerial videography.

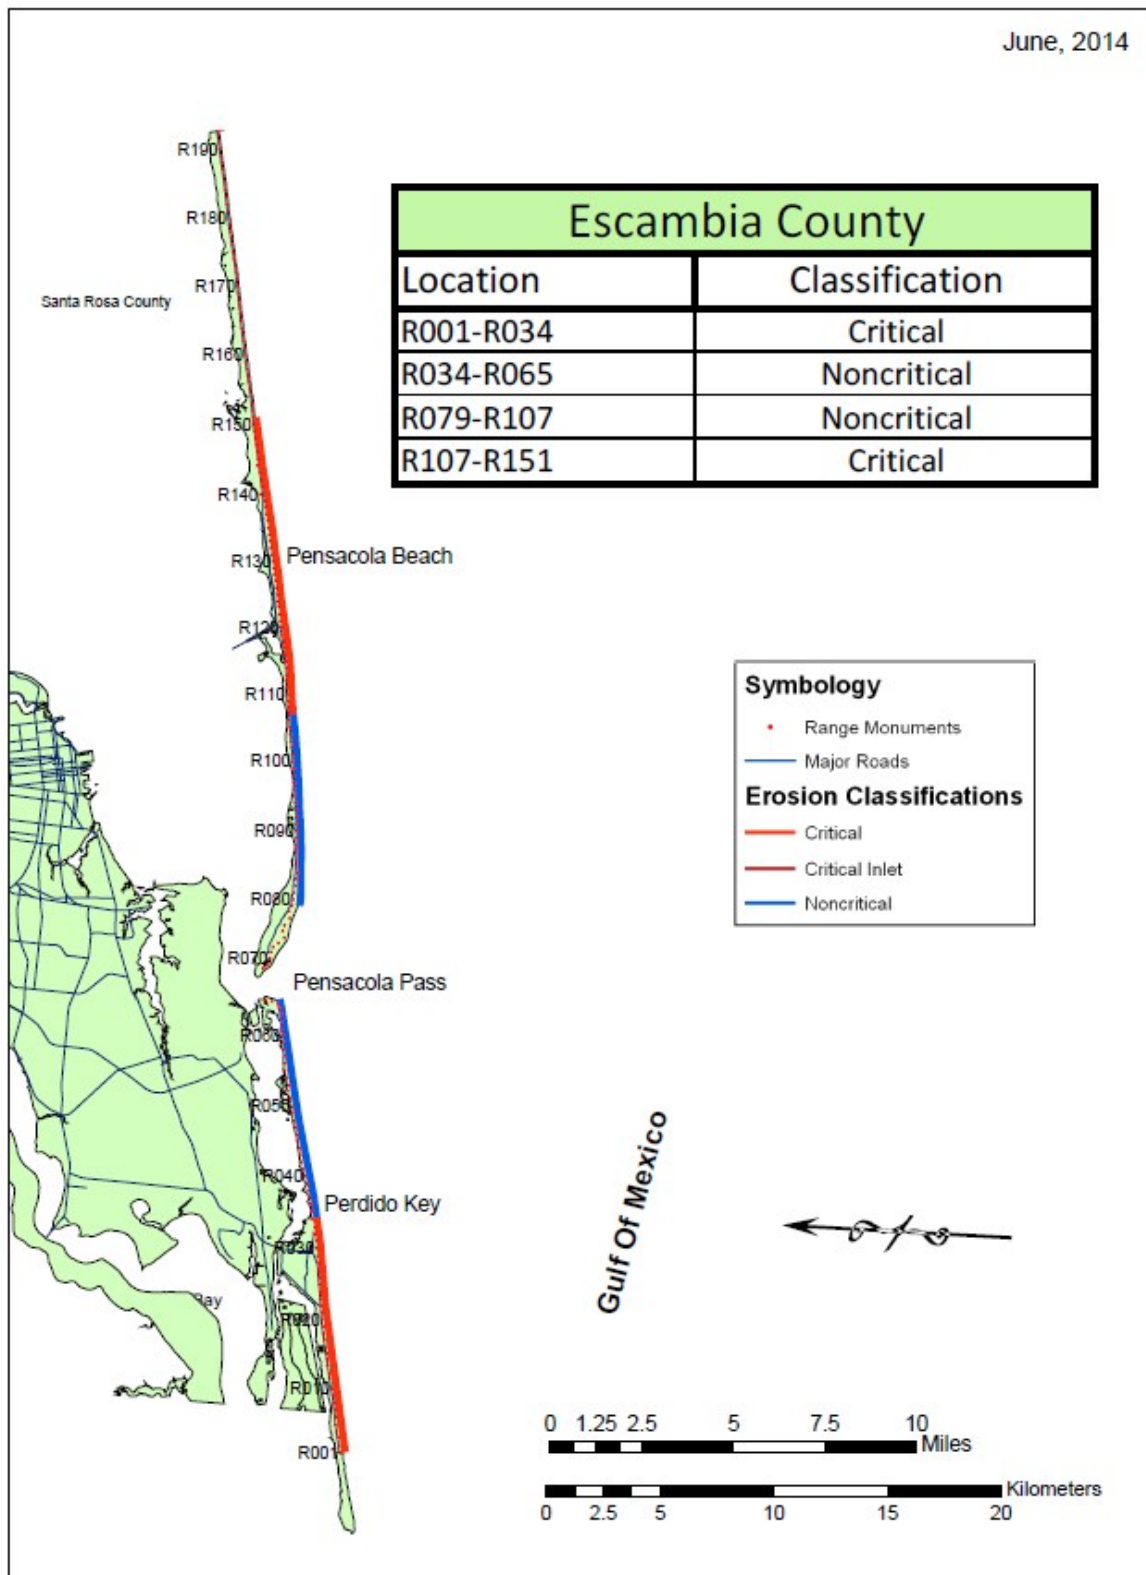
There are two critically eroded areas (14.7 miles) and two non-critically eroded areas (11.2 miles) in Escambia County.

The entire 8.2-mile length of Pensacola Beach (R107-R151) is critically eroded threatening development and recreational interests. Dune restoration was conducted after the storms of 1995, 1998, 2002, and 2004. Beach restoration was completed in 2003.

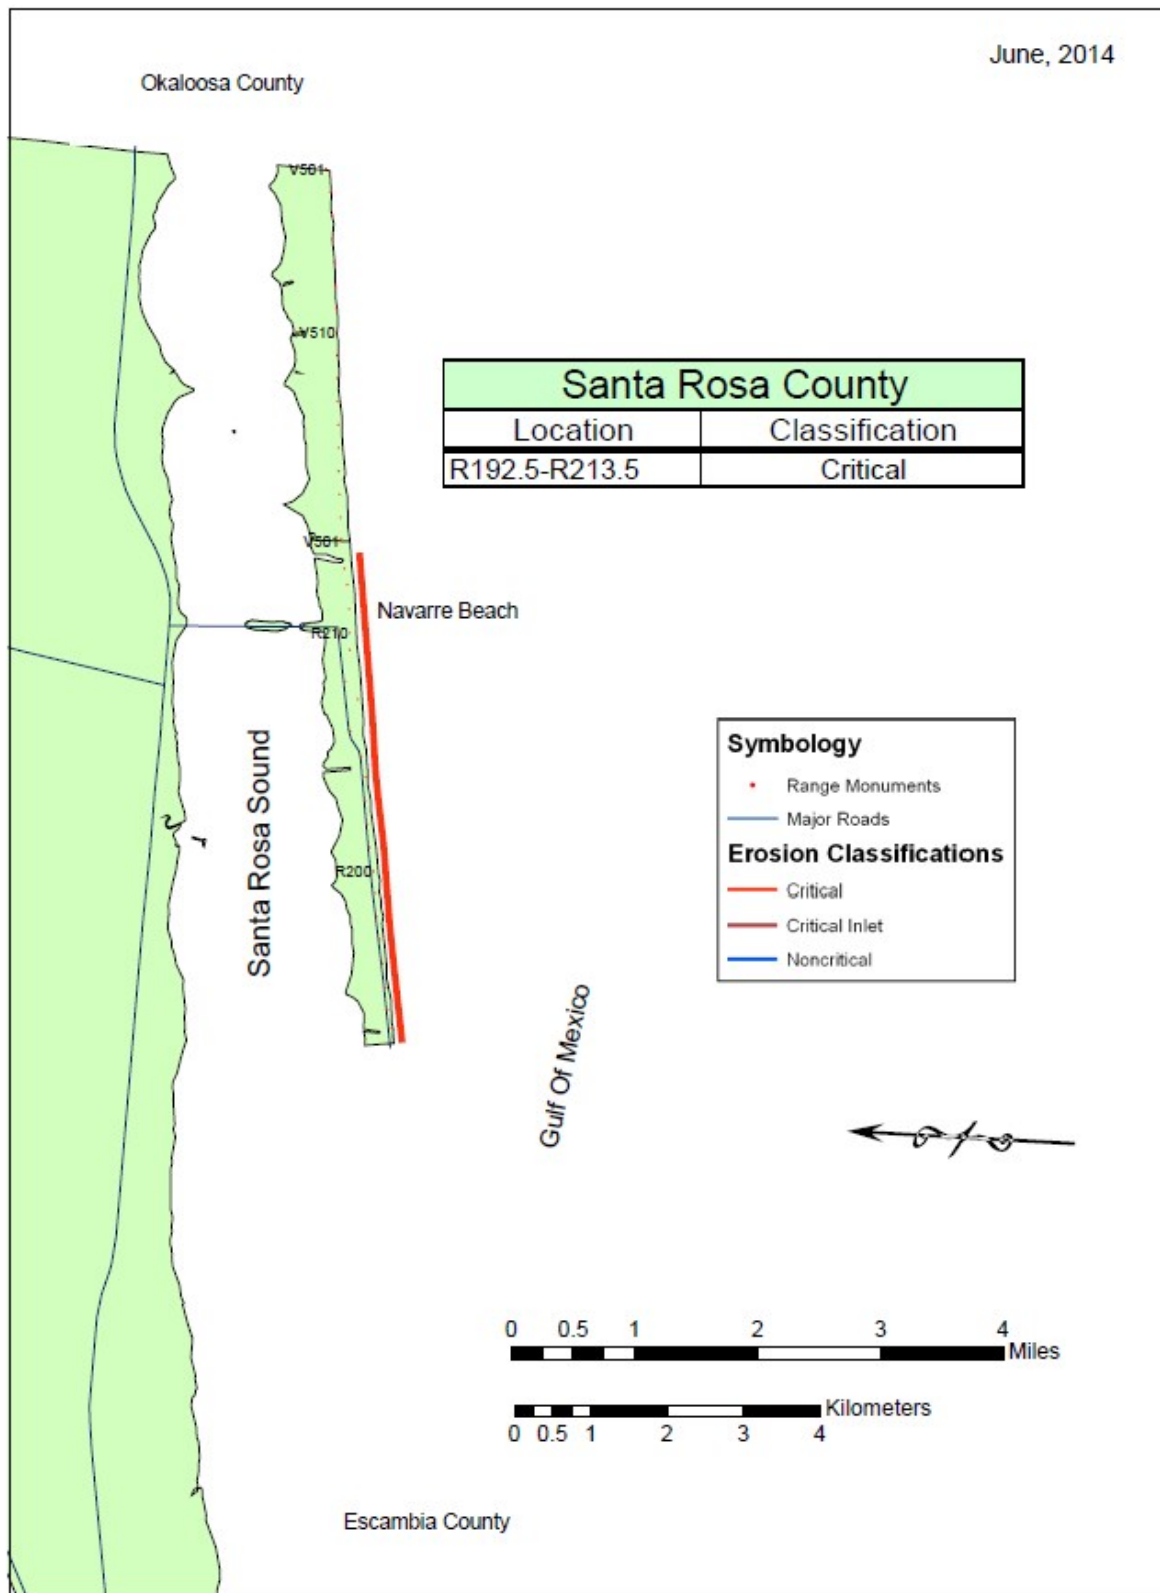
There is one critically eroded area in Santa Rosa County (4.1 miles). The critically eroded area along Navarre Beach (R192.5-R213.5) threatens development and recreational interests. Following hurricanes in 1995 and 1998, dune restoration projects were constructed. A beach restoration project was completed in 2006.

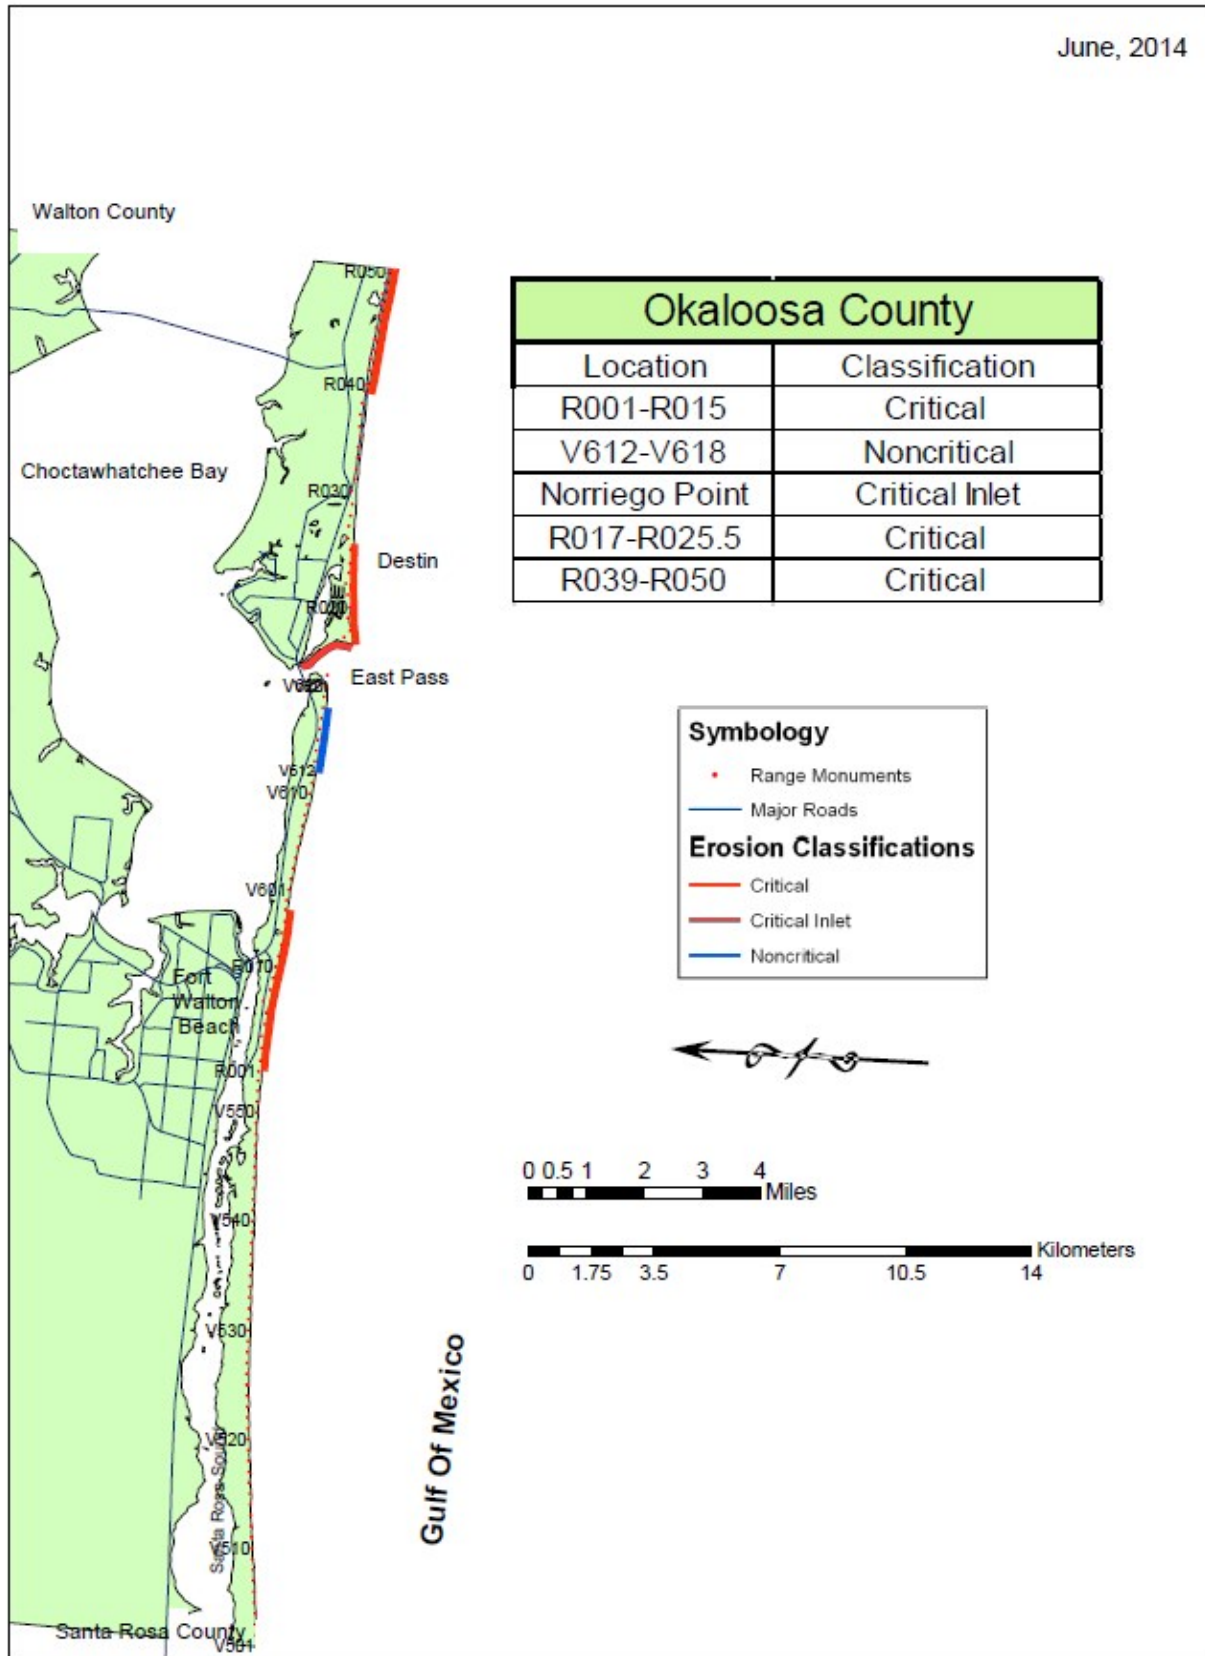
There are three critically eroded beach areas (6.5 miles), and one critically eroded inlet shoreline area (0.8 mile) in Okaloosa County.

The western 1.6 miles of Destin (R17-R25.5) is designated critically eroded following the severe impact of the 2005 hurricane season and on-going erosion conditions. The western portion on Holiday Isles (R17.2-R19.8) received emergency nourishment in 2010, and the entire beach restoration project was completed in 2013. The eastern 2.1 miles of Destin (R39-R50) is designated critically eroded threatening development and the coastal road. This area is a beach restoration project constructed in 2007.

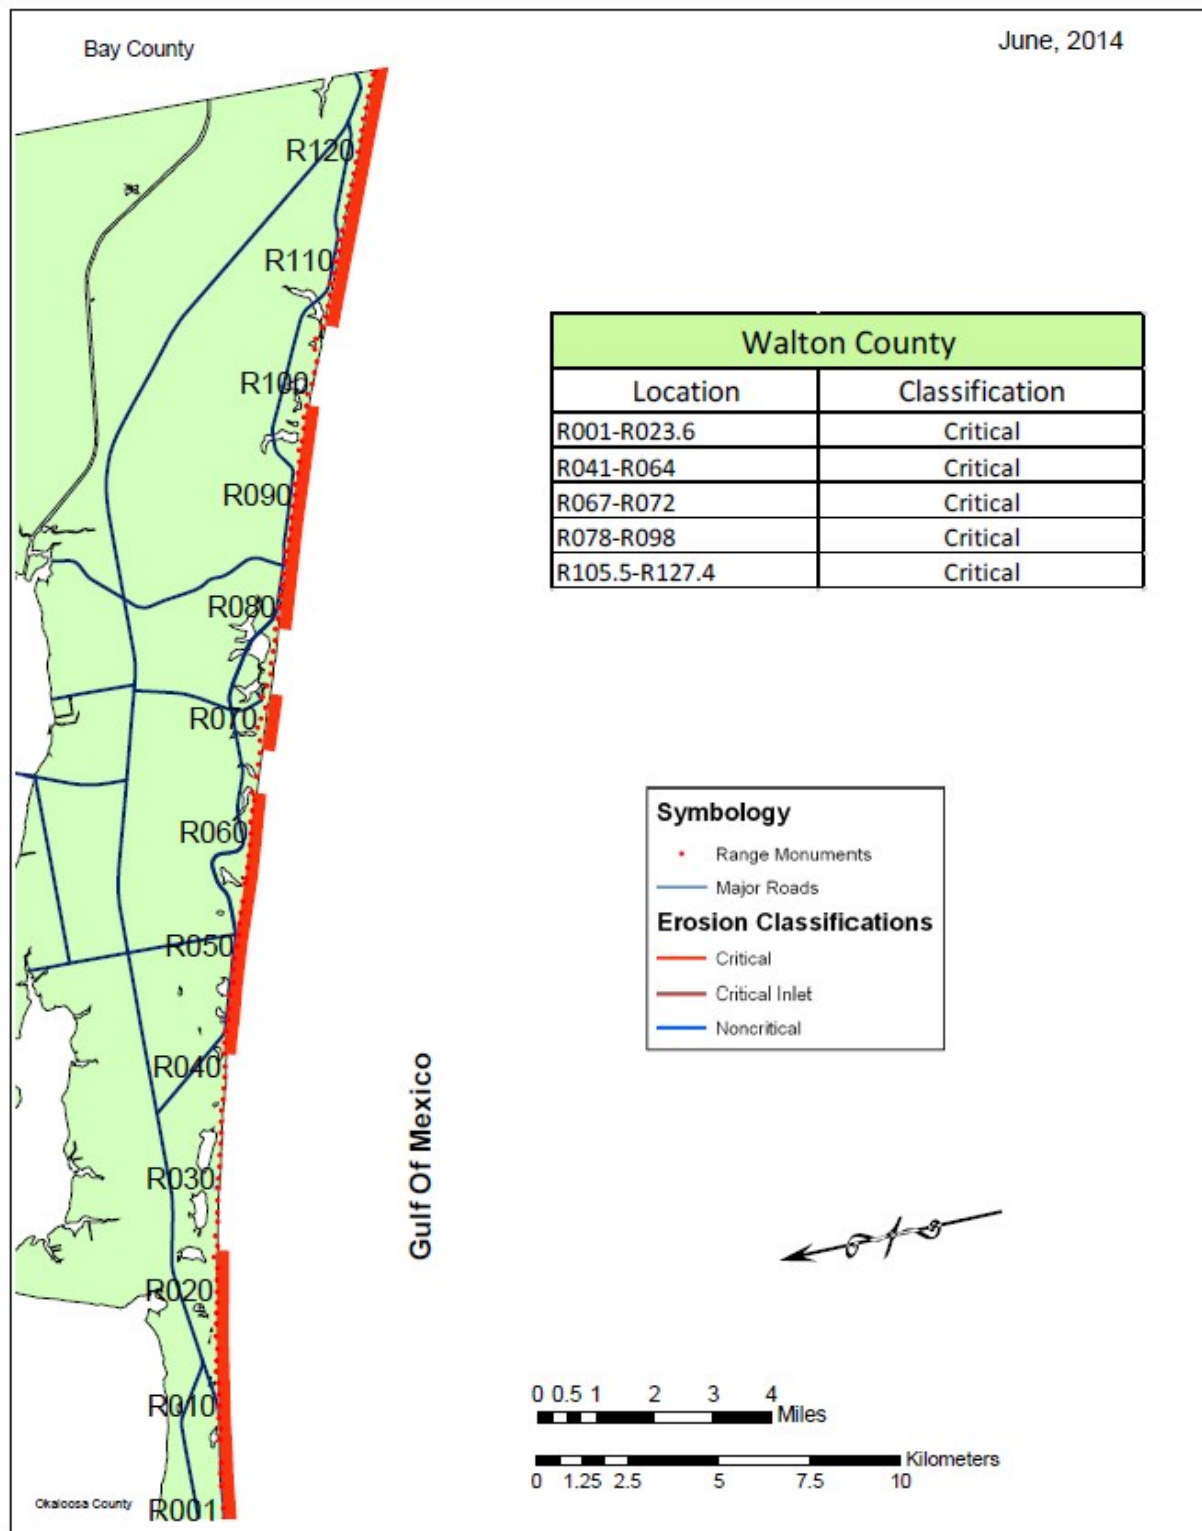
There are five critically eroded areas designated in Walton County (18.8 miles). Within these areas, 3.1 miles were added following Congressional authorization of the Walton County Hurricane and Storm Damage Reduction Project.

The eastern 4.2 miles of Walton County (R105.5-R127.4) is designated critically eroded. Along Seacrest Beach is a 1.8-mile segment (R105.5-R114.7) where development is threatened by erosion of the bluff. To the east at Inlet Beach a 1.0-mile segment (R122-R127) was previously designated critically eroded. The portion between R122 and R124 was designated critical due to its post-storm vulnerability threatening development interests. The portion between R124 and R127 was designated critical for the design integrity of the beach restoration project. Between R114.7 and R122 is a 1.4-mile gap between threatened areas where nearly all of the development is completely landward of the CCCL. This area and a 400-foot segment at the east end where there is currently no development seaward of the CCCL, were added for continuity of management of the coastal system following federal project authorization.

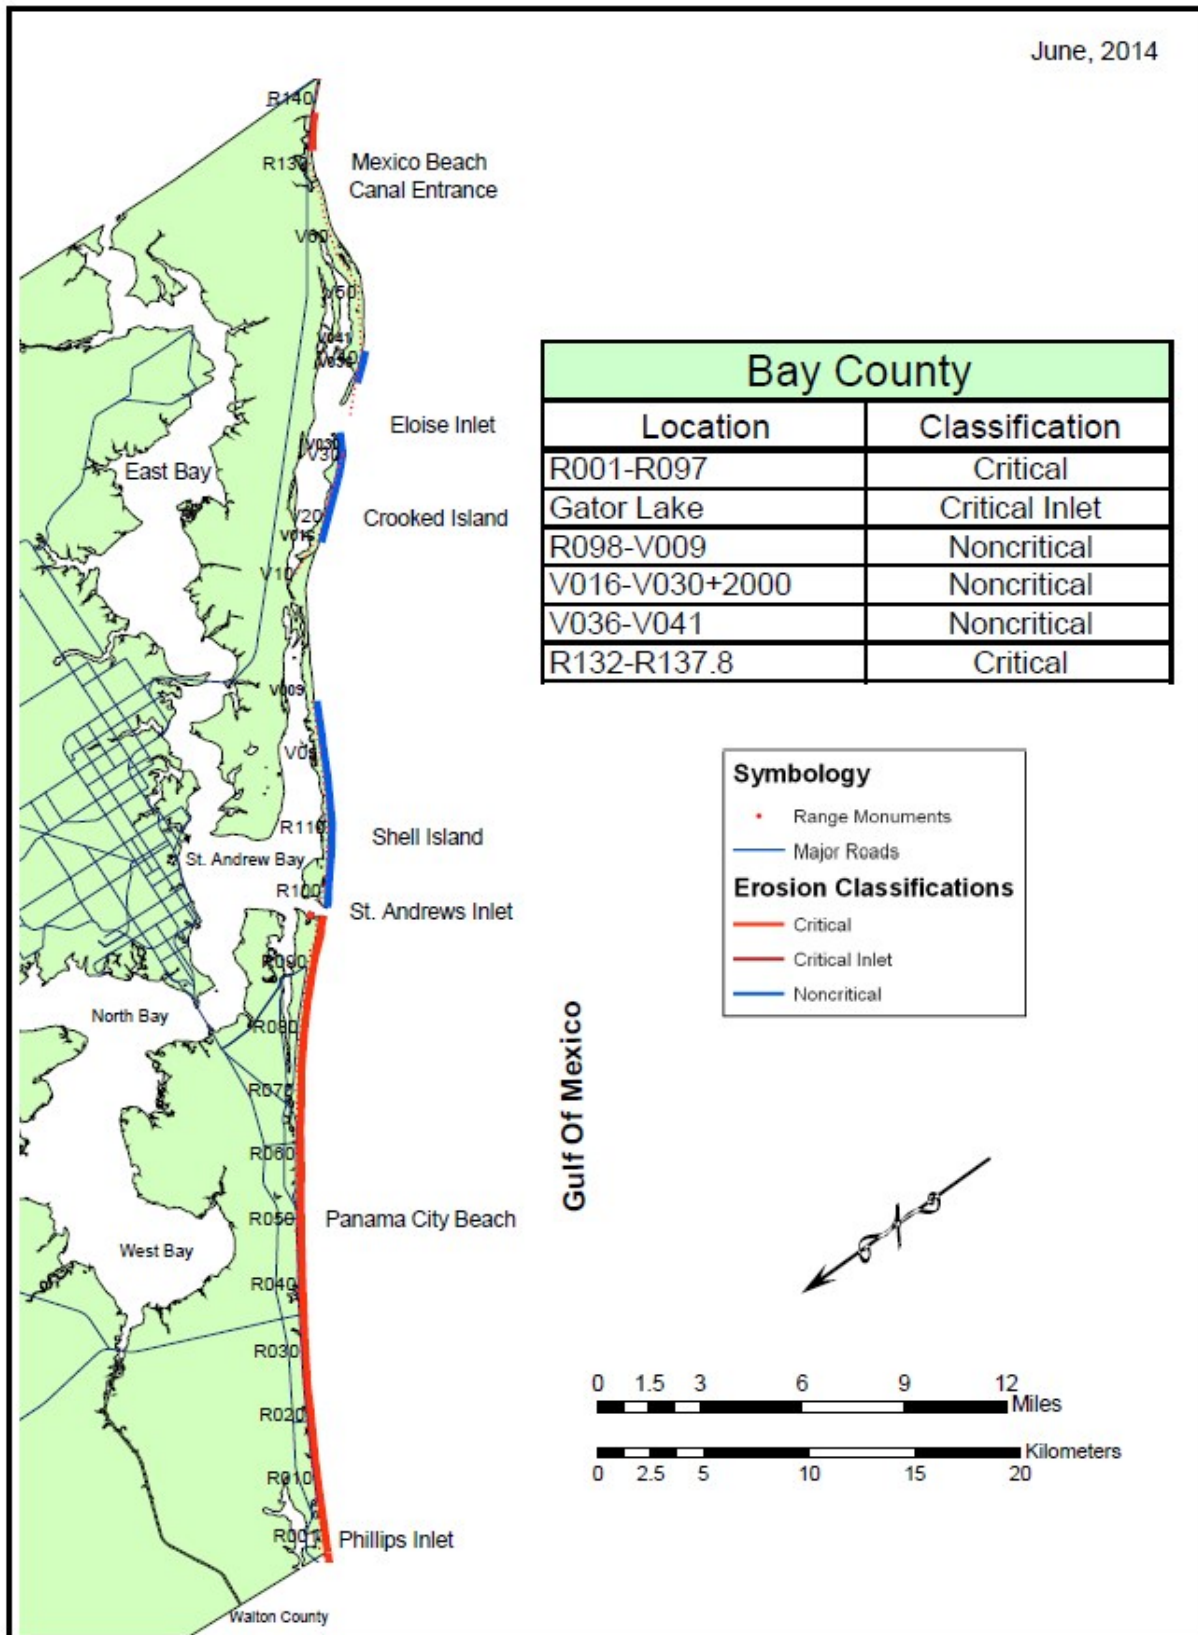
There are two critically eroded beach areas (19.5 miles), three non-critically eroded beach areas (10.1 miles), and one critically eroded inlet shoreline (0.2 mile) in Bay County.

The eastern 0.9 miles of Bay County (R132-R137.8) along the Town of Mexico Beach is critically eroded. Inlet sand transfer is periodically conducted at Mexico Beach Inlet and dune restoration has been conducted following Hurricanes Opal (1995) and Dennis (2005).

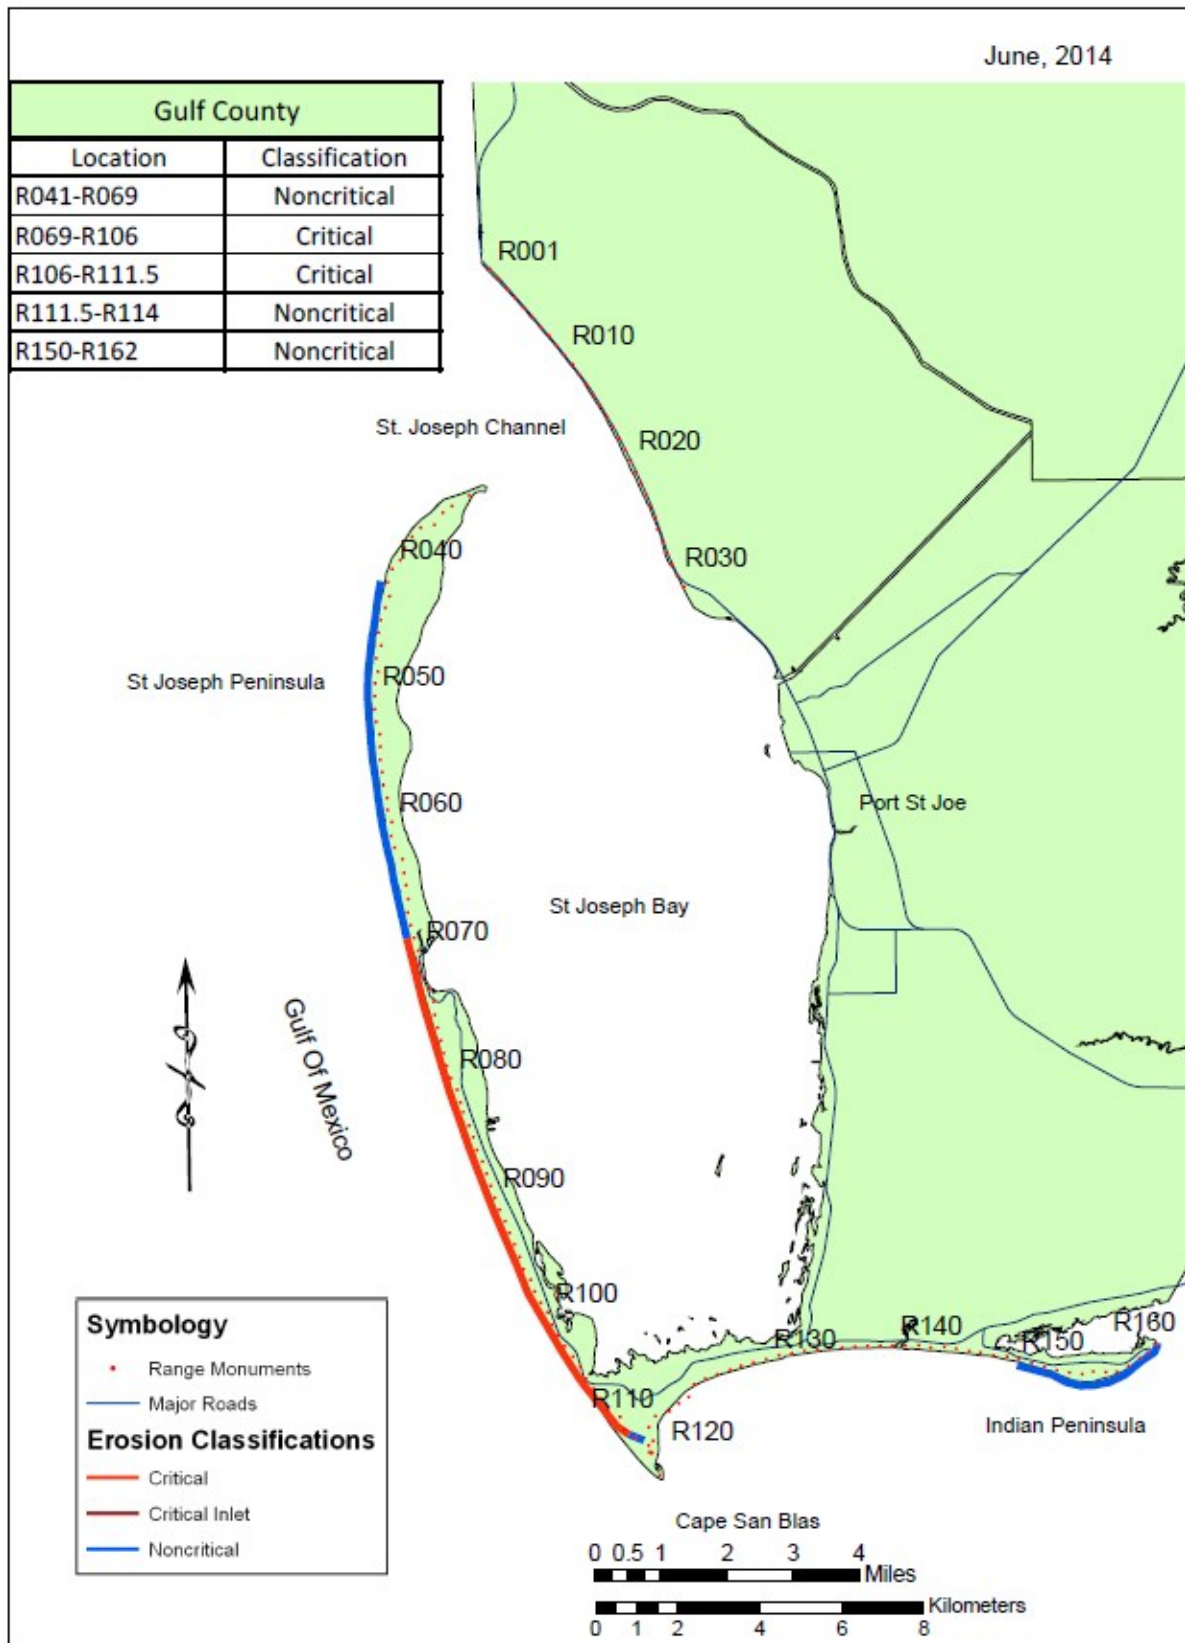
There are two critically eroded areas (8.3 miles) and three non-critically eroded areas (8.6 miles) in Gulf County.

The west shoreline of Cape San Blas is severely eroded and is considered to have the highest erosion rate along the coast of Florida. The segment between R106 and R111.5 (1.1 mile) is designated critically eroded from Stump Hole to the threatened and damaged U.S. Air Force facilities, because the erosion has destroyed nesting sea turtle habitat along Cape San Blas. After Hurricane Opal (1995), a rock mound structure was constructed to protect the county road at Stump Hole. Likewise, the U.S. Air Force constructed a rock mound structure in front of their road to the rocket launch site after Hurricane Kate (1985), but both the road and the rock mound structure were destroyed by Hurricane Opal (1995). The rock mound at Stump Hole was extended and subsequently damaged by Hurricanes Ivan (2004) and Dennis (2005). An engineered boulder mound structure was constructed in 2009 to replace the earlier rock mound to provide major storm protection to the county road. South of the U.S. Air Force facilities, Cape San Blas (111.5-R114) has sustained severe but non-critical erosion for an additional 0.5 mile.

Indian Peninsula (R150-R162) at the east end of the county is also eroded for 2.6 miles with no threatened interests at this time.

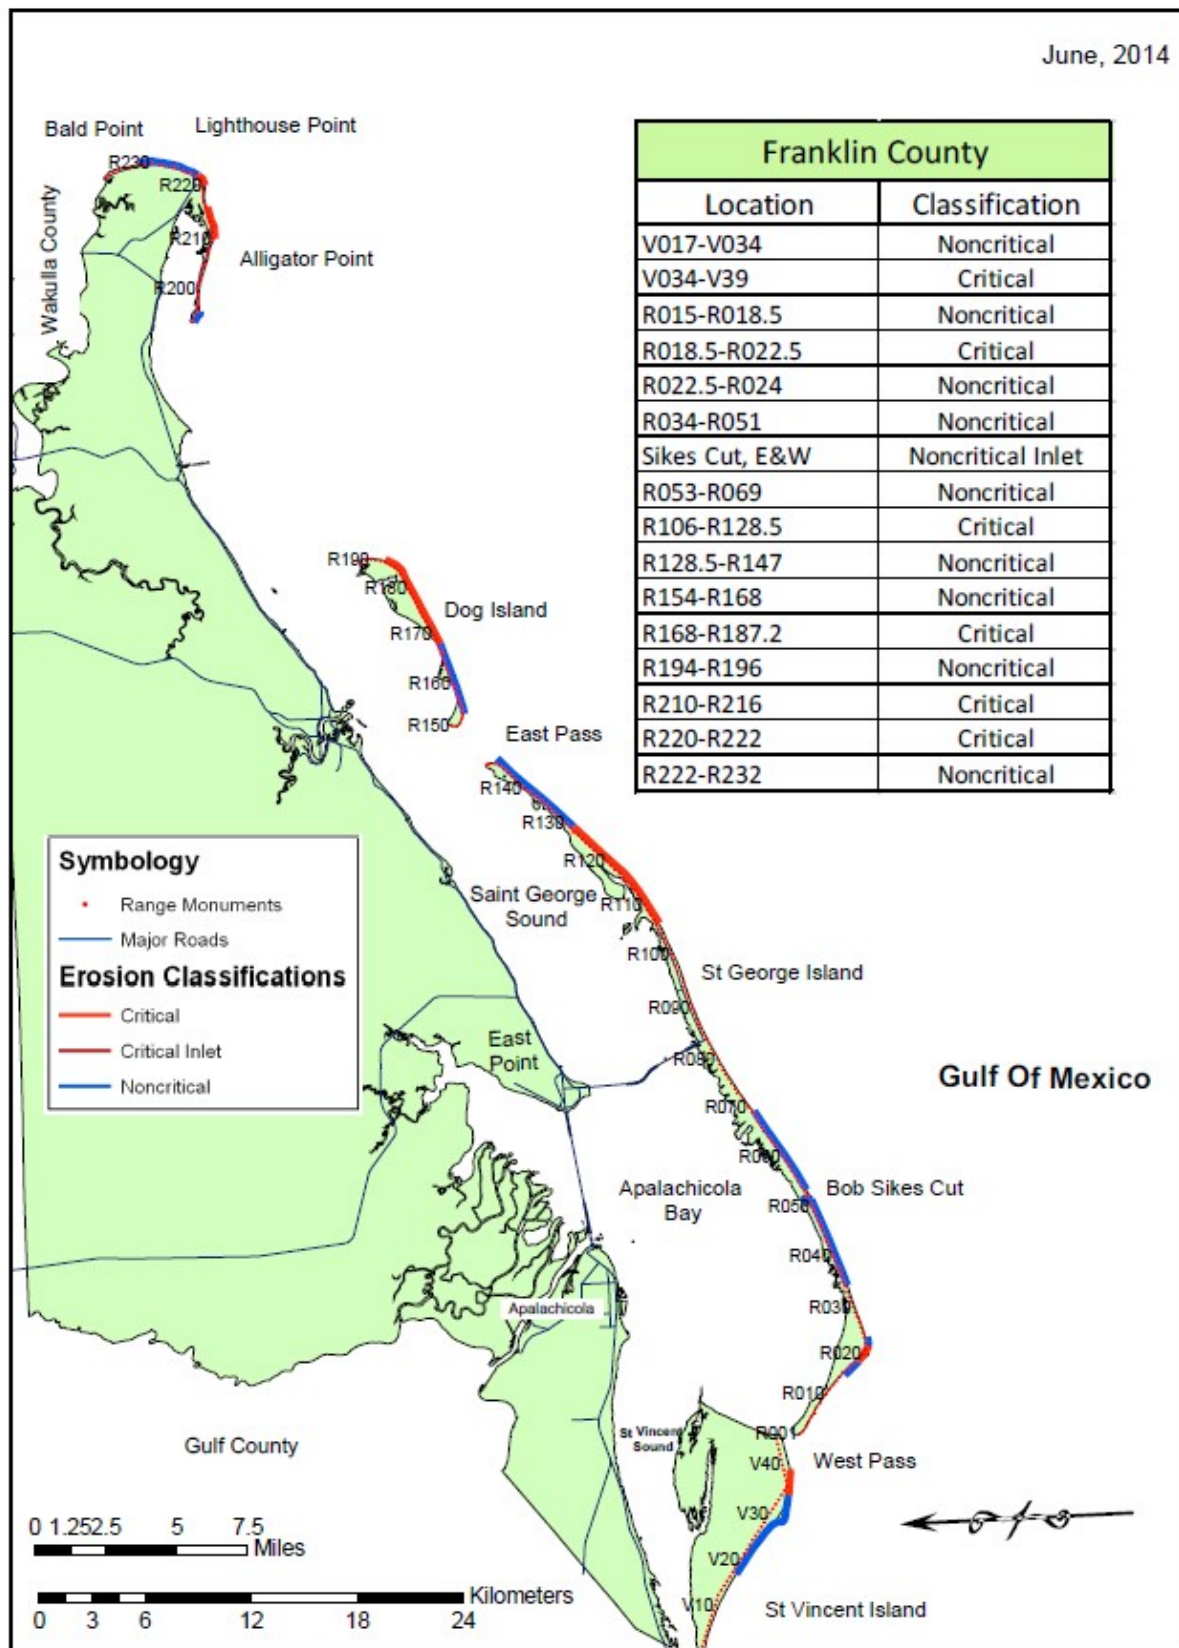
There are six critically eroded beach areas (11.1 miles), nine non-critically eroded beach areas (19.7 miles), and one non-critically eroded inlet shoreline area (0.5 mile) in Franklin County.

St. Vincent Island has a 3.2-mile long non-critically eroded area along its most gulfward protruding midsection (V17-V34). Resources on the St. Vincent National Wildlife Refuge do not currently appear threatened by this ongoing erosion condition. To the east, a 0.9-mile segment of St. Vincent Island (V34-V39) is critically eroded into the maritime forest resulting in the loss of beach wildlife habitat.

The southeast end of St. James Island is critically eroded extending north from Lighthouse Point (R220-R222) for 0.4 mile threatening residential development. Further north from Lighthouse Point (R222-R232), a non-critically eroded area extends for 2.1 miles.

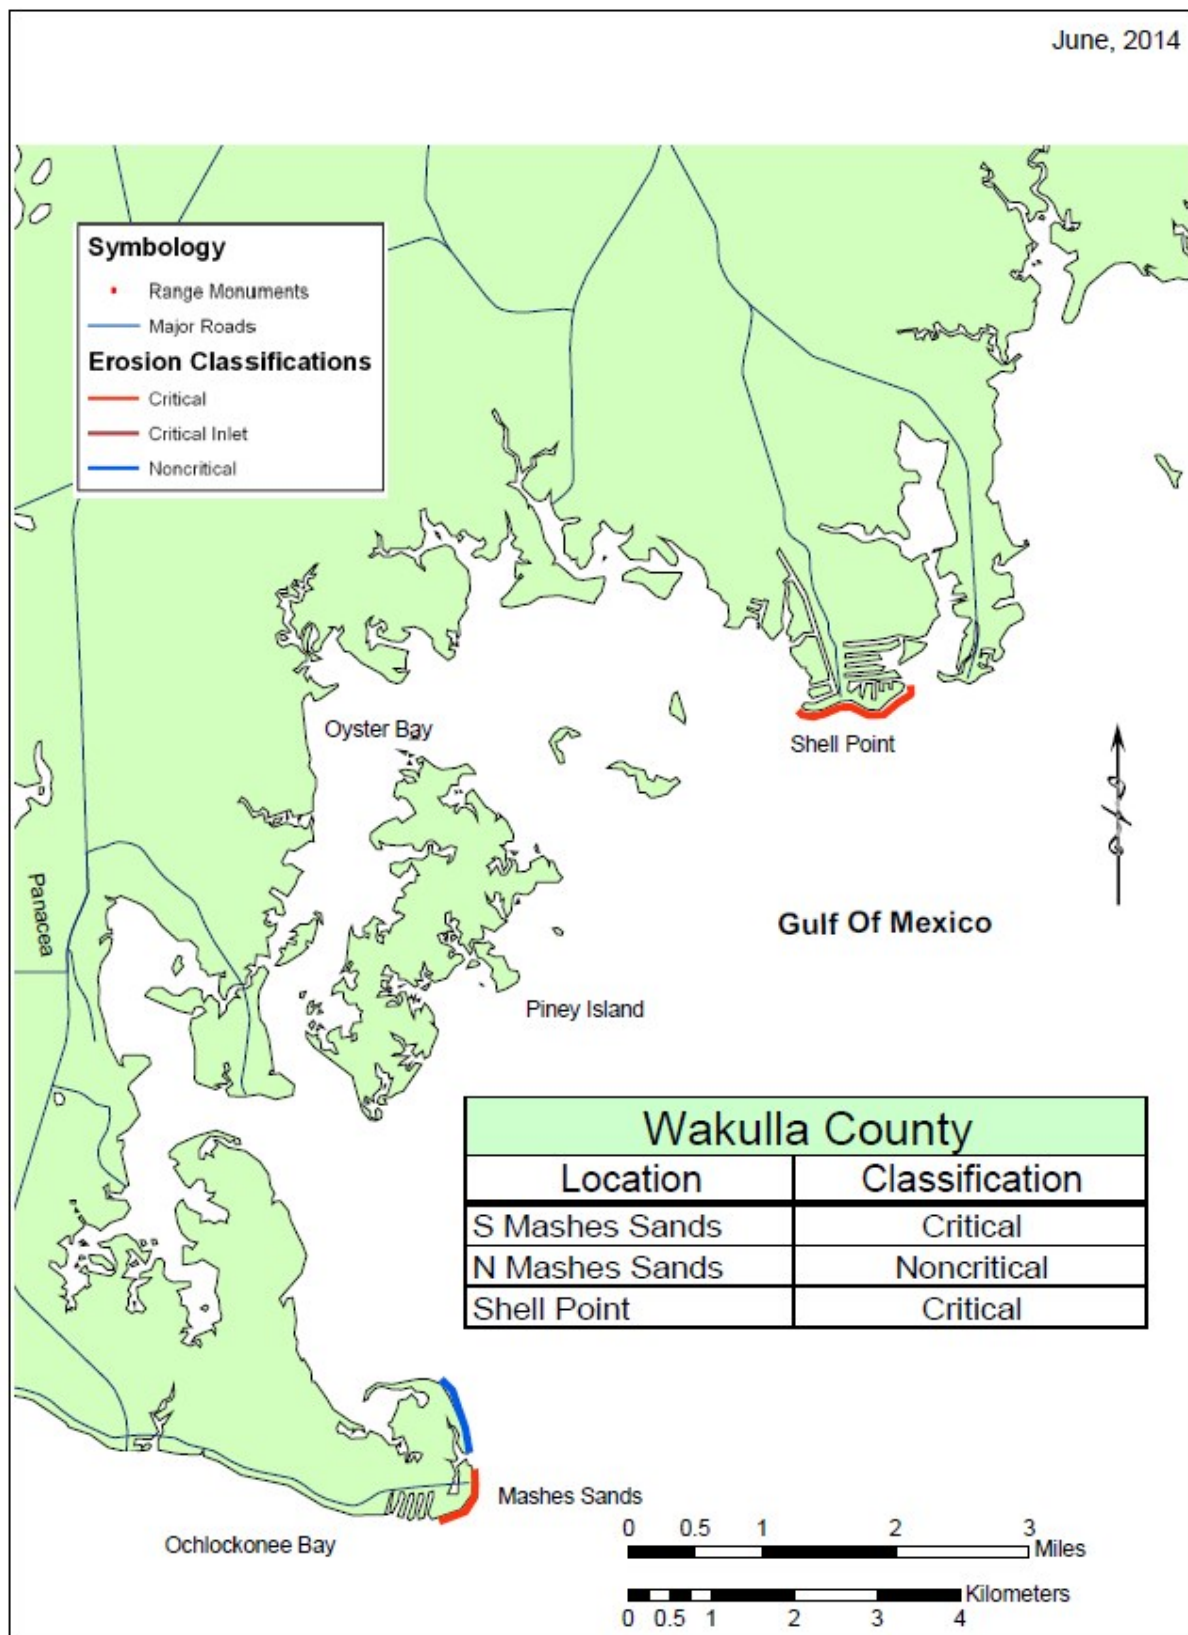
There are two critically eroded beach areas (1.3 miles) and one non-critically eroded beach area (0.4 mile) in Wakulla County.

Shell Point has 1.0 mile of critical erosion threatening development and a county park. Most of the private properties have bulkheads, retaining walls, and one rock revetment.
