# **Critically Eroded Beaches In Florida**

**Updated June, 2014**

**ENGINEERING, HYDROLOGY, AND GEOLOGY PROGRAM  
DIVISION OF WATER RESOURCE MANAGEMENT  
DEPARTMENT OF ENVIRONMENTAL PROTECTION  
STATE OF FLORIDA**

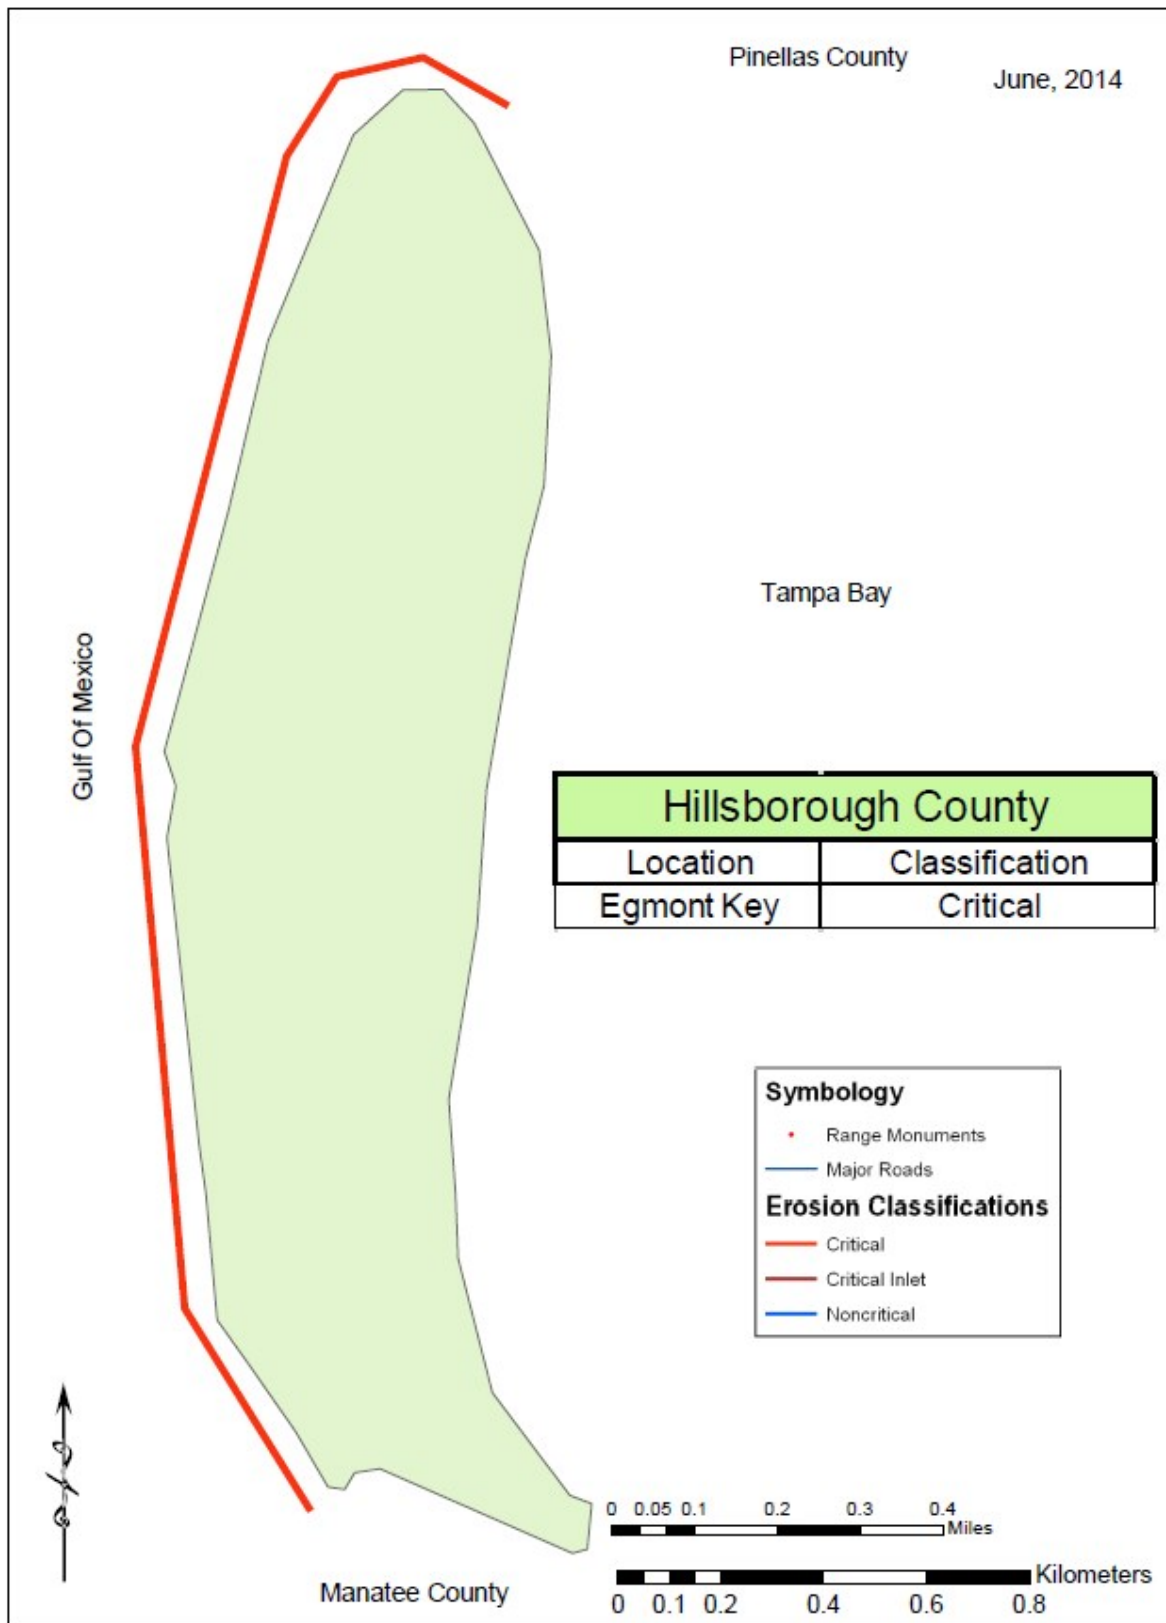
Hillsborough County has one coastal island, Egmont Key, at the entrance to Tampa Bay. Most of the length of Egmont Key (1.6 miles) is critically eroded threatening recreational interests and important cultural resources. A St. Petersburg harbor maintenance dredging project in December, 2000, provided the material for nourishment of the north end of Egmont Key for the protection of three Spanish-American War era batteries. Another nourishment project using Egmont Channel maintenance dredging material was conducted in 2007.

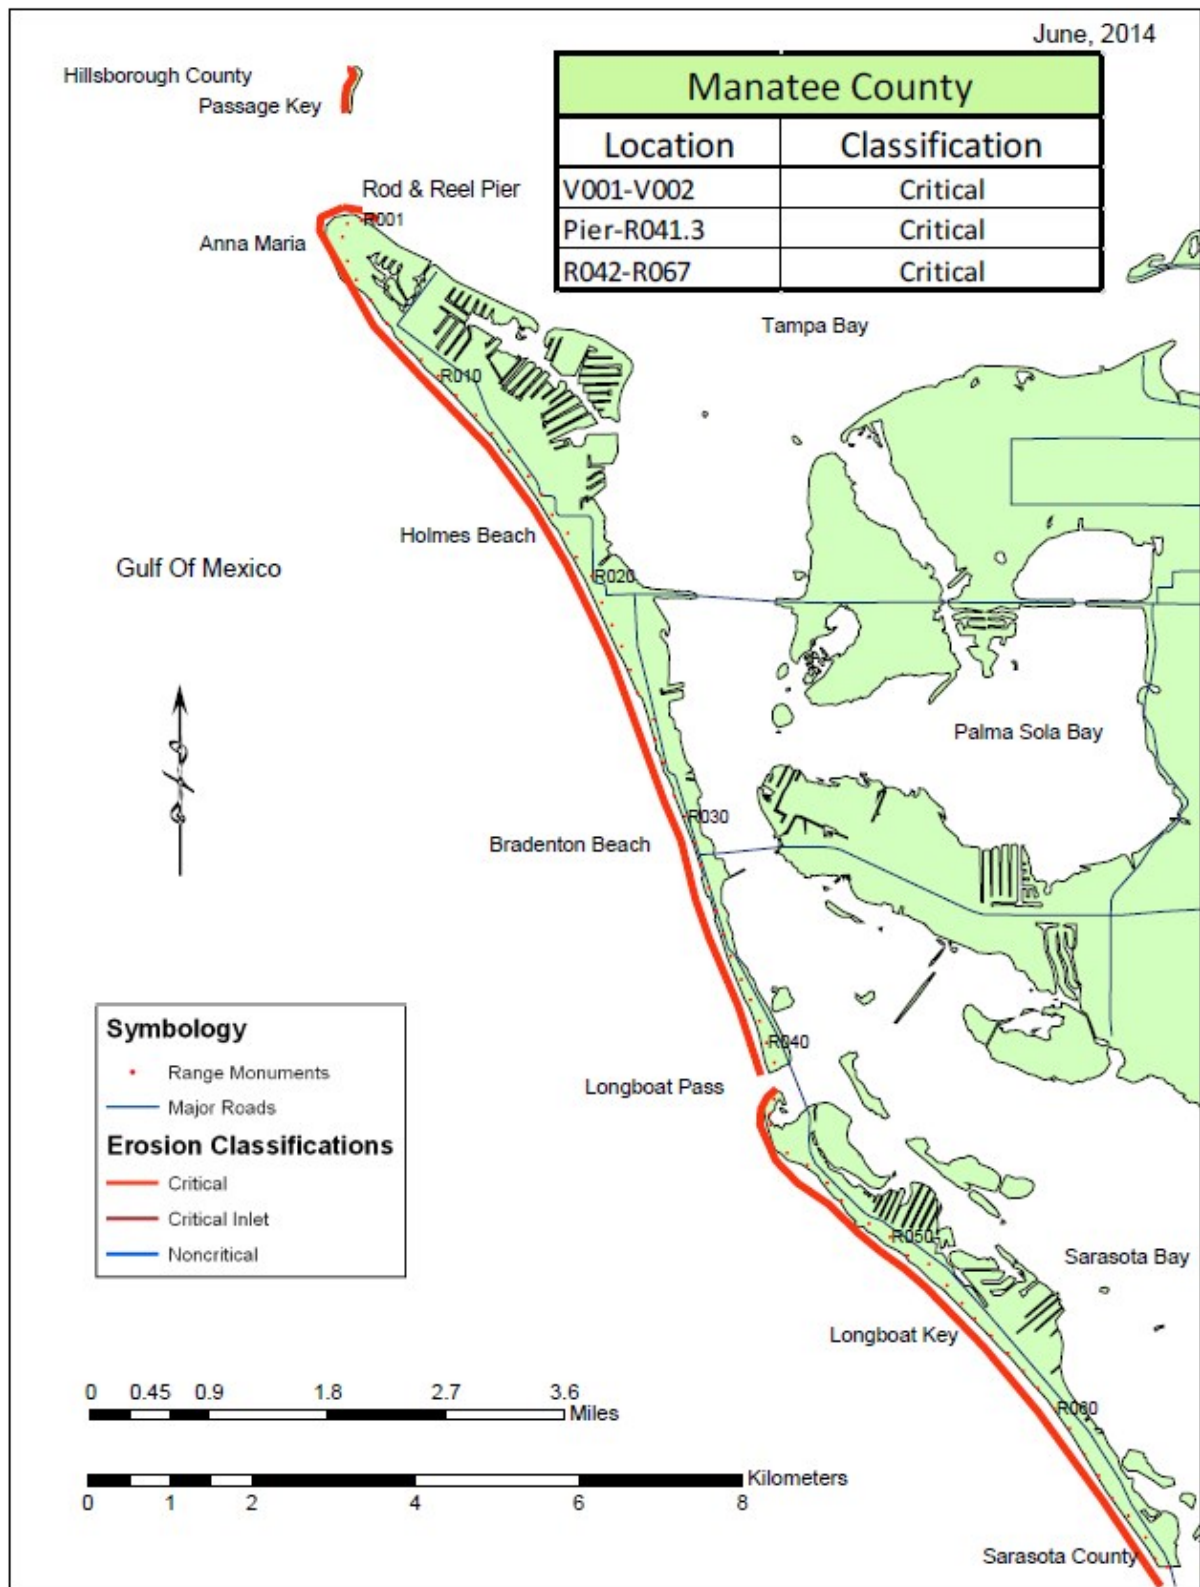
All of Manatee County is critically eroded (13.0 miles). Passage Key (0.3 mile) is a national wildlife refuge, which has been reduced to an intertidal shoal due to erosion that has threatened a major sea bird rookery. The full length of Anna Maria Island between the Rod and Reel Pier and Longboat Pass (R41.3) has 7.9 miles of critically eroded beach that has threatened development and recreational interests. This barrier island has a federal beach restoration project, and numerous bulkheads and revetments exist along the road and in front of private development. A groin field and terminal groin exist at the island's south end.

Between Longboat Pass and Sarasota County, the northern half of Longboat Key (R42-R67.3) has 4.8 miles of critically eroded beach that has threatened development and recreational interests. This barrier island has a beach restoration project, and numerous concrete bulkheads exist along the north end fronting the private development.

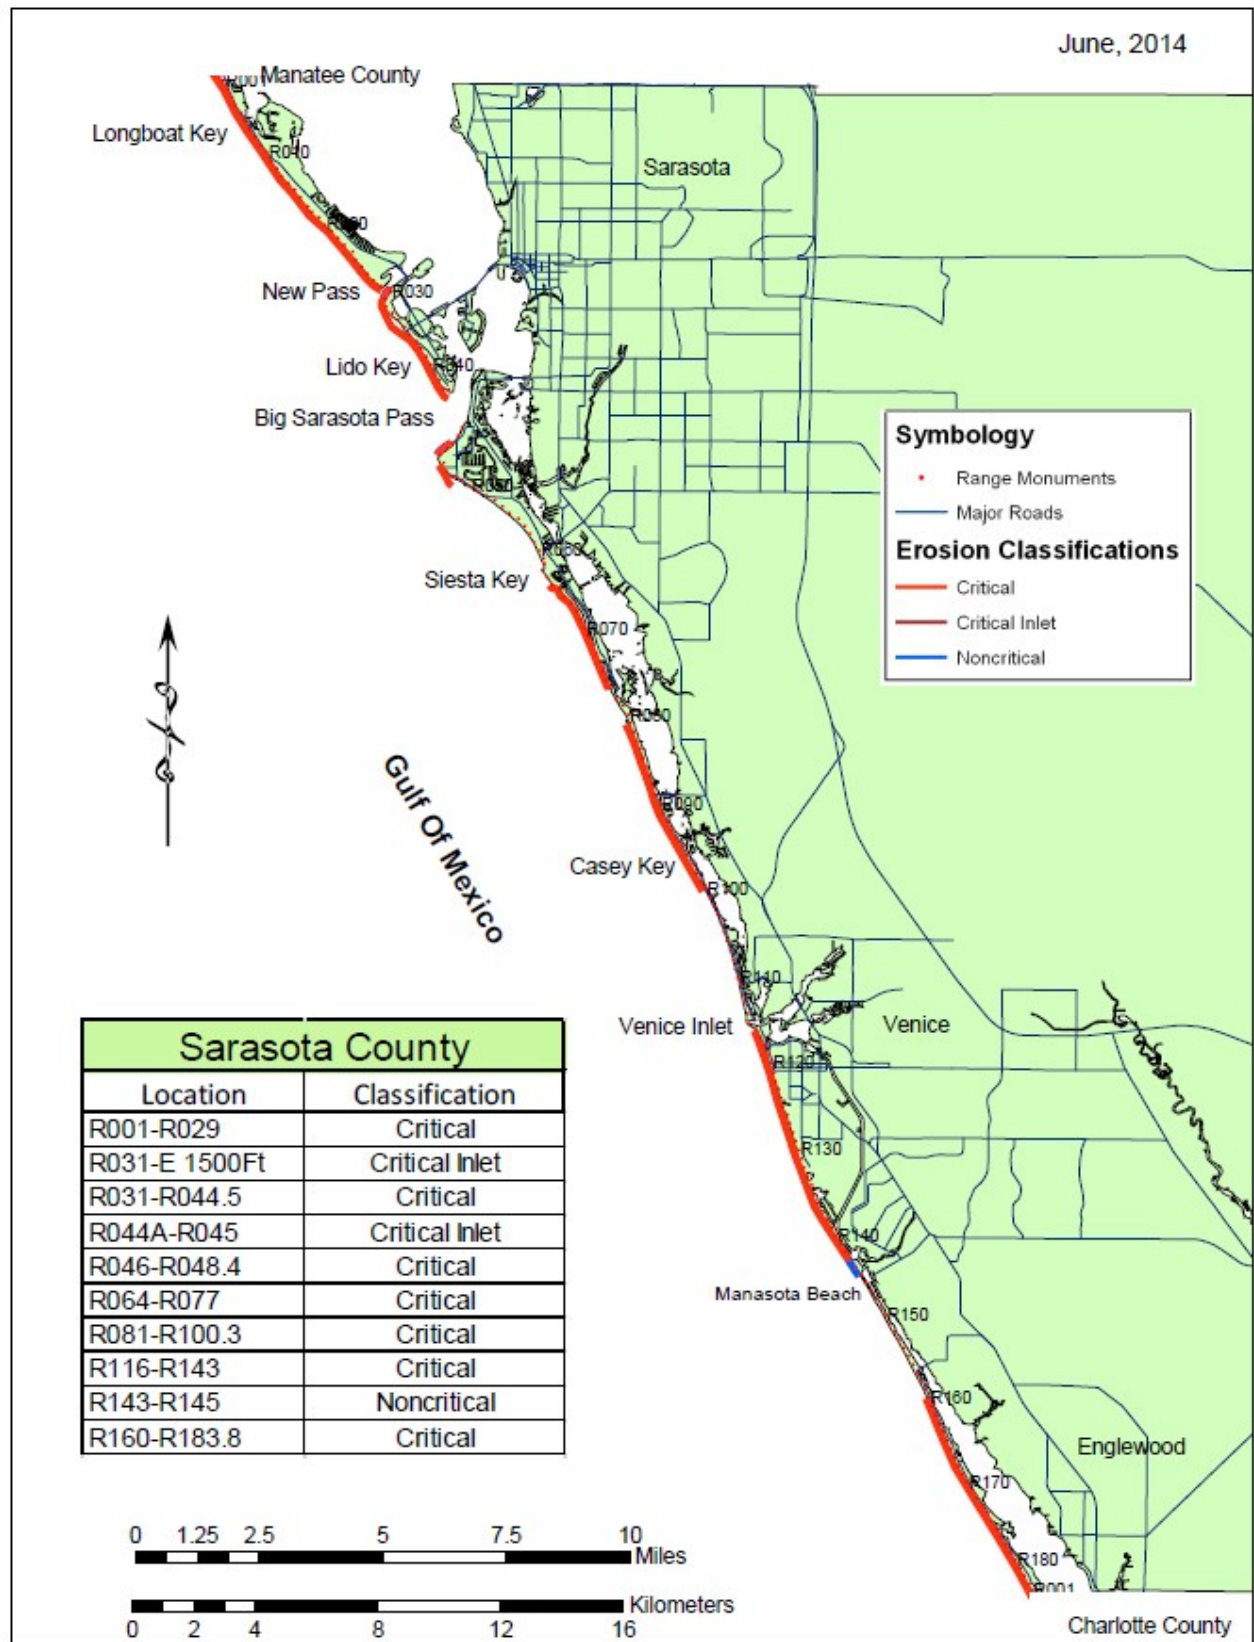
There are seven designated critically eroded beach areas (23.9 miles), one non-critically eroded beach area (0.4 mile), and two critically eroded inlet shoreline areas (1.1 miles) in Sarasota County.

The south end of Sarasota County (R160-R183.7) is critically eroded for 4.5 miles along Manasota Key threatening private development as well as Manasota Key Road. Some rock revetments have been constructed in this area.

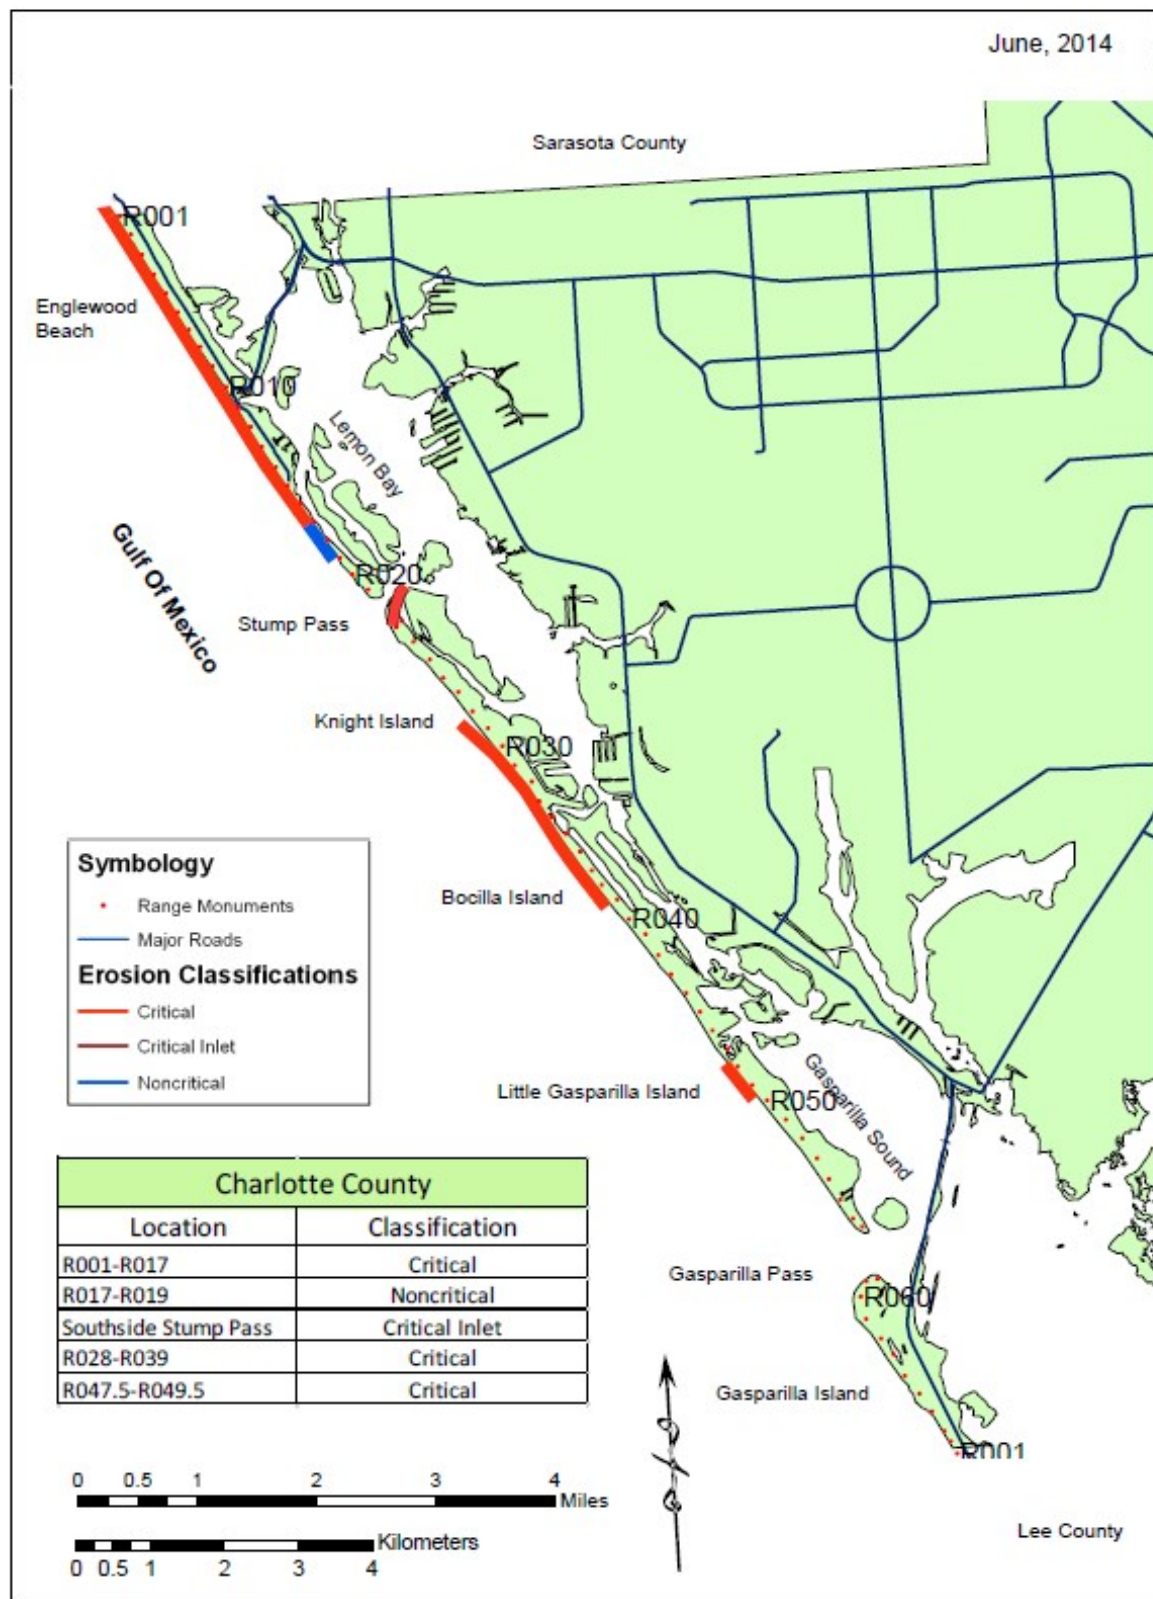
There are three critically eroded areas (5.2 miles), one non-critically eroded area (0.4 mile), and one critically eroded inlet shoreline (0.1 mile) in Charlotte County.

South of Little Gasparilla Pass, which is closed, is a 0.4-mile segment of critically eroded beach on Little Gasparilla Island. This erosion threatens private development.

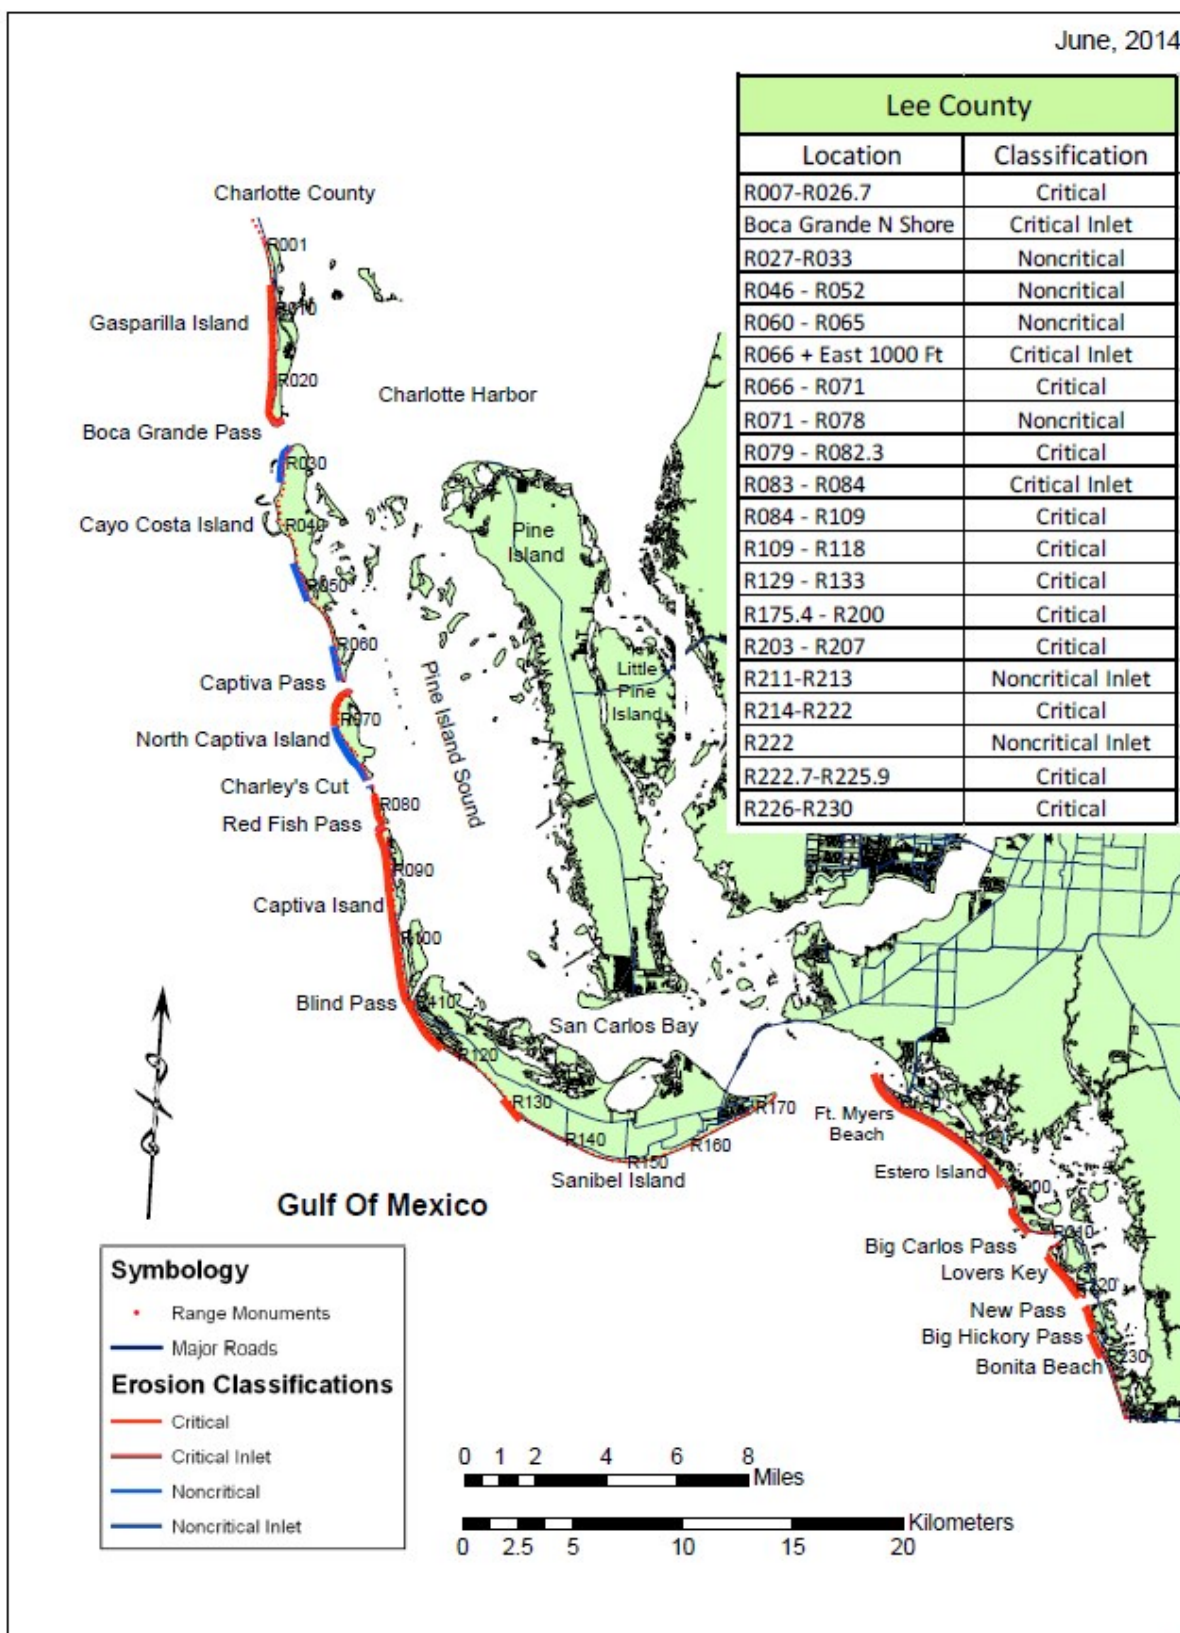
There are eleven critically eroded beach areas (22.4 miles), four non-critically eroded beach areas (5.3 miles), three critically eroded inlet shoreline areas (0.6 mile), and two non-critically eroded inlet shoreline areas (0.4 mile) in Lee County.

Between New Pass and Big Hickory Pass, Big Hickory Island (R222.7-R225.9) has 0.8 mile that is critically eroded where wildlife habitat and recreation has been lost. South of Big Hickory Pass, Little Hickory Island (R226-R230) has 0.9 mile of critically eroded beach threatening development interests in Bonita Beach. This area has a beach restoration project with bulkheads and two terminal groins at the north end.

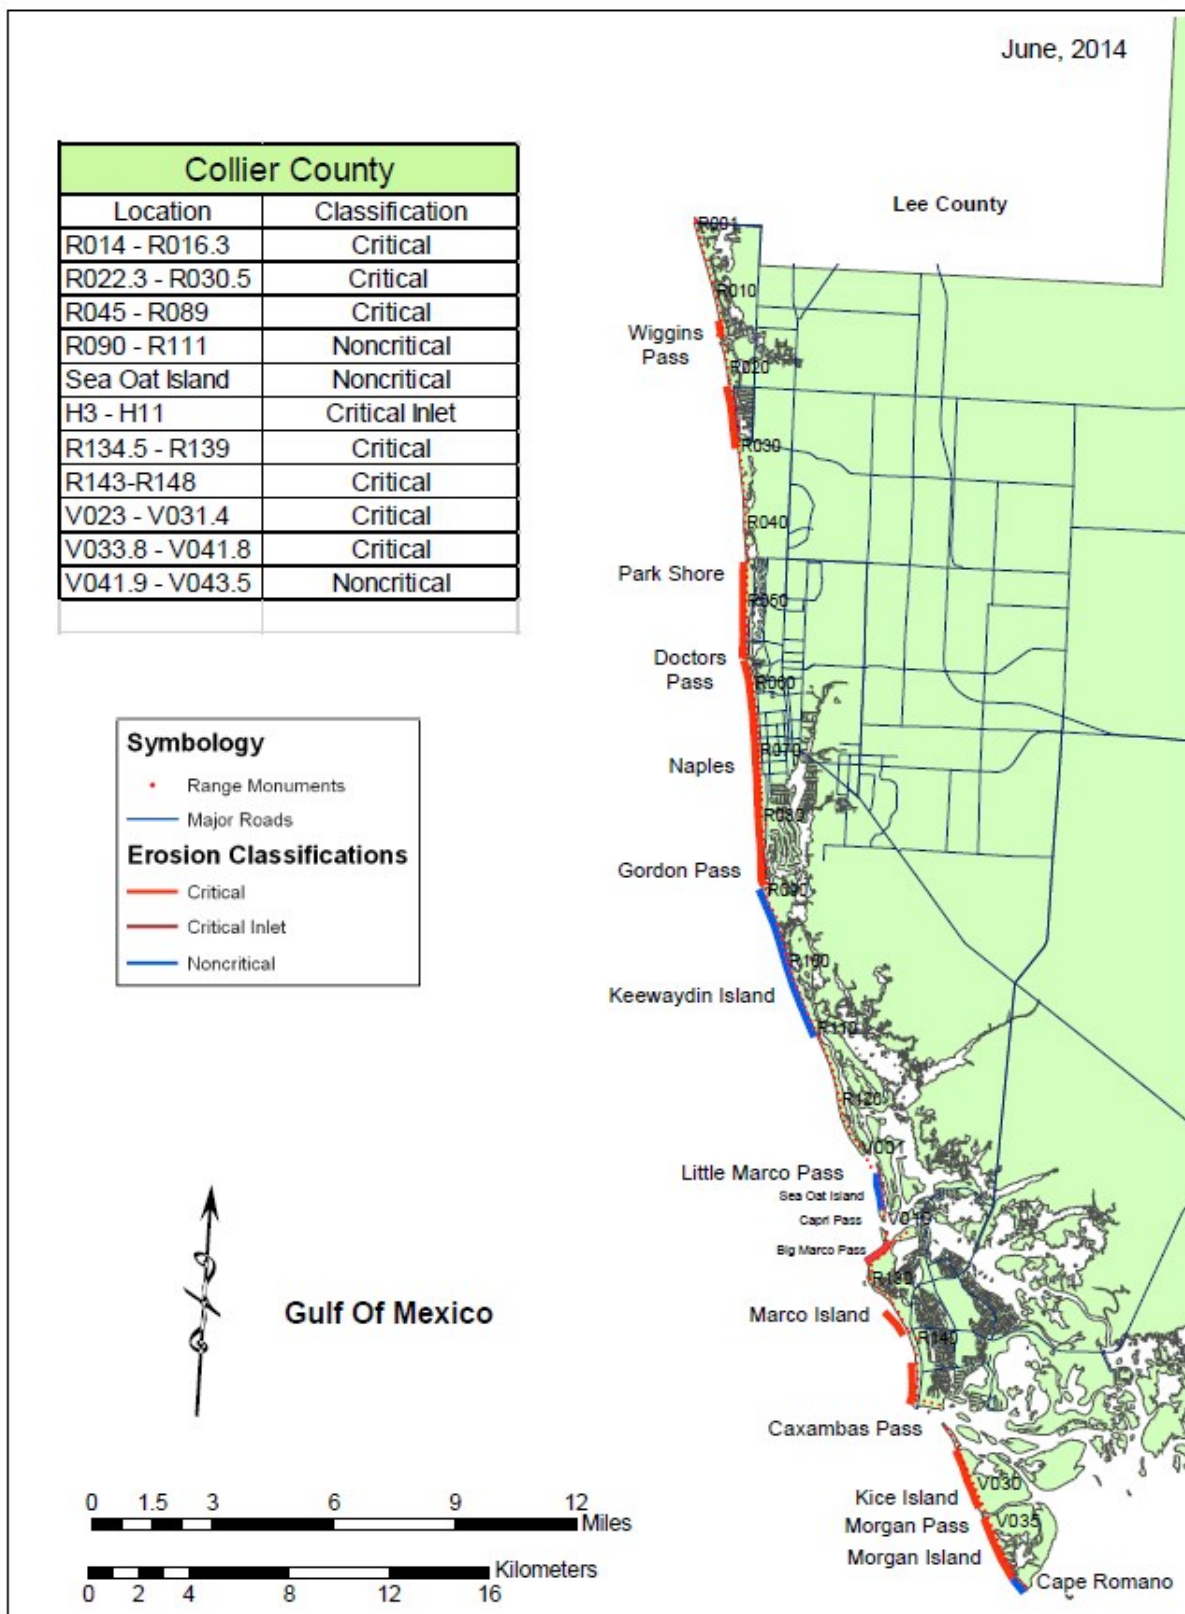
There are eight critically eroded beach areas (14.8 miles), three non-critically eroded beach areas (5.1 miles), and one critically eroded inlet shoreline area (0.8 mile) in Collier County.
