# ***Critically Eroded Beaches In Florida***

**Division of Water Resource Management  
Florida Department of Environmental Protection  
June 2017**

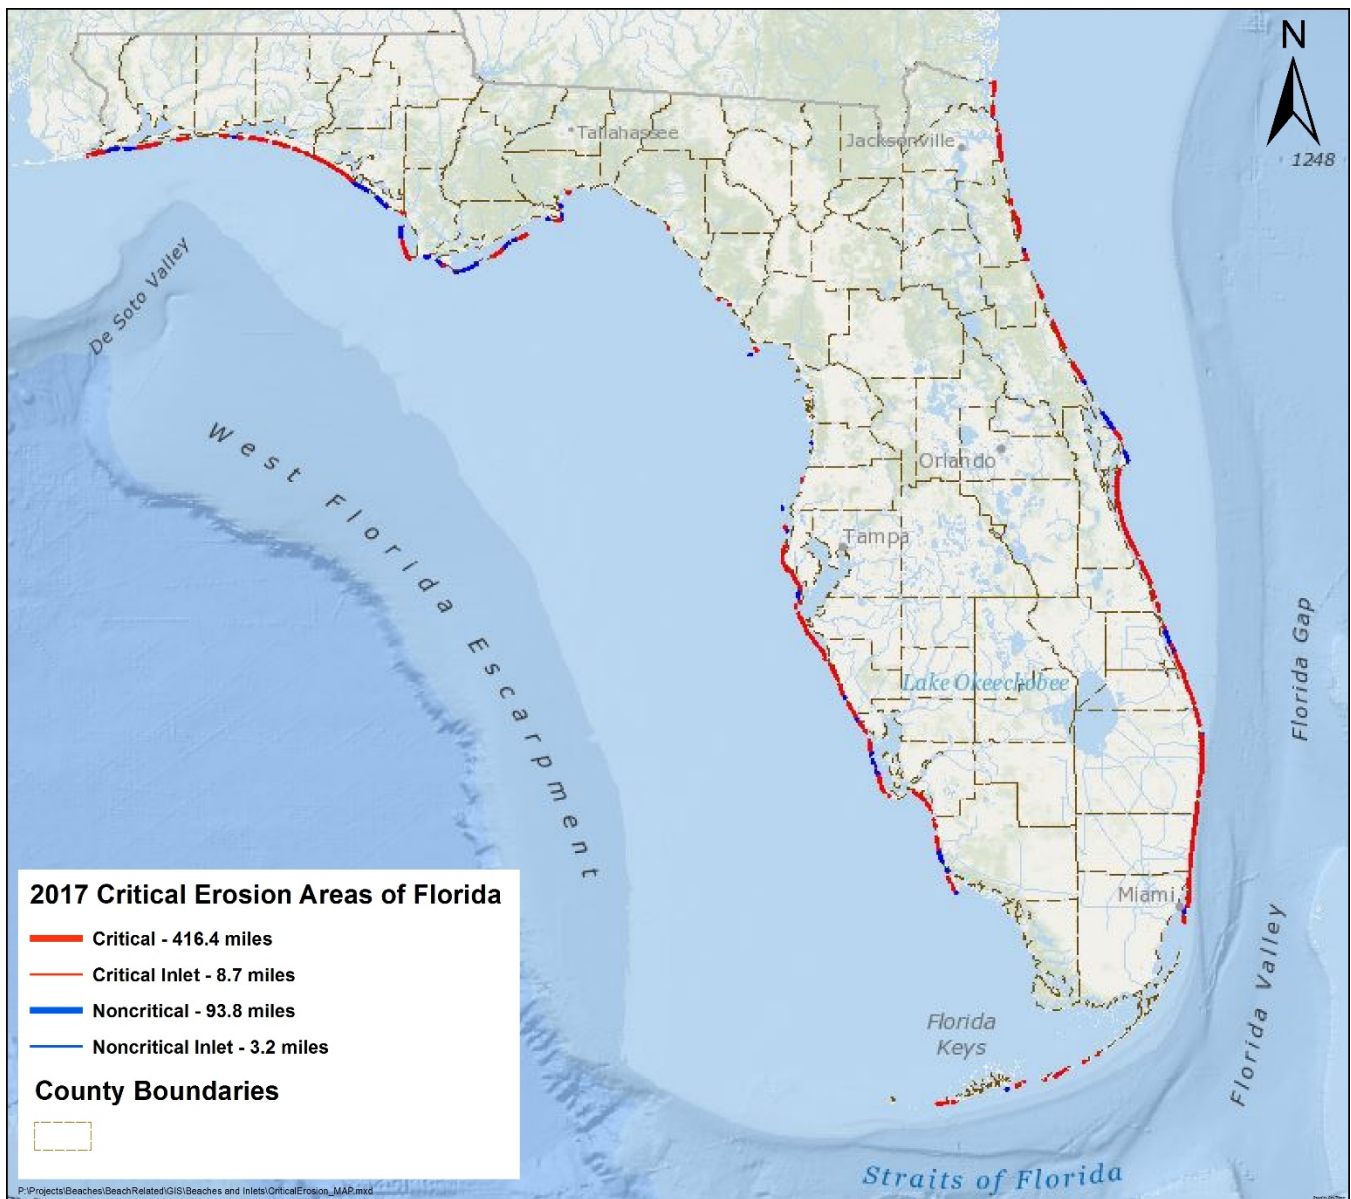
eroded beach, 8.7 miles of critically eroded inlet shoreline, 93.8 miles of non-critically eroded beach, and 3.2 miles of non-critically eroded inlet shoreline statewide, as shown in *Figure 1*.

Figure 1. Statewide areas of critically and non-critically eroded shoreline [Graphic from [ROSSI](#) database]. View an [interactive map](#) with aerial imagery showing R monuments and the critical erosion areas.

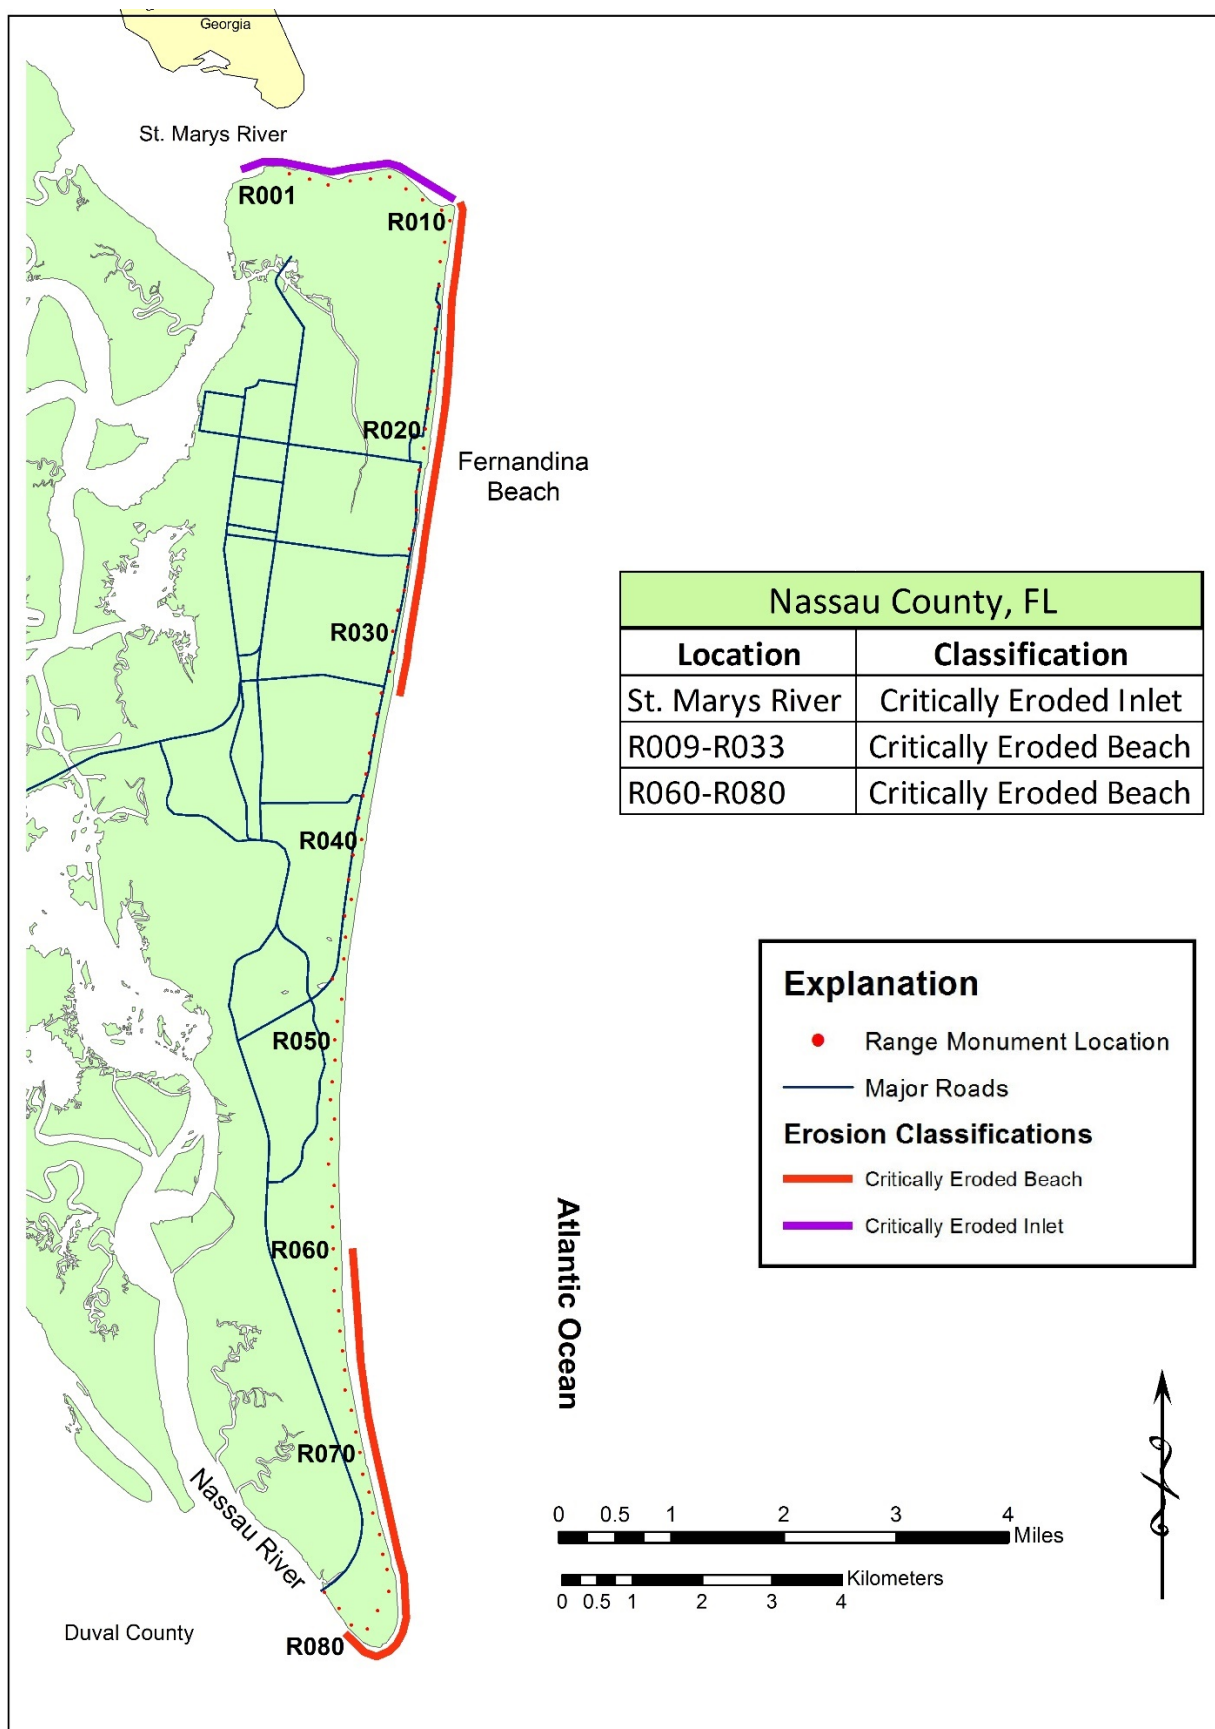
The southern 3.3 miles of Atlantic Ocean fronting beaches of Amelia Island (R60-R80) are critically eroded threatening development and recreational interests. A beach restoration project has been constructed along much of this area. A terminal groin has been constructed at R80 and a nearshore breakwater has been constructed south of R75.

Figure 2. Critically eroded shoreline within Nassau County.

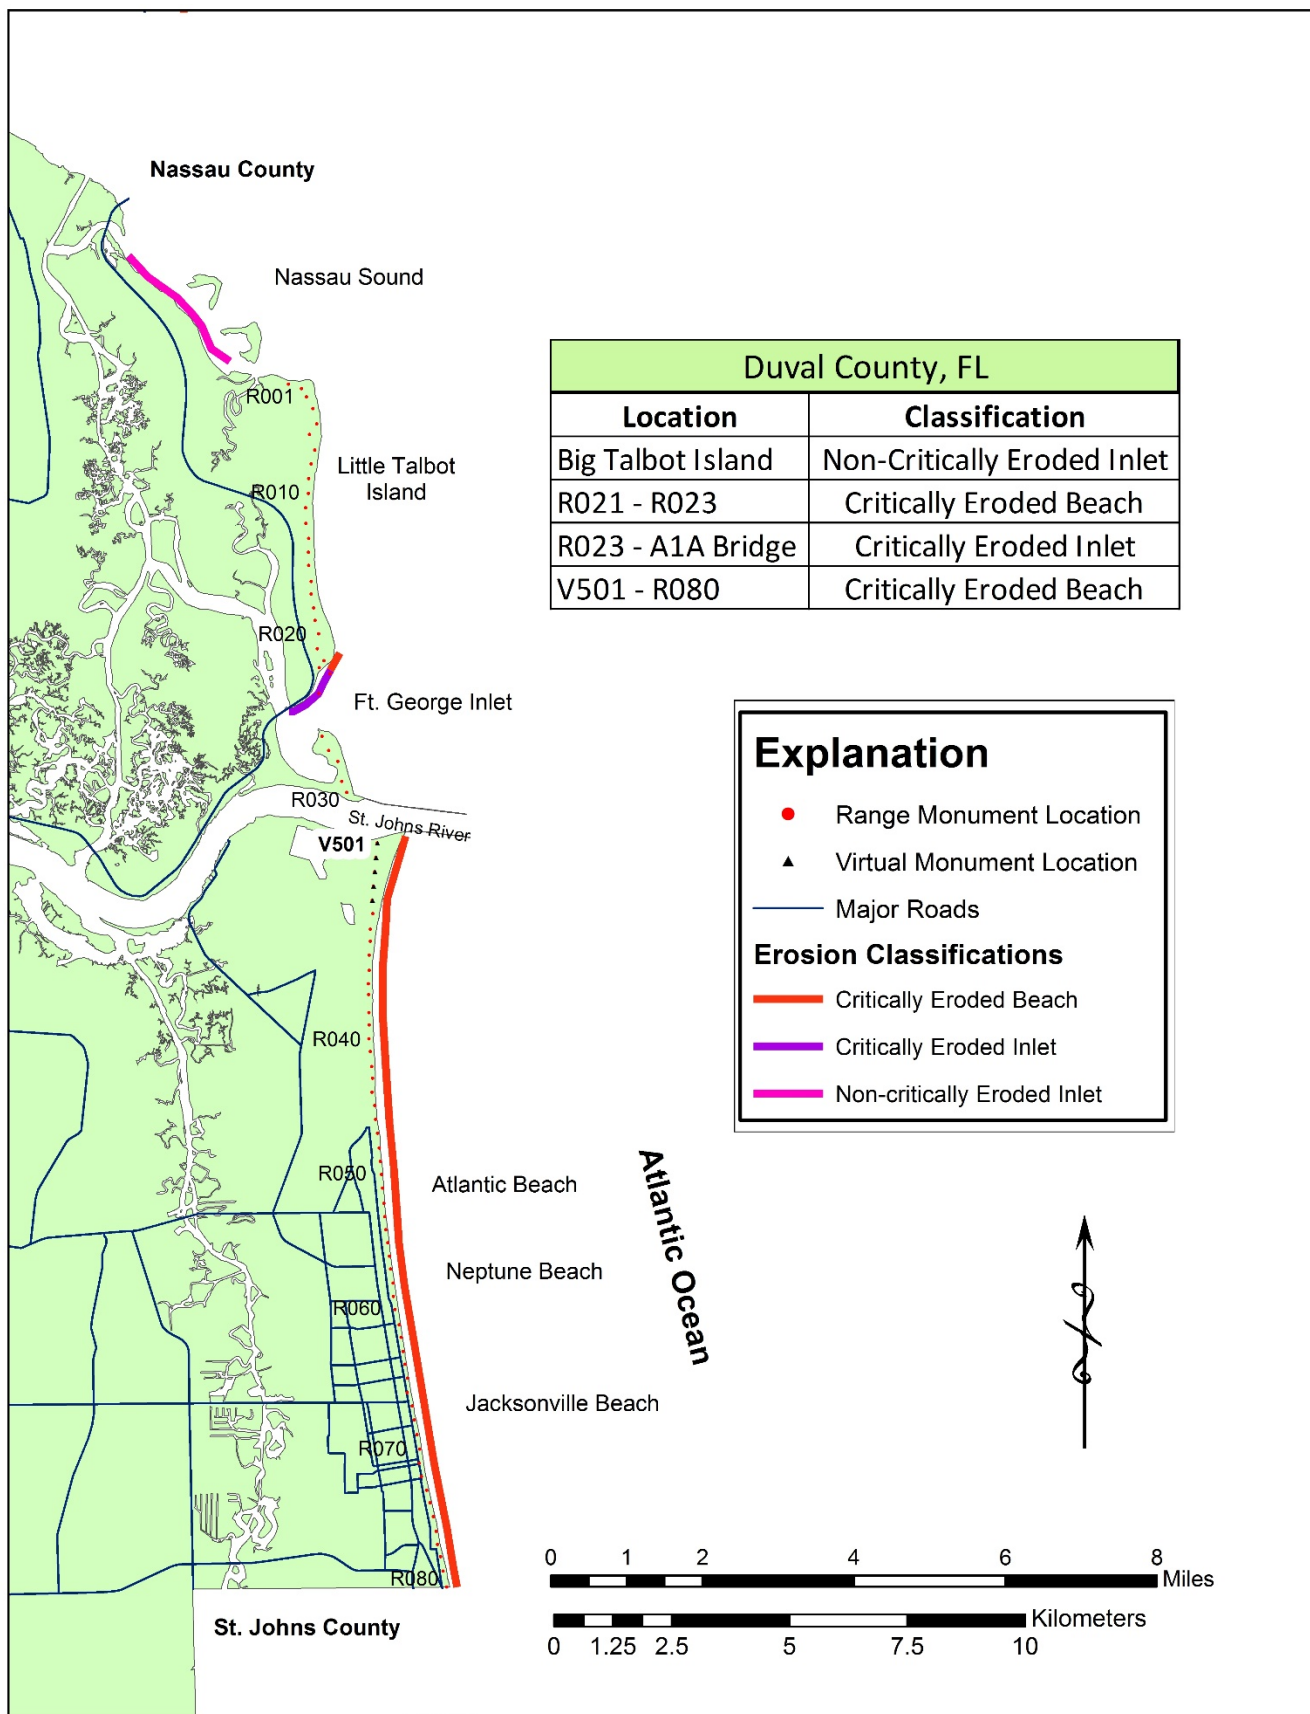
The southern 10.1 miles of Atlantic Ocean fronting beaches in Duval County (V501-R80) are designated as critically eroded due to past threats to development and recreational interests. This area is part of a beach restoration project, which is continually maintained.

Figure 3. Critically eroded shoreline within Duval County.

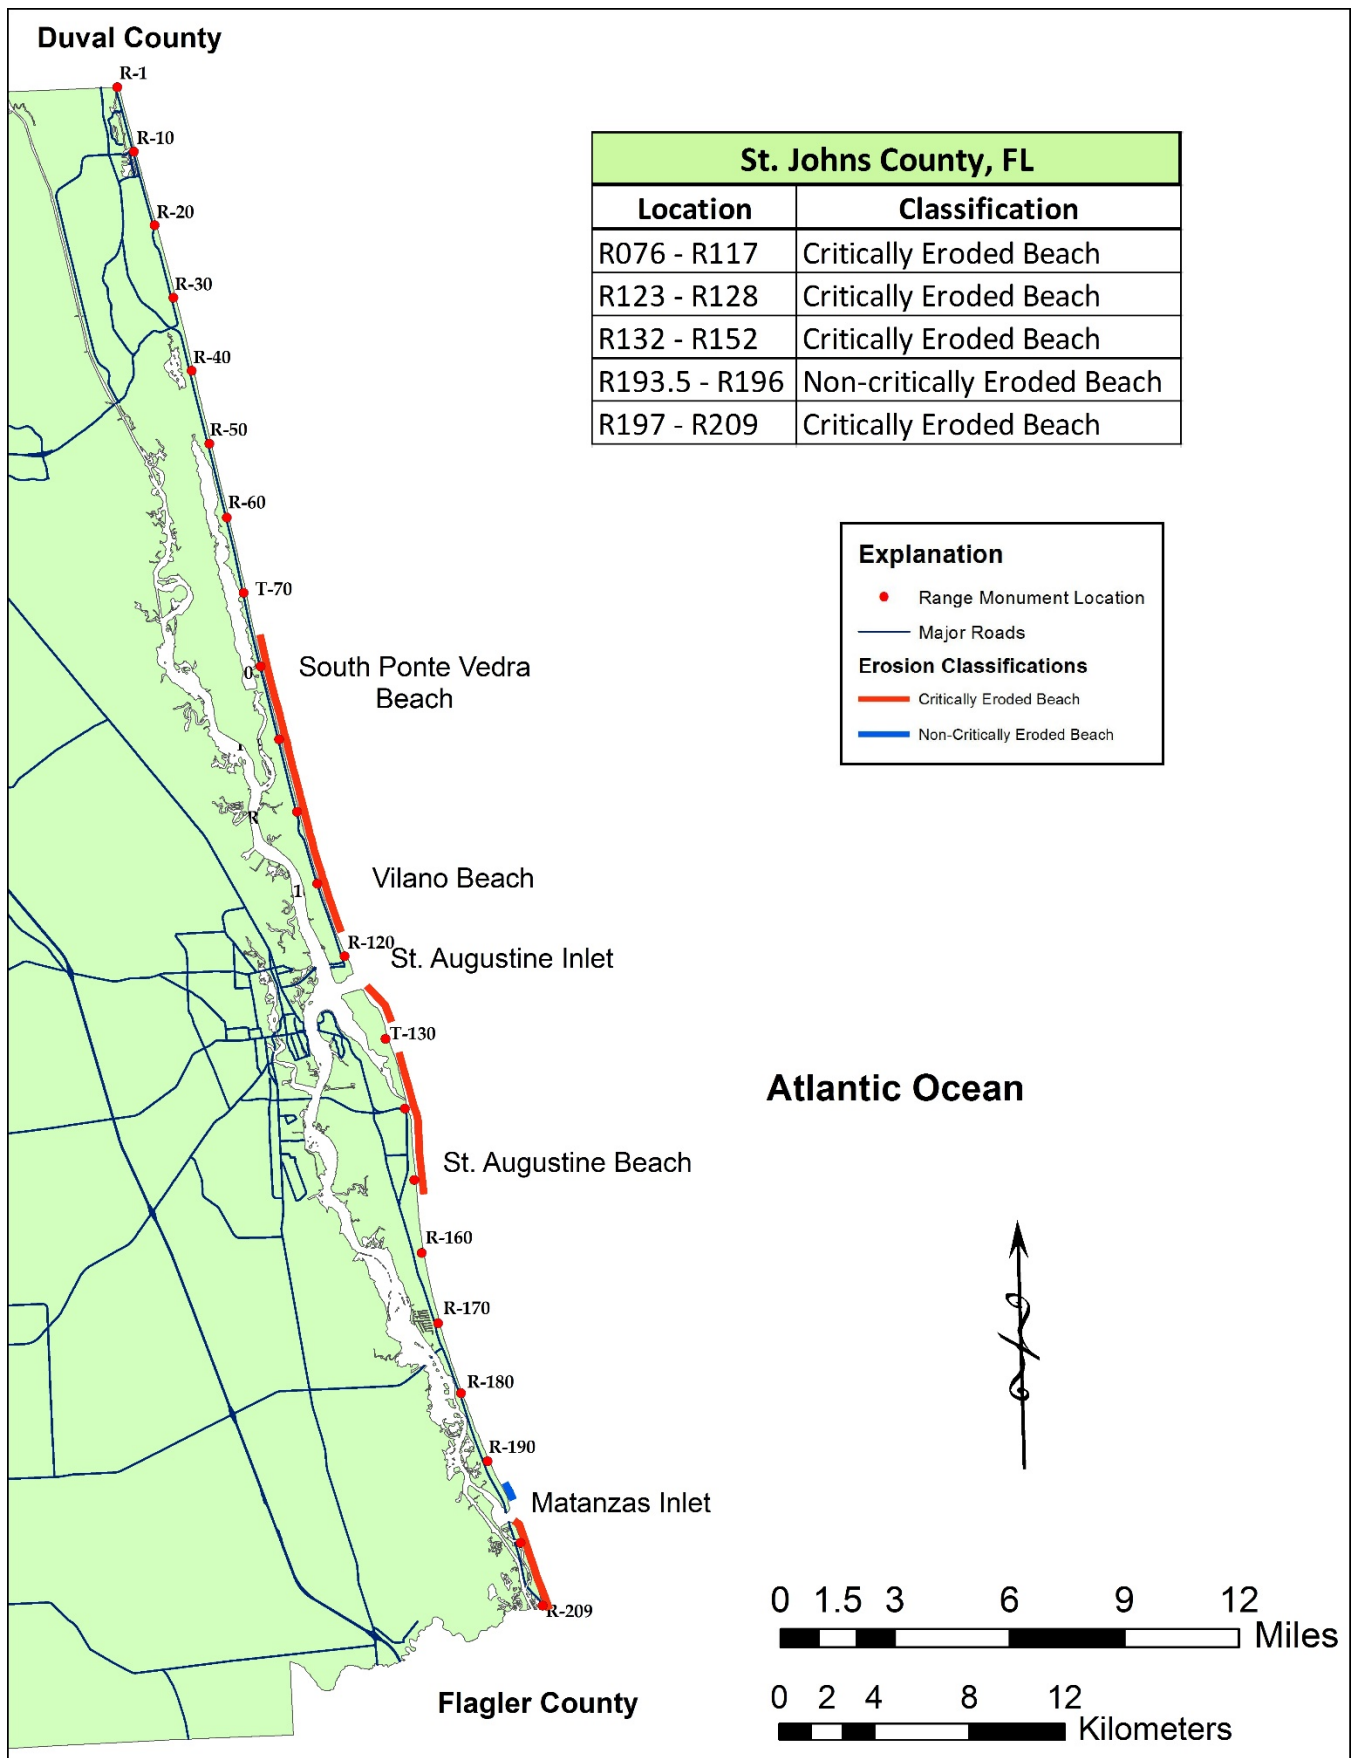
The southern 2.4 miles of St. Johns County beaches (R197-R209) are critically eroded between Matanzas Inlet and the Flagler County line. The northern portion threatens State Road AIA and private development. Although the State Road AIA roadbed has been abandoned along the southern segment, wildlife habitat within the Matanzas River lagoon is being threatened. This area has been nourished from Atlantic Intracoastal Waterway dredge disposal.

Figure 4. Critically eroded shoreline within St. Johns County.

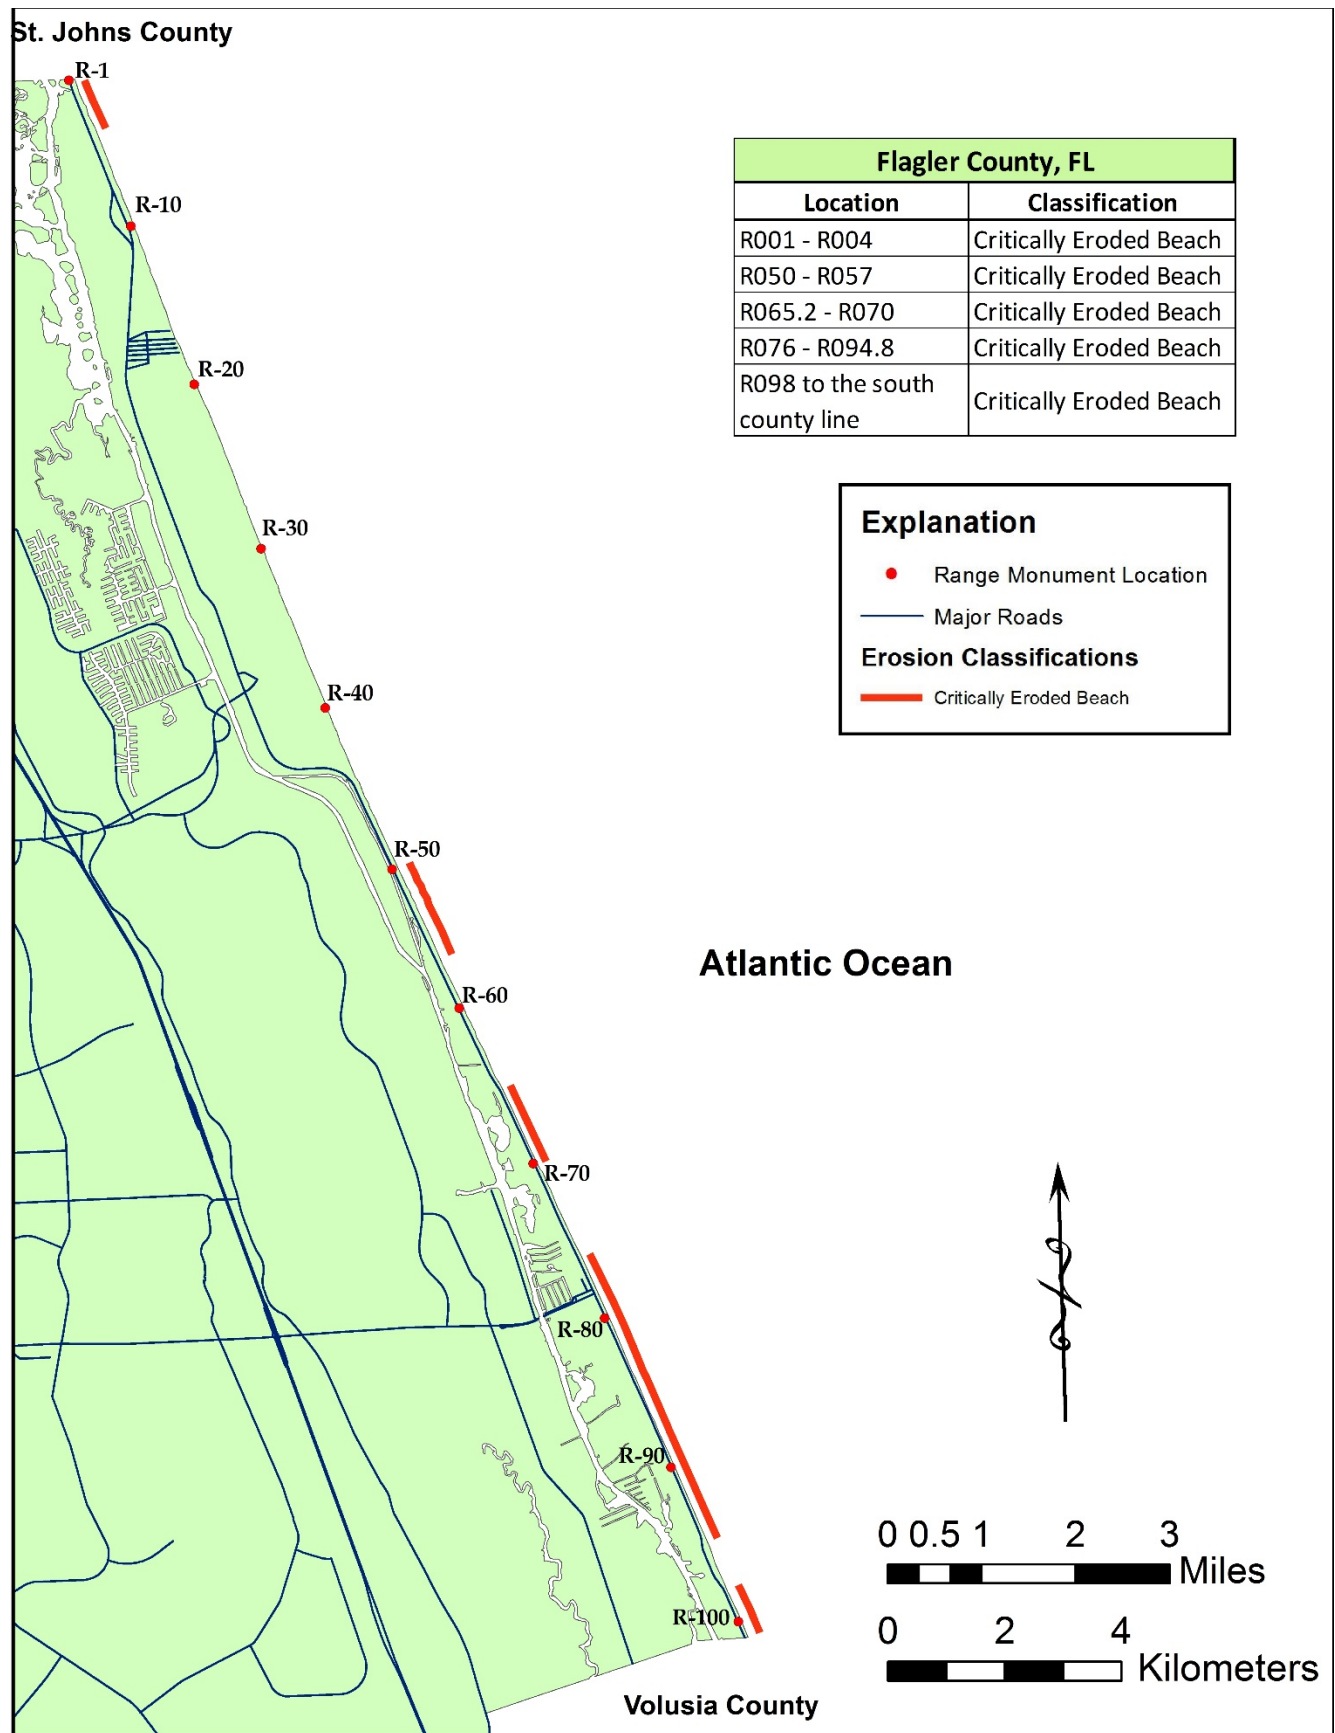
Erosion at the northern 0.6 mile of beach (R1-R4) is threatening development and recreational interests at Marineland. This area has a rock revetment and coquina rock groins. Following storm damage by Hurricane Floyd in 1999, the revetment was restored and a new revetment constructed to the south at a more landward alignment with dune restoration.

Following the impact of Hurricane Matthew in 2016, the southernmost 0.6 mile of Flagler Beach is critically eroded threatening State Road A1A between R98 and the south county line.

Figure 5. Critically eroded shoreline within Flagler County.

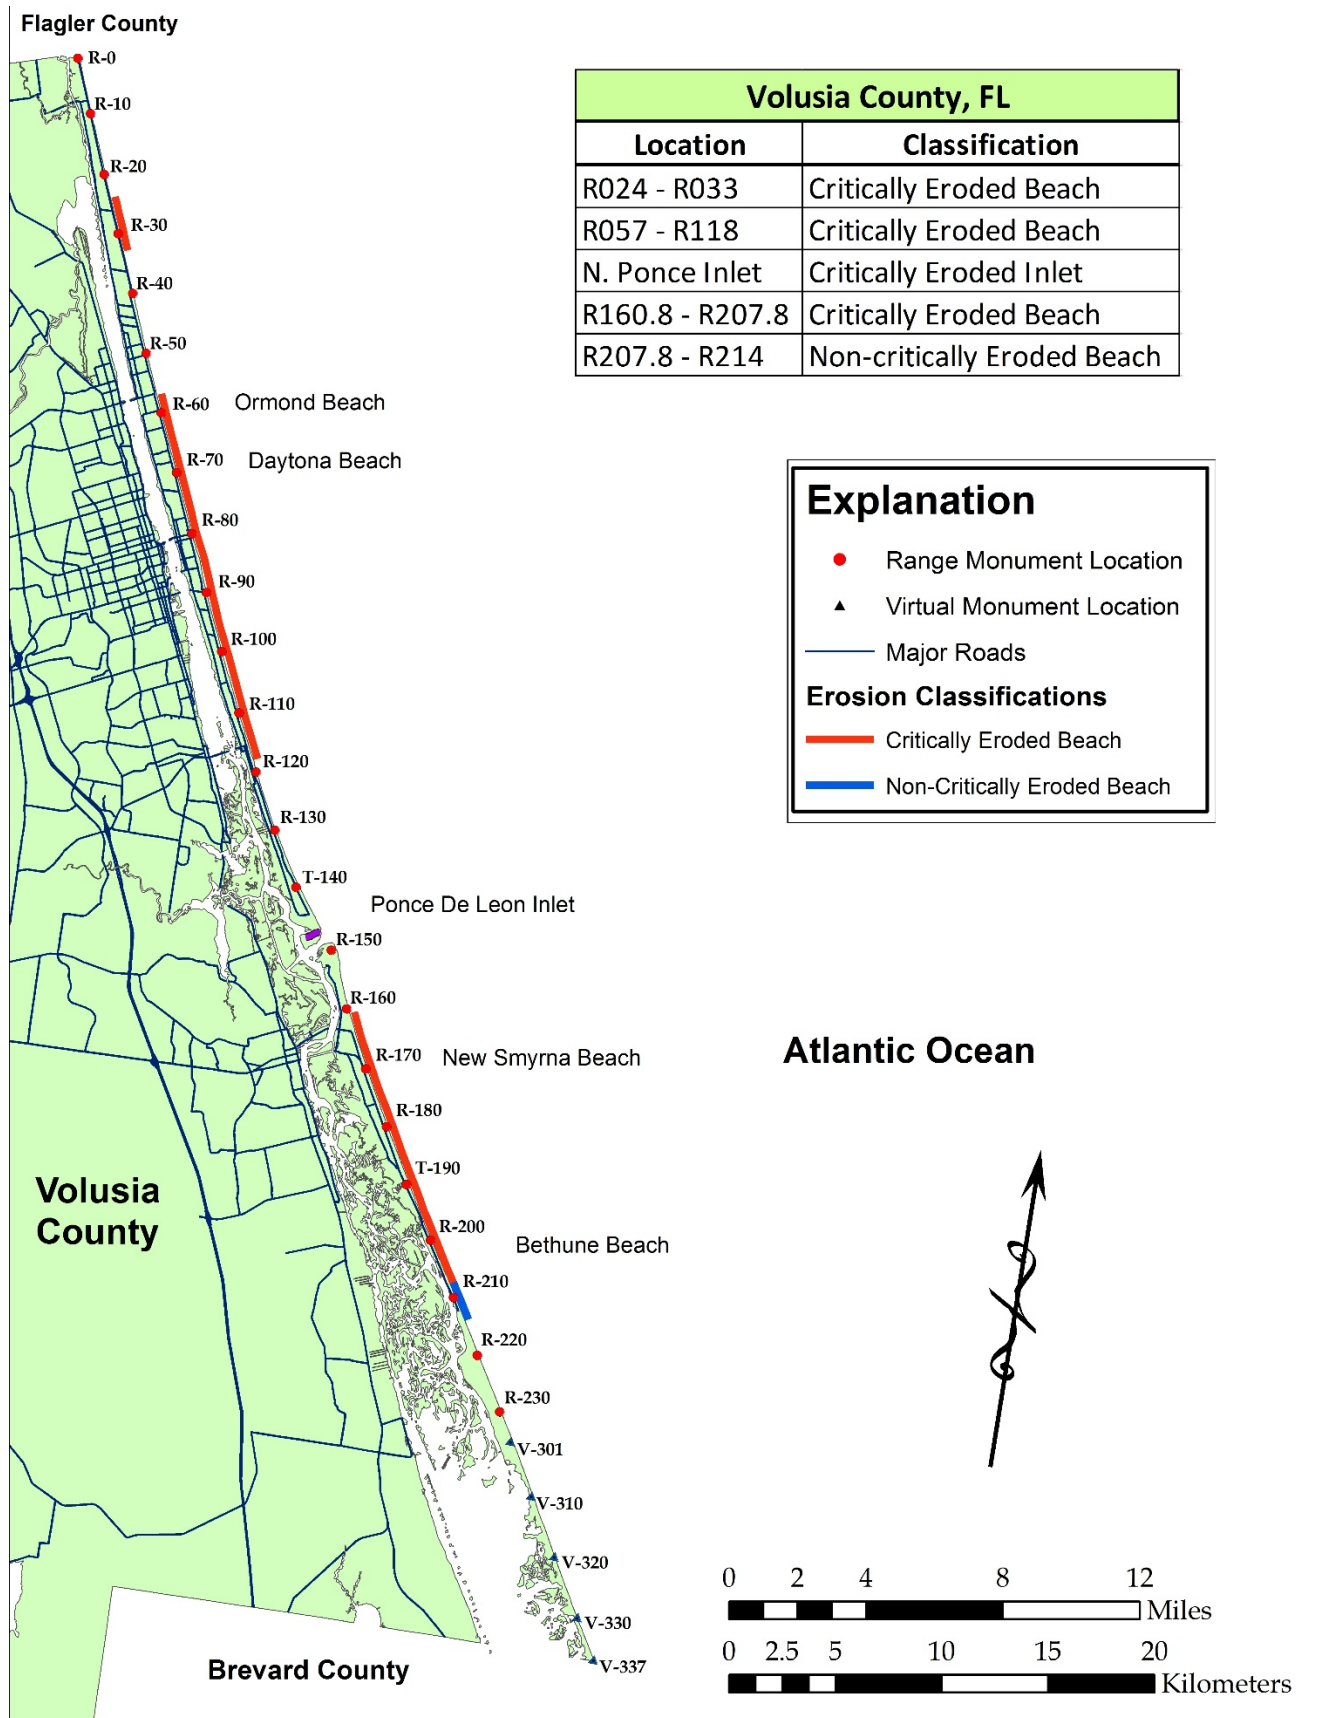
A 1.1-mile segment of the Canaveral National Seashore (R207.8-R214) south of Bethune Beach is also non-critically eroded without any threatened interests at this time.

Figure 6. Critically eroded shoreline within Volusia County.

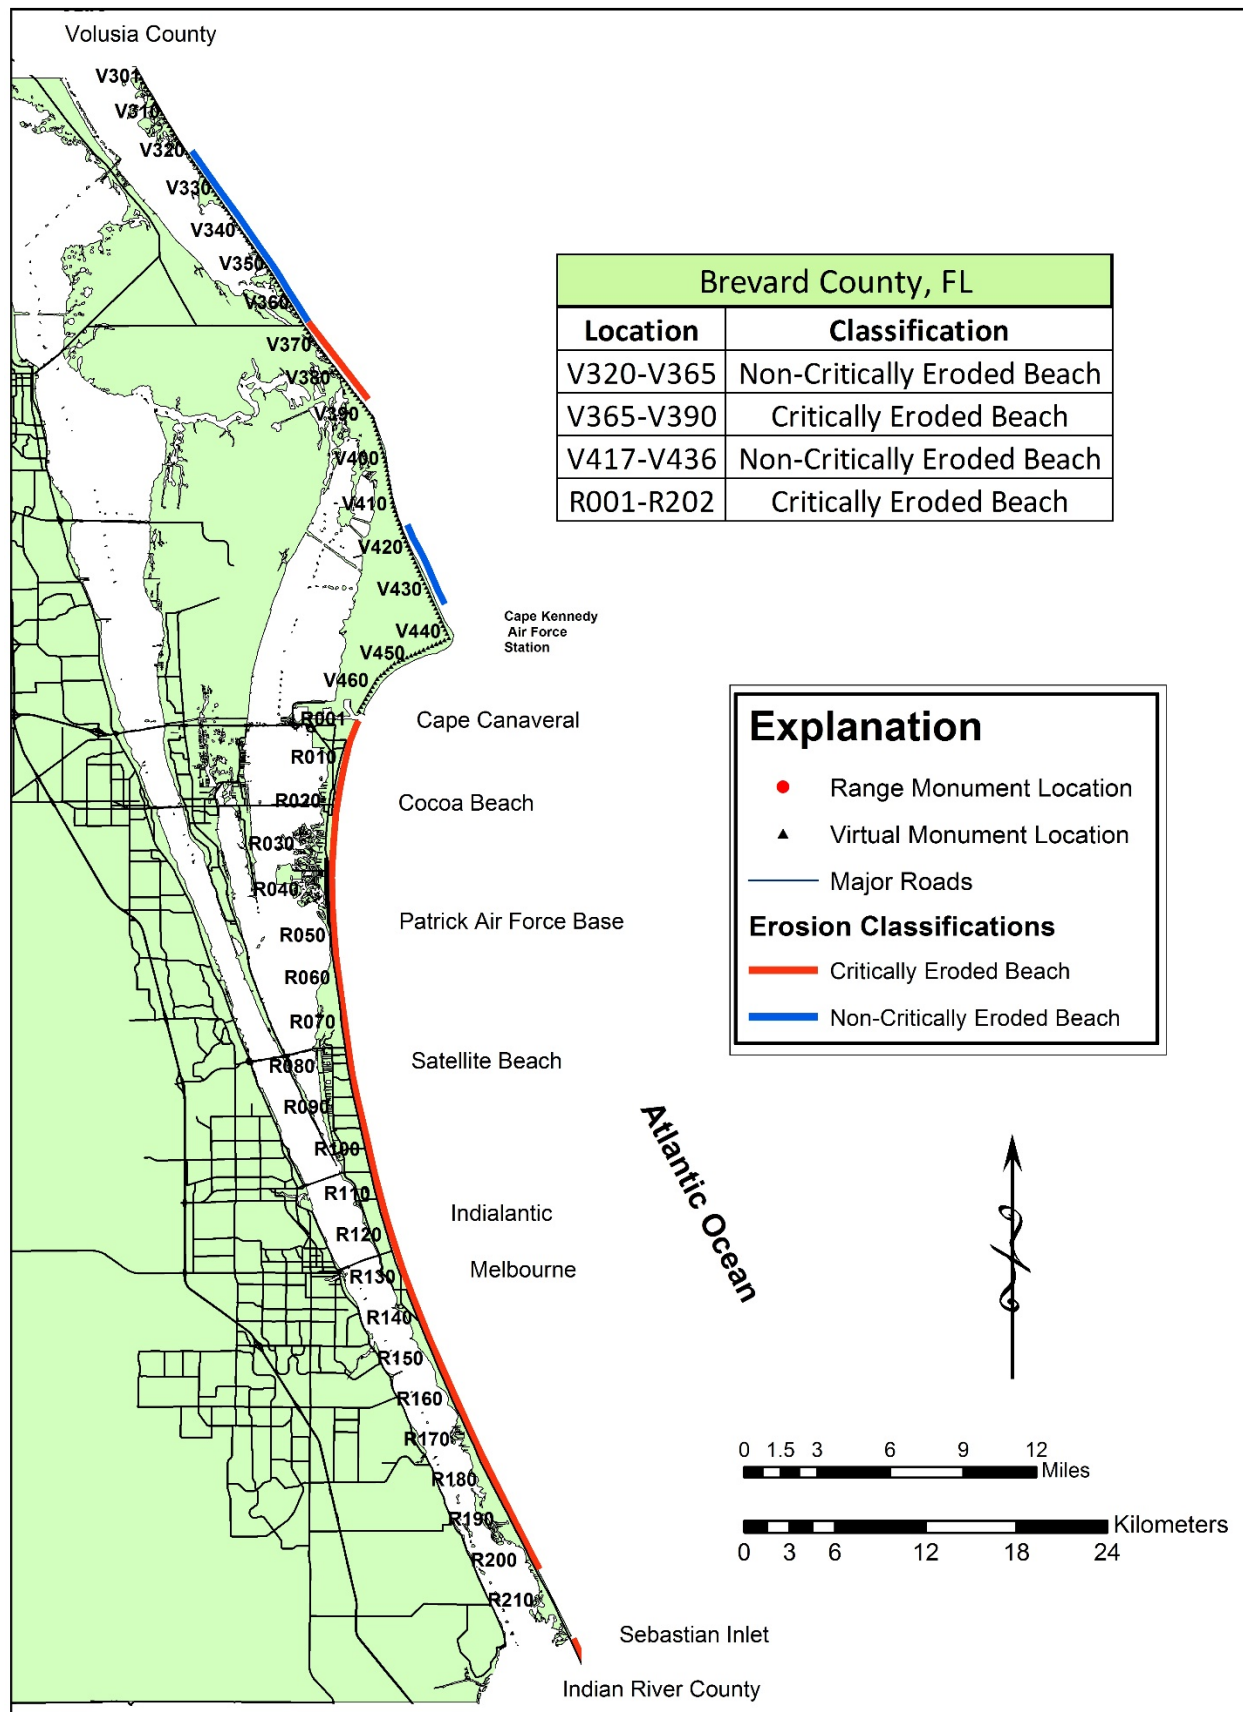
From Canaveral Inlet extending 36.5 miles to the south is a long coastal segment (R1-R202) designated as critically eroded. With the impact of Hurricanes Frances and Jeanne in 2004, the southerly 11.5 miles of this segment became critically eroded. Threatened are development, recreational interests, and wildlife habitat. Beach restoration projects have been conducted in Canaveral, Cocoa Beach, Patrick Air Force Base, Indialantic, and Melbourne Beach.

Figure 7. Critically eroded shoreline within Brevard County.

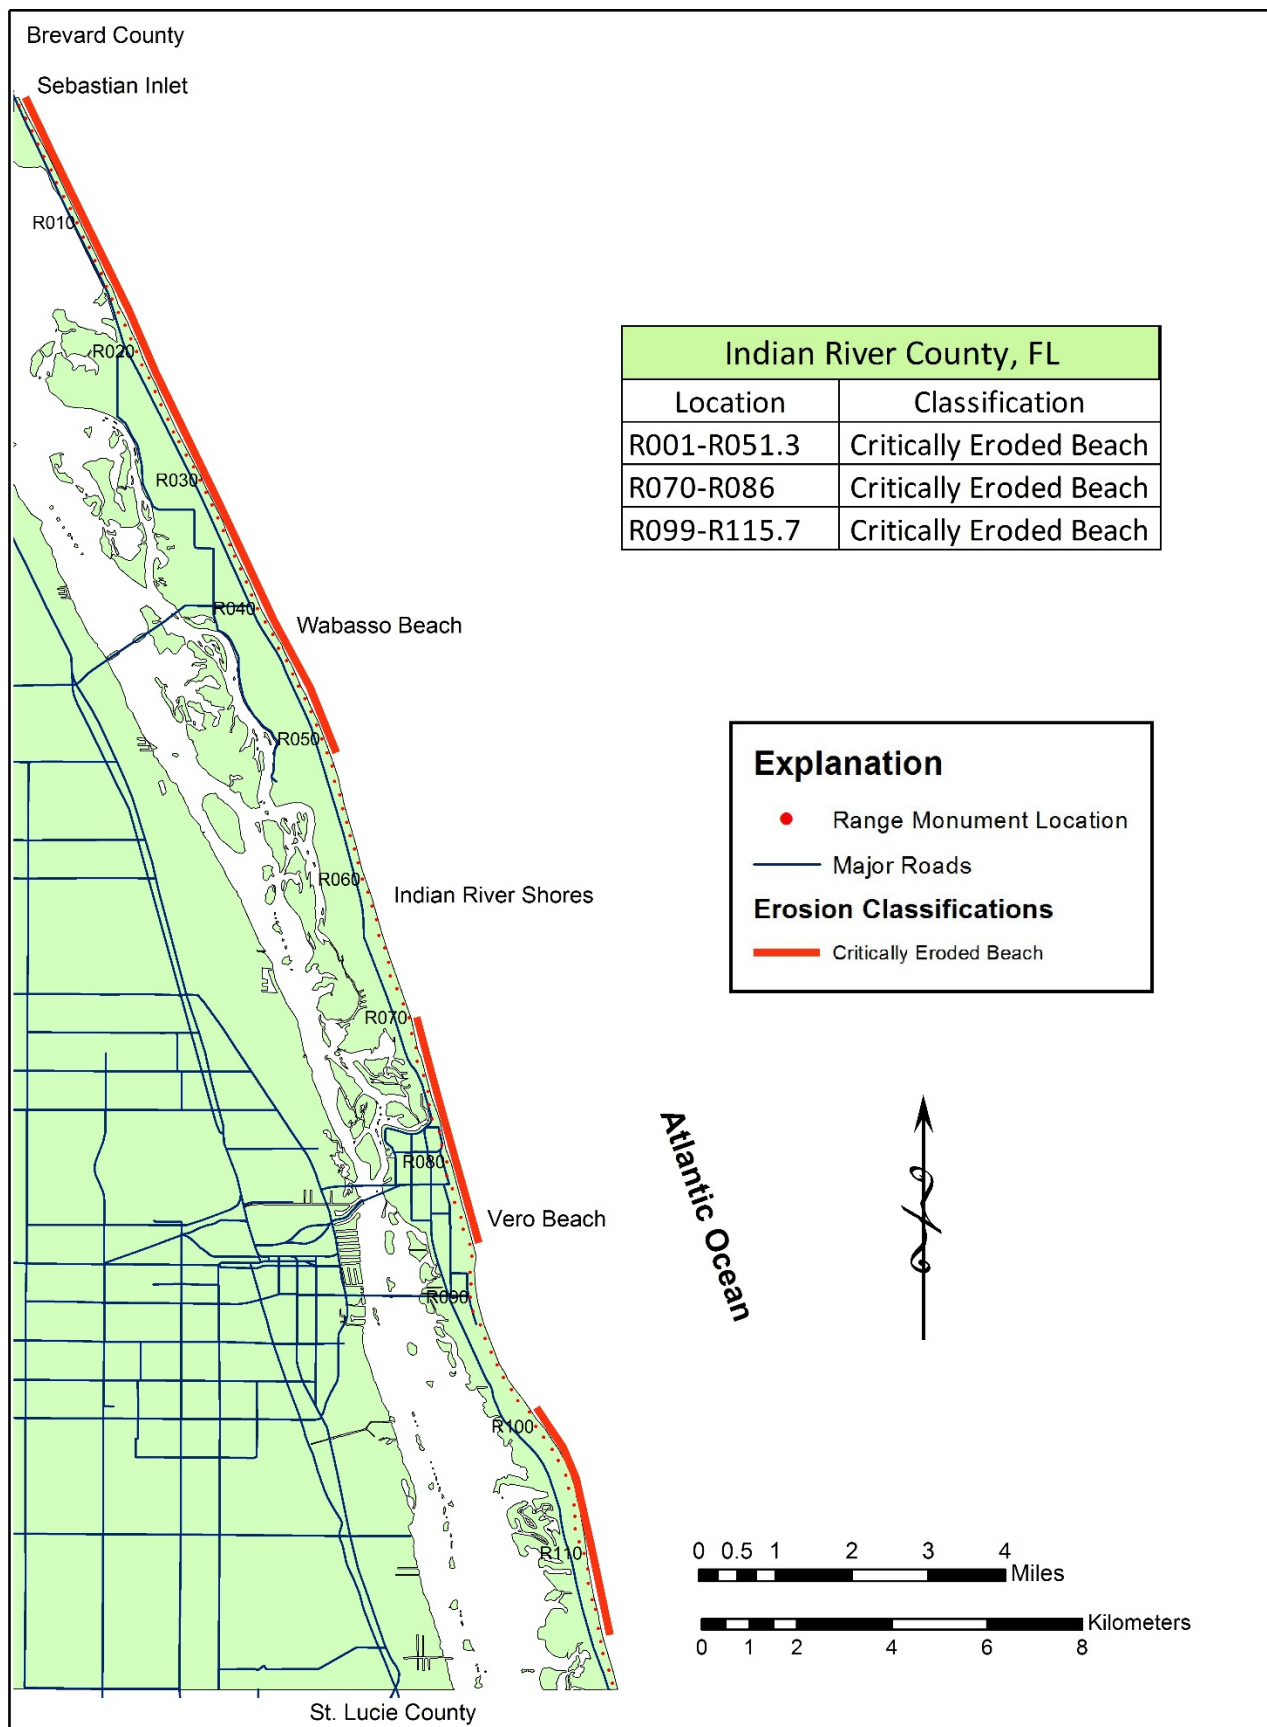
In southern Indian River County, a 3.1-mile segment (R99-R115.7) is critically eroded threatening development interests. A beach restoration project has been constructed along a portion of this area.

Figure 8. Critically eroded shoreline within Indian River County.

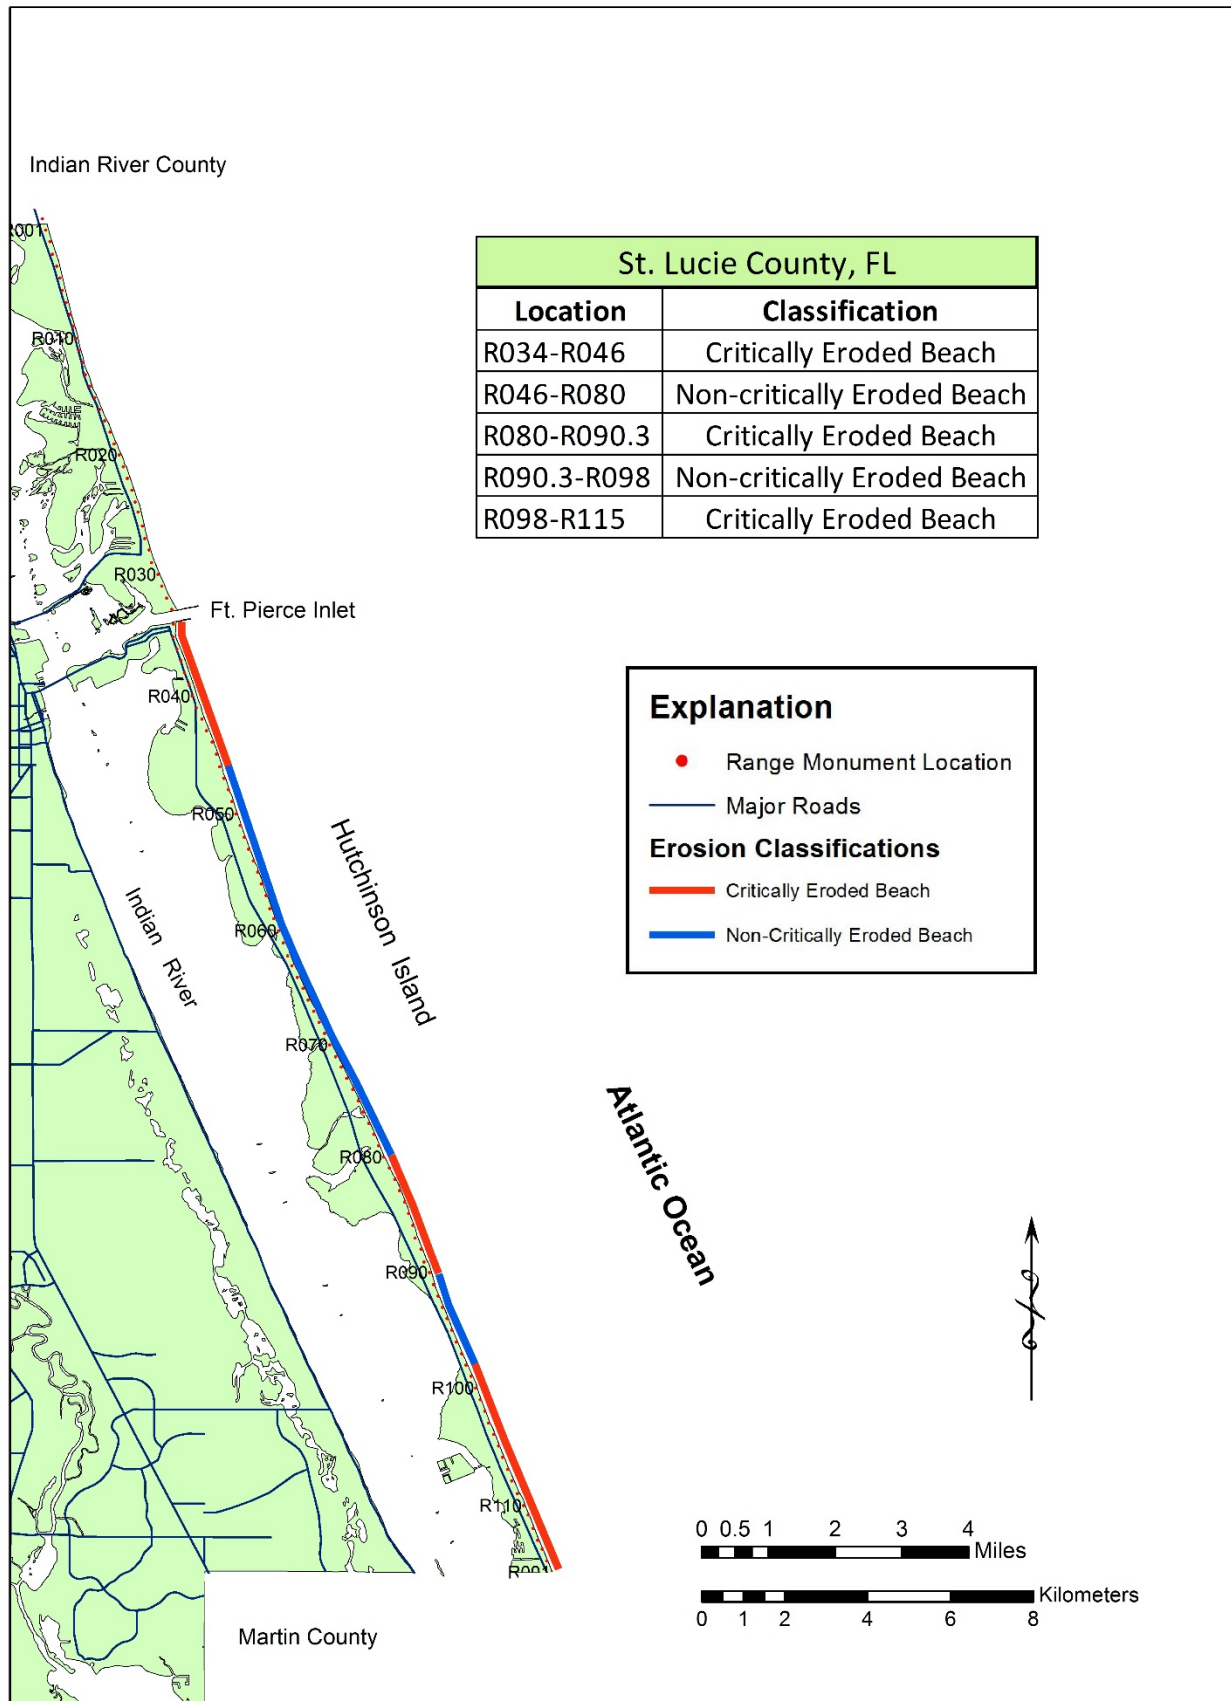
The southern 3.4 miles of the county shoreline (R98-R115+1000) is critically eroded with development interests threatened.

Figure 9. Critically eroded shoreline within St. Lucie County.

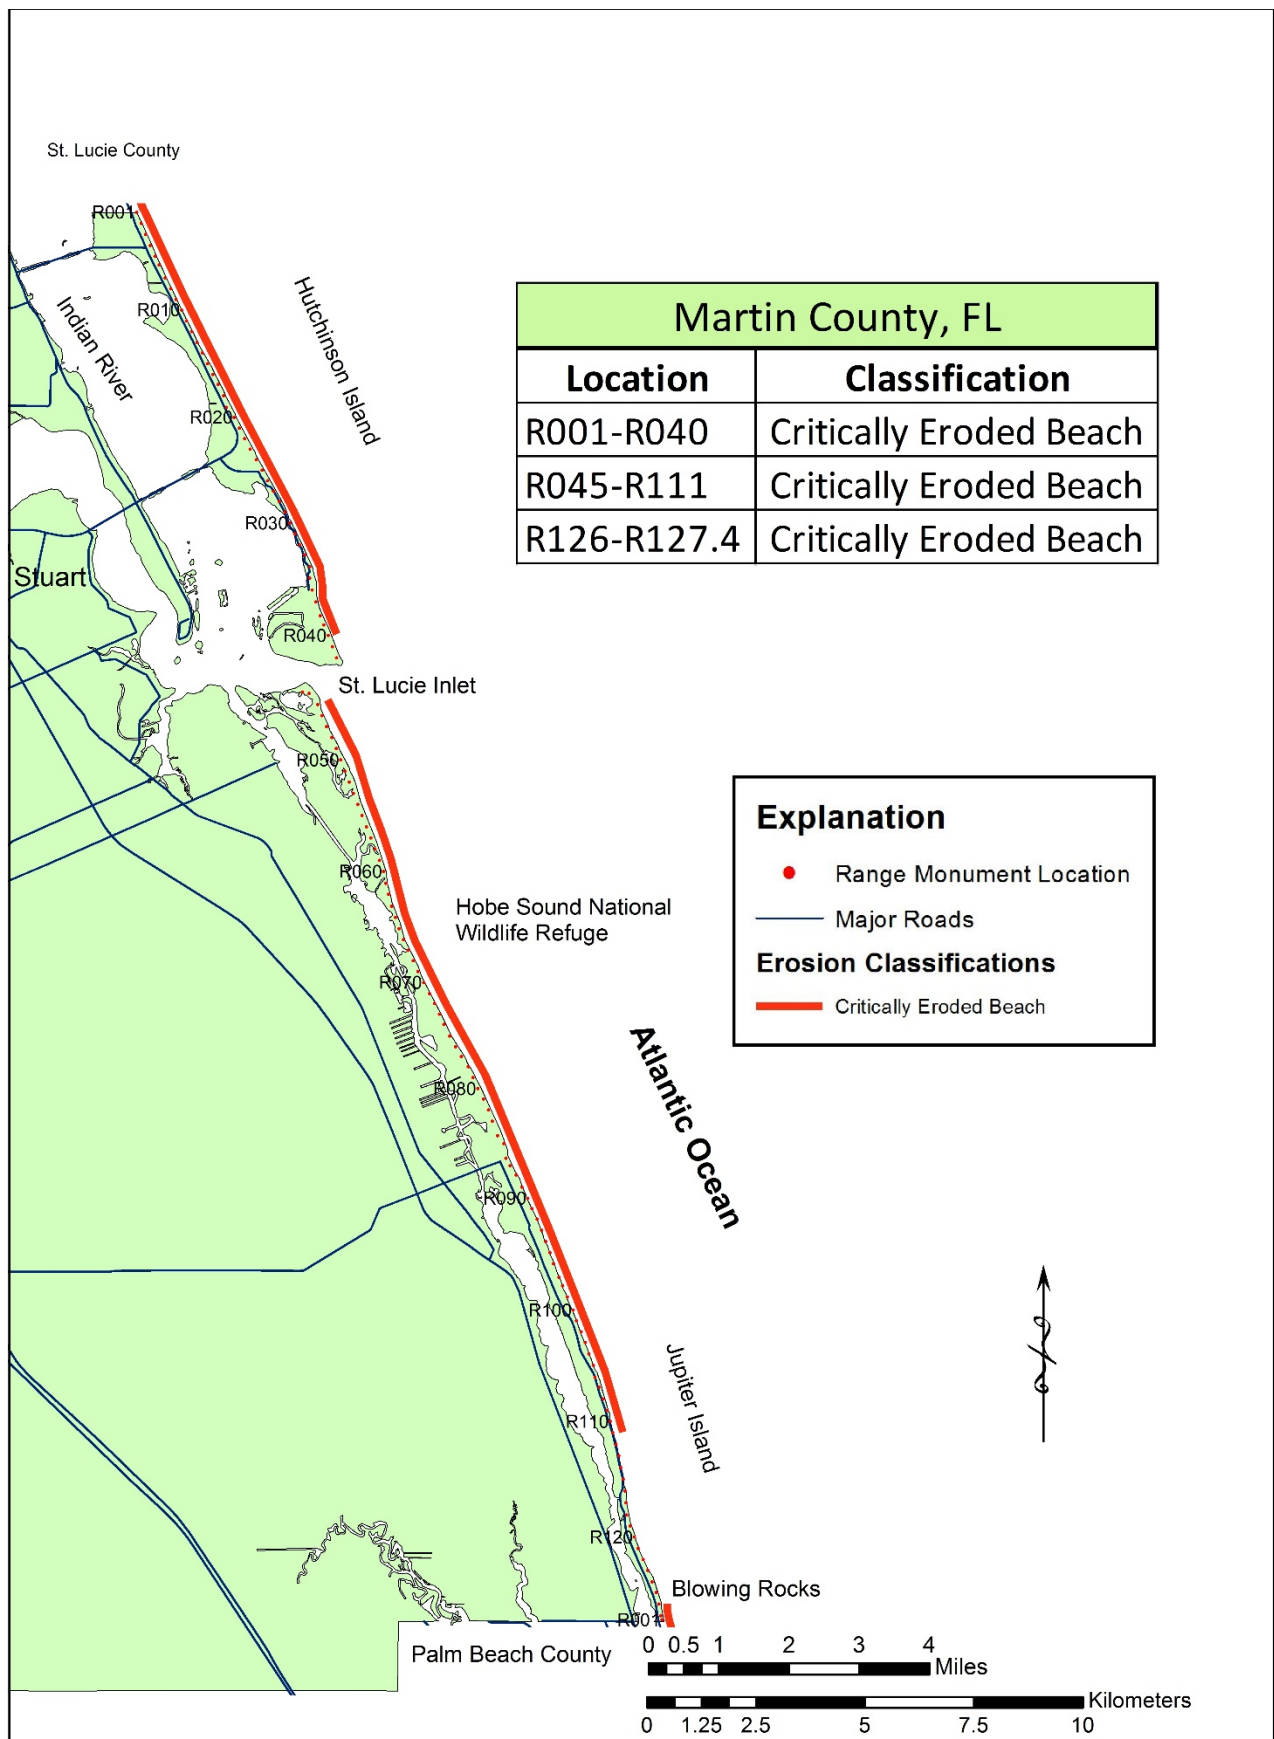
South of Blowing Rocks Preserve is another critically eroded area (R126-R127.4) extending 0.2 mile to the Palm Beach County line and threatening private development.

Figure 10. Critically eroded shoreline within Martin County.
