# ***Critically Eroded Beaches In Florida***

**Division of Water Resource Management  
Florida Department of Environmental Protection  
June 2017**

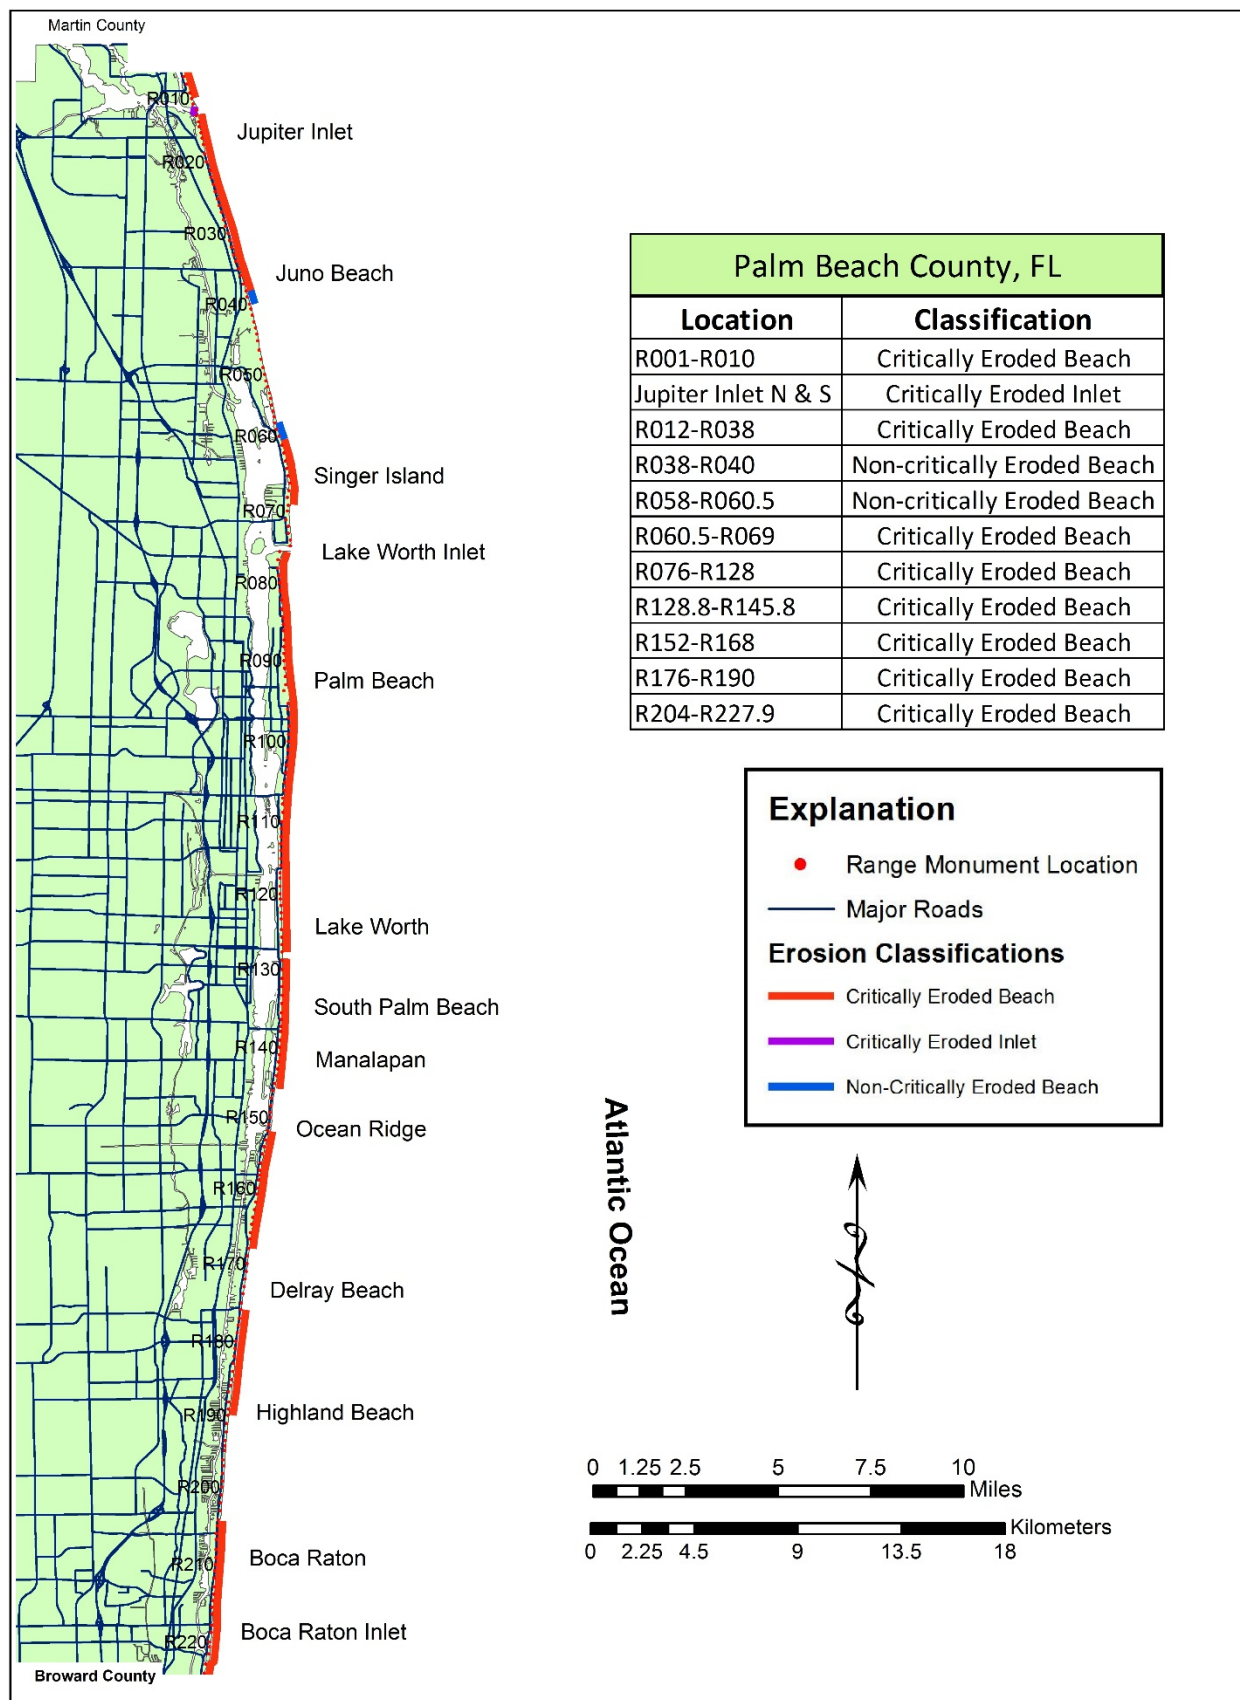
The City of Boca Raton at the south end of Palm Beach County has critical erosion (R204-R227.9) extending 5.0 miles to the Broward County line, which threatens recreation interests at Spanish River Park, Red Reef Park, and South Inlet Park as well as State Road A1A and private development. Beach restoration has been constructed throughout Boca Raton, and inlet sand transfer and seawalls exist south of Boca Raton Inlet.

Figure 11. Critically eroded shoreline within Palm Beach County.

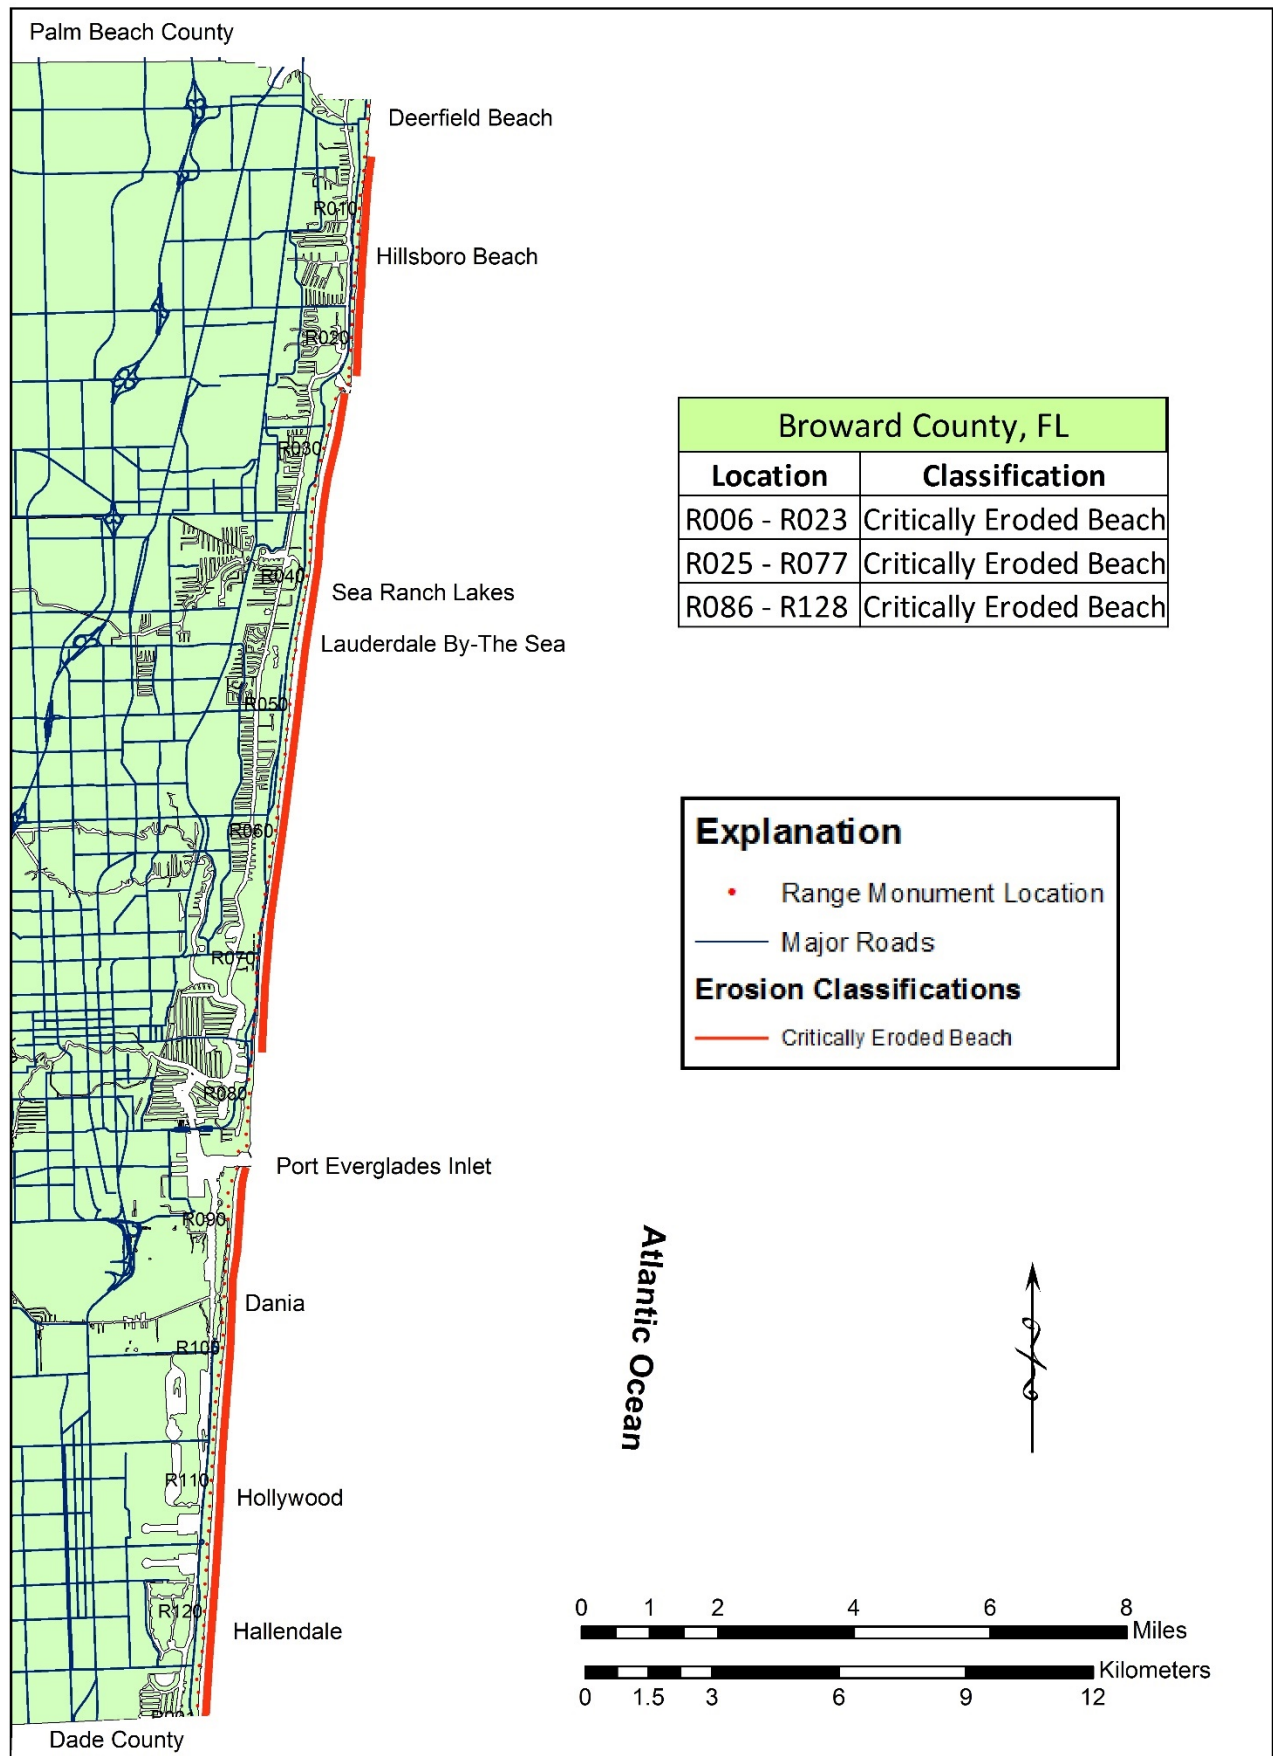
Along the southern 8.1 miles of Broward County south of Port Everglades Entrance is a critically eroded area (R86-R128) that threatens recreational interests at John U. Lloyd State Park and development and recreational interests along the communities of Dania, Hollywood, and Hallandale. Beach restoration projects are ongoing at J.U. Lloyd State Park and at Hollywood and Hallandale. Seawalls also exist along the private development.

Figure 12. Critically eroded shoreline within Broward County.

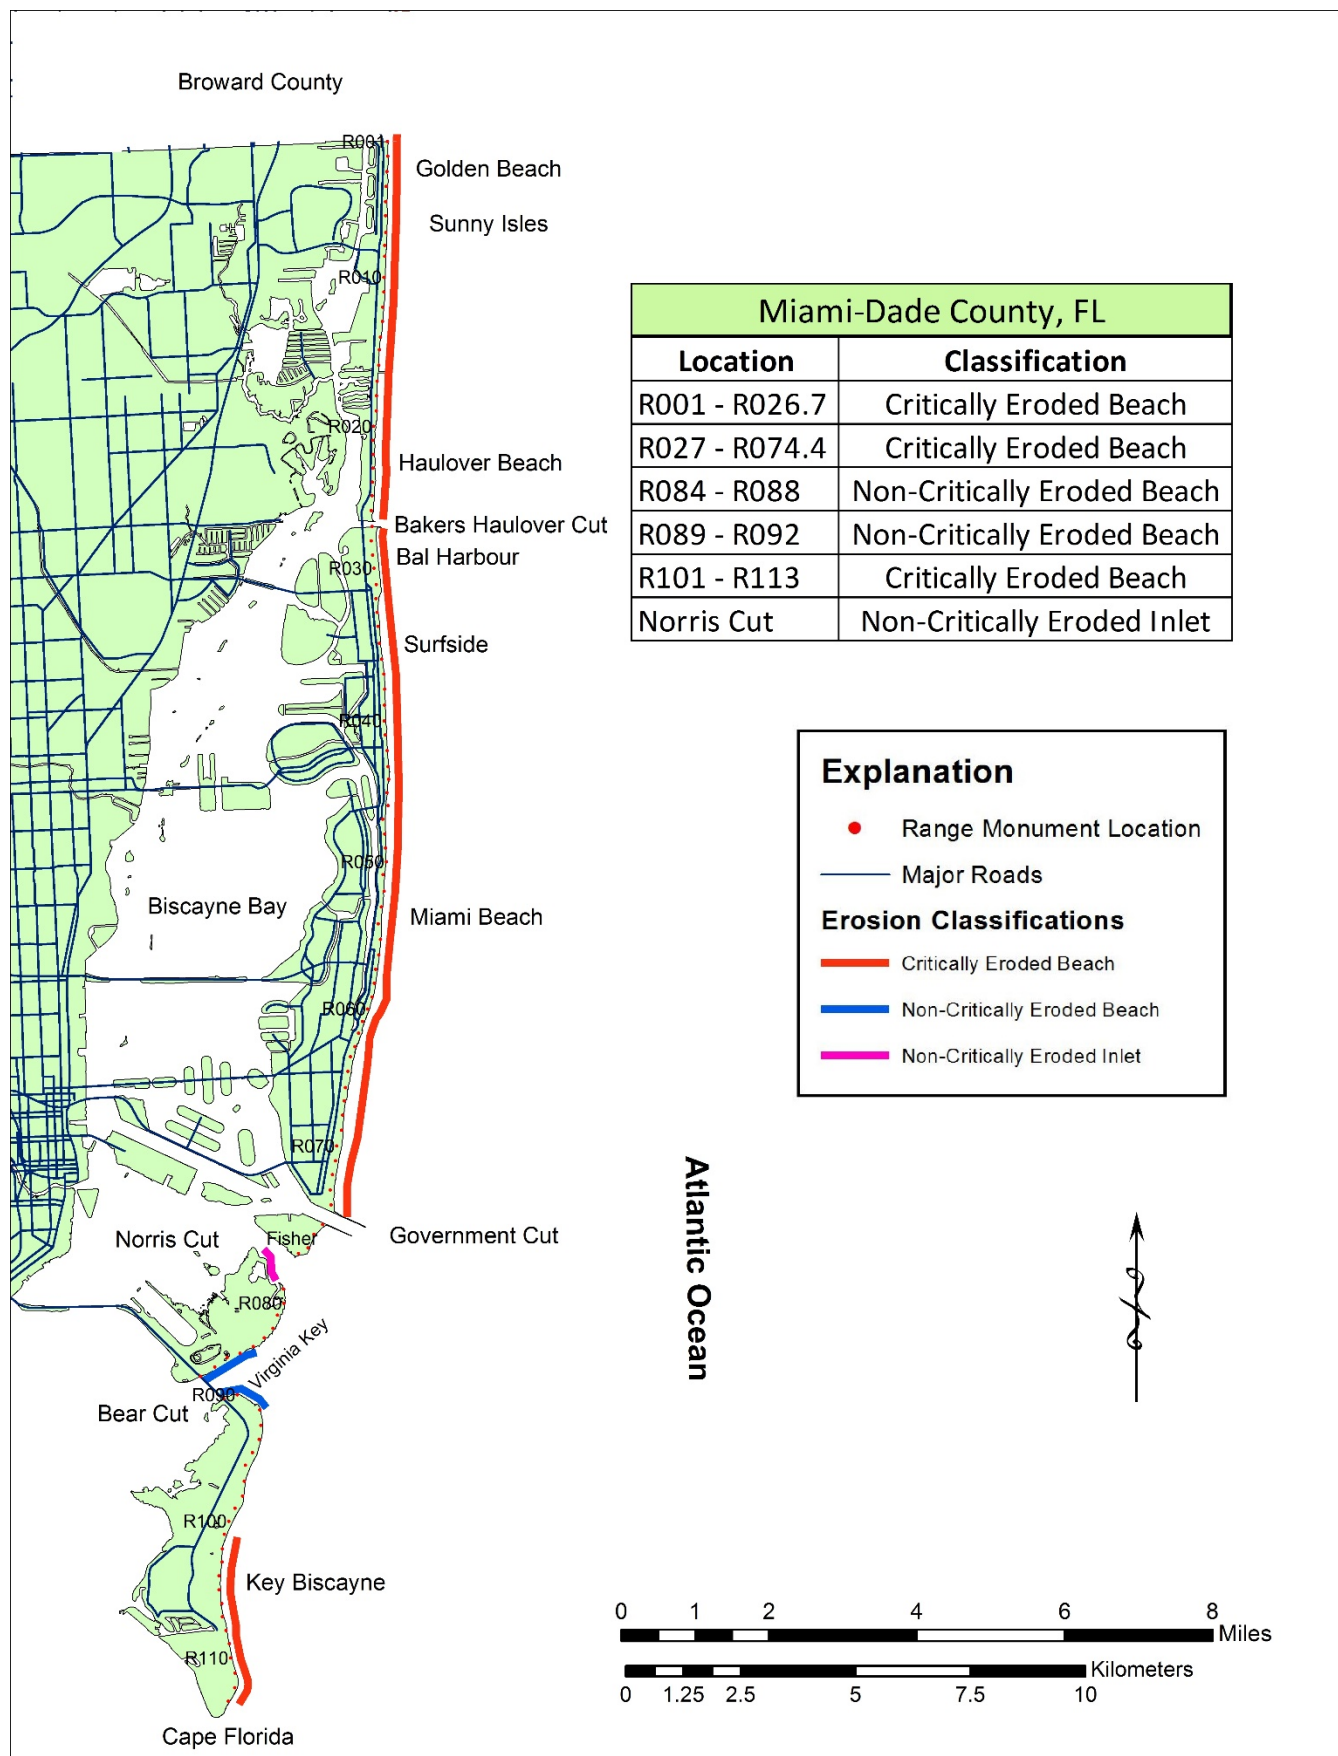
The northern end of Key Biscayne (R89-R92) has 0.6 mile of non-critical erosion, and the southern half of Key Biscayne (R101-R113) has 2.5 miles of critical erosion. The critically eroded area threatens development in the Village of Key Biscayne and recreational interests at Bill Baggs Cape Florida State Park. This segment is a beach restoration project.

Figure 13. Critically eroded shoreline within Dade County.

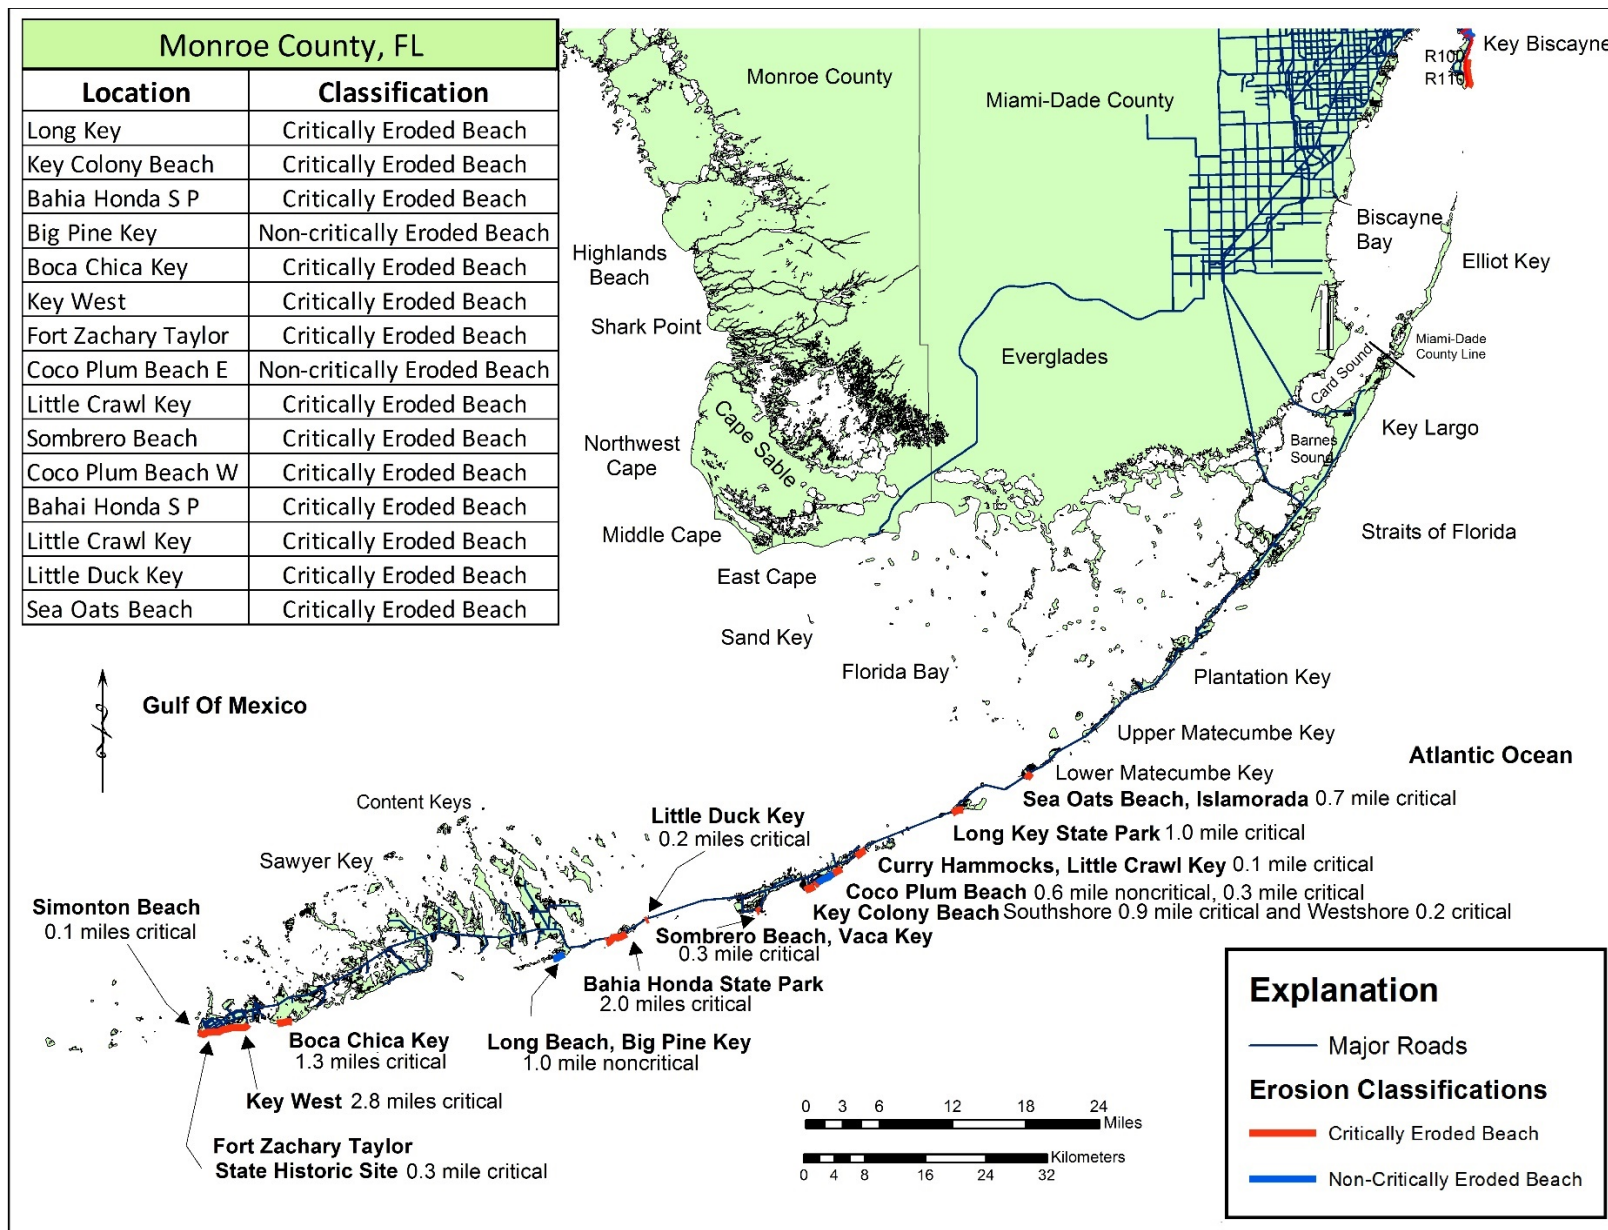
There are 13 critically eroded beach areas (10.2 miles) and two non-critically eroded beach areas (1.6 miles) along the Florida Keys fronting on the Straits of Florida and Gulf of Mexico between Key Largo and Key West (*Figure 14*). The distal sand keys west of Key West including Woman Key, Boca Grande Key, the Marquesas Keys, and the Tortugas Keys, also have beach erosion conditions that have not been adequately studied for inclusion in this report. Also not included at this time are the mainland beaches of Key McLaughlin and Cape Sable that front on the Gulf of Mexico. These beaches sustained severe erosion conditions due to Hurricane Wilma in 2005.

The distal sand keys west of Key West are known to have erosion areas; however, insufficient data is currently available. Particularly susceptible to erosion conditions are Woman Key, Boca Grande Key, the Marquesas Keys, and the Tortugas Keys. Cape Sable and Key McLaughlin on the mainland coast of Monroe County fronting the Gulf of Mexico were severely impacted by Hurricane Wilma in 2005. These areas are now being monitored by aerial videography.

Figure 14. Critically eroded shoreline within Monroe County – Florida Keys.

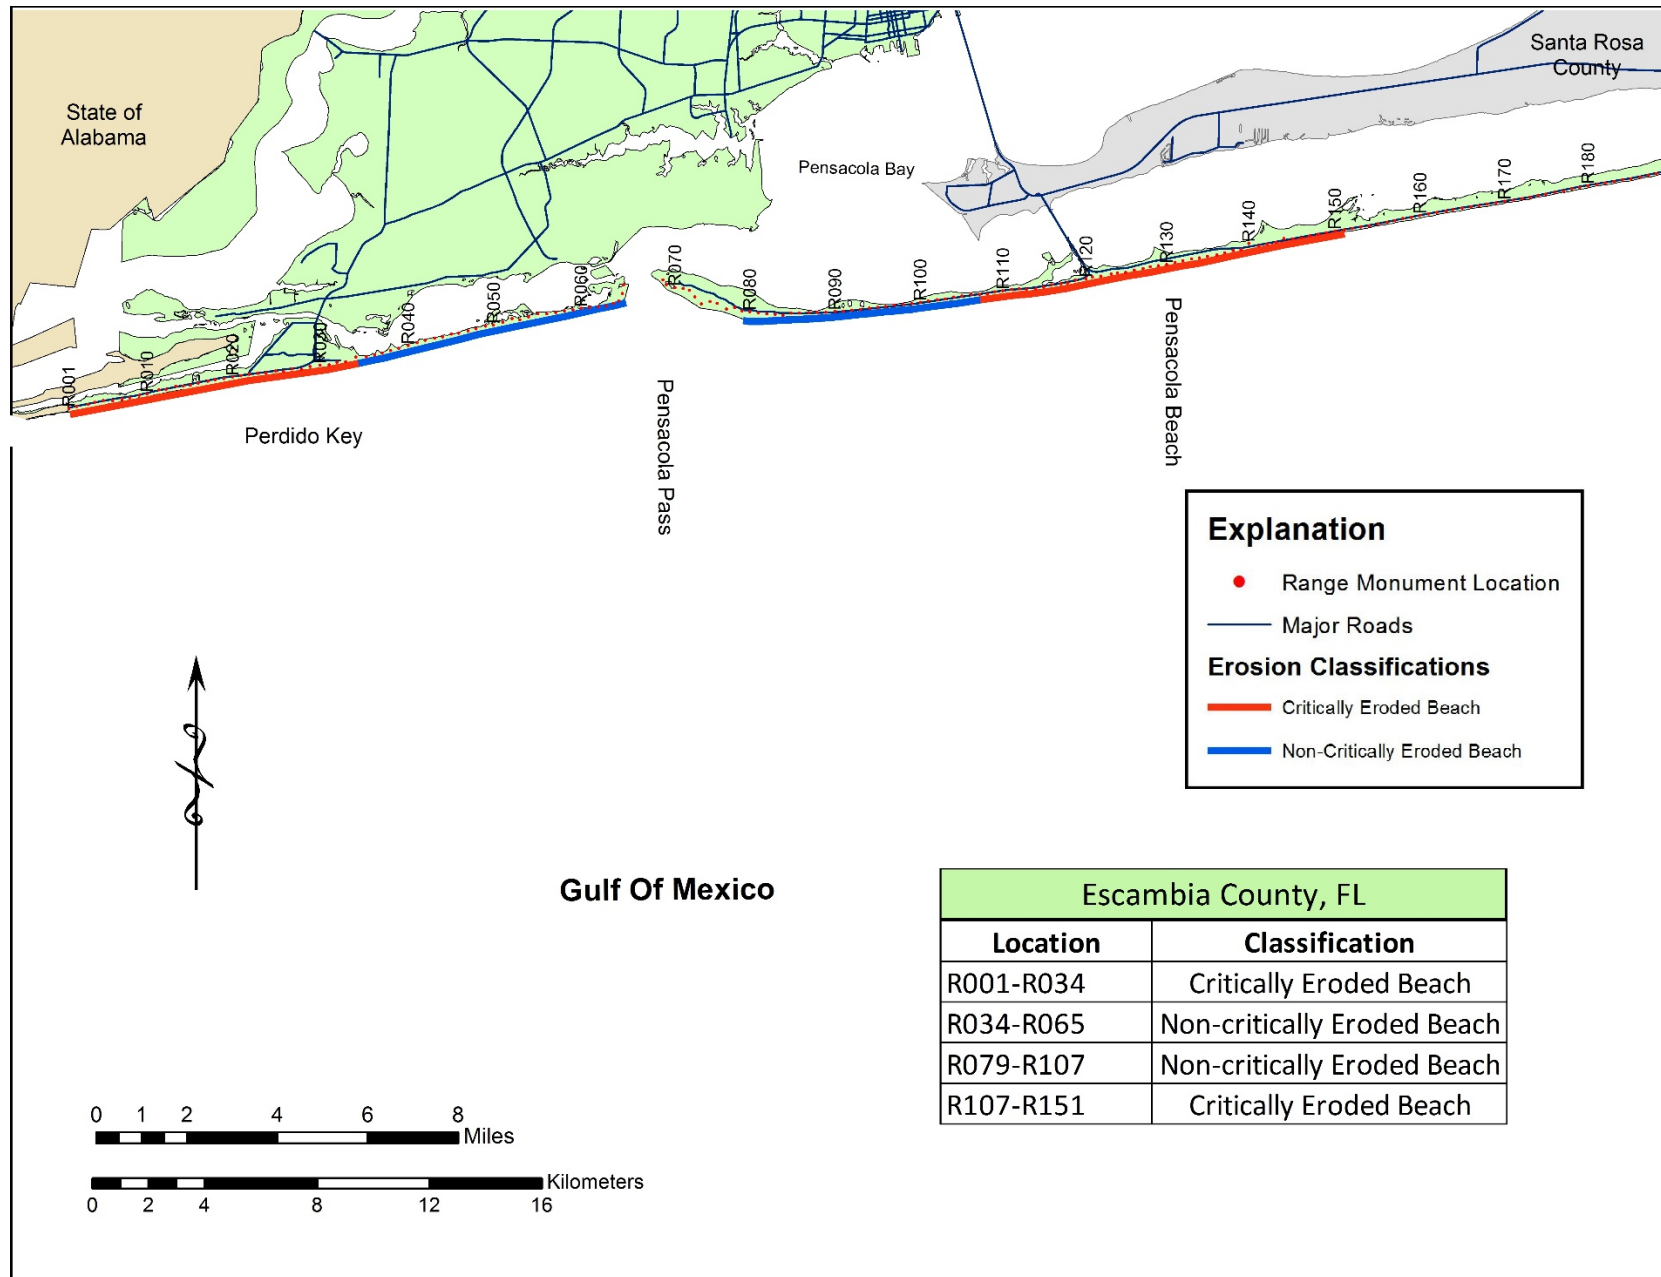
The entire 8.2-mile length of Pensacola Beach (R107-R151) is critically eroded threatening development and recreational interests. Dune restoration was conducted after the storms of 1995, 1998, 2002, and 2004. Beach restoration was completed in 2003.

Figure 15. Critically eroded shoreline within Escambia County.

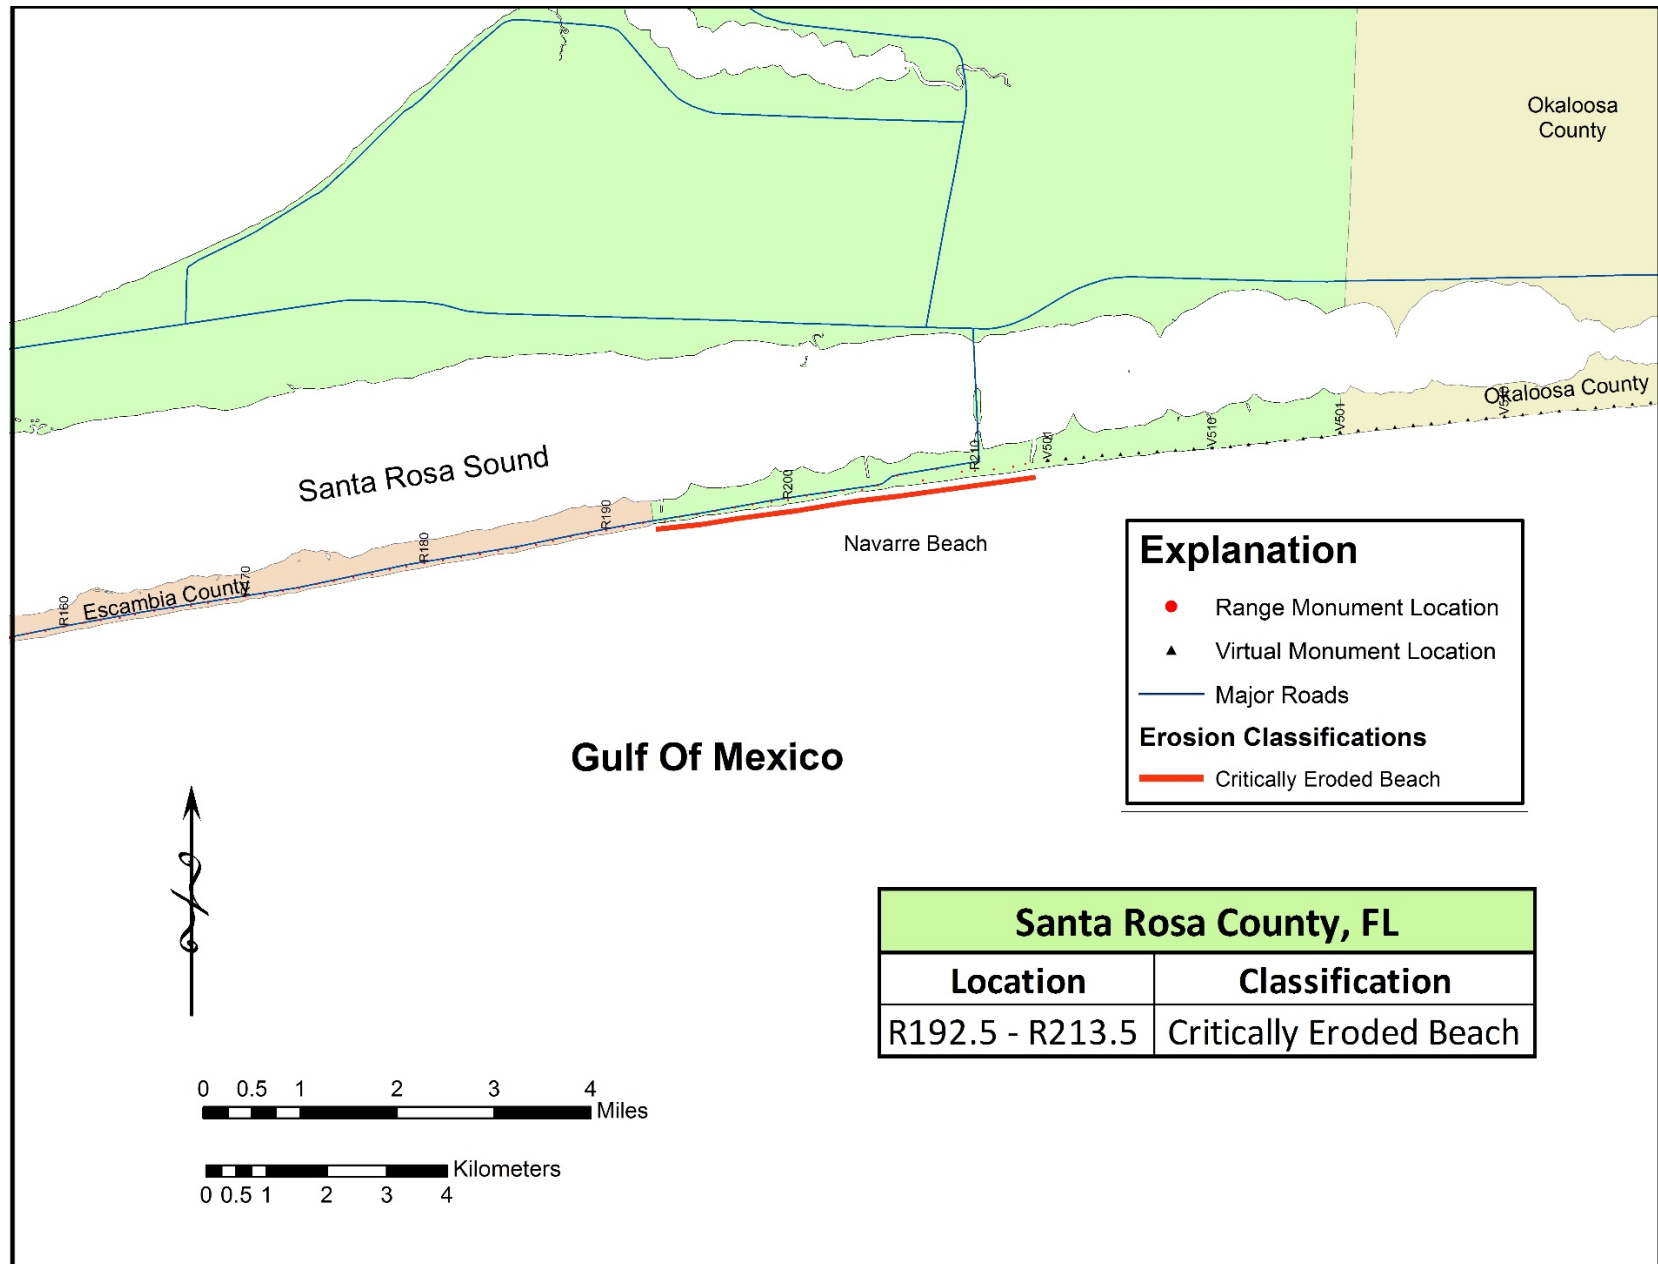
There is one critically eroded area (4.1 miles) in Santa Rosa County (*Figure 16*). The critically eroded area along Navarre Beach (R192.5-R213.5) threatens development and recreational interests. Following hurricanes in 1995 and 1998, dune restoration projects were constructed. A beach restoration project was completed in 2006.

Figure 16. Critically eroded shoreline within Santa Rosa County.

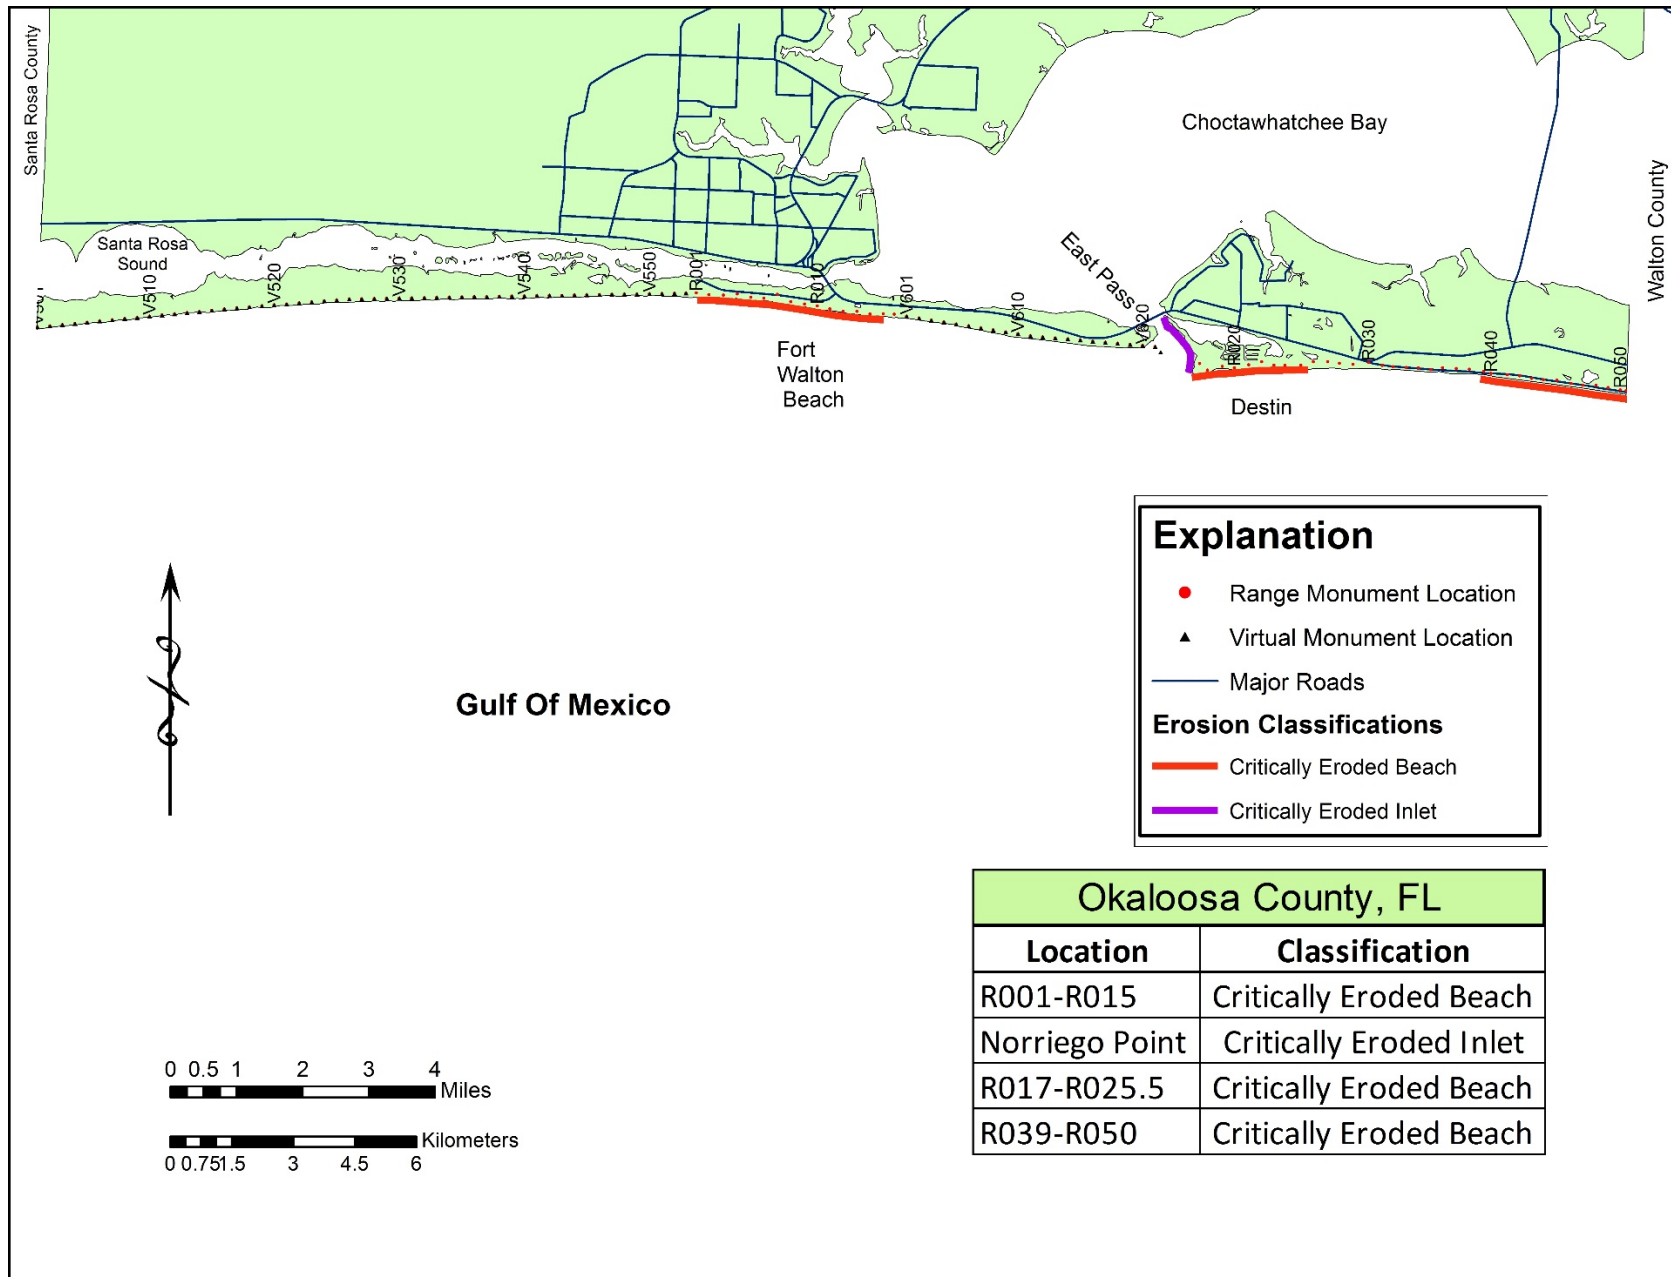
The western 1.6 miles of Destin (R17-R25.5) is designated critically eroded following the severe impact of the 2005 hurricane season and on-going erosion conditions. The western portion on Holiday Isles (R17.2-R19.8) received emergency nourishment in 2010, and the entire beach restoration project was completed in 2013. The eastern 2.1 miles of Destin (R39-R50) is designated critically eroded threatening development and the coastal road. This area is a beach restoration project constructed in 2007.

Figure 17. Critically eroded shoreline within Okaloosa County.

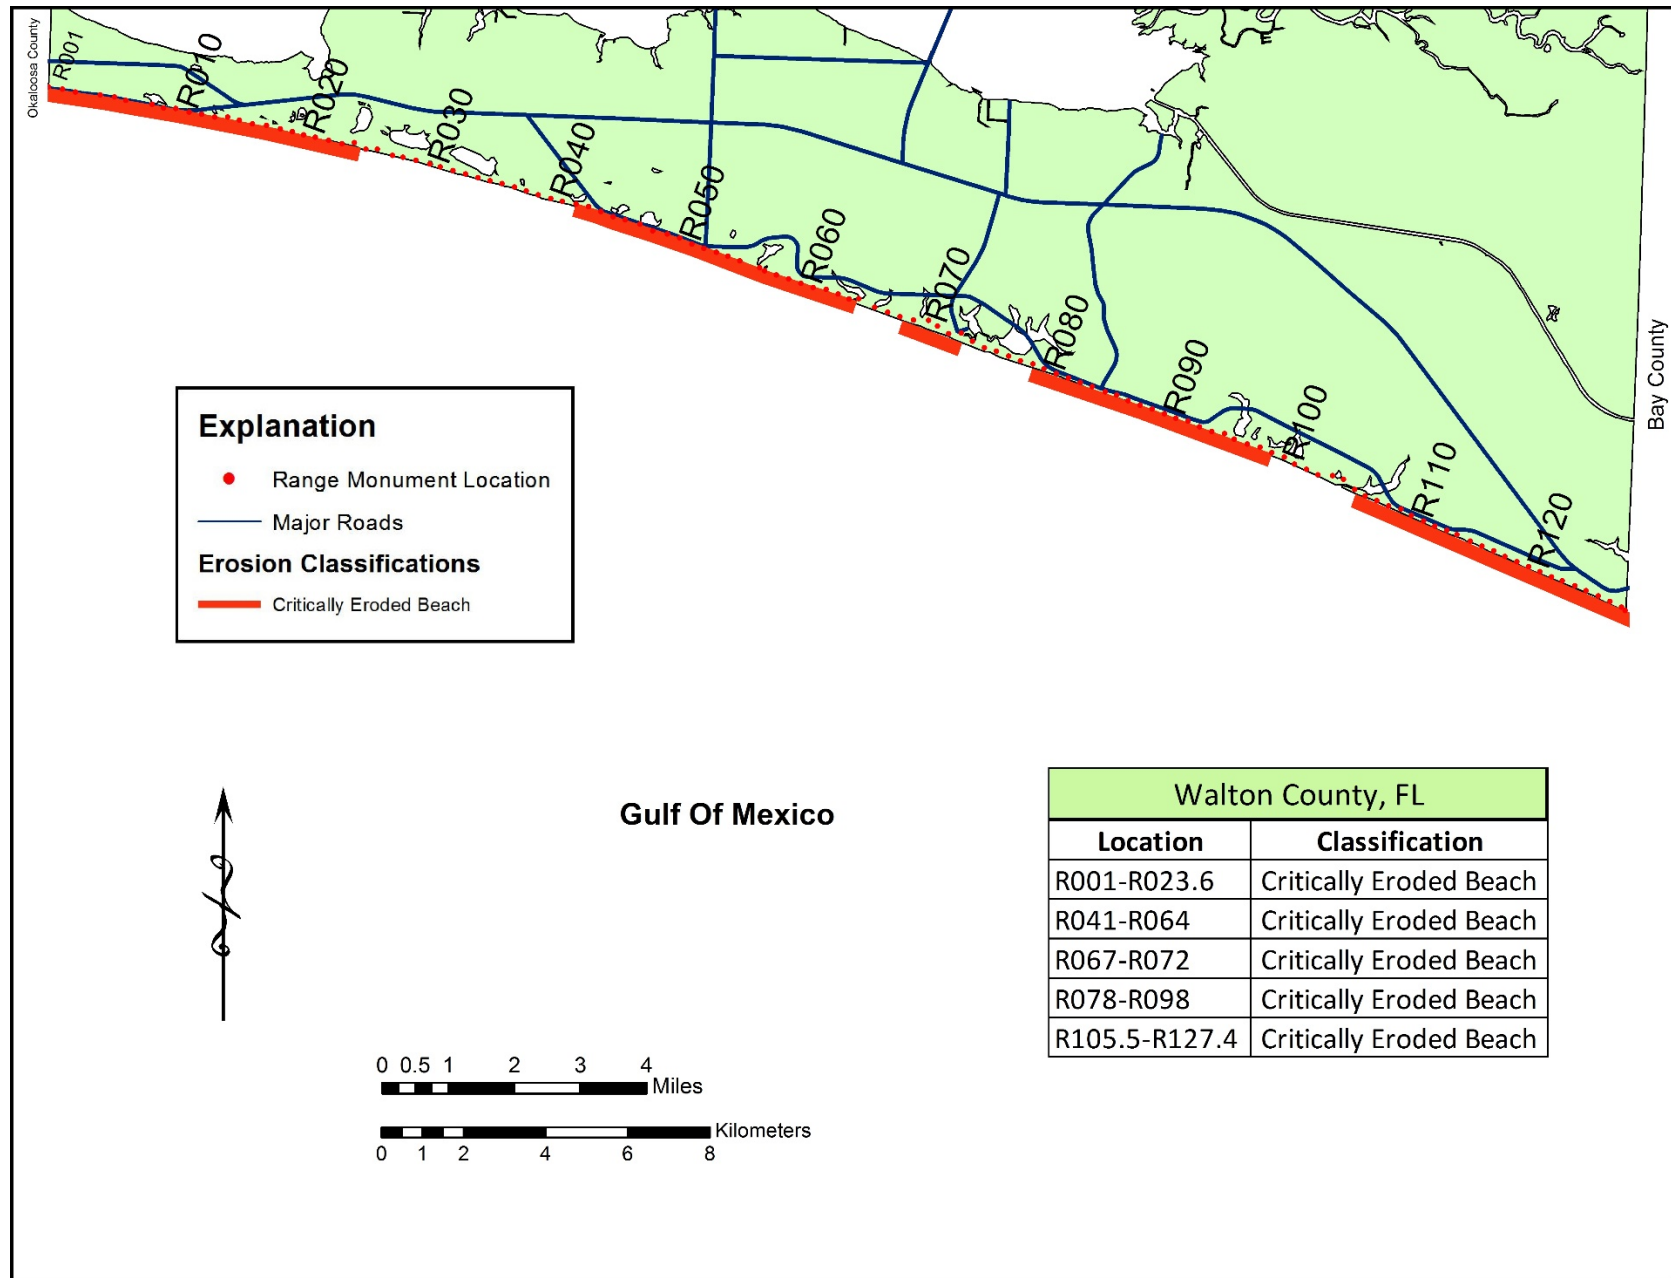
There are five critically eroded areas (18.8 miles) designated in Walton County (*Figure 18*). Within these areas, 3.1 miles were added following Congressional authorization of the Walton County Hurricane and Storm Damage Reduction Project.

critically eroded. The portion between R122 and R124 was designated critical due to its post-storm vulnerability threatening development interests. The portion between R124 and R127 was designated critical for the design integrity of the beach restoration project. Between R114.7 and R122 is a 1.4-mile gap between threatened areas where nearly all of the development is completely landward of the CCCL. This area and a 400-foot segment at the east end where there is currently no development seaward of the CCCL, were added for continuity of management of the coastal system following federal project authorization.

Figure 18. Critically eroded shoreline within Walton County.

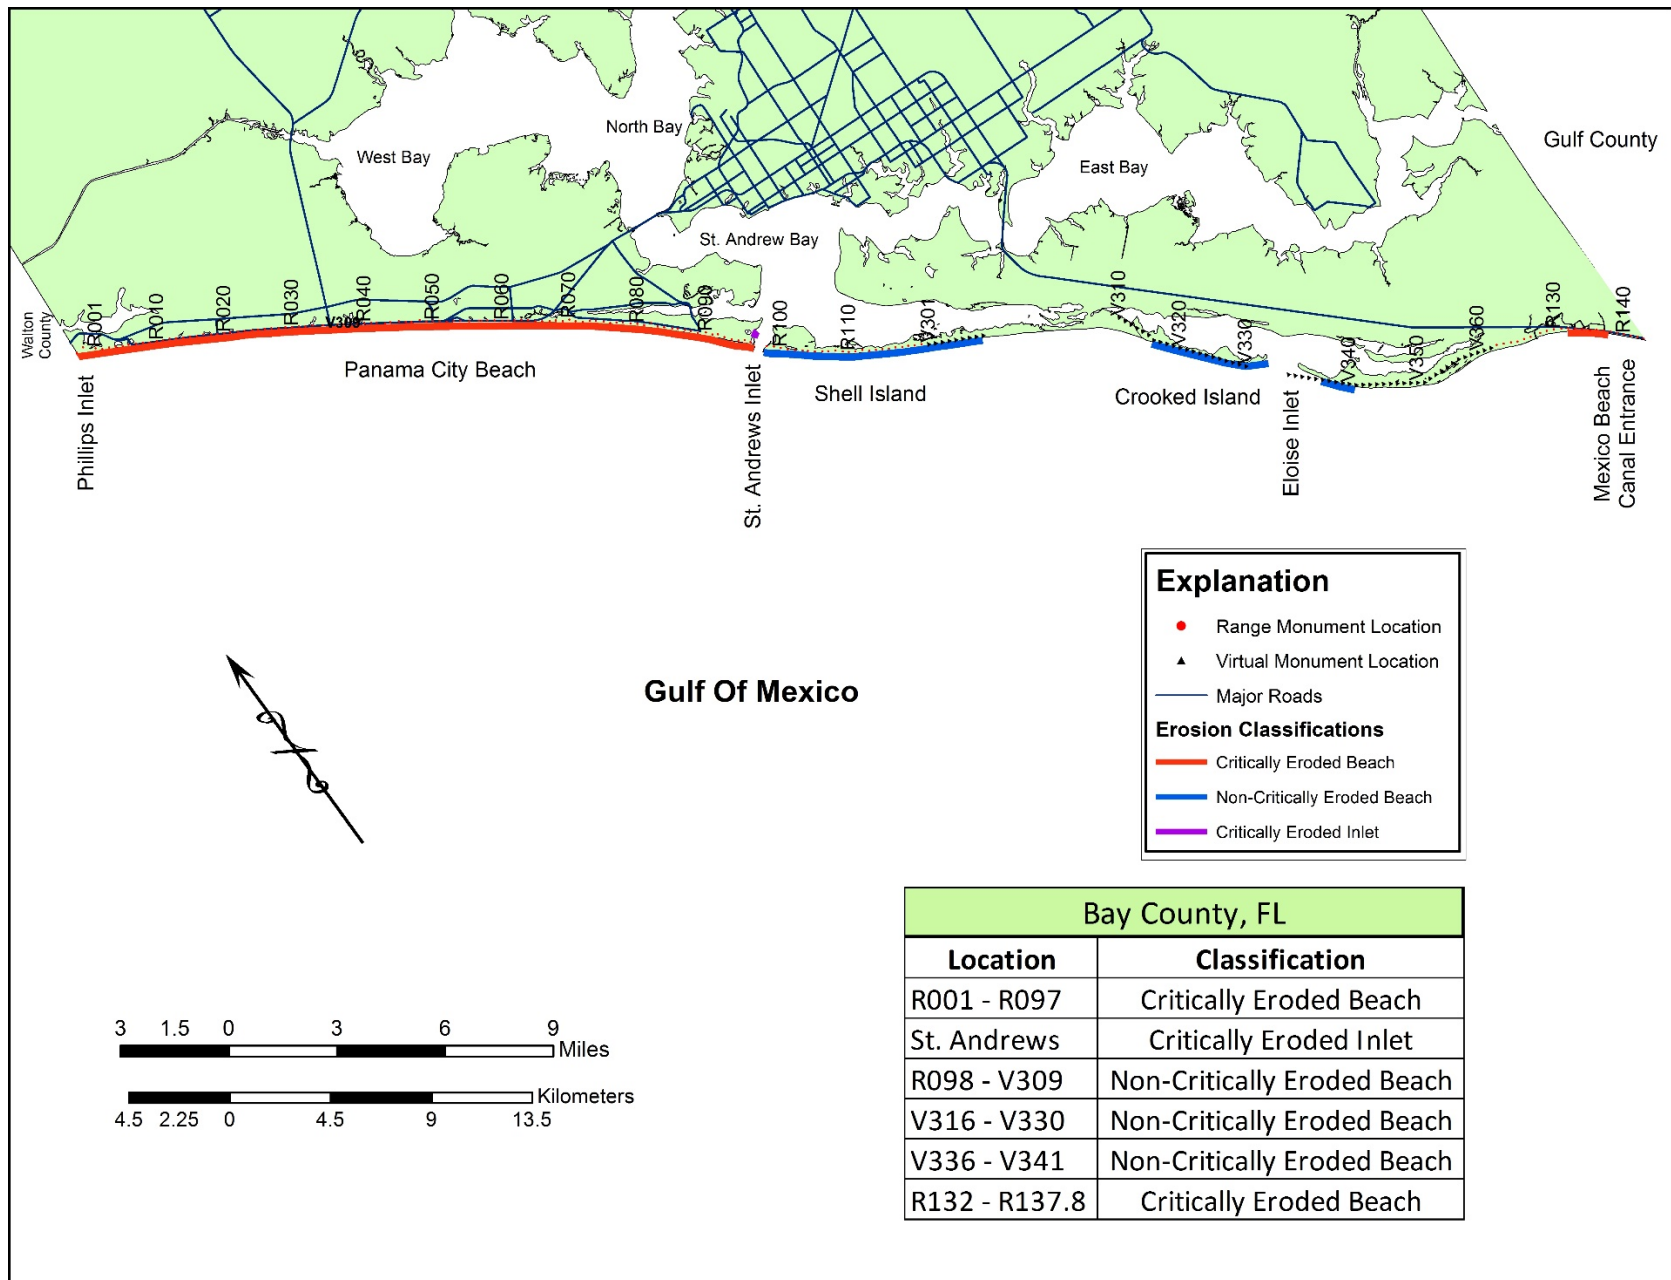
The eastern 0.9 miles of Bay County (R132-R137.8) along the Town of Mexico Beach is critically eroded. Inlet sand transfer is periodically conducted at Mexico Beach Inlet and dune restoration has been conducted following Hurricanes Opal (1995) and Dennis (2005).

Figure 19. Critically eroded shoreline within Bay County.

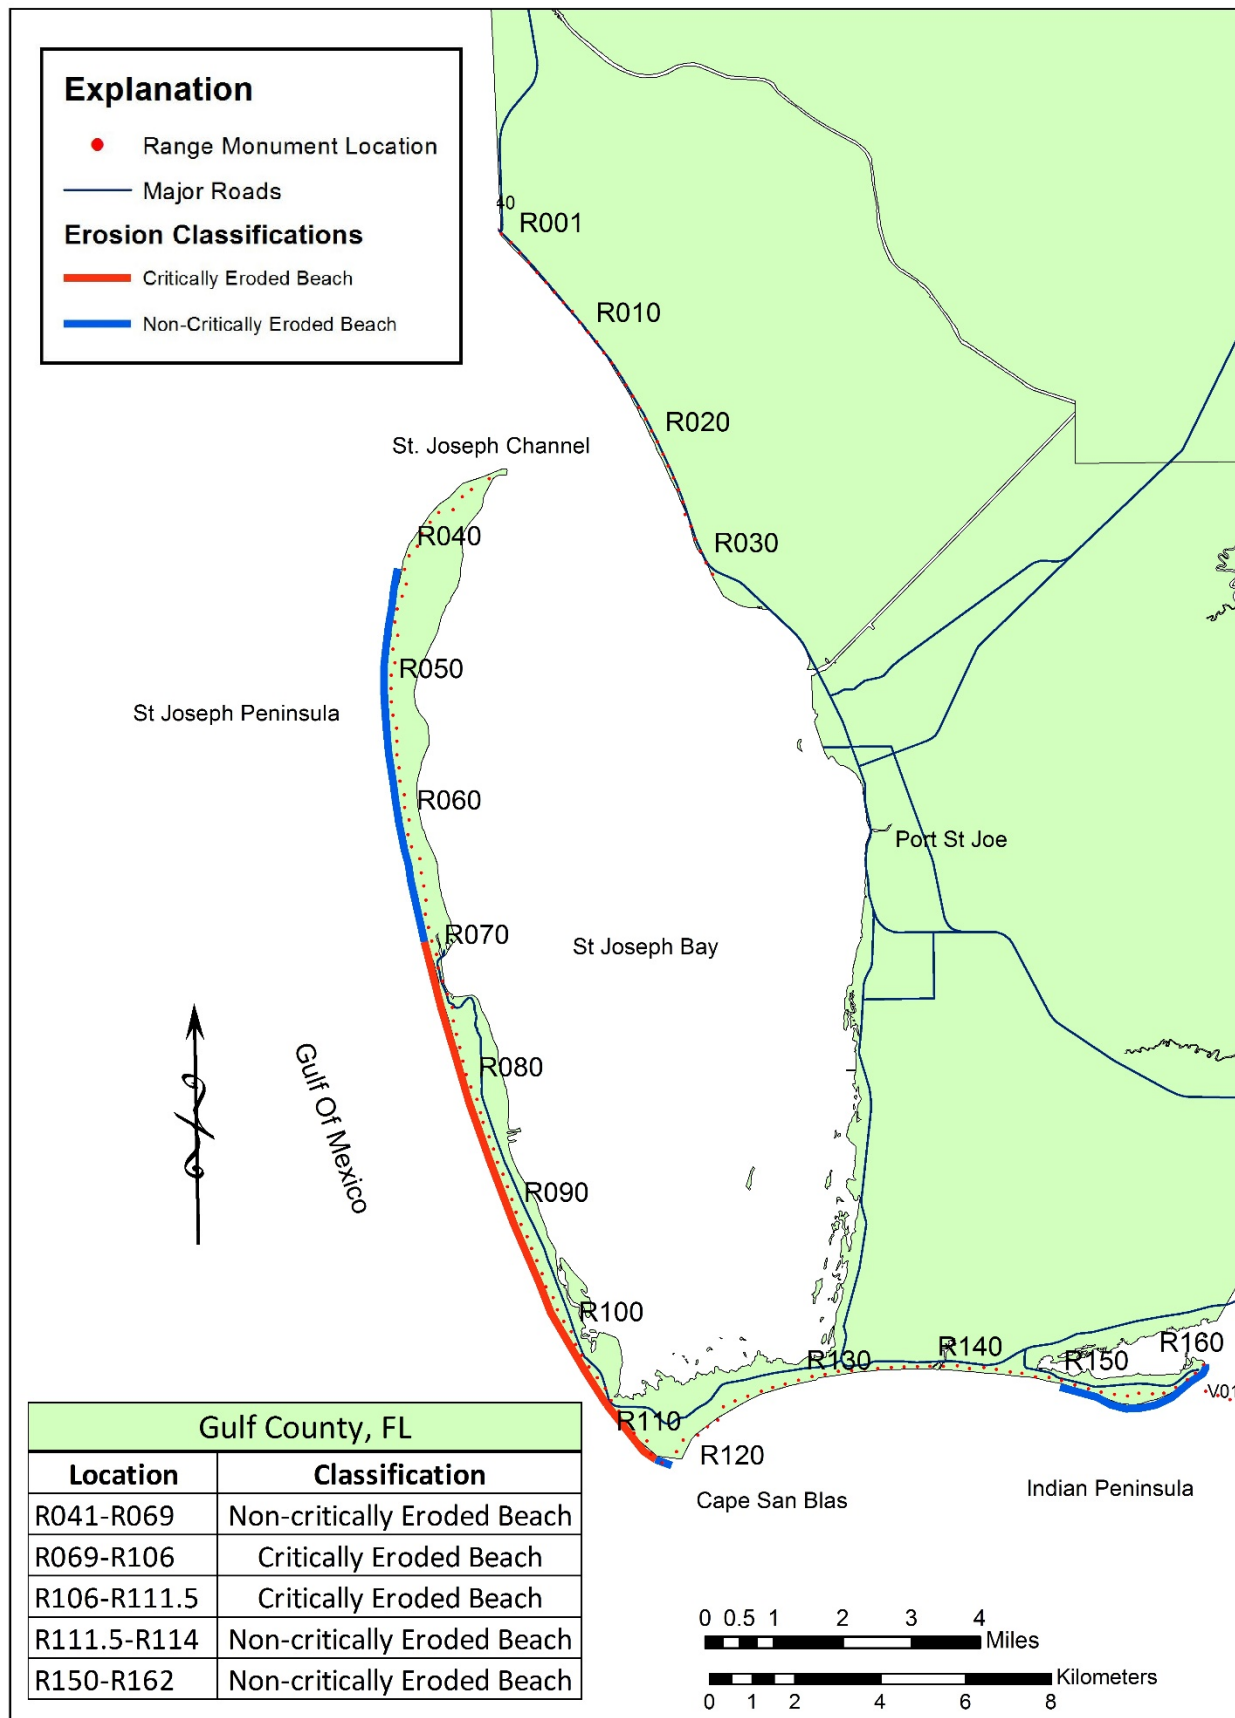
The west shoreline of Cape San Blas is severely eroded and is considered to have the highest erosion rate along the coast of Florida. The segment between R106 and R111.5 (1.1 mile) is designated critically eroded from Stump Hole to the threatened and damaged U.S. Air Force facilities, because the erosion has destroyed nesting sea turtle habitat along Cape San Blas. After Hurricane Opal (1995), a rock mound structure was constructed to protect the county road at Stump Hole. Likewise, the U.S. Air Force constructed a rock mound structure in front of their road to the rocket launch site after Hurricane Kate (1985), but both the road and the rock mound structure were destroyed by Hurricane Opal (1995). The rock mound at Stump Hole was extended and subsequently damaged by Hurricanes Ivan (2004) and Dennis (2005). An engineered boulder mound structure was constructed in 2009 to replace the earlier rock mound to provide major storm protection to the county road. South of the U.S. Air Force facilities, Cape San Blas (111.5-R114) has sustained severe but non-critical erosion for an additional 0.5 mile.

Indian Peninsula (R150-R162) at the east end of the county is also eroded for 2.6 miles with no threatened interests at this time.

Figure 20. Critically eroded shoreline within Gulf County.
