# ***Critically Eroded Beaches In Florida***

**Division of Water Resource Management  
Florida Department of Environmental Protection  
June 2017**

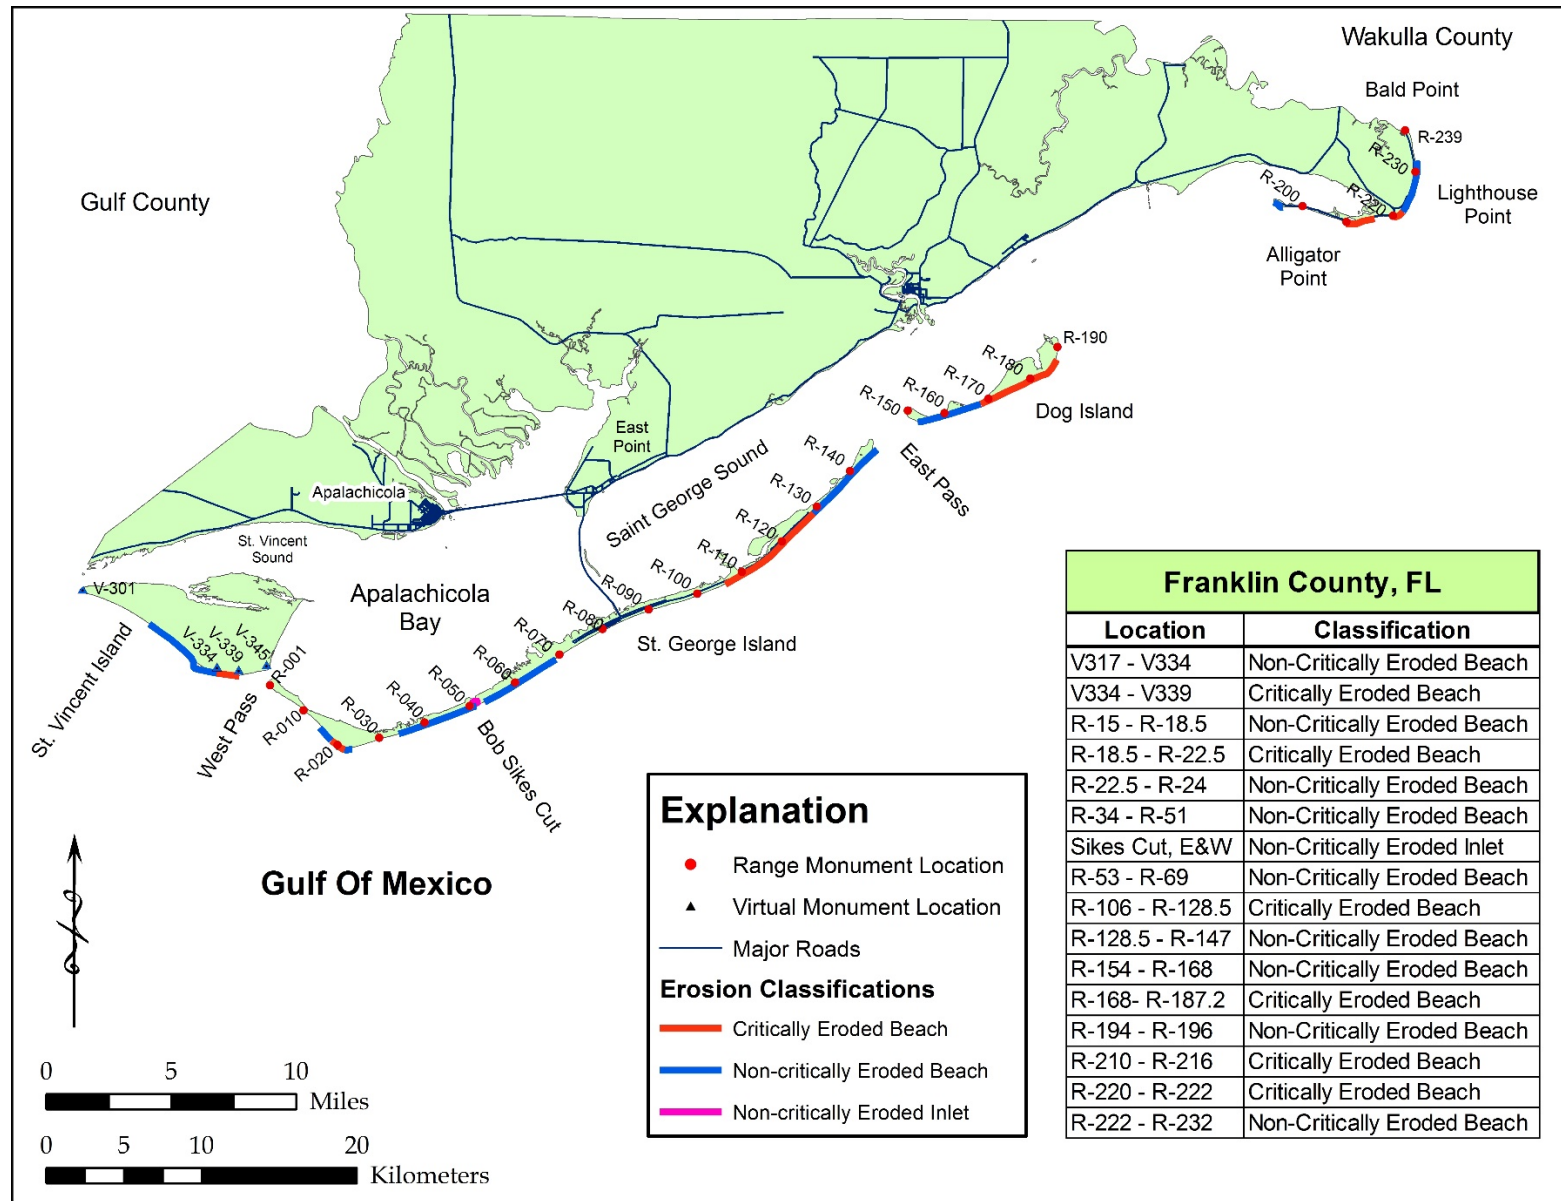
St. Vincent Island has a 3.2-mile long non-critically eroded area along its most gulfward protruding midsection (V317-V334). Resources on the St. Vincent National Wildlife Refuge do not currently appear threatened by this ongoing erosion condition. To the east, a 0.9-mile segment of St. Vincent Island (V334-V339) is critically eroded into the maritime forest resulting in the loss of beach wildlife habitat.

The southeast end of St. James Island is critically eroded extending north from Lighthouse Point (R220-R222) for 0.4 mile threatening residential development. Further north from Lighthouse Point (R222-R232), a non-critically eroded area extends for 2.1 miles.

Figure 21. Critically eroded shoreline within Franklin County.

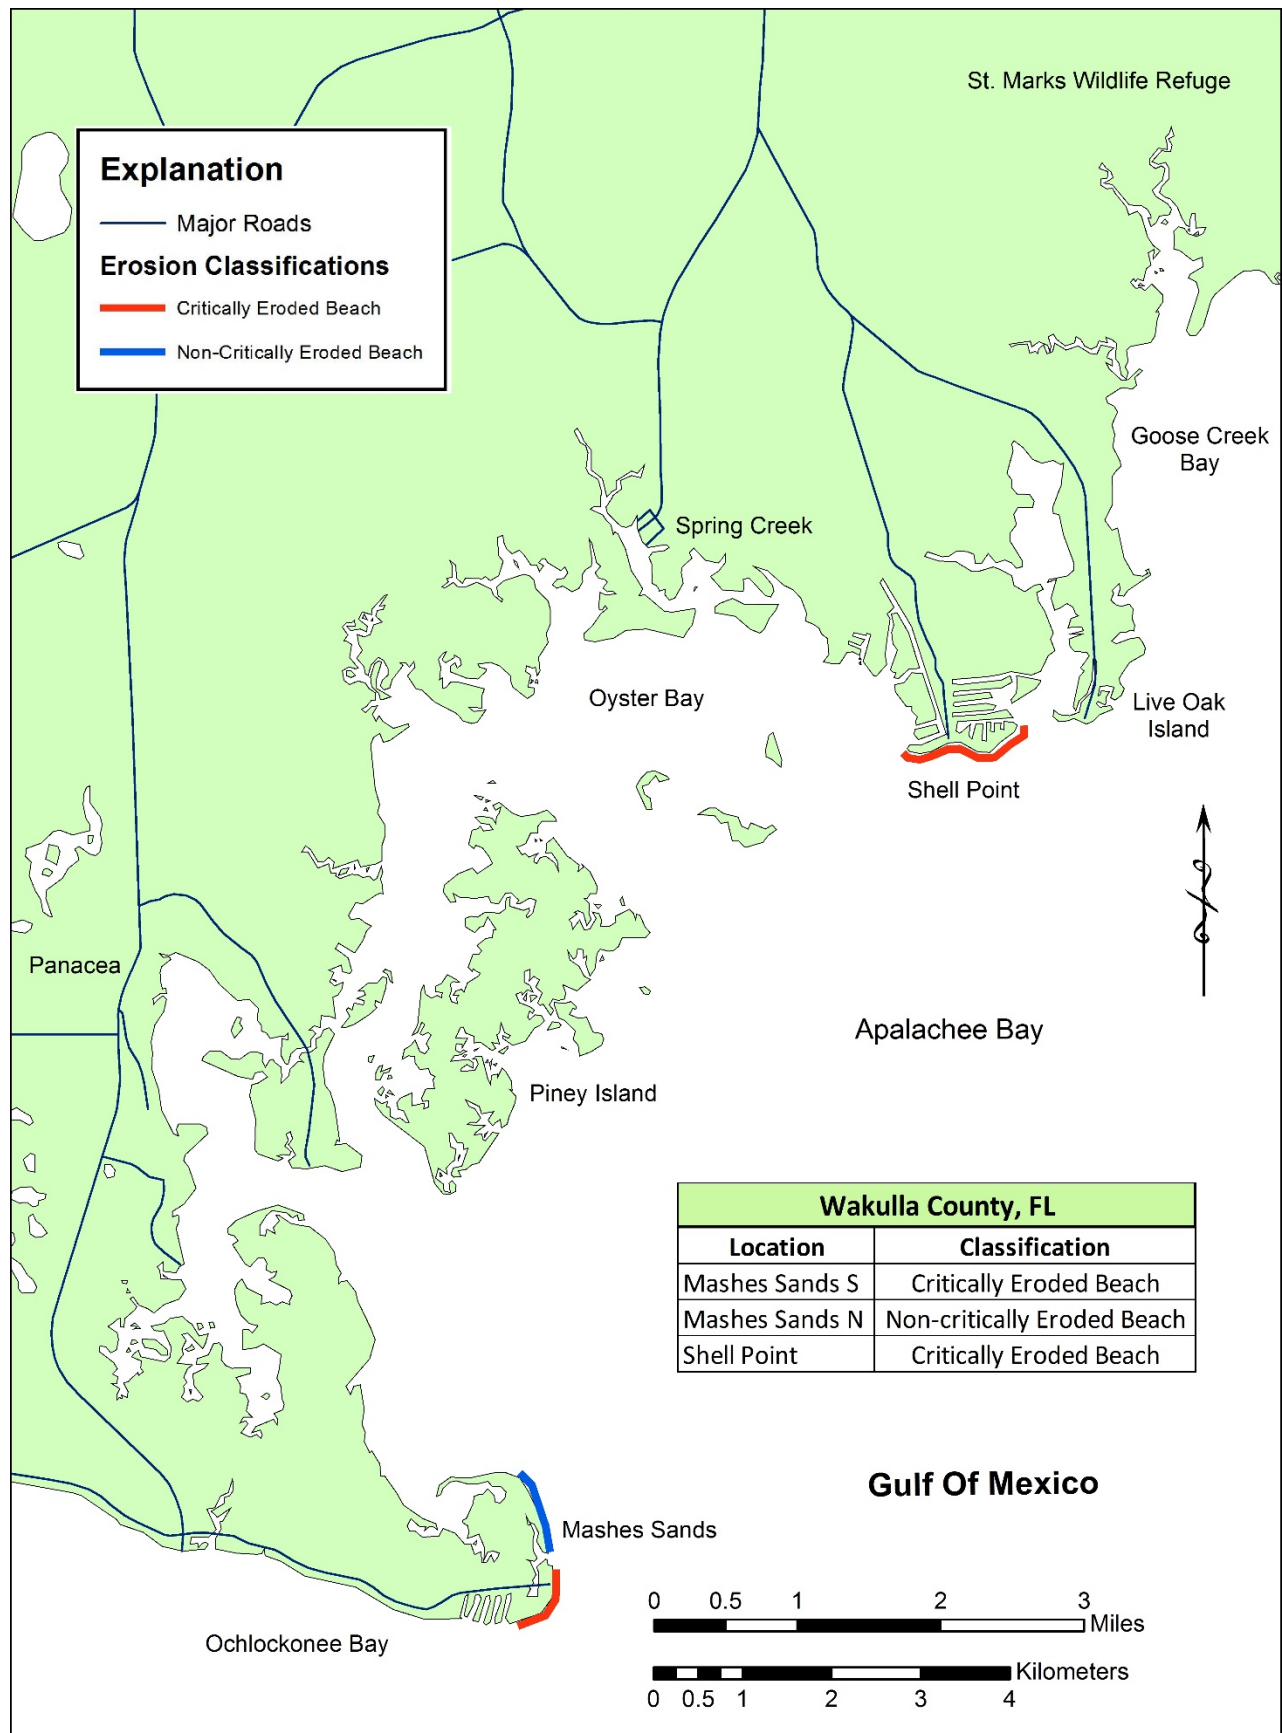
Shell Point has 1.0 mile of critical erosion threatening development and a county park. Most of the private properties have bulkheads, retaining walls, and one rock revetment.

Figure 22. Critically eroded shoreline within Wakulla County.

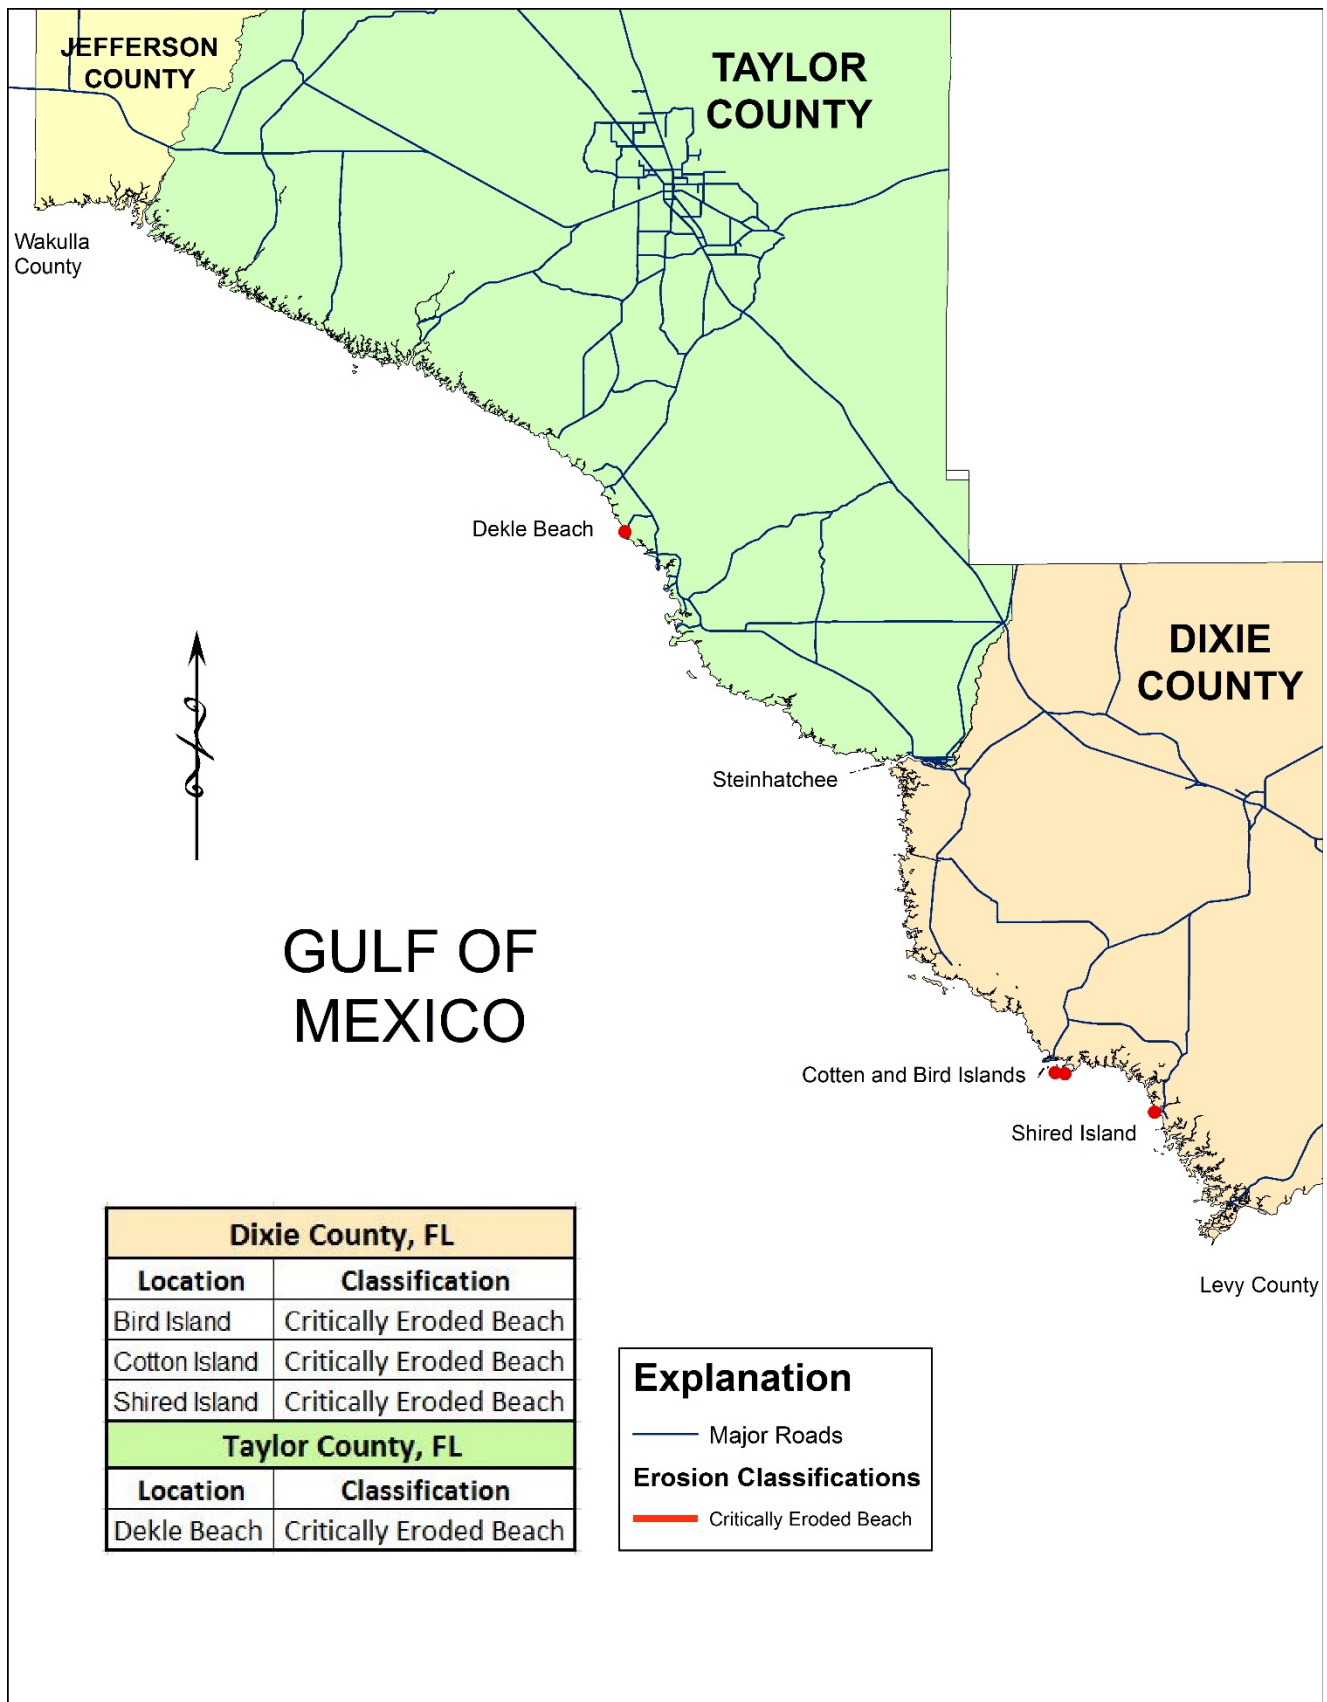
There are three critically eroded areas in Dixie County (0.6 mile) identified at this time. Each area extends for 0.2 mile on the three separate islands of Shired Island, Bird Island, and Cotton Island. The erosion of these islands threatens ancient pre-Columbian shell middens and burial sites dating as far back as the late archaic period (BC2250-BC1500).

Figure 23. Critically eroded shoreline within Dixie and Taylor Counties.

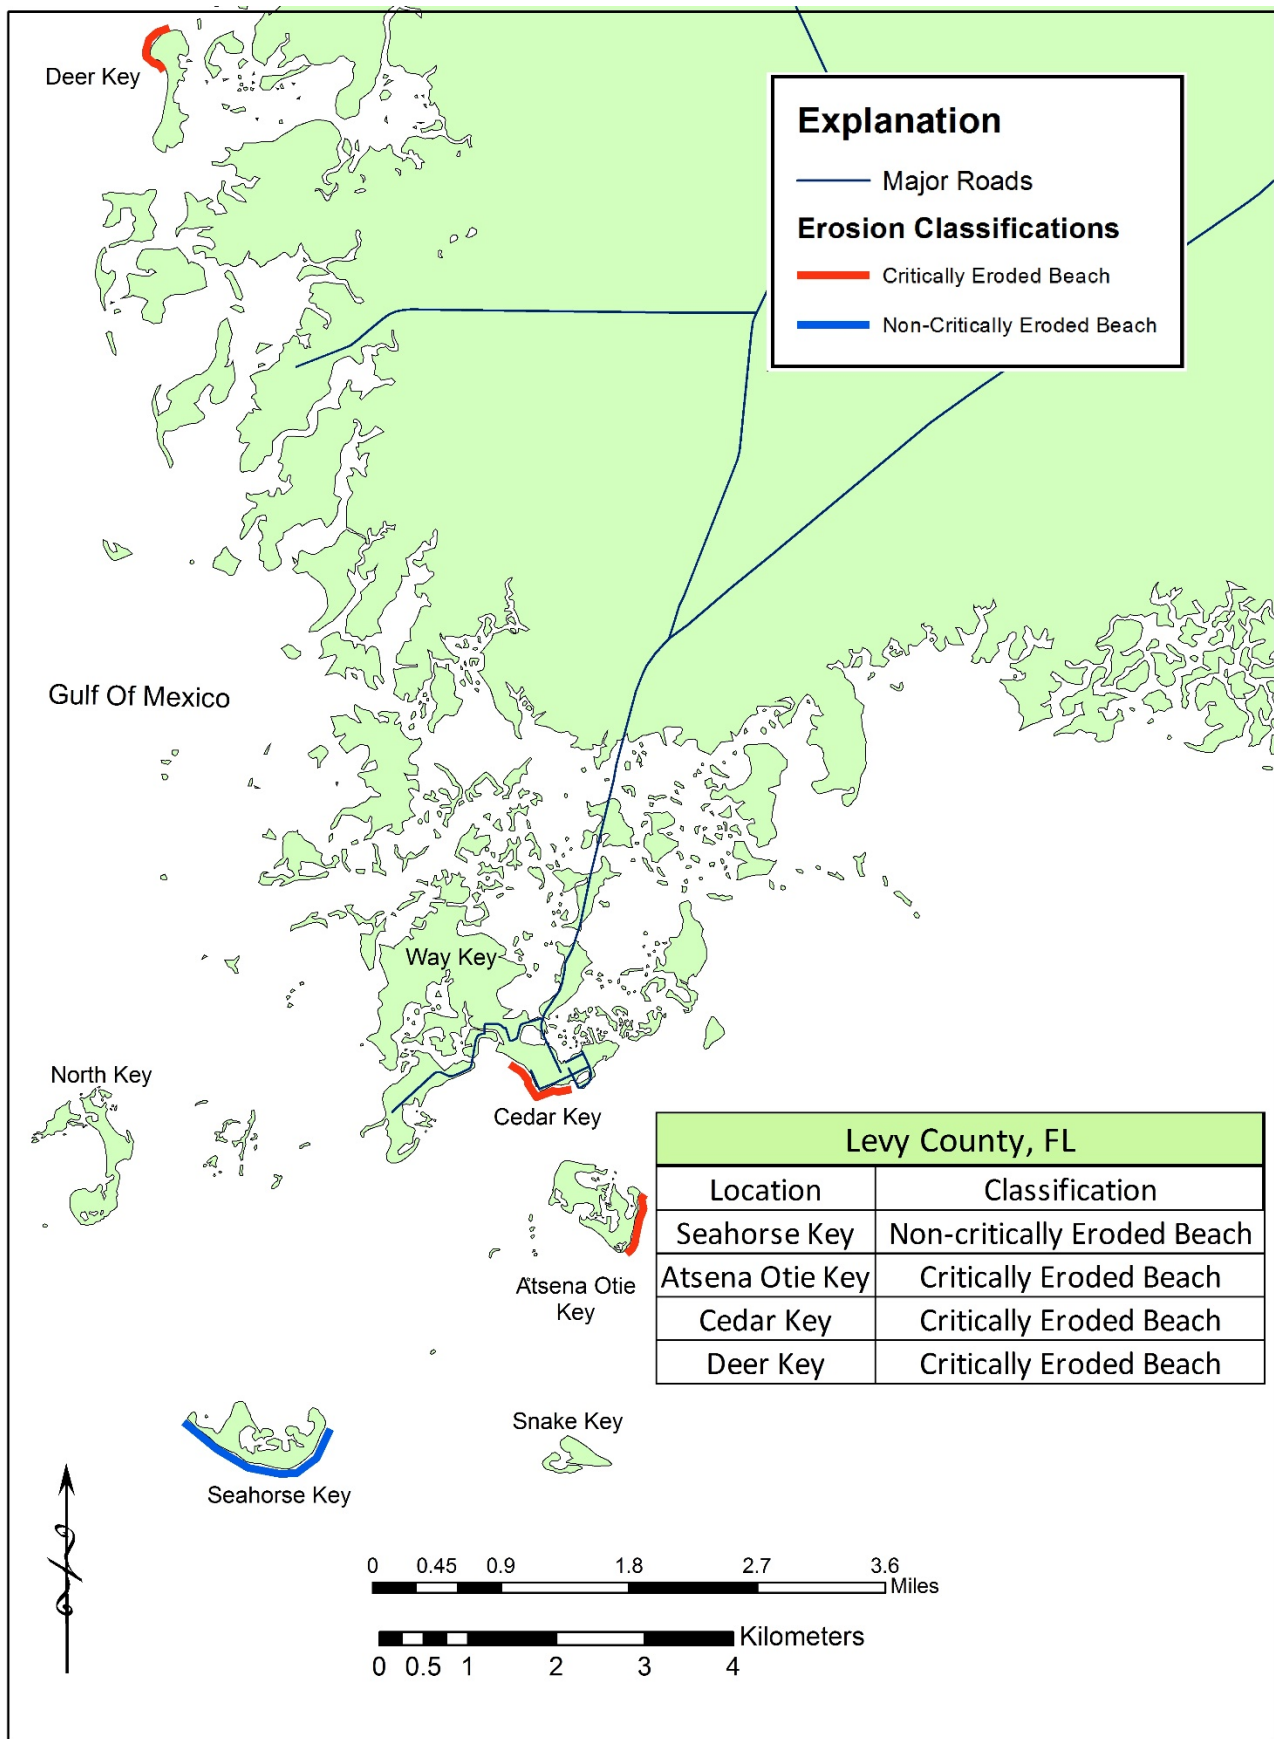
On the state-owned Atsena Otie Key, 0.2 mile of the east shoreline is critically eroded threatening the Seminole holding area and its grave sites of the Second Seminole War as well as other pre-Columbian graves from ancient occupation of the island.

Figure 24. Critically eroded shoreline within Levy County.

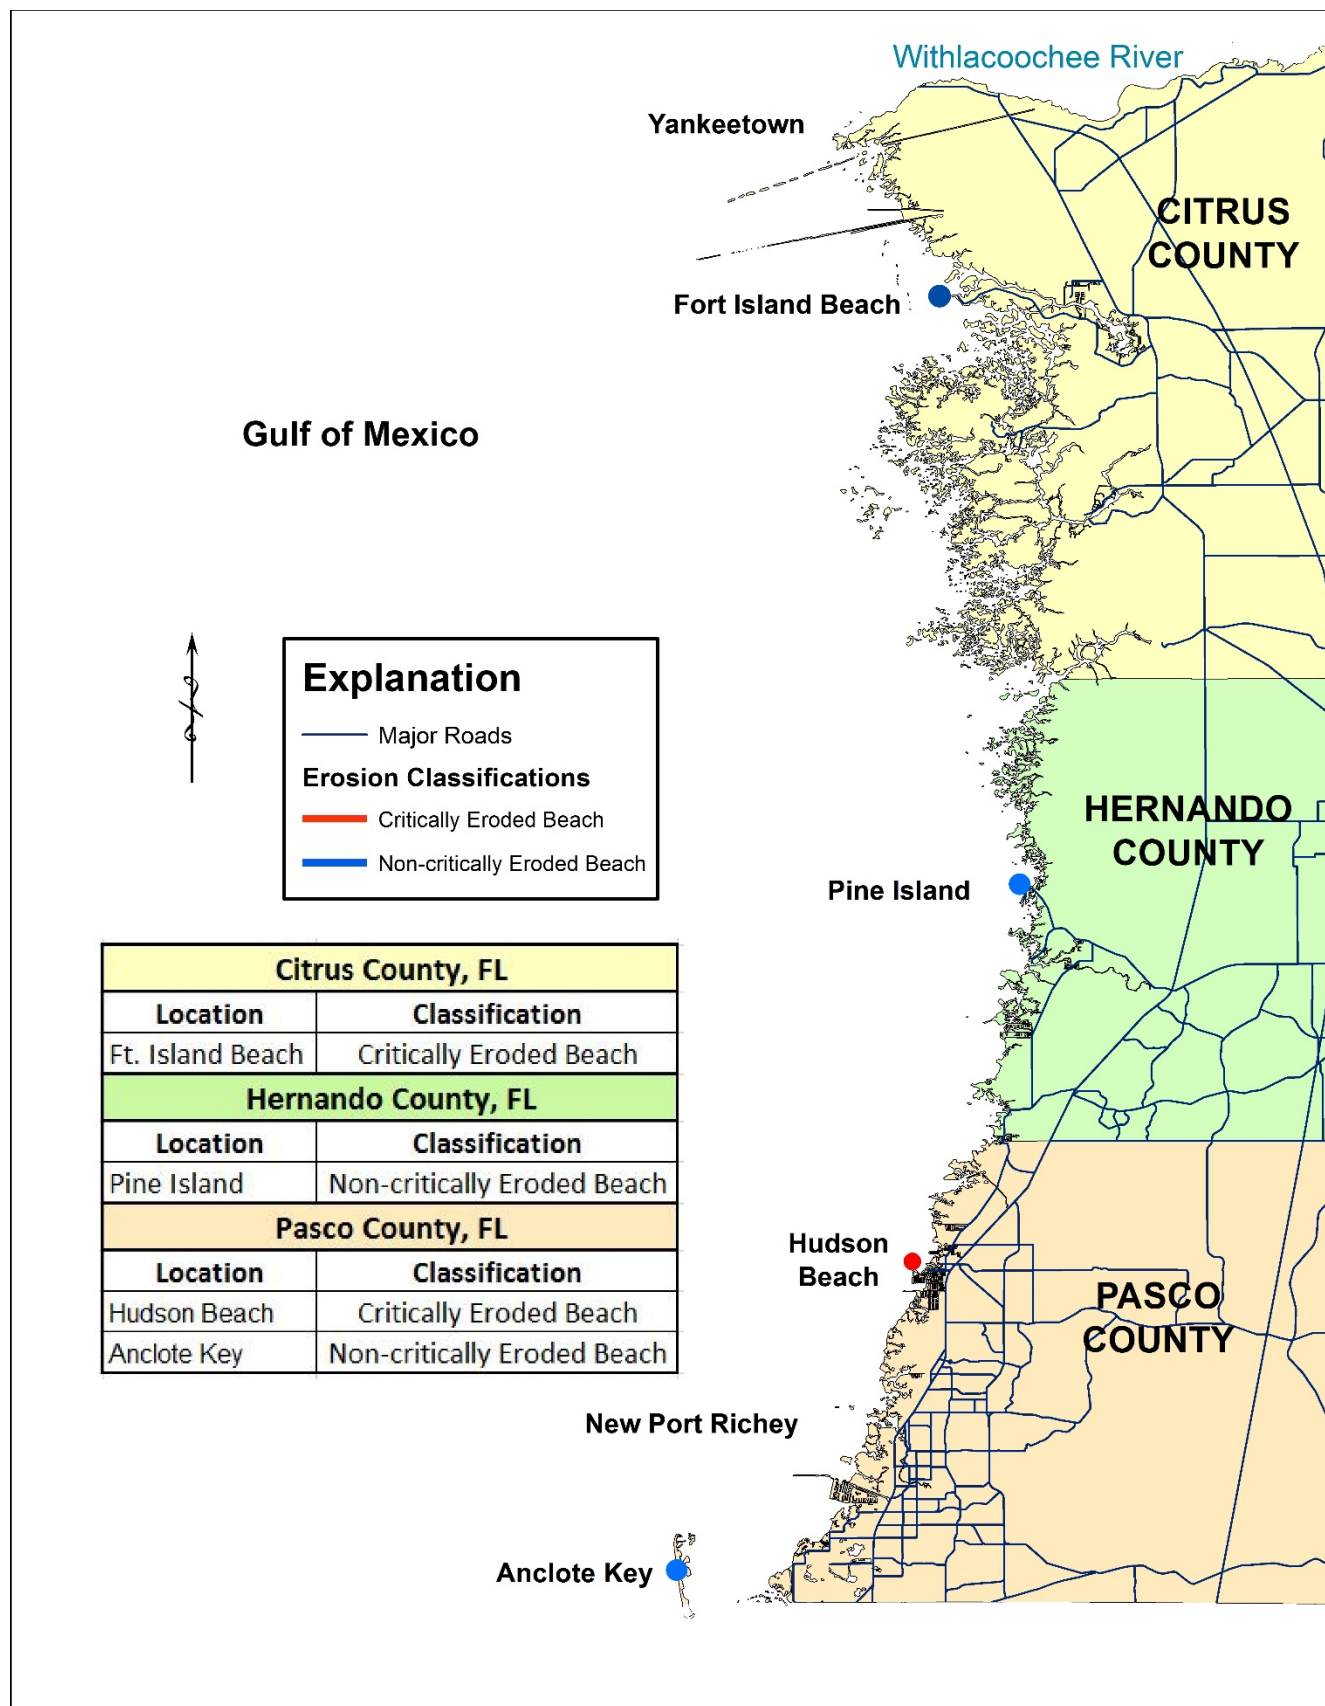
There is one critically eroded beach area (0.2 mile) and one non-critically eroded beach area (1.1 miles) in Pasco County. A small segment of public beach at Hudson Beach is critically eroded threatening recreational interests. Anclote Key has 1.1 miles of non-critically eroded beach.

Figure 25. Critically eroded shoreline within Citrus, Hernando and Pasco Counties.

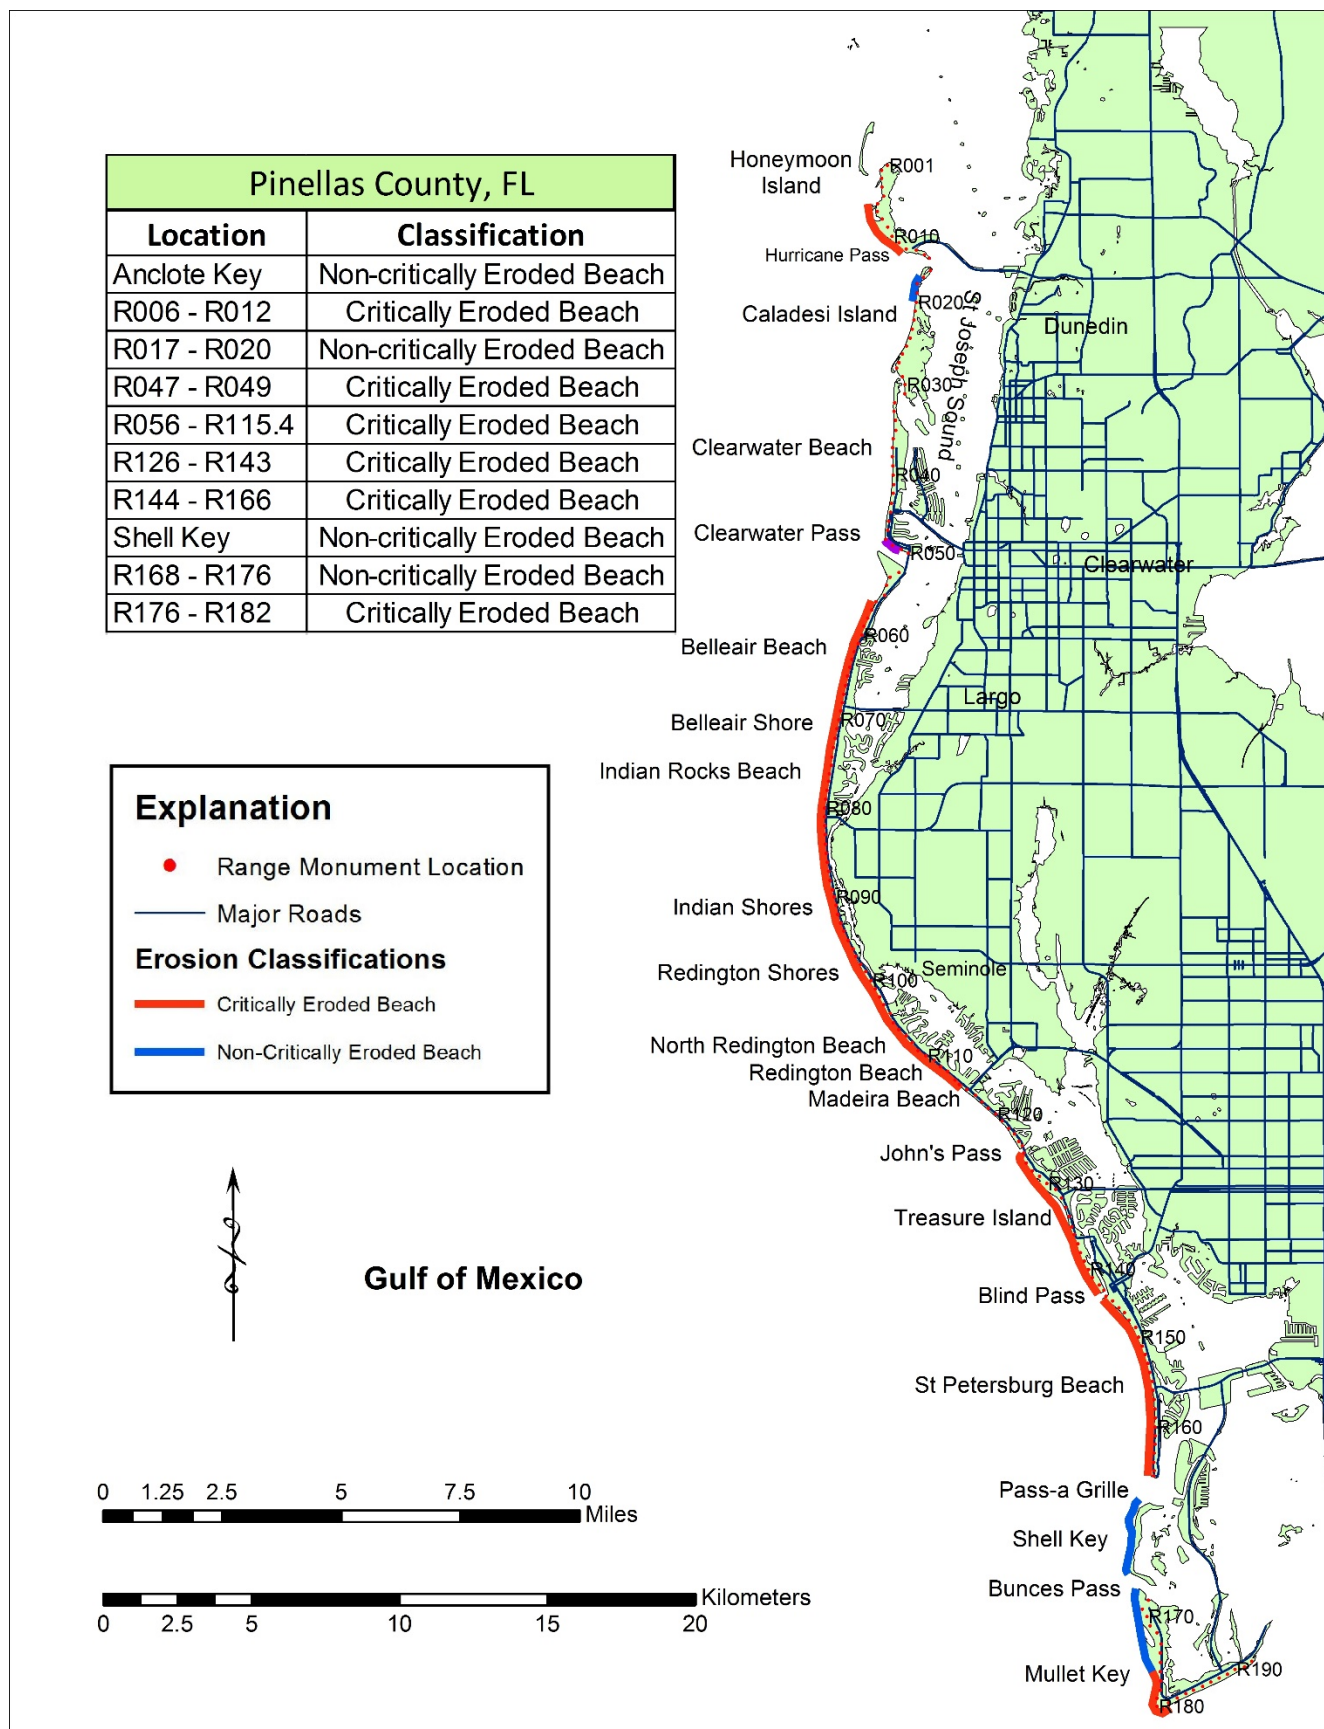
Beach fill has been placed in the past (most recently in 2007) using Egmont Channel maintenance dredge material.

Figure 26. Critically eroded shoreline within Pinellas County.

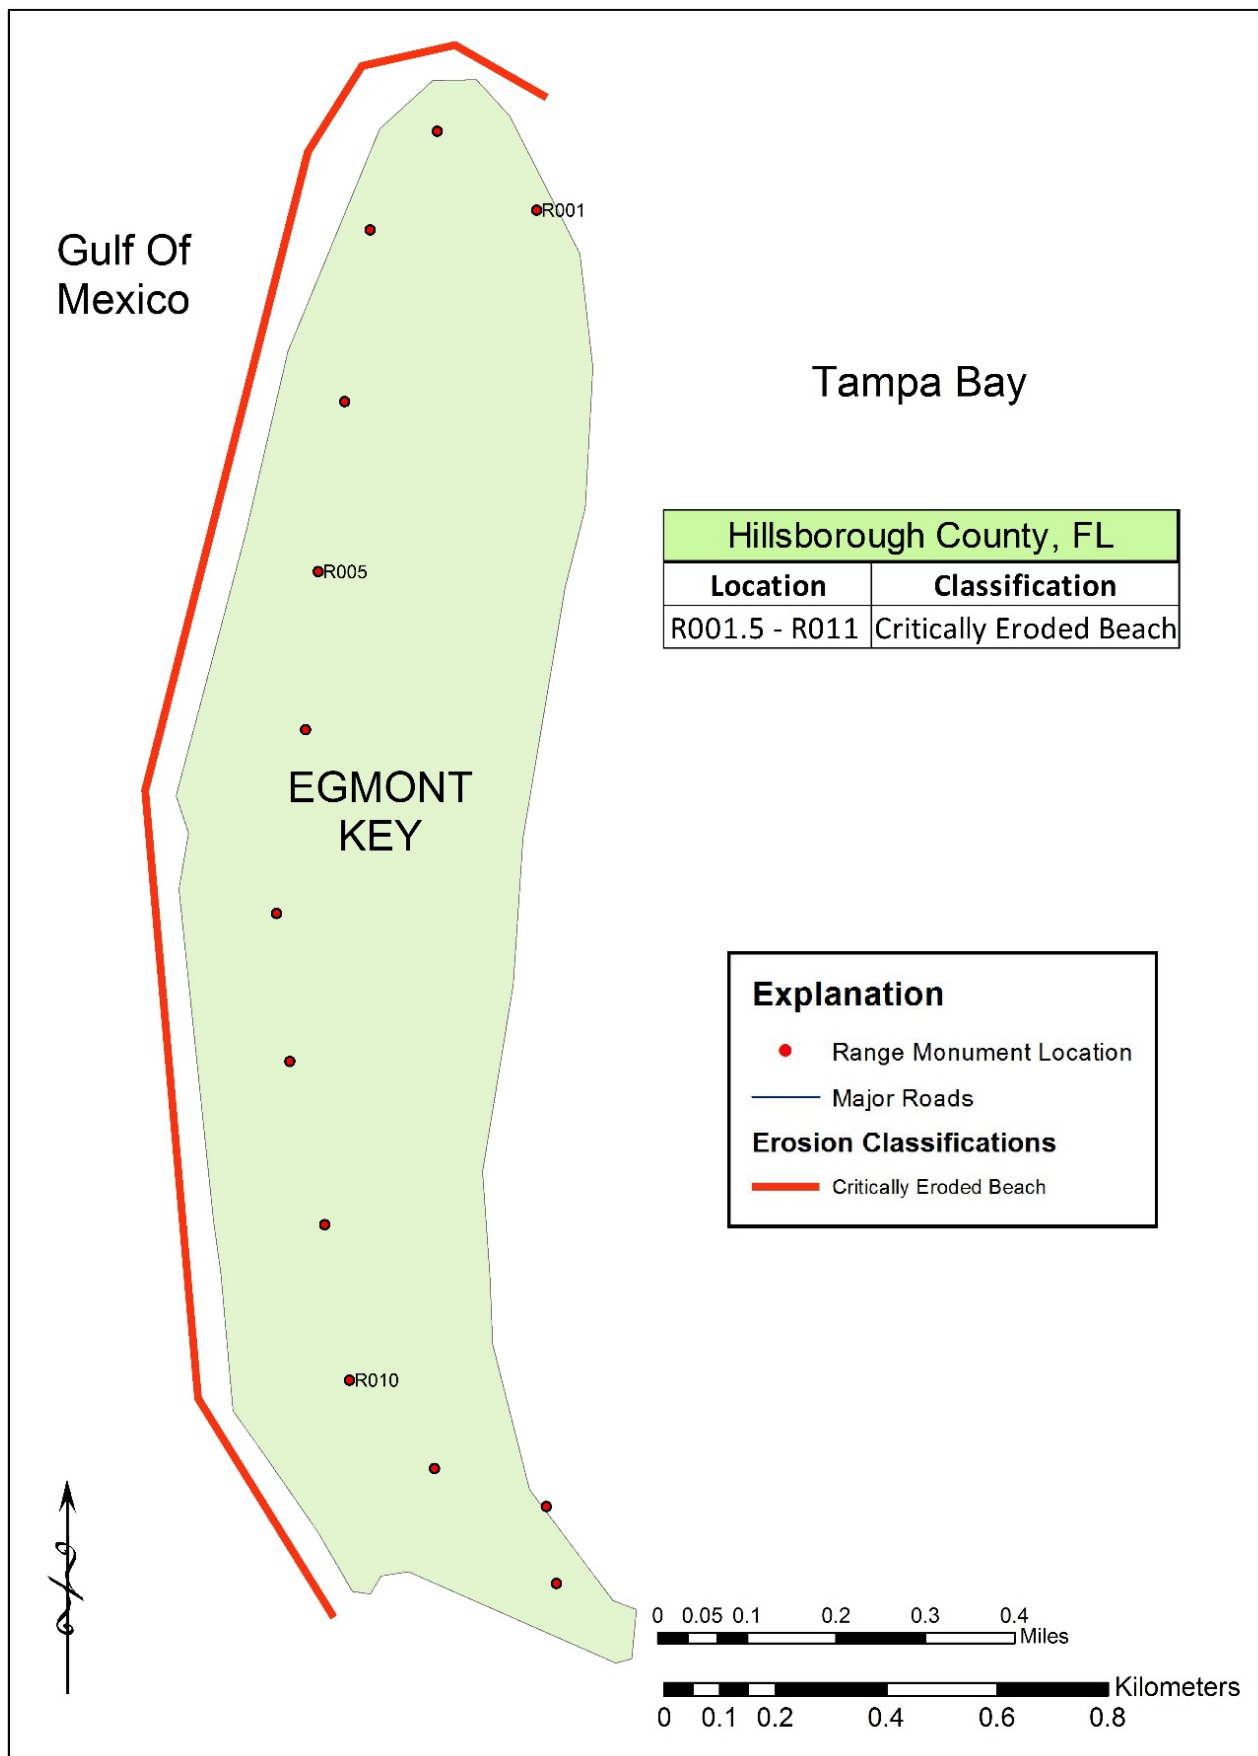
Hillsborough County has one coastal island, Egmont Key, at the entrance to Tampa Bay. Most of the length of Egmont Key (1.6 miles) is critically eroded threatening recreational interests and important cultural resources (*Figure 28*). A St. Petersburg harbor maintenance dredging project in December 2000, provided the material for nourishment of the north end of Egmont Key for the protection of three Spanish-American War era batteries. Nourishment projects using Egmont Channel maintenance dredging material were also conducted in 2006 and 2015.

Figure 27. Critically eroded shoreline within Hillsborough County.

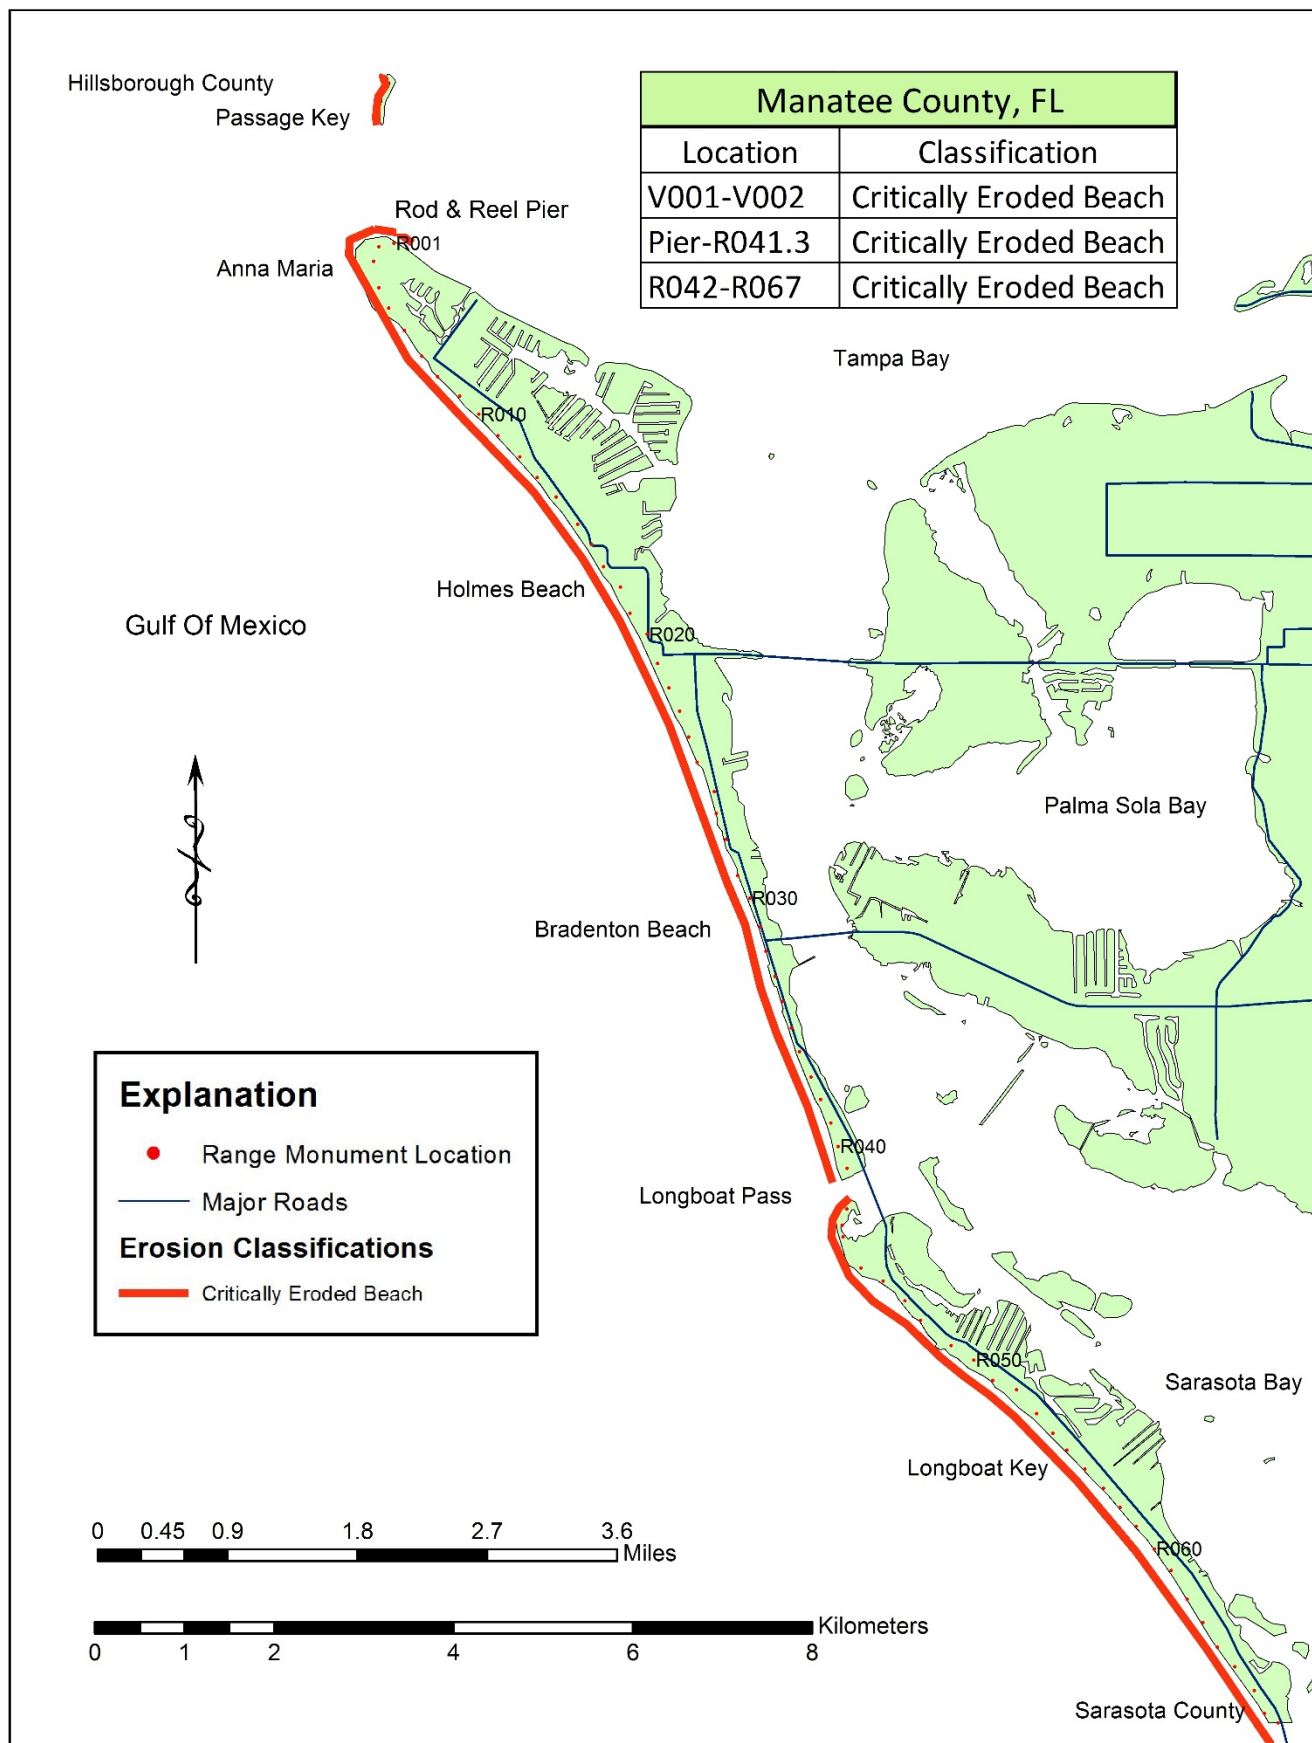
Between Longboat Pass and Sarasota County, the northern half of Longboat Key (R42-R67.3) has 4.8 miles of critically eroded beach that has threatened development and recreational interests. This barrier island has a beach restoration project, and numerous concrete bulkheads exist along the north end fronting the private development.

Figure 28. Critically eroded shoreline within Manatee County.

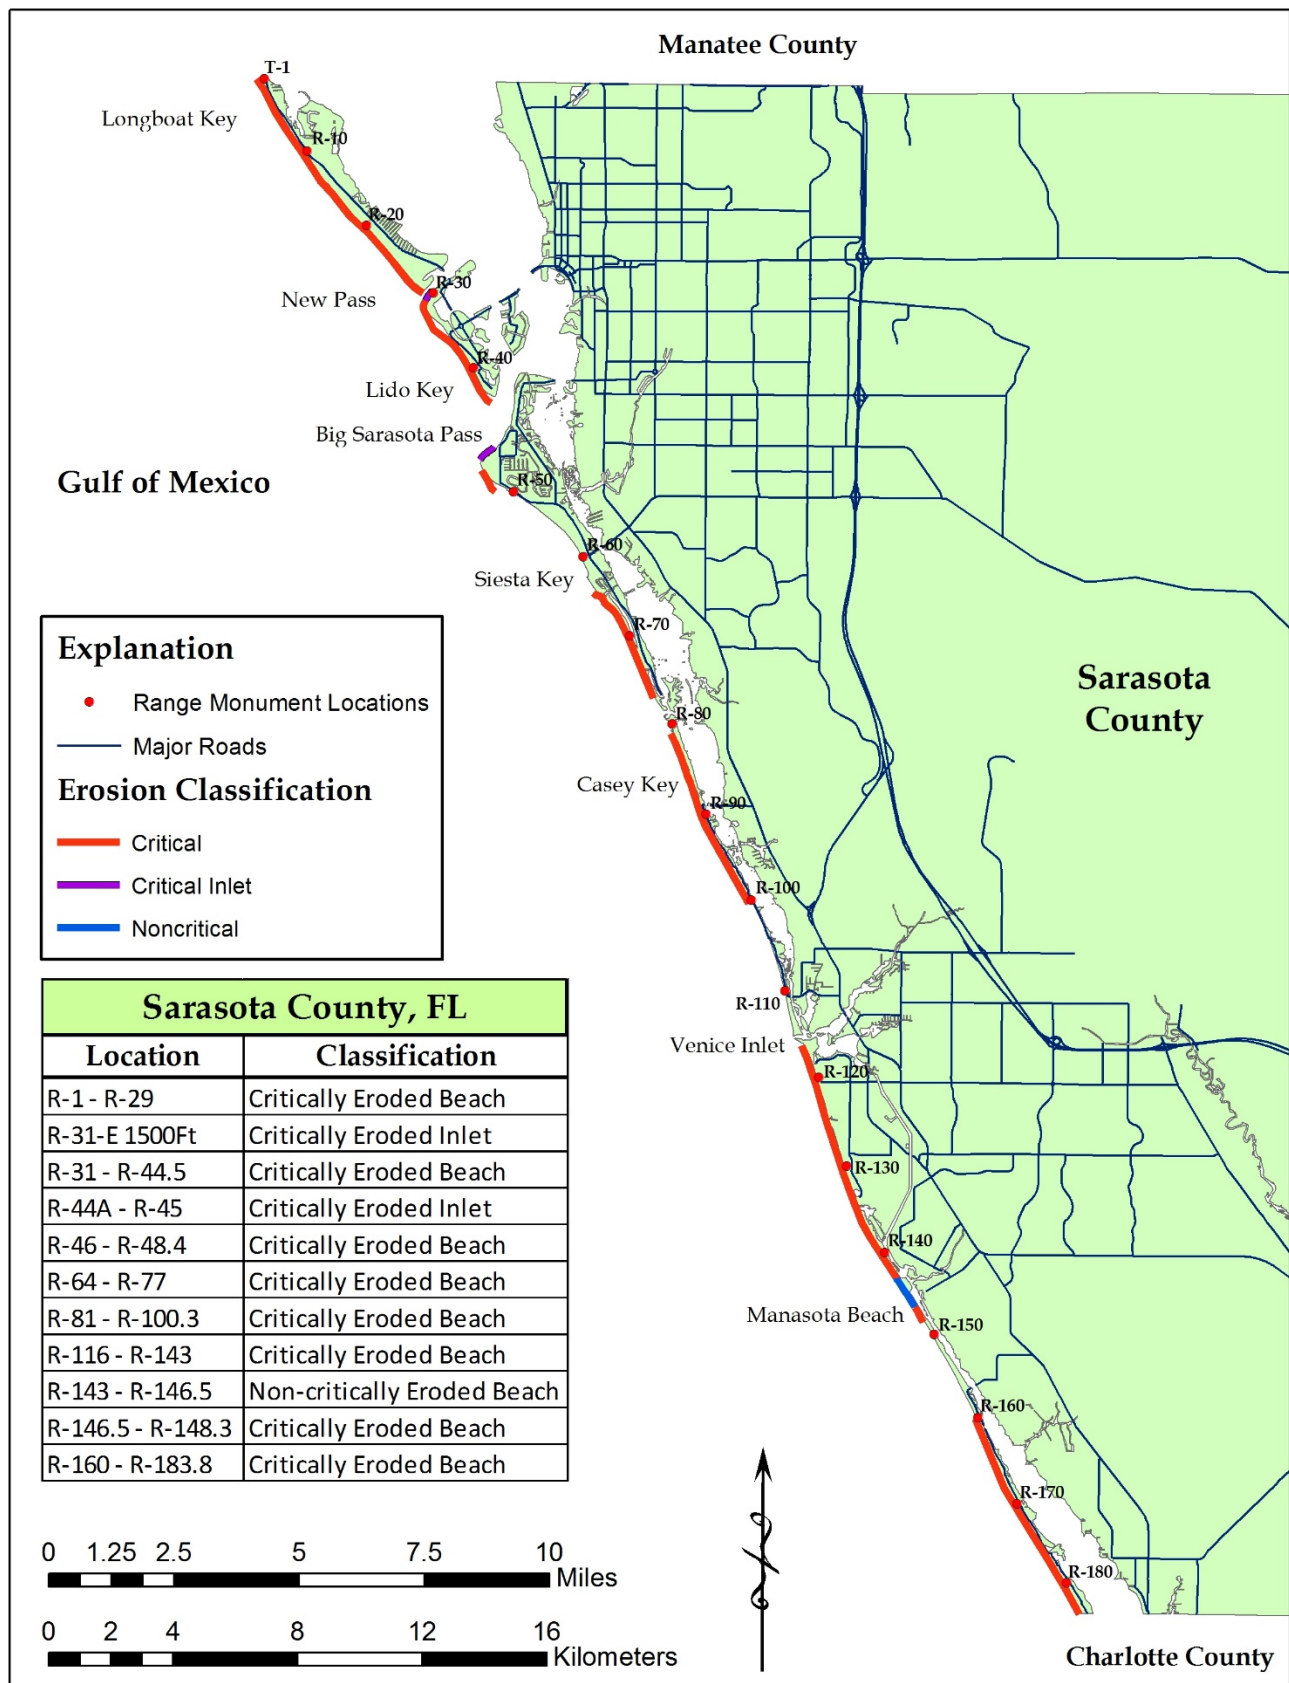
The south end of Sarasota County (R160-R183.7) is critically eroded for 4.5 miles along Manasota Key threatening private development as well as Manasota Key Road. Some rock revetments have been constructed in this area.

Figure 29. Critically eroded shoreline within Sarasota County.

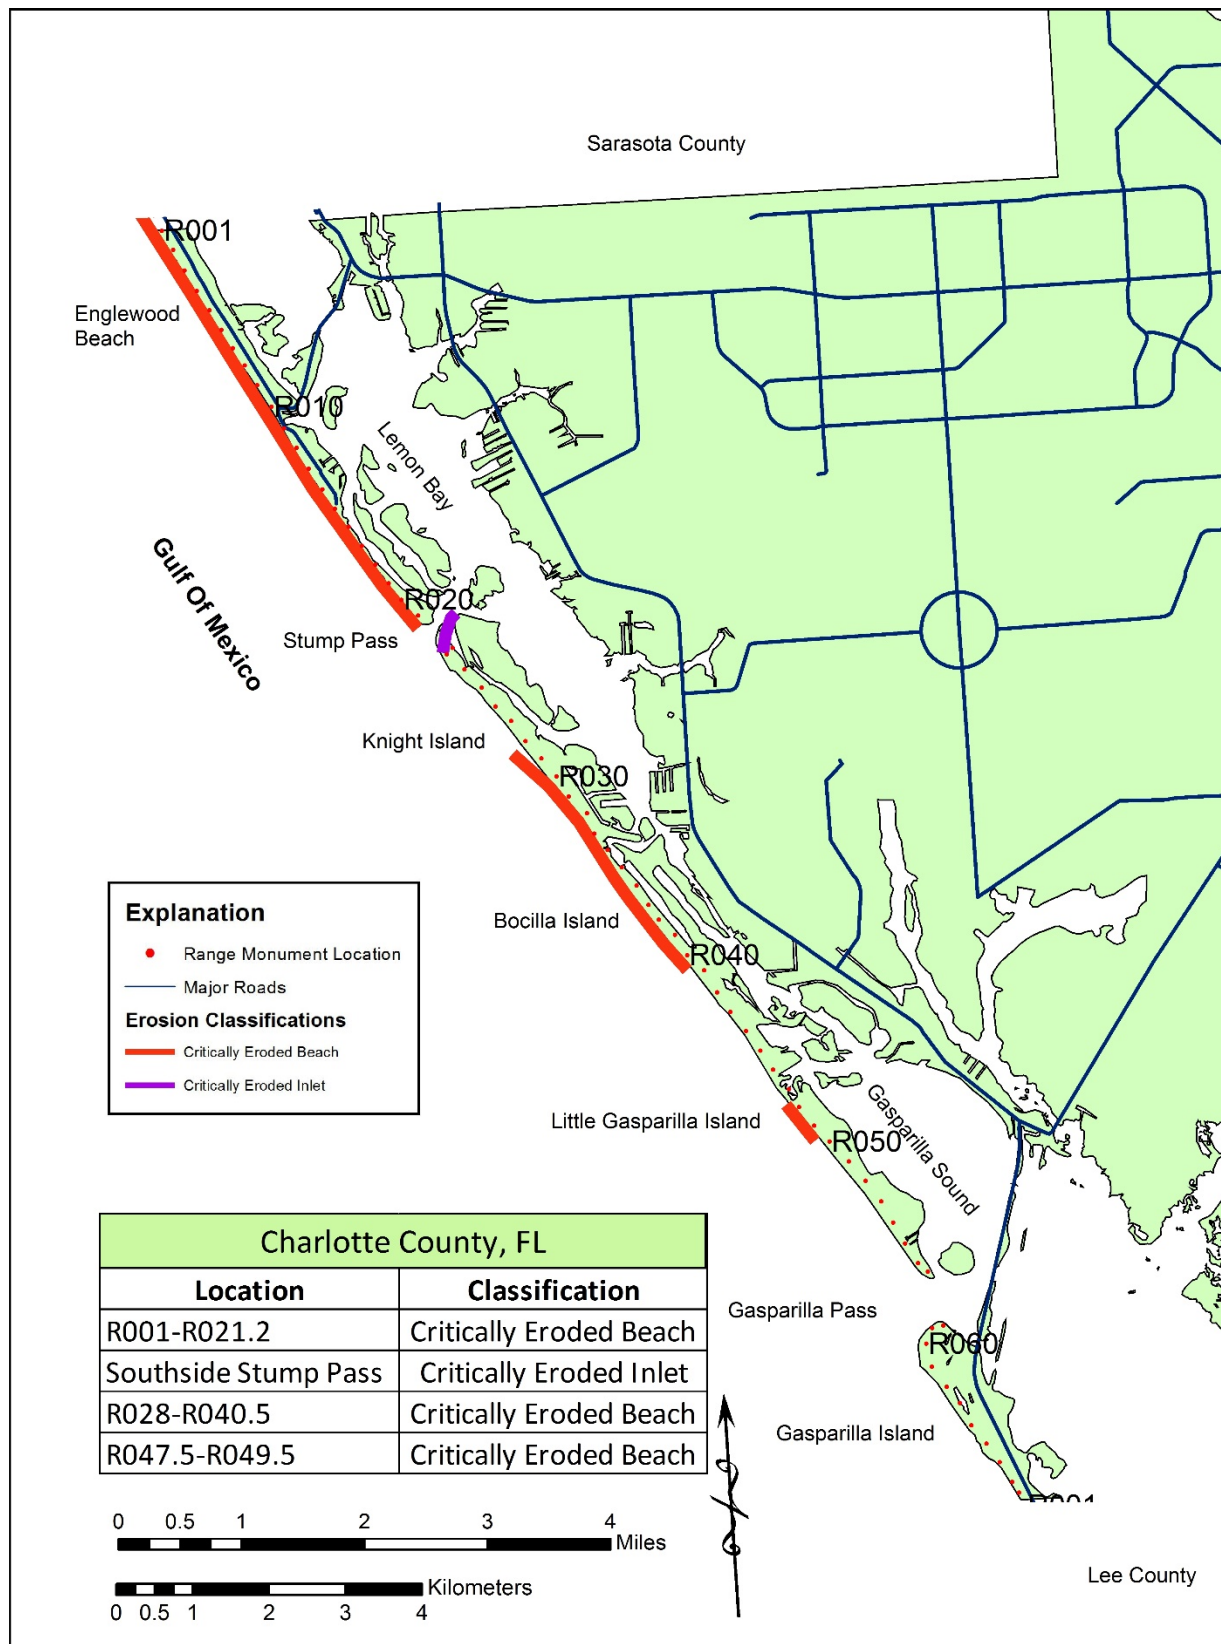
South of Little Gasparilla Pass, which is closed, is a 0.4-mile segment of critically eroded beach on Little Gasparilla Island. This erosion threatens private development.

Figure 30. Critically eroded shoreline within Charlotte County.
