# ***Critically Eroded Beaches In Florida***

**Division of Water Resource Management  
Florida Department of Environmental Protection  
June 2017**

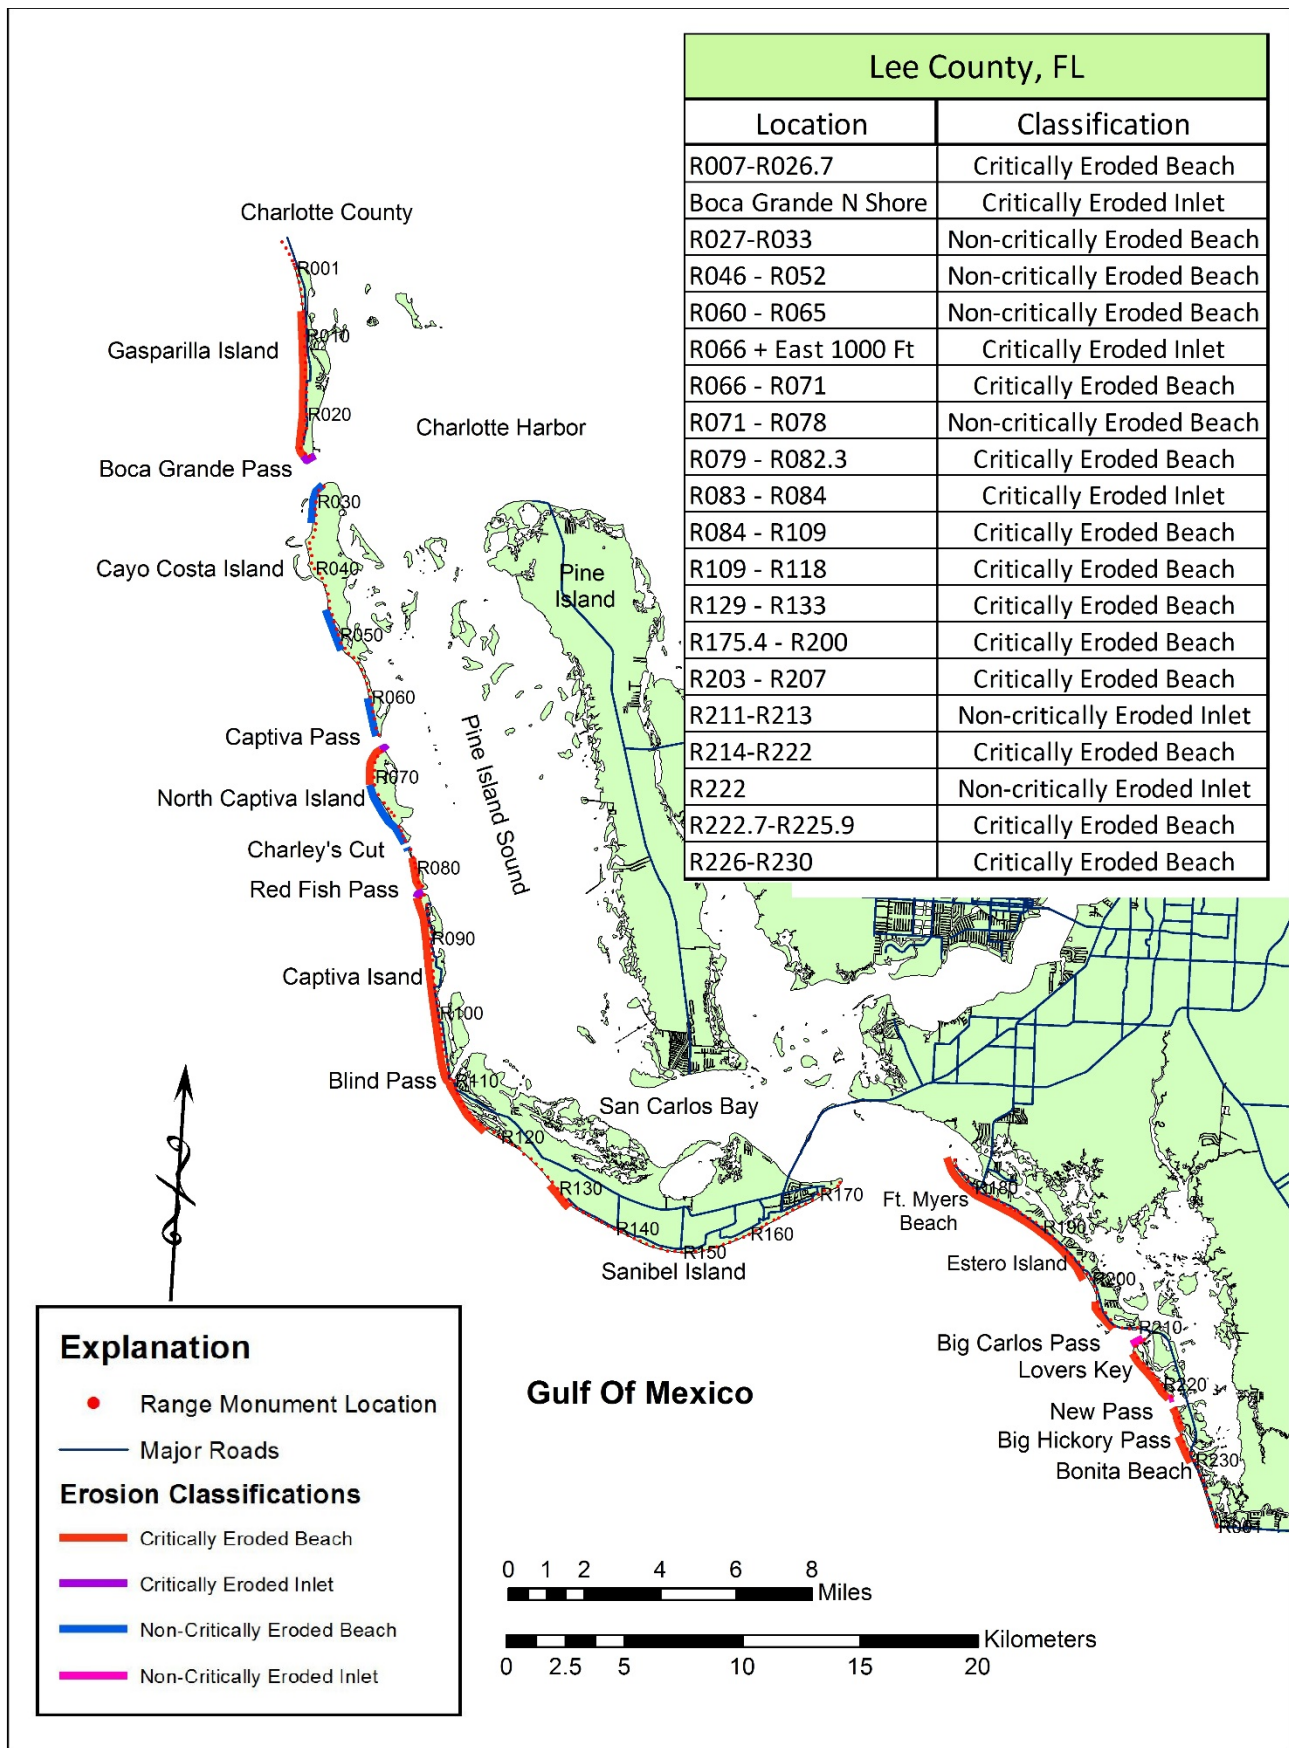
Between New Pass and Big Hickory Pass, Big Hickory Island (R222.7-R225.9) has 0.8 mile that is critically eroded where wildlife habitat and recreation has been lost. South of Big Hickory Pass, Little Hickory Island (R226-R230) has 0.9 mile of critically eroded beach threatening development interests in Bonita Beach. This area has a beach restoration project with bulkheads and two terminal groins at the north end.

Figure 31. Critically eroded shoreline within Lee County.

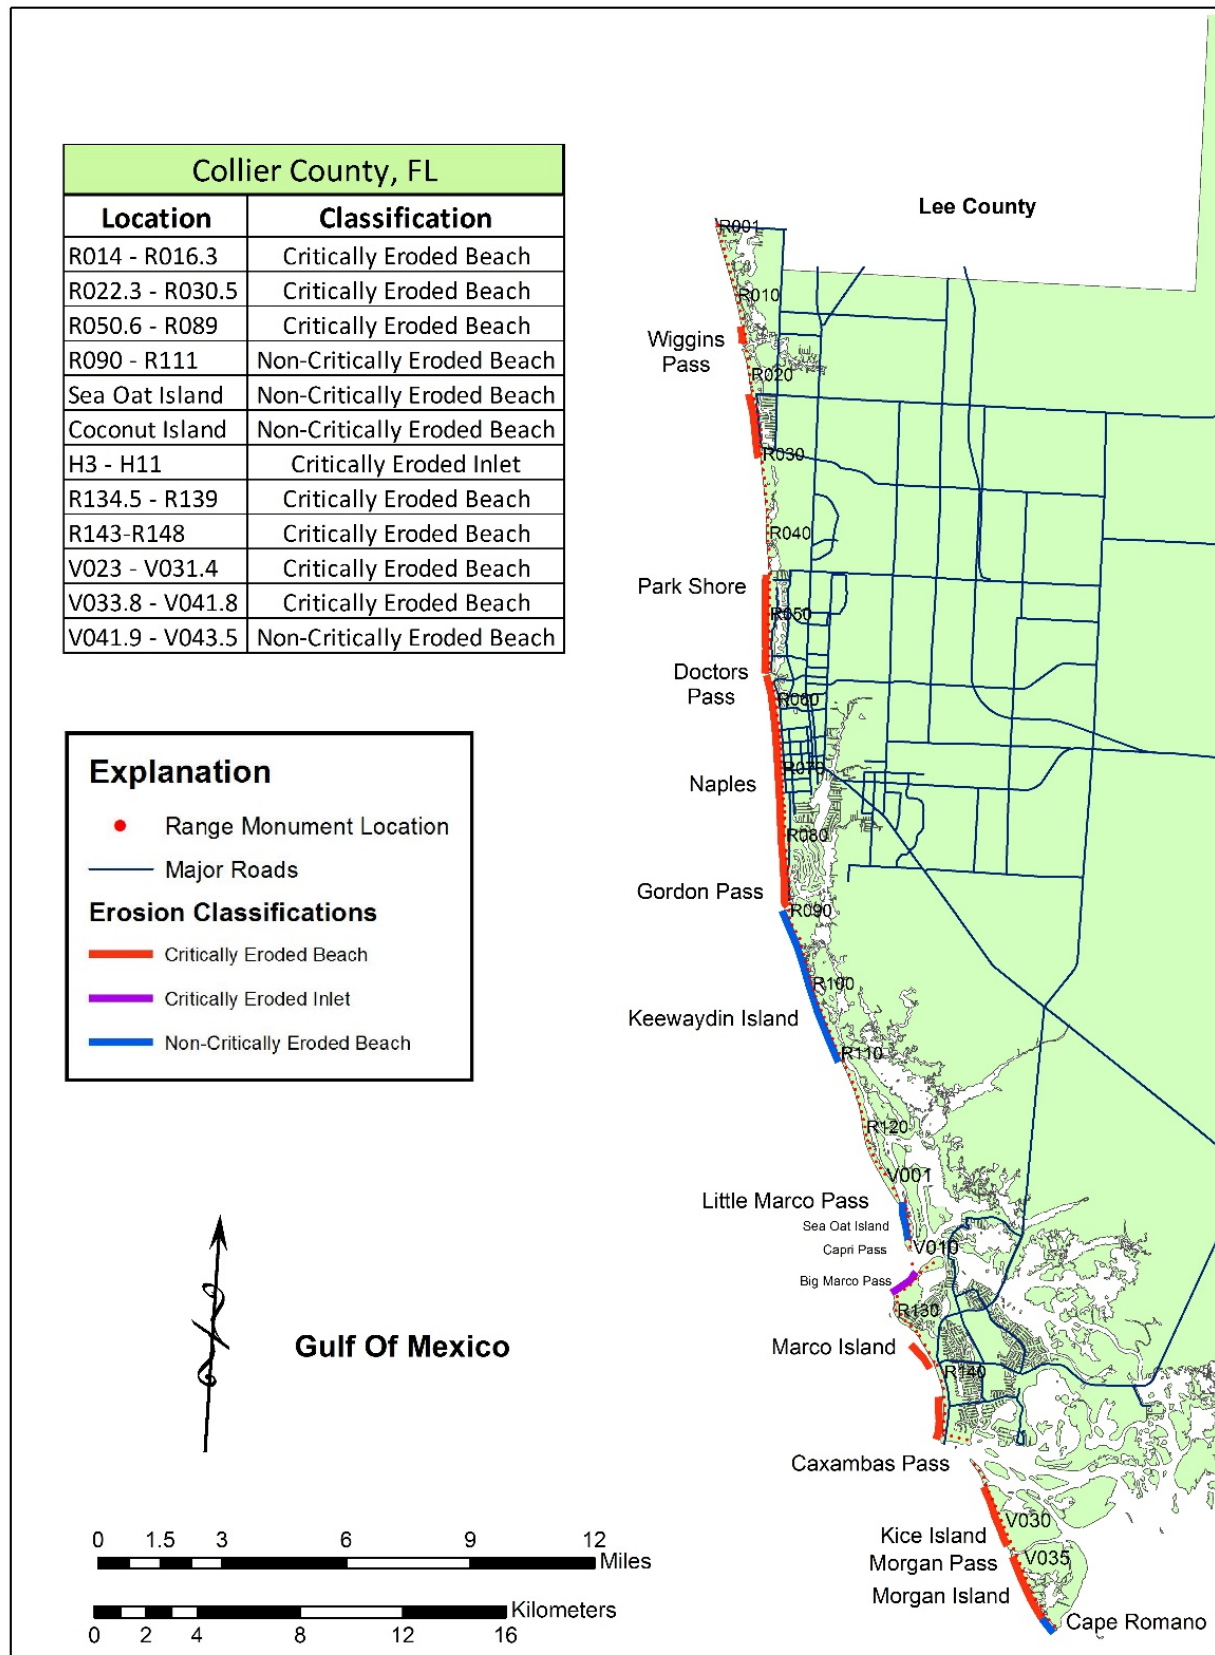
Erosion on the two southern barrier islands in Collier County has progressed into the backshore mangrove forest resulting in the loss of beach wildlife habitat. Following Hurricane Wilma (2005), a 1.6-mile segment of Kice Island (V23-V31.4) is critically eroded. South of Morgan Pass, Morgan Island has a 1.5-mile segment (V33.8-V41.8) that is critically eroded and a 0.3-mile segment (V41.8-V43.5) that is non-critically eroded.

Figure 32. Critically eroded shoreline within Collier County.
