# EcoSummary

BioRecon Report

## Open Branch below Eglin Road 214/374, Walton County July 18, 2000

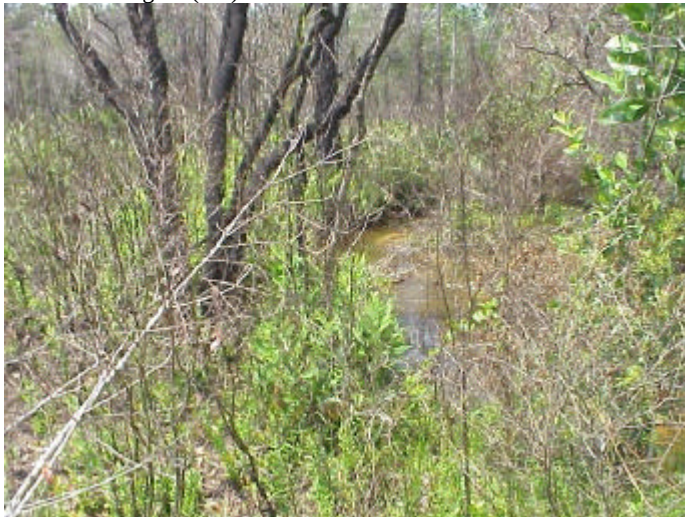
Although the biometrics passed the thresholds, only 3 specimens of stoneflies, clean water indicators were found. Tolerant hydropsychid caddisflies and midges usually found below impoundments dominated the sample. Sediment loading, hydrological and buffer zone modifications negatively impacted fish and wildlife in this stream reach. Stream habitats were smothered by silt/sand (84%) from road sediments and weapons test range C-72 runoff. The Eglin Road 214/374 culverts and fill material used to span the stream and riparian zone acted as a dam. The culverts created a waterfall barrier to upstream fish migration. Compared to other local streams, hydrological modifications to Open Branch had increased water temperature by 3.9° C, lowered the dissolved oxygen concentration by

1.8 mg/l, and created a new channel after the original filled with sediment. Human disturbance reduced the east bank riparian buffer zone to a width of 1 meter. The riparian zone's tree canopy was eliminated in much of the lower reach as silvicultural management burned to the water. The riparian zone canopy cover originally consisted of an Atlantic white cedar type forest, which heavily shaded the stream.

Removing road fill and replacing with a bridge spanning Open Branch Creek and its floodplain would help restore the stream's natural morphological characteristics. Adding habitat such as large woody debris, along with stream bank protection and channel restoration during the stream rehabilitation program for the Okaloosa Darter should enhance fish and wildlife productivity and diversity. Proper placement of large pine logs along the stream bank would enhance riffle/pool habitat (velocity and depth) for the darters and other stream wildlife. Riparian buffer zones greater than 18 meters should be created and maintained. The buffer zones provide the shade, food, habitat (woody debris/leaf fall) and filter runoff necessary for the propagation of Open Branch's biota. Restoration of the stream's natural hydrology (i.e. increase depth/width ratio) and riparian forests (replanting native Atlantic white cedars, allowing streamside tree growth) buffer zones would benefit the watershed's fish and wildlife including the endangered Okaloosa darter. For more information, contact Donald Ray, FDEP Northwest District, 160 Governmental Center, Pensacola, FL 32501 (850) 595-8300 x1126 or SC 695-8300
