# EcoSummary

BioRecon Report

## Hickory Hammock Branch below lower Coachman Road Santa Rosa County February 24, 2000

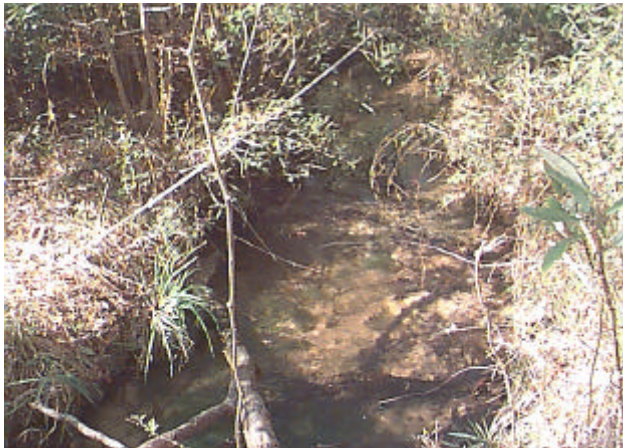
Hickory Hammock Branch at the bioassessment site is a second order stream originating near Hickory Hammock Church south of I-10. The creek is located about 3 miles southeast of Milton in Santa Rosa County (Lat. 30° 35' 01.1" Long. 86° 58' 53.8"). This stream flows to Ward Basin in Blackwater Bay, east of Petersen Point, then into Pensacola Bay. This site drains the Gulf Coast Flatwoods subcoregion (75a).
