## **Appendix B**

### **Beach Profile Plots**

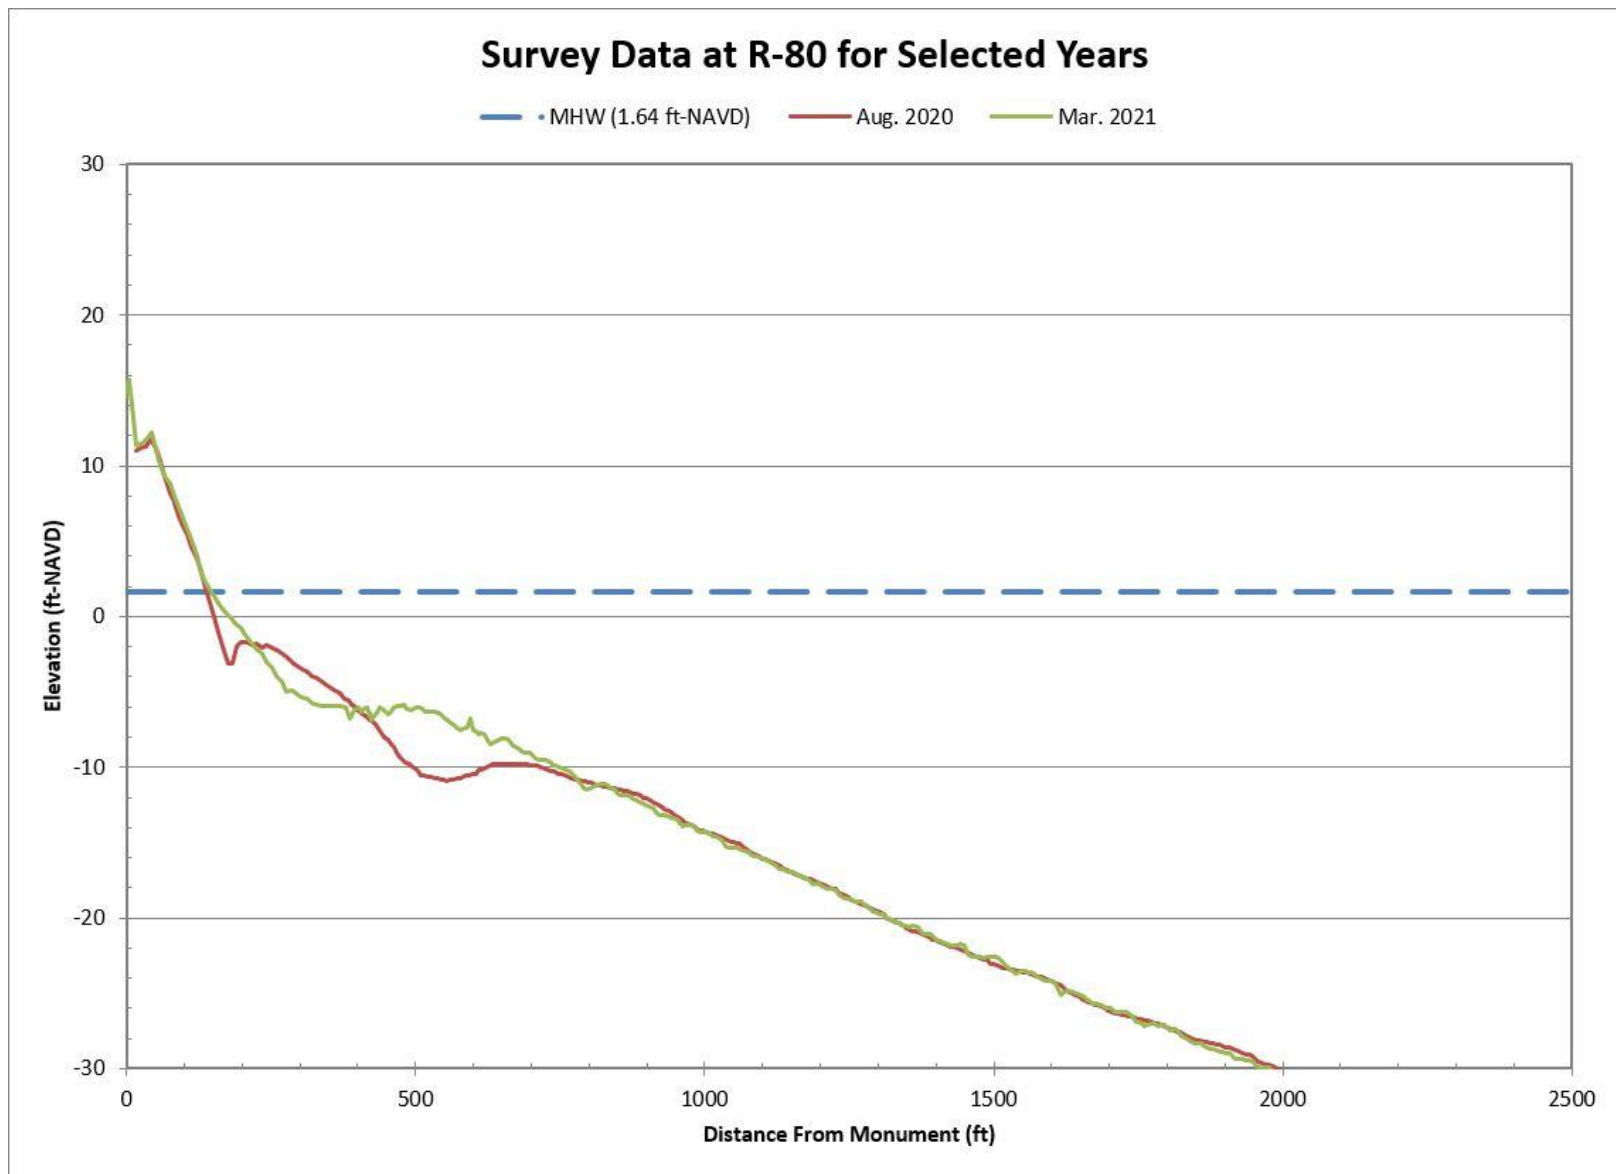
**Figure B-1. Aug. 2020 Pre-Construction vs. Mar. 2021 Post-Construction Beach Profiles Along R-80**

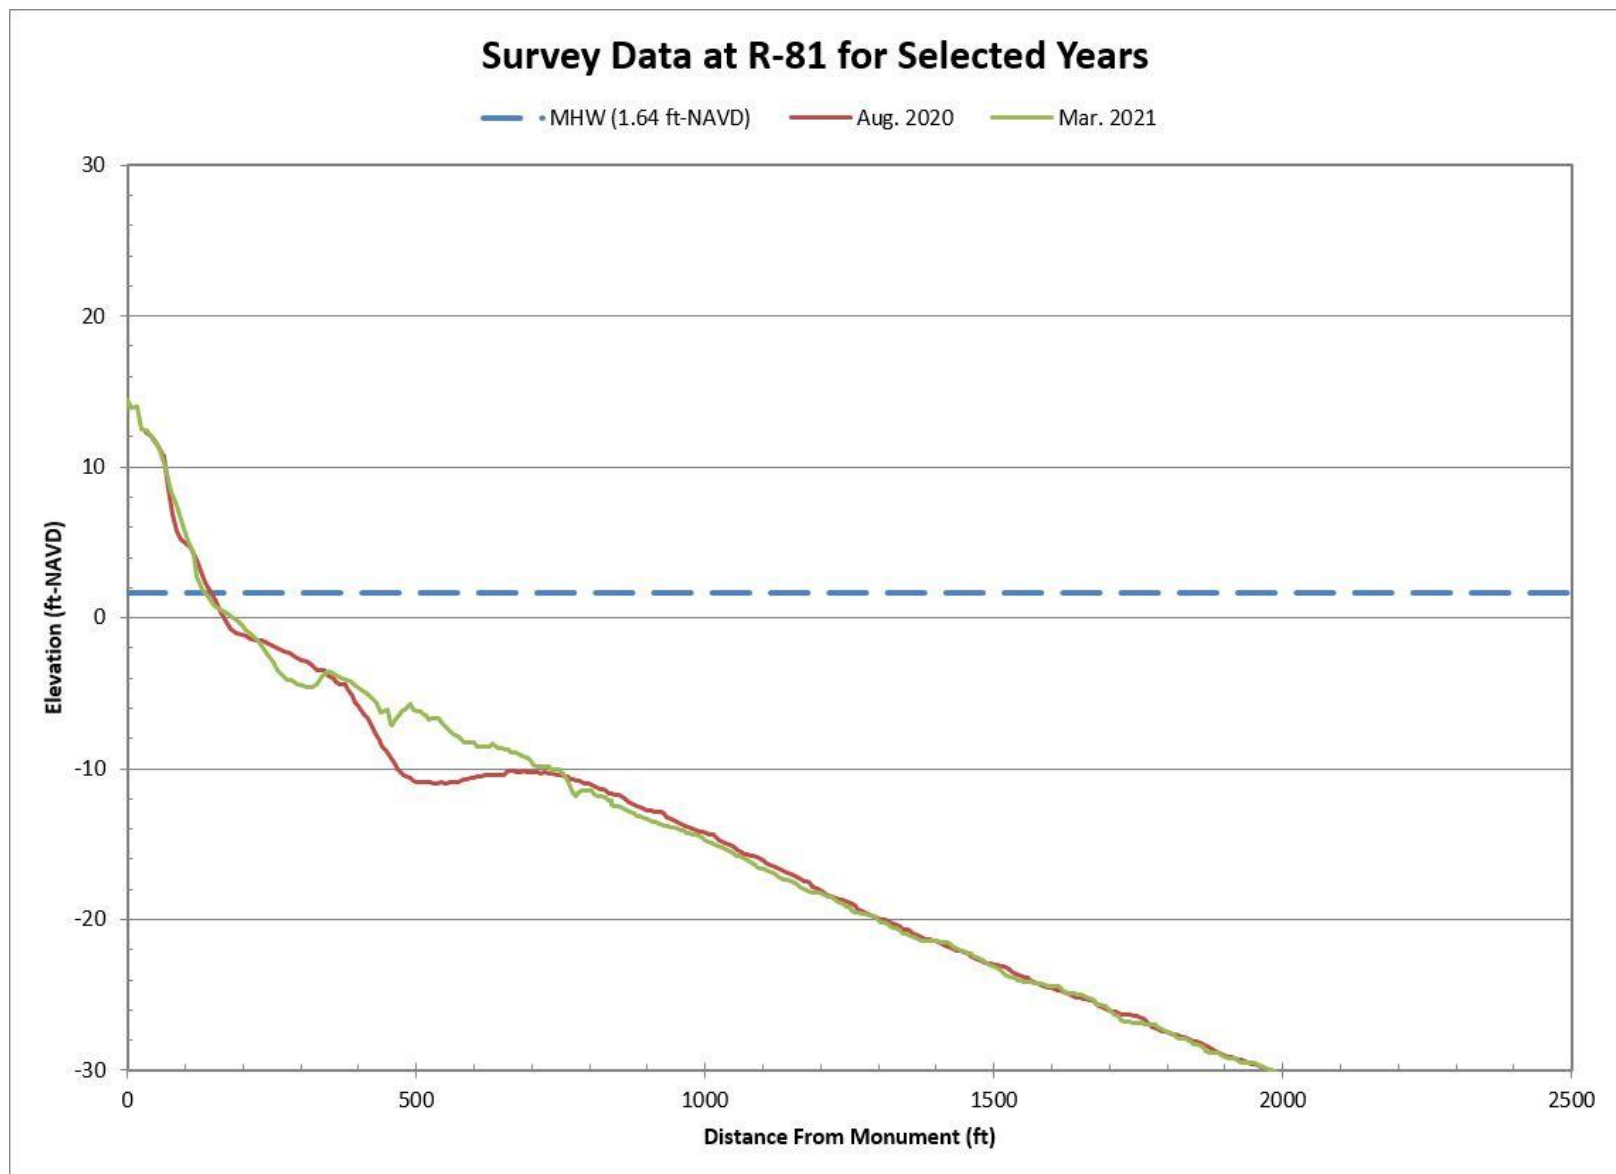
**Figure B-2. Aug. 2020 Pre-Construction vs. Mar. 2021 Post-Construction Beach Profiles Along R-81**

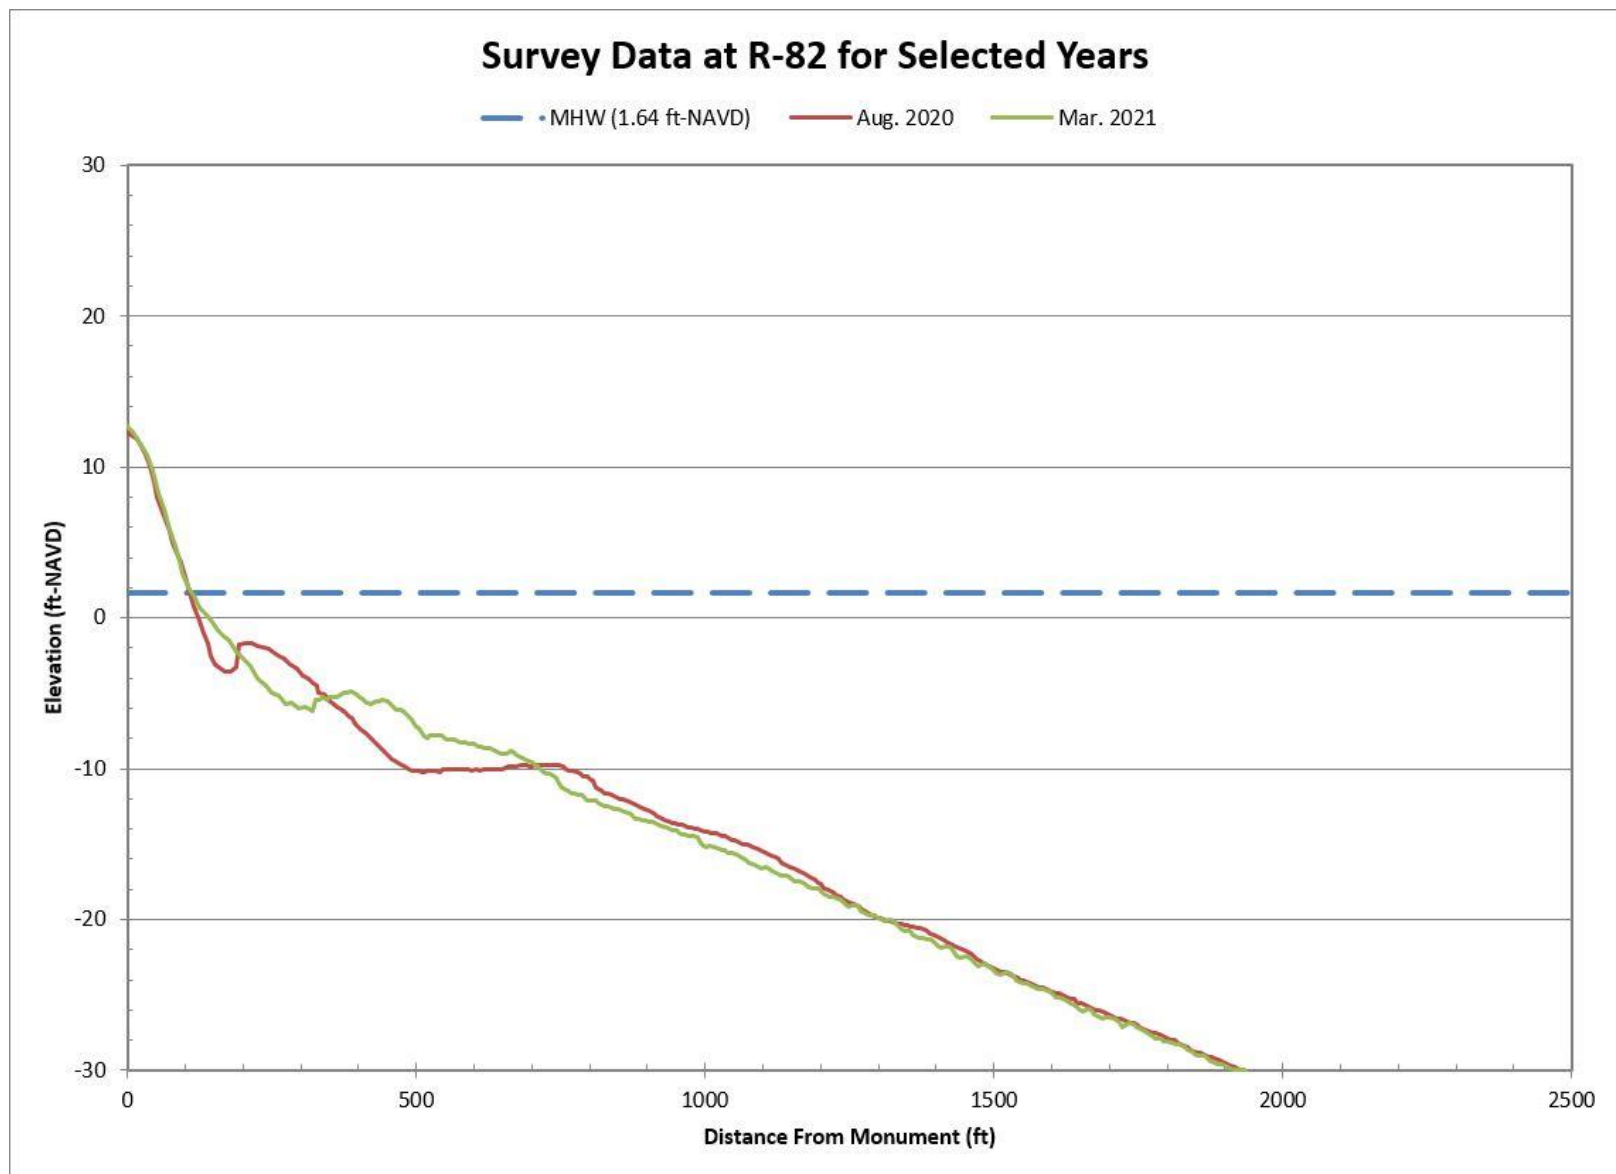
Figure B-3. Aug. 2020 Pre-Construction vs. Mar. 2021 Post-Construction Beach Profiles Along R-82

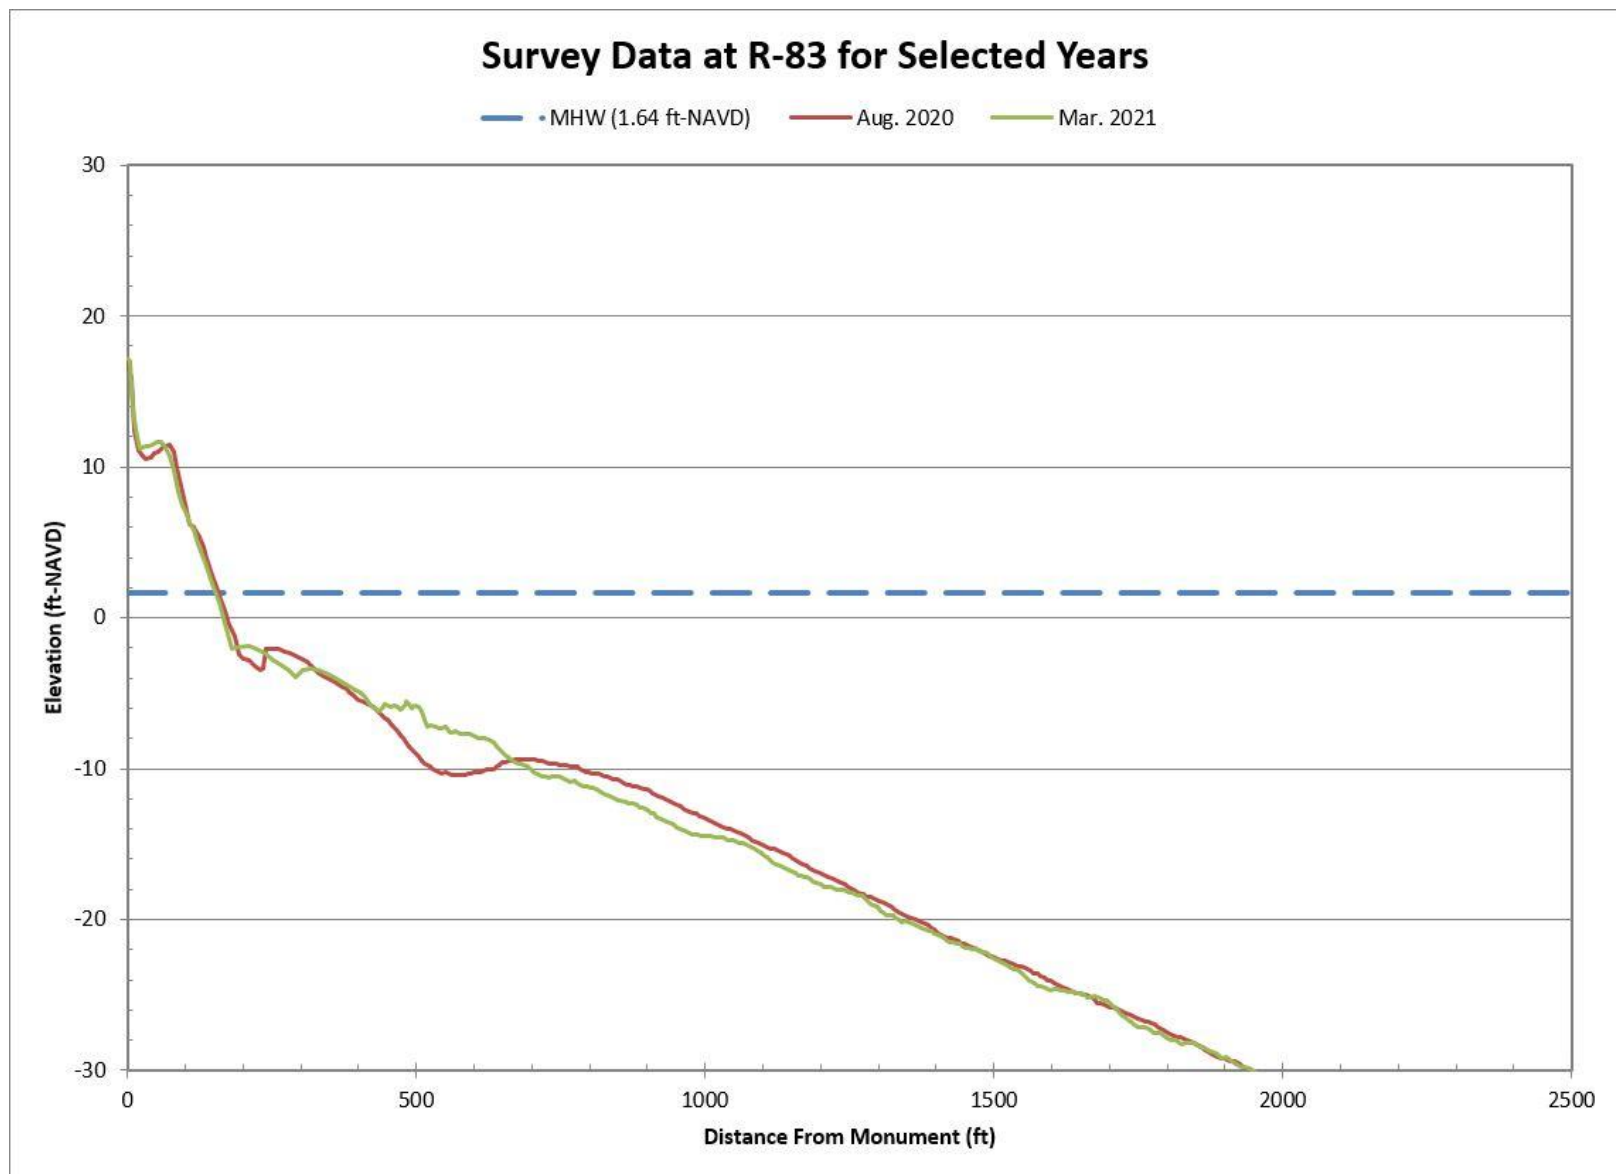
**Figure B-4. Aug. 2020 Pre-Construction vs. Mar. 2021 Post-Construction Beach Profiles Along R-83**

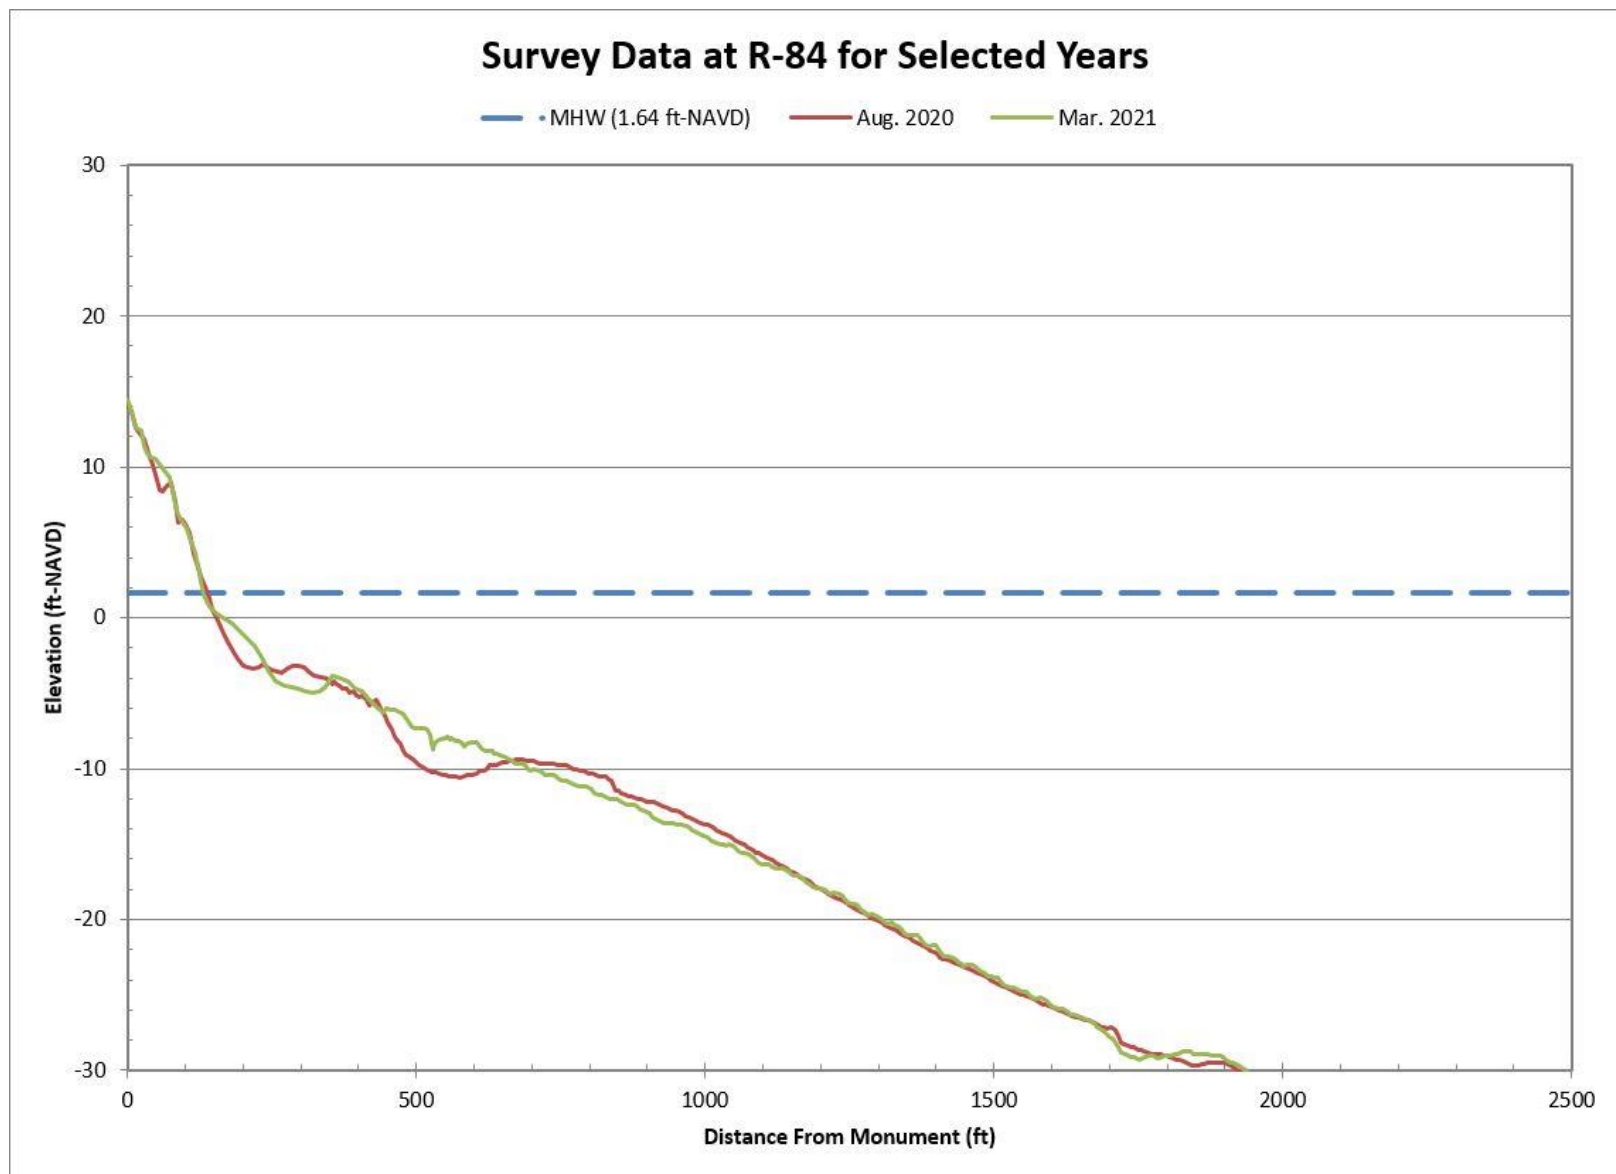
Figure B-5. Aug. 2020 Pre-Construction vs. Mar. 2021 Post-Construction Beach Profiles Along R-84

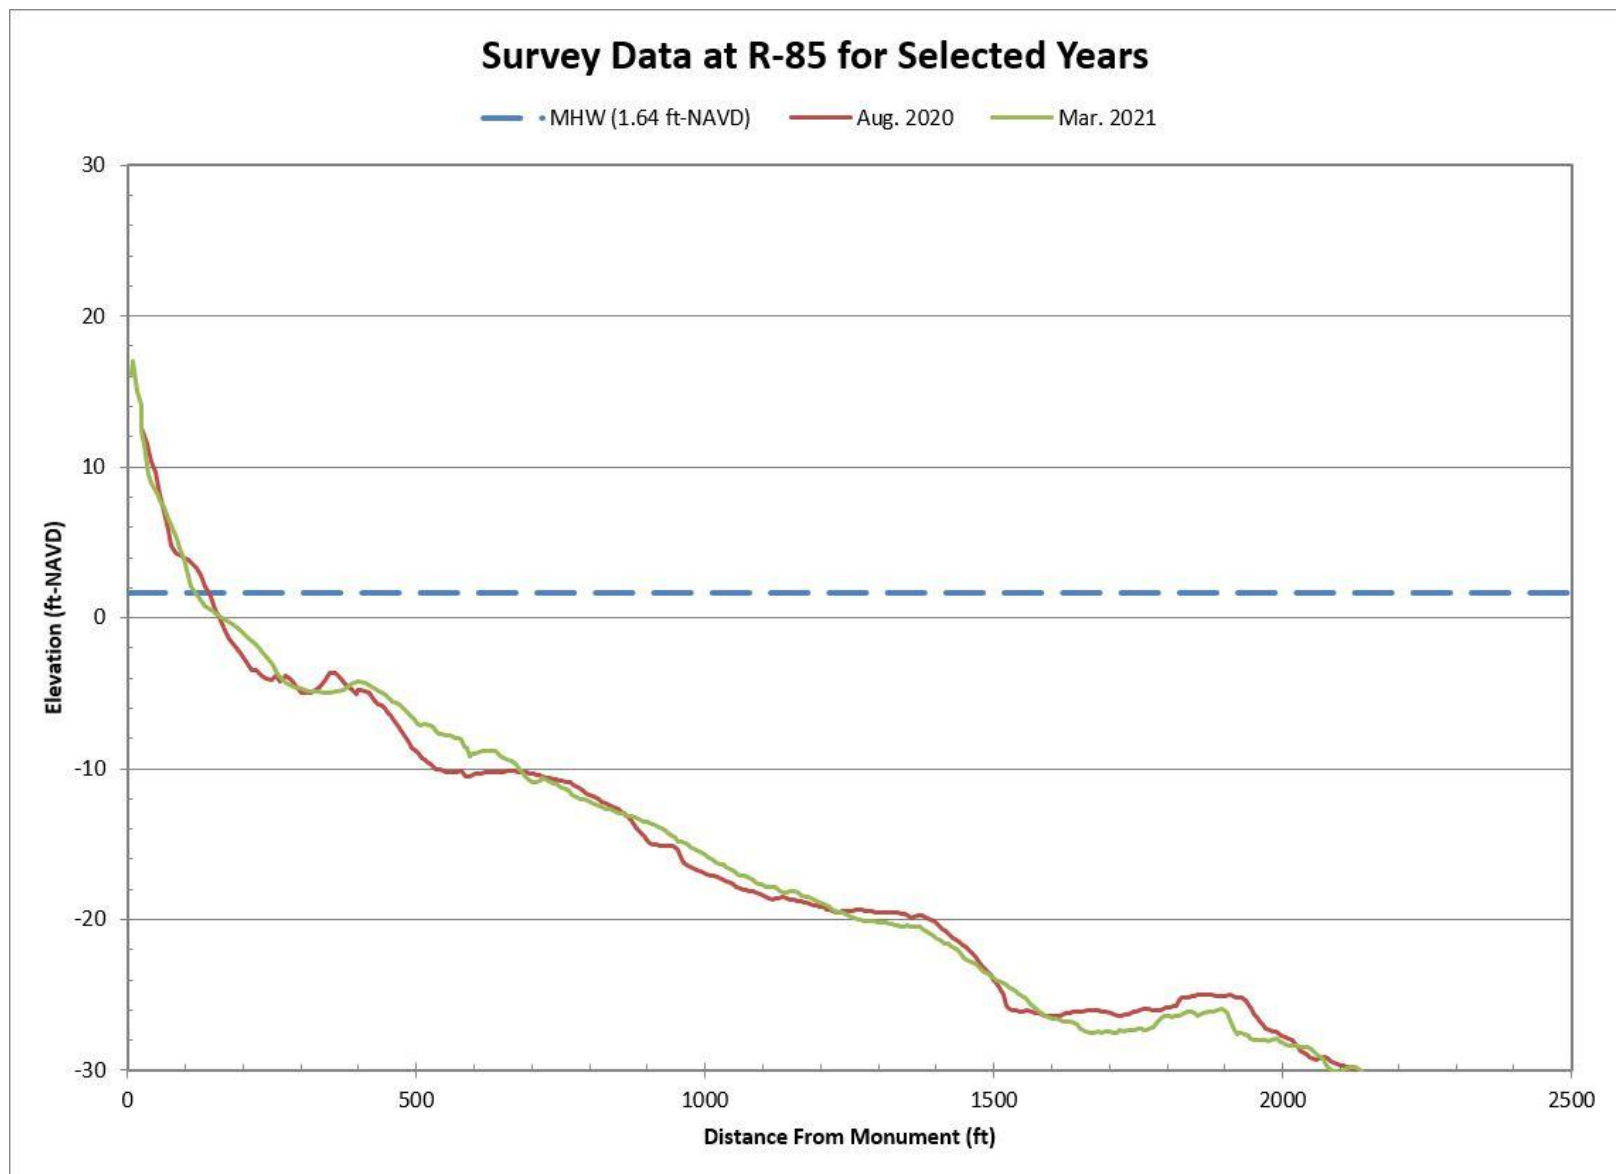
Figure B-6. Aug. 2020 Pre-Construction vs. Mar. 2021 Post-Construction Beach Profiles Along R-85

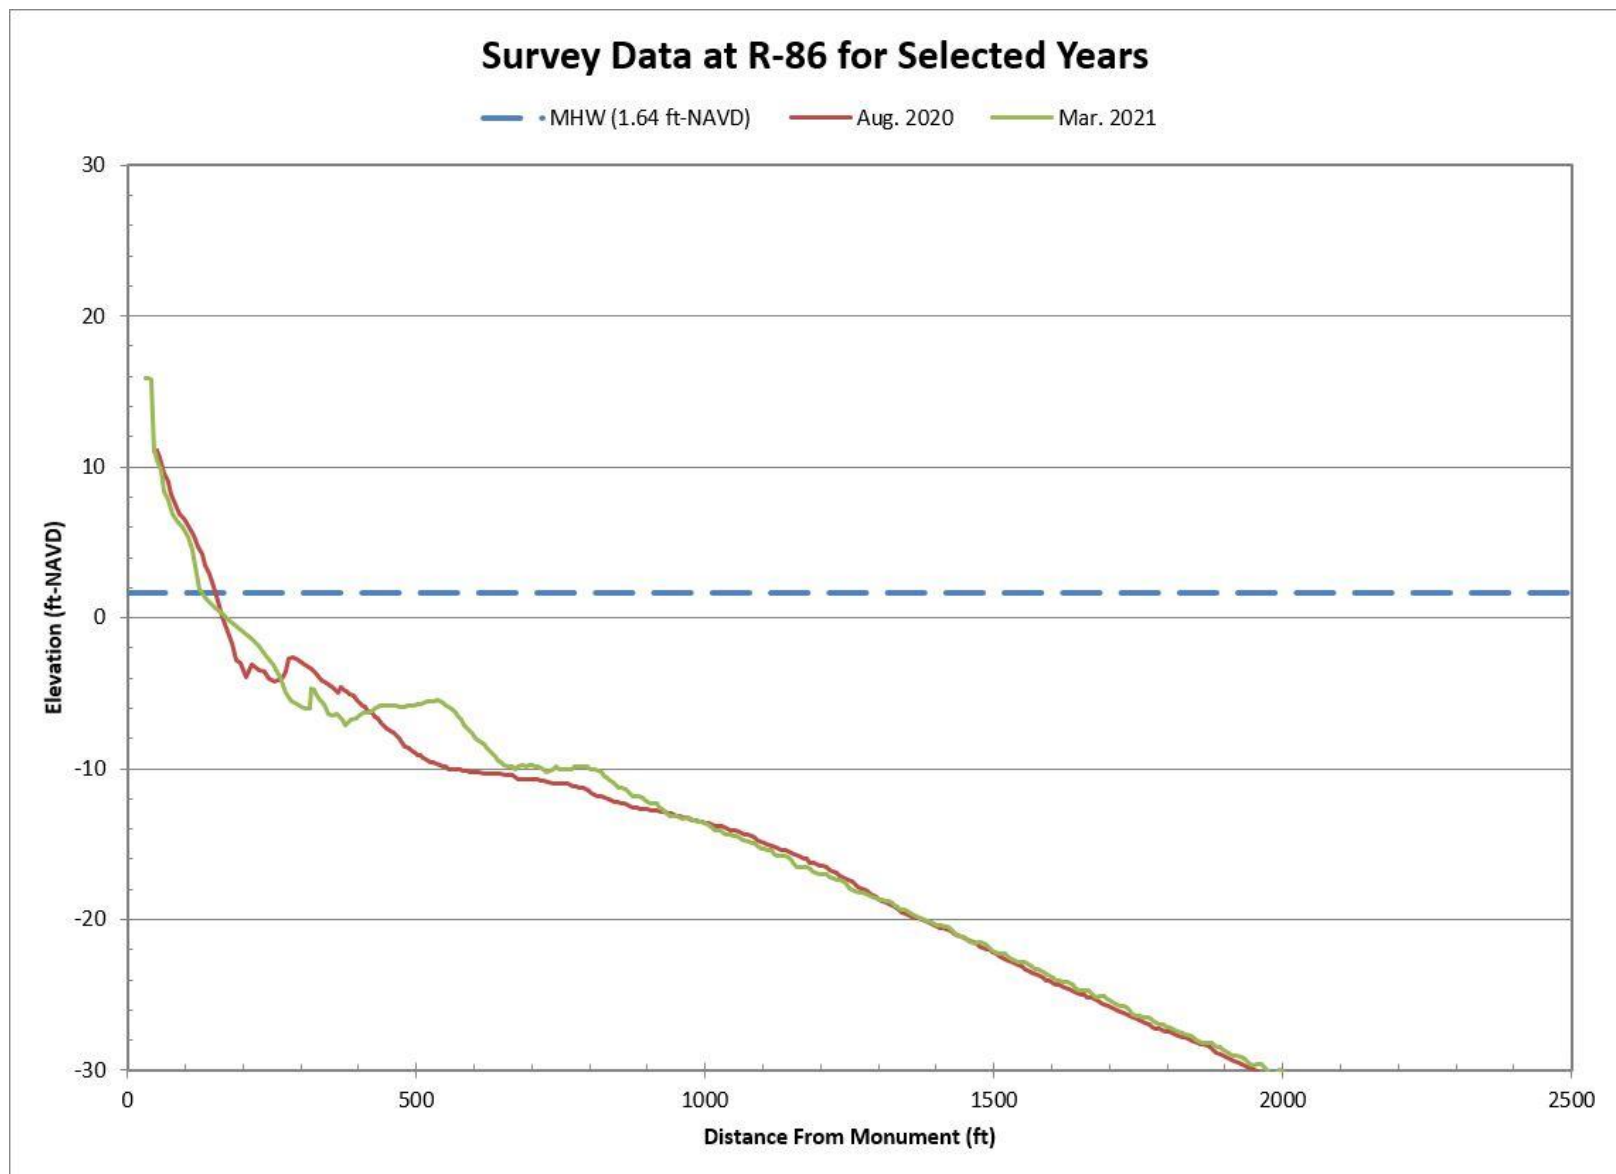
Figure B-7. Aug. 2020 Pre-Construction vs. Mar. 2021 Post-Construction Beach Profiles Along R-86

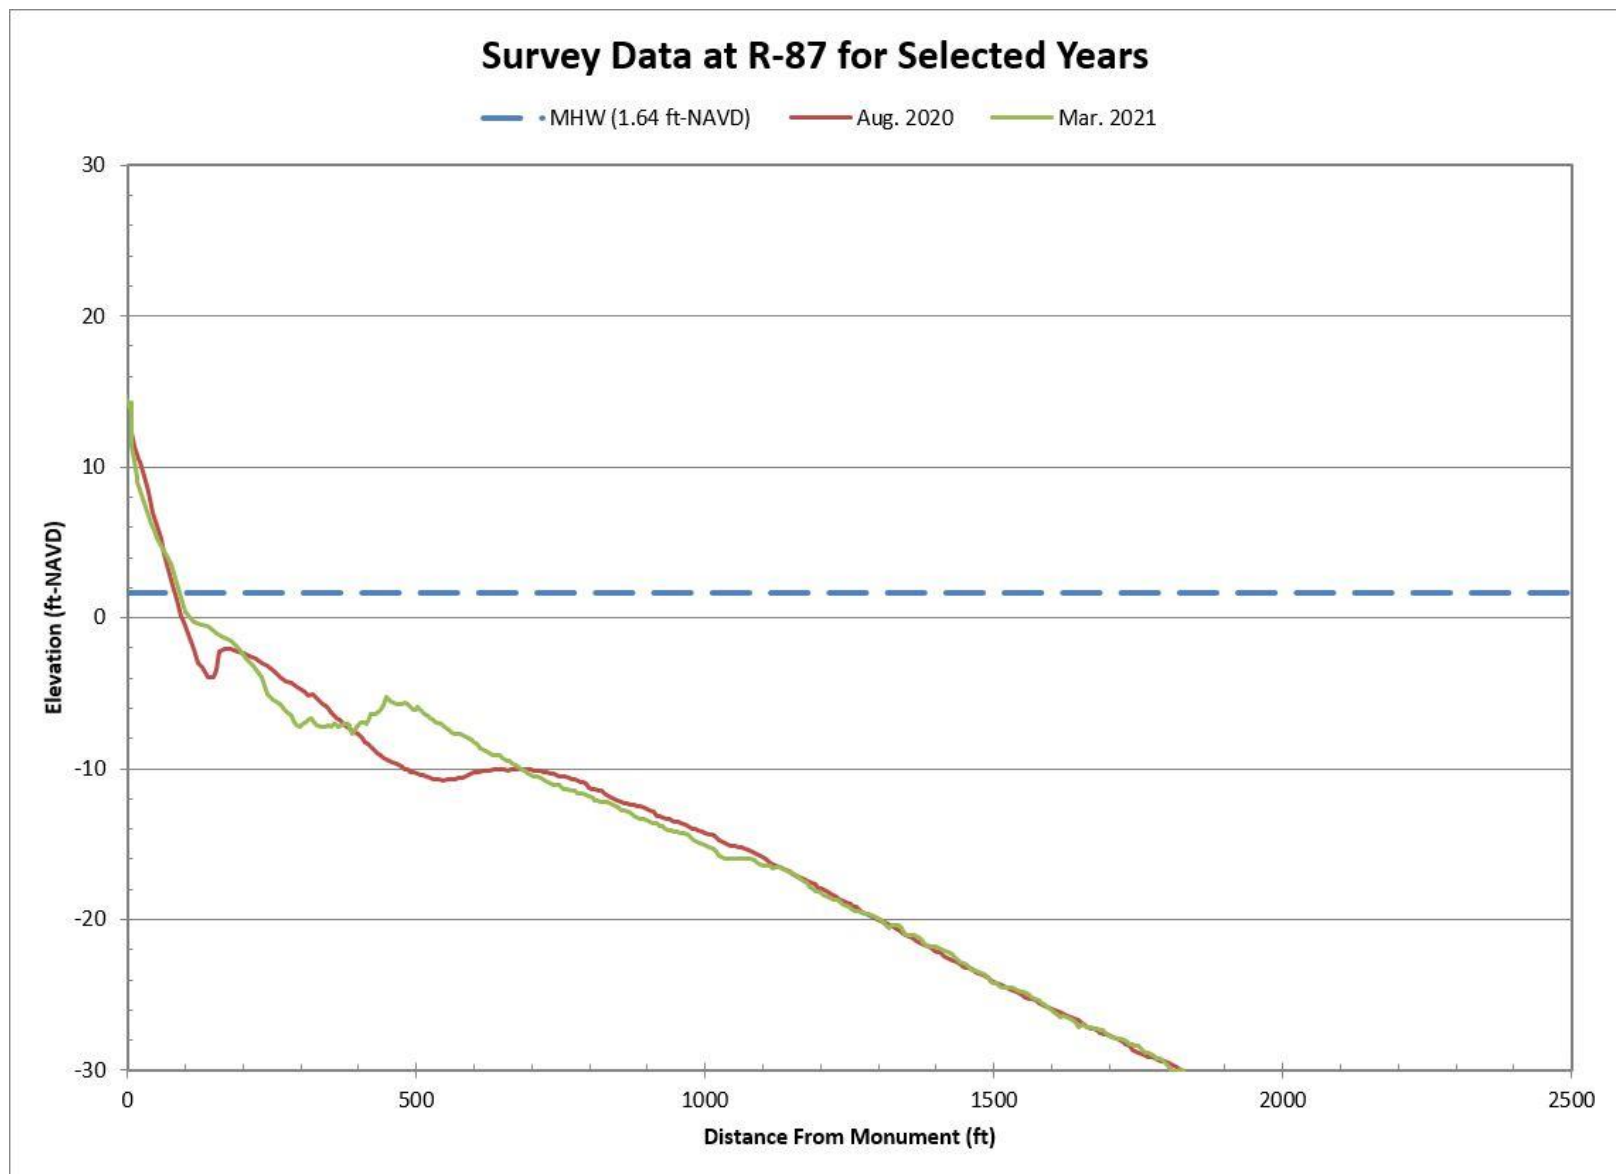
Figure B-8. Aug. 2020 Pre-Construction vs. Mar. 2021 Post-Construction Beach Profiles Along R-87

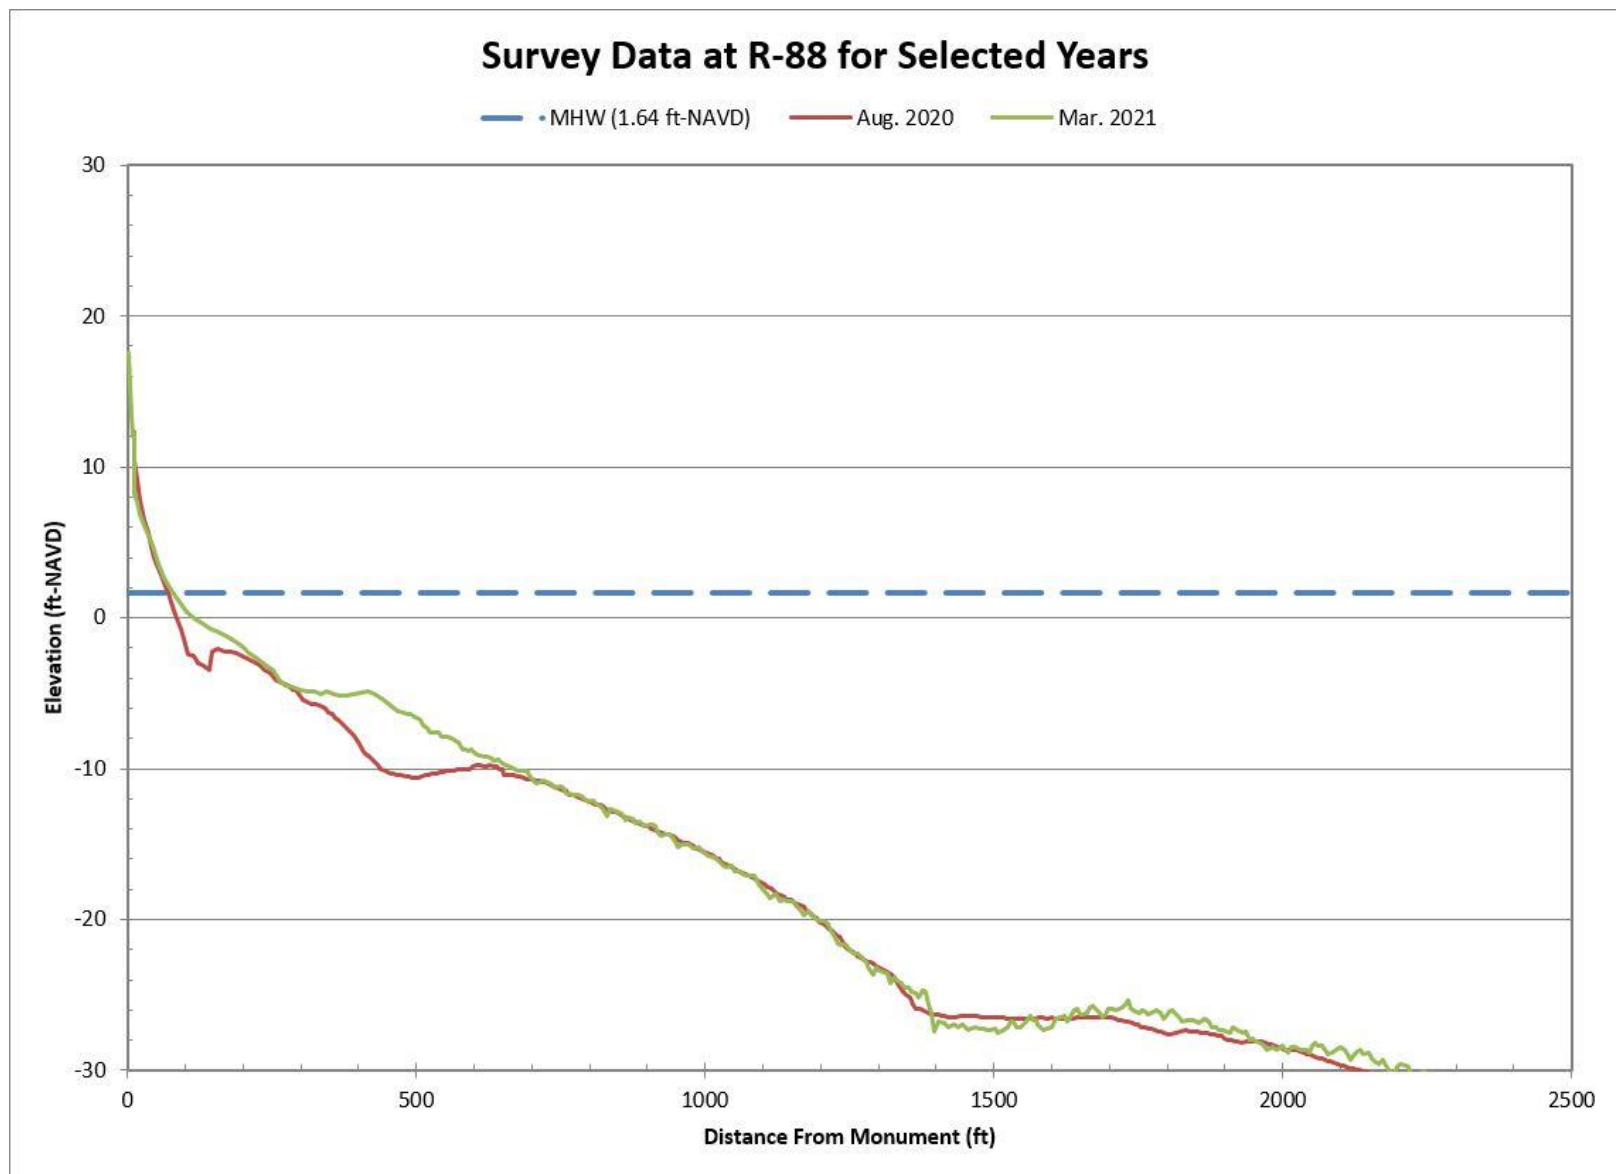
Figure B-9. Aug. 2020 Pre-Construction vs. Mar. 2021 Post-Construction Beach Profiles Along R-88

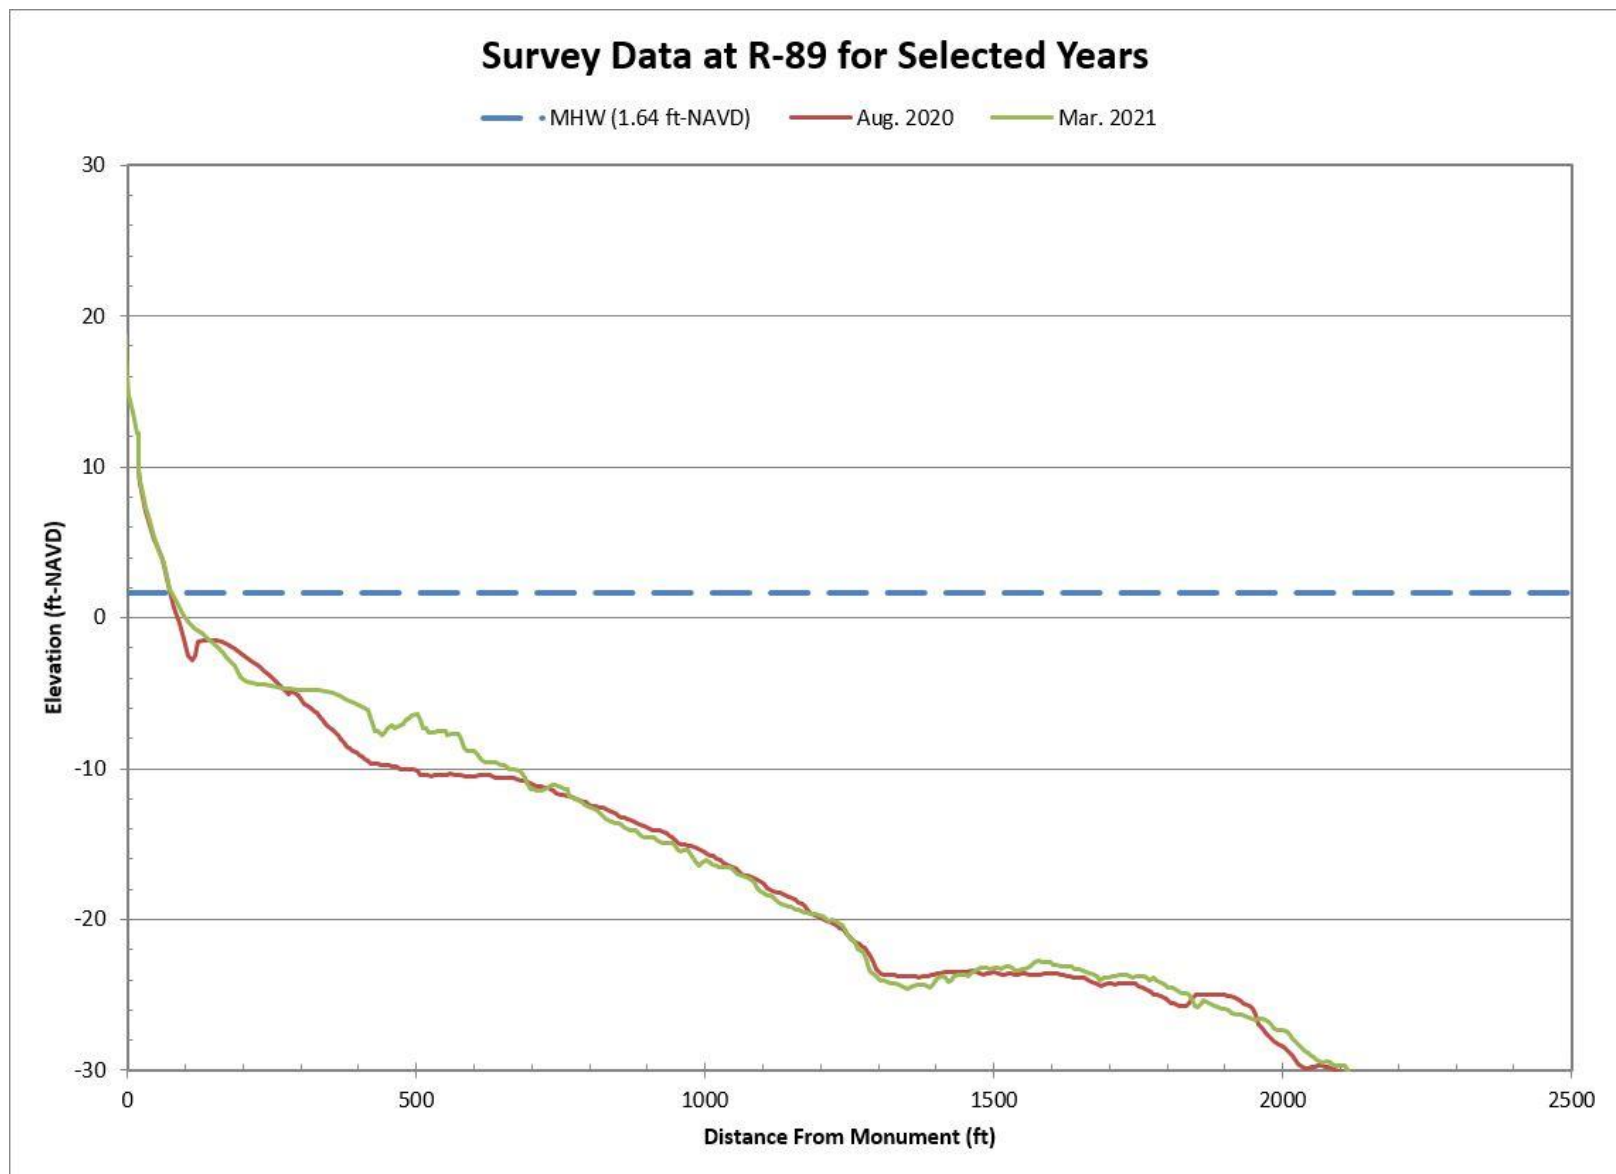
**Figure B-10. Aug. 2020 Pre-Construction vs. Mar. 2021 Post-Construction Beach Profiles Along R-89**

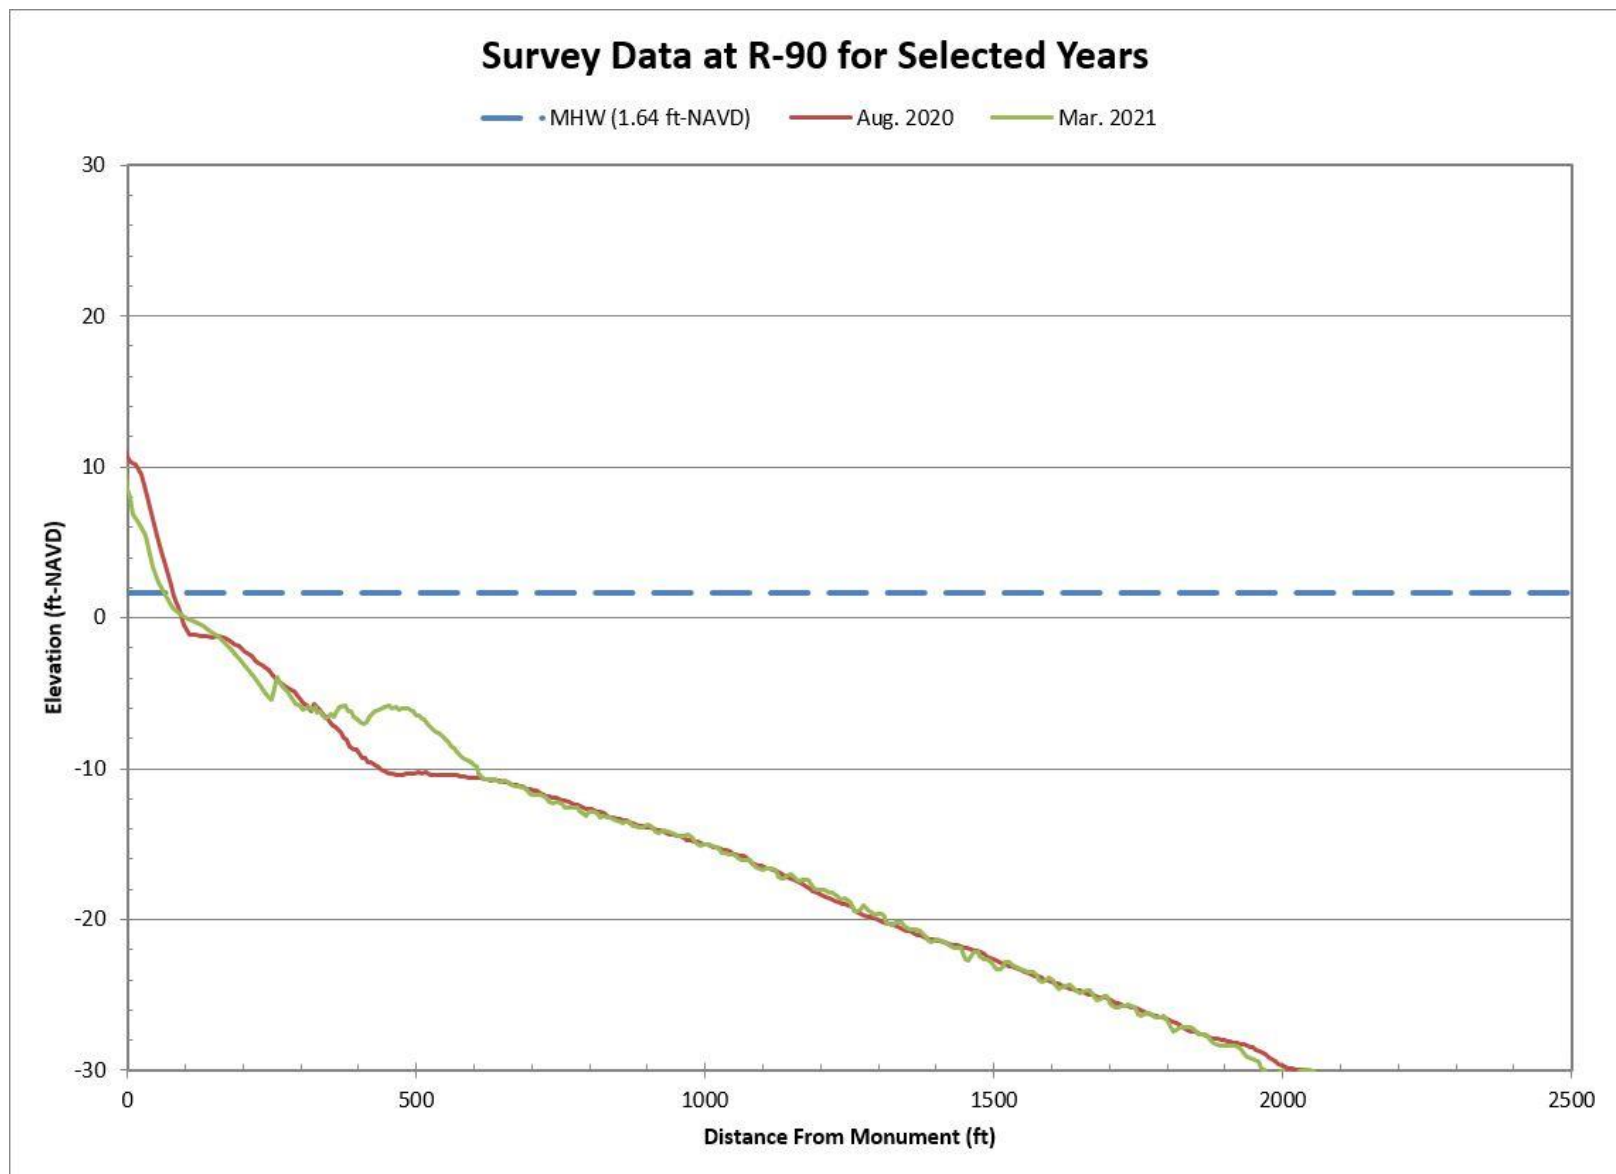
**Figure B-11. Aug. 2020 Pre-Construction vs. Mar. 2021 Post-Construction Beach Profiles Along R-90**

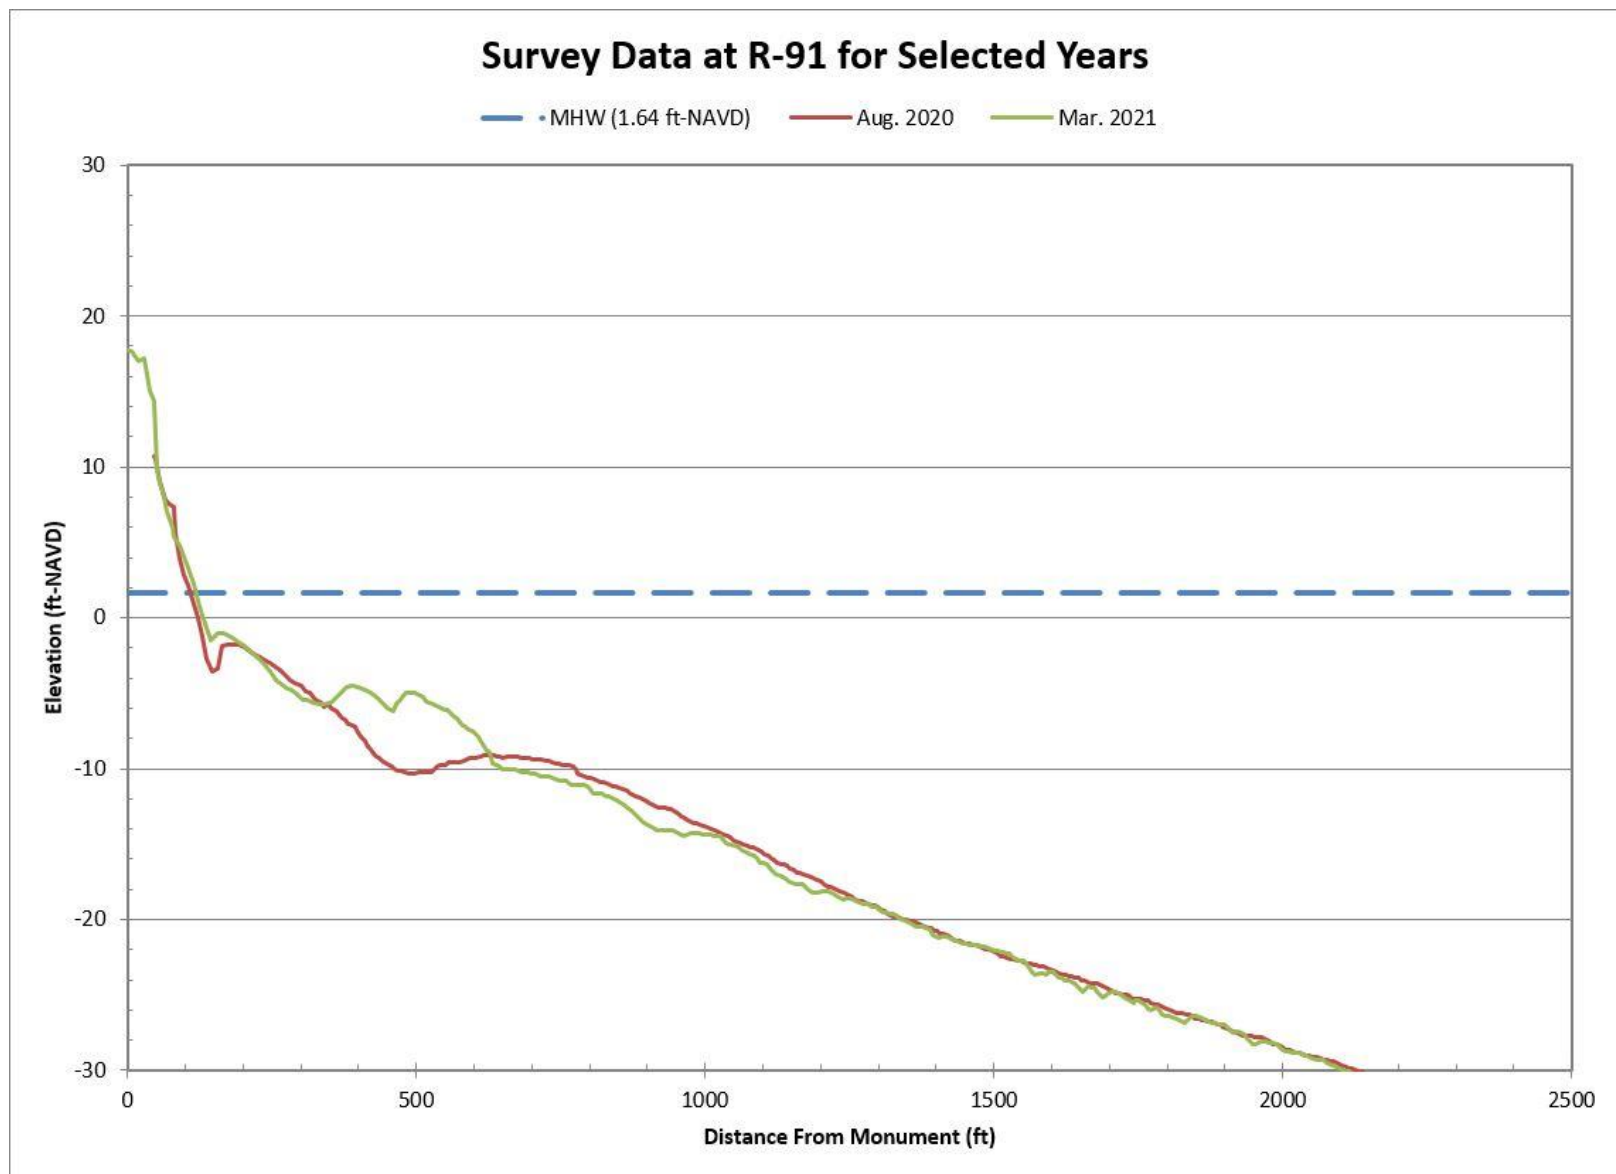
Figure B-12. Aug. 2020 Pre-Construction vs. Mar. 2021 Post-Construction Beach Profiles Along R-91
